**PHOTOGRAPHIC RECORD**  
**Fort Wainwright**

OU-3/OU-5 (Birch Hill Tank Farm)

**Safety Clearance Survey to Support the Evaluation of the Proposed  
Staging Area for the Tanana River Burial Pit Removal Action  
Project Photographs**

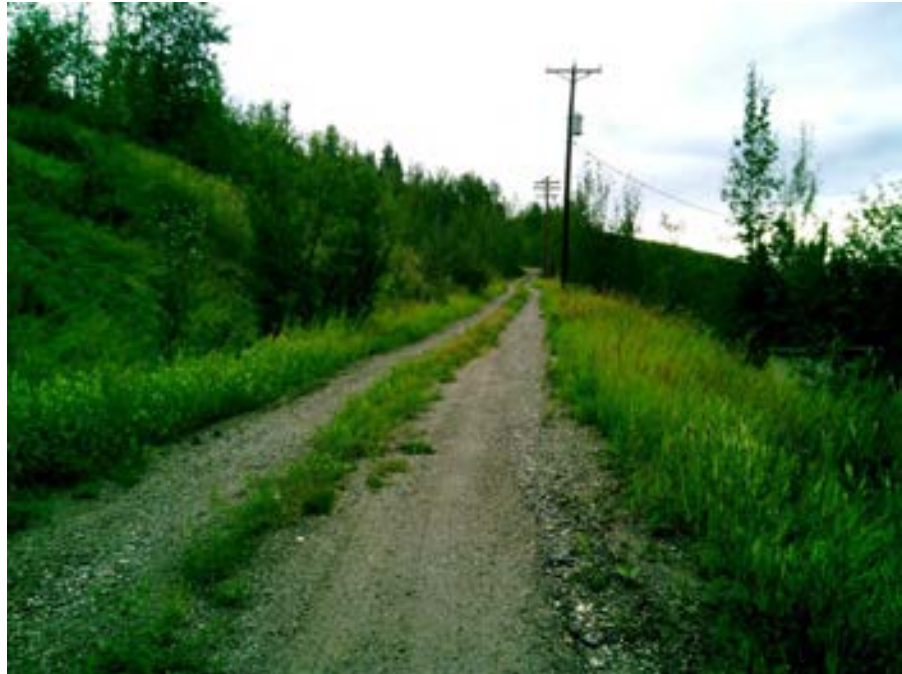
Photo No. 33  
(11-August-2015)

View looking east  
up the Birch Hill  
Tank Farm access  
road.

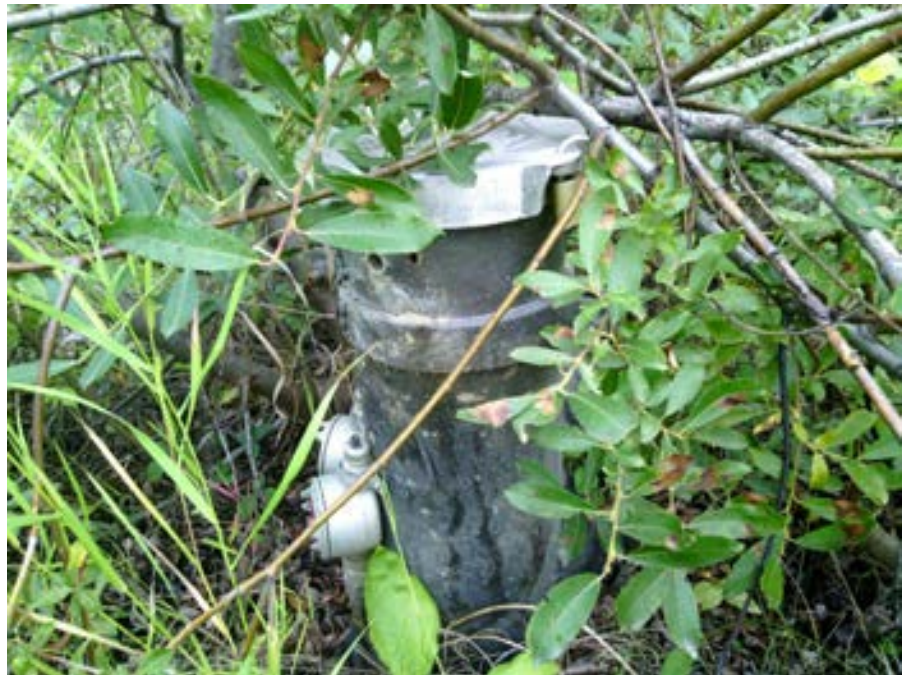
Photo No. 34  
(11-August-2015)

View of  
underground fuel  
piping access  
along the access  
road to the Birch  
Hill Tank Farm.

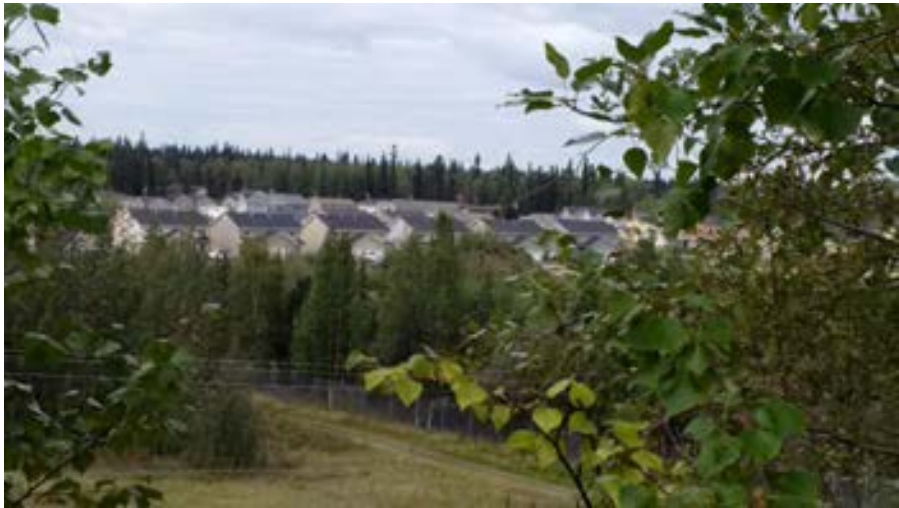
PHOTOGRAPHIC RECORD Fort Wainwright	
OU-3/OU-5 Birch Hill Tank Farm	
Photo No. 37 (11-August-2015)

<u>Description:</u>  View of off-site residential units from Birch Hill.	
Photo No. 38 (11-August-2015)

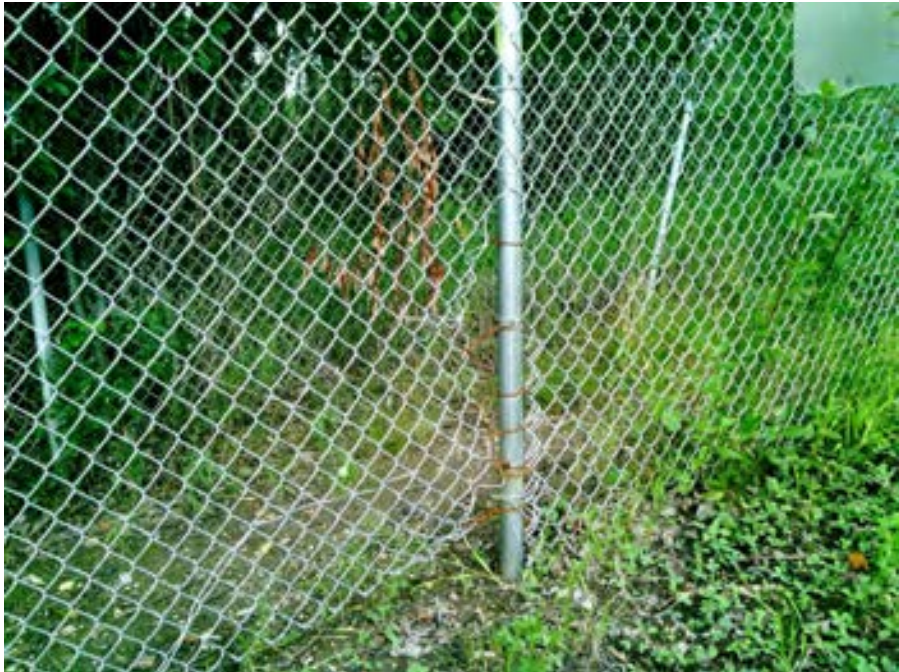
<u>Description:</u>  View of repaired fence at the Birch Hill Tank Farm.

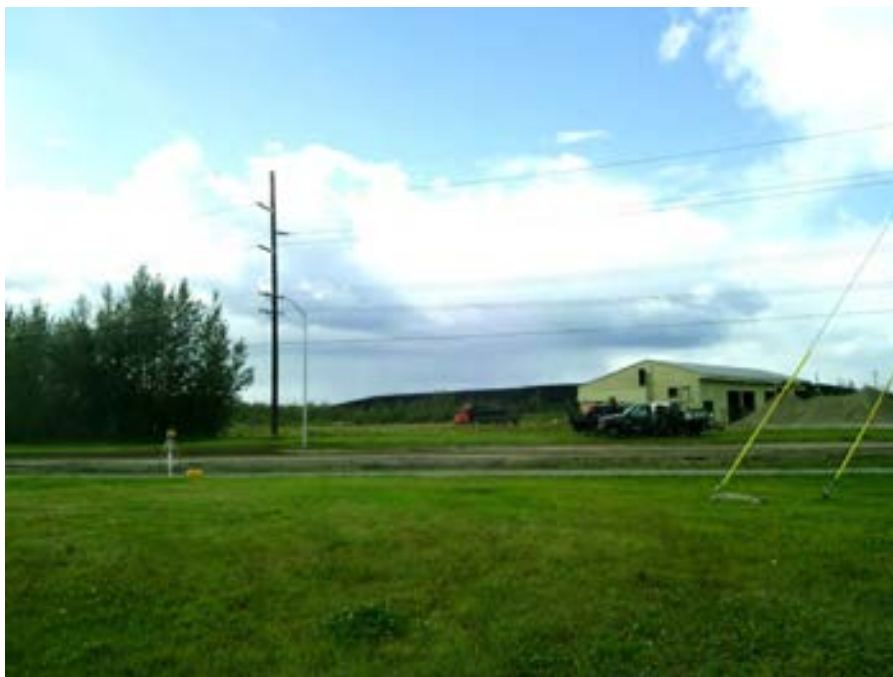
Photo No. 41  
(11-August-2015)

View looking  
west across to the  
Coal Storage  
Yard.

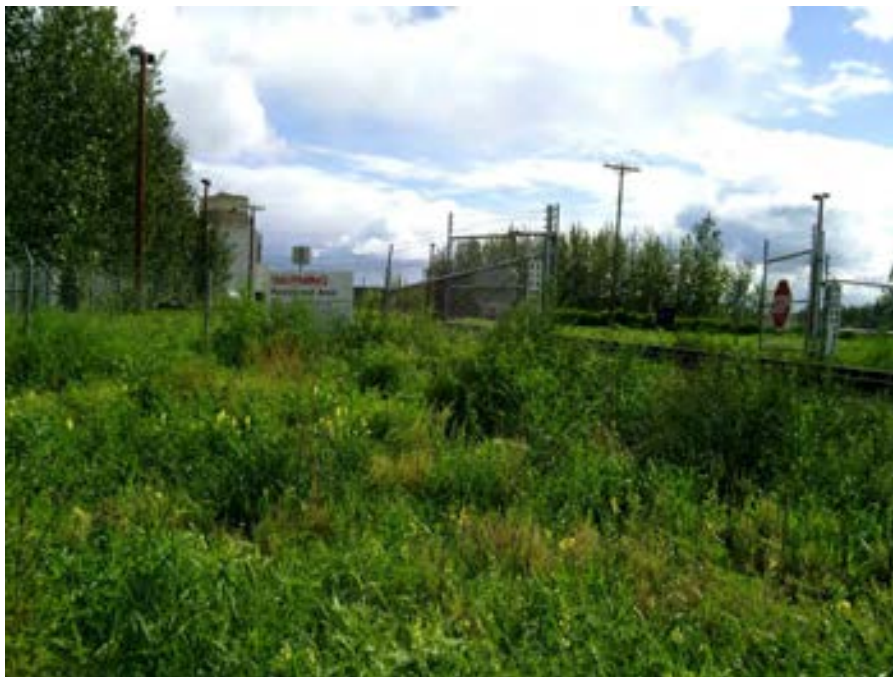
Photo No. 42  
(11-August-2015)

View looking  
south at access  
fencing and signs  
at the Coal  
Storage Yard.

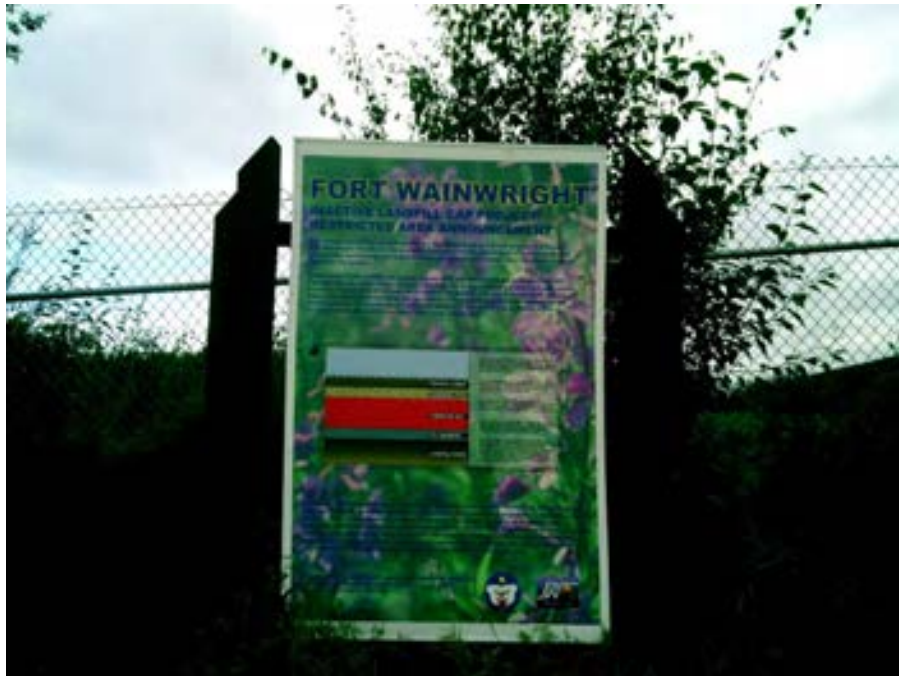
<b>PHOTOGRAPHIC RECORD</b> <b>Fort Wainwright</b>	
OU-4	
<p>Photo No. 43 (11-August-2015)</p> <p><u>Description:</u></p> <p>View of the informational sign posted outside the Landfill.</p>

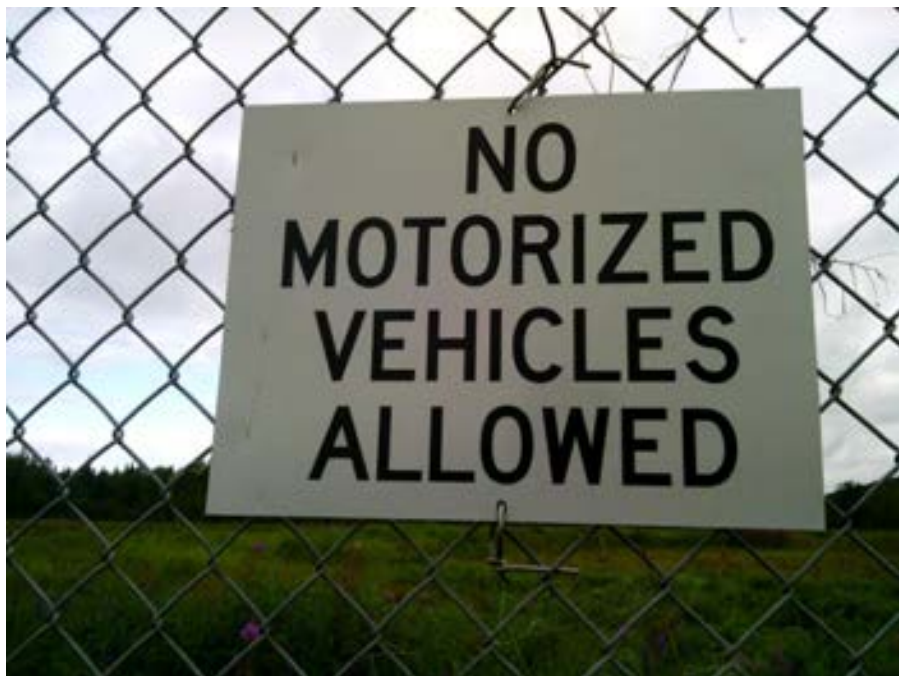
<p>Photo No. 44 (11-August-2015)</p> <p><u>Description:</u></p> <p>View of an access control sign outside the Landfill.</p>

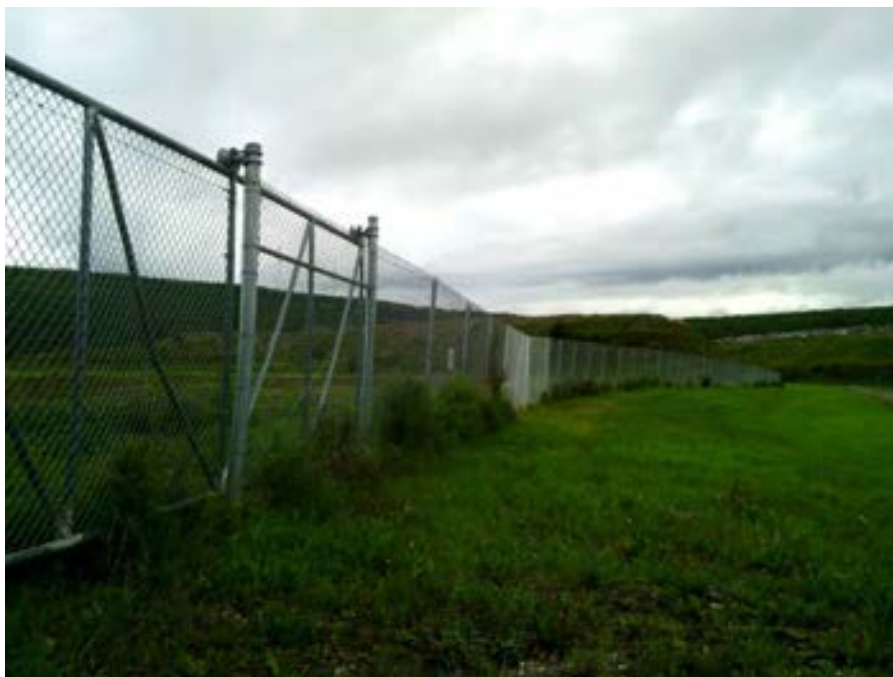
Photo No. 45  
(11-August-2015)

View looking  
northeast along  
the Landfill  
fencing.

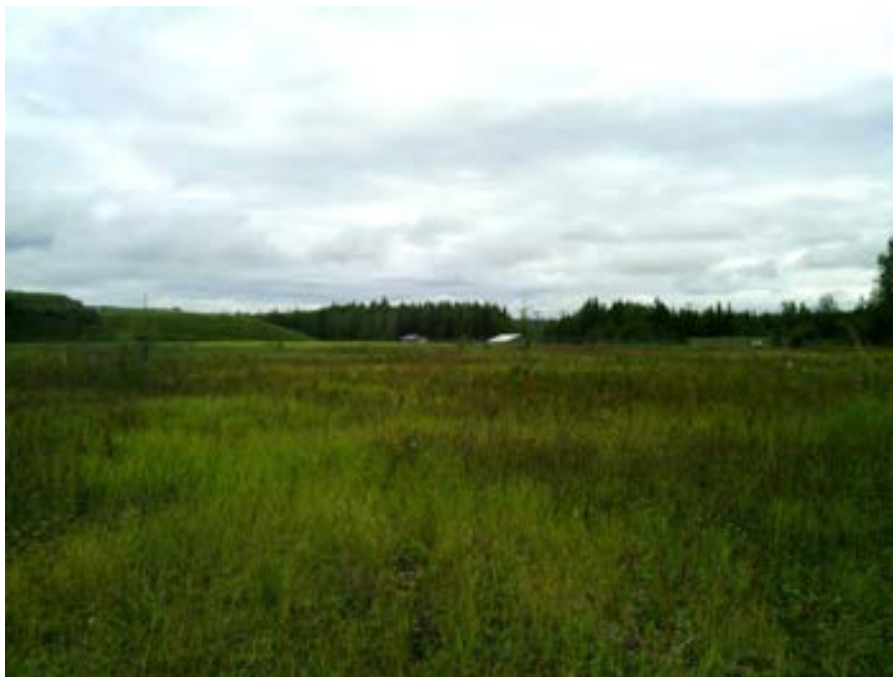
Photo No. 46  
(11-August-2015)

View looking east  
across the Landfill  
cap.

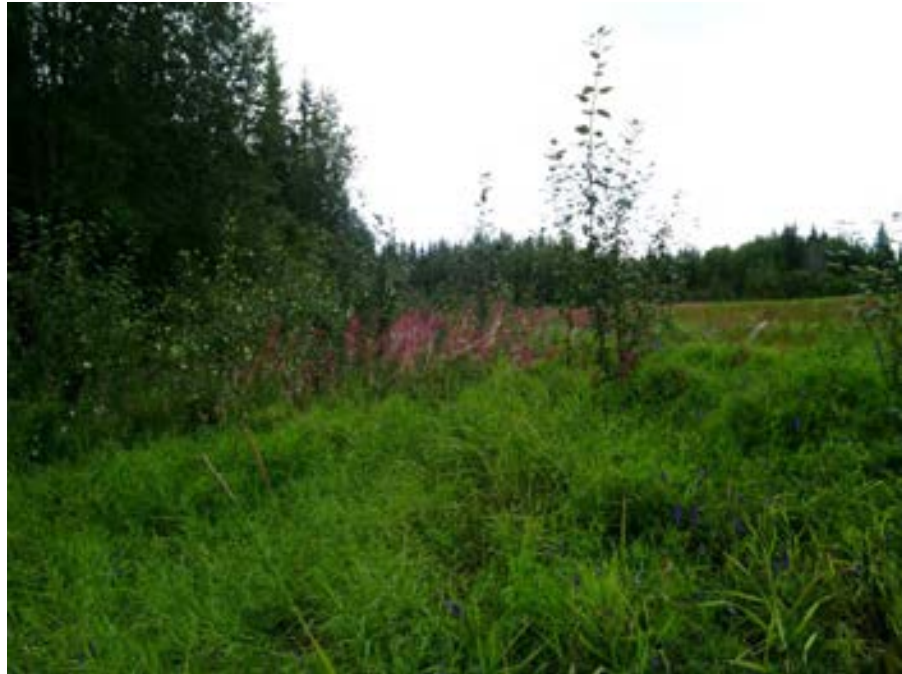
Photo No. 47  
(11-August-2015)

View of tree growth on the southeastern portion of the Landfill.

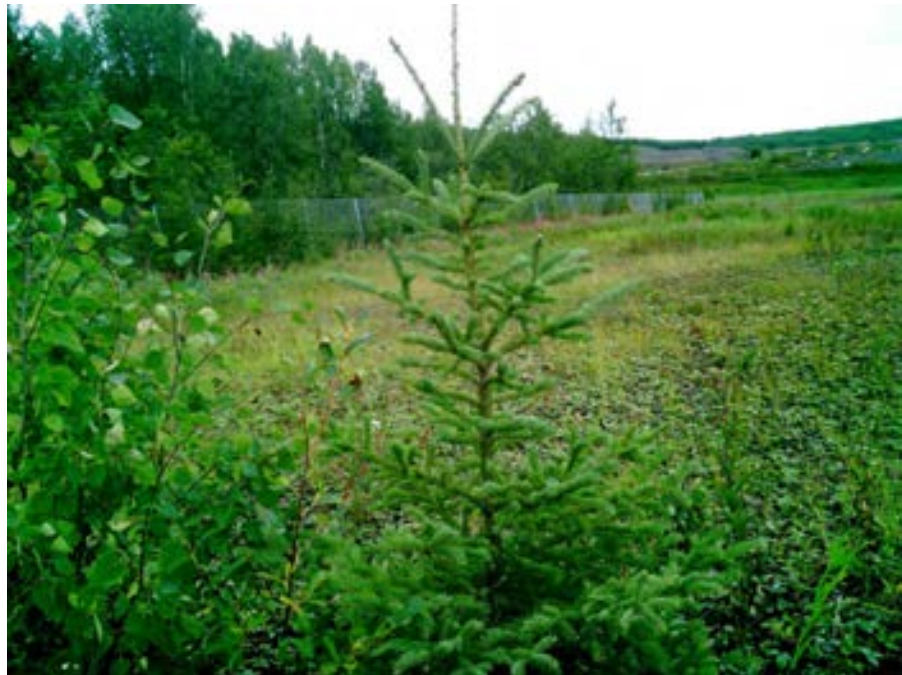
Photo No. 48  
(11-August-2015)

View of tree growth on western portion of the Landfill cap.

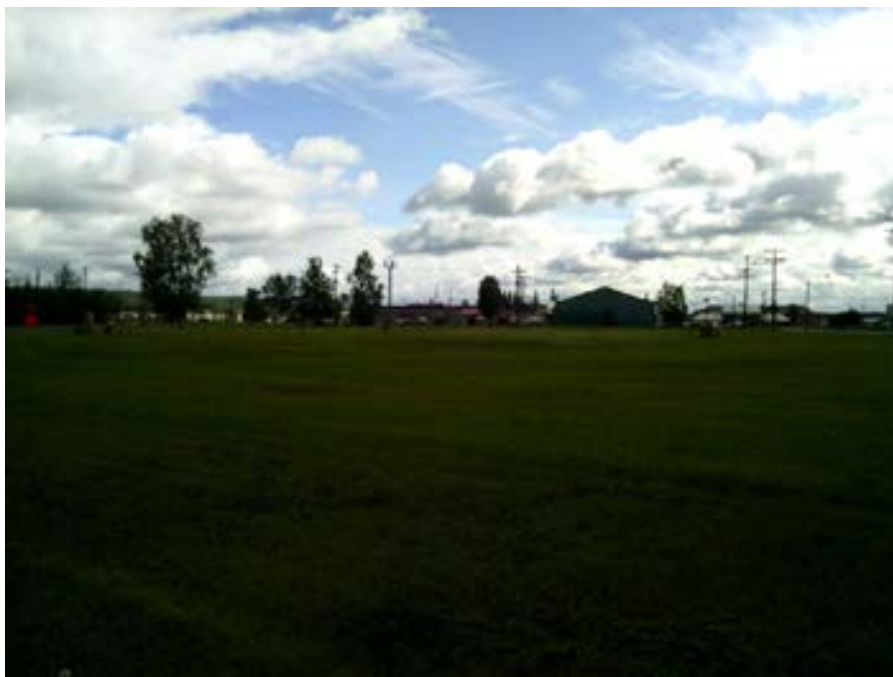
Photo No. 49  
(11-August-2015)

View looking east  
across the EQFS.

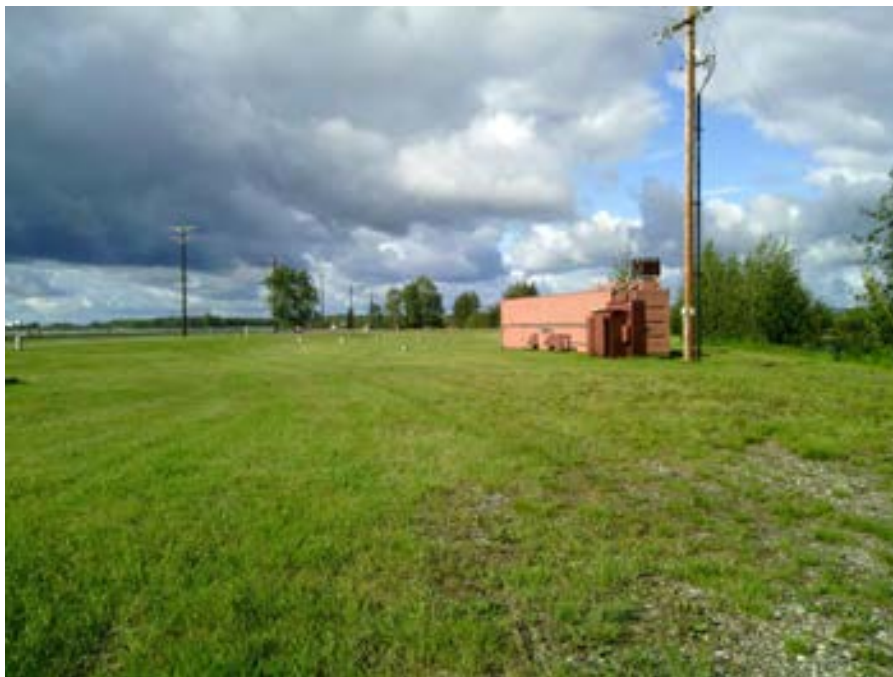
Photo No. 50  
(11-August-2015)

View looking  
west across the  
WQFS former  
remediation  
system.

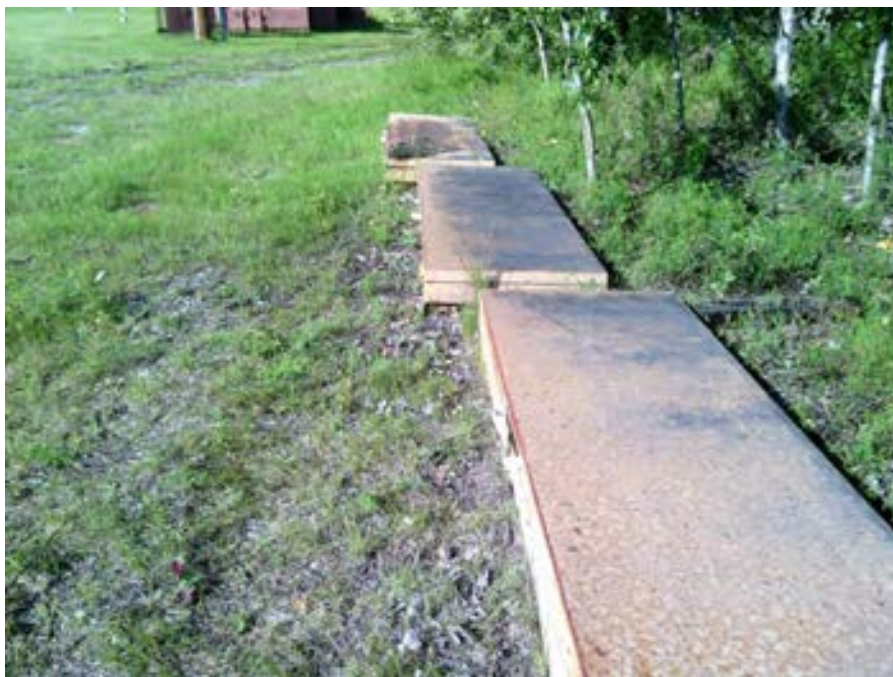
Photo No. 51  
(11-August-2015)

View looking  
west across the  
former injection  
banks on WQFS.

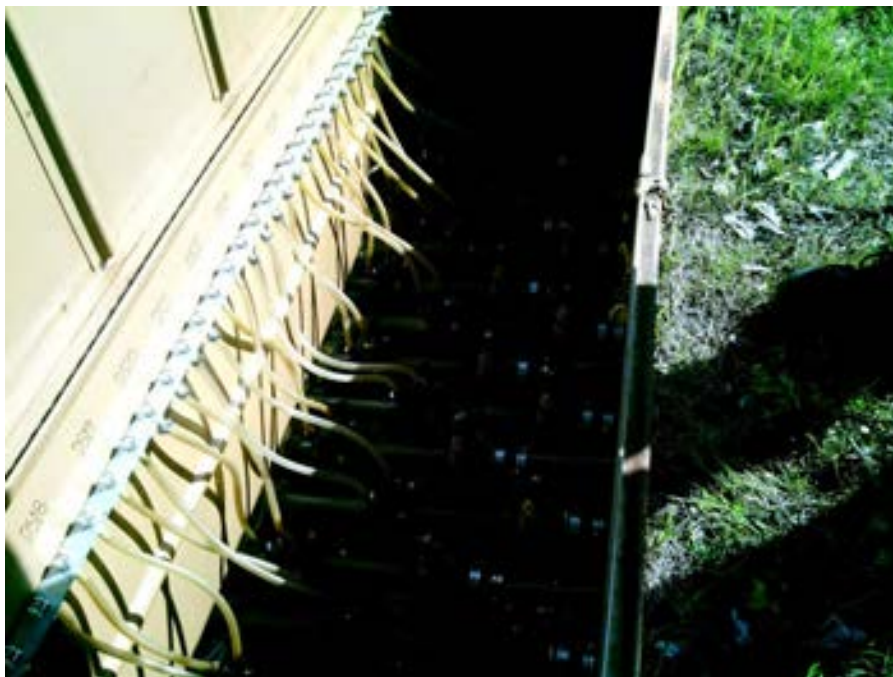
Photo No. 52  
(11-August-2015)

View of the  
interior of an  
injection bank on  
WQFS.

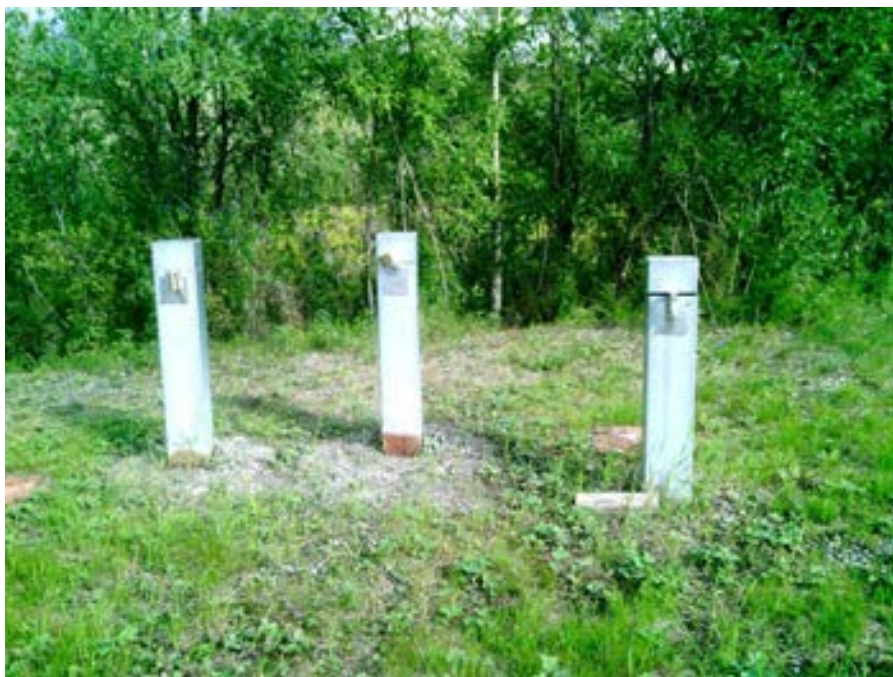
Photo No. 53  
(11-August-2015)

View of typical  
monitoring wells  
at WQFS.

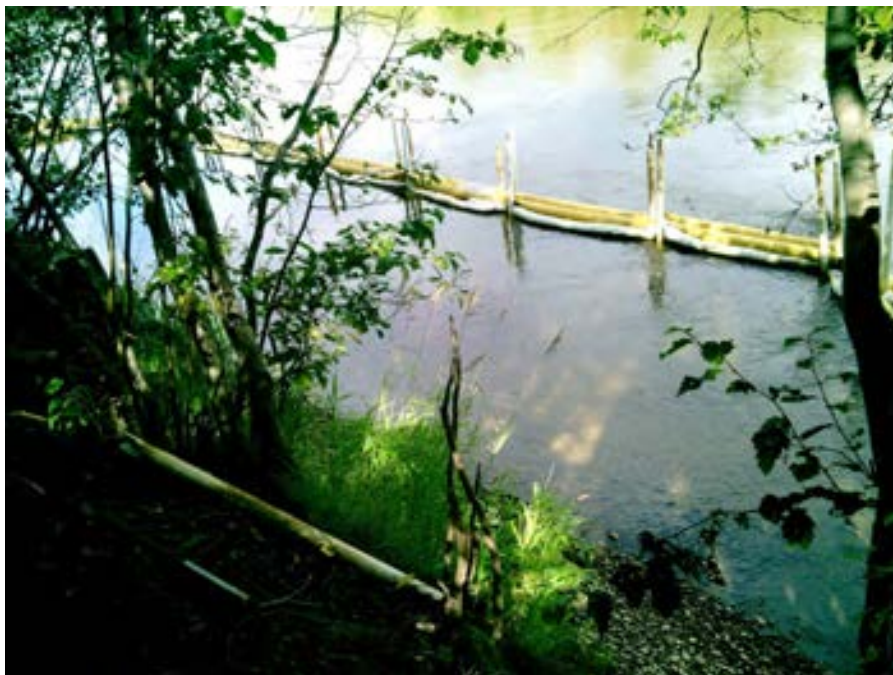
Photo No. 54  
(11-August-2015)

View of the boom  
in the Chena  
River at WQFS.

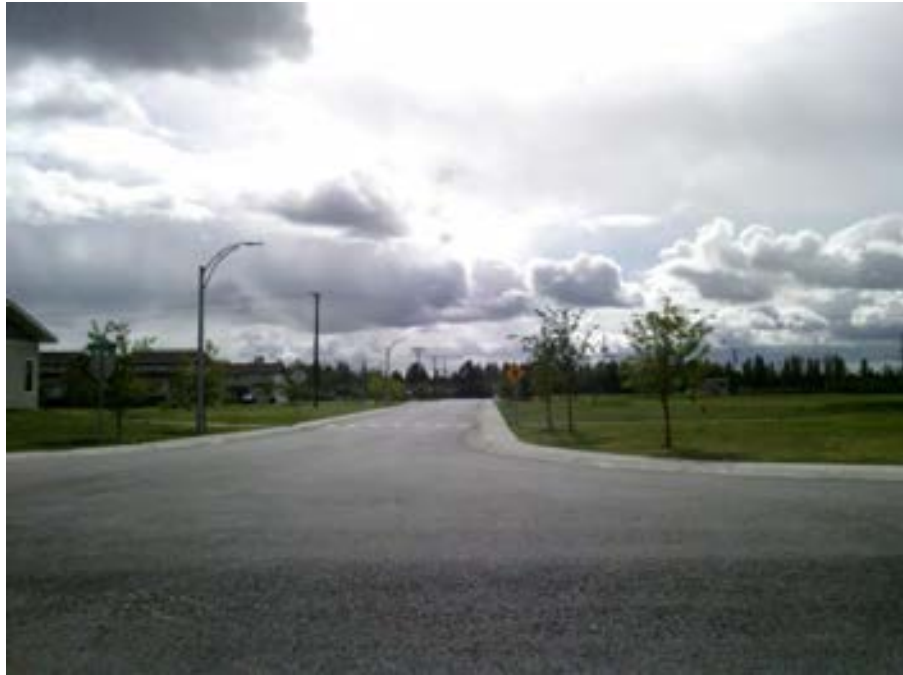
Photo No. 55  
(11-August-2015)

View looking  
south down  
Linden Avenue  
from Scapberry  
Loop.

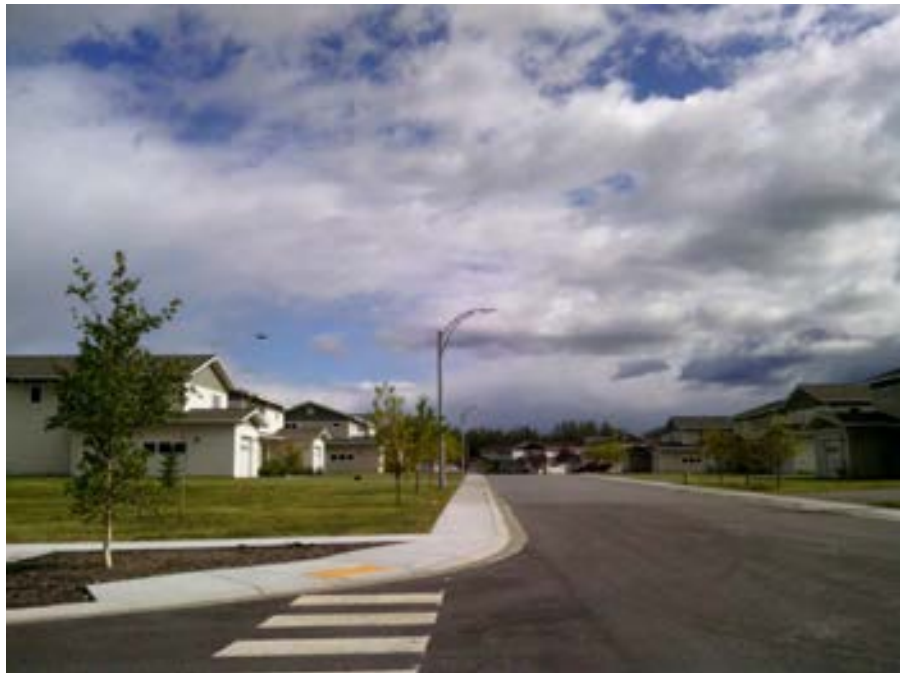
Photo No. 56  
(11-August-2015)

Typical view of  
housing looking  
east down  
Scapberry Loop.

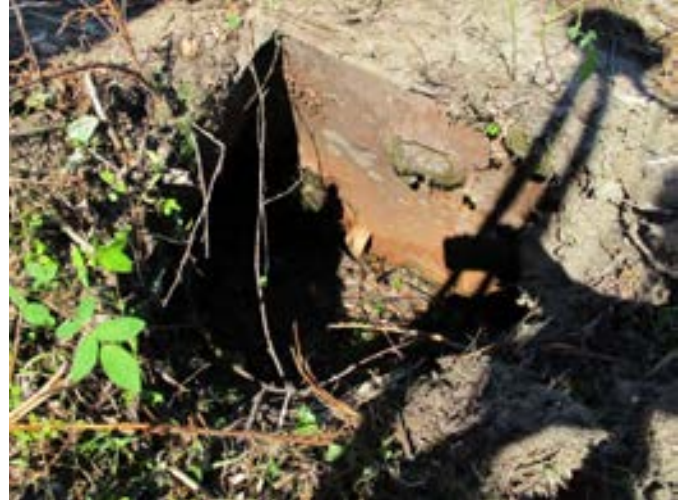
10) Surface/subsurface object identified as a target that yielded the highest response in the survey area.

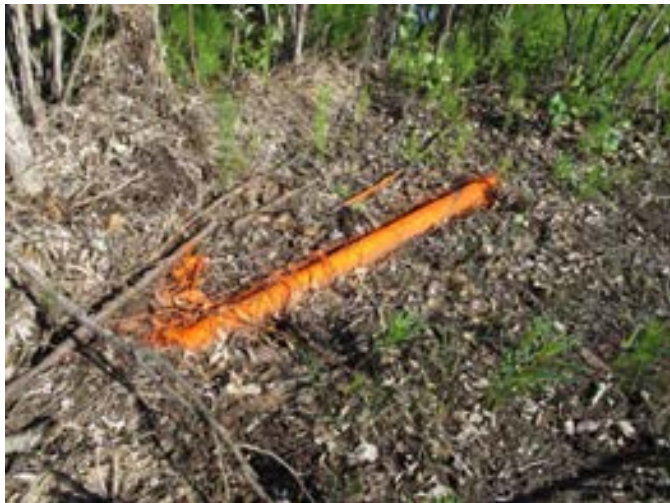
8) Surface metal debris located within study area.

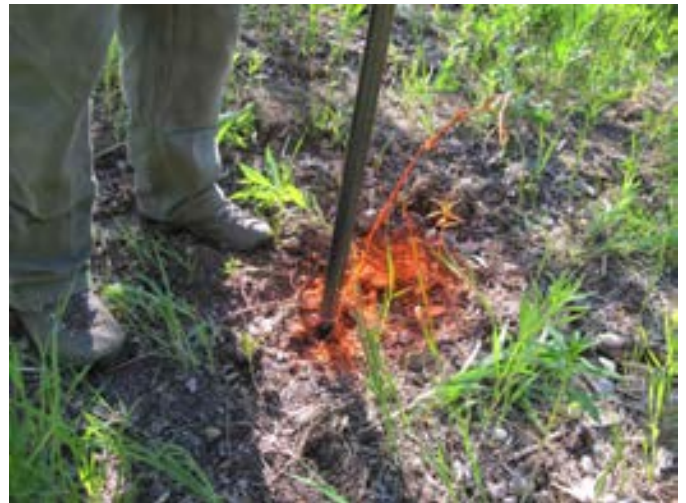
11) Buried and exposed razor wire within study area.

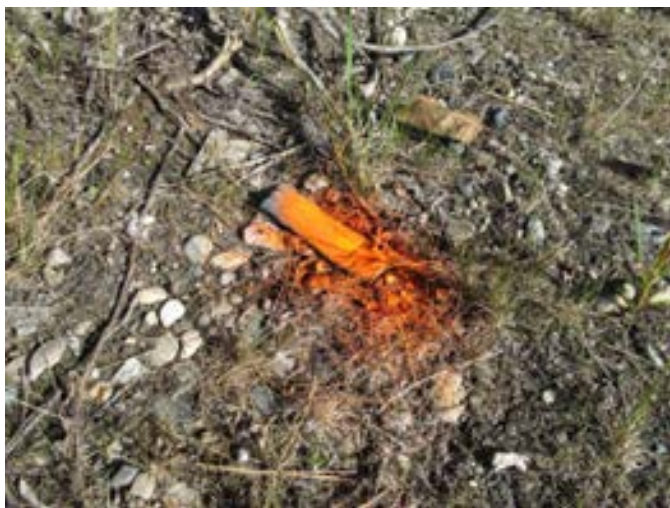
9) Surface metal debris located within study area.
