**PHOTOGRAPHIC RECORD  
Fort Wainwright**

OU-1

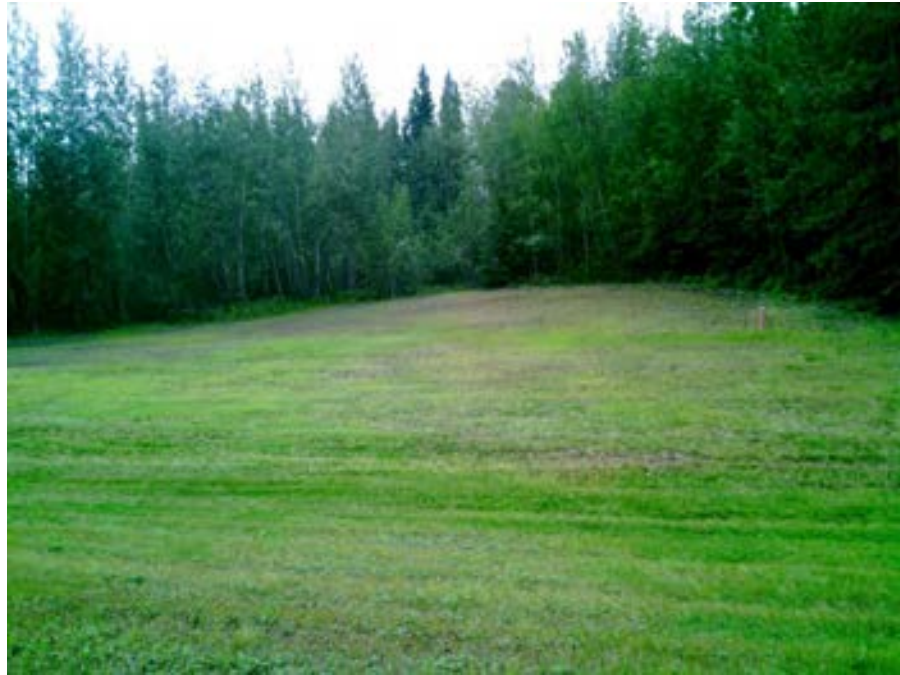
Photo No. 1  
(11-August-2015)

View looking east across the western portion of the 801 Drum Burial Site from River Road. Note monitoring well AP-6631.

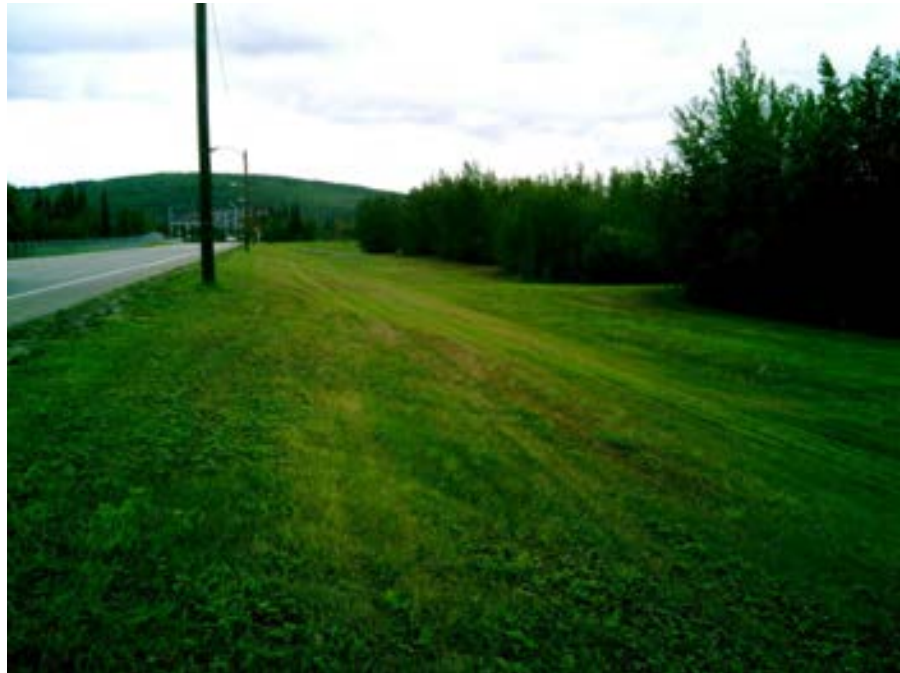
Photo No. 2  
(11-August-2015)

View looking north across the western portion of the 801 Drum Burial Site and River Road.

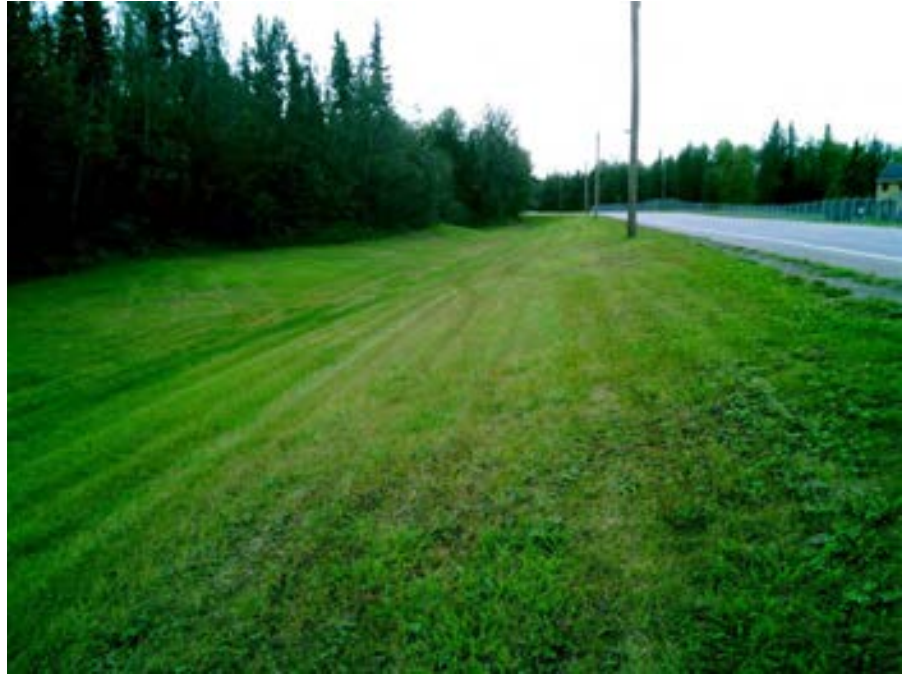
Photo No. 3  
(11-August-2015)

Description:  
View looking south across the western portion of the 801 Drum Burial Site and River Road.

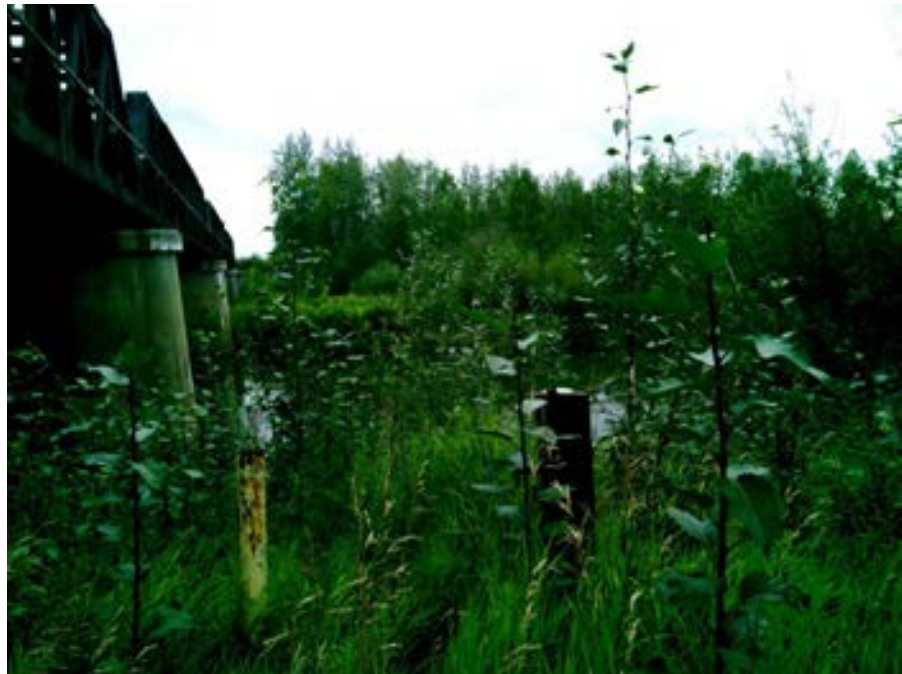
Photo No. 4  
(11-August-2015)

Description:  
View looking east at the Chena River from the northern portion of the 801 Drum Burial Site. Note monitoring well AP-6065 associated with OU-3 Valve Pit A.

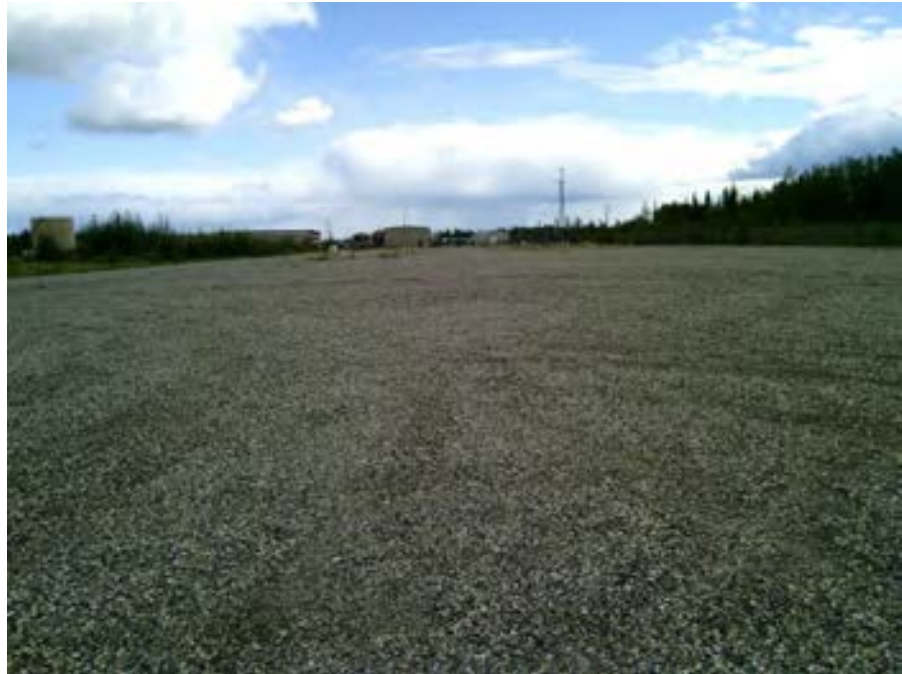
Photo No. 5  
(11-August-2015)

View looking east  
across DRMO  
Salvage Yards 4  
and 5.

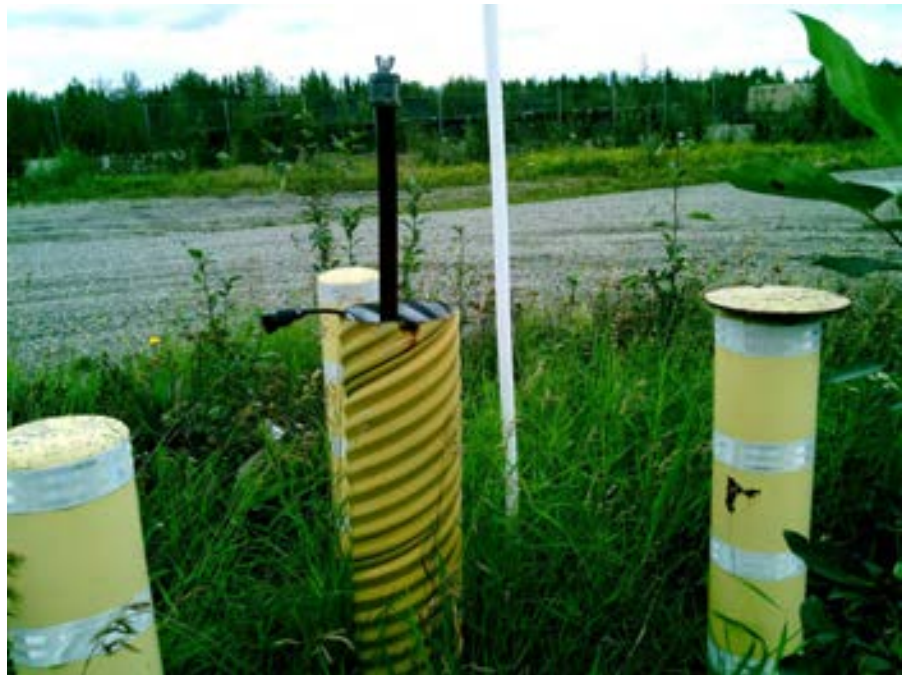
Photo No. 6  
(11-August-2015)

Example of a  
“frost jacked”  
probe at DRMO 5  
(Probe D, not  
included in the  
2014 sampling  
event).

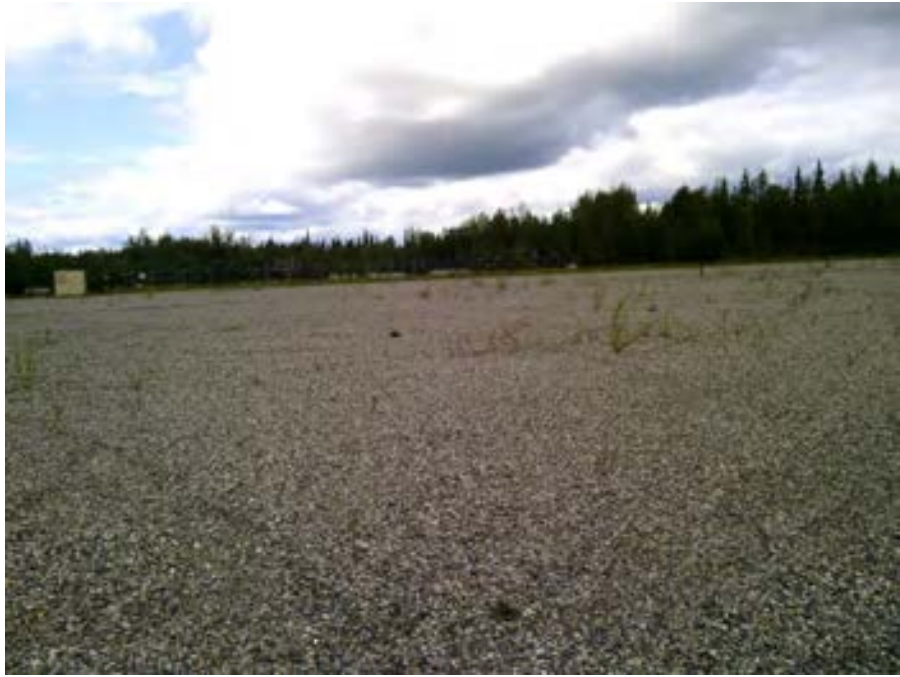
Photo No. 7  
(11-August-2015)

View looking  
north across  
DRMO Salvage  
Yard 1.

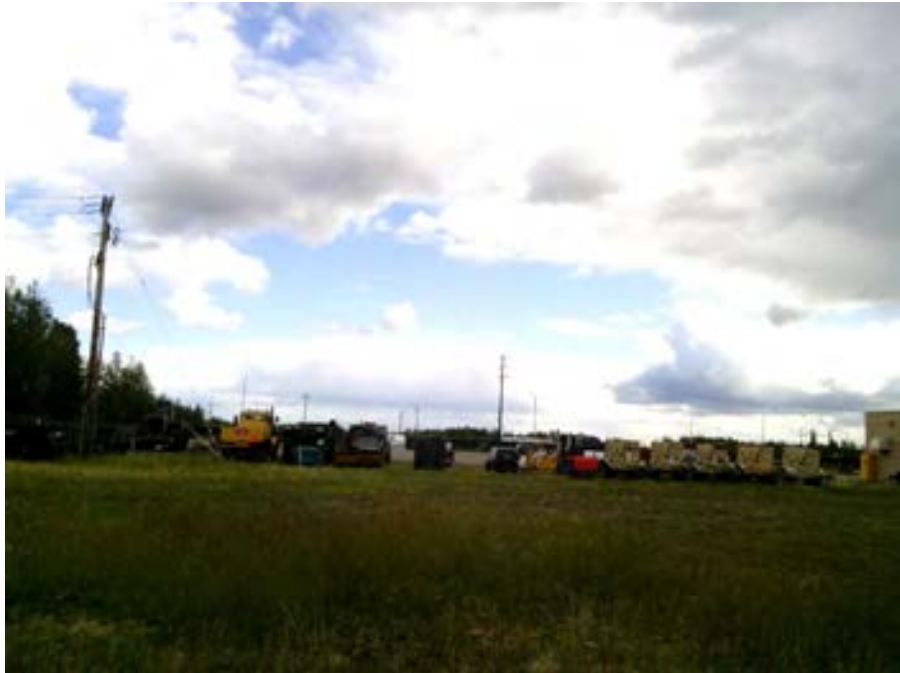
Photo No. 8  
(11-August-2015)

View looking east  
across DRMO  
Salvage Yards 1  
and 2.

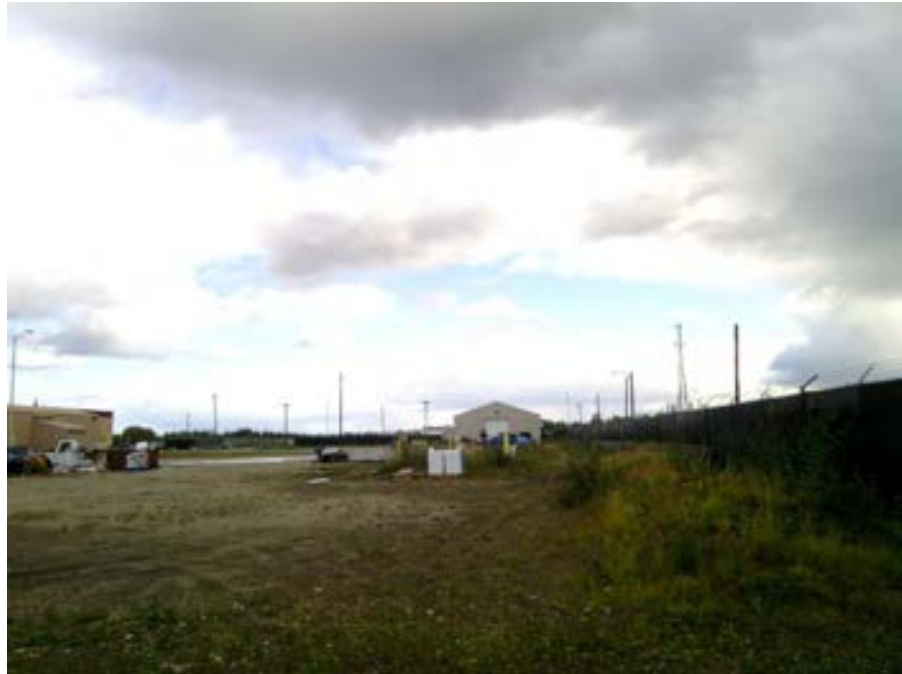
Photo No. 9  
(11-August-2015)

View looking east  
across DRMO  
Salvage Yard 3.

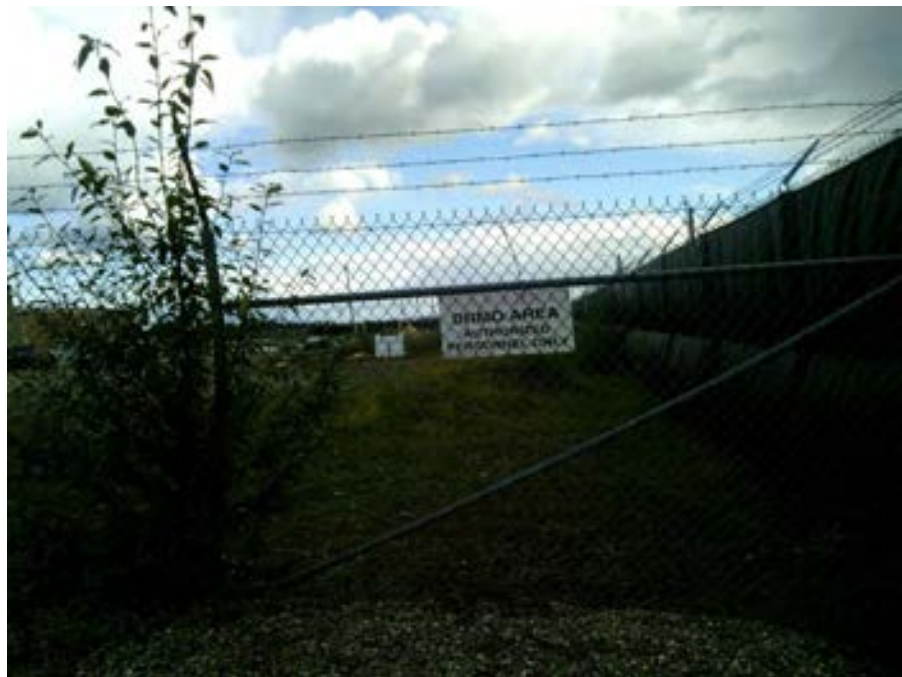
Photo No. 10  
(11-August-2015)

View of typical  
fencing and a sign  
at the OU-2  
DRMO Salvage  
Yard.

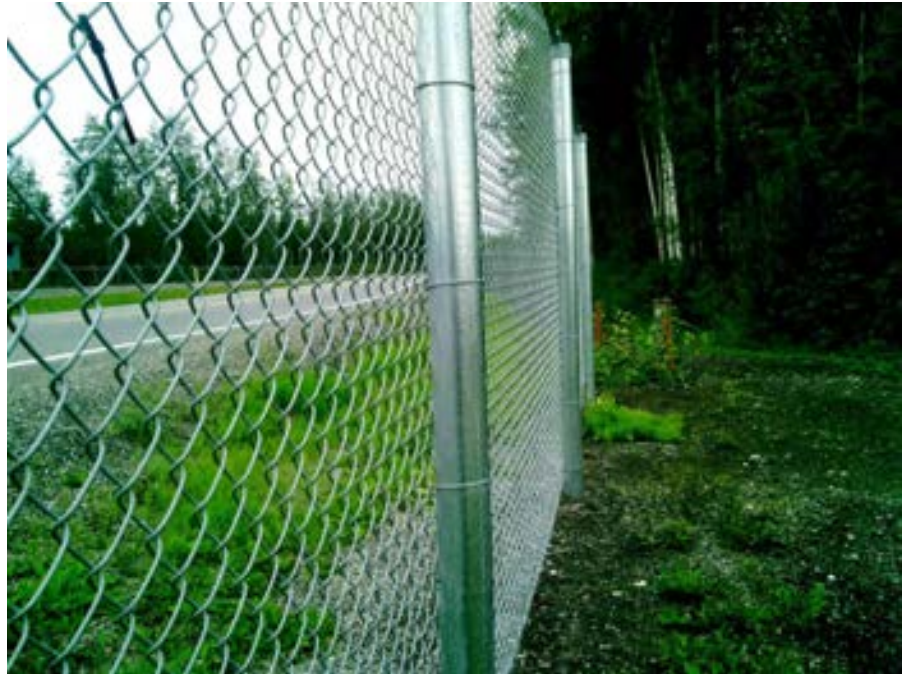
Photo No. 11  
(11-August-2015)

View looking west at fencing at the Building 1168 site along Trainor Gate Road. Note monitoring well AP-6809.

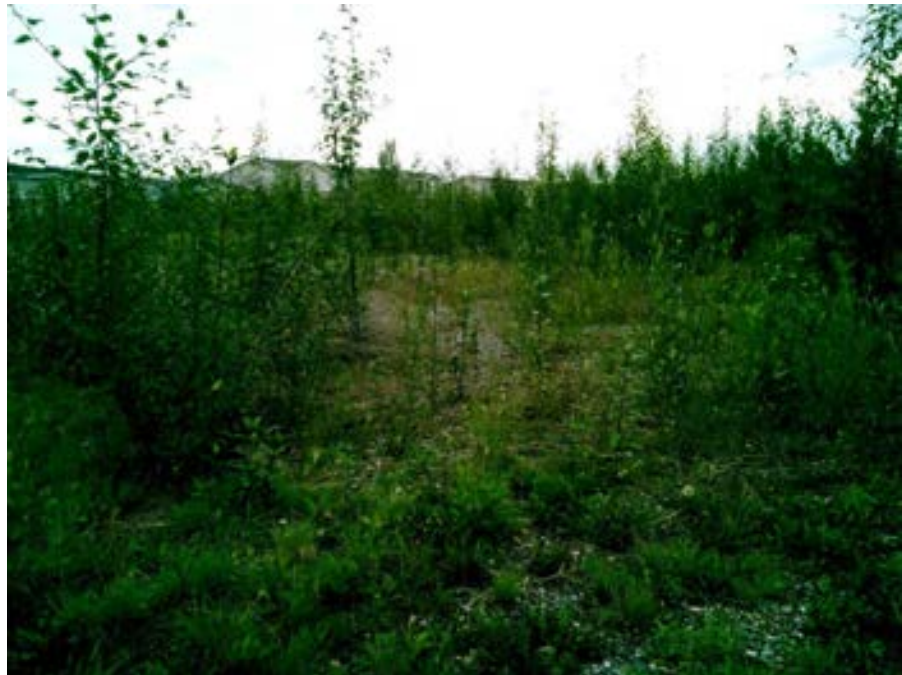
Photo No. 12  
(11-August-2015)

View looking northeast across the Building 1168 site.

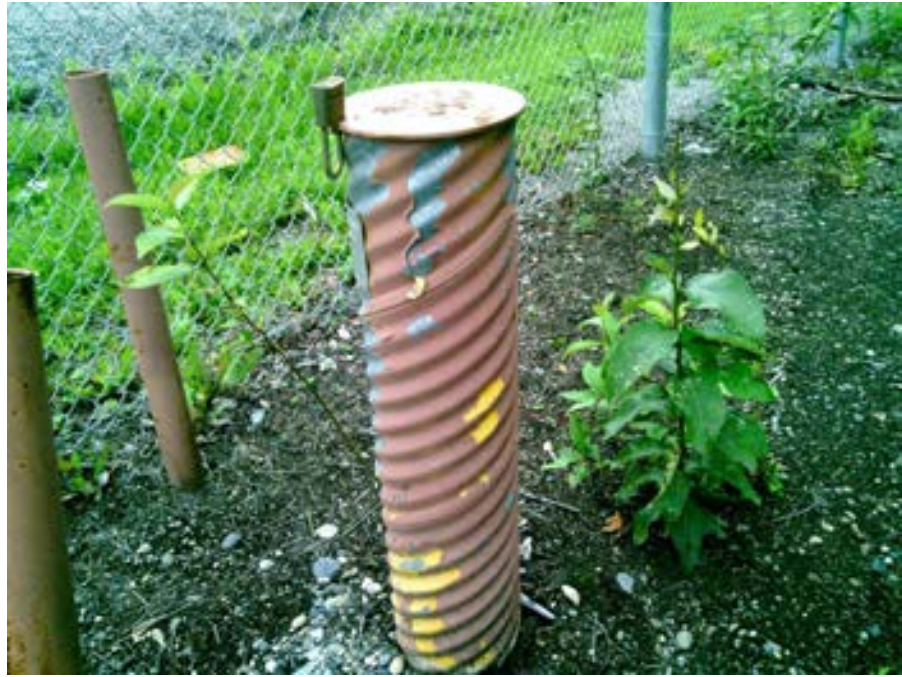
Photo No. 13  
(11-August-2015)

View of locked and labeled monitoring well AP-6809.

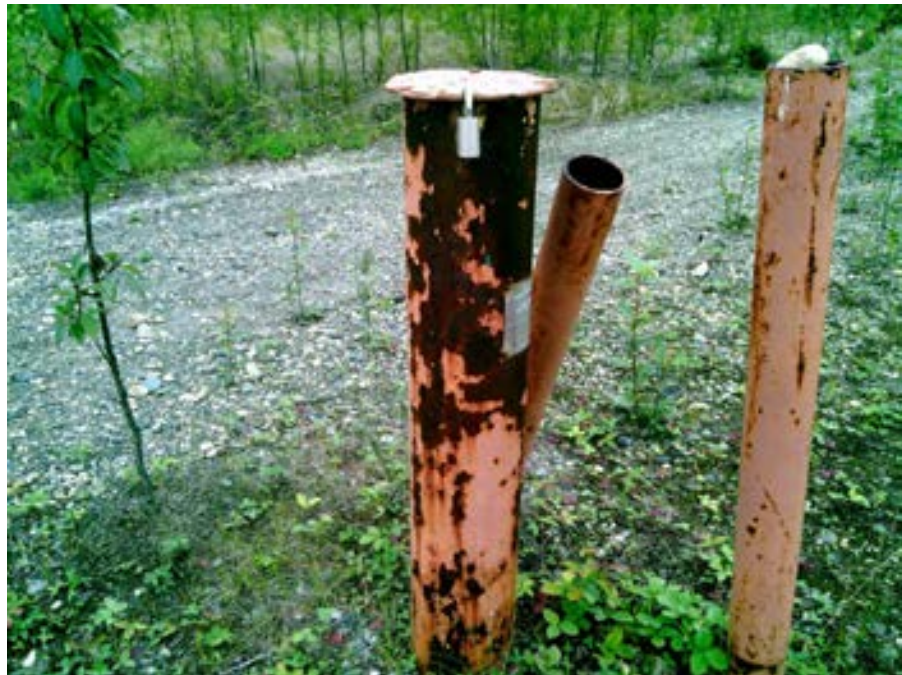
Photo No. 14  
(11-August-2015)

View of monitoring well AP-7143 with damaged bollard (not sampled in 2014).

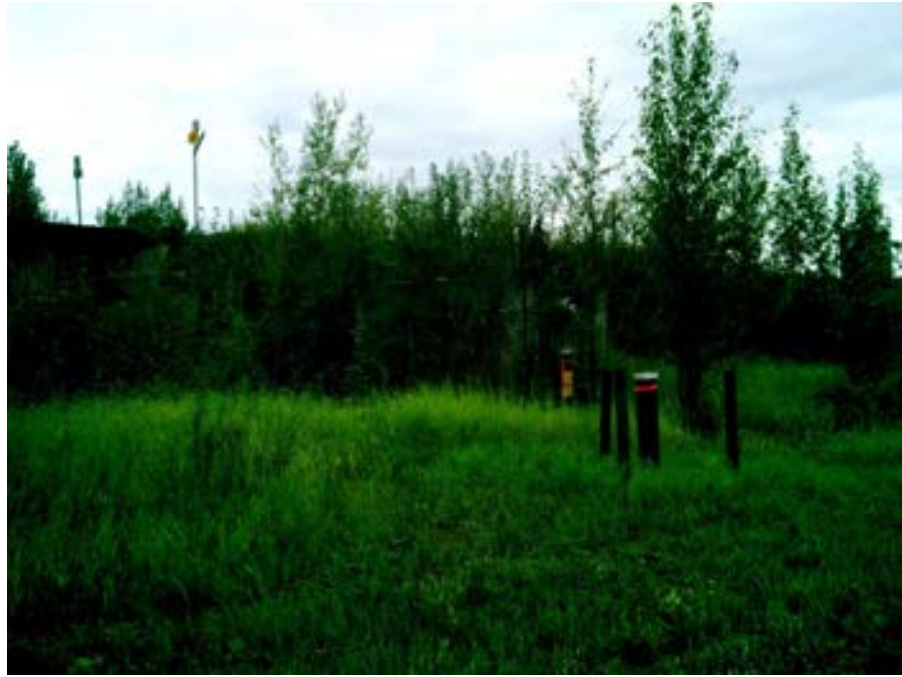
Photo No. 15  
(11-August-2015)

View looking southeast at Valve Pit A. Note VPA-MP2 and VPA-MP5.

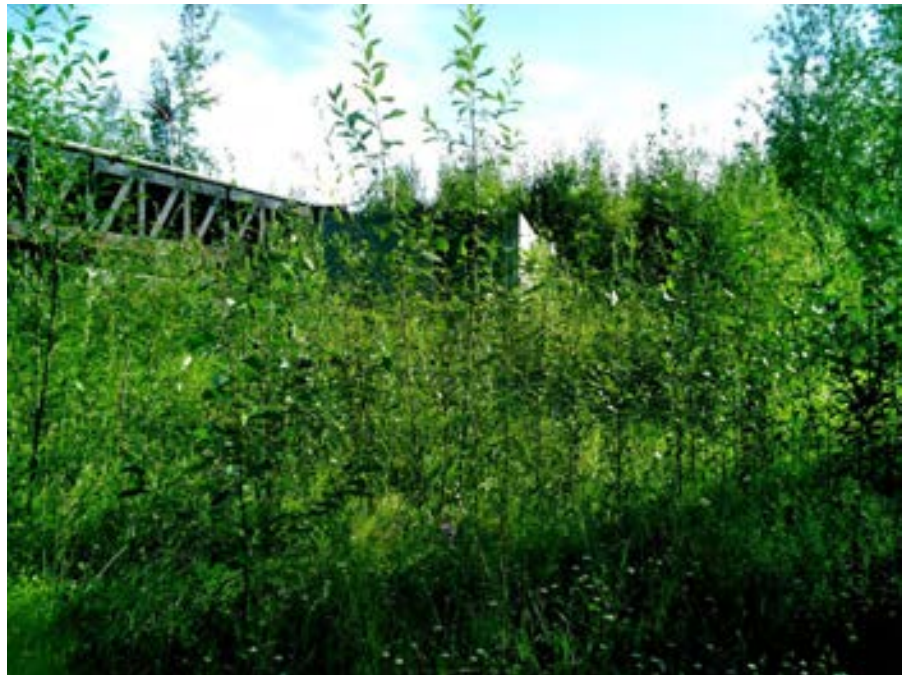
Photo No. 16  
(11-August-2015)

View looking north at Valve Pit B.

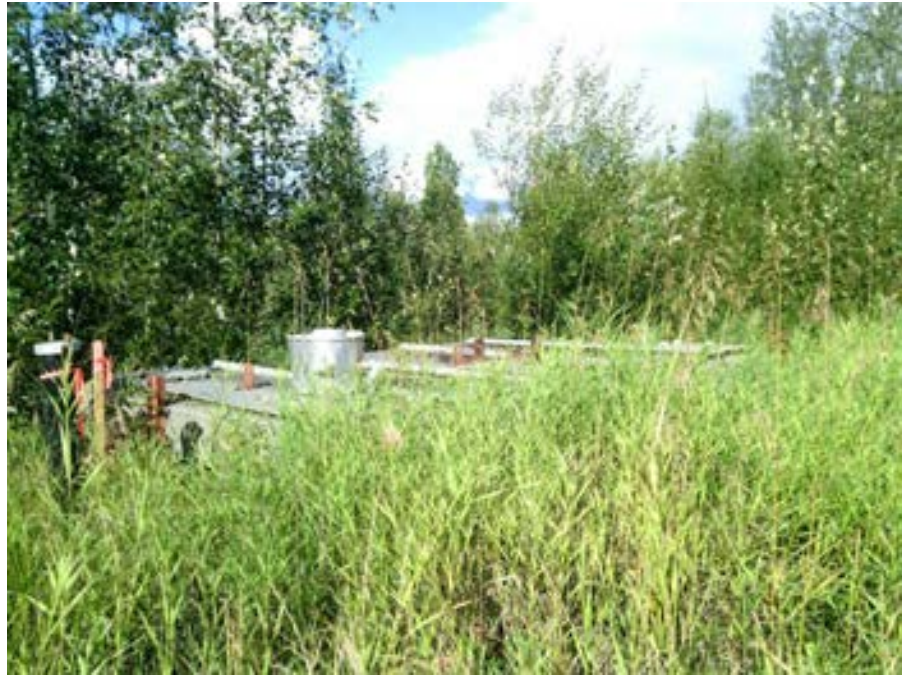
Photo No. 17  
(11-August-2015)

View looking west at Valve Pit C. Note VPC-MP2.

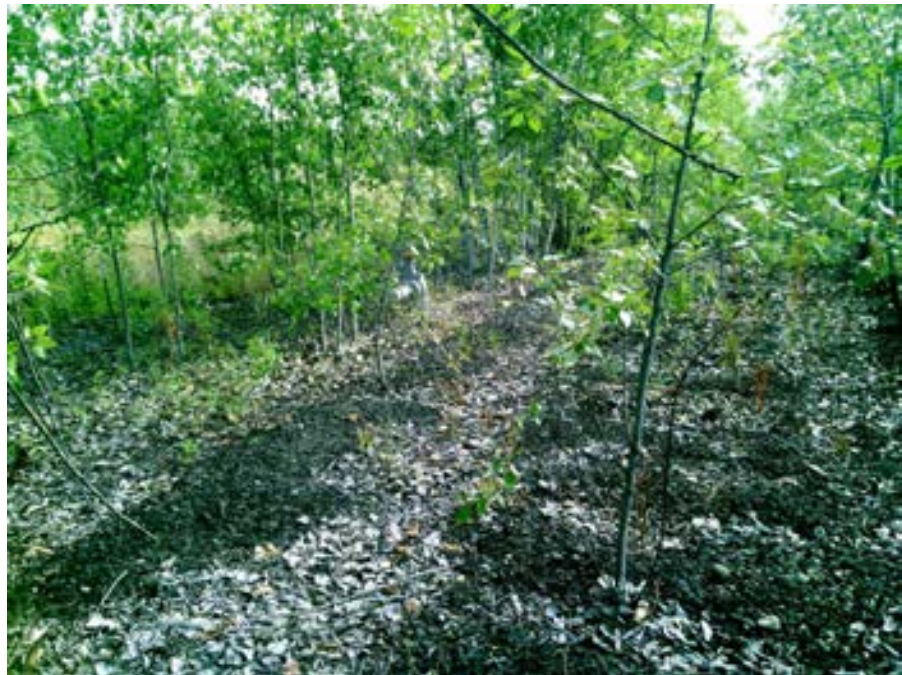
Photo No. 18  
(11-August-2015)

View of underground fuel piping at the ROLF.

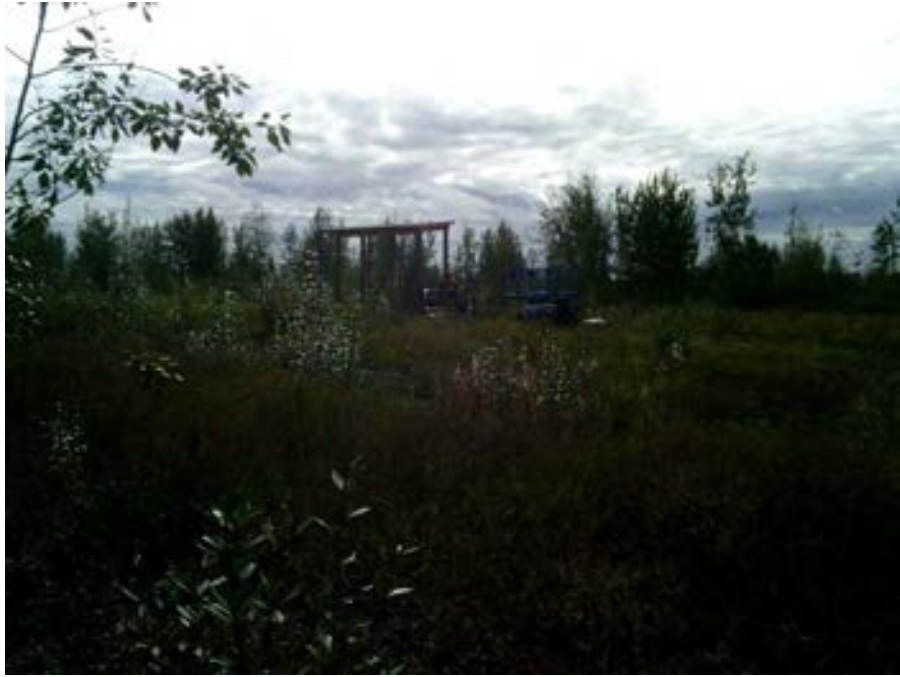
Photo No. 19  
(11-August-2015)

View of a bird habitat under construction at the ROLF.

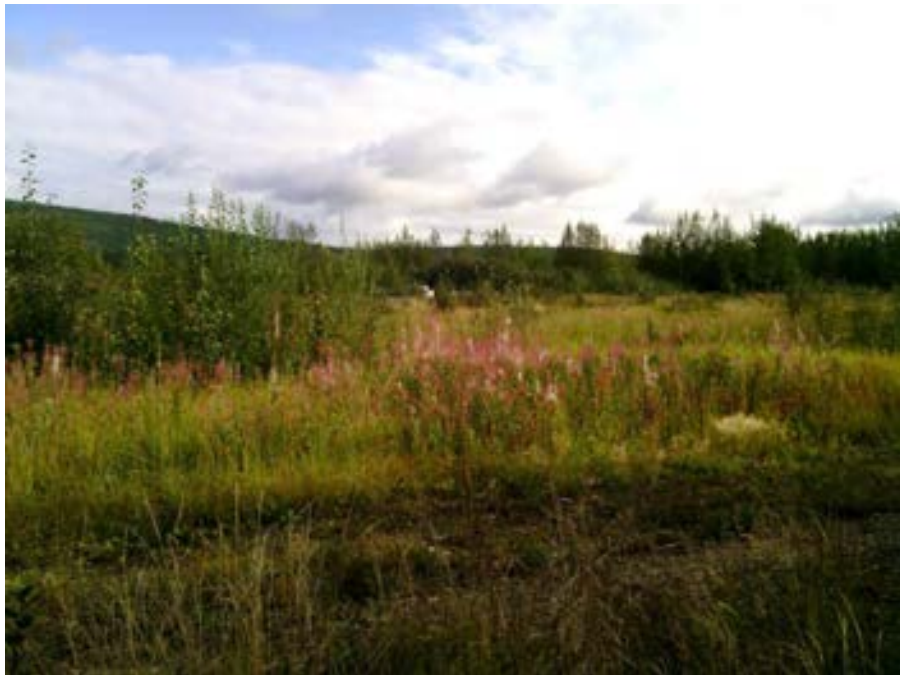
Photo No. 20  
(11-August-2015)

View of typical vegetation and concrete construction materials staged on ROLF.

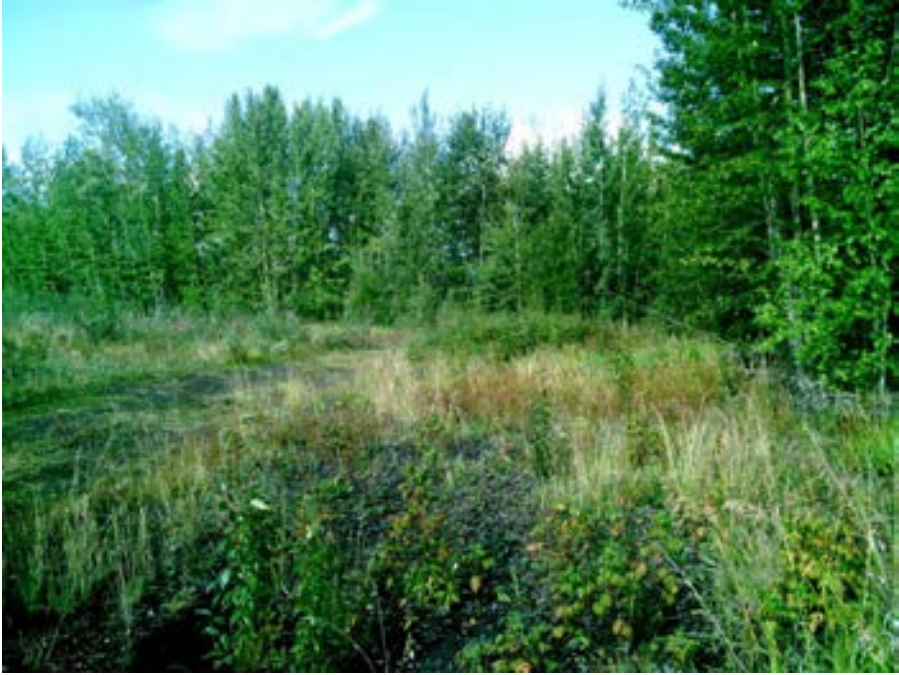
Photo No. 21  
(11-August-2015)

Typical view of  
vegetation at the  
ROLF.

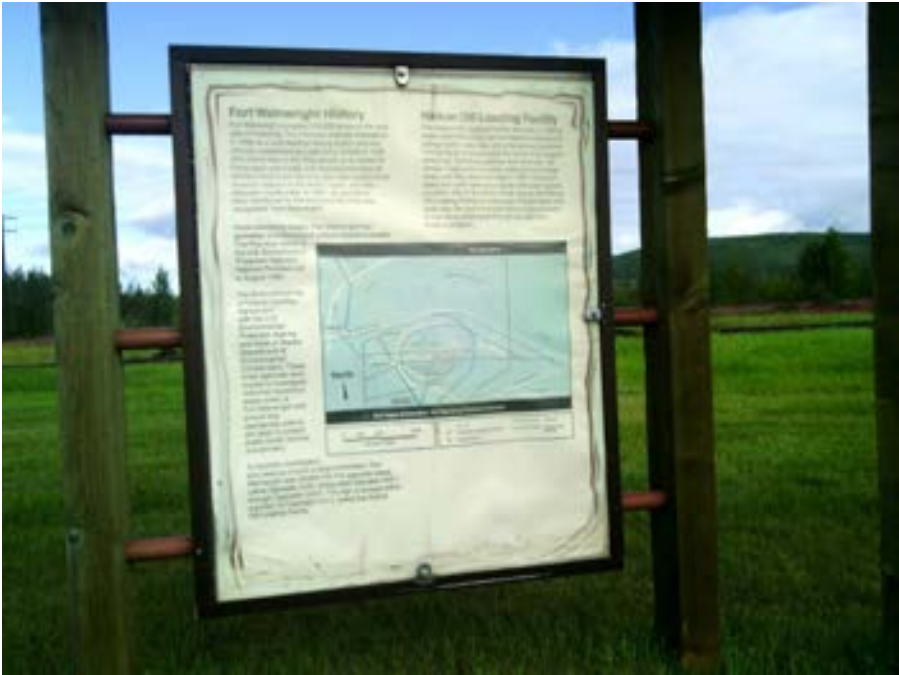
Photo No. 22  
(11-August-2015)

View of the  
ROLF  
informational  
sign.

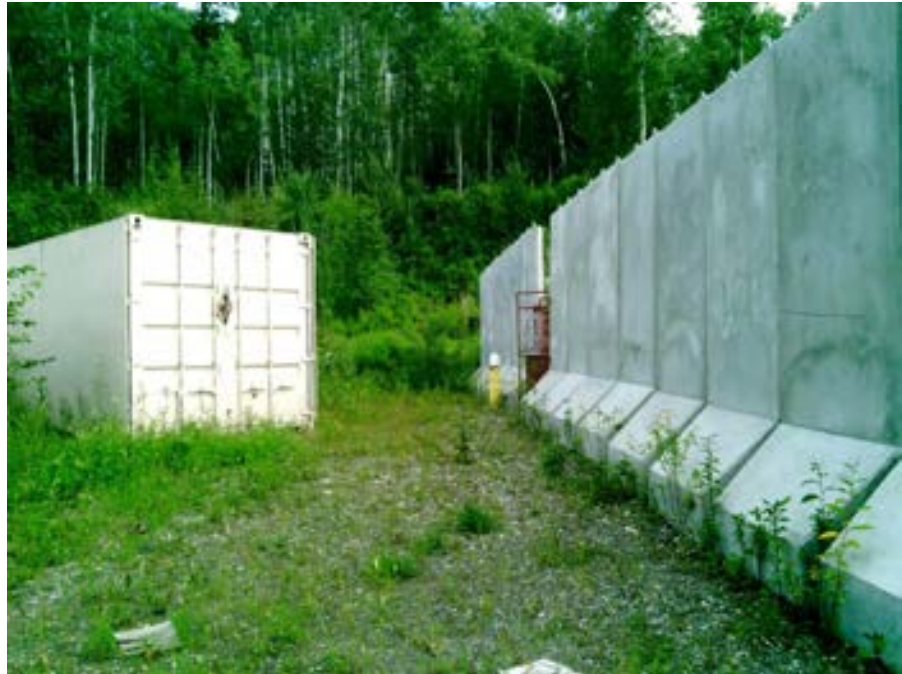
Photo No. 23  
(11-August-2015)

View looking east across a training area just south of the Milepost 3.0 excavation. Note monitoring well AP-8711.

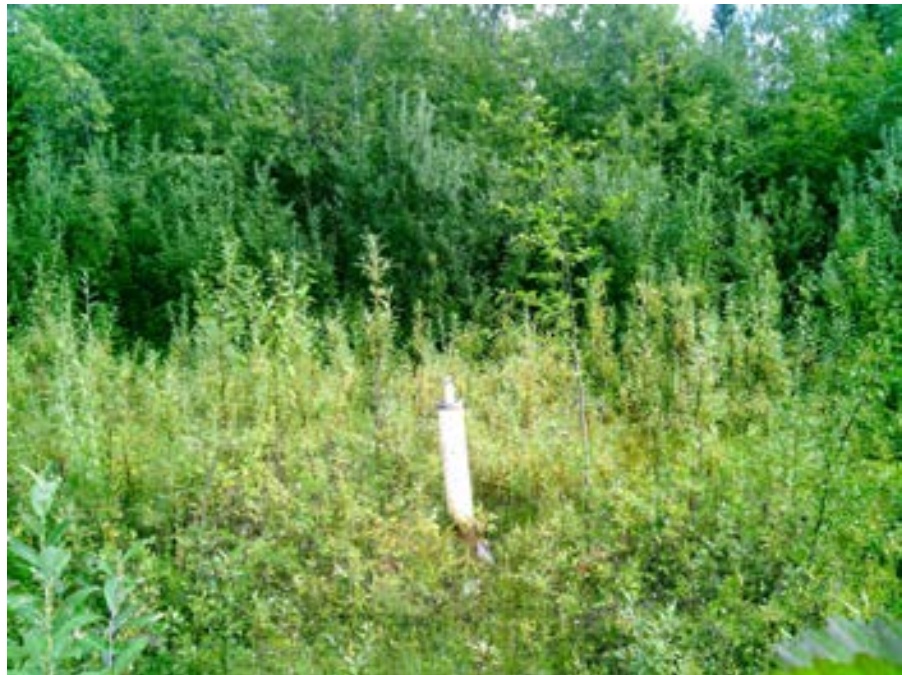
Photo No. 24  
(11-August-2015)

Example of a “frost jacked” monitoring well at Milepost 2.7.

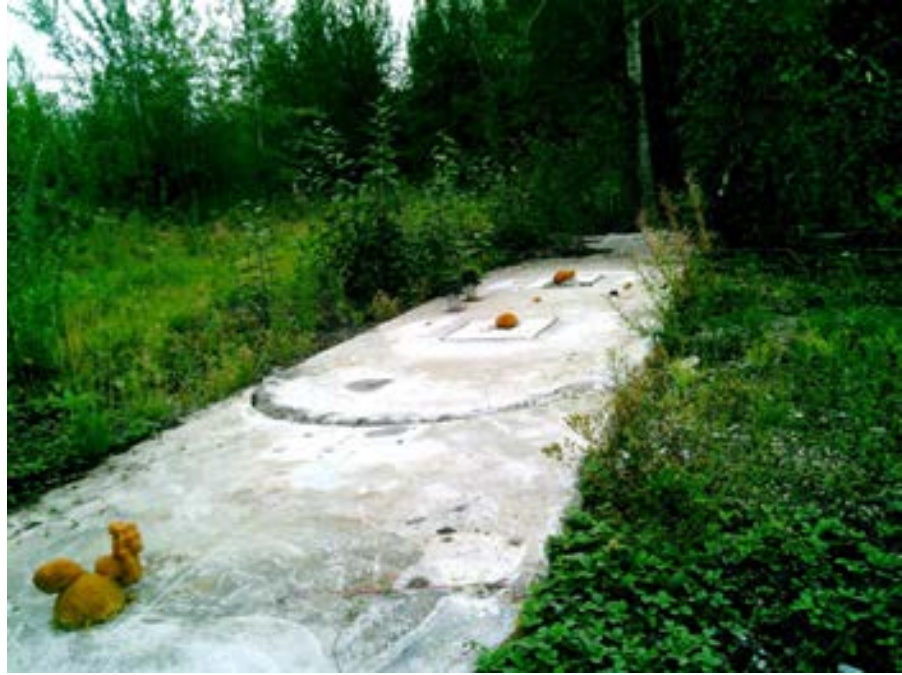
Photo No. 25  
(11-August-2015)

View looking north at a former truck fill stand on the southern portion of the Birch Hill Tank Farm.

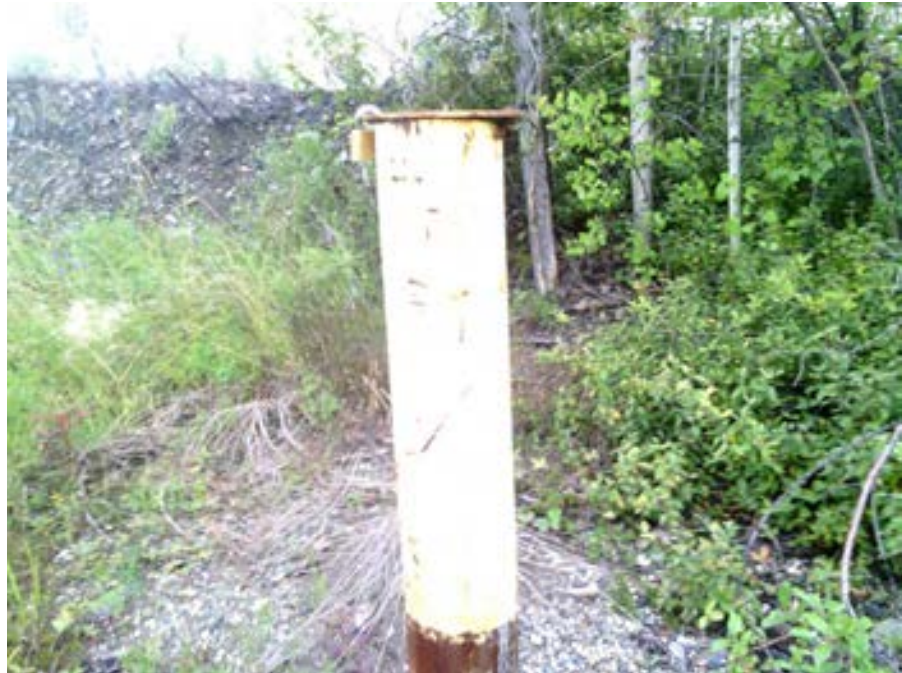
Photo No. 26  
(11-August-2015)

View of locked and labeled monitoring well AP-10229MW (GWP-121).

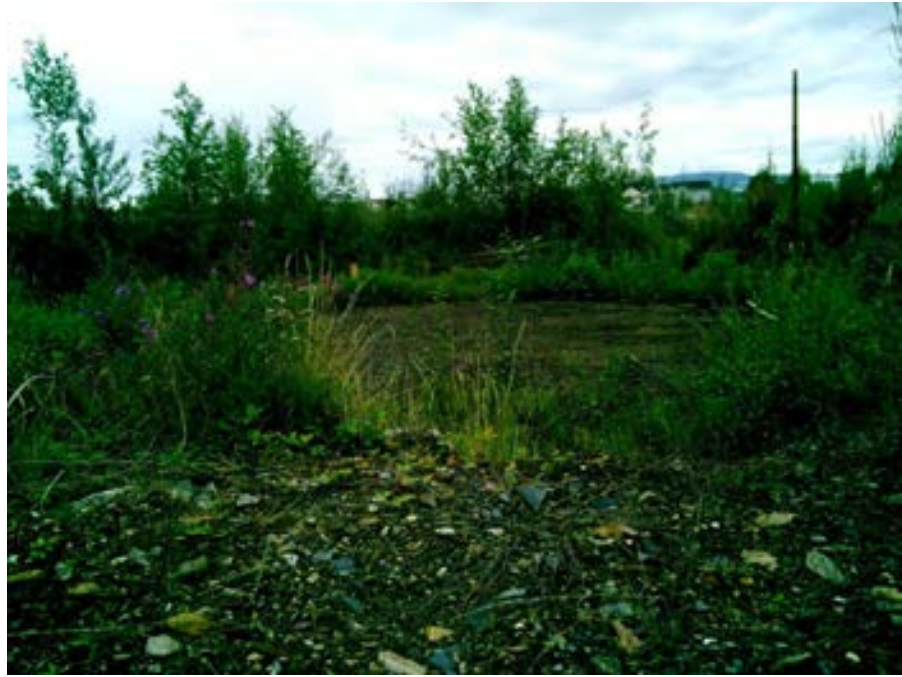
Photo No. 27  
(11-August-2015)

View of a former  
AST location in  
the southern Birch  
Hill Tank Farm.

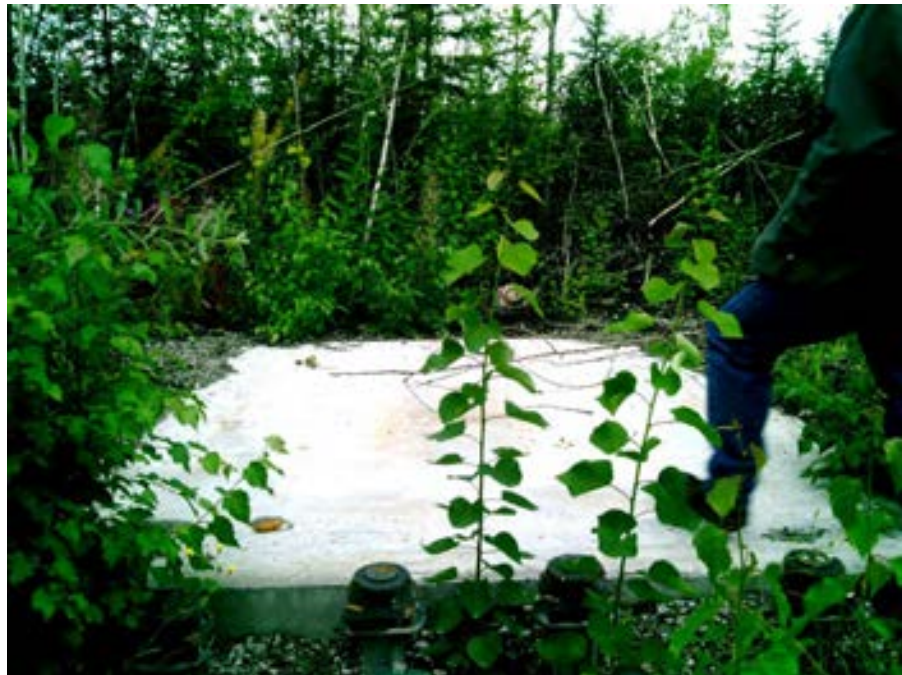
Photo No. 28  
(11-August-2015)

View of a  
concrete pad and  
underground fuel  
lines in the  
southern Birch  
Hill Tank Farm.

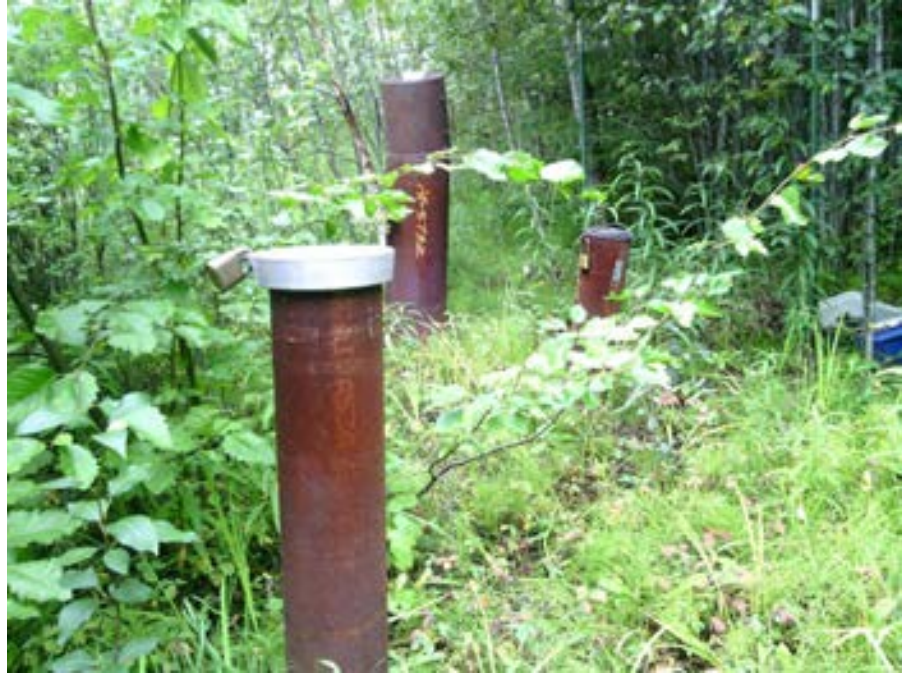
Photo No. 29  
(11-August-2015)

Typical monitoring wells on the southern Birch Hill Tank Farm. Note monitoring wells AP-5782, AP-5783, and AP-7952.

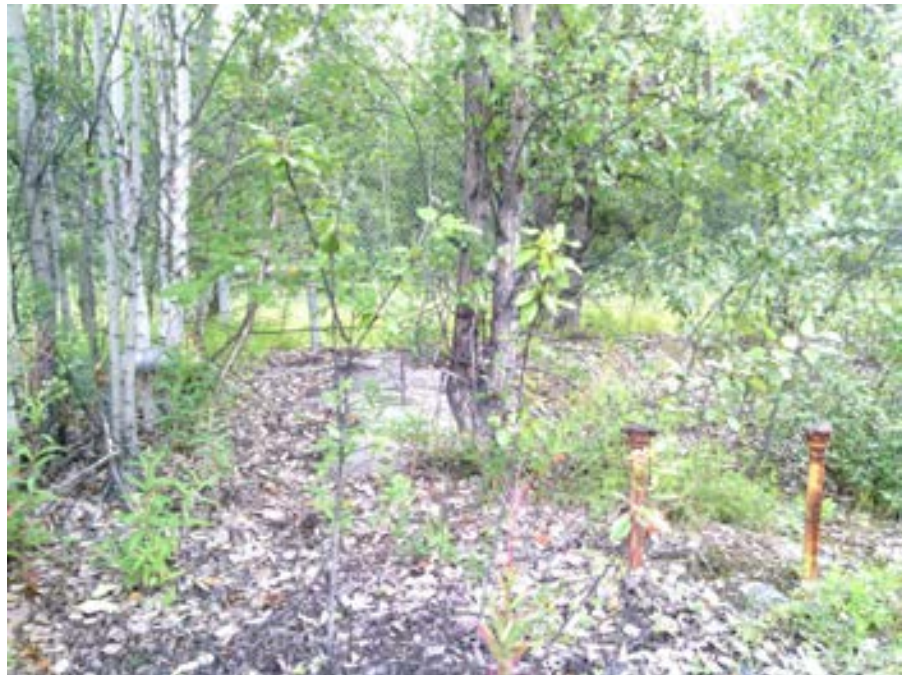
Photo No. 30  
(11-August-2015)

View of typical underground fuel piping located on the southern Birch Hill Tank Farm.
