APPENDIX H

Site Reconnaissance Photo Log

**APPENDIX H – SITE RECONNAISSANCE PHOTO LOG
USAEC PFAS PRELIMINARY ASSESSMENT/SITE INSPECTION**

Aberdeen Proving Ground, Maryland

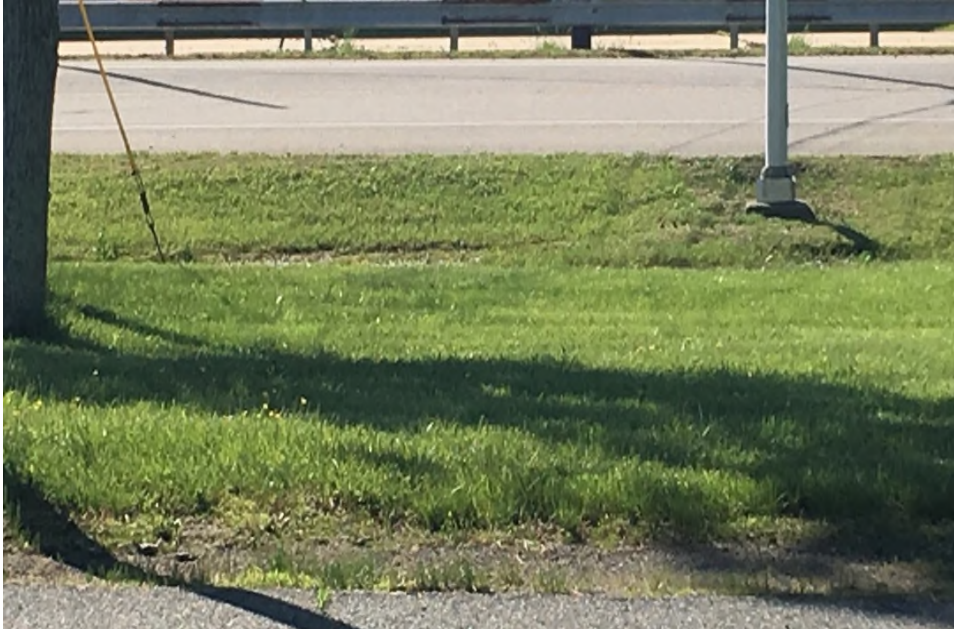
Photograph: 2

Description:
Surface drainage ditch
located parallel to fire
station building.

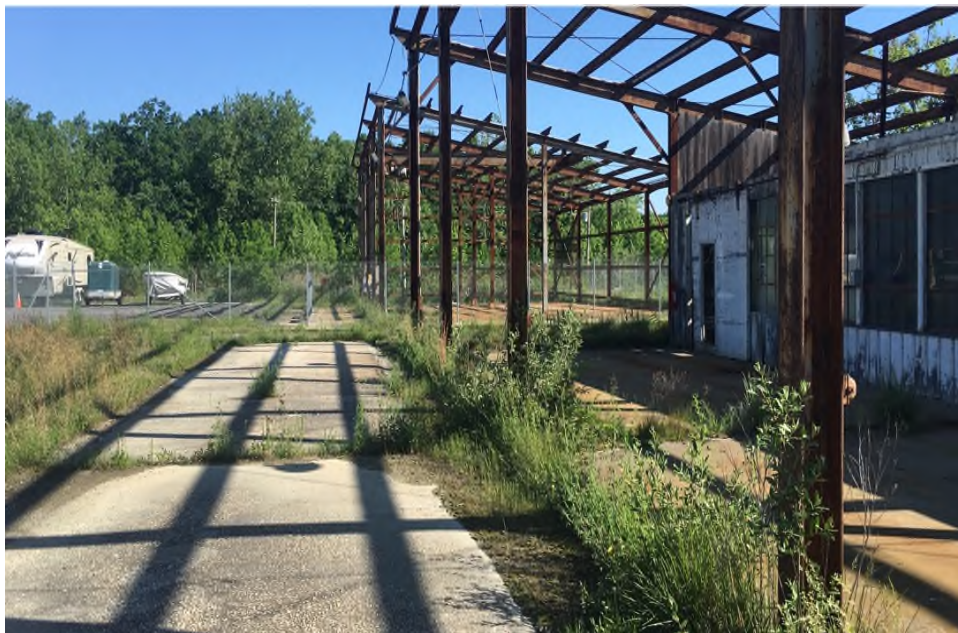
Photograph: 7

Photo from eastern and downgradient portion of area where AFFF was sprayed as part of chemical suppressant exercises.

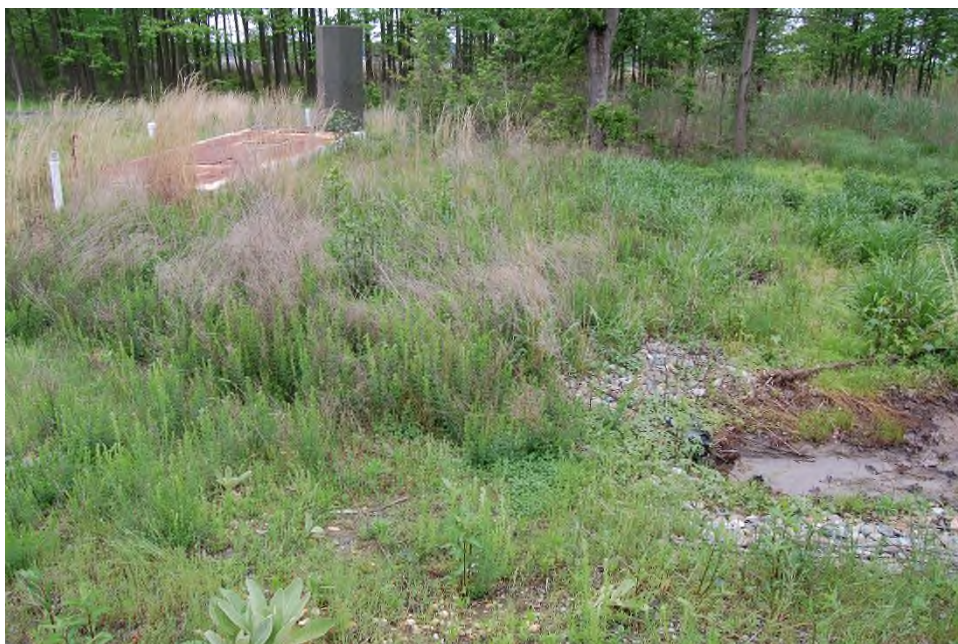
Photograph: 16

View of oil-water separator present within the AA5 Range.

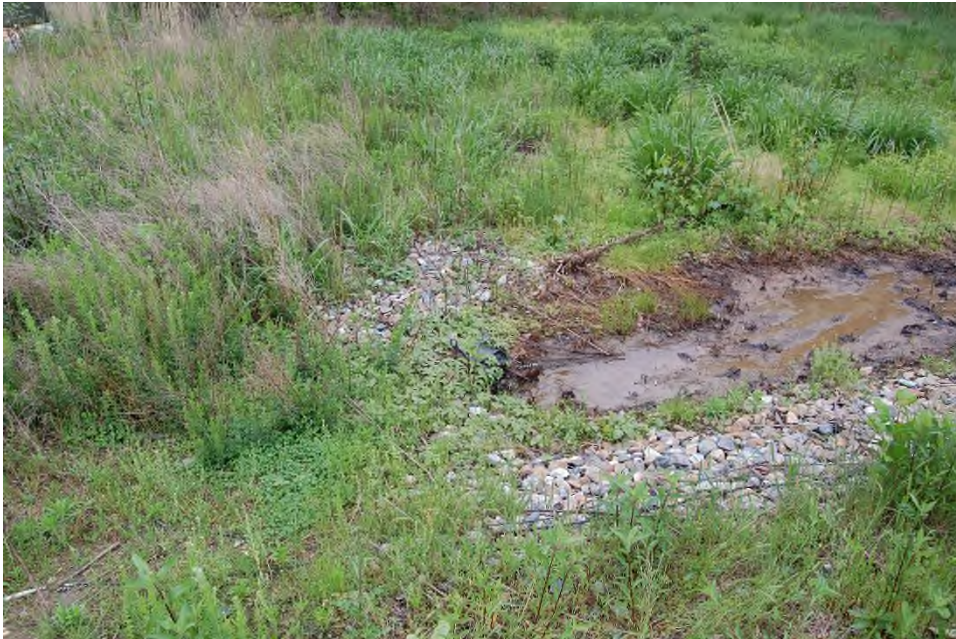
Photograph: 17

AA5 Range drainage outfall located to the south of the range area.

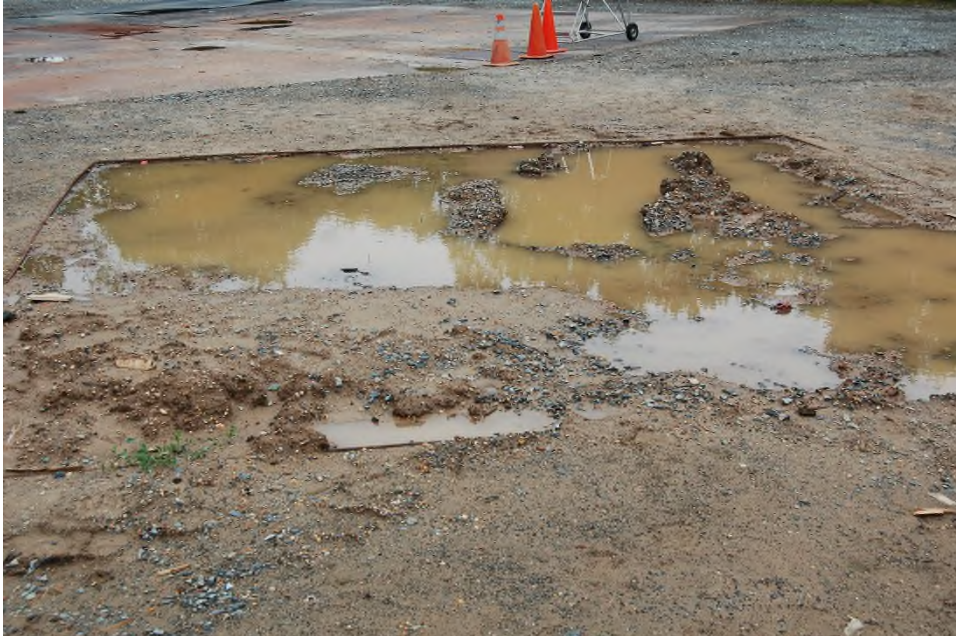
Photograph: 18

Photograph of test area at AA5 Range where AFFF was released to surface.

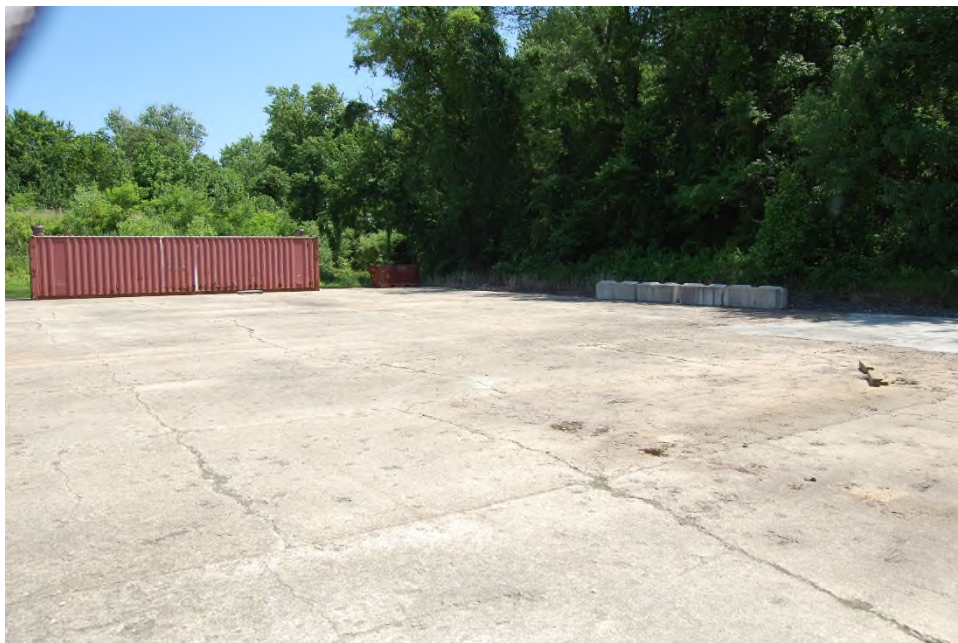
Photograph: 19

View of Air Base Range 3 from the northeastern side of the test area. Surface drainage is directed towards the southwest (focal point of photo).

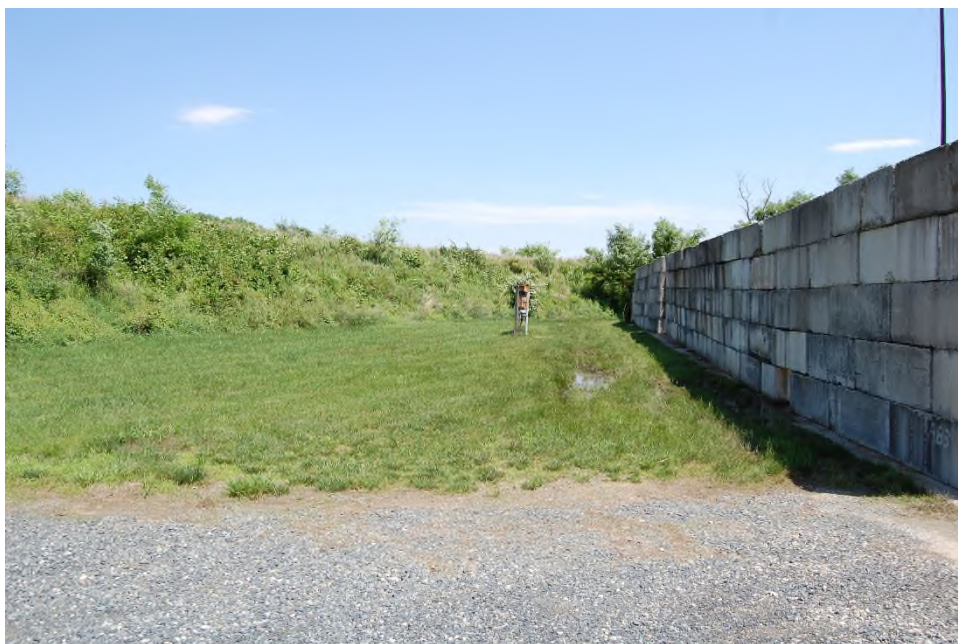
Photograph: 20

Boundary wall of test pad for Air Base Range 3.

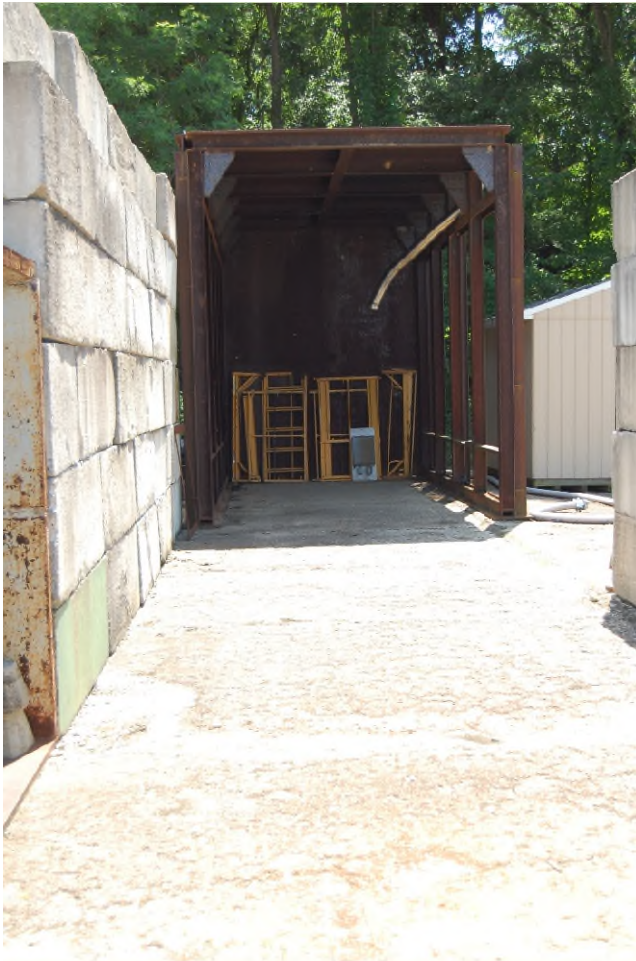
Photograph: 21

Storage area at Air
Base Range 3.

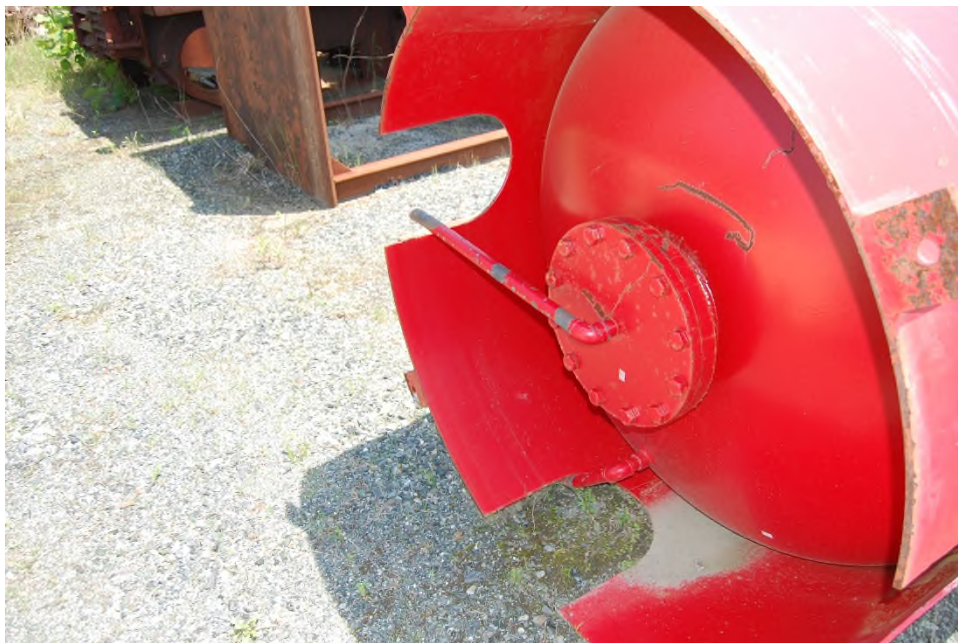
Photograph: 22

Description:
Unspecified tank system identified at Air Base Range 3 by Army Test Center representative.

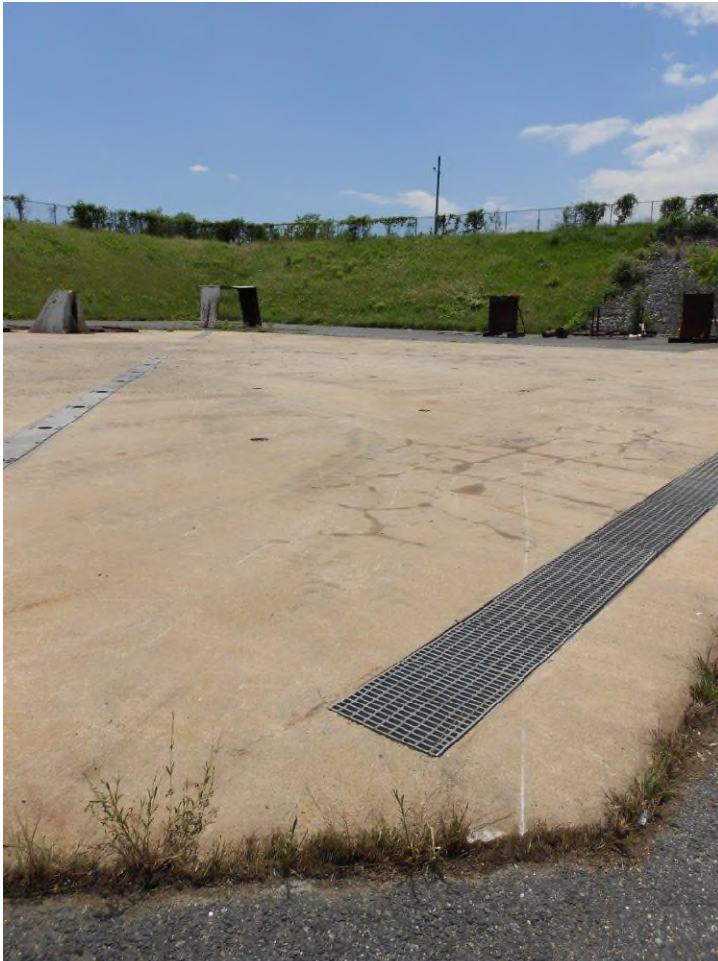
Photograph: 24

View of environmental
test pad at Air Base
Range 6

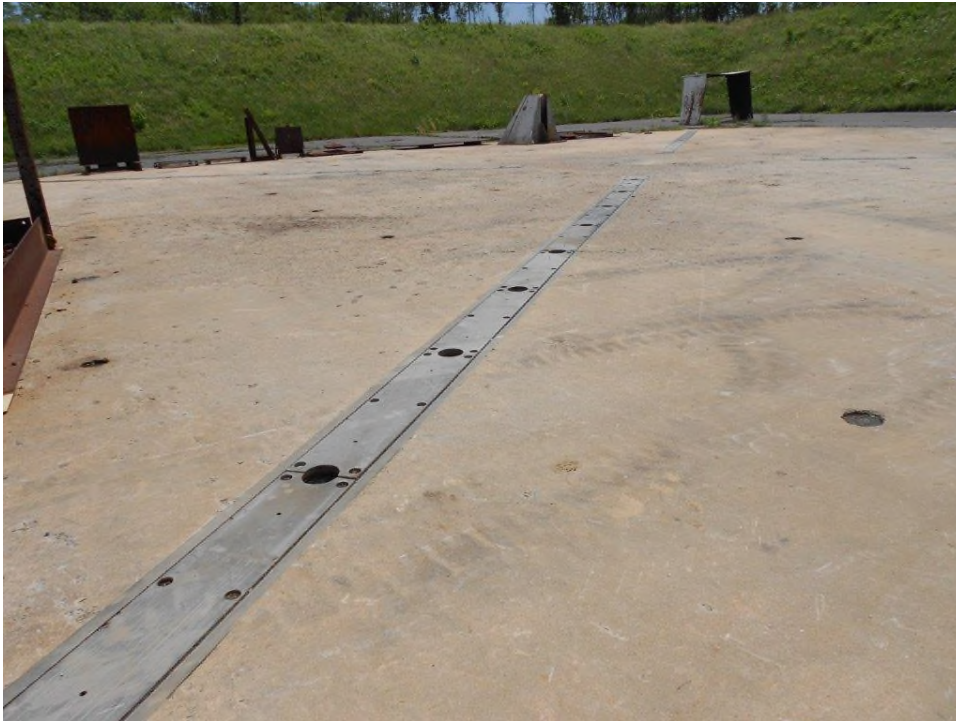
Photograph: 25

Description:
Alternative view of
environmental test pad
at Air Base Range 6.

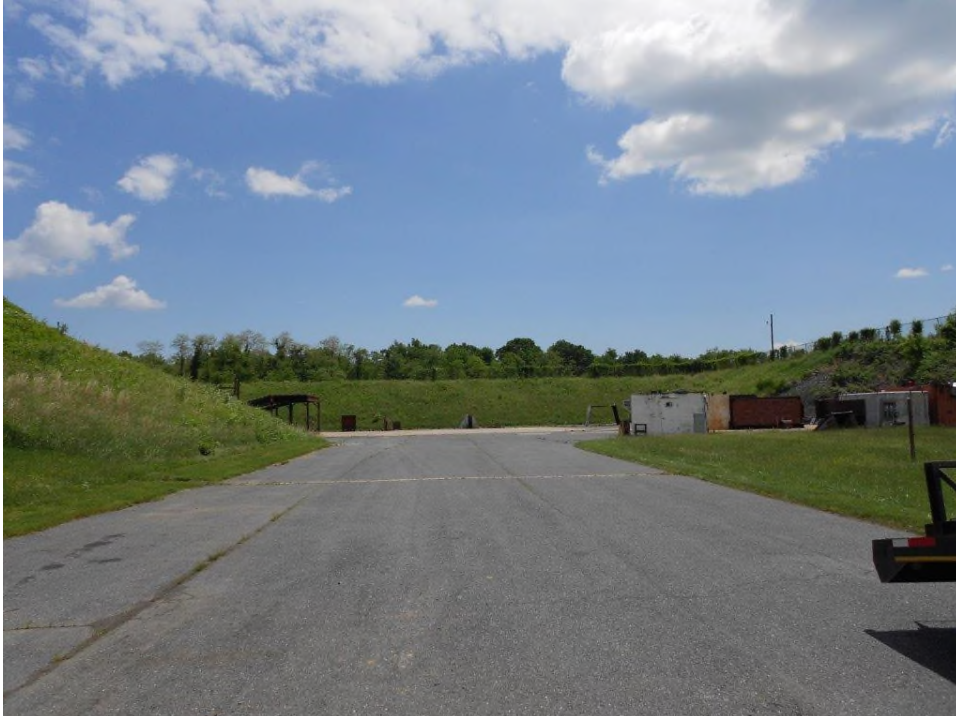
Photograph: 26

Description:
View of Air Base Range 6
from the vantage
point of fire response
vehicles that deployed
AFFF during testing
exercises.

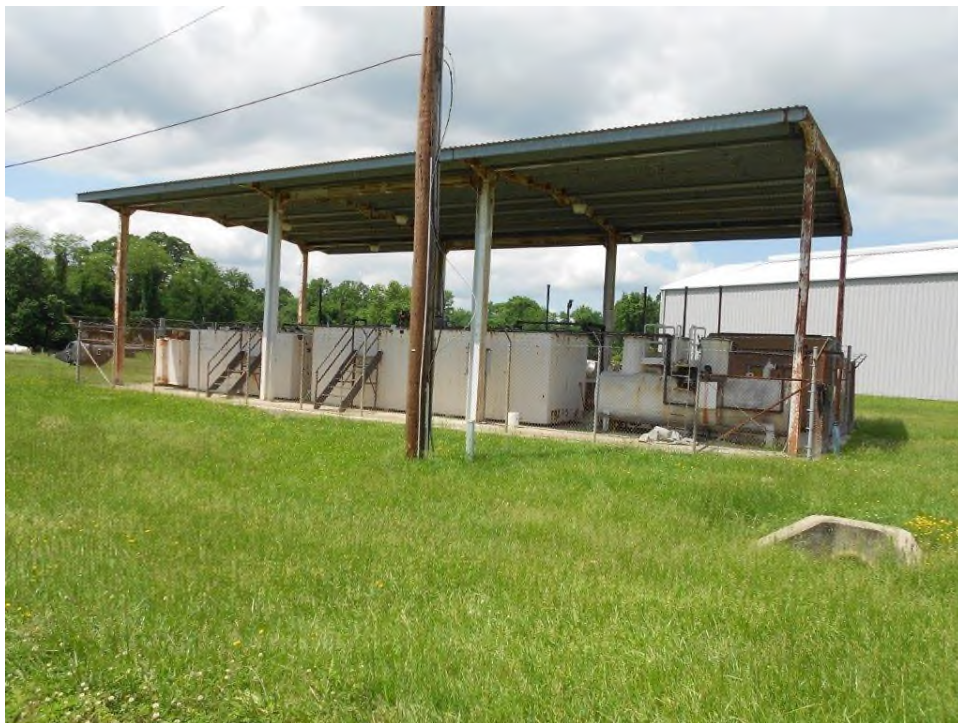
Photograph: 27

Oil-water separator system for Air Base Ranges 6 and 7

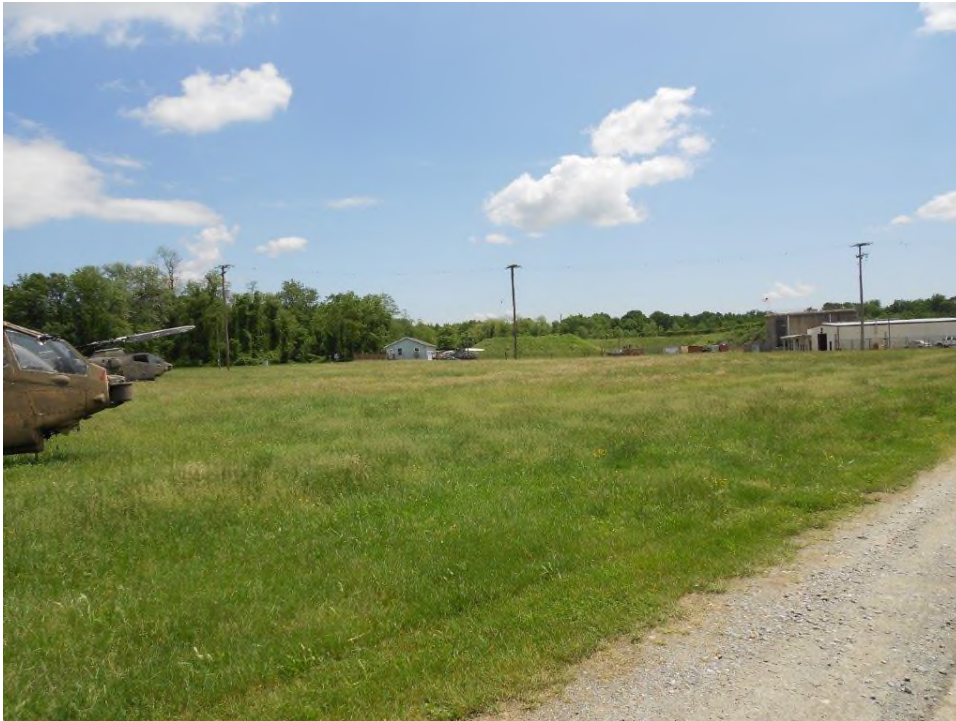
Photograph: 29

Field where aircraft are parked as part of testing exercises.

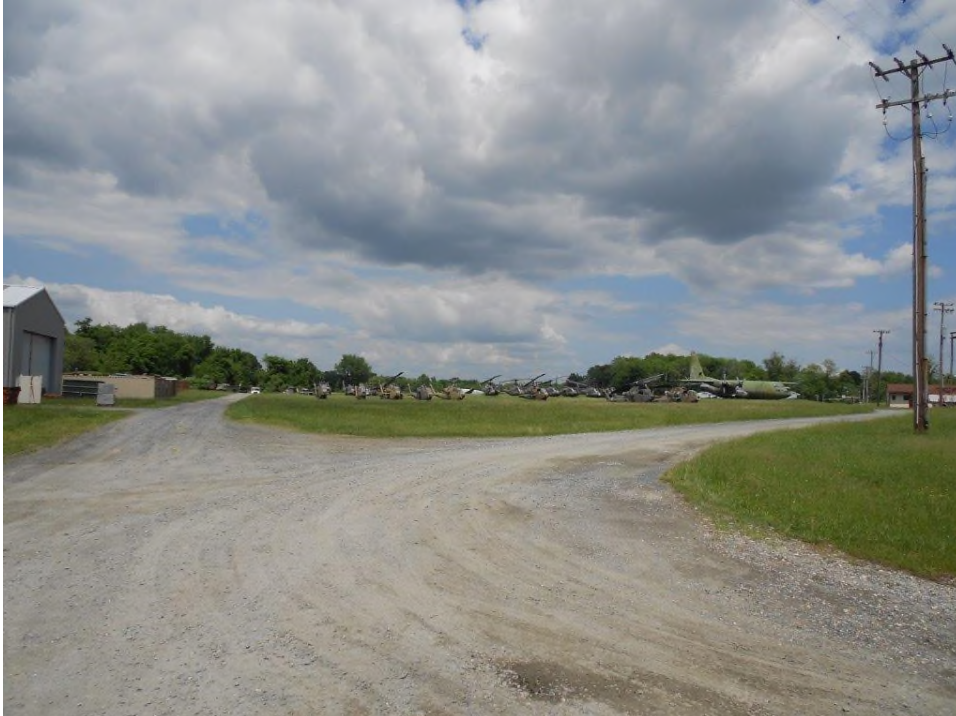
Photograph: 30

Aircraft boneyard as viewed from the southwest.

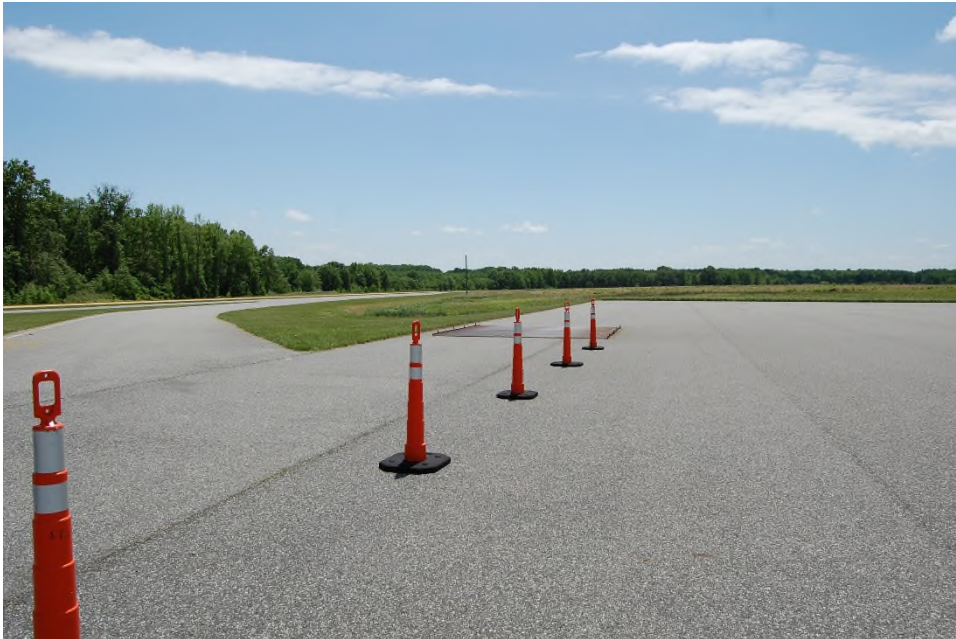
Photograph: 31

View of the Phillips Army Airfield (PAAF) Loading Pad from the PAAF runway.

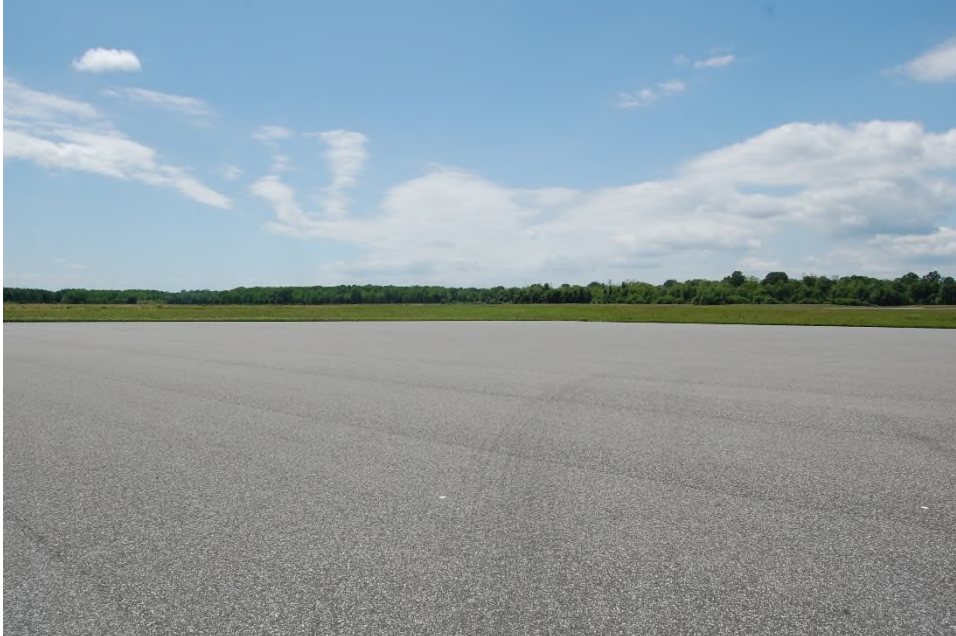
Photograph: 32

Alternative view of the PAAF Loading Pad

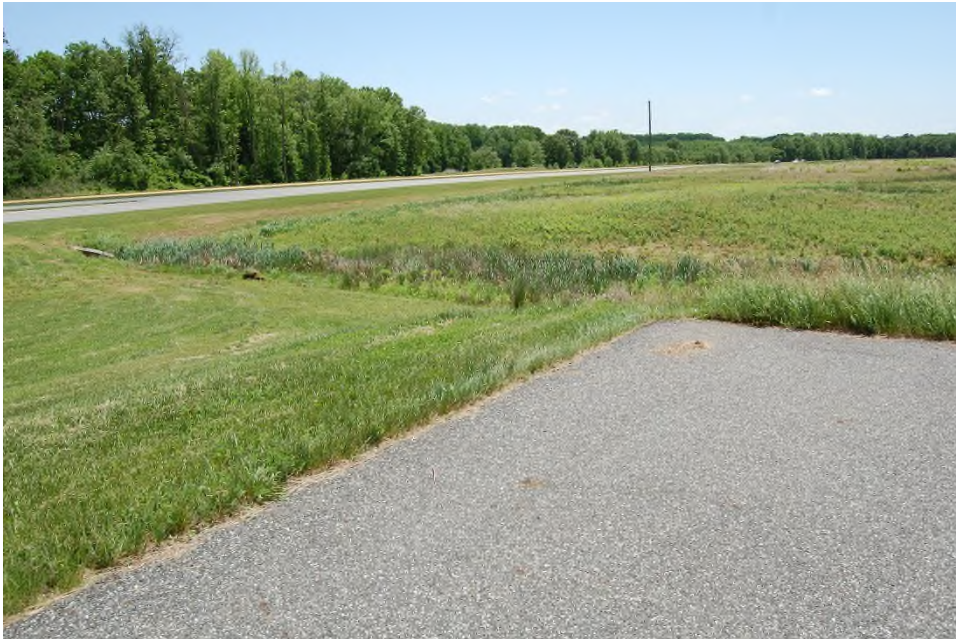
Photograph: 33

Corner of PAAF Loading Pad where AFFF was released during emergency response.

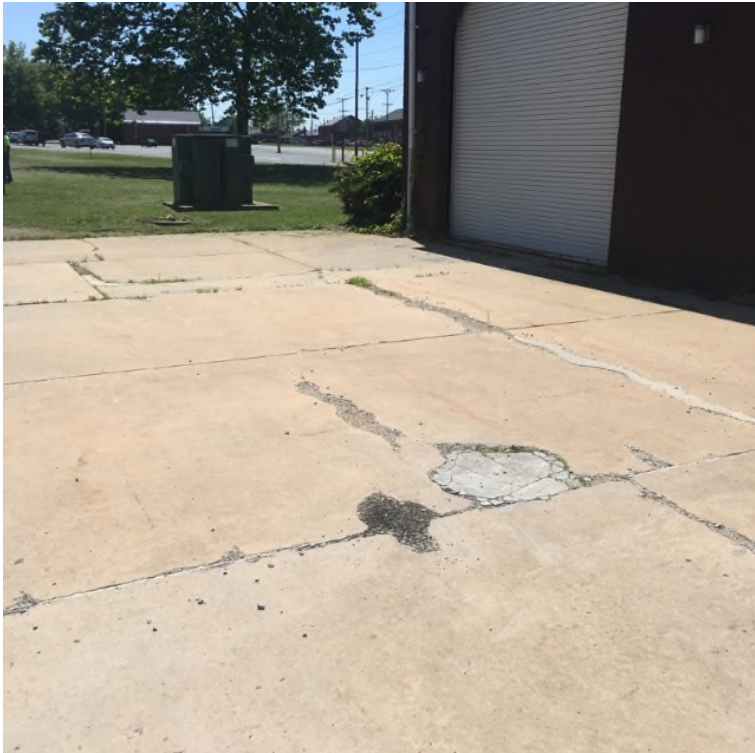
Photograph: 39

Description:
Cracks in main
driveway of the former
Aberdeen Fire Station

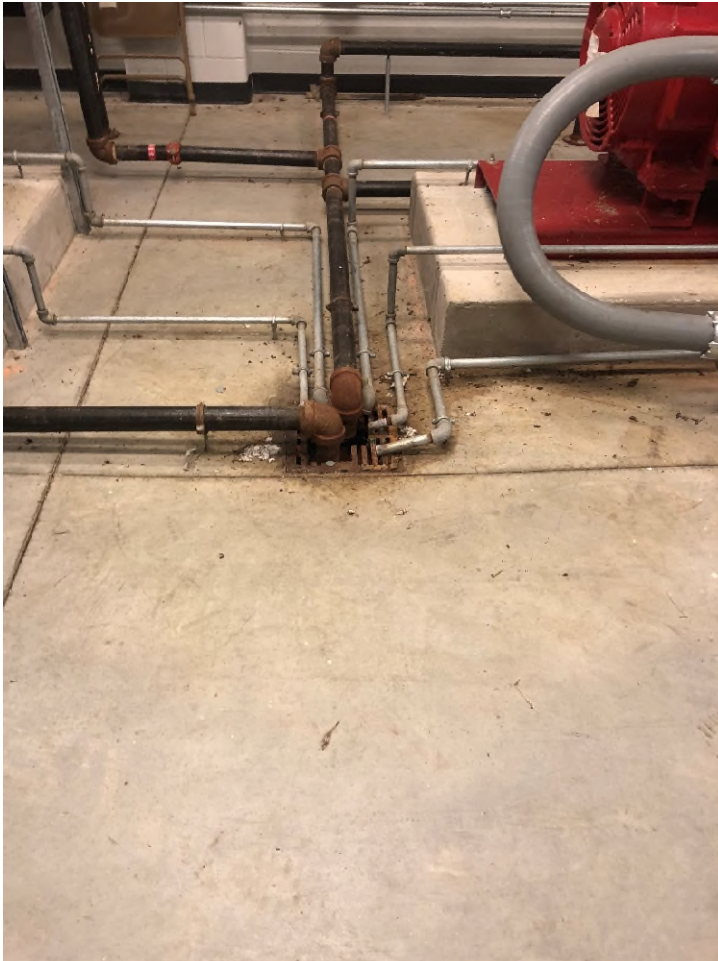
Photograph: 43

Piping extending from
AFFF suppression tank
within Building E4081

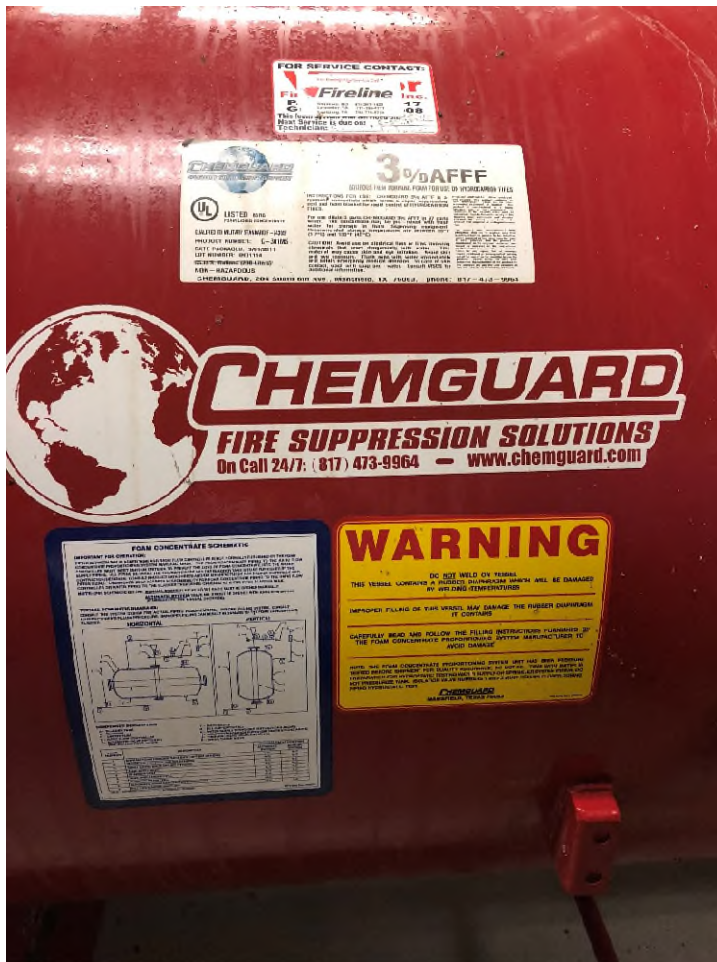
Photograph: 44

Decals detailing the contents of an AFFF suppression system located within Building E4081

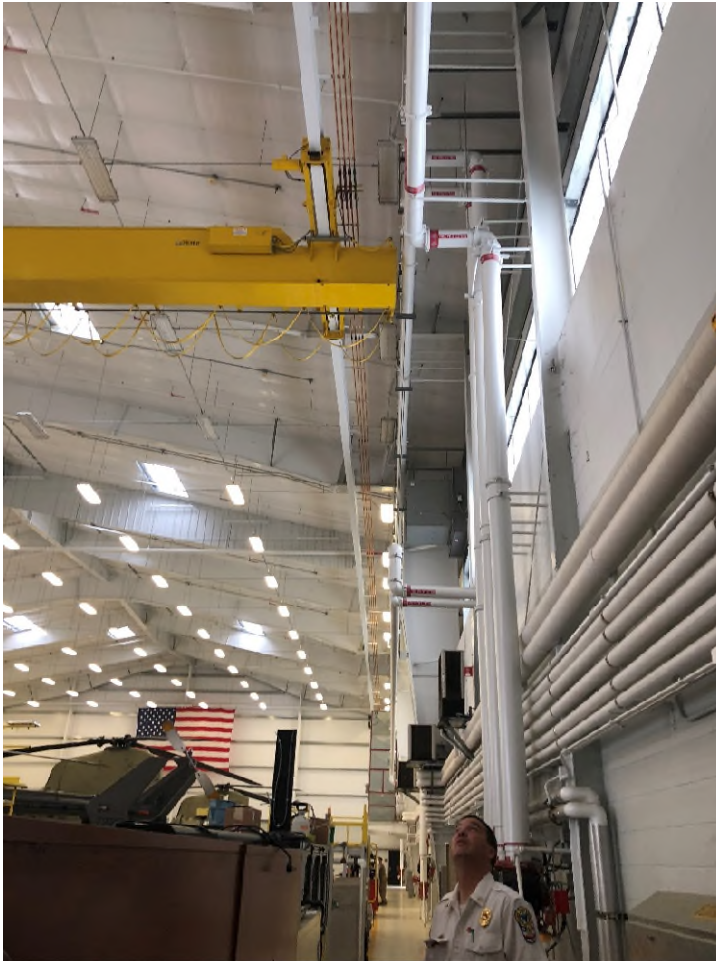
Photograph: 45

Photo of hangar ceiling and AFFF suppression system piping at Hangar E4081.

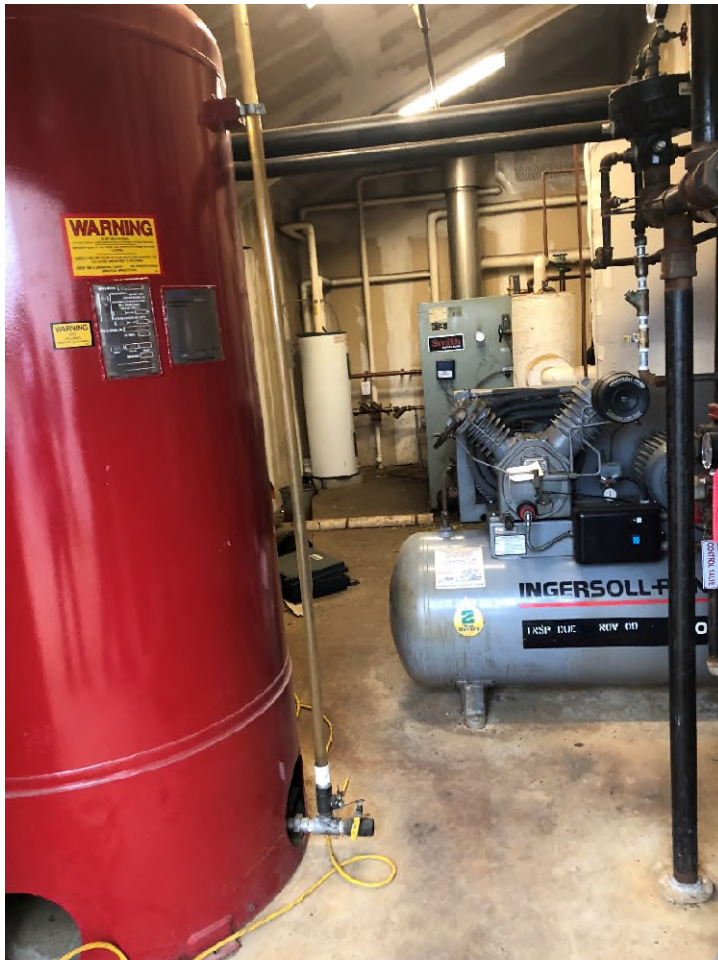
Photograph: 48

Description:
AFFF suppression
system tank located
within Building E4040.

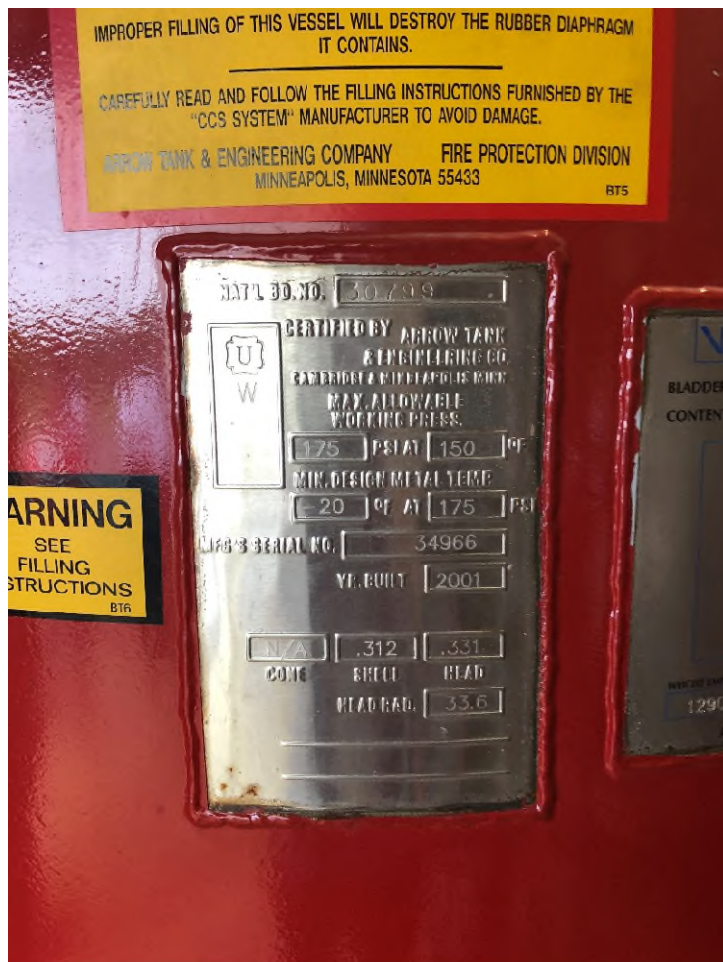
Photograph: 49

Placard detailing the contents of an AFFF suppression system tank located inside Building E4040

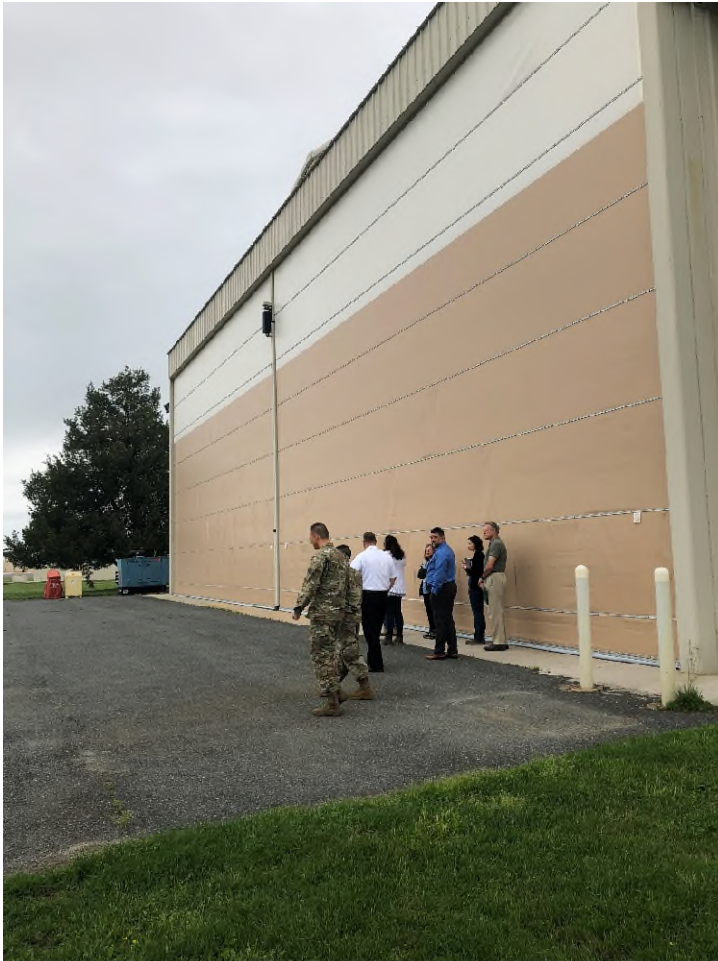
Photograph: 51

Photo of hangar bay doors at Building E4040.

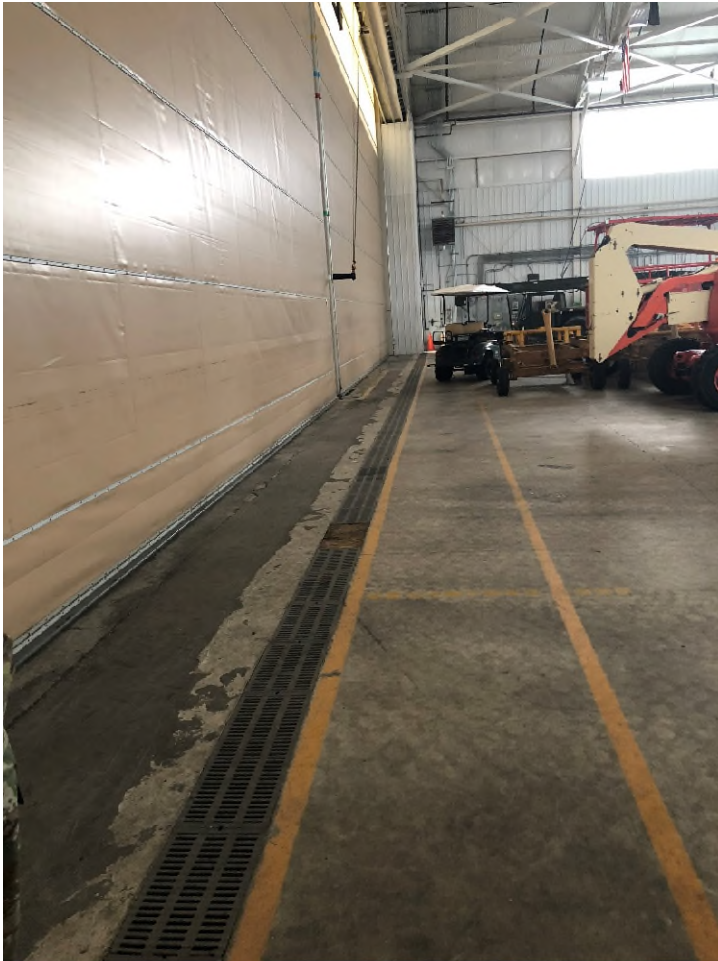
Photograph: 52

Interior hangar of
Building E4040 along
with interior drainage
inlets.

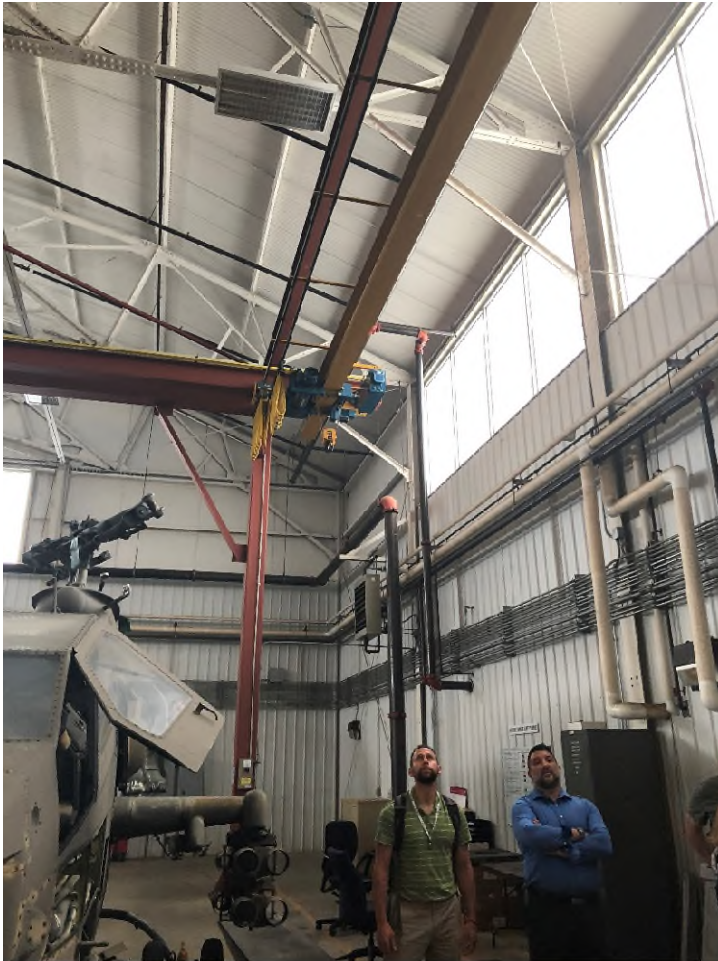
Photograph: 53

Ceiling view of Building E4040, including piping for AFFF suppression system.

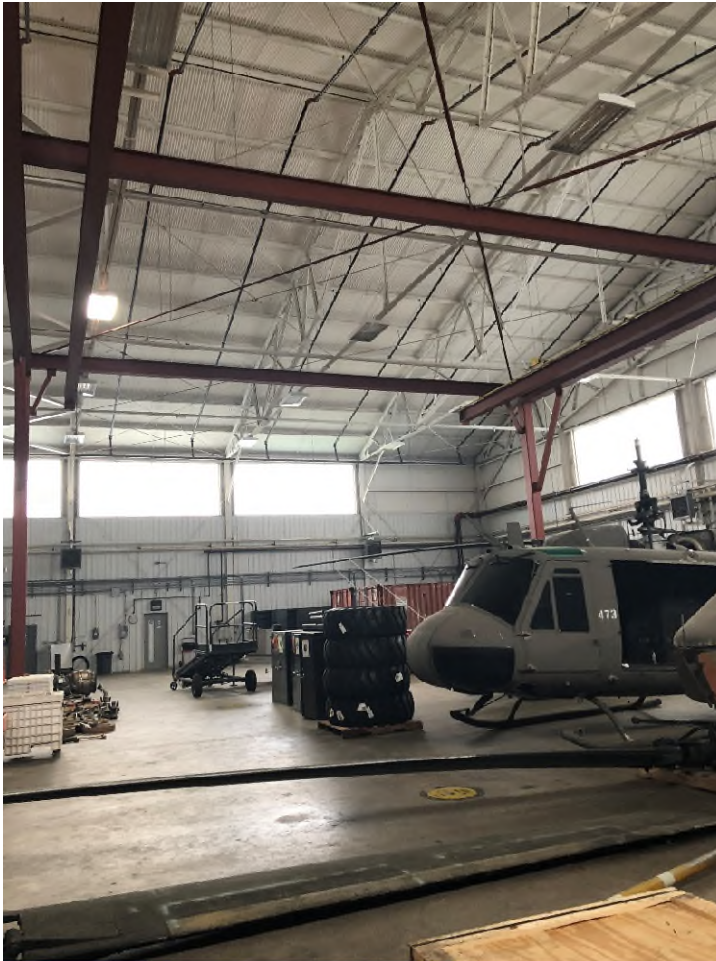
Photograph: 54

Alternative view of
Building E4040 hangar
area.

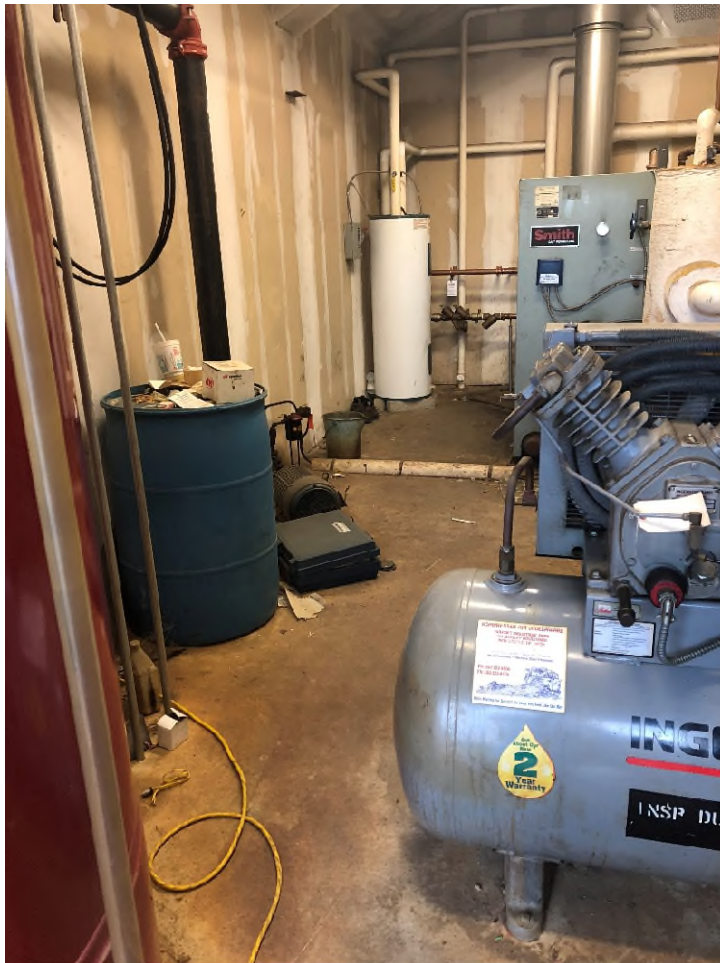
Photograph: 55

Description:
Tank area located
within Building E4040.

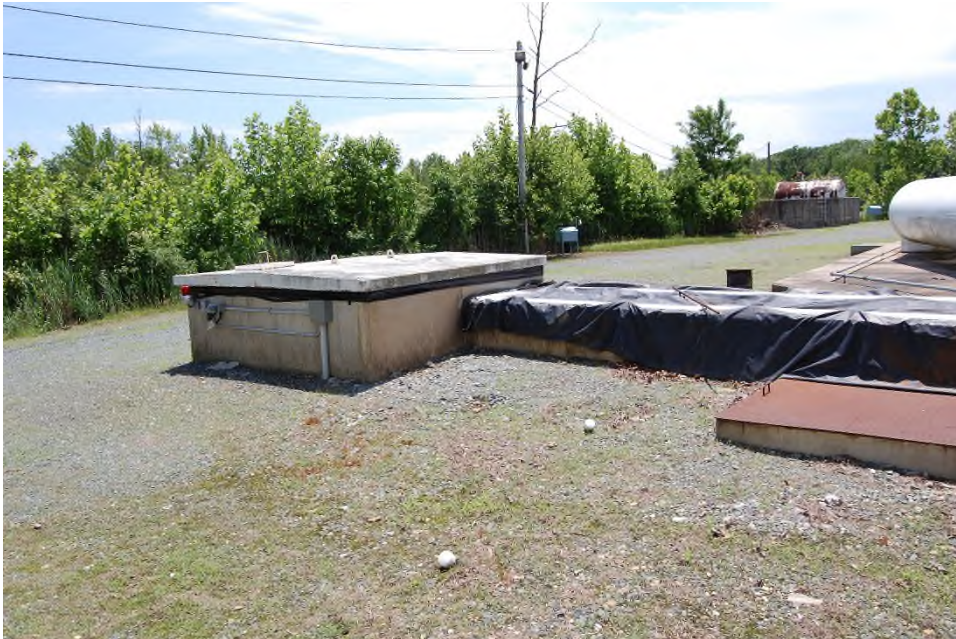
Photograph: 56

Description:
Containment trough
located alongside test
dome area at Ford's
Farm range.

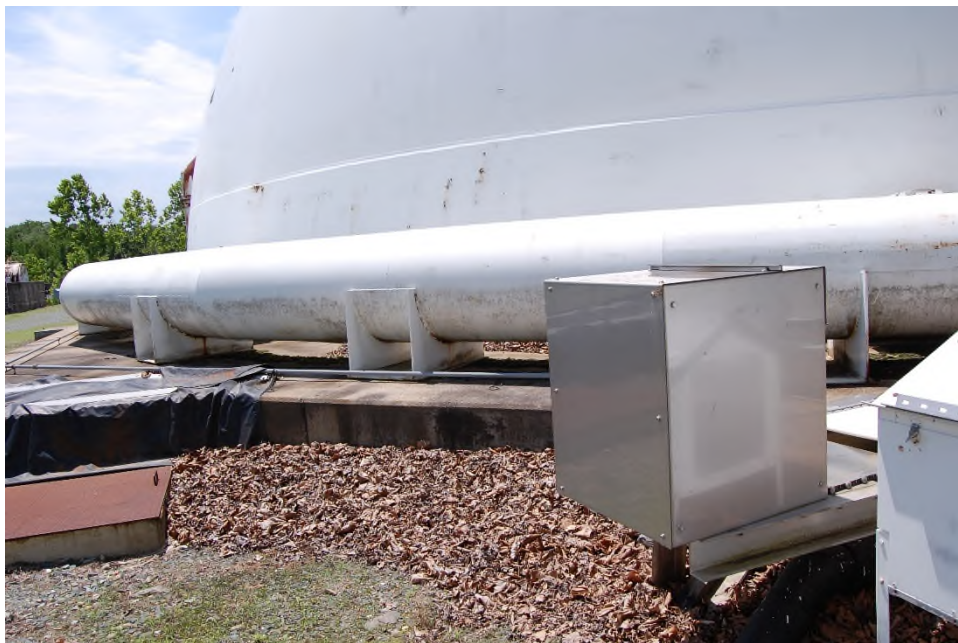
Photograph: 58

Description:
Alternative view of test dome located at Ford's Farm.

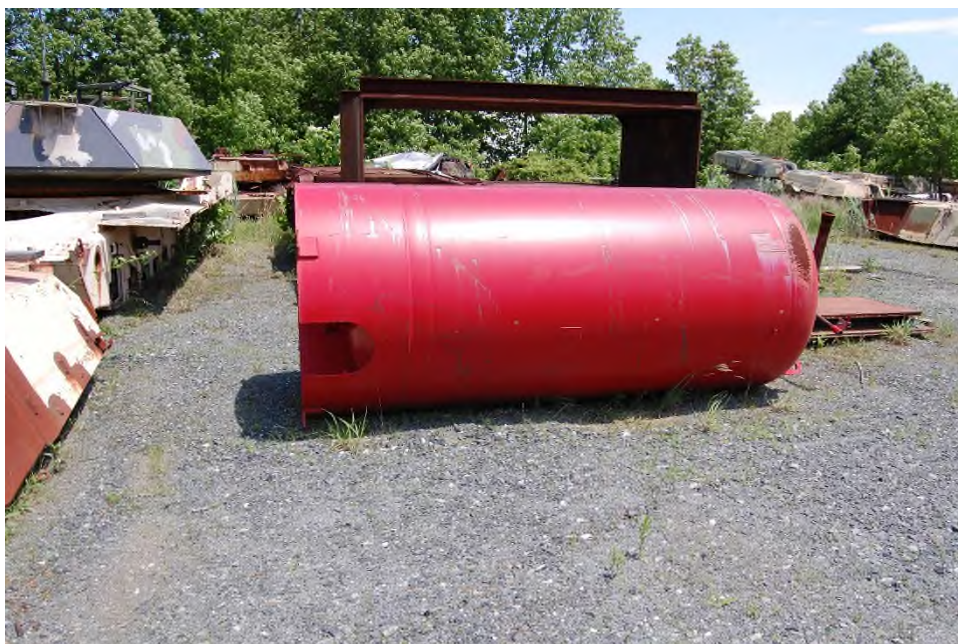
Photograph: 59

Description:
Empty tank used to store AFFF for suppression test exercises.

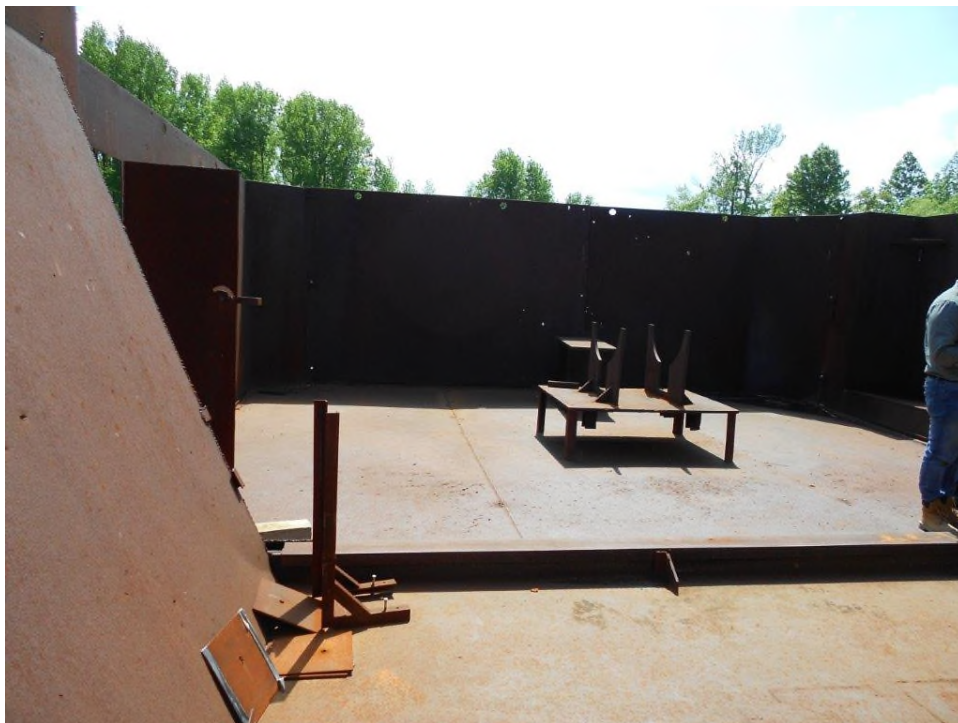
Photograph: 65

Description:
Alternative view of Fuze Range testing area from the range exterior.

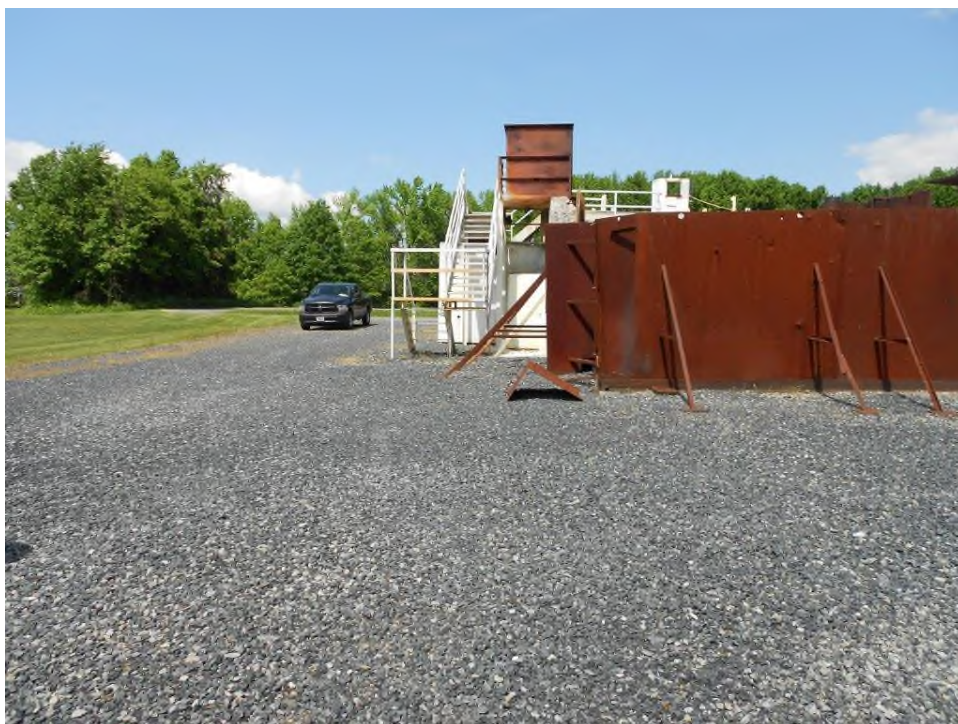
Photograph: 66

Description:
Full view of Fuze Range testing area from southern vantage point.
