APPENDIX H

Site Reconnaissance Photo Log

**APPENDIX H – SITE RECONNAISSANCE PHOTO LOG
USAEC PFAS PRELIMINARY ASSESSMENT/SITE INSPECTION**

Aberdeen Proving Ground, Maryland

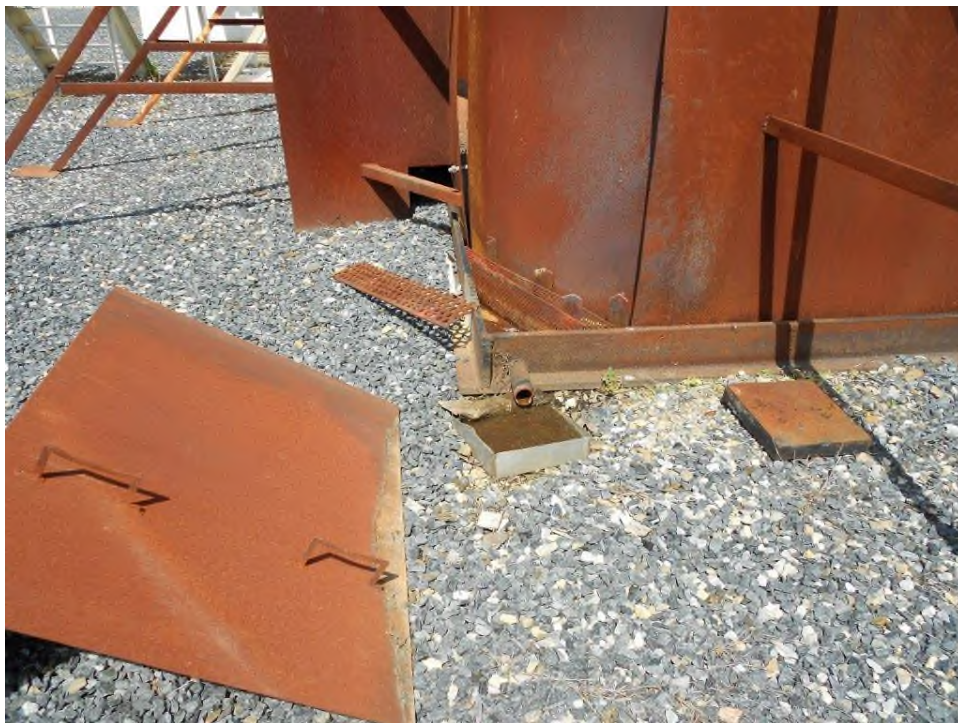
Photograph: 67

Pipe outlet from Fuze Range testing area where fire department personnel extracted test waste (including AFFF) for on-site storage in hazardous-waste containers.

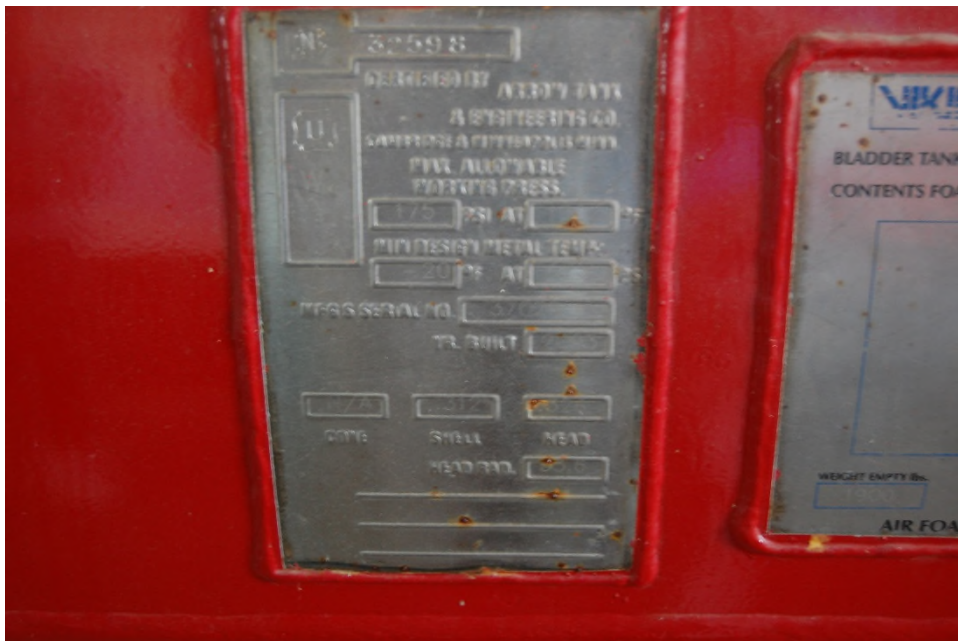
Photograph: 85

Description:
 Close up of decal located on AFFF suppression tank within PAAF Hangar 1060.

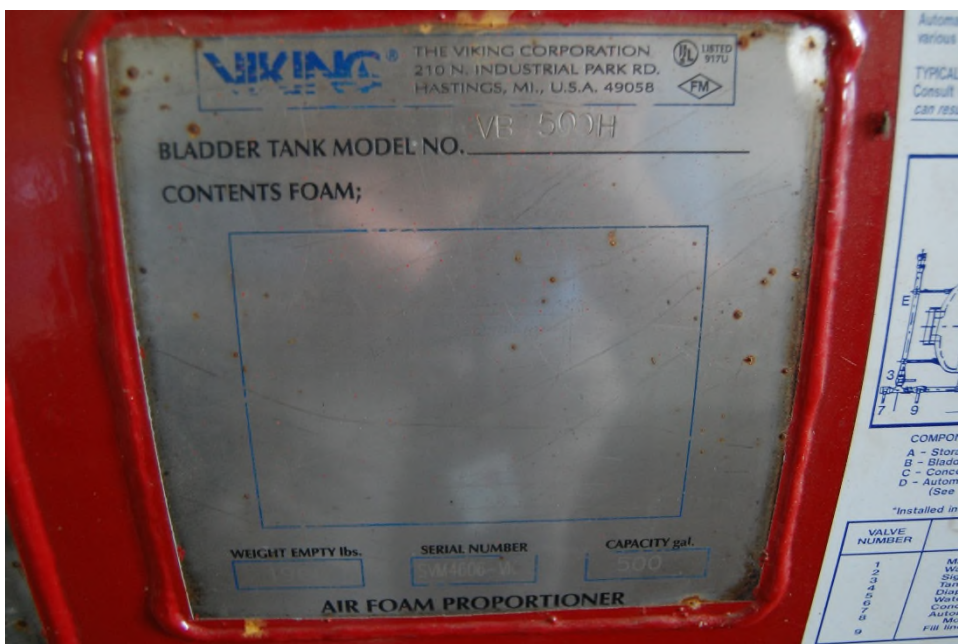
Photograph: 86

Description:
 Close up of decal located on AFFF suppression tank within PAAF Hangar 1060.

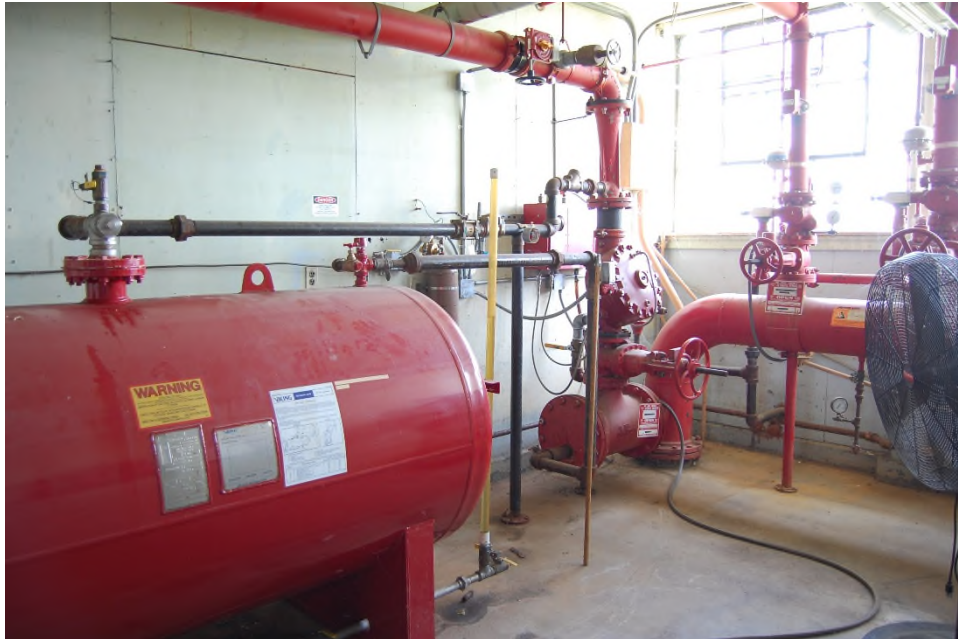
Photograph: 87

Description:
View of AFFF suppression tank and room within PAAF Hangar 1060.

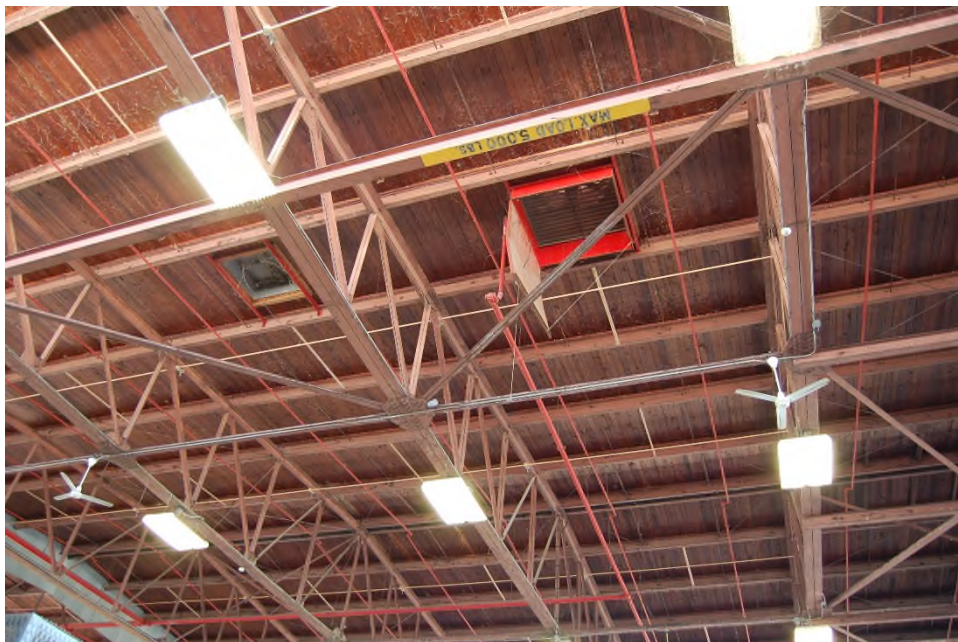
Photograph: 88

Description:
View of the Hangar 1060 ceiling and AFFF suppression system piping.

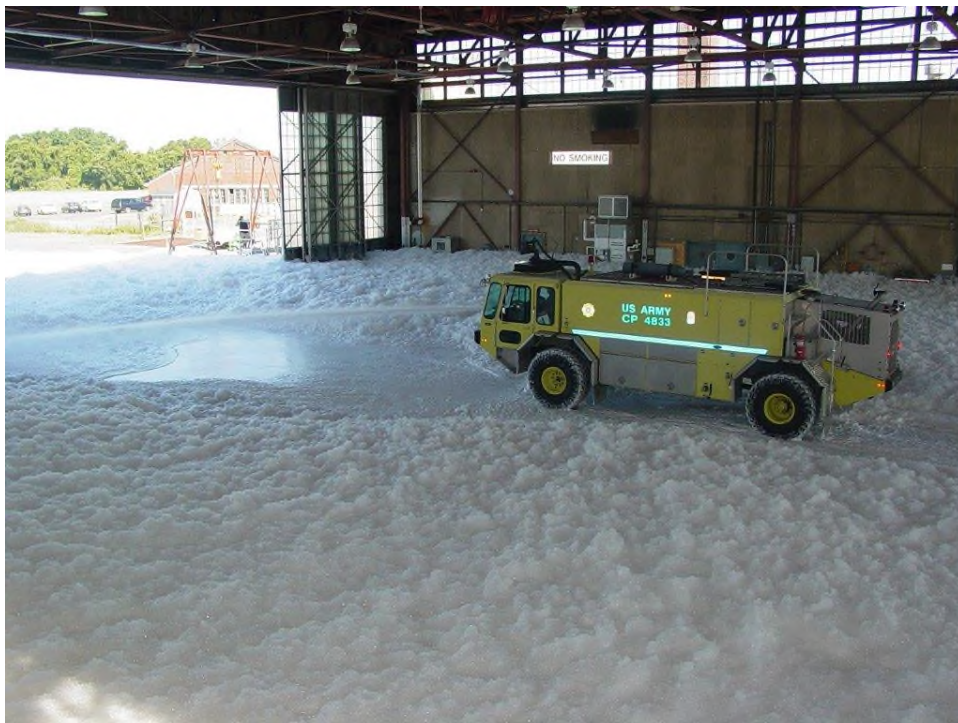
Photograph: 89

Description:
Historical photo showing the release of AFFF within the main hangar of PAAF Hangar 1060.

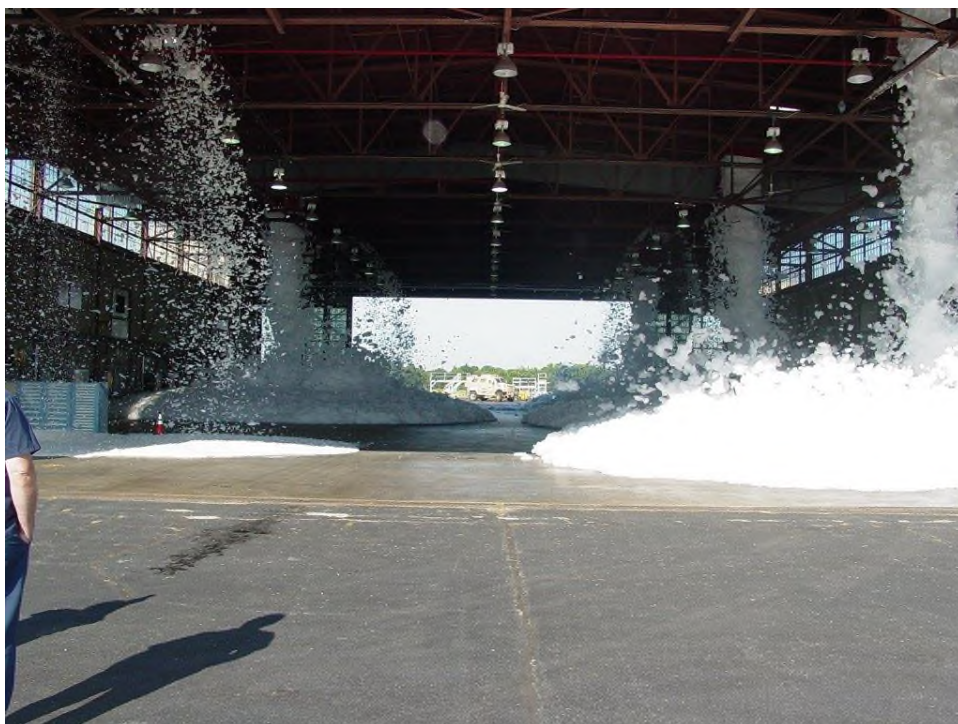
Photograph: 90

Description:
Historical photo showing the release of AFFF from the Hangar 1060 AFFF suppression system.

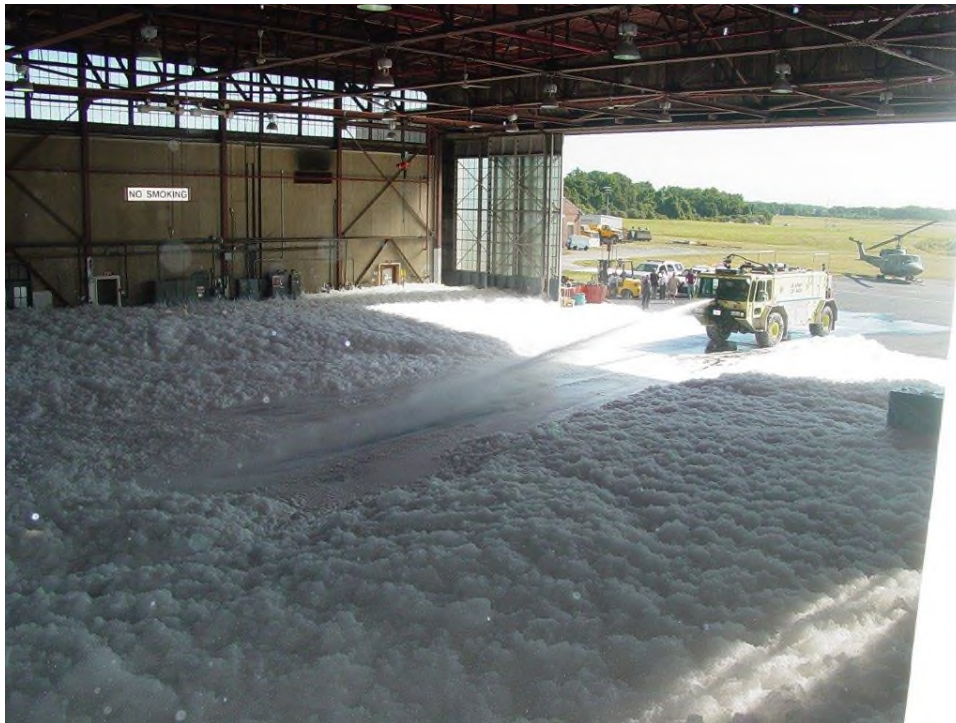
Photograph: 93

Description:
Historical photo showing the interior of Hangar 1060 following AFFF suppression system and fire response testing.

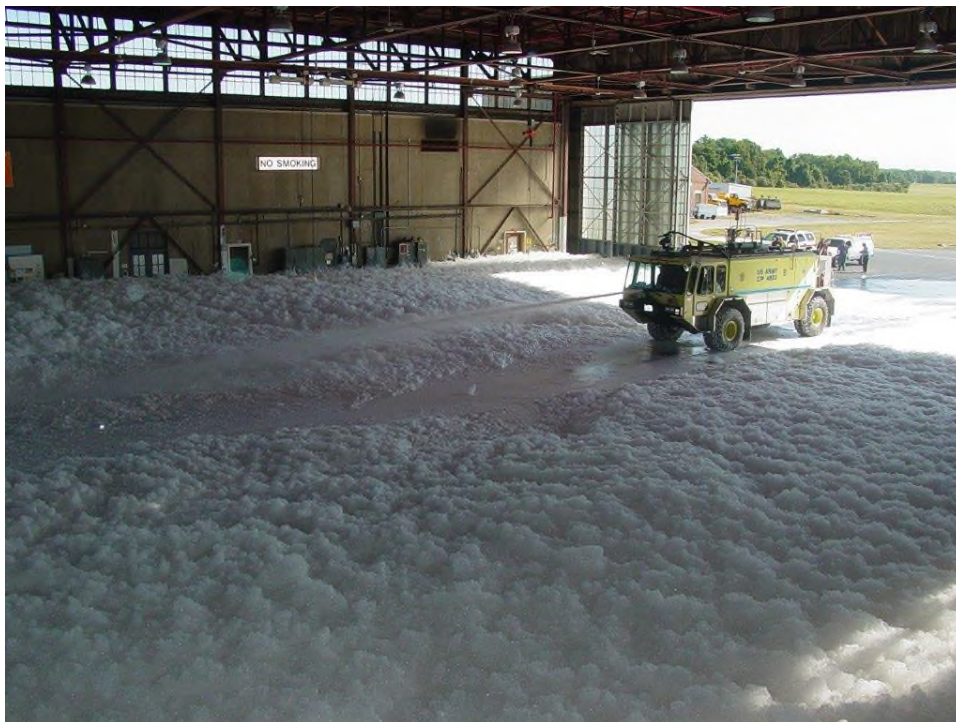
Photograph: 94

Description:
Historical photo showing the interior of Hangar 1060 following AFFF suppression system and fire response testing.

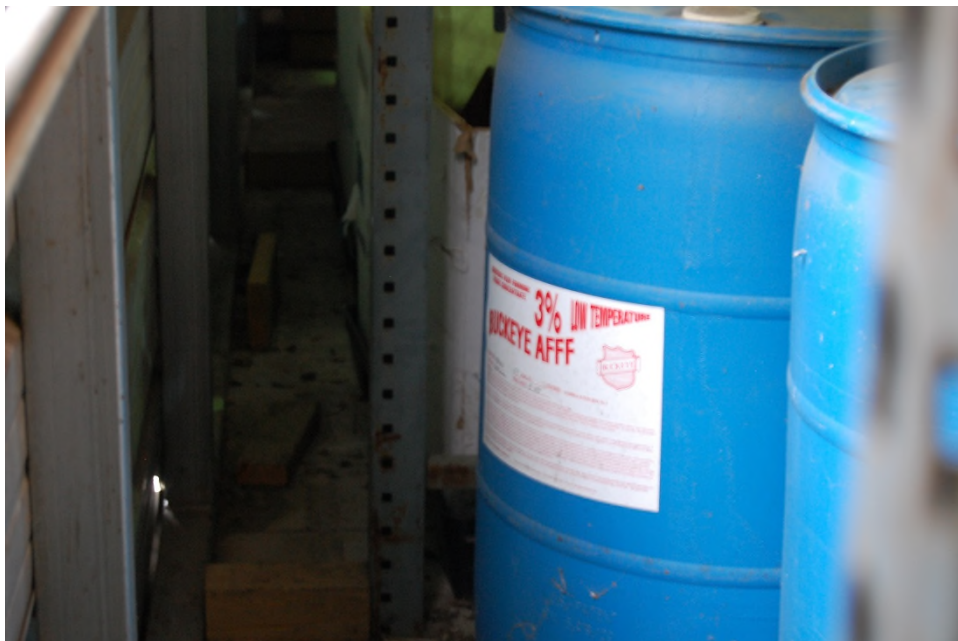
Photograph: 95

Description:
55-gallon drum of 3% Buckeye AFFF observed at the Poverty Island – Minefield Range

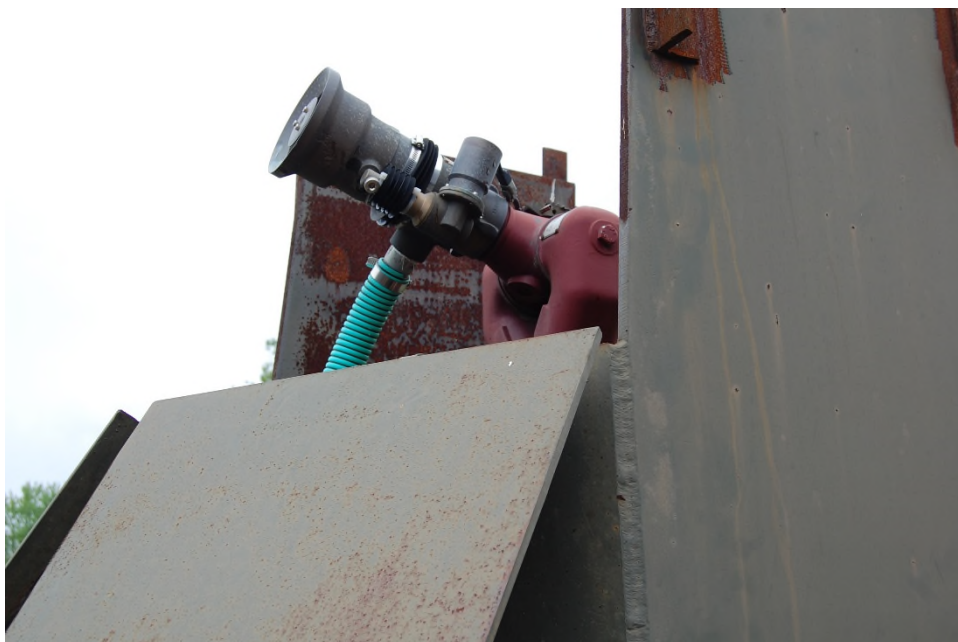
Photograph: 96

Description:
AFFF suppression cannon used to extinguish test fires observed at the Poverty Island – Minefield Range.

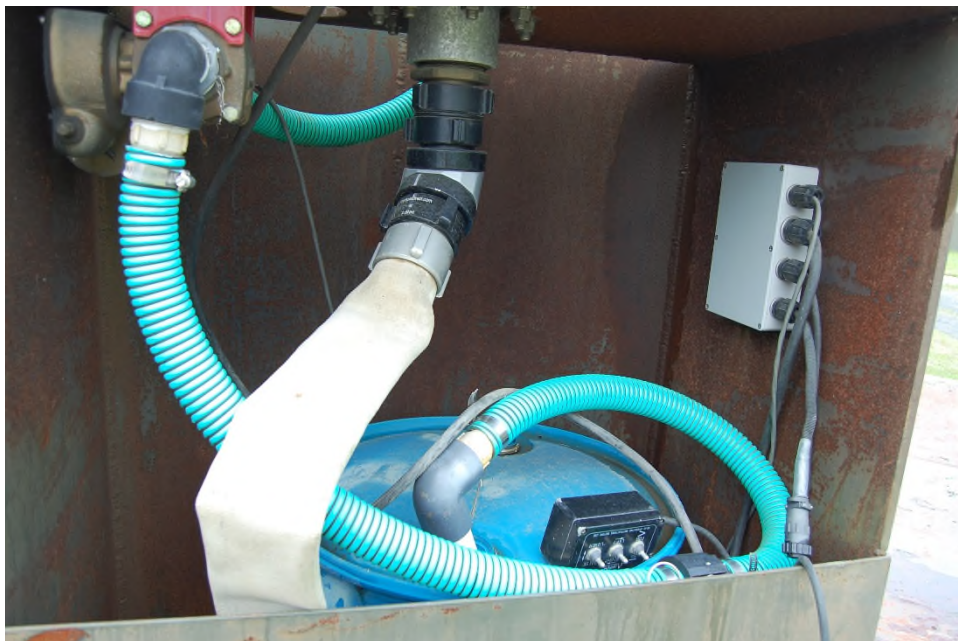
Photograph: 97

55-gallon drum of AFFF connected to an AFFF suppression cannon used to extinguish test fires observed at the Poverty Island – Minefield Range.

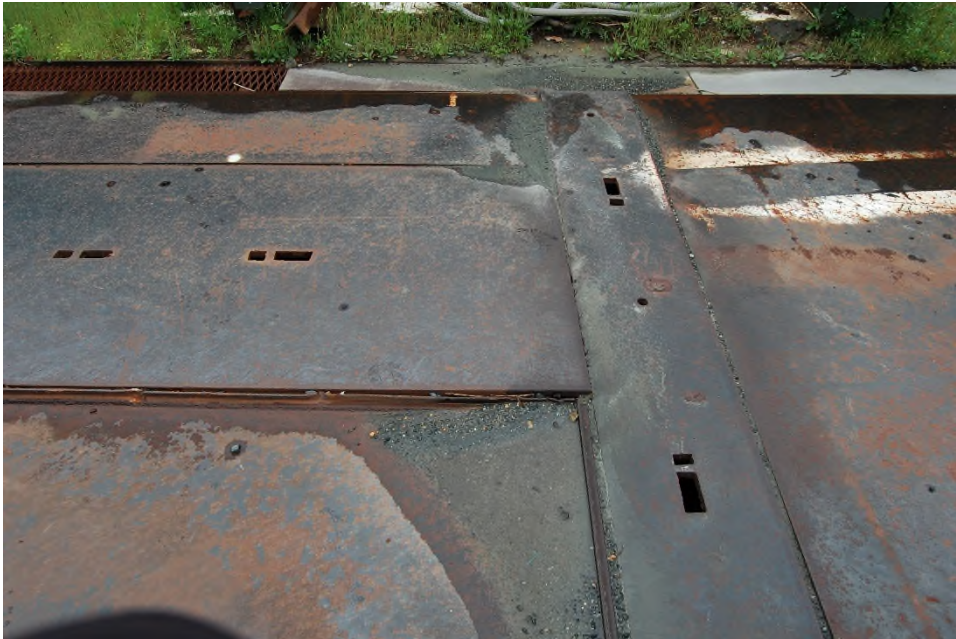
Photograph: 99

Description:
View of Poverty Island
– Minefield Range test
pad.

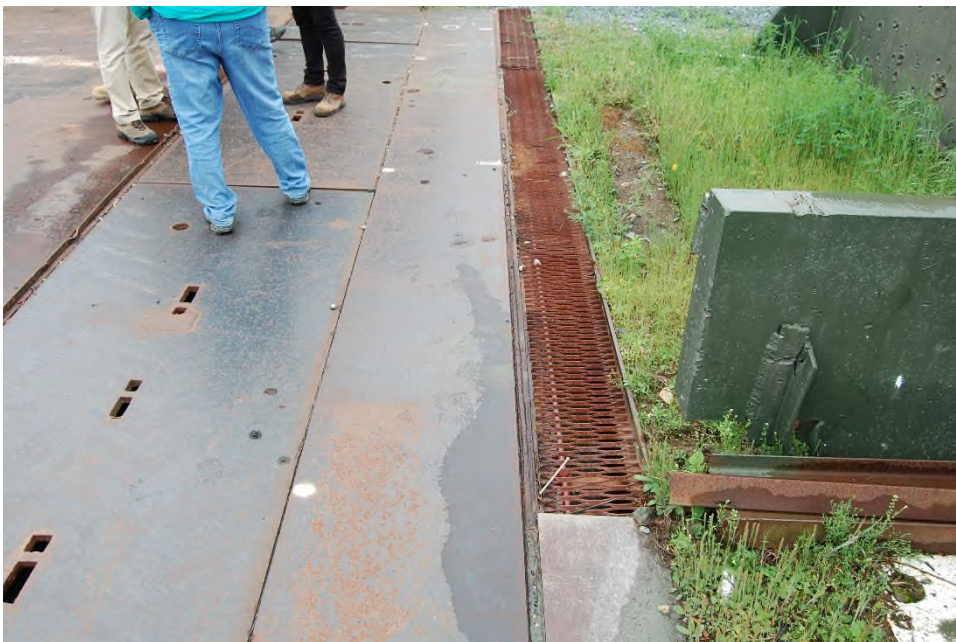
Photograph: 100

Description:
View of Poverty Island
– Minefield Range test
pad along with drainage
inlets to capture test
wastes generated
during testing
exercises.
