Project Name and No.: MSWLF - Limit of Waste Investigation, Fort Bliss, TX

A3. Daily Quality Control Reports

DAILY QUALITY CONTROL REPORT

Site Name	Fort Bliss Municipal Solid Waste Landfill	Weather	
USACE Contract No.	W912BV-19-D-0012 Task Order No. W912BV20F0183	Temperature	71F – 88F
Project Manager		Wind	5 mph – 35 mph
Field Personnel		Humidity	10% - 15%
			Report No. 01

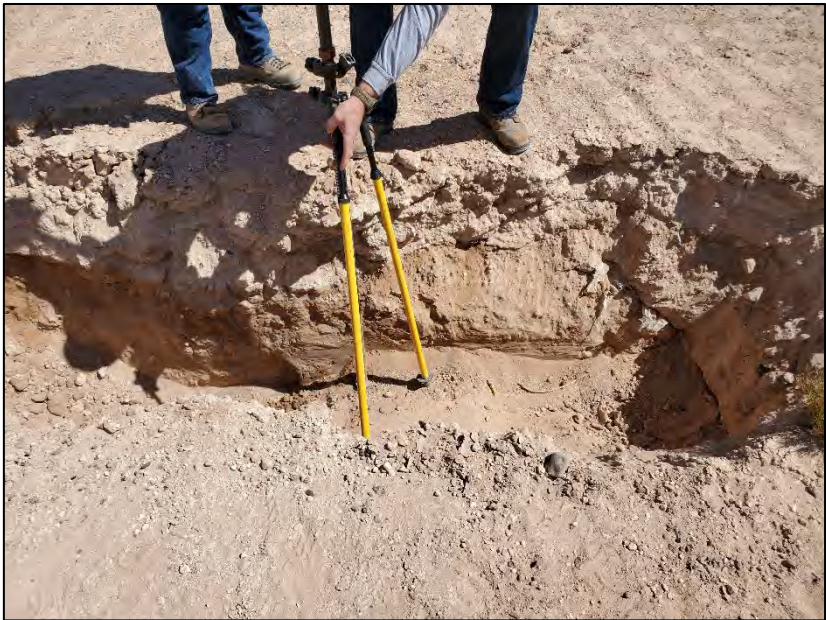
1044- Begin backfilling TT20-21 following logging and mapping of observed waste, which was located approximately 15 feet from the outer edge of the landfill cover.

Description: Plastic trash and rope observed within trench TT20-21 at the right side (east) of the trench. Surveying the western extent of waste within the trench, facing north.

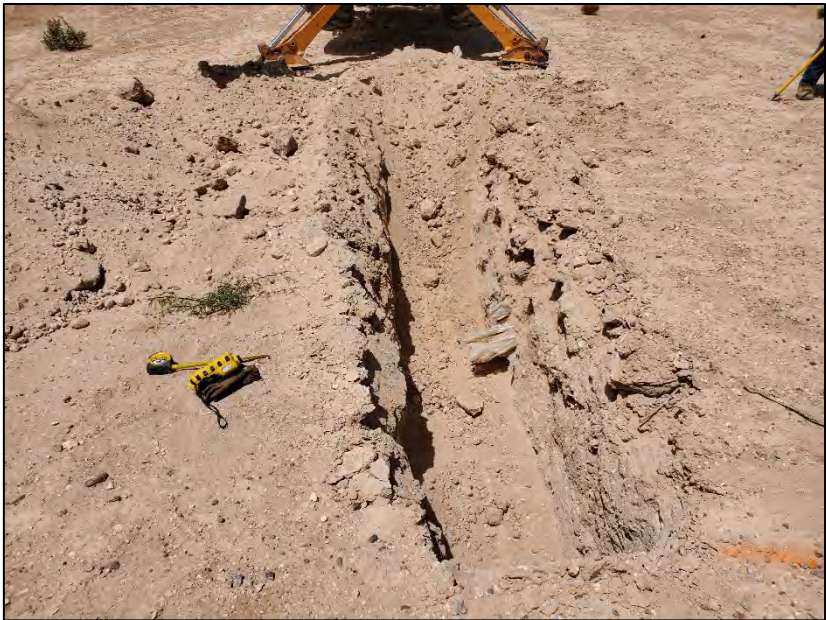
1230- Waste logged and surveyed at TT20-23. Trench backfilled and returned to grade within landfill cover.

Description: Extent excavation and plastic waste observed within trench TT20-23, facing west.

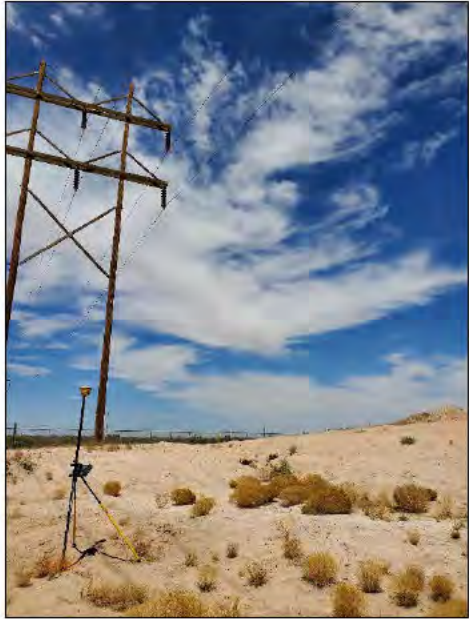
1505- Due to overhead powerlines, actual location for TT20-25 was moved approximately 60 feet southward to ensure adequate distance between the backhoe and the overhead powerlines.

Description: Original location of planned trench TT20-25 was approximately 50 ft east of where the survey staff is located, facing northeast. Trench relocated due to overhead utilities.

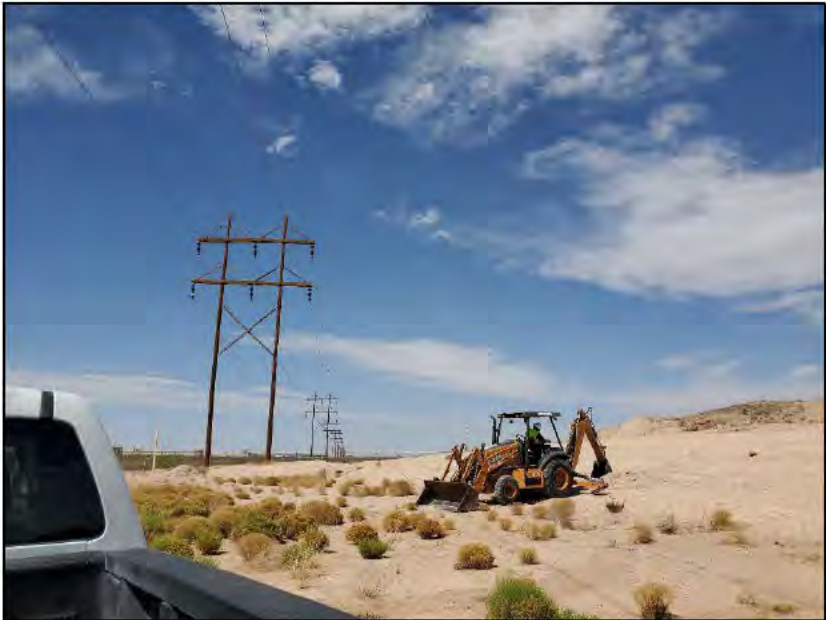
1515- Waste encountered approximately 1.5 feet below grade near western extent of the trench (TT20-25). Due to the presence of overhead powerlines, the backhoe was limited in the availability to move westward and the trenching was terminated at that point. After logging and surveying, the trench was backfilled and returned to the original grade.

Description: Actual location of trench TT20-25 while being backfilled to grade, facing northeast.

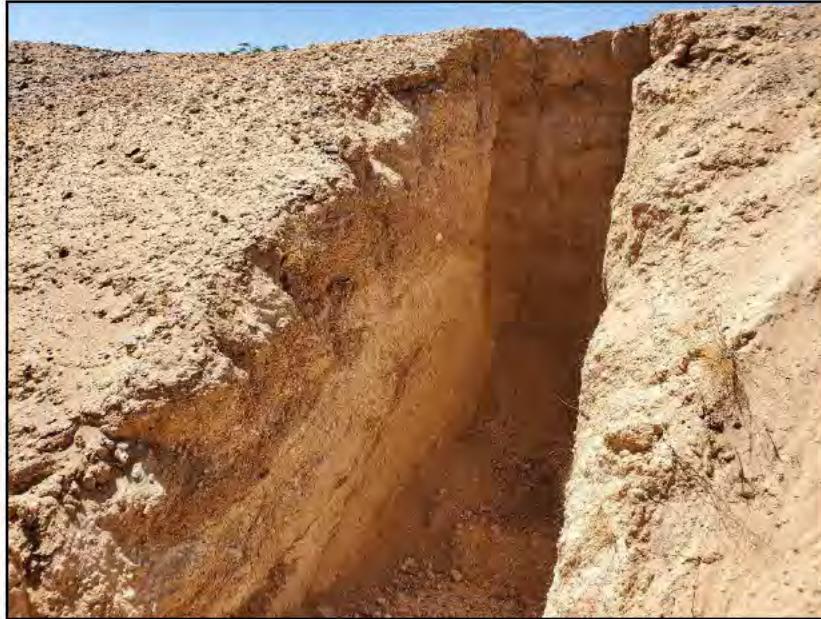
3

1130- During trenching at TT20-05, the backhoe had reached its extent due to the narrow separation between the steep slope of landfill and the fence line. No waste was observed above native soil. [REDACTED] spoke with Scott Brown at Arcadis, and it was decided to move 30 feet westward where the slope was shallower and excavate further southward into the landfill.

Facing south within the excavation for trench TT20-05 at the designated location. No waste observed to the extent of the backhoe.

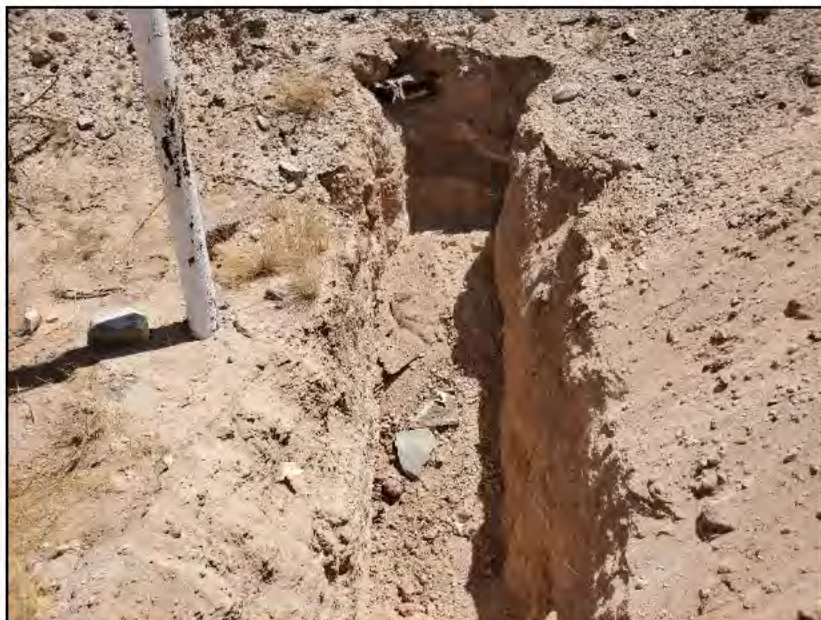
1420- Complete trenching at TT20-05-2; waste observed approximately 3 feet outside of the white post that designates the limit of the landfill. Excavation left open and caution tape to be installed around the perimeter until it is surveyed.

Facing south within the excavation for trench TT20-05-2 at the alternate location, 30 feet west of TT20-05.

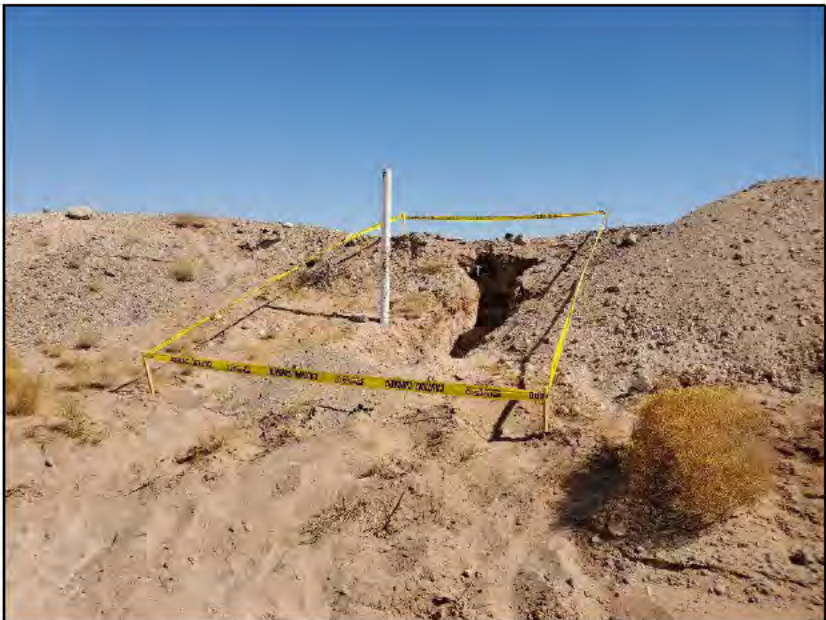
Description: Trench TT20-05-2 remaining open until replacement survey equipment arrives onsite. Caution tape installed around the perimeter, facing south. Typical.

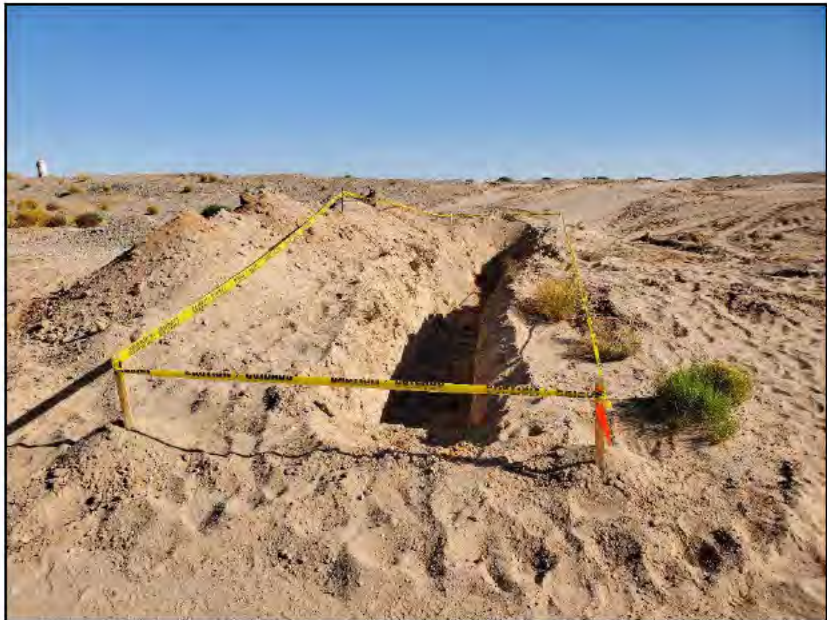
Description: Trench TT20-07 remaining open until replacement survey equipment arrives onsite. Caution tape installed around the perimeter, facing south. Typical at all open excavations.
