Project Name and No.: MSWLF - Limit of Waste Investigation, Fort Bliss, TX

A3. Daily Quality Control Reports

DAILY QUALITY CONTROL REPORT

Site Name	Fort Bliss Municipal Solid Waste Landfill	Weather	
USACE Contract No.	W912BV-19-D-0012 Task Order No. W912BV20F0183	Temperature	71F – 88F
Project Manager		Wind	5 mph – 35 mph
Field Personnel		Humidity	10% - 15%
		Report No.	01

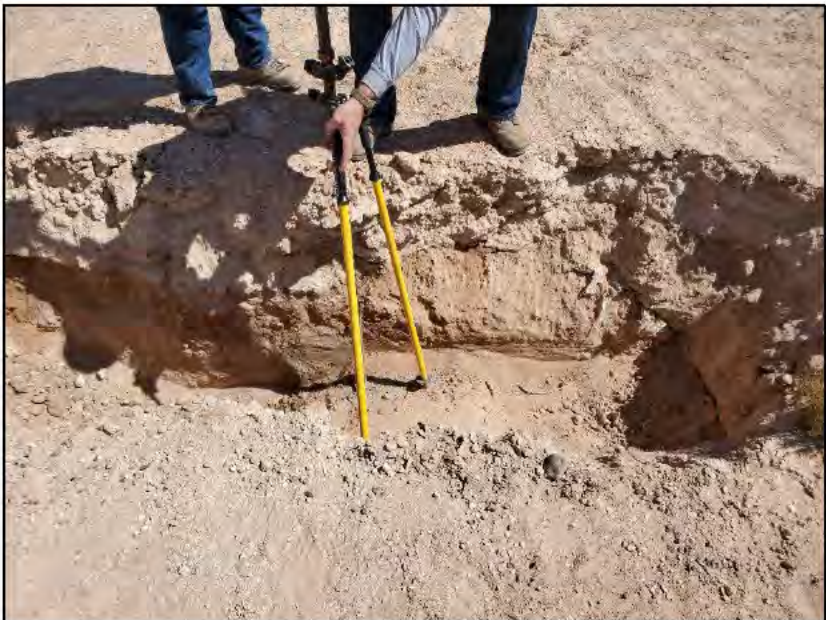
Description: Plastic trash and rope observed within trench TT20-21 at the right side (east) of the trench. Surveying the western extent of waste within the trench, facing north.

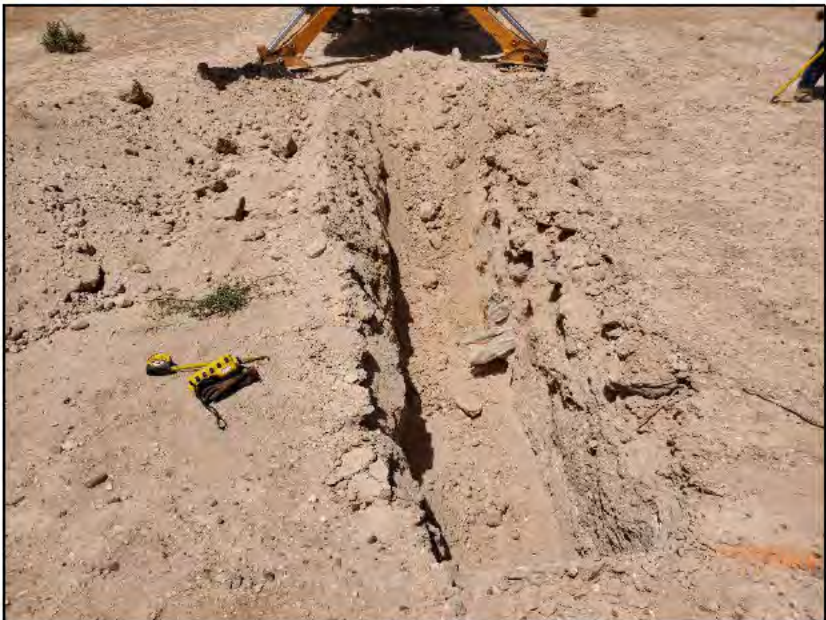
1230- Waste logged and surveyed at TT20-23. Trench backfilled and returned to grade within landfill cover.

Description: Extent excavation and plastic waste observed within trench TT20-23, facing west.

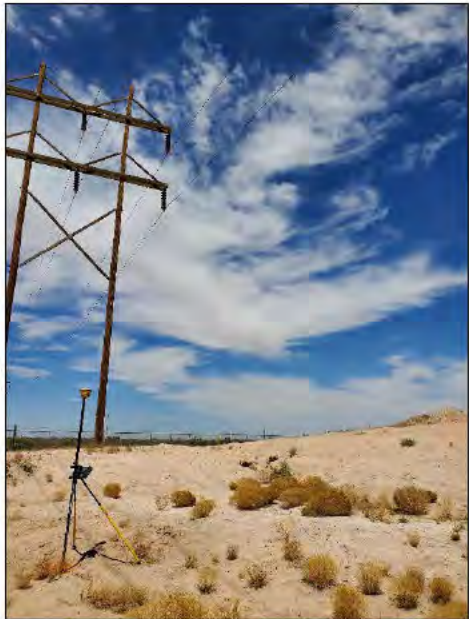
1505- Due to overhead powerlines, actual location for TT20-25 was moved approximately 60 feet southward to ensure adequate distance between the backhoe and the overhead powerlines.

Description: Original location of planned trench TT20-25 was approximately 50 ft east of where the survey staff is located, facing northeast. Trench relocated due to overhead utilities.

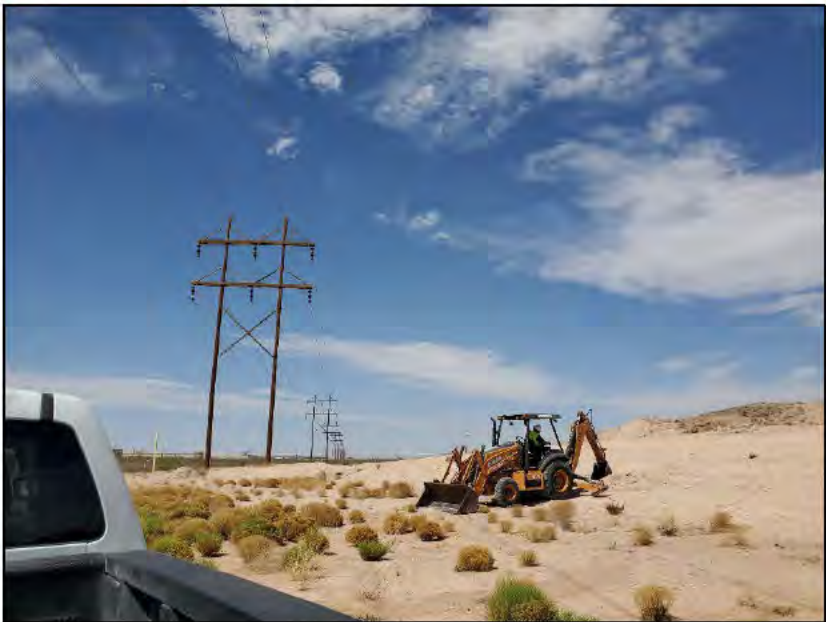
1515- Waste encountered approximately 1.5 feet below grade near western extent of the trench (TT20-25). Due to the presence of overhead powerlines, the backhoe was limited in the availability to move westward and the trenching was terminated at that point. After logging and surveying, the trench was backfilled and returned to the original grade.

Description: Actual location of trench TT20-25 while being backfilled to grade, facing northeast.

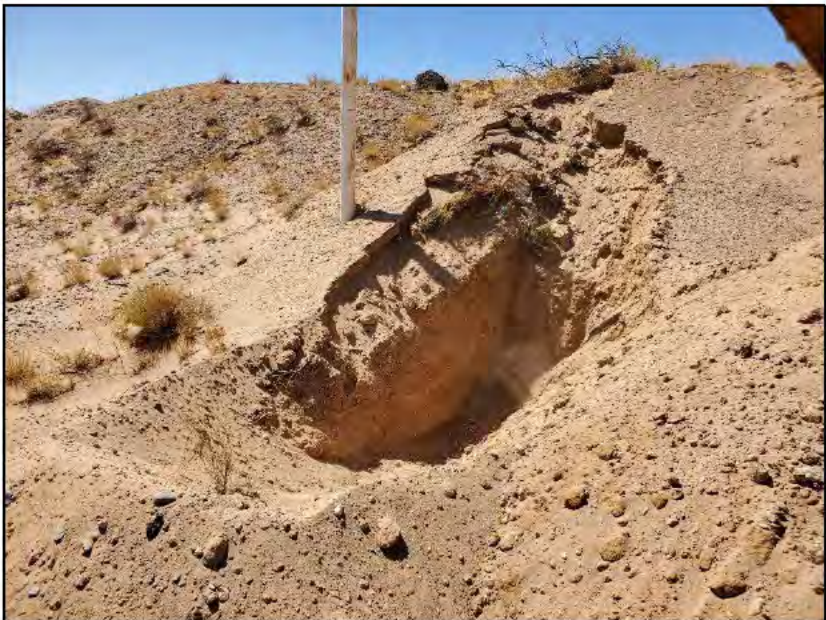
1030- Complete trenching at TT20-04; waste observed at the large white post that designates the edge of the landfill. Excavation remains open with caution tape installed around perimeter, pending survey tomorrow. Relocate to begin trenching at TT20-05 within steep slope.

Description: Plastic trash observed within trench TT20-04 immediately at the white post for the landfill extent; facing southeast.

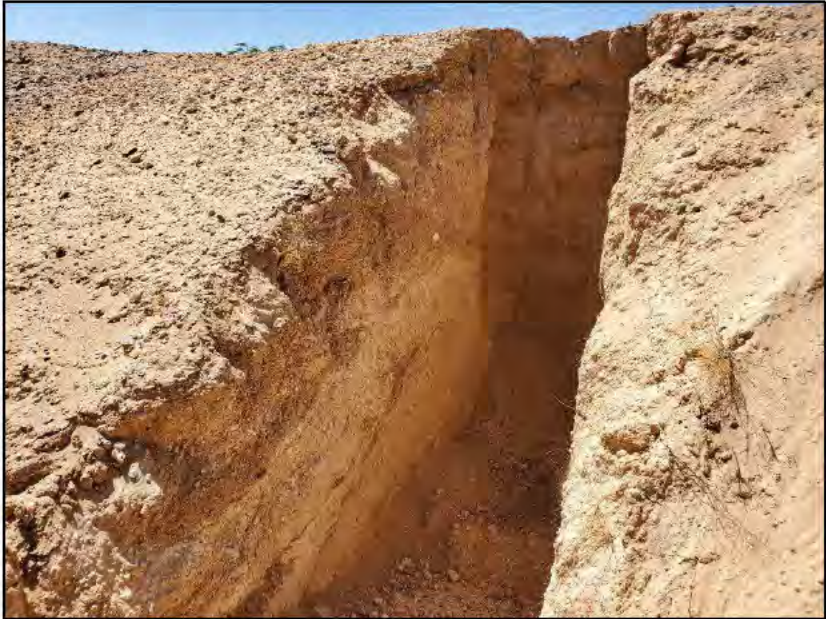
1130- During trenching at TT20-05, the backhoe had reached its extent due to the narrow separation between the steep slope of landfill and the fence line. No waste was observed above native soil. JP spoke with [REDACTED], and it was decided to move 30 feet westward where the slope was shallower and excavate further southward into the landfill.

Description: Facing south within the excavation for trench TT20-05 at the designated location. No waste observed to the extent of the backhoe.

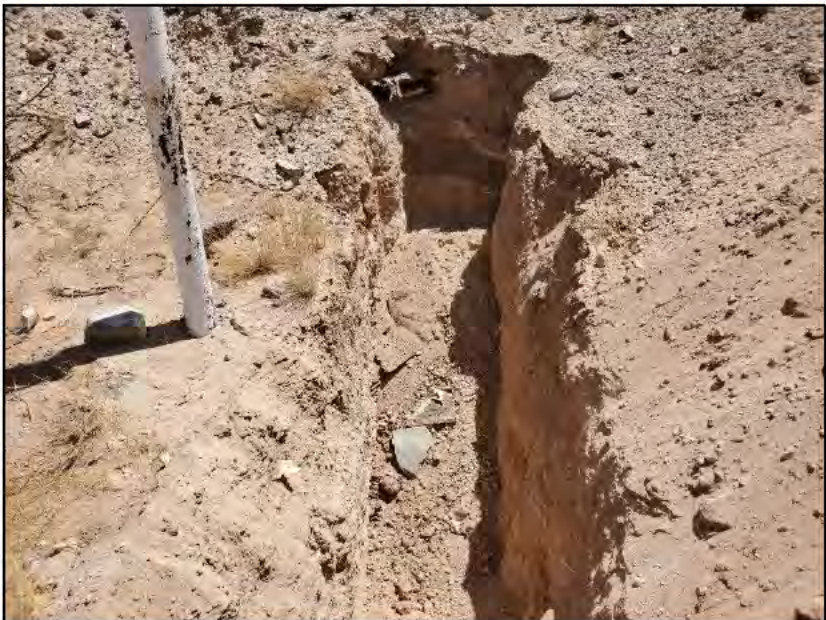
1420- Complete trenching at TT20-05-2; waste observed approximately 3 feet outside of the white post that designates the limit of the landfill. Excavation left open and caution tape to be installed around the perimeter until it is surveyed.

Description: Facing south within the excavation for trench TT20-05-2 at the alternate location, 30 feet west of TT20-05.

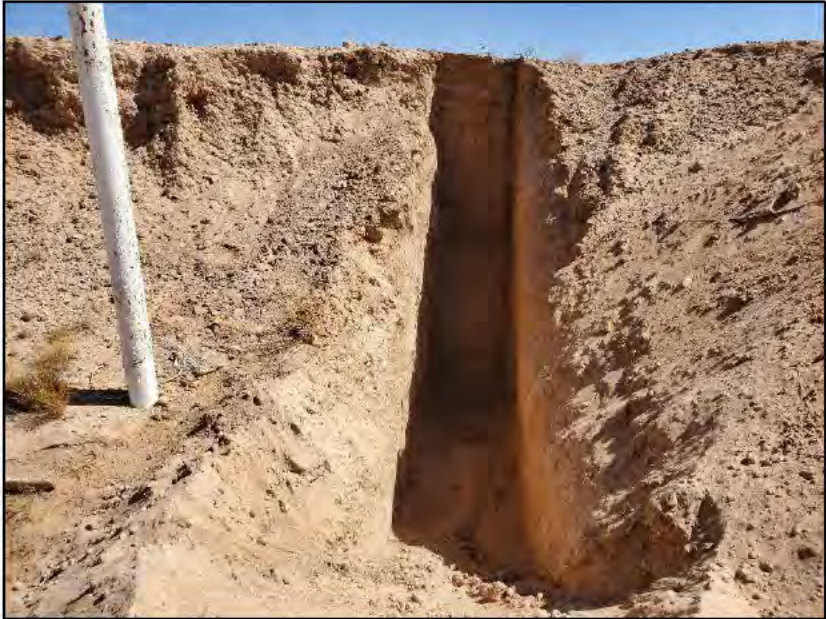
1550- No waste was observed in trench TT20-06-2. Trench extended 9 feet south of the white post that designates the limit of the landfill, and to native soil at a maximum depth of 8.5 feet below the top of the berm and landfill cover. As shown on Figure 2, "2020 Proposed Trench and Pit Locations", trench TT20-06 is shown at the eastern extent of the assumed cell boundary of Cell 3. No waste was observed at the proposed location (TT20-06) nor the second location (TT20-06-2) that was 28 feet west. Begin backfilling to existing grade. JP offsite.

Description: Facing south within the excavation for trench TT20-06-2 at the relocated position, 28 feet west of the designated location TT20-06. No waste observed.

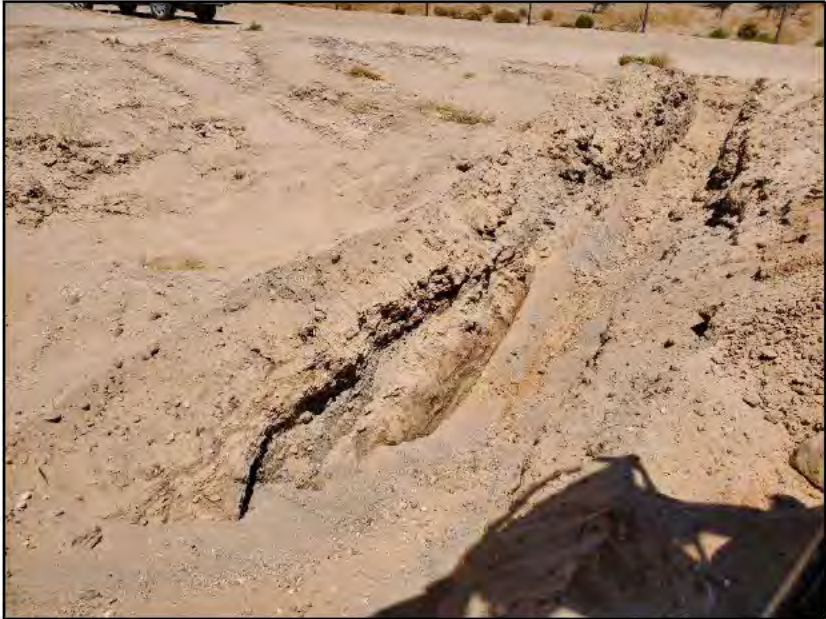
Title: Quality Control Manager

Description: Asphalt debris seam along western side of trench TT20-07, facing north.

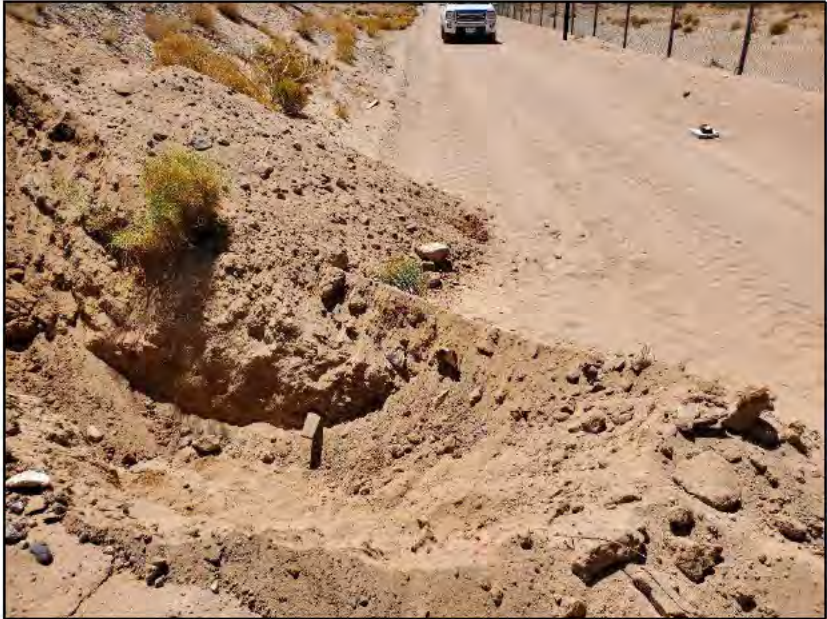
1515- TT20-09 excavation logged at current condition and left open, pending survey and decision on path forward. DS proceed to cordon off open trenches that were completed earlier in the day.

Description: Waste present within excavation at TT20-09 at the interface with the northern perimeter road, facing west.
