**ELIGIBILITY ASSESSMENT OF CHILDERS HOUSE, BUILDING 6081,
FT. CAMPBELL, KENTUCKY**

**Prepared for:
USACE Louisville District
600 Martin Luther King Drive
Louisville, Kentucky 40202-2232**

**Prepared by:
Samiran Chanchani, Ph.D
Principal Investigator
BHE Environmental, Inc.
11733 Chesterdale Road
Cincinnati OH 45246-3405
www.bheenv.com**

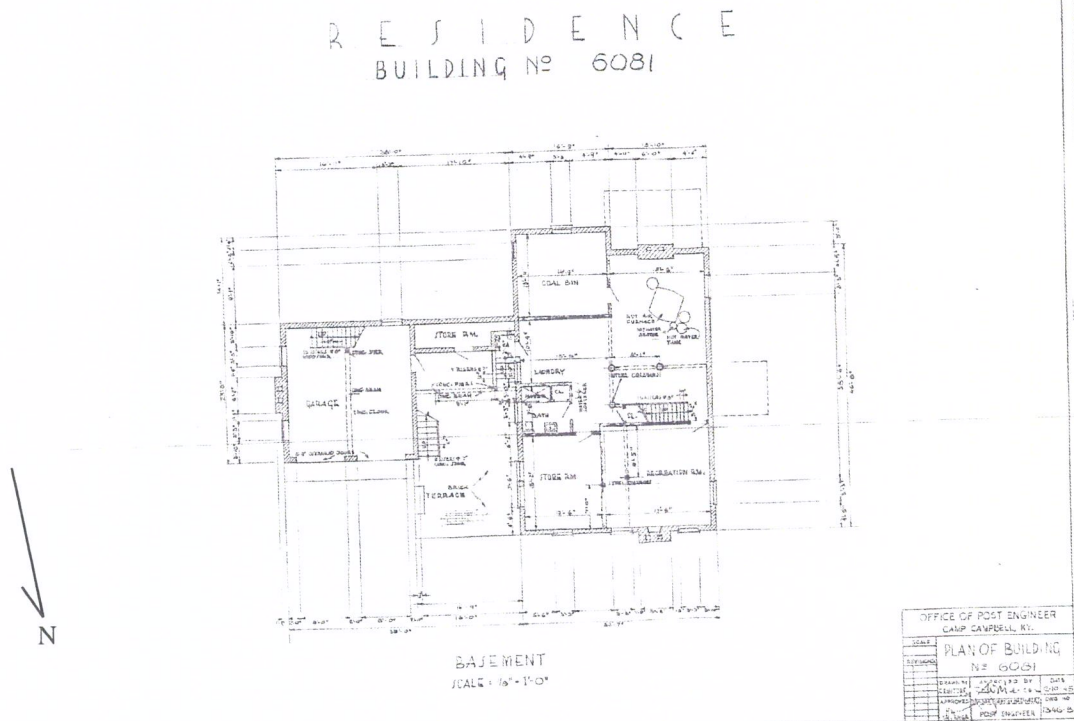
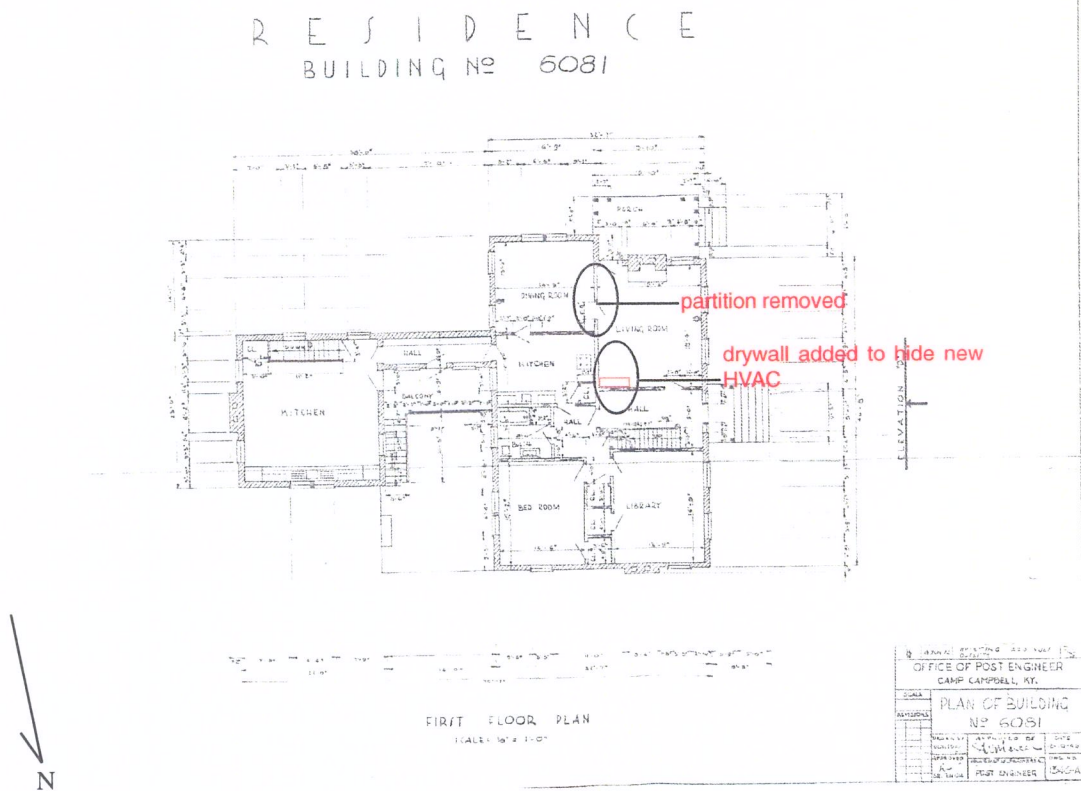
Fig. 11 (a) & (b): Basement and First Floor Plans of Childers House, Post Engineers, Camp Campbell, 1947. The partition between the living and dining rooms has been removed, and drywall added, as and where indicated in the drawing

BHE recommends that the same practice be continued for any new drawings that are made for the Childers House, and that these new drawings be made using AutoCAD, Microstation, or another drawing and design computer application. BHE also recommends that if any revisions are made, the older versions of the drawings be stored on CD-ROMs as historical records to changes in the property. BHE recommends that at least three more Elevation Drawings – one for each façade - and at least two Sectional Drawings be made if the relevant portions of the façade and interior are accessible and can be measured. In addition, a part plan showing the latest condition of the Living and Dining Rooms without the partition needs to be made.

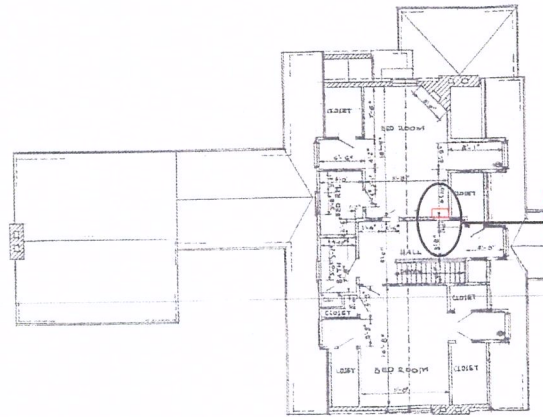
drywall added to hide new
HVAC

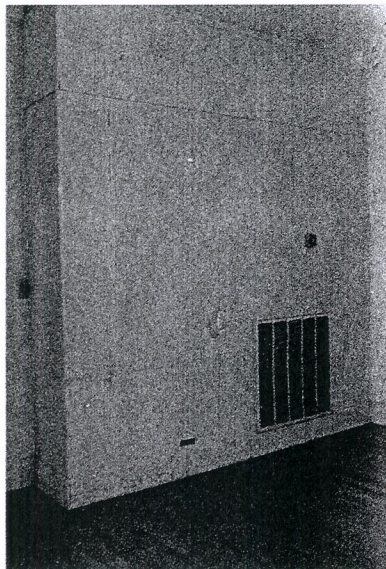
20

Inside, certain clues reveal that the structure has been partly modified. The most significant of these is associated with changing heating systems over the years. Initially the building’s heating plant was a hot water or steam boiler that circulated to radiator cabinets positioned throughout the house. A variety of indicators, observed during the survey, show that original radiator cabinets have been removed. First, pipe holes that would have lead from the boiler to the radiators remain in the floor near the walls. Second, in the same places, newer sections of base trim were mated into the trim at those places where the radiator cabinets were located. Third, in the entry hall, the Anaglypta wall covering was painted over except where it had been behind radiator cabinets; these sections remain unpainted, marking the original locations of the missing radiators (Fig. 19). The 1947 Post Engineers’ drawings identify a forced air furnace in the basement, but neither that nor its ductwork is currently used. A pair of high efficiency, gas-fired, combination heating/air-conditioning units replaced the earlier air system. This resulted in a major alteration to the building to accommodate the new ducts, with a large hole cut in the first

Fig. 20: View of the living room showing the built-out wall, looking northeast
