ROCKY MOUNTAIN ARSENAL

ANNUAL COVERS REPORT FOR INTEGRATED COVER SYSTEM 2023

**Revision 0
November 15, 2023**

**U.S. Department of the Army
Shell Oil Company**

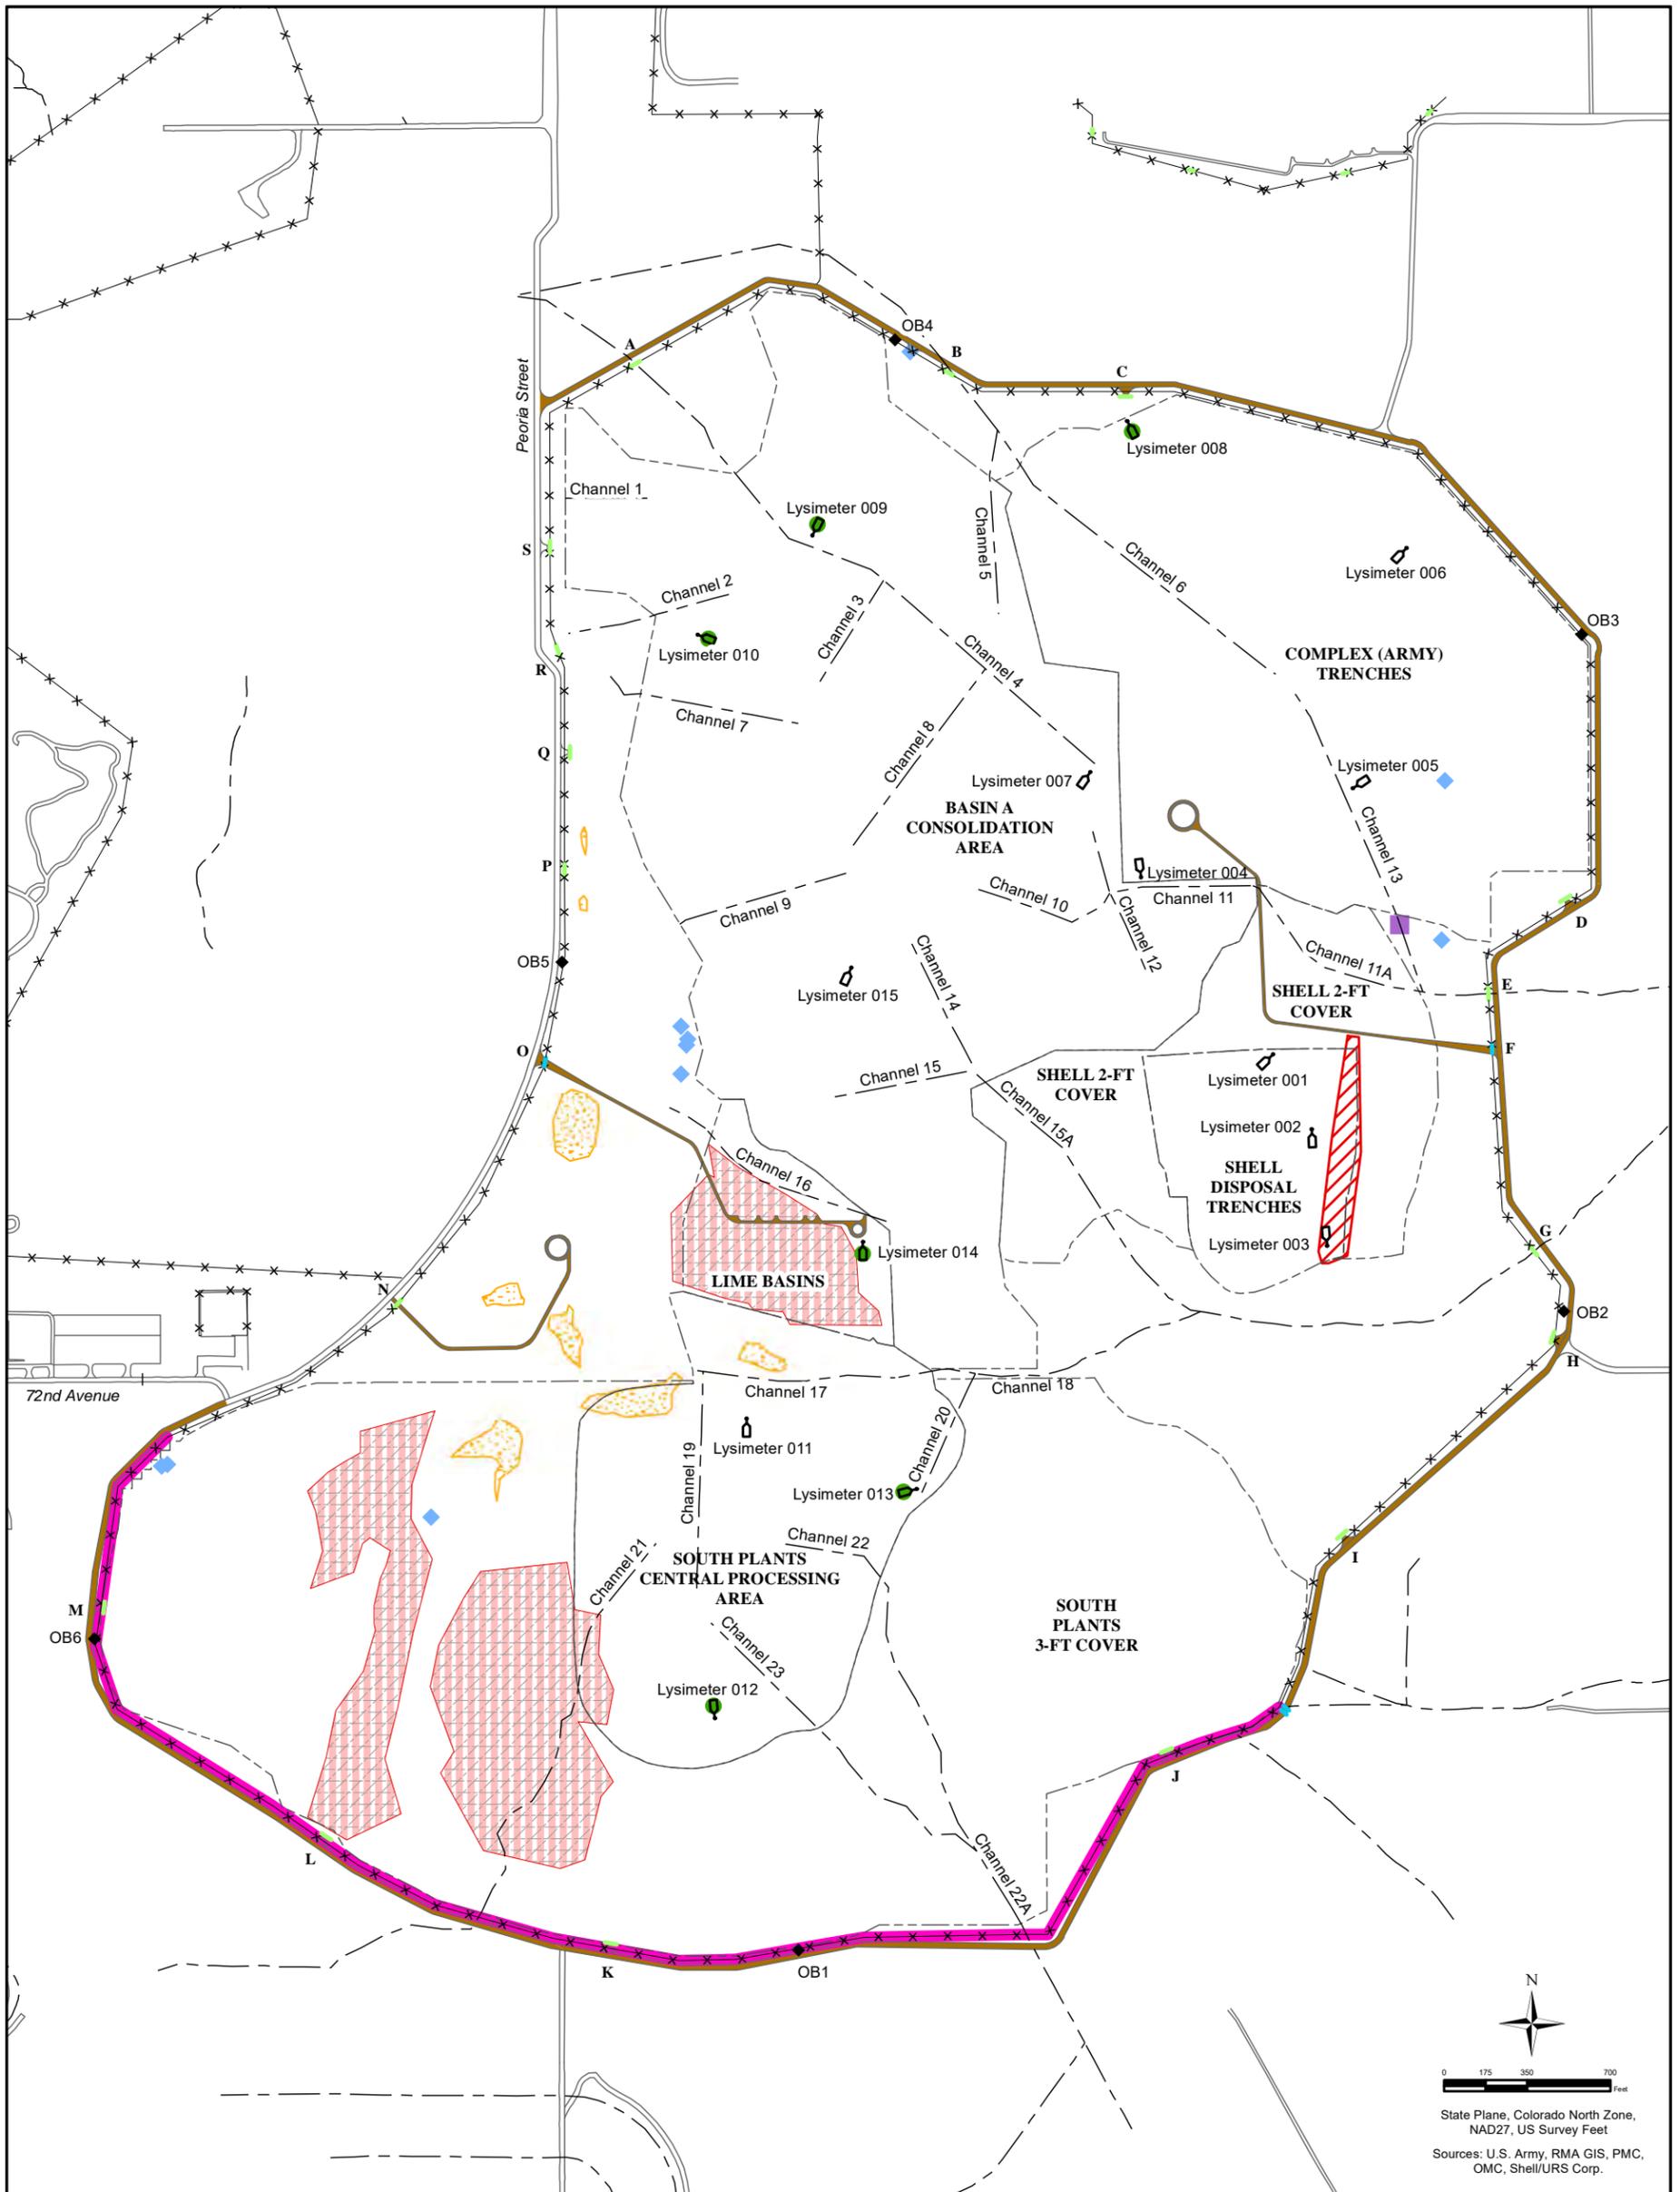
Other maintenance-related observations were made during normal field activities, independent from formal pre-scheduled inspections. The repair actions associated with these observations are also shown on Figure 4.0-1 and are described below.

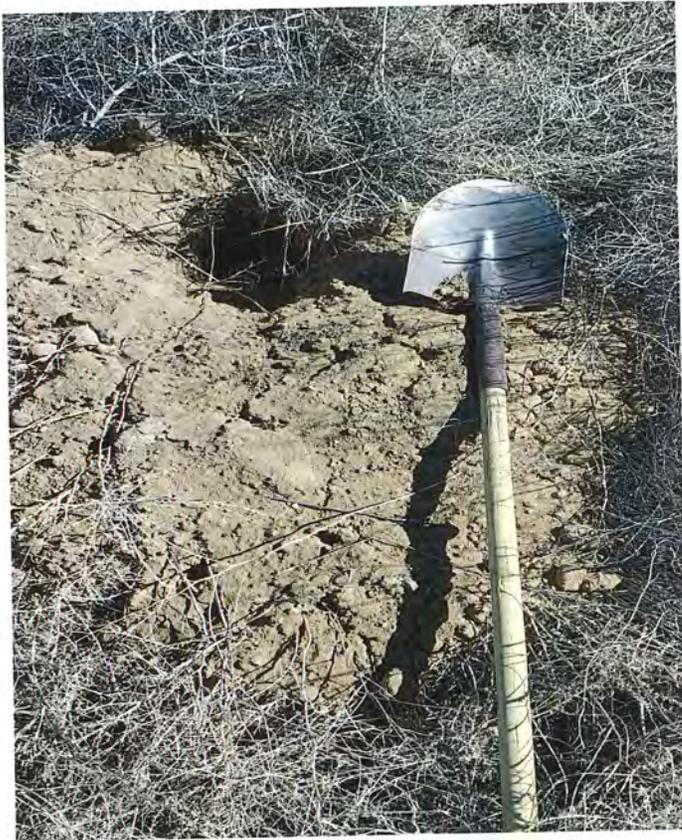
Photo 1

An example of a hole observed and backfilled

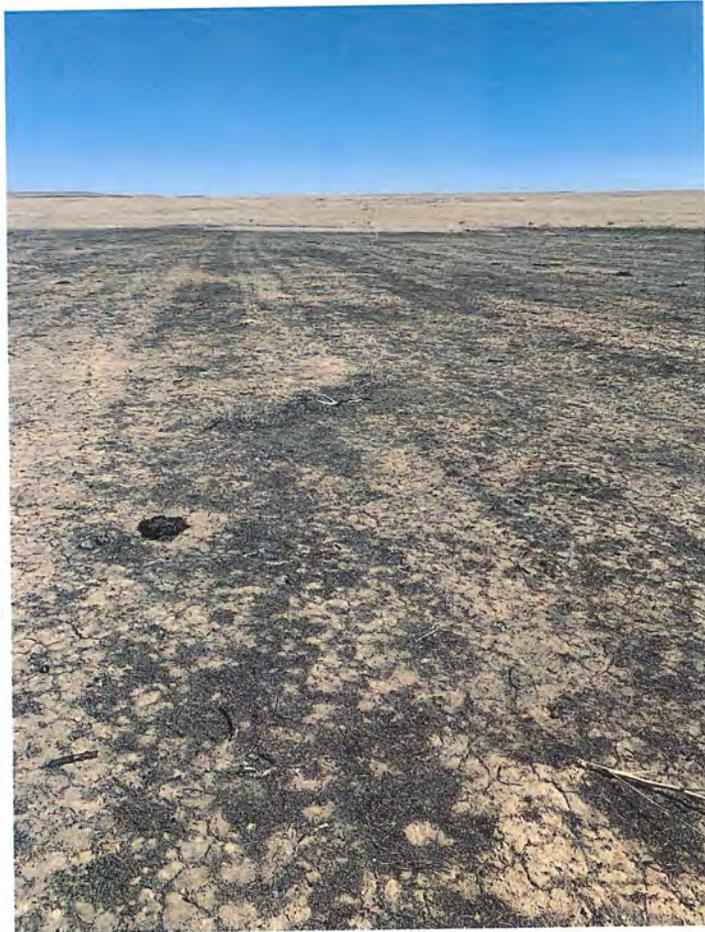
Photo 3
The bare area observed in the
prescribed burn area

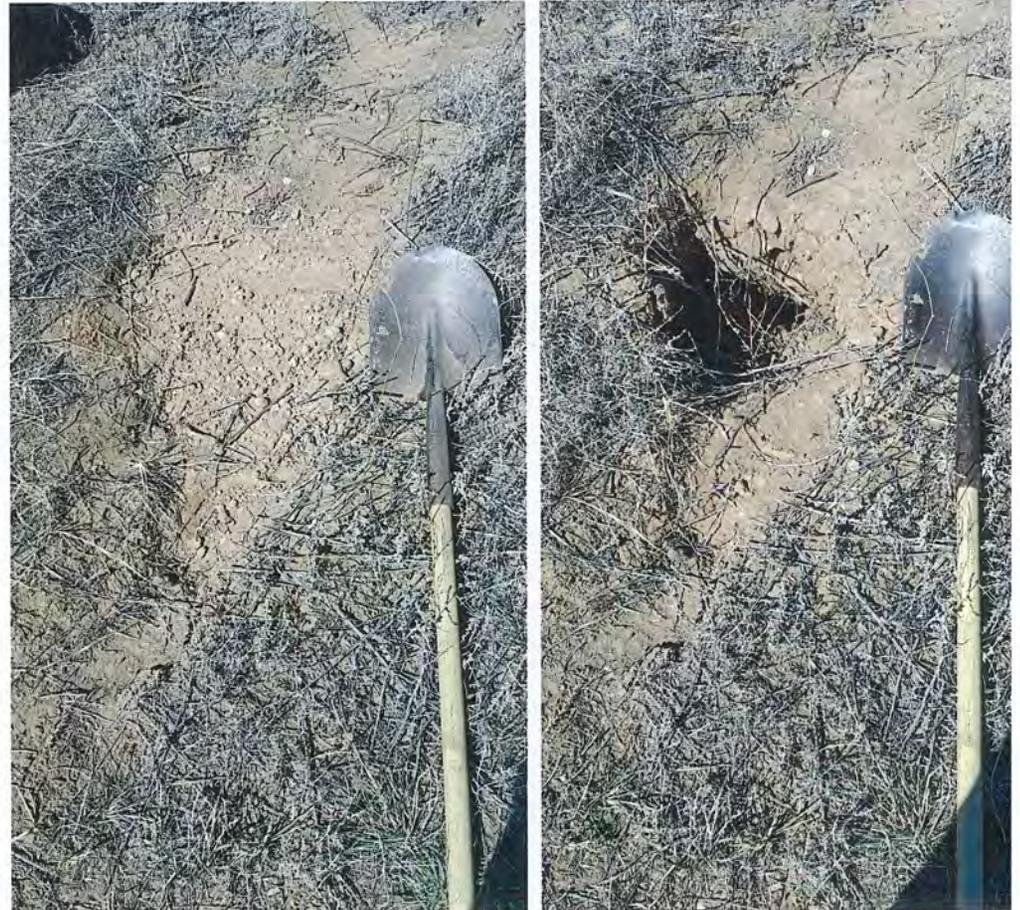
Photos 4 and 5

Sinkhole
repaired using
soil in buckets on
west transects

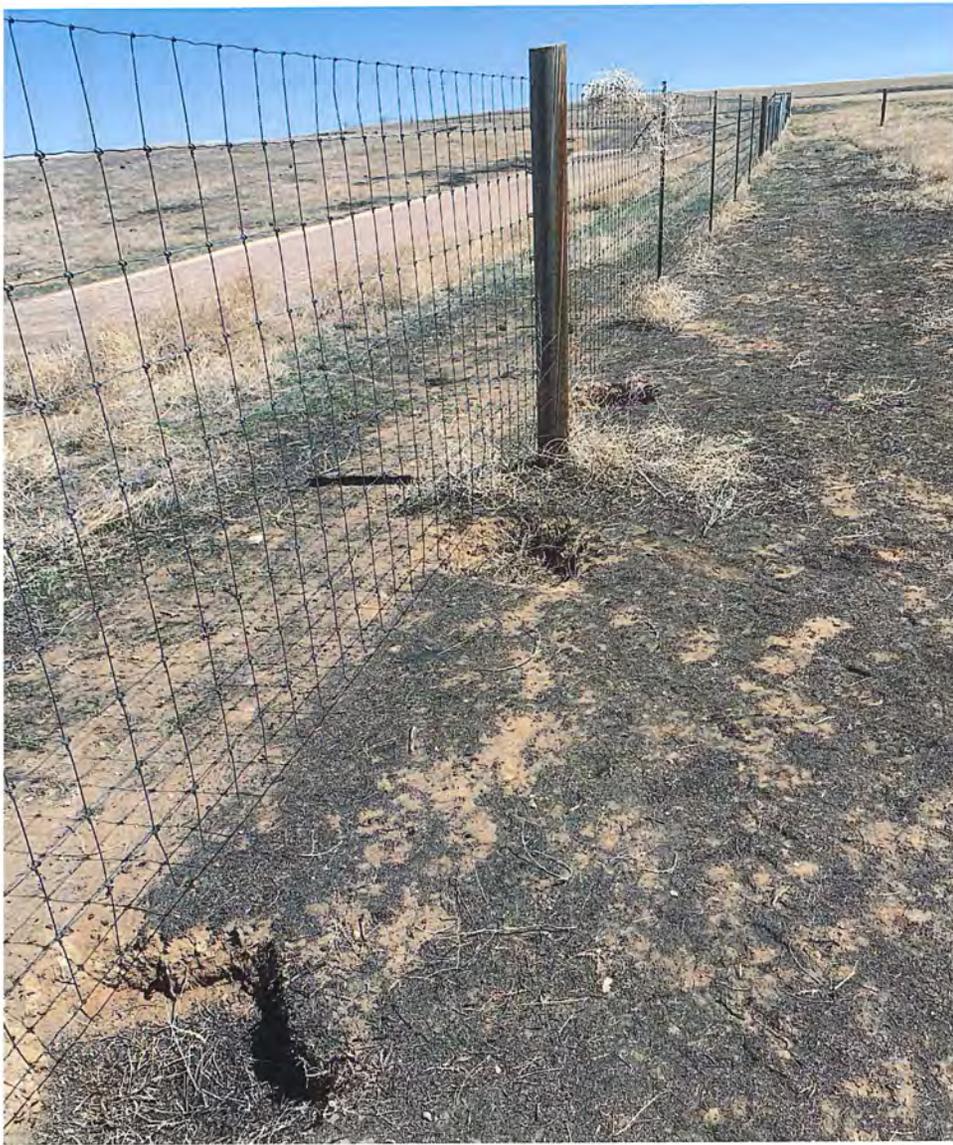
Photo 6
Sinkholes under perimeter fence

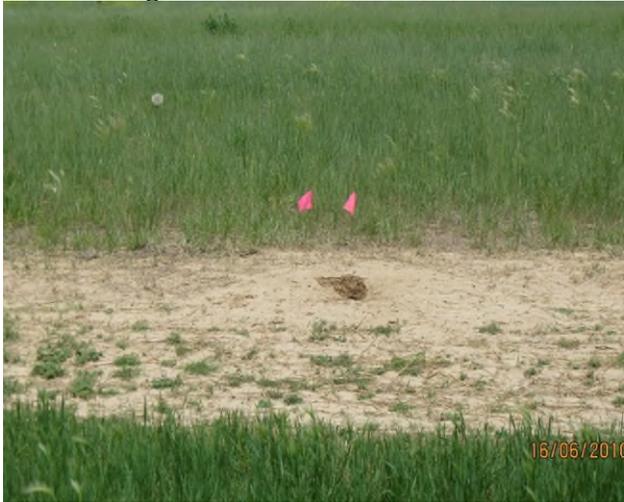
Prairie Dog Hole from June 2010

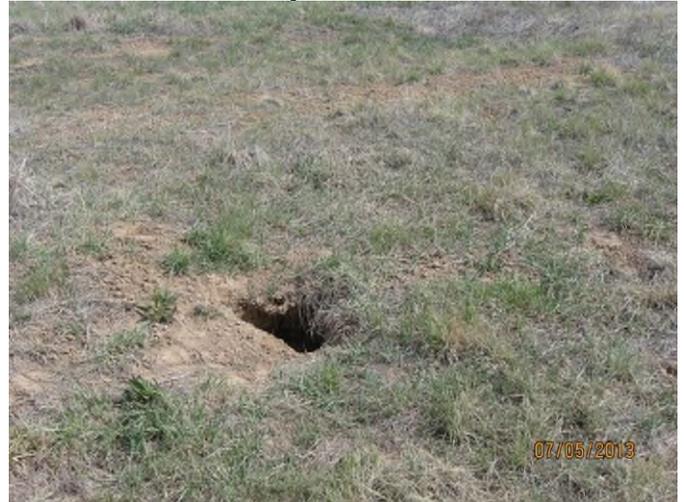
Hole Photo from May 2013

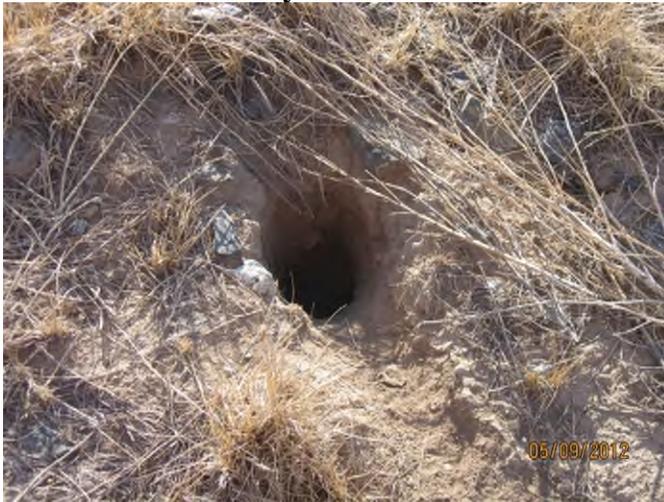
Hole Photo from May 2012
