ROCKY MOUNTAIN ARSENAL

2022 RCRA Landfills and Groundwater Monitoring Report

**Revision 0
June 17, 2022**

**U.S. Department of the Army
Shell Oil Company**

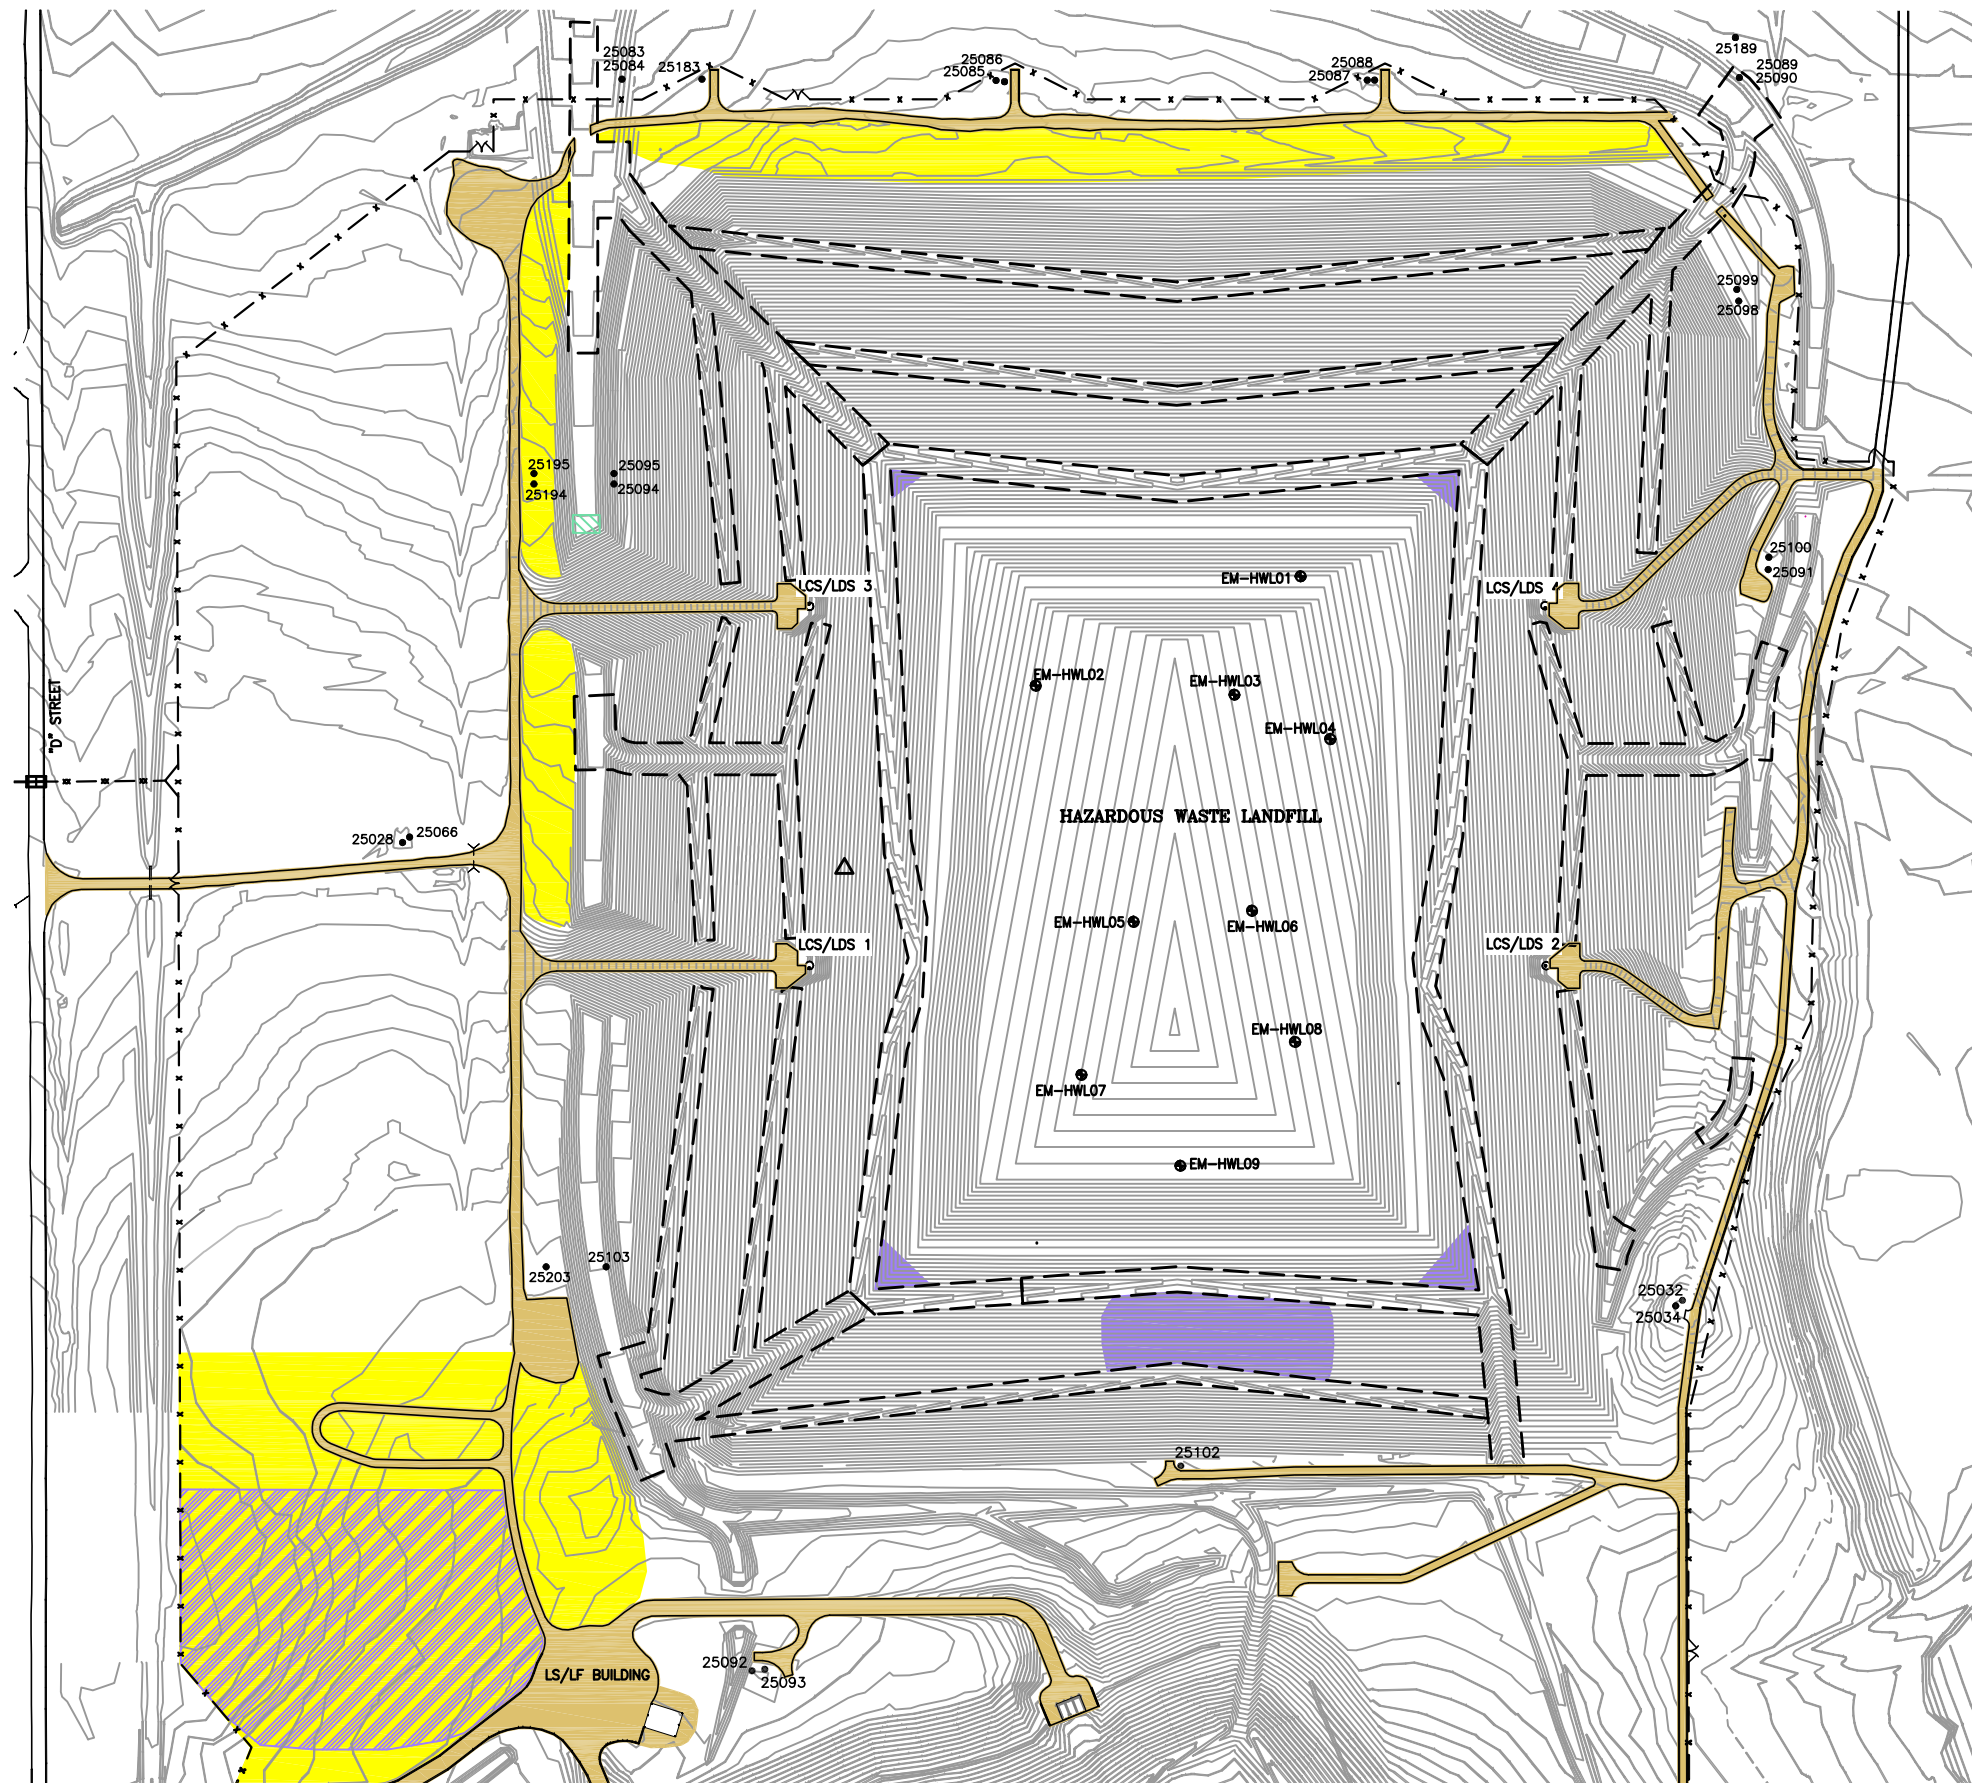
ROCKY MOUNTAIN ARSENAL COMMERCE CITY, COLORADO		
PROJECT NAME		
2022 RCRA LANDFILLS AND GROUNDWATER MONITORING REPORT		
TITLE		
HWL ROUTINE ACTIVITIES MAP		
CAD FILE:	DATE	FIGURE NUMBER
Figure 4.2-1.DWG	05.25.22	4.2-1

- Excessive buildup of tumbleweeds was observed in the articulated concrete block channels, the perimeter channels, and along the perimeter fence. The OMC staff removed tumbleweeds from the perimeter fence in December of 2021 and mowed tumbleweed piles on the north perimeter road in March of 2022 to provide access to sumps and monitoring wells on the east side of the landfill. Tumbleweed maintenance will continue to be a point of emphasis in 2022 and will be discussed in the 2023 RCRA Landfills and Groundwater Monitoring Report.

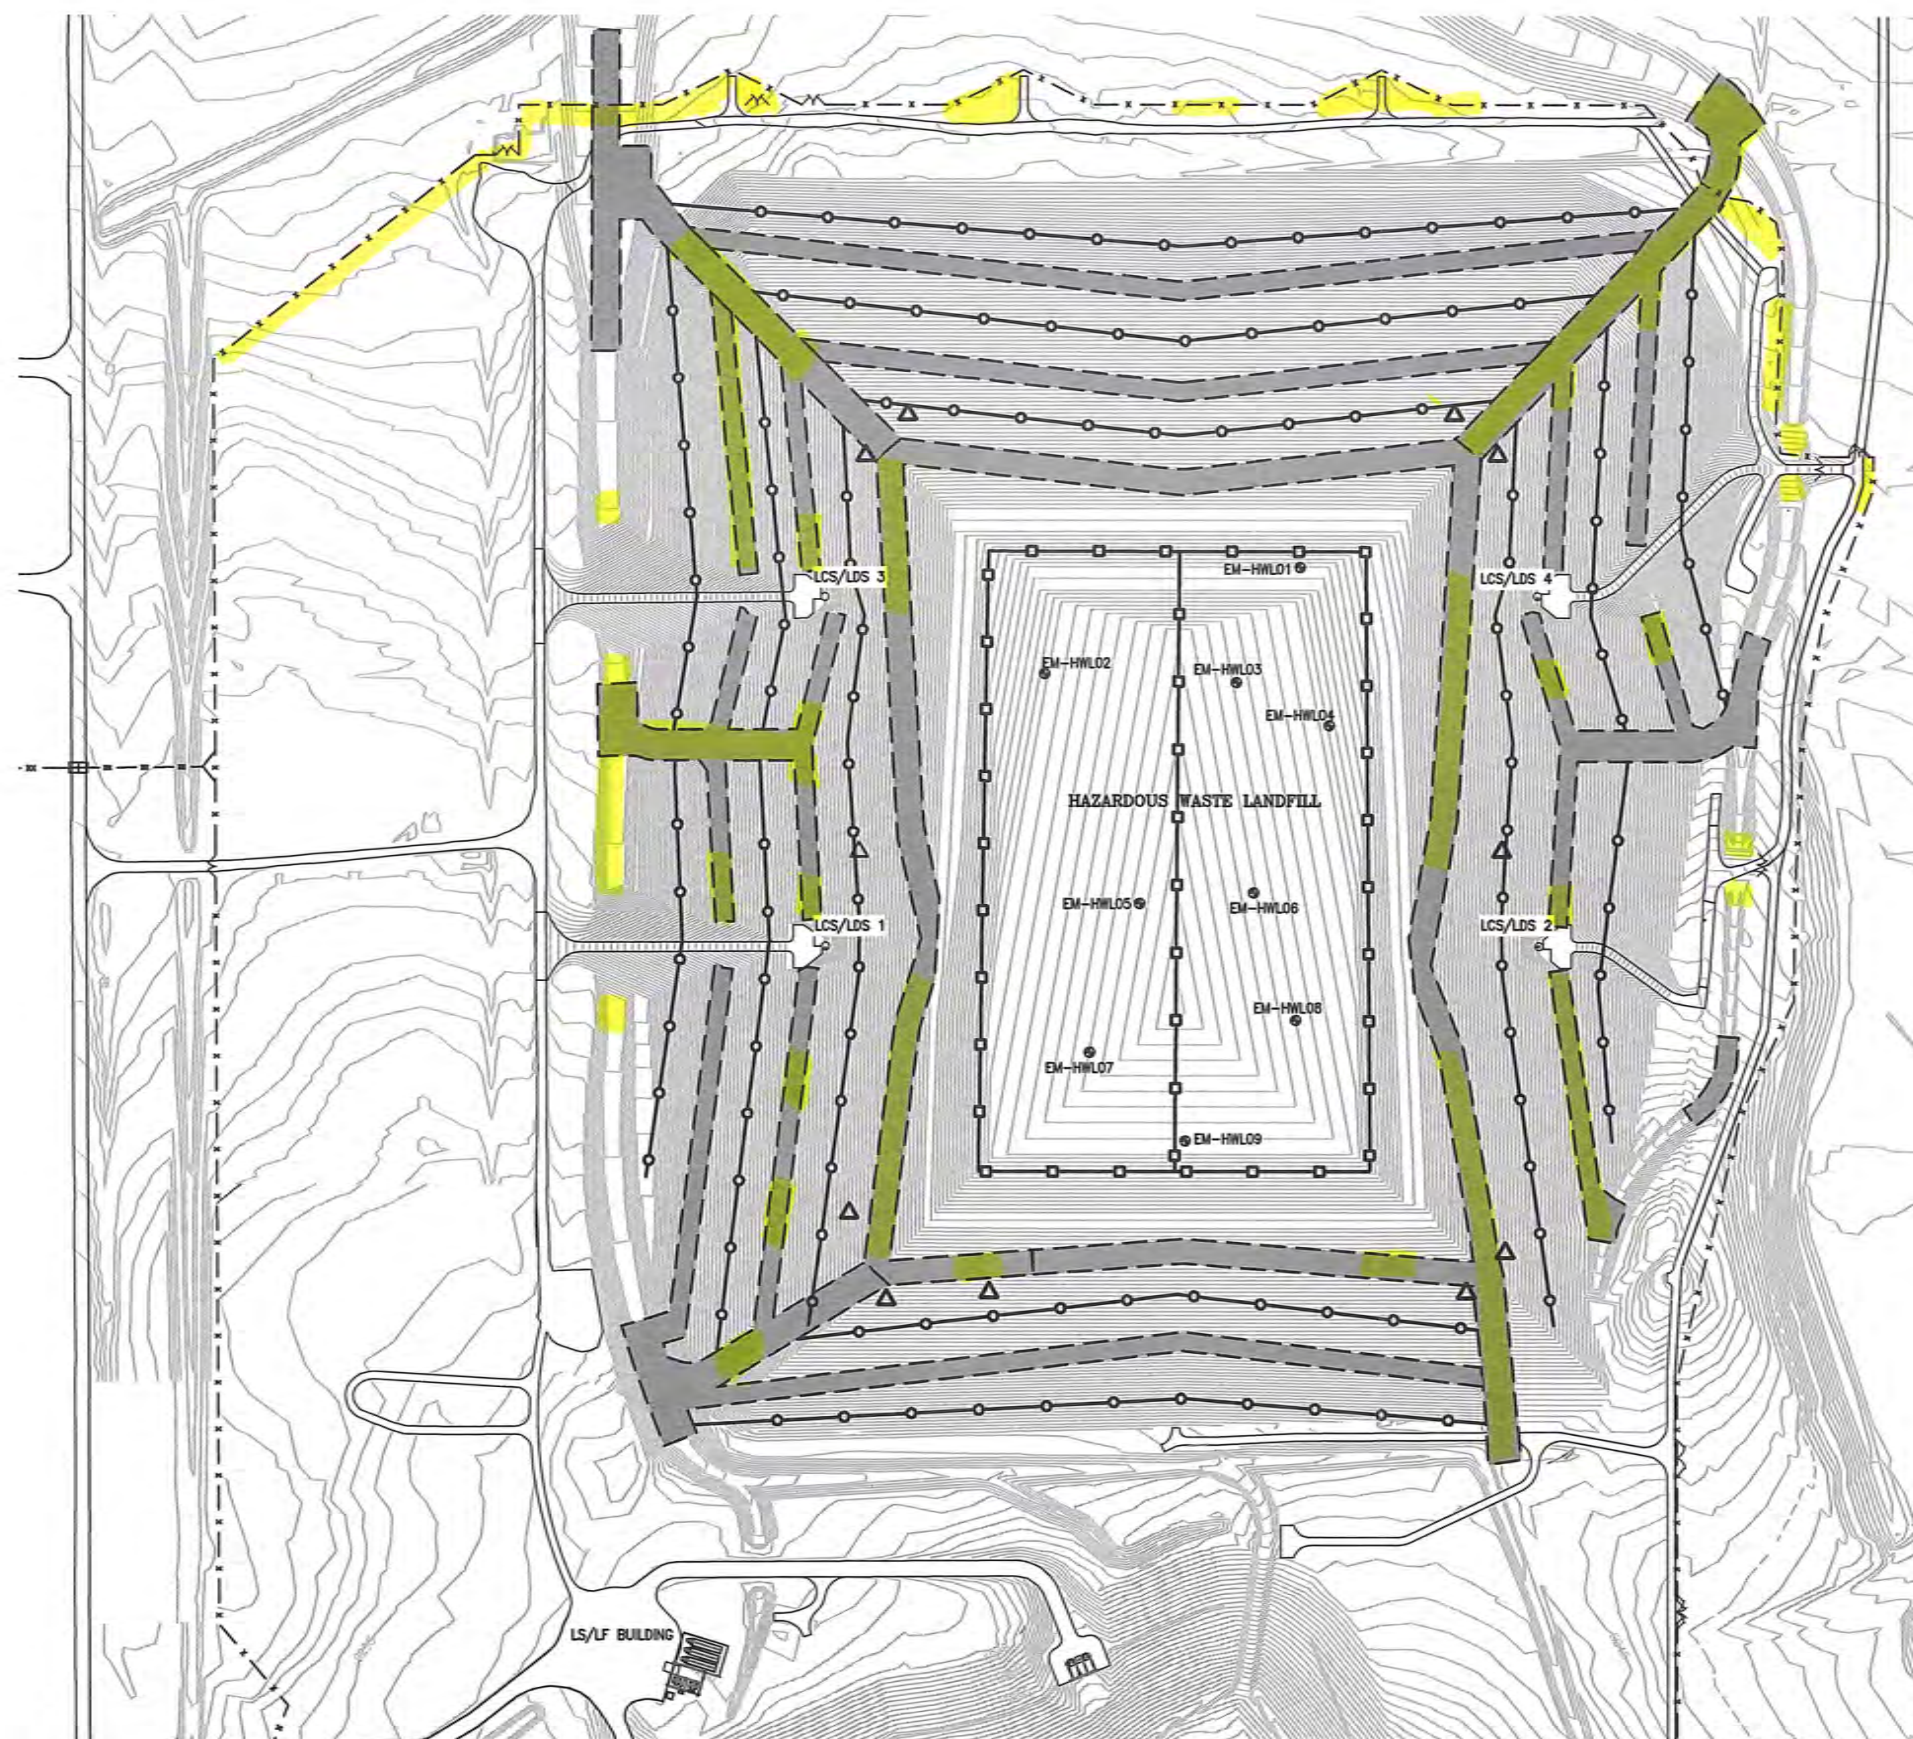
Note 1: significant tumbleweed accumulation was observed due to high winds over the past few months. Please see attached figure for location information.

▬ : tumble weed accumulation
