ROCKY MOUNTAIN ARSENAL

2023 RCRA Landfills and Groundwater Monitoring Report

**Revision 0
June 21, 2023**

**U.S. Department of the Army
Shell Oil Company**

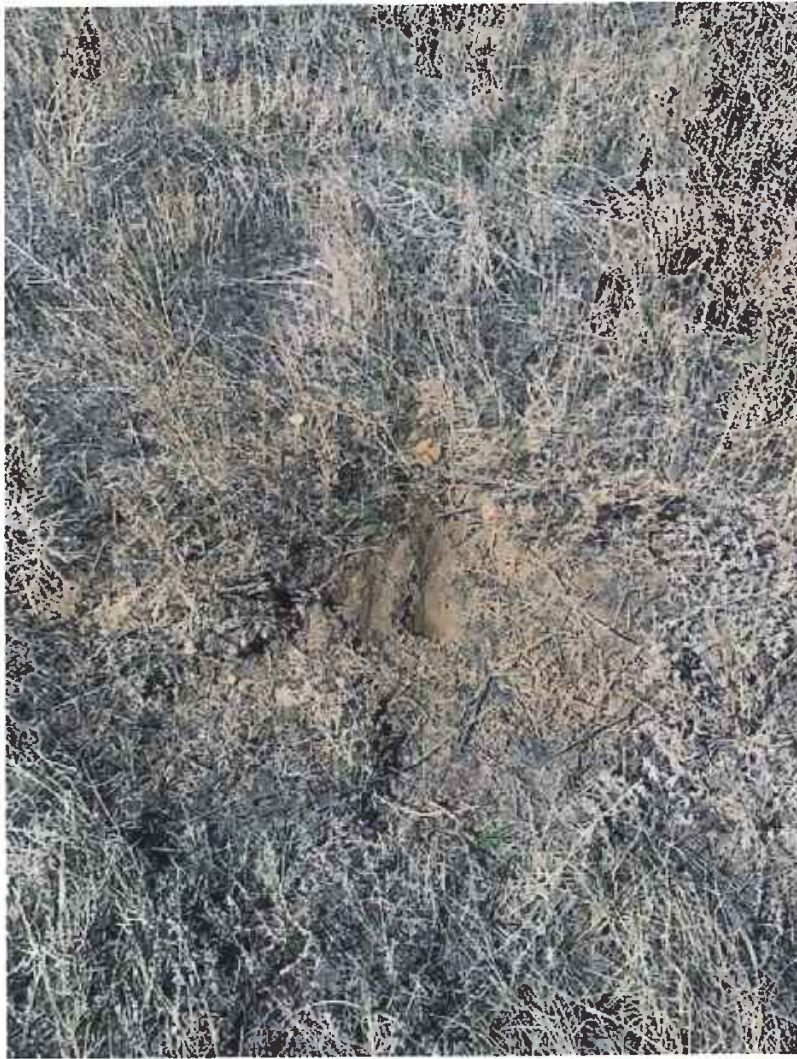
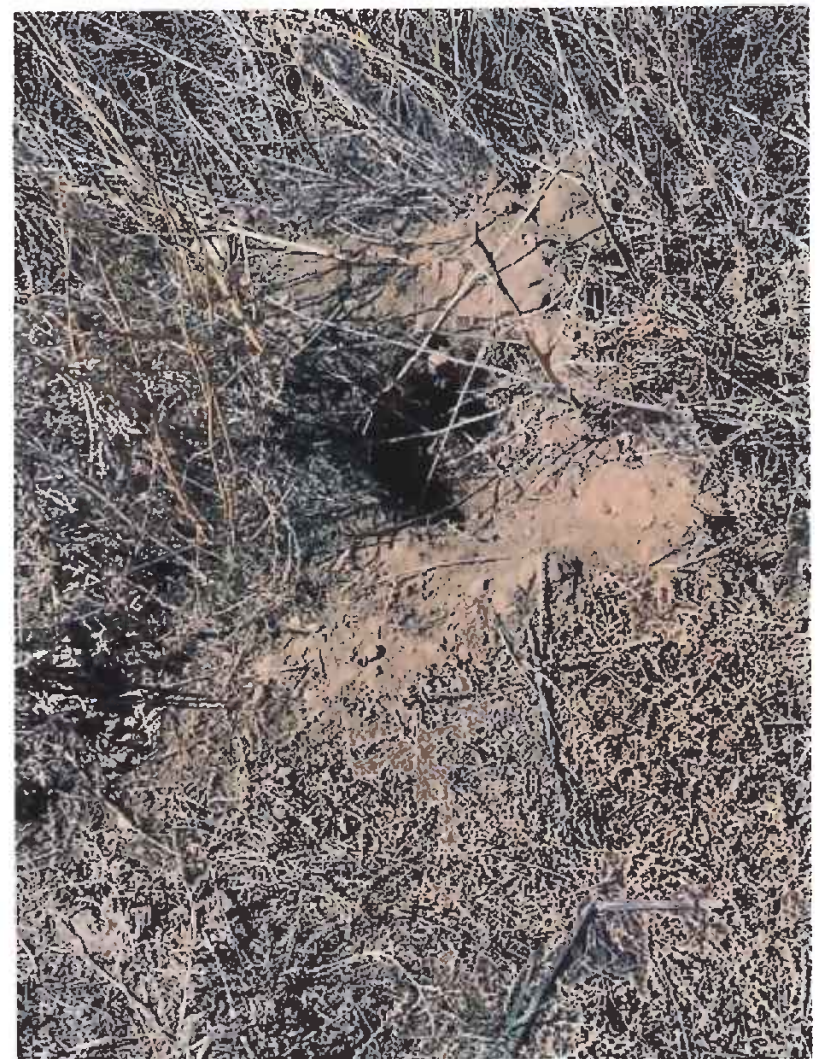
- Burrowing animal holes (Inspection Form Item 1.6): An animal hole was identified during the 2023 spring Type II inspection on top of the landfill. This hole was repaired during the inspection with existing soil next to the hole by using a shovel and tamping the soil into place.

Hole observed on the HWL and backfilled using existing soil.

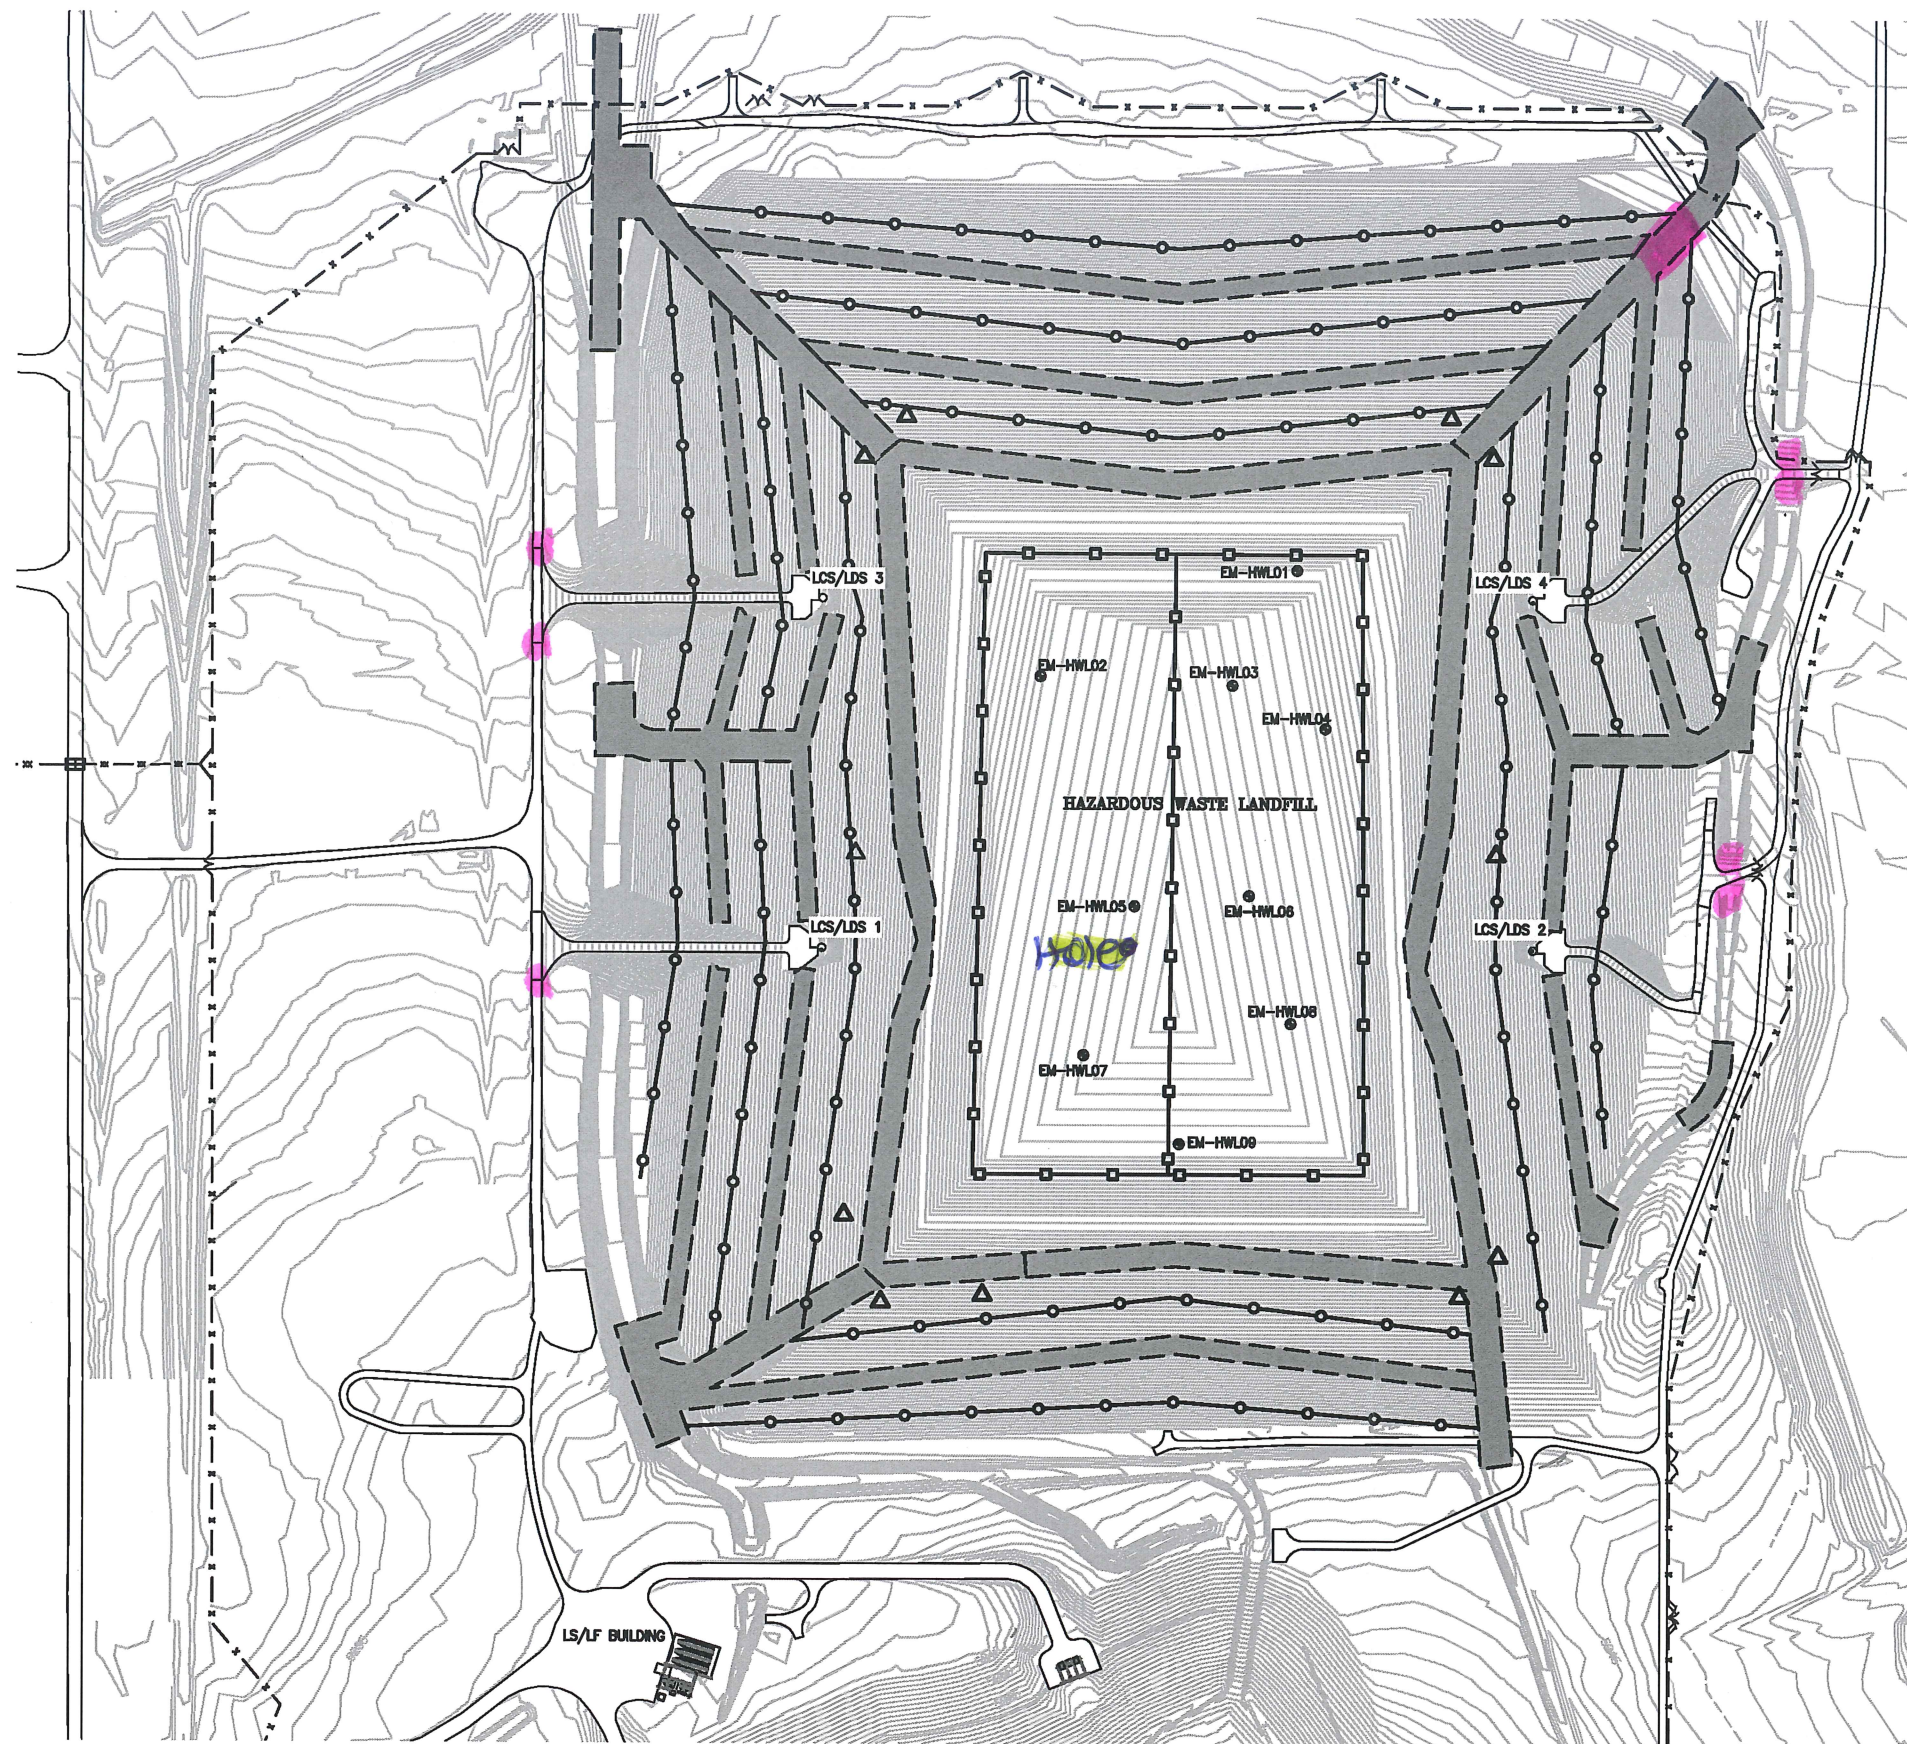
- Debris present in the channel (Inspection Form Item 6.3): Tumbleweeds were observed in some of the articulated concrete block and perimeter channels during the 2023 spring Type II inspection performed on April 10, 2023. This maintenance issue was not addressed before the end of this reporting period. The channels will be maintained during the 2024 reporting period and will therefore be reported in the 2024 LGMR.

Note 1: Fumple weeds were observed in some of the channels.
see attached figure for location information.

■ tumble weed accumulation

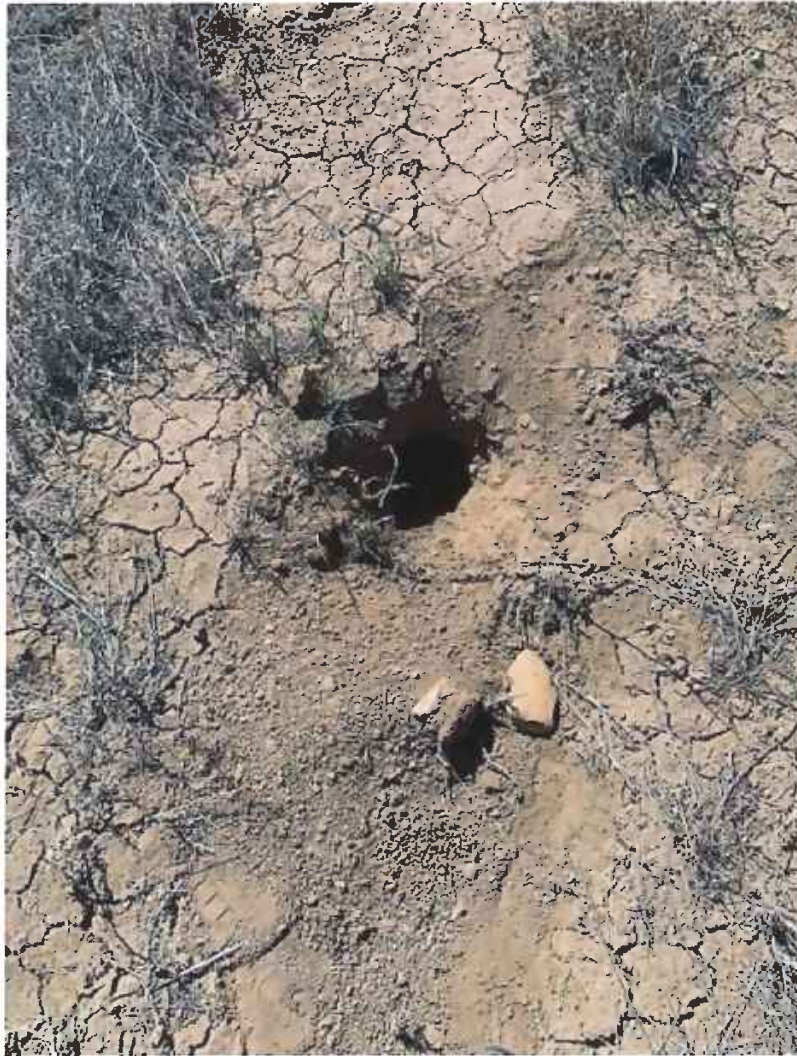
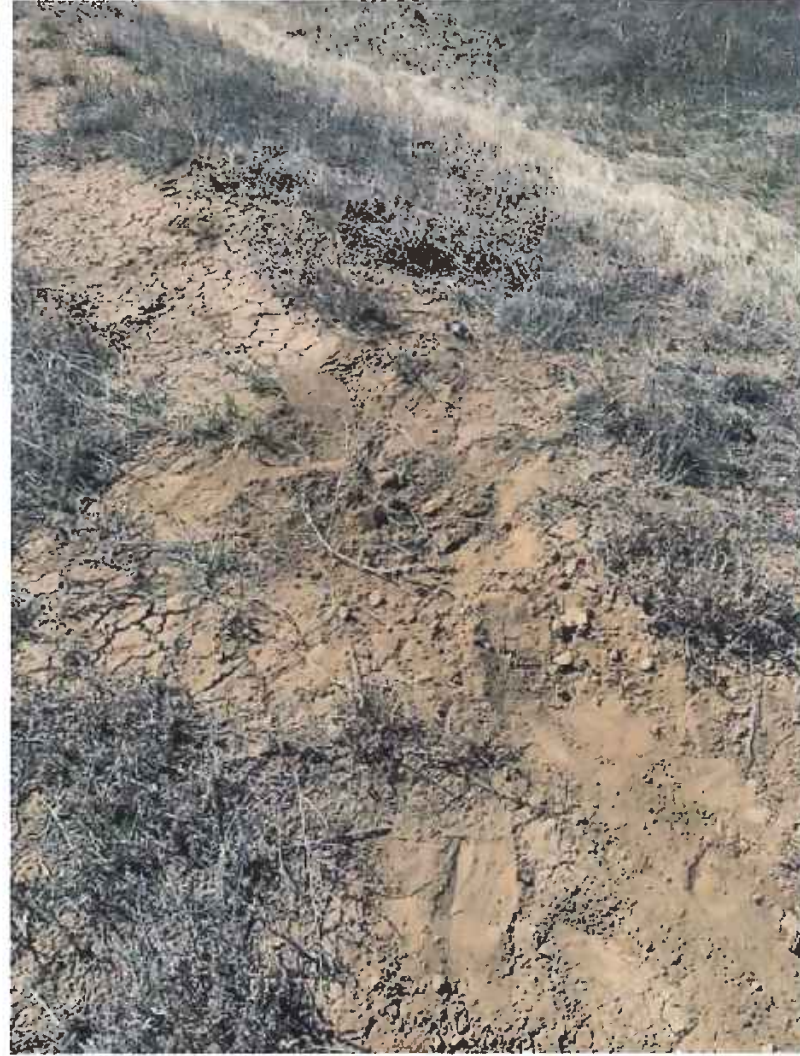
Hole observed along the perimeter channel at the ELF and backfilled using existing soil.

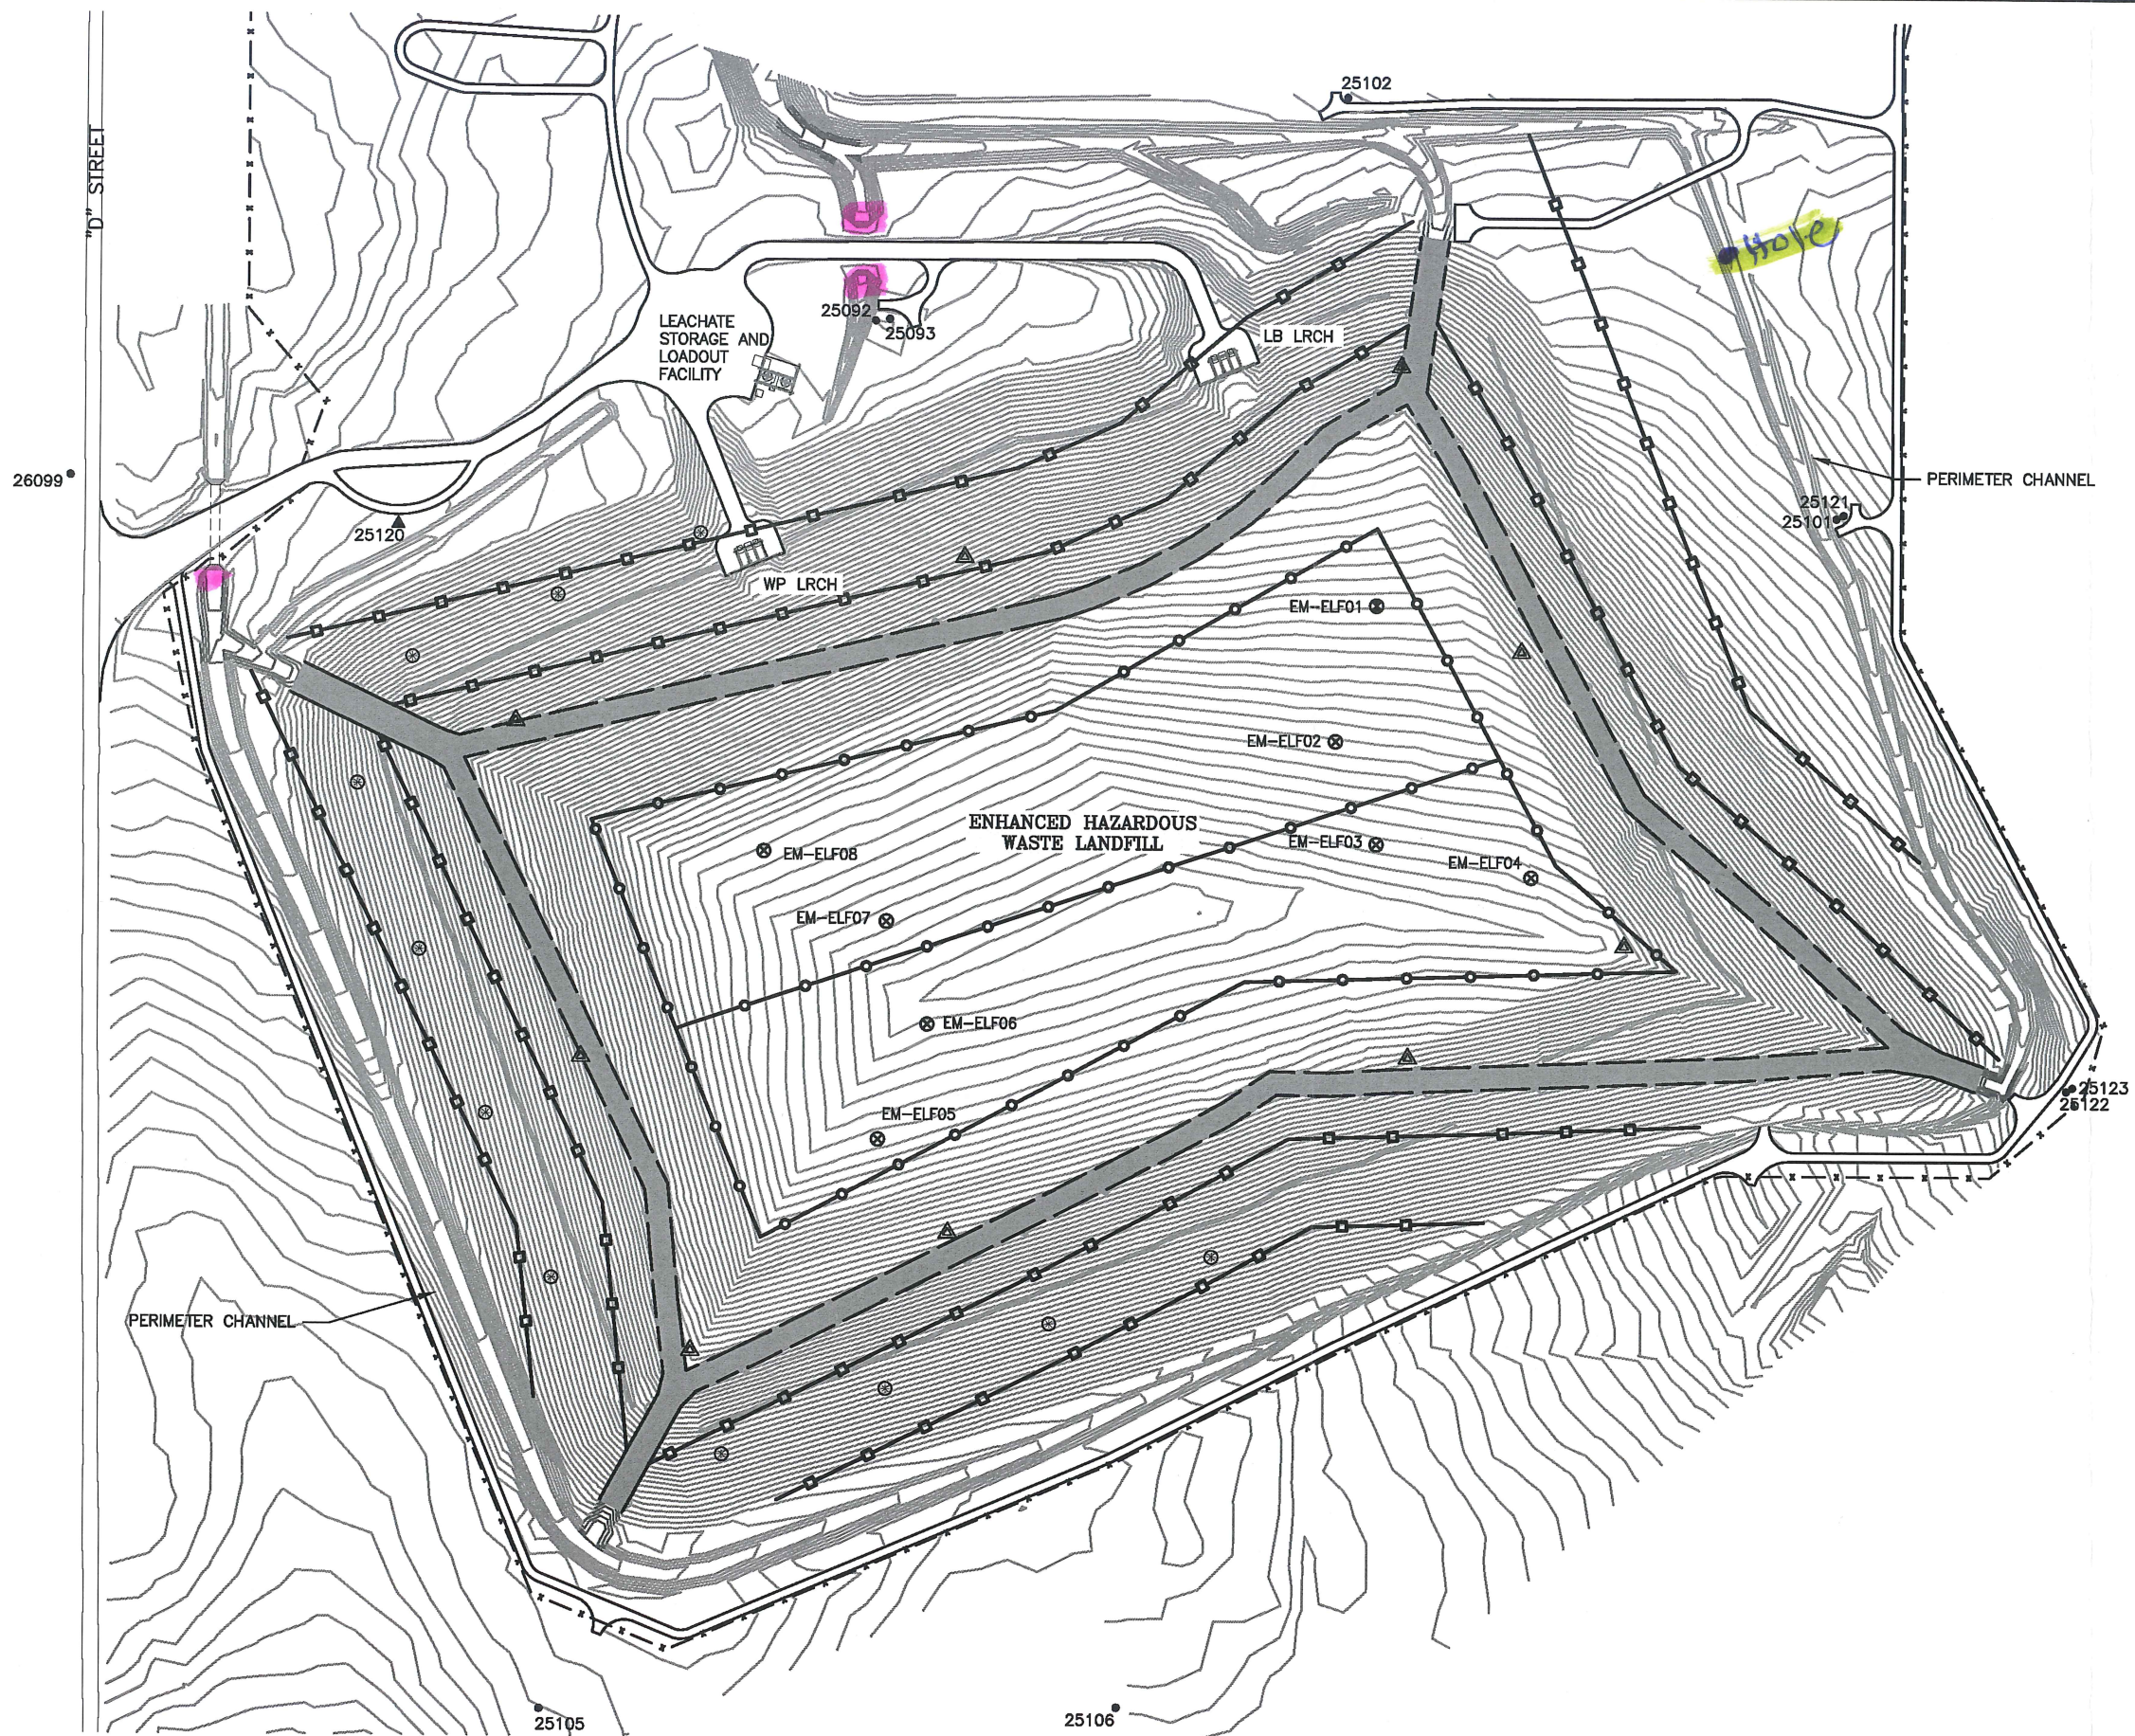
- Debris has collected along the perimeter fence (Inspection Form Item 3.2) and Debris present in the channel (Inspection Form Item 6.3): Excessive buildup of tumbleweeds was observed in the articulated concrete block channels, in the perimeter channels, and along the perimeter fence. In July and August, a subcontractor used a mower mounted to a skid steer and cleared out the tumbleweeds from the channels and along the perimeter fence.
- Debris present in the channel (Inspection Form Item 6.3): Tumbleweeds were observed in some of the articulated concrete block and perimeter channels during the 2023 spring
