ROCKY MOUNTAIN ARSENAL

2024 RCRA Landfills and Groundwater Monitoring Report

**Revision 0
June 20, 2024**

**U.S. Department of the Army
Shell Oil Company**

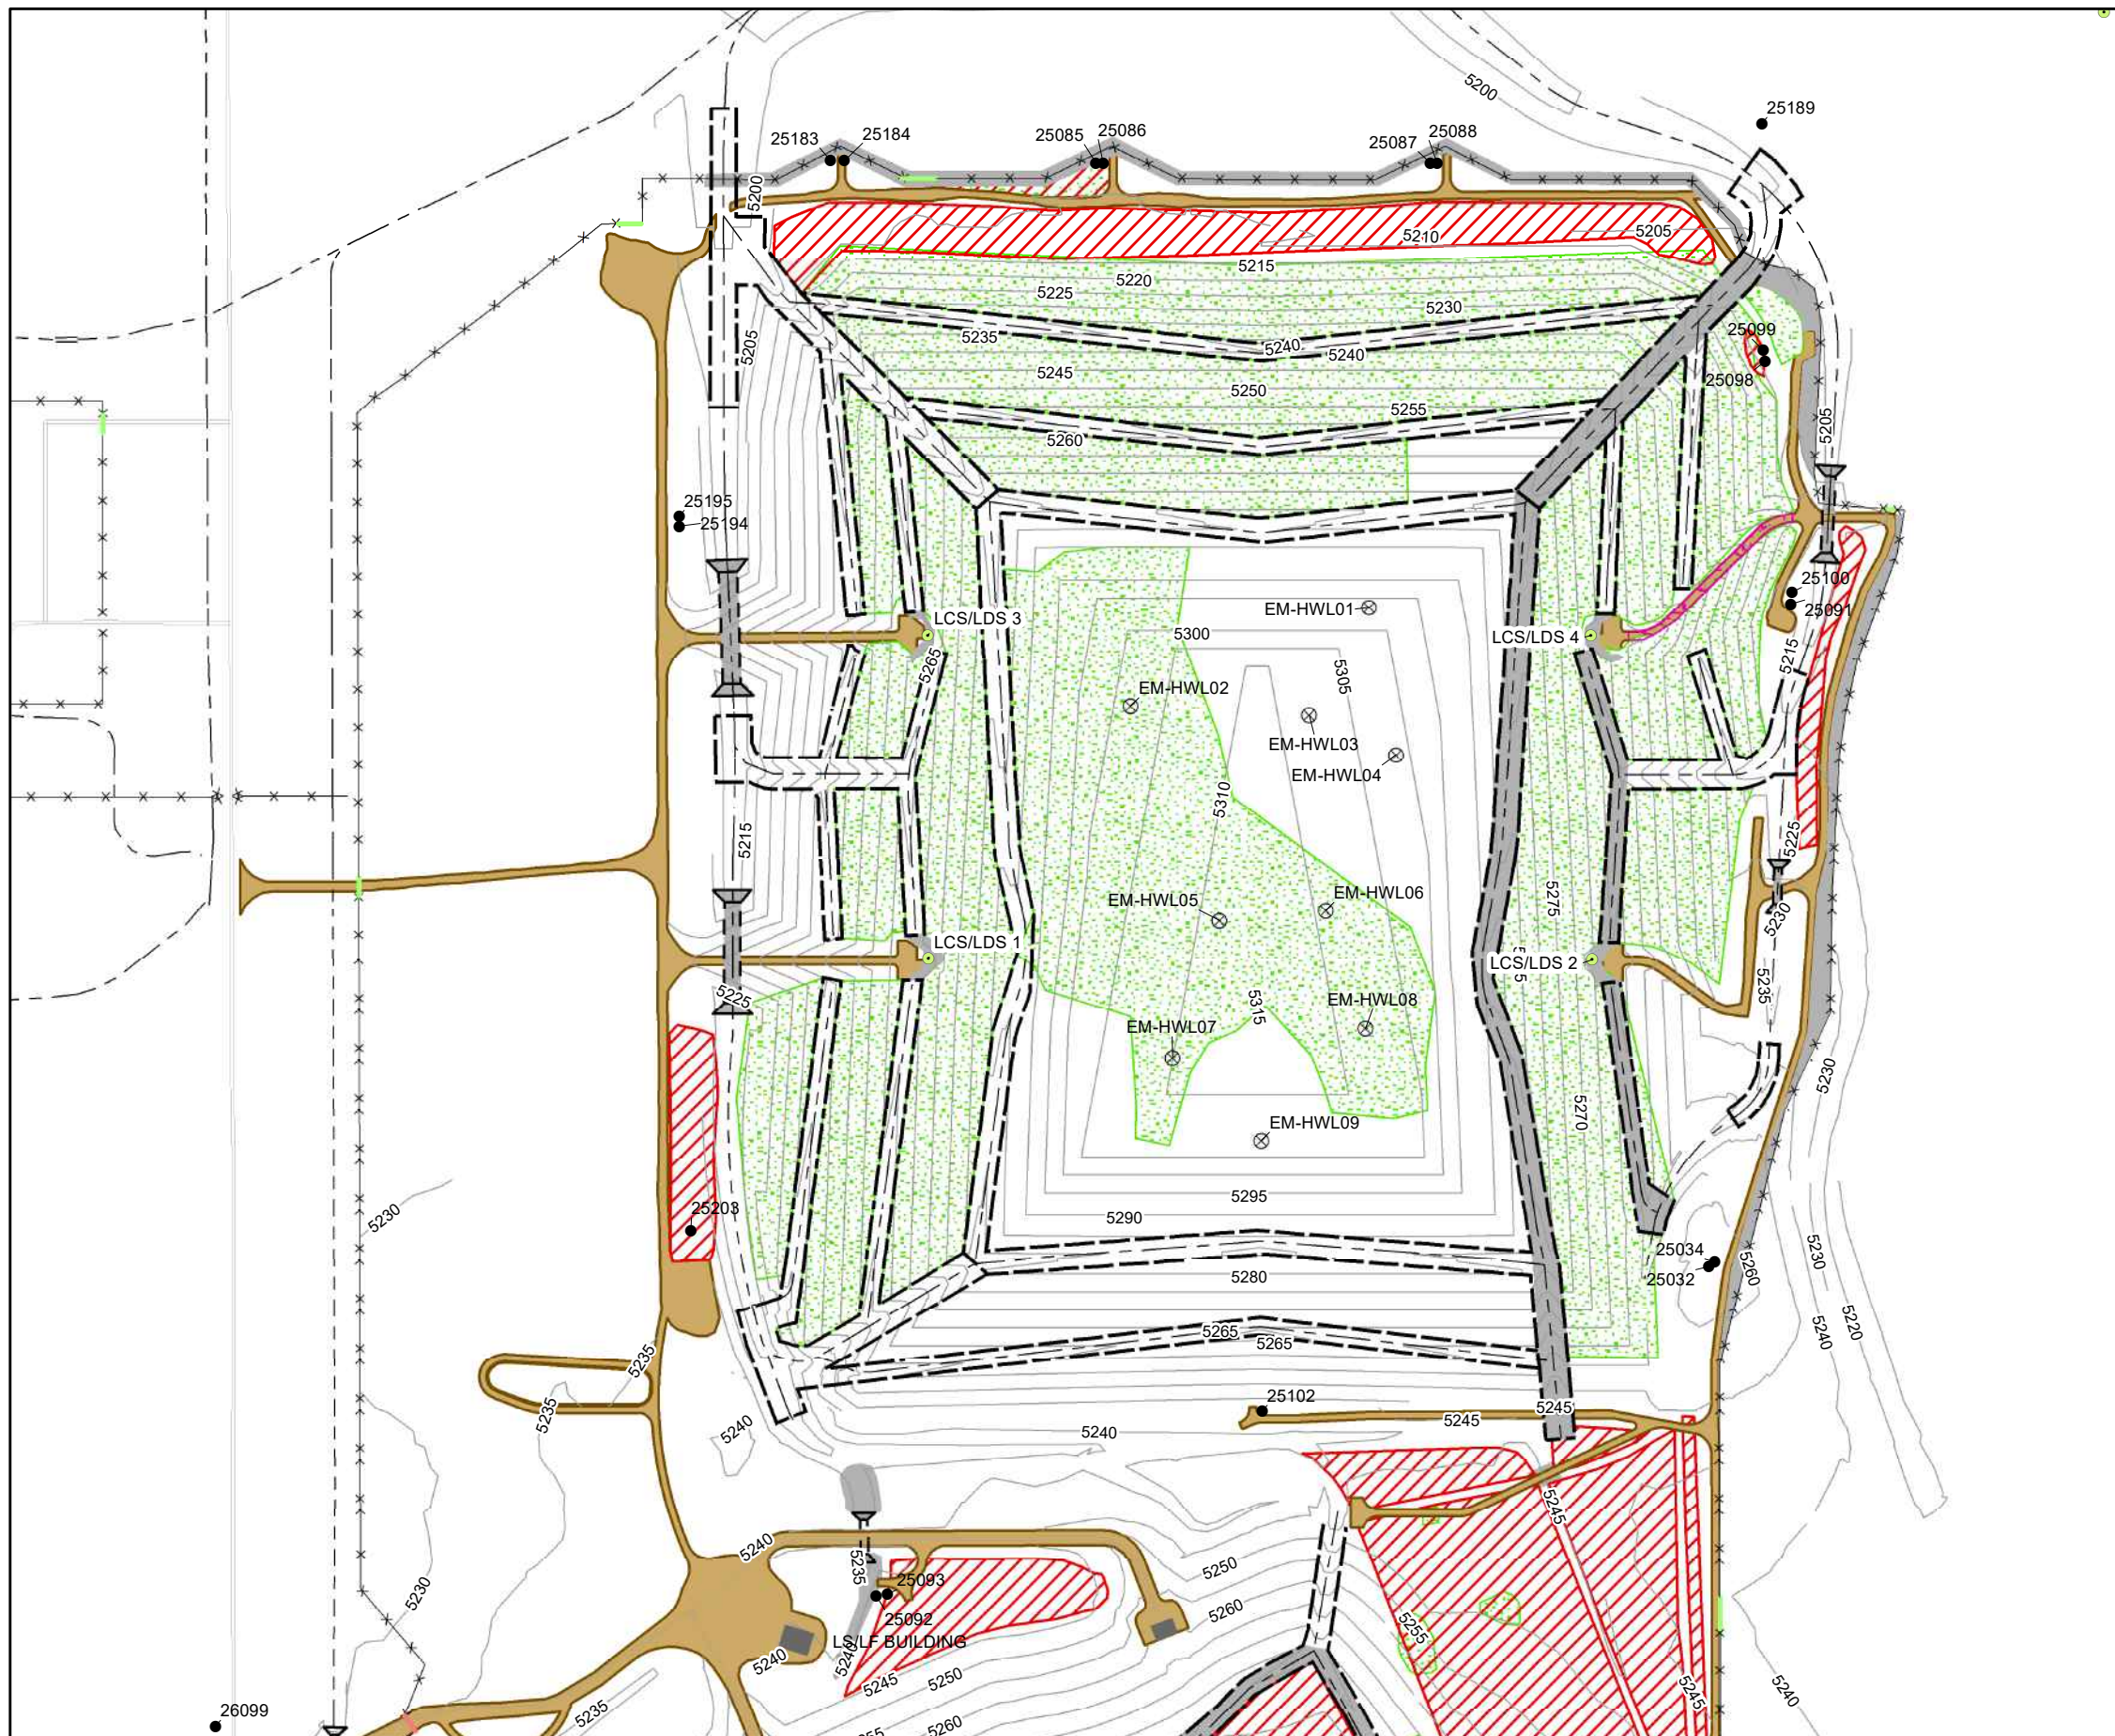
Figure 2.0-1 illustrates the locations of routine activities performed on the HWL cap and surrounding areas, while Figure 2.0-2 shows the locations of routine maintenance and repair

Debris present in a channel or downchute	Tumbleweeds observed in some of the channels. (Inspection Form: 4/10/23)	Addressed in May 2023. A subcontractor used a skid steer with mower attachment to remove tumbleweeds from the channels, downchutes and fence line.
Erosion rills or gullies in a channel or downchute	None	N/A
Areas of degraded Articulated Concrete Block (ACB) or extensively cracked grout around ACB	None	N/A
Subsidence or undercutting of the downchutes or perimeter drainage channels	None	N/A

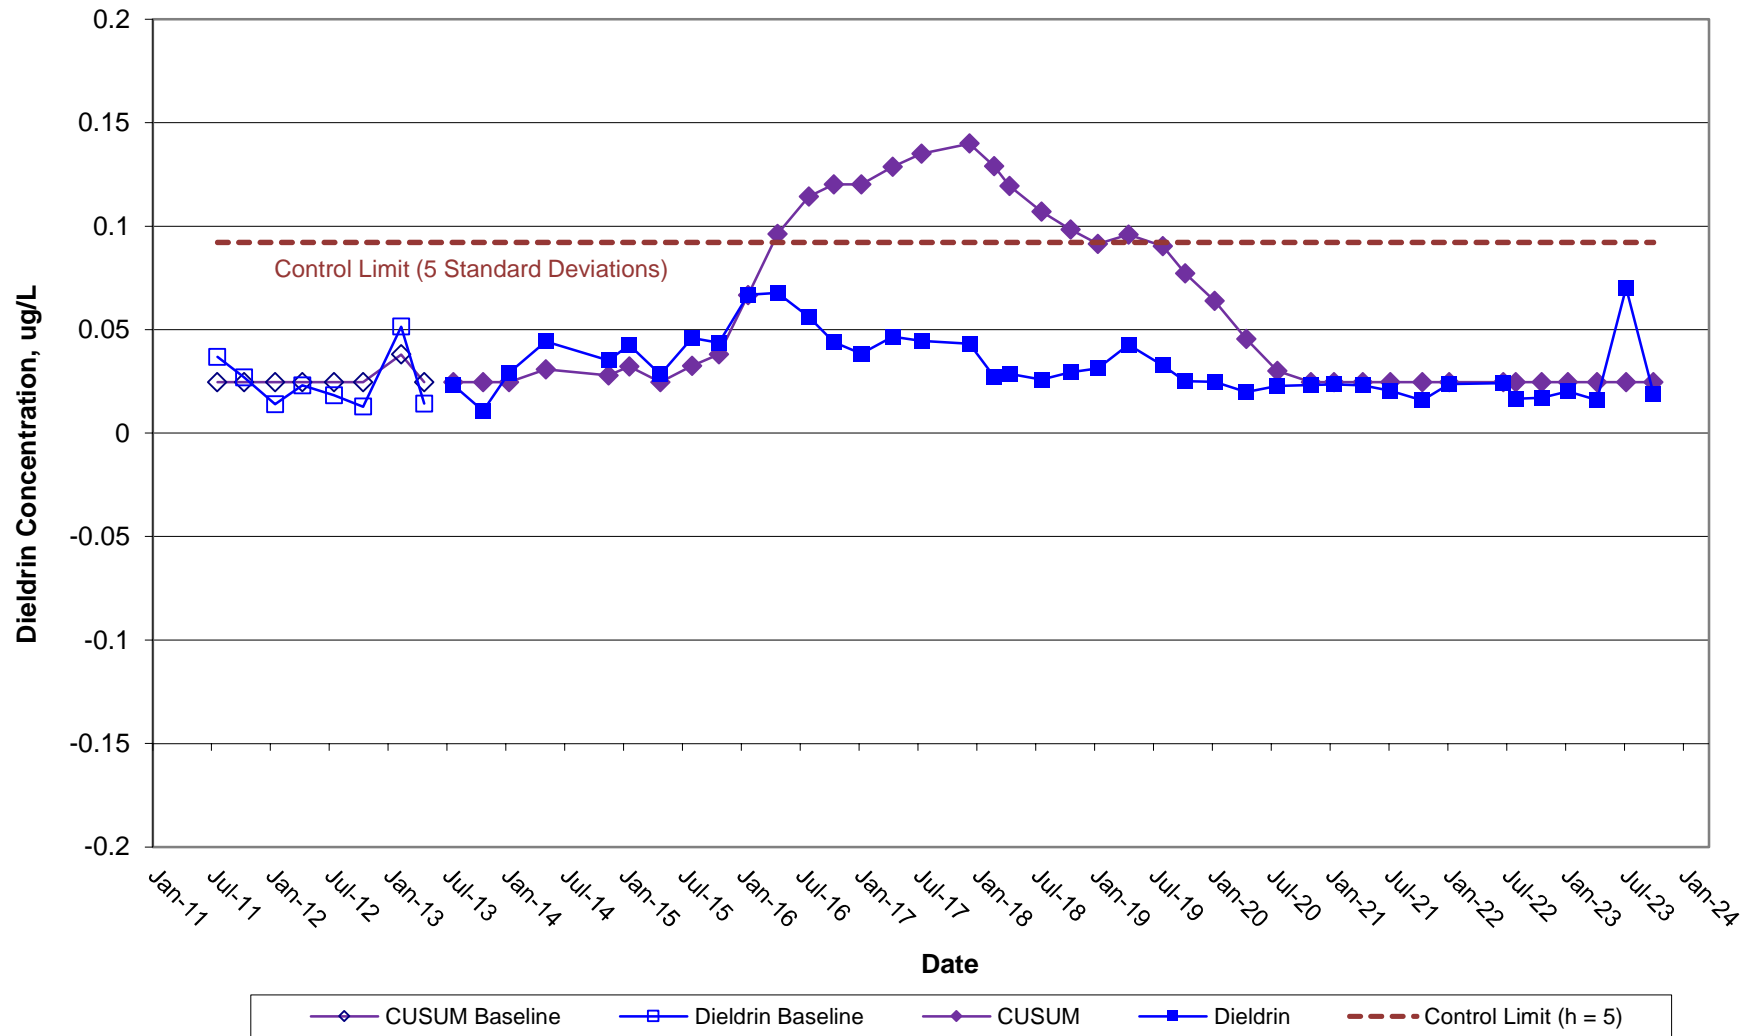
Figure 3.1-1
Shewhart-CUSUM Control Chart
for Dieldrin Concentrations in HWL Well 25194

NRAP-2023-003 (Navarro 2023e) documents that the dieldrin concentration in a sample collected from well 25194 on July 17, 2023, was above the 2023 Prediction Limit. The recommended actions were to continue routine quarterly sampling of well 25194, evaluate the dieldrin concentrations using an intrawell comparison and Mann-Kendall trend analysis, and report the conclusions in the annual HWL Post-Closure Groundwater Monitoring Report
