# **ROCKY MOUNTAIN ARSENAL**

## **ANNUAL COVERS REPORT FOR INTEGRATED COVER SYSTEM 2025**

**November 17, 2025**

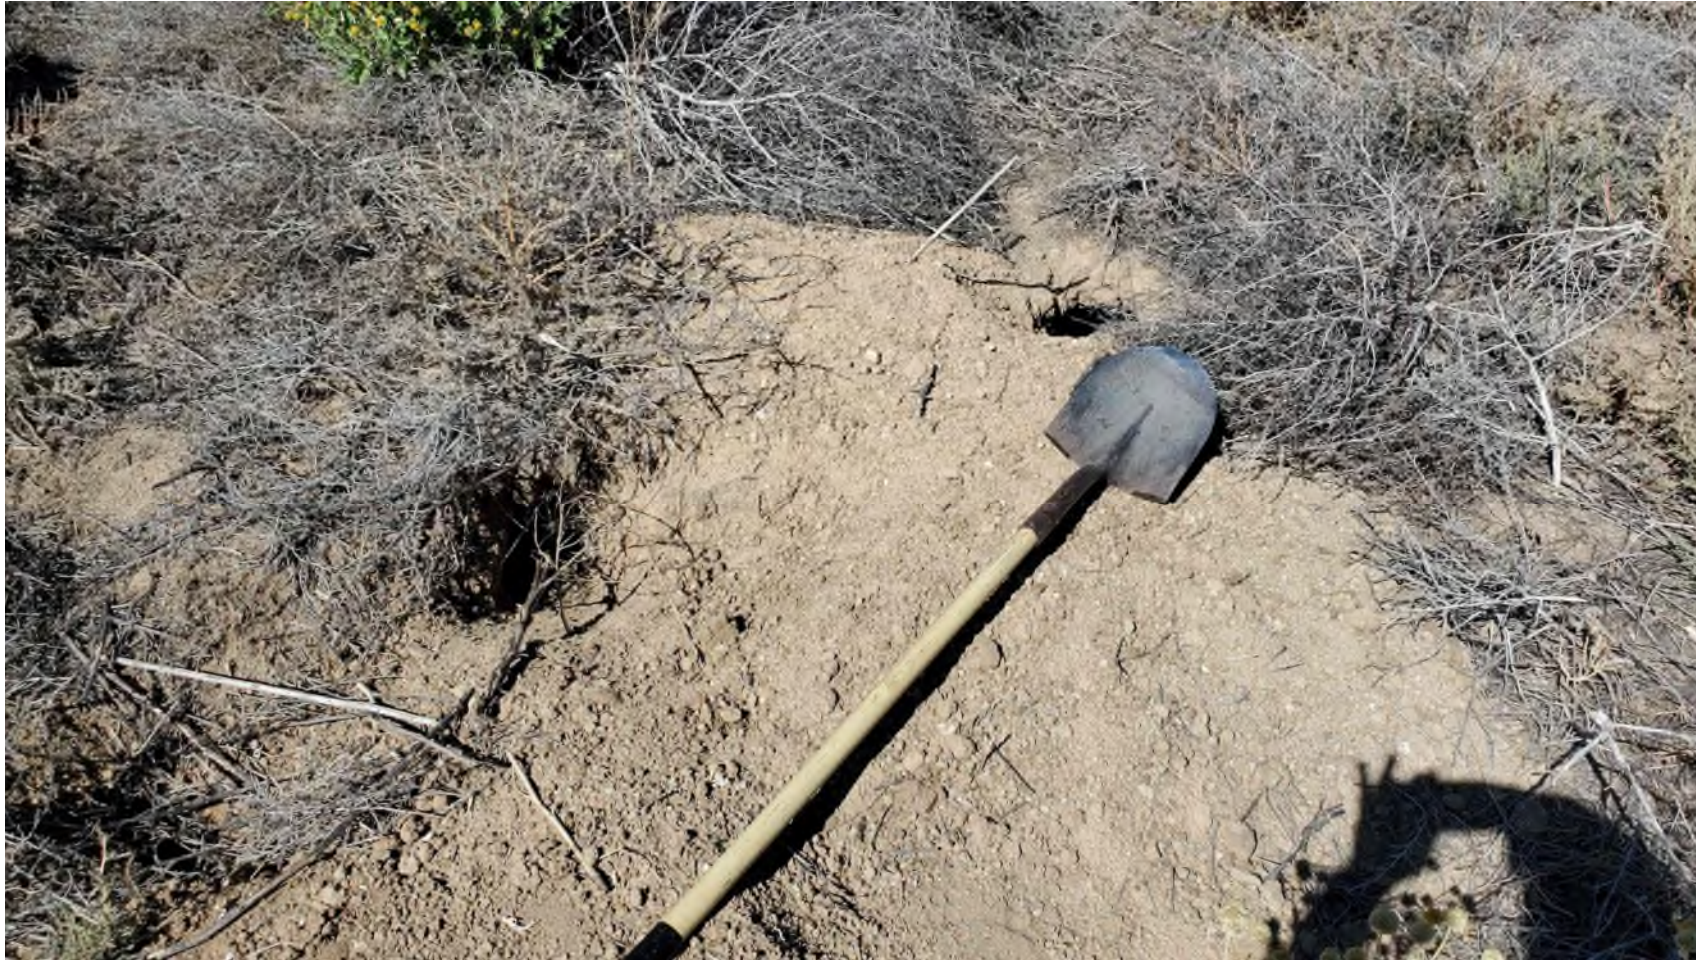
Note 1: An animal hole greater than 3" was observed near ER39. GPS coordinates N39° 49.863' W104° 50.484'. Please see attached Photo 1.

# Photo 1: ICS animal hole near ER39

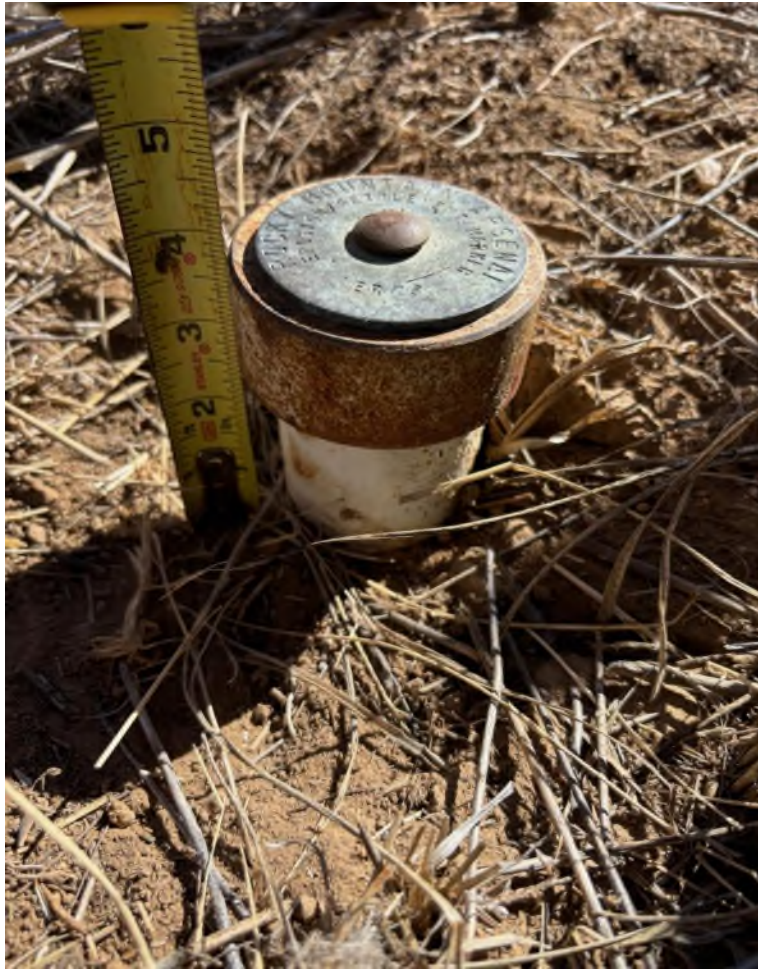
Monument ER76 exceeded the non-routine action trigger level during the fall 2024 Type I inspection and prompted the preparation of NRAP-2024-002. Measurements are taken on the north side of each monument, where the NRAP notes that soil loss resulted from rodent activity. In November 2024, the cover was repaired around Monument ER76 in accordance with the approved NRAP.

**ER76 measured on north side 4.0"**

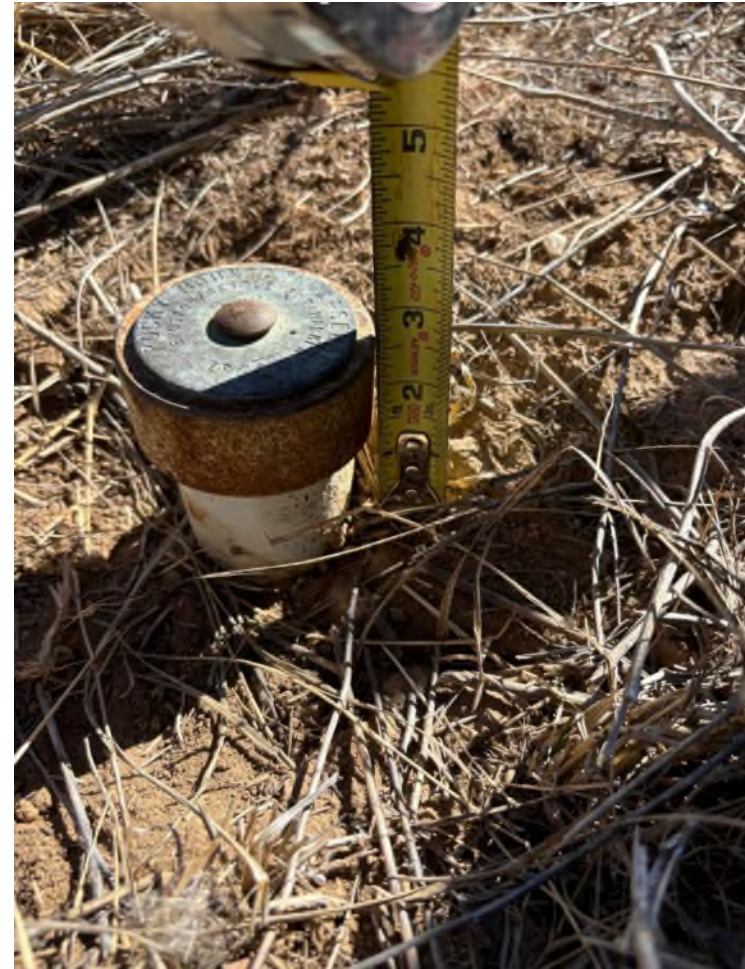
**ER76 measured on south side 2.75"**

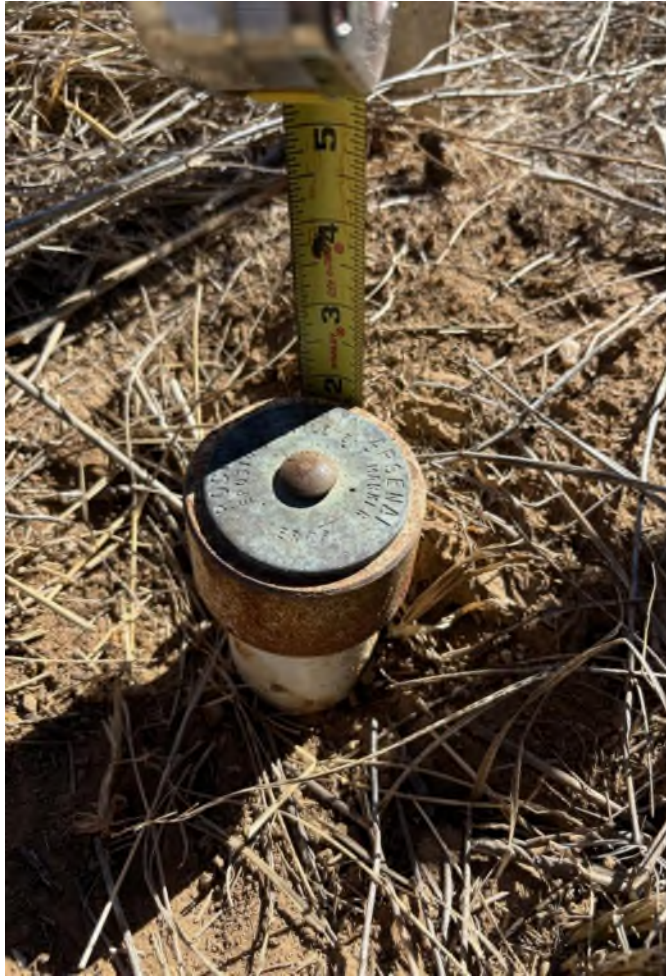
**ER 76 measured east side 1.75"**

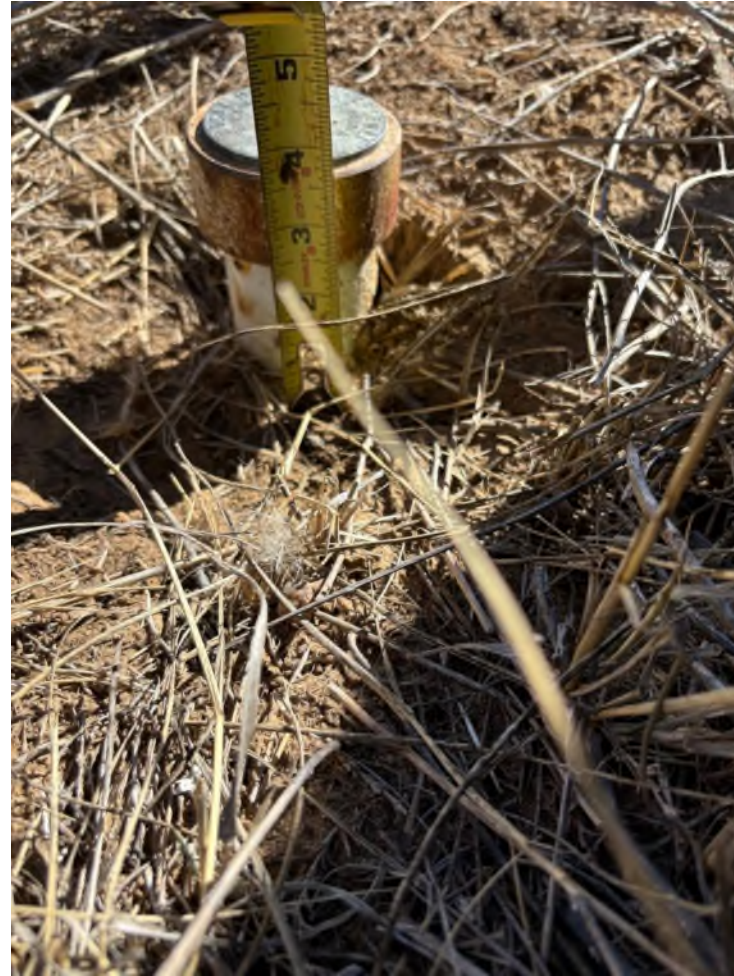
**ER 76 measured west side 3.75"**

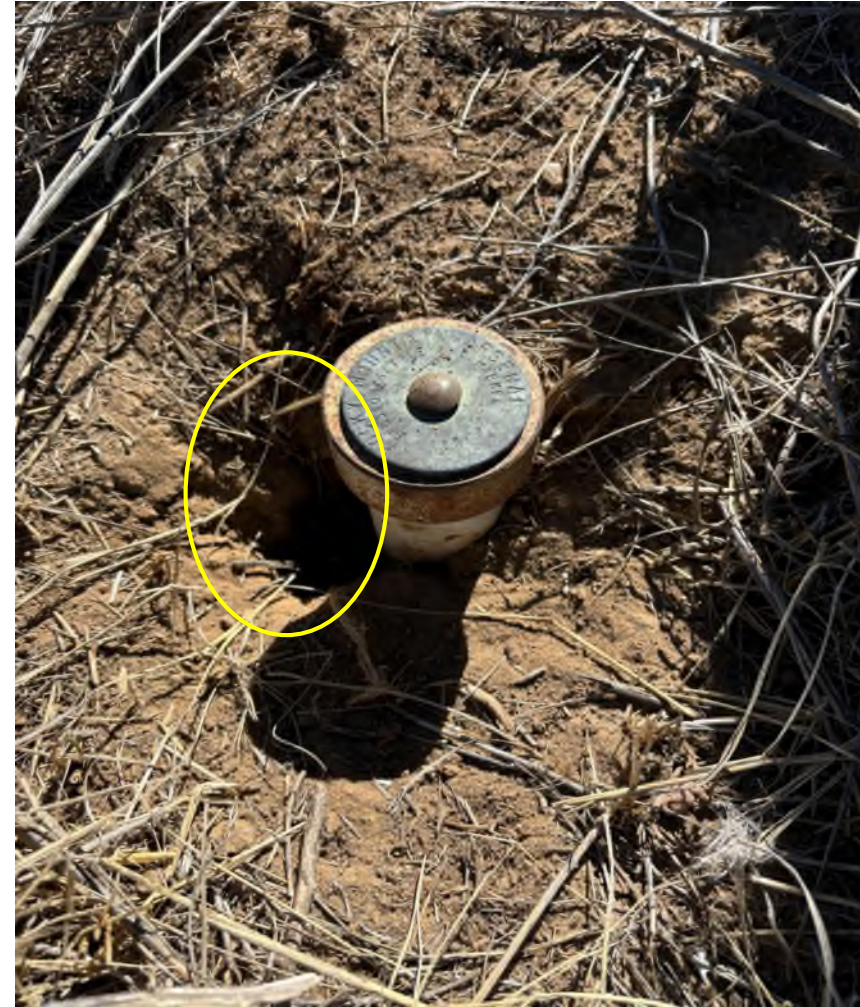
| Inspection Item | Observation | Action |
|---|---|---|
| Erosion/Settlement Monuments | A rodent hole was present on the north side of ER76, contributing to the monument's soil loss exceeding the Non-Routine Trigger Level of 3 inches.<br>(Inspection Form: 10/2/24) | Repaired the area around the monument in accordance with Non-Routine Action Plan (NRAP)-2024-002 in November 2024. |

## ER 76 animal hole north side of monument

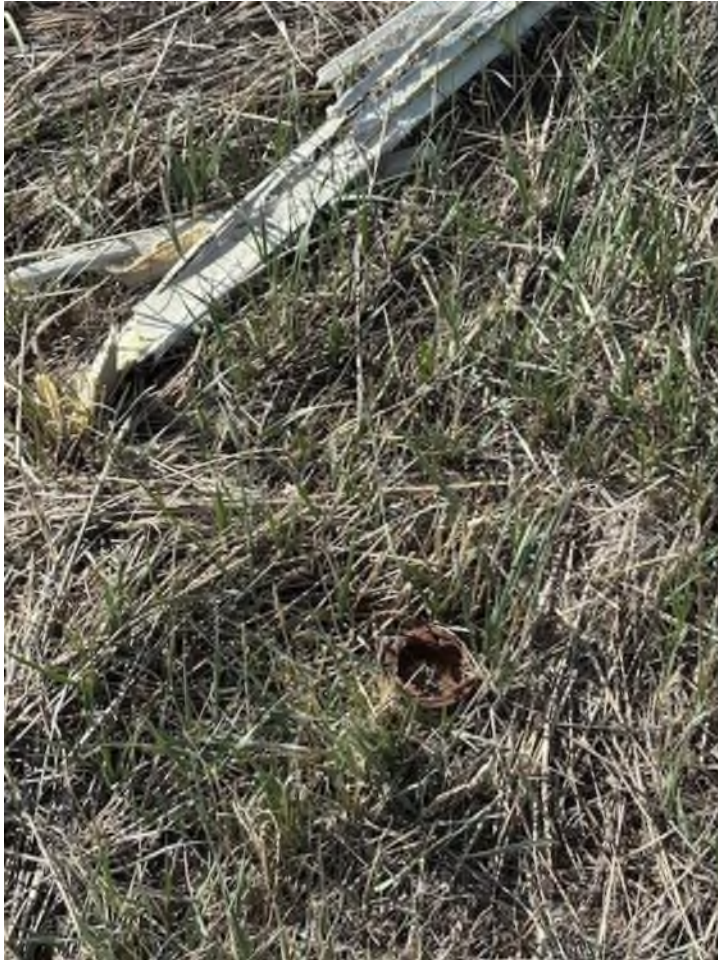
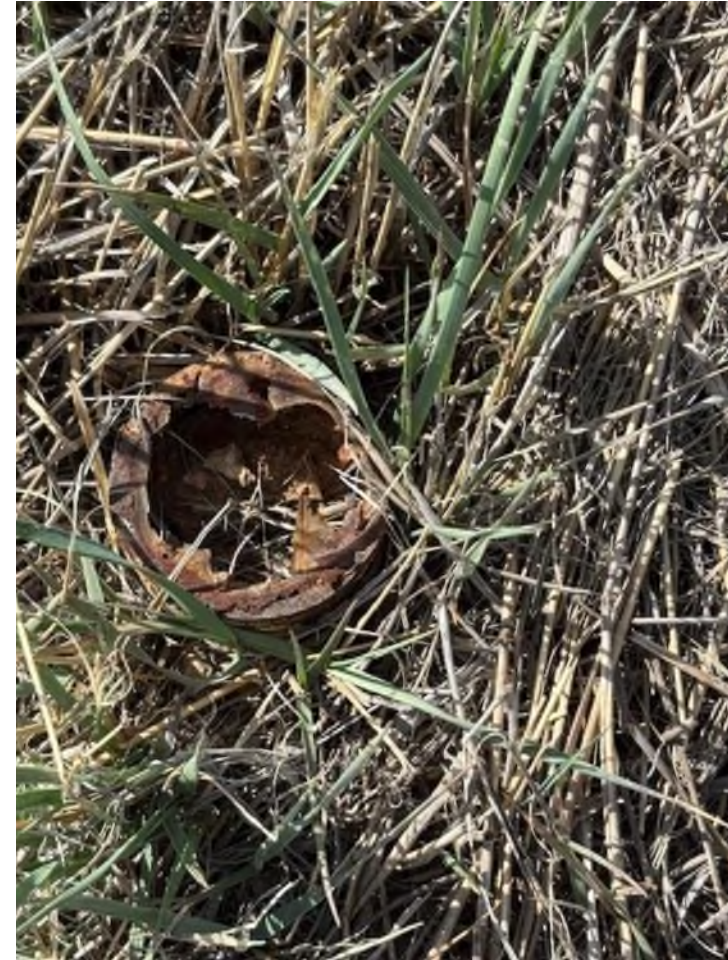
Monument ER60 was observed without its erosion monument cap during the spring 2025 Type II inspection. The disturbance was likely attributed to vegetation management activities conducted in October 2024. On April 15, 2025, Navarro personnel located the displaced cap, reinstalled it on ER60, and documented 1.5 inches of soil cover thickness loss. In July 2025, the cap was permanently secured to the monument shaft with epoxy to prevent future displacement.

The damaged Carsonite marker and erosion monument observed at ER060.

| Inspection Item | Observation | Action |
|---|---|---|
| | Replace damaged Carsonite markers for Monument ER60 and ER85.<br>(Inspection Form: 4/9/25) | Carsonite markers for Monuments ER60 and ER85 were replaced in April 2025. |
| | Erosion Monument ER60 was missing the monument cap and could not be measured during the April 2025 Type II inspection.<br>(Inspection Form: 4/9/25) | The cap for Monument ER60 was found near the monument and replaced on April 15, 2025. The monument measured 1.5" soil loss. The cap was permanently affixed to the shaft in July 2025. |

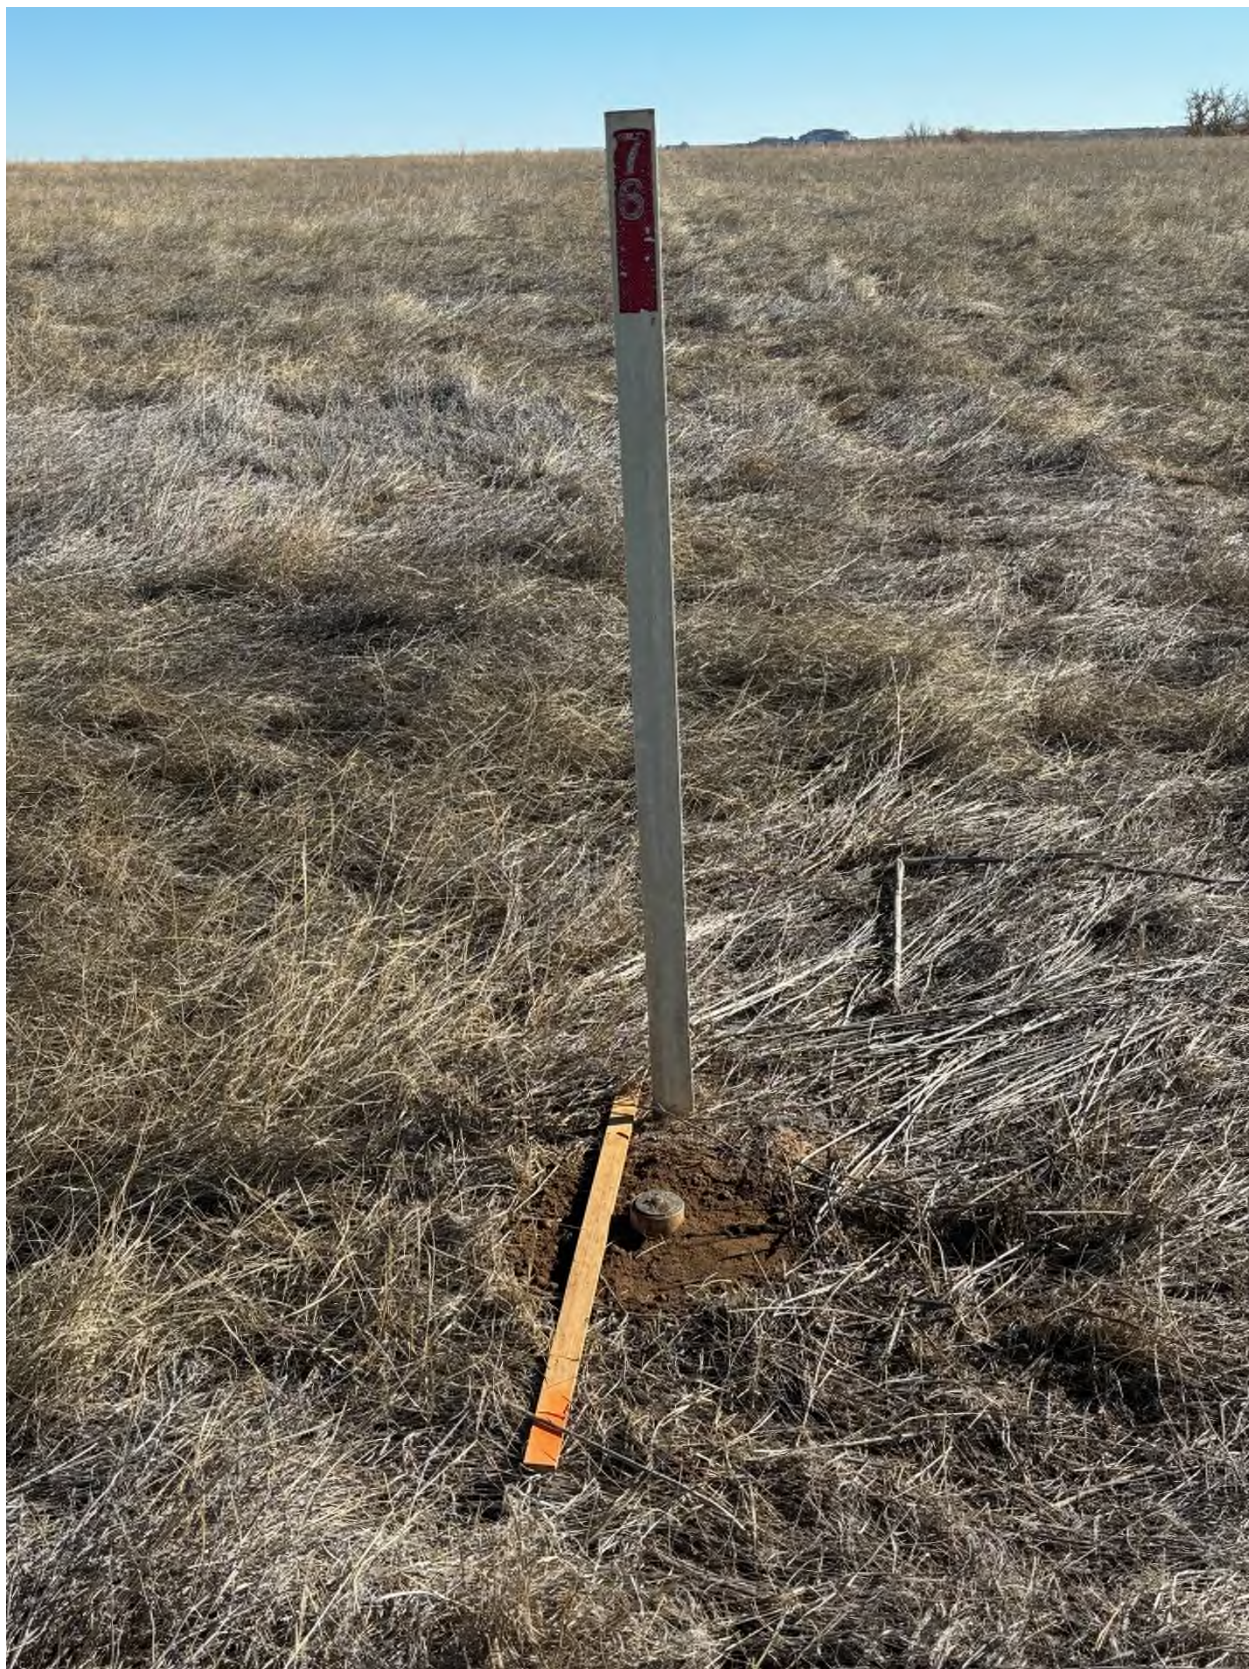
The north side of the repair at ER76.

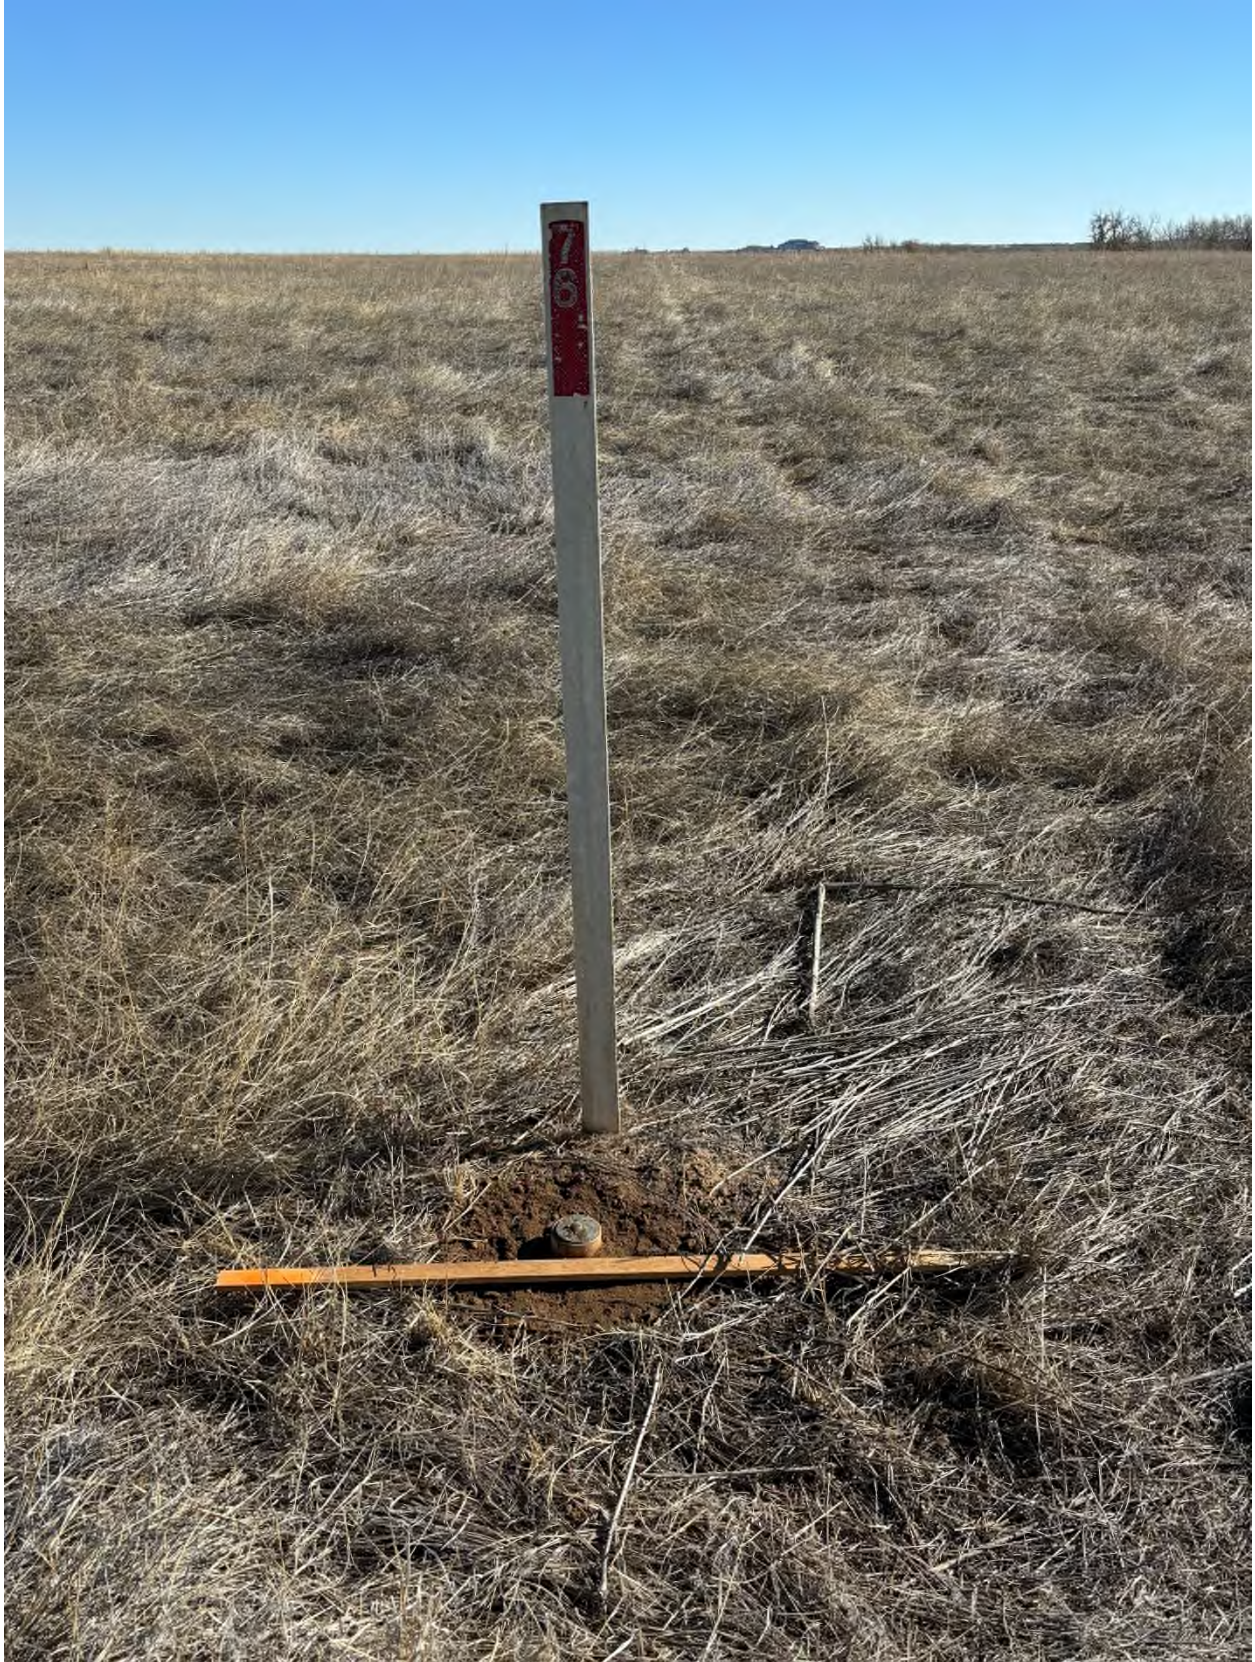
The west side of the repair at ER76.

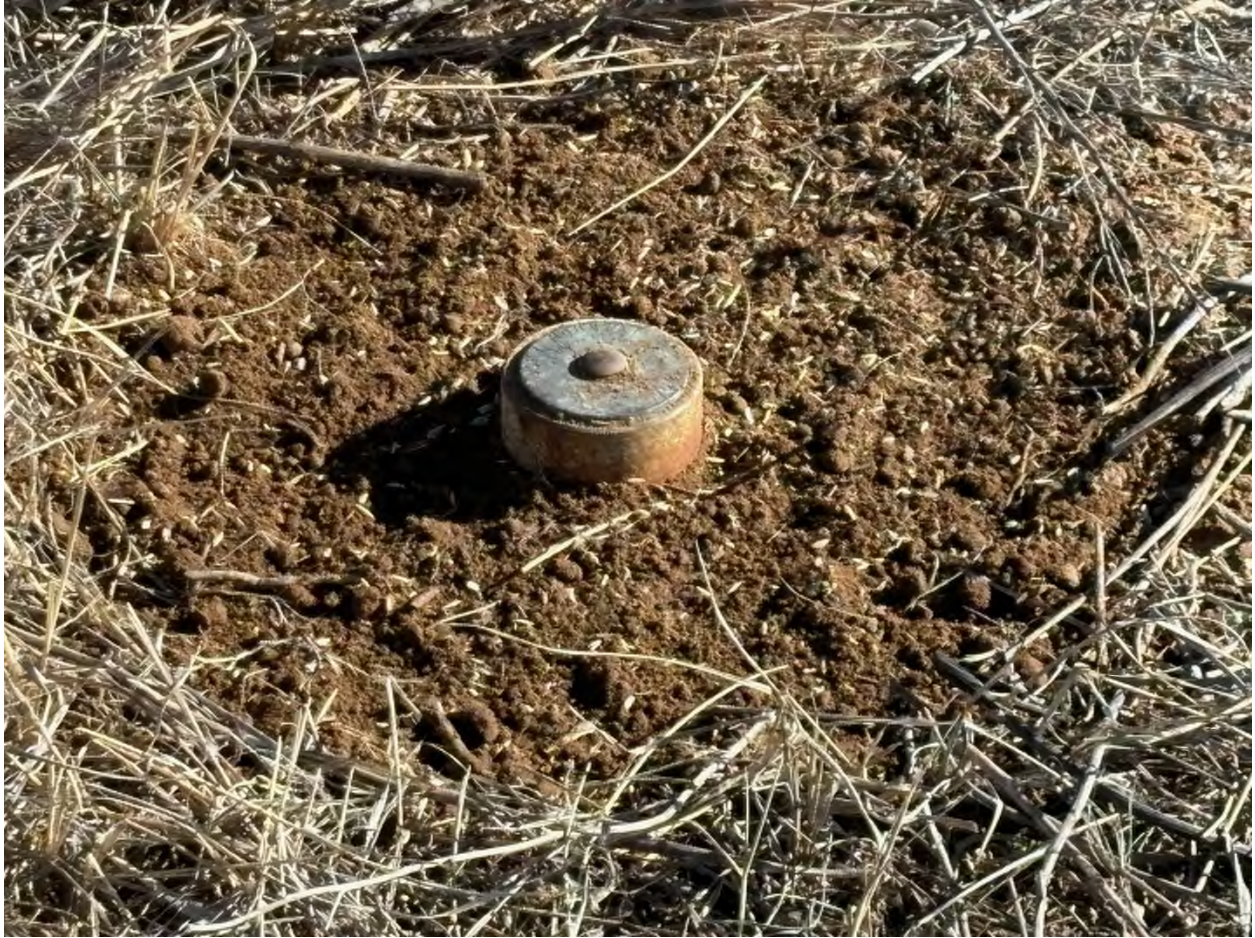
The repaired area at ER76 seeded.

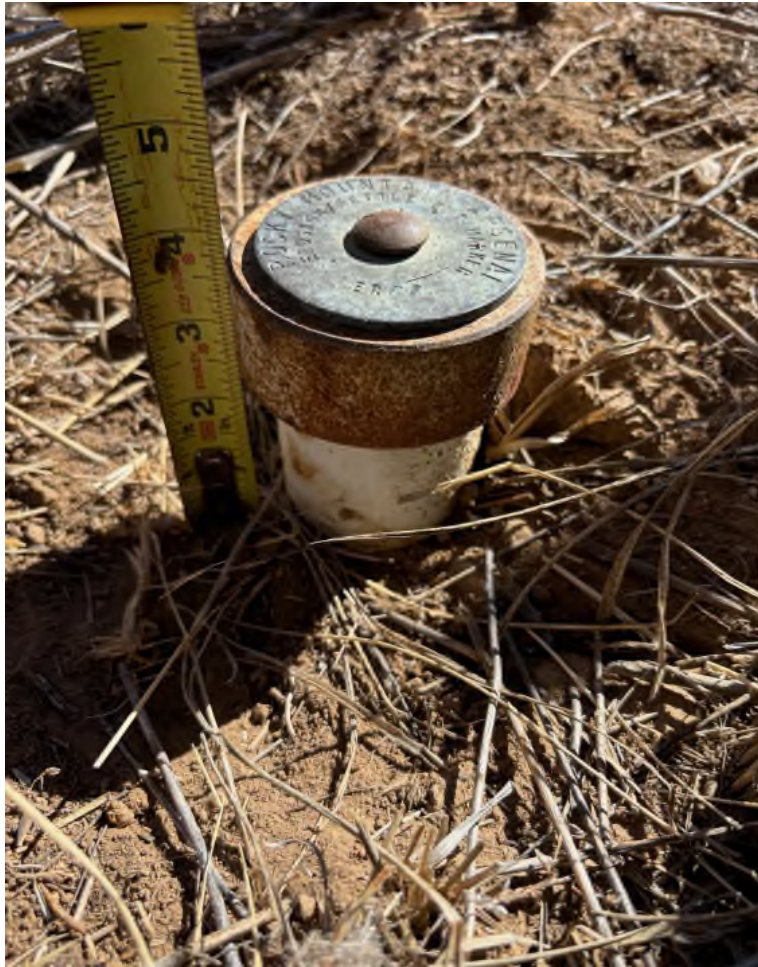
**1: ER76 measured on north side 4.0"**

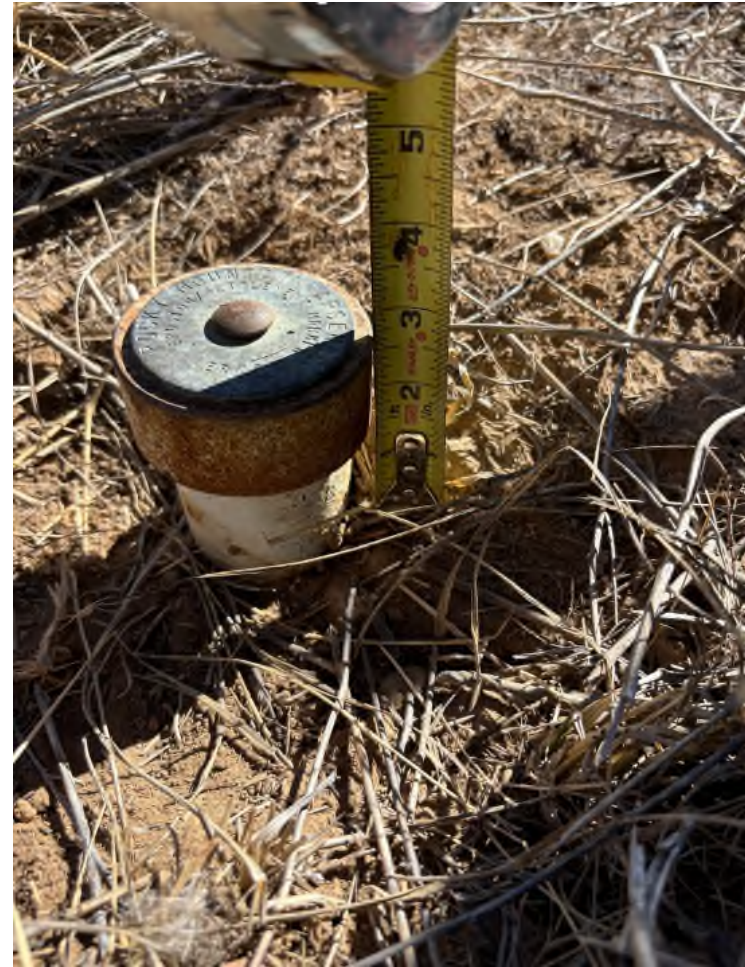
**2: ER76 measured on south side 2.75"**

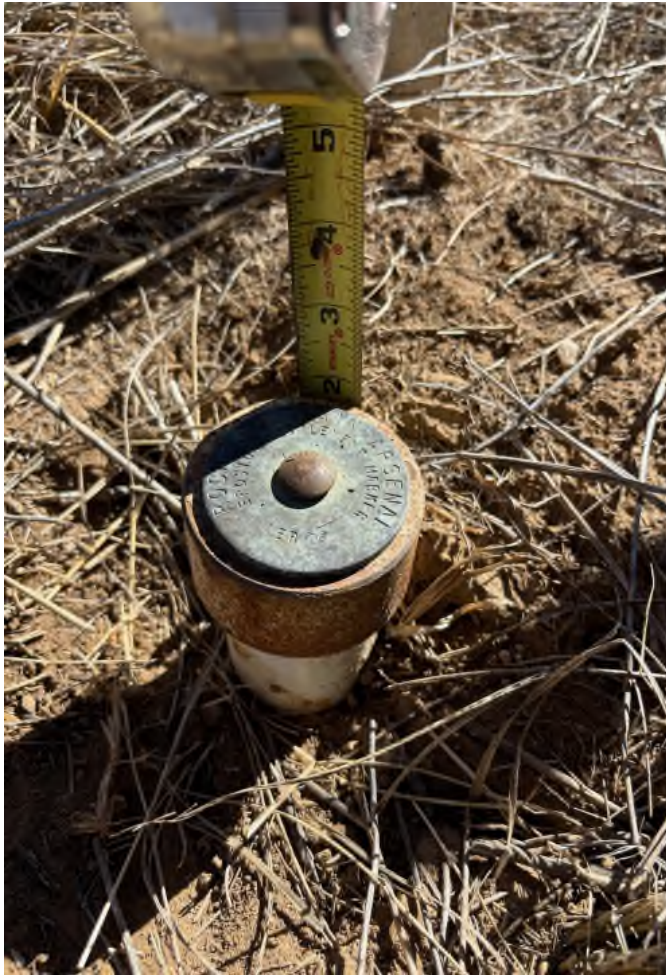
**3: ER 76 measured east side 1.75”**

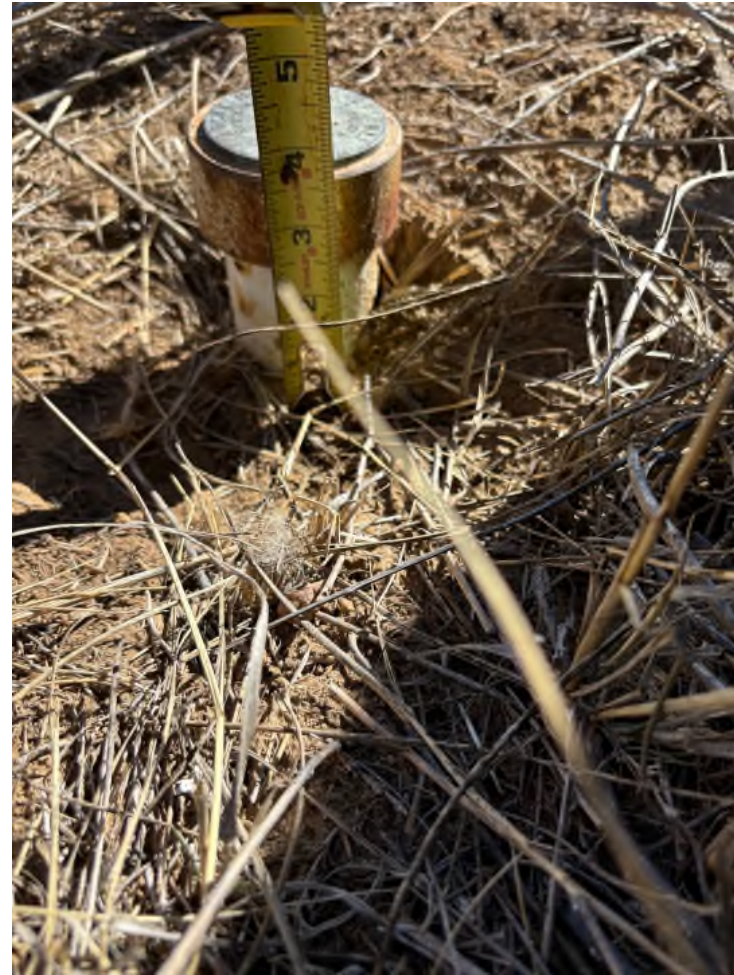
**4: ER 76 measured west side 3.75”**

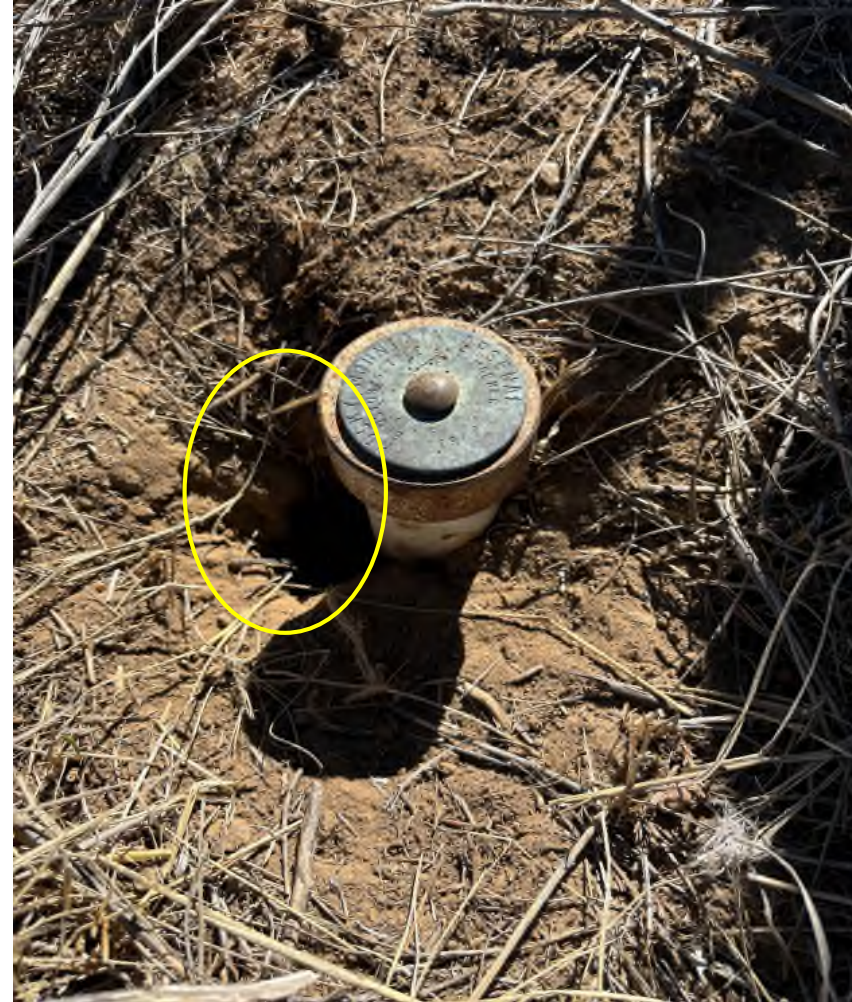
**6: ER 76 animal hole north side of monument**
