**Building 214, Fort Myer**  
77,310 SQFT

## **Attachment A: Photographs**

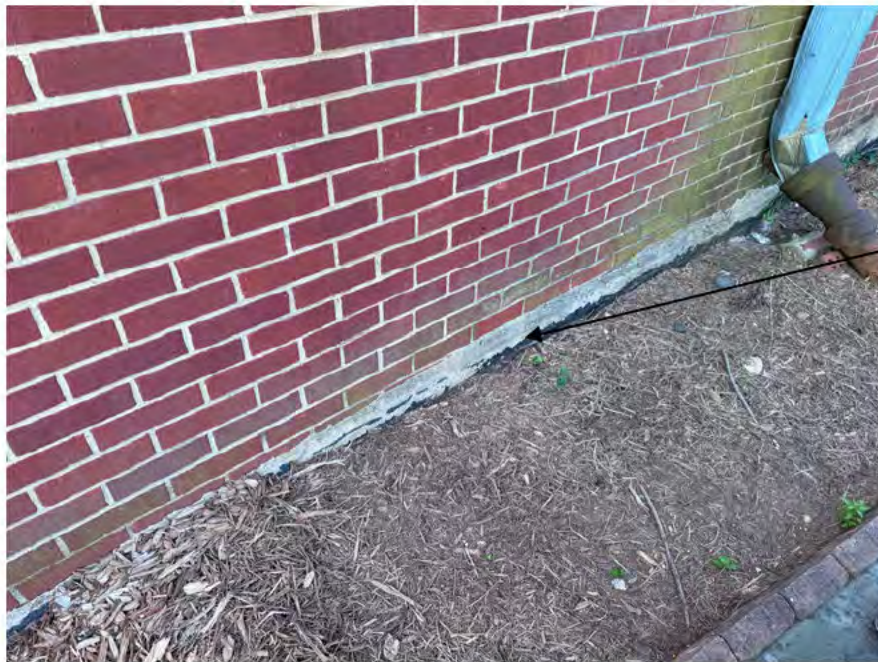
ACM  
BLACK  
MASTIC

Photo 3: ACM black mastic observed at the base of the brick wall around the building (Sample #7).

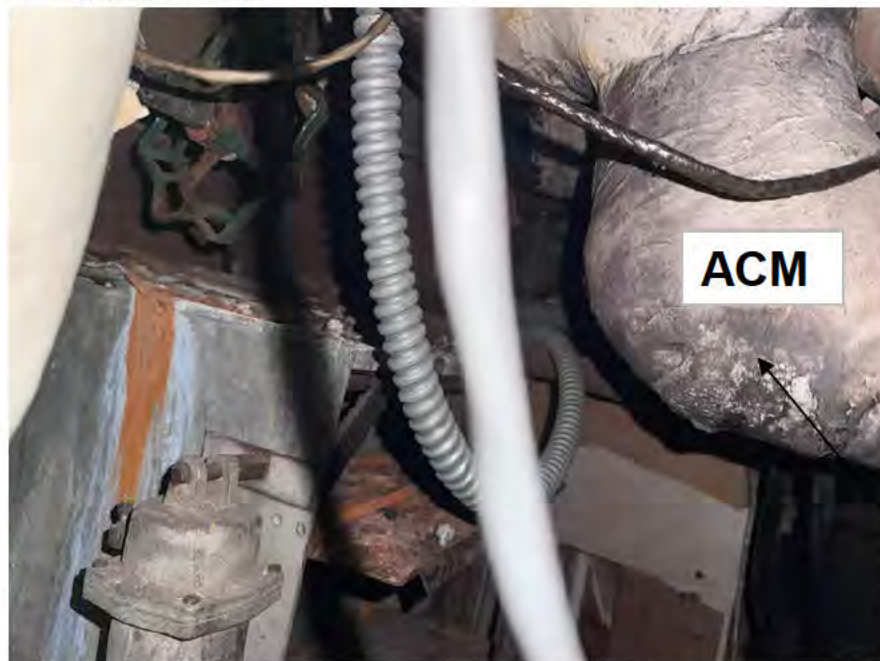
ACM  
MUDDIED  
FITTING

Photo 4: ACM muddied fitting observed in Mech. Room 060 (Sample #14).

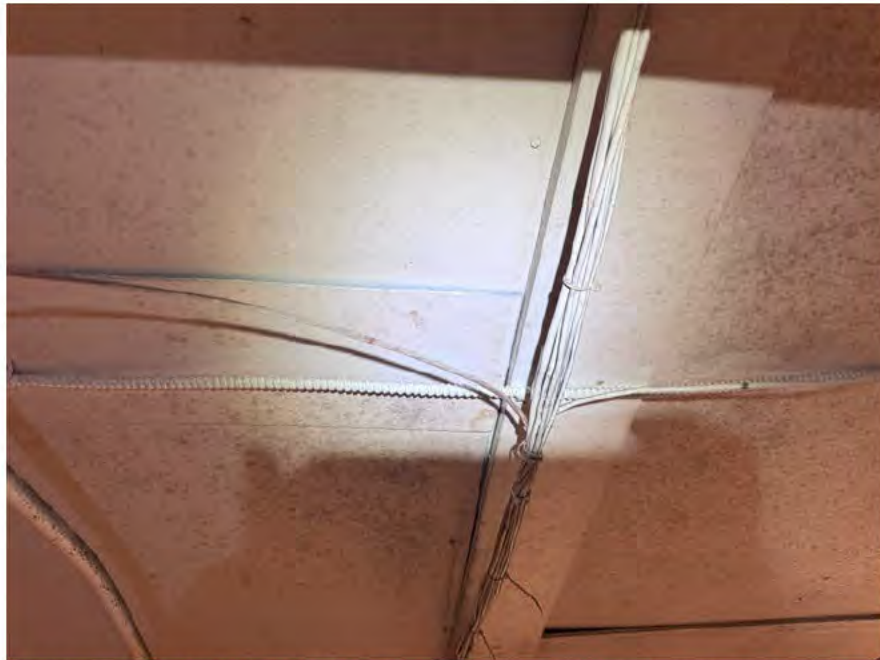
Photo 7: ACM Transite panel observed on the ceiling of Basement Mech. Room 006 (Sample #50).

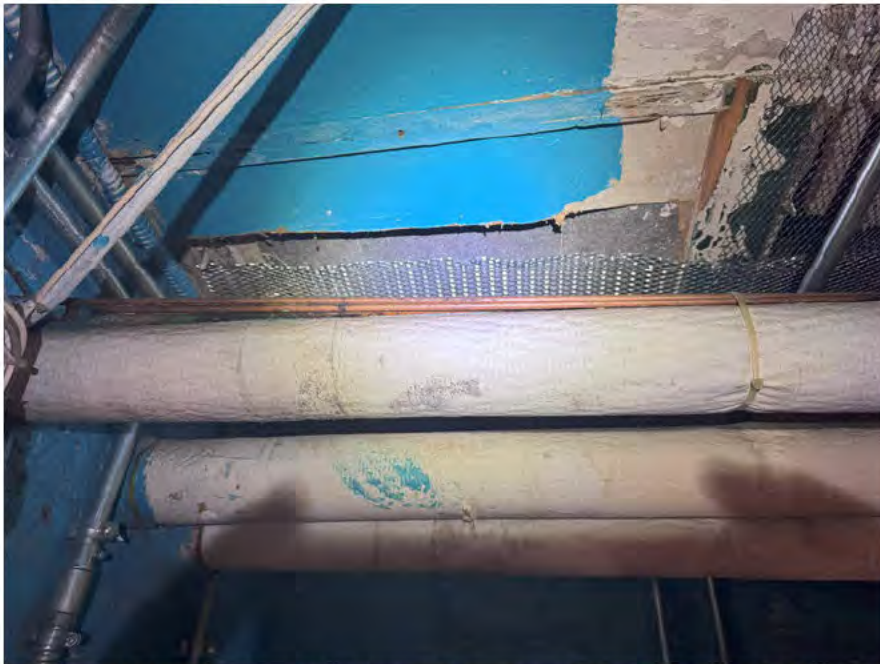
Photo 8: ACM Transite panel observed on the ceiling in Basement Mech. Room 004.

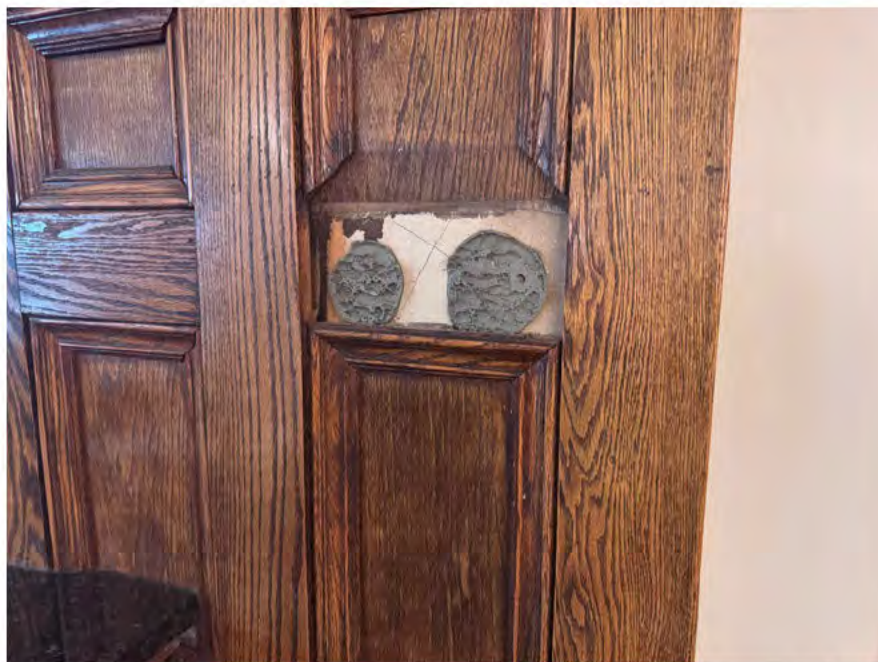
Photo 9: ACM brown adhesive pucks observed behind wood wainscoting in Dining Room 116 (Sample #61).

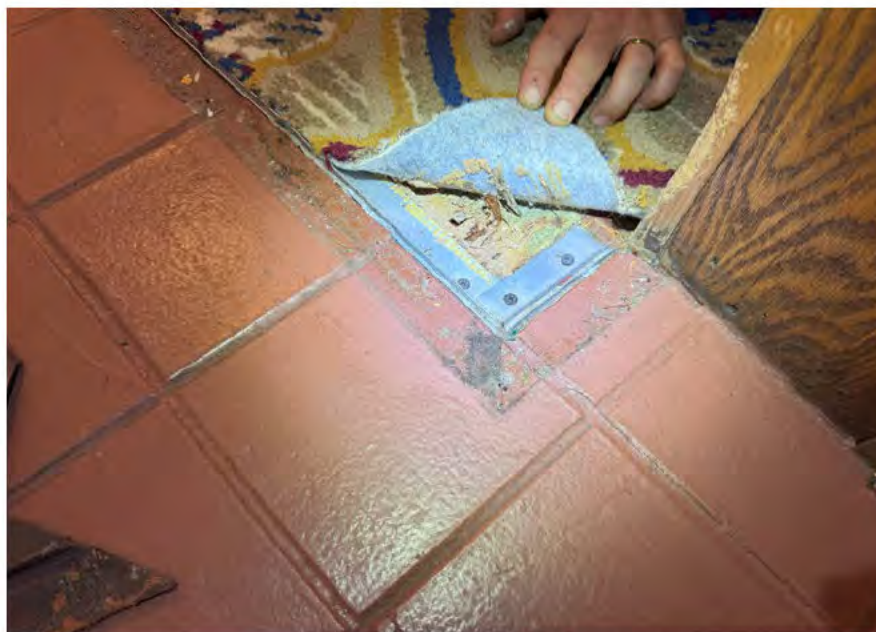
Photo 10: ACM yellow carpet mastic observed on the wood subfloor beneath the carpet in Dining Room 116 (Sample #63).

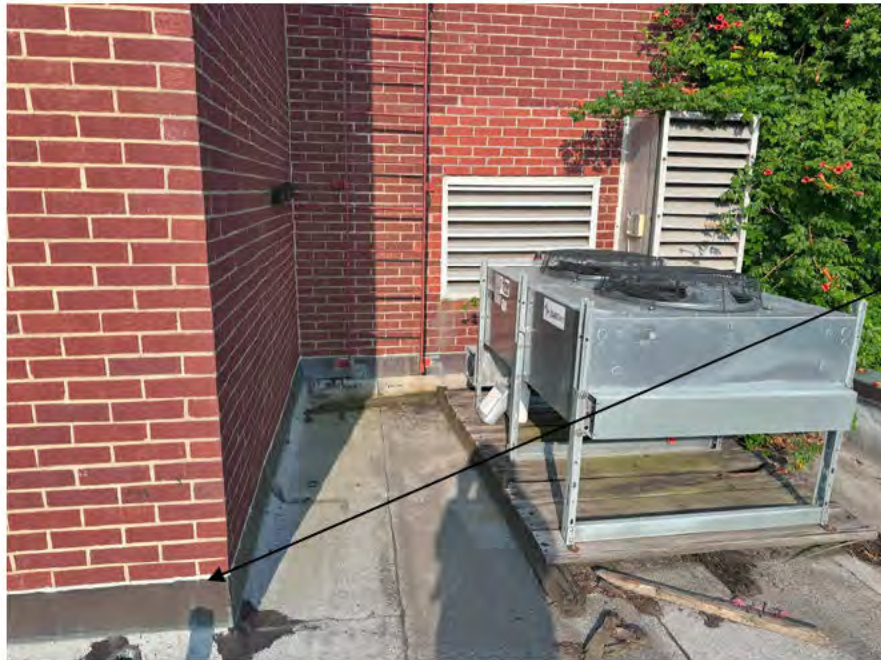
ACM  
WHITE  
SEALANT

Photo 11: ACM white sealant observed on the base flashing on the roof (Sample #83).

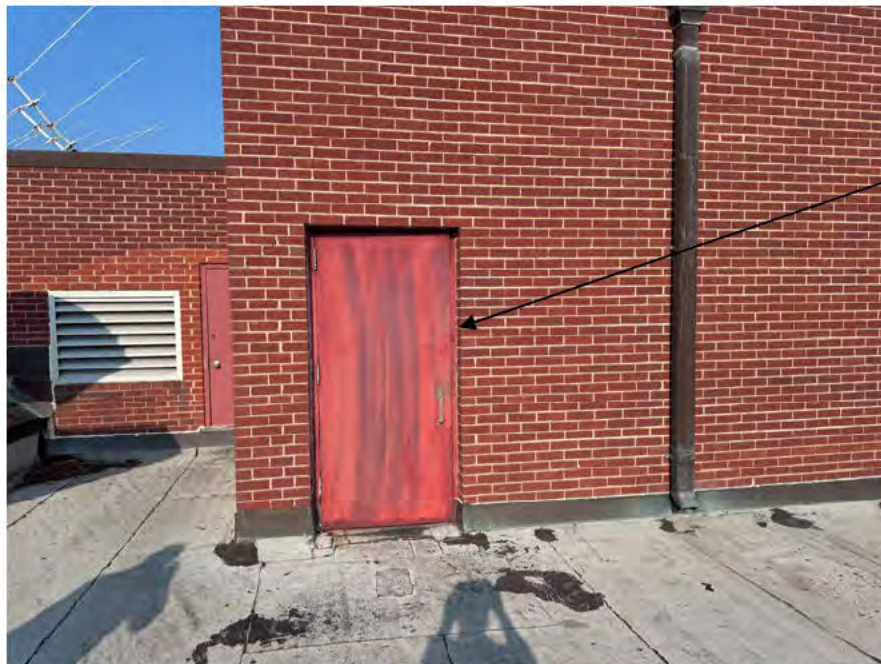
ACM WHITE  
DOOR  
FRAME  
SEALANT

Photo 12: ACM white door frame sealant on the roof access door (Sample #84 & #85).

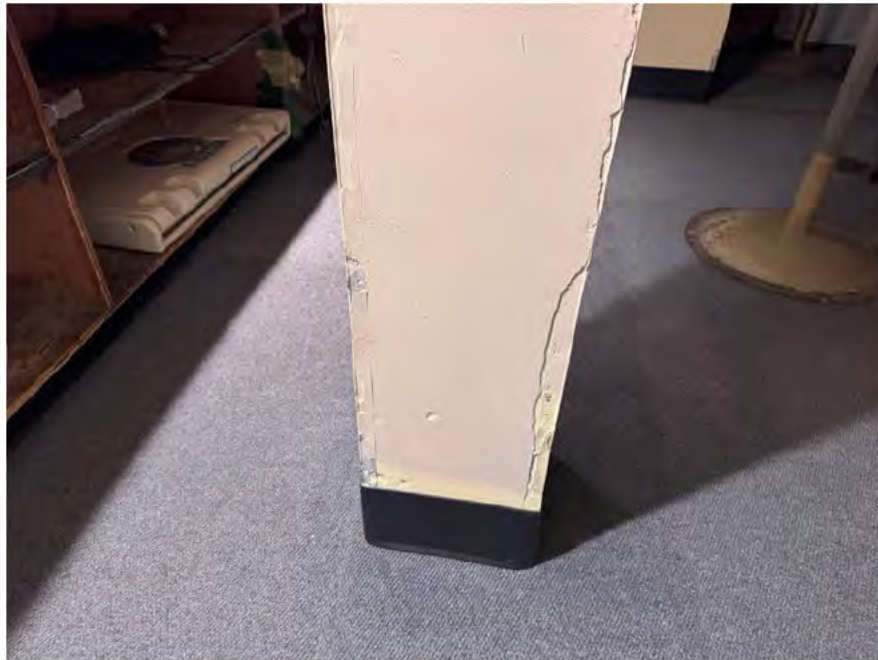
Photo 13: Gypsum wallboard and joint compound observed in Coat Room 151. The joint compound contains <1% asbestos (Sample #103).

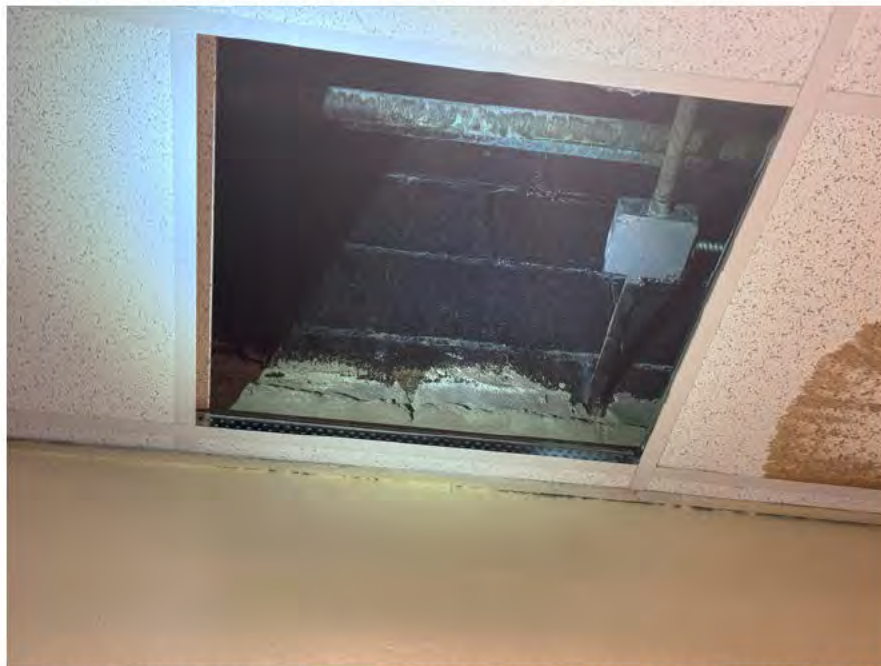
Photo 14: ACM black mastic observed on the CMU wall above the SACT in Kitchen Corridor 129 (Sample #132 & #133).

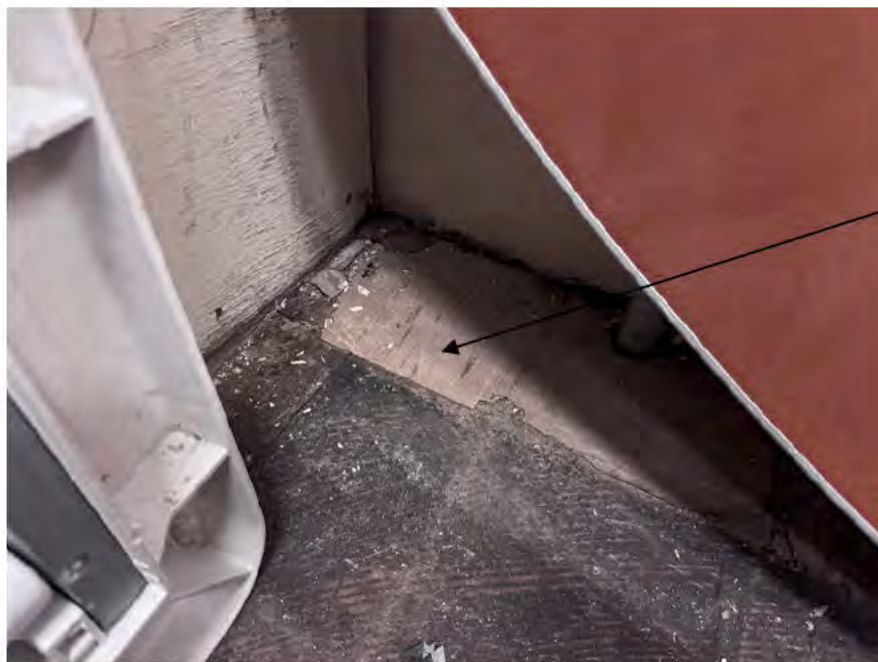
ACM  
FLOOR  
TILE

Photo 15: ACM brown 12-inch for tile observed in Mech. Room 237 (Sample #142 & 143).

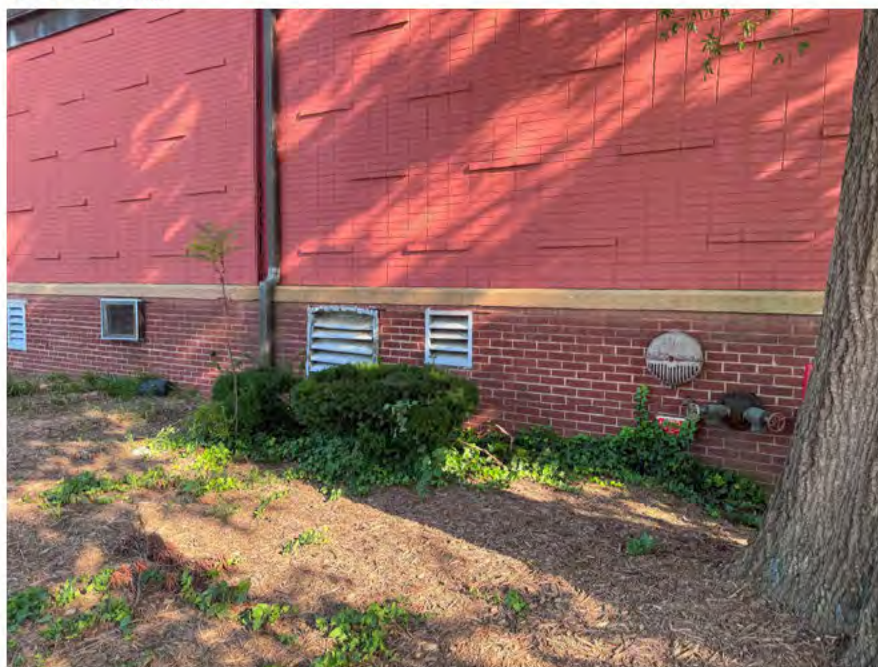
Photo 16: Exterior vents on the building. The white sealant on the vents is ACM (Sample #154).

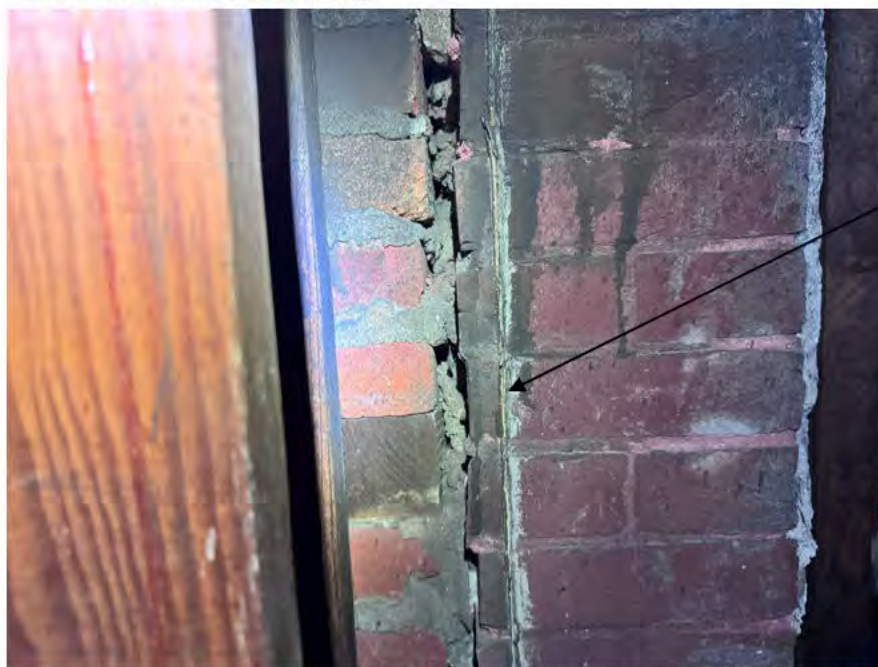
ACM WHITE  
SEALANT

Photo 18: ACM white window frame sealant observed on a former exterior window in Mech. Room 222 and Storage Room 242 (Sample #173 & 174).

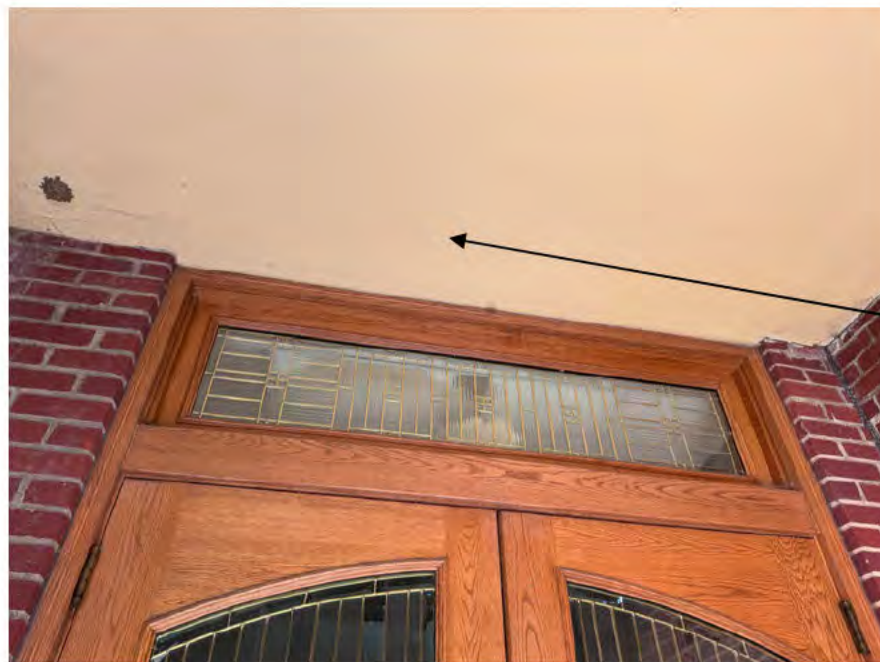
ACM PLASTER  
CEILING

Photo 19: ACM plaster ceiling observed above the entrance to Room 134 (Sample #187 & #188).

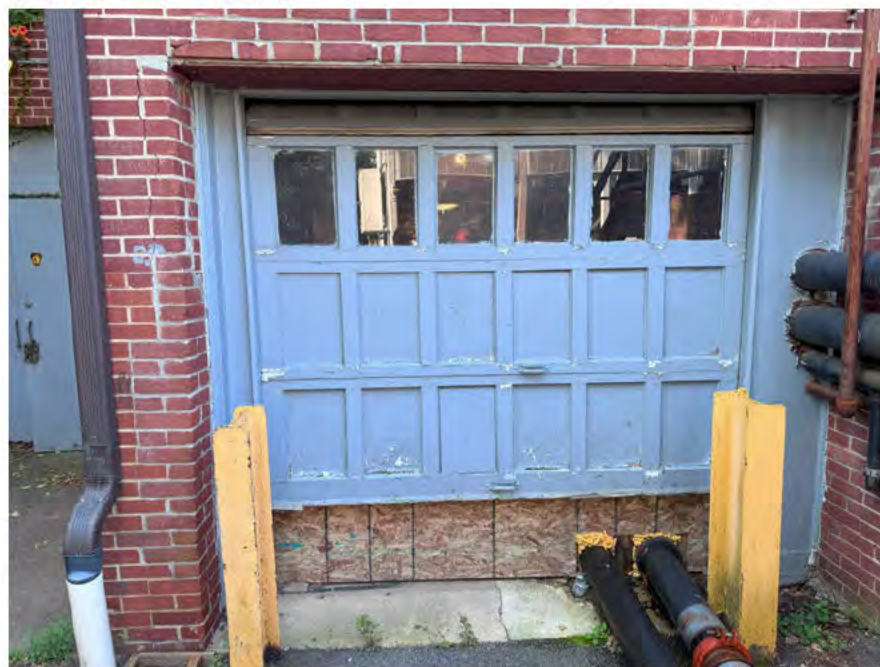
Photo 20: ACM white sealant was observed around the door frame (Sample #190).

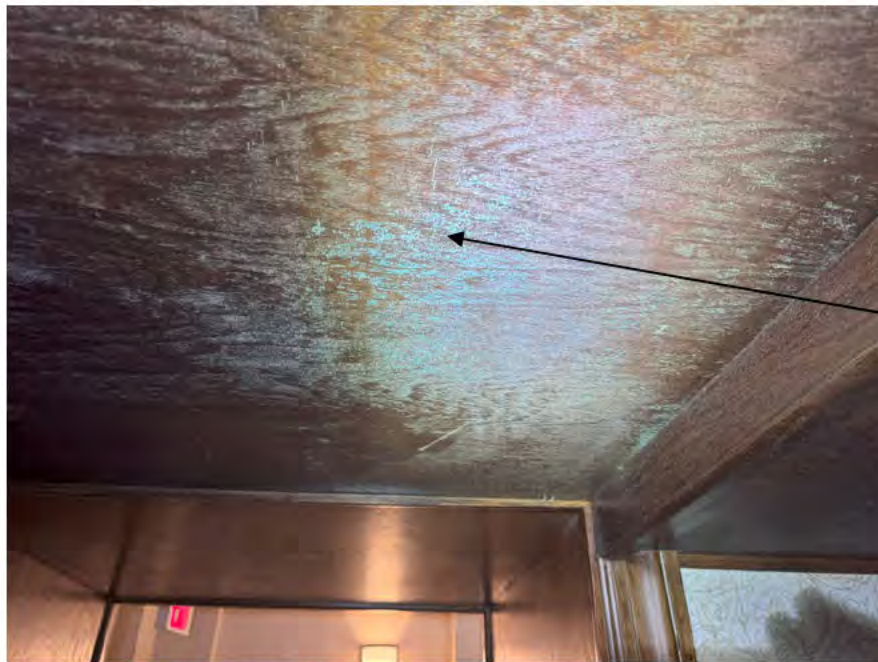
The mold is related to the building materials becoming wet either through lack of humidity control or water leaks. These conditions need to be corrected to ensure the mold growth does not continue.

VISIBLE MOLD  
GROWTH ON  
WOOD SOFFIT

Photo 21: Mold growth observed on a wood soffit in Basement Room 055 (Sample #M1).

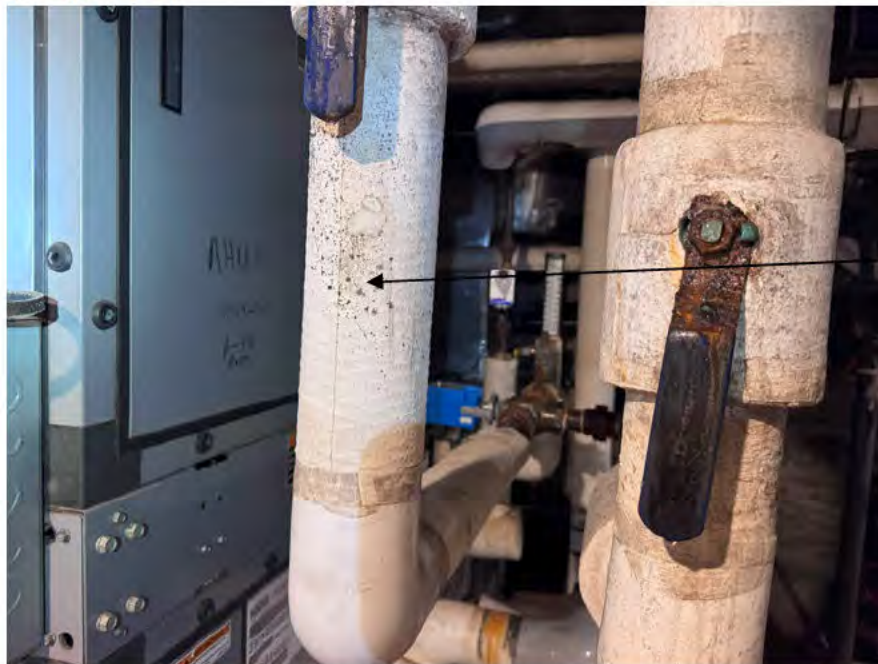
VISIBLE MOLD  
GROWTH ON  
TSI

Photo 22: Mold growth observed on TSI in Basement Mech. Room 042 (Sample #M2).

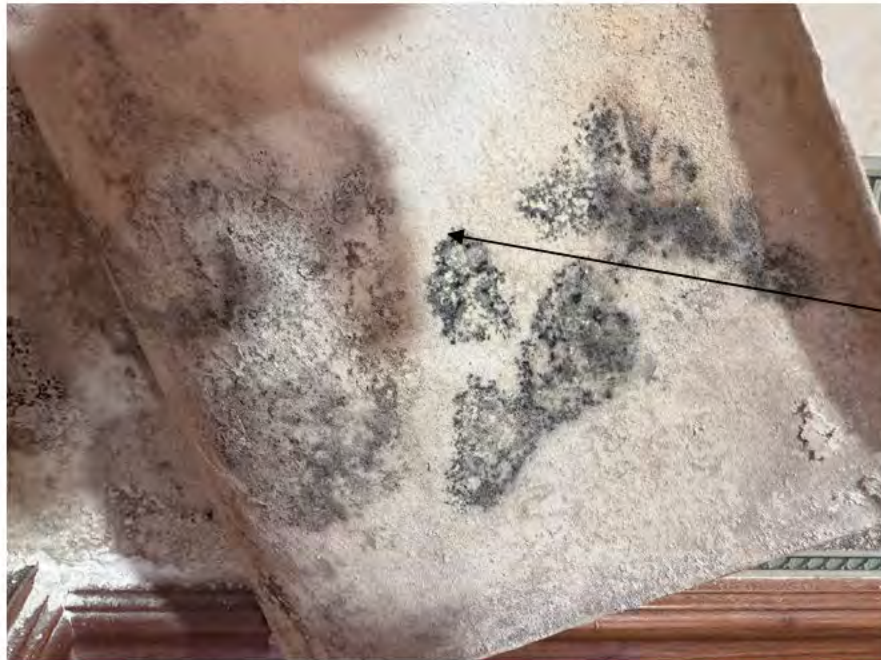
VISIBLE MOLD  
GROWTH ON  
BACKSIDE OF

Photo 23: Mold growth observed on the backside of wallpaper in Dining Room 130 (Sample #M3).

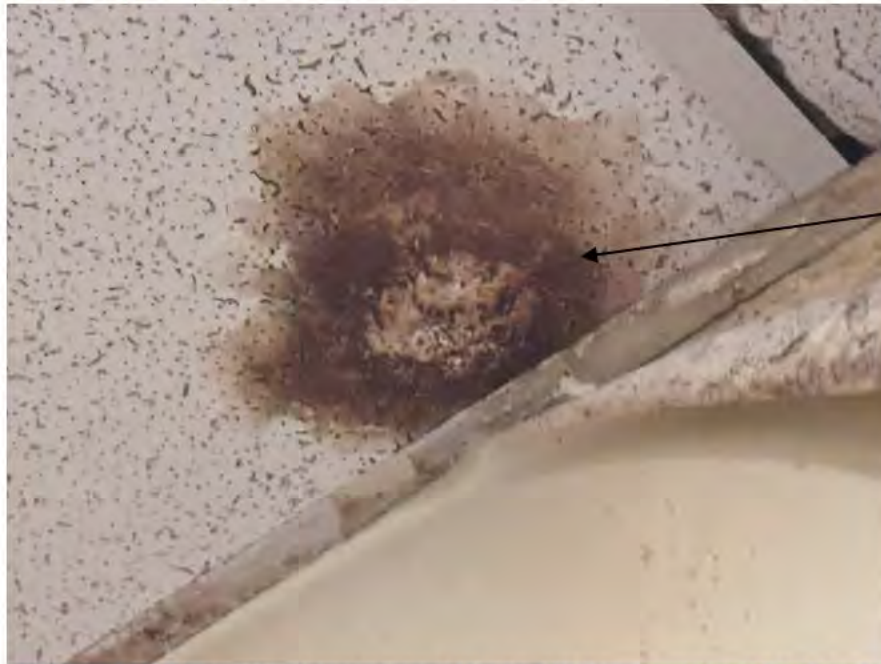
VISIBLE MOLD  
GROWTH ON  
SACT

Photo 24: Mold growth observed on SACT in Kitchen Corridor 129 (Sample #M4).

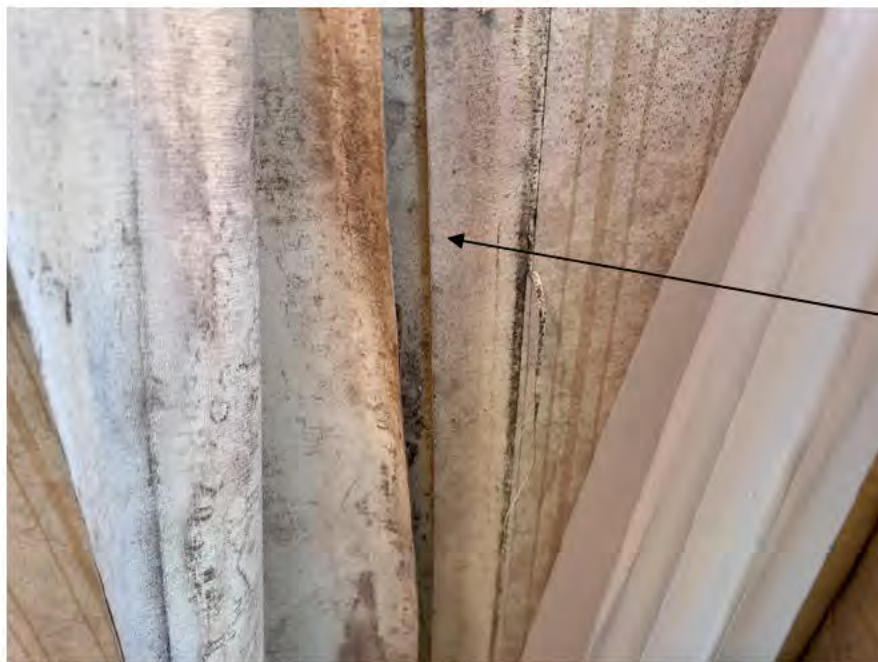
VISIBLE MOLD  
GROWTH ON  
BACKSIDE OF

Photo 25: Mold growth observed on the backside of wallpaper in Corridor Room 228 (Sample #M5).

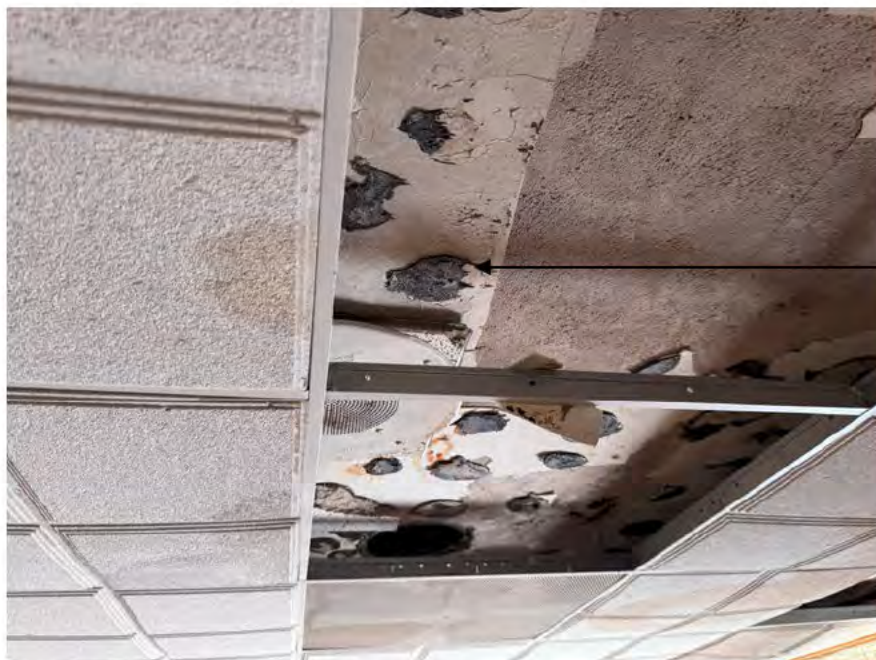
BROWN  
ADHESIVE  
PUCKS FOR  
CEILING TILE,  
NO ACM.

Photo 26: Brown adhesive puck associated with ceiling tile in Vestibule Room 134 (Sample #10).

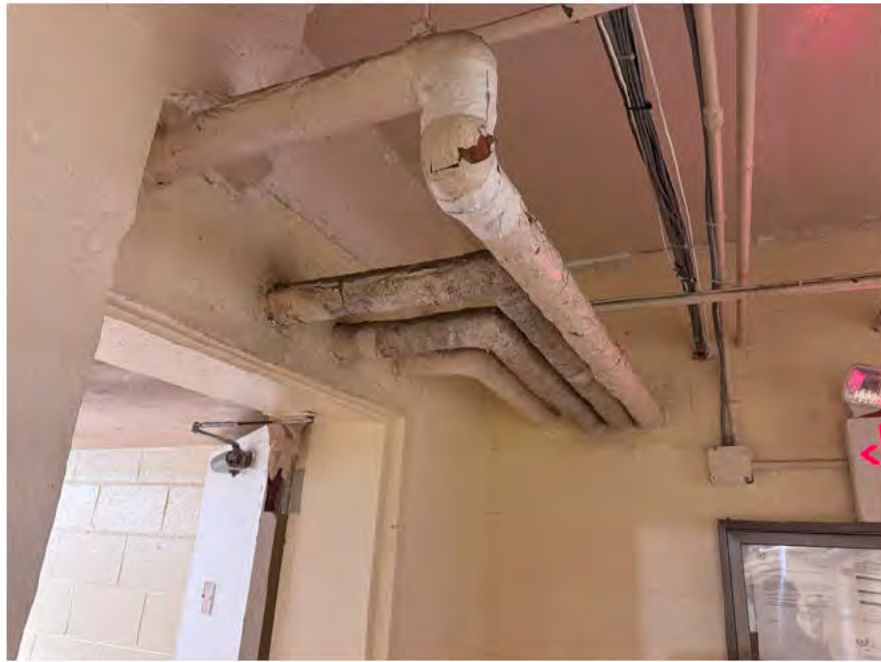
Photo 27: ACM mudded pipe fittings observed in Basement Vestibule 039.

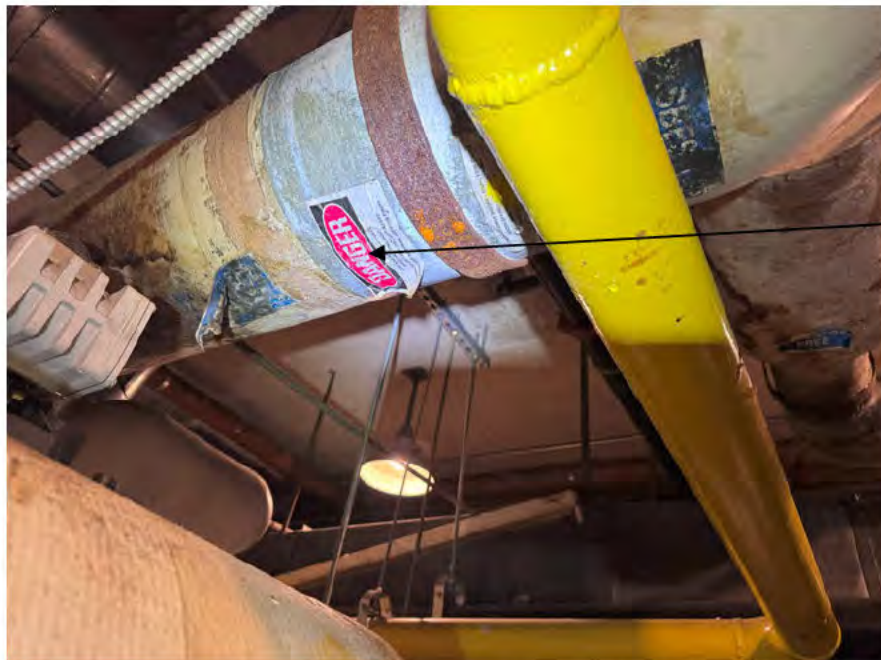
Photo 28: ACM pipe insulation observed in Basement Mech. Room 012.

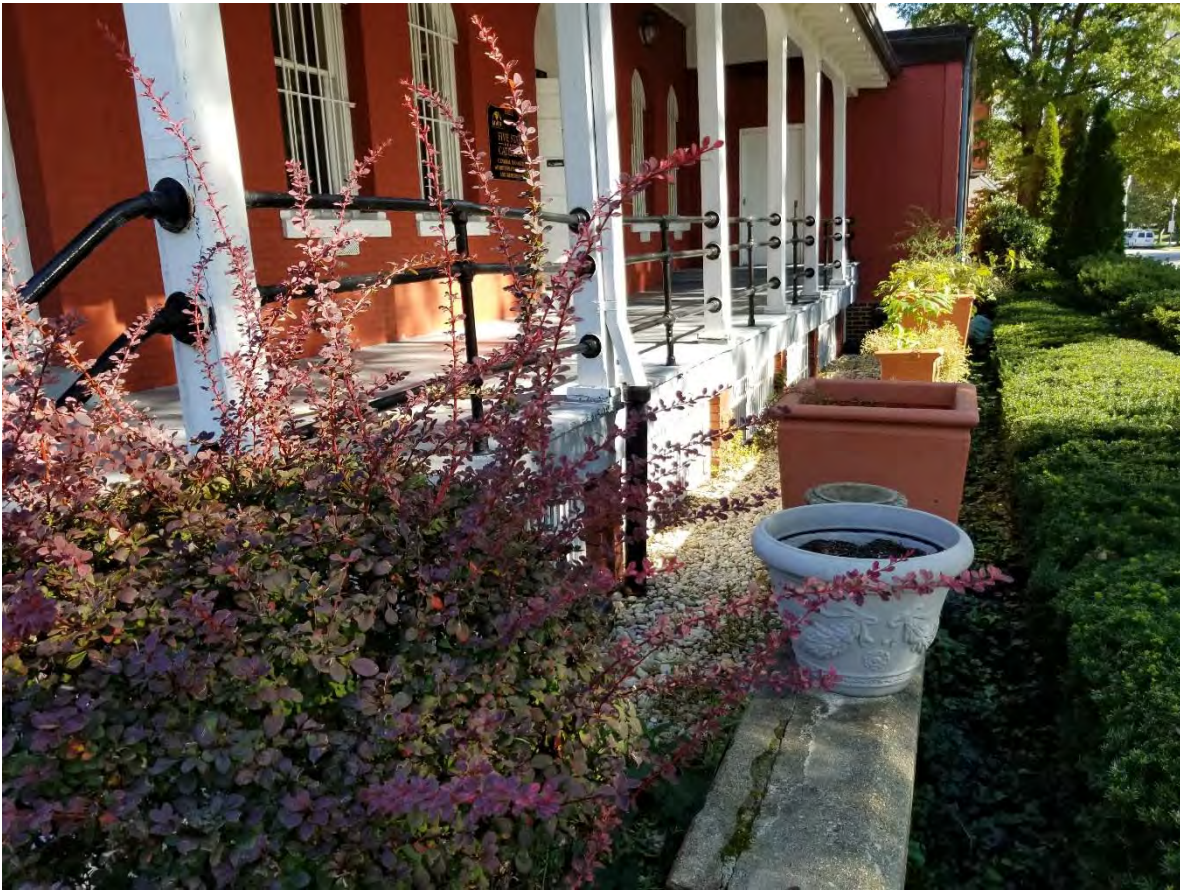
Hedges blocking access to roof drains

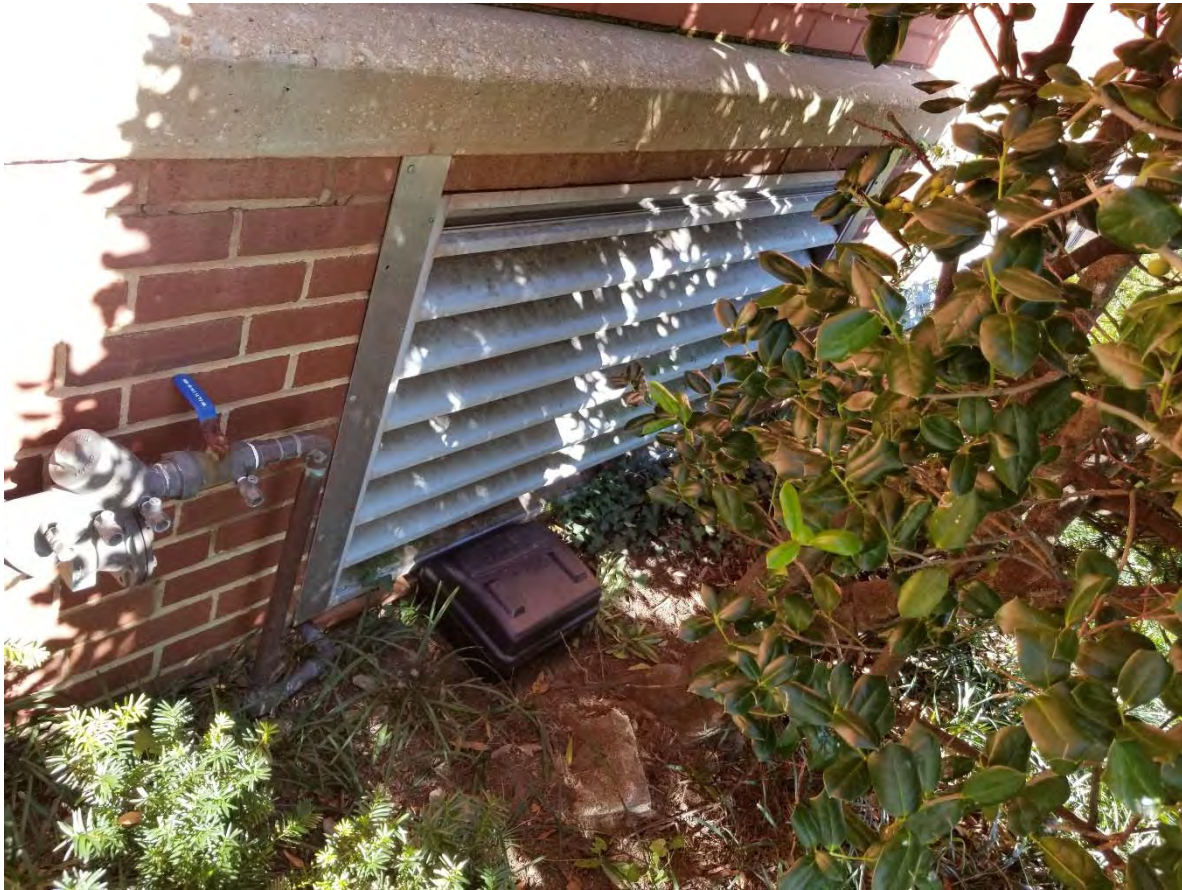
Rat trap at Low Air Intake

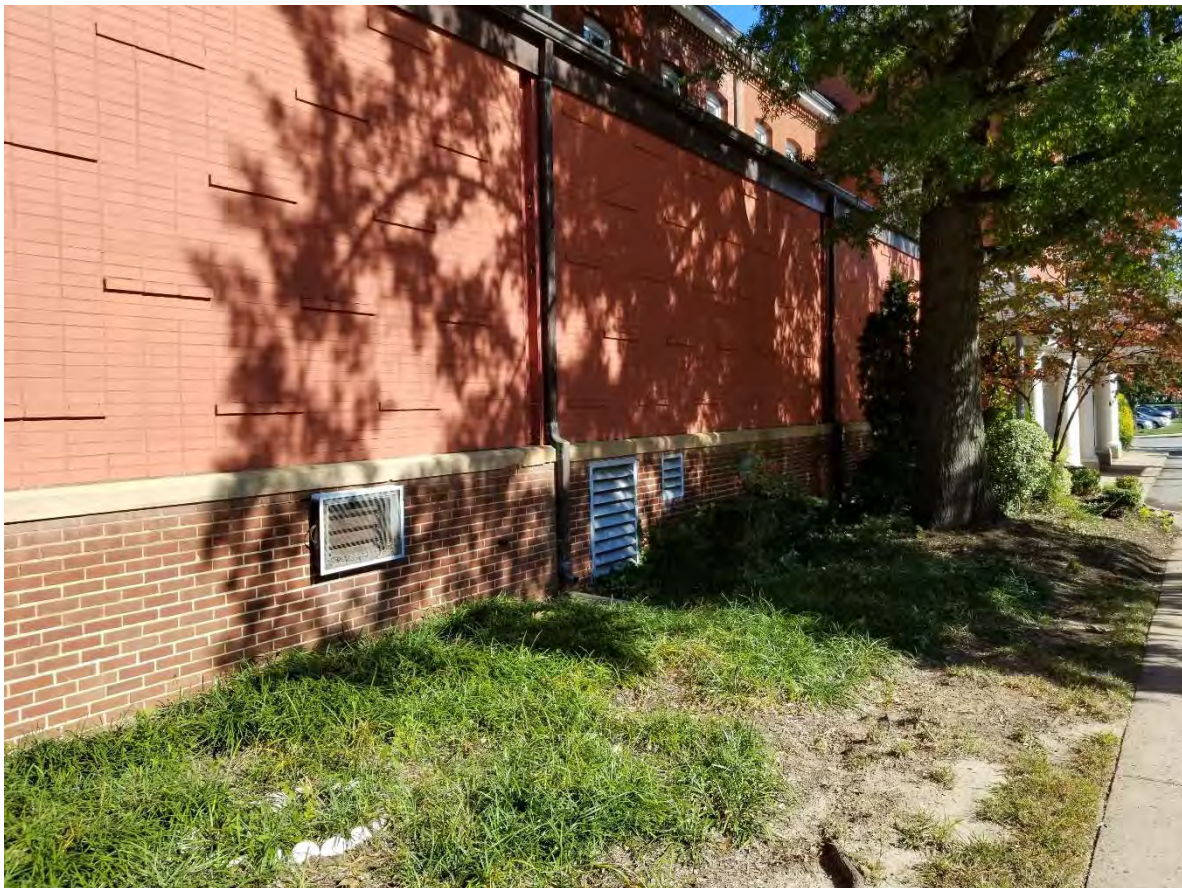
Low air intakes

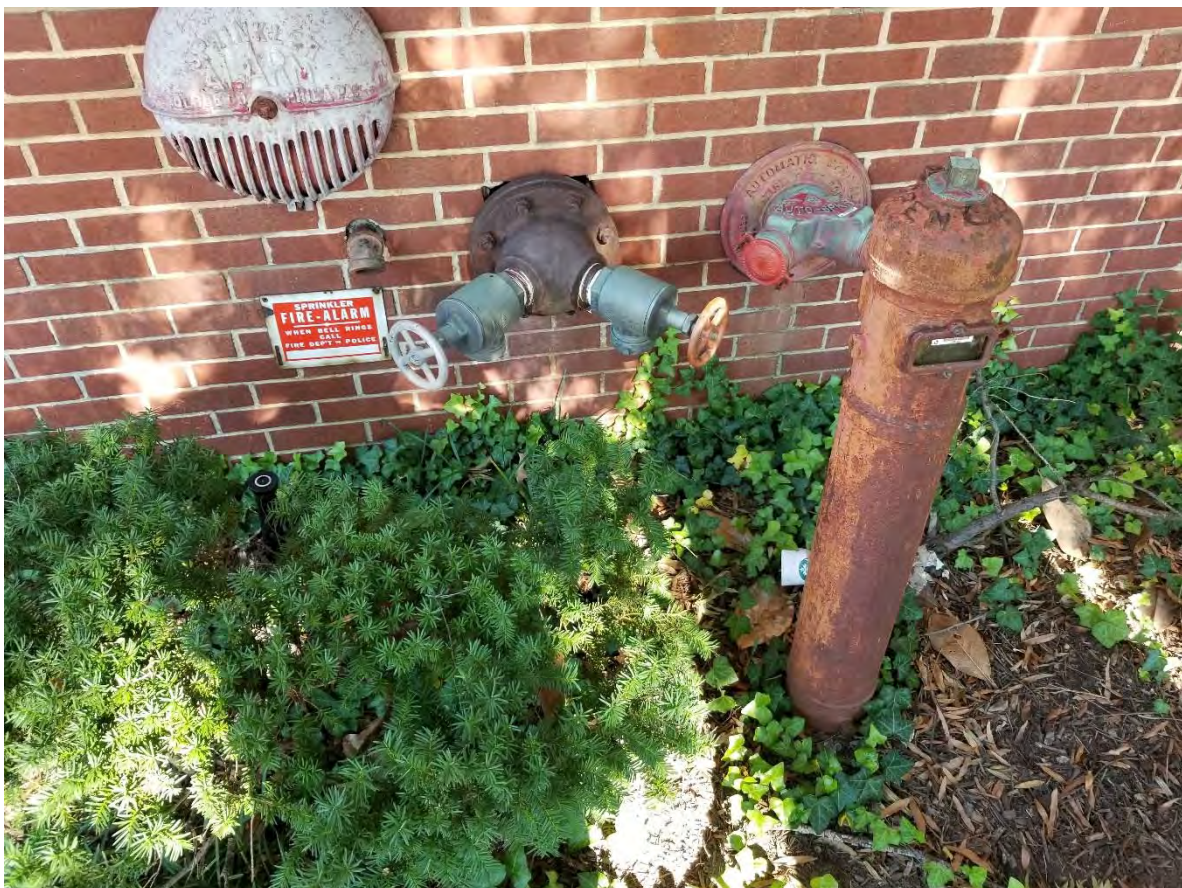
Irrigation spout in hedges at grade near facility

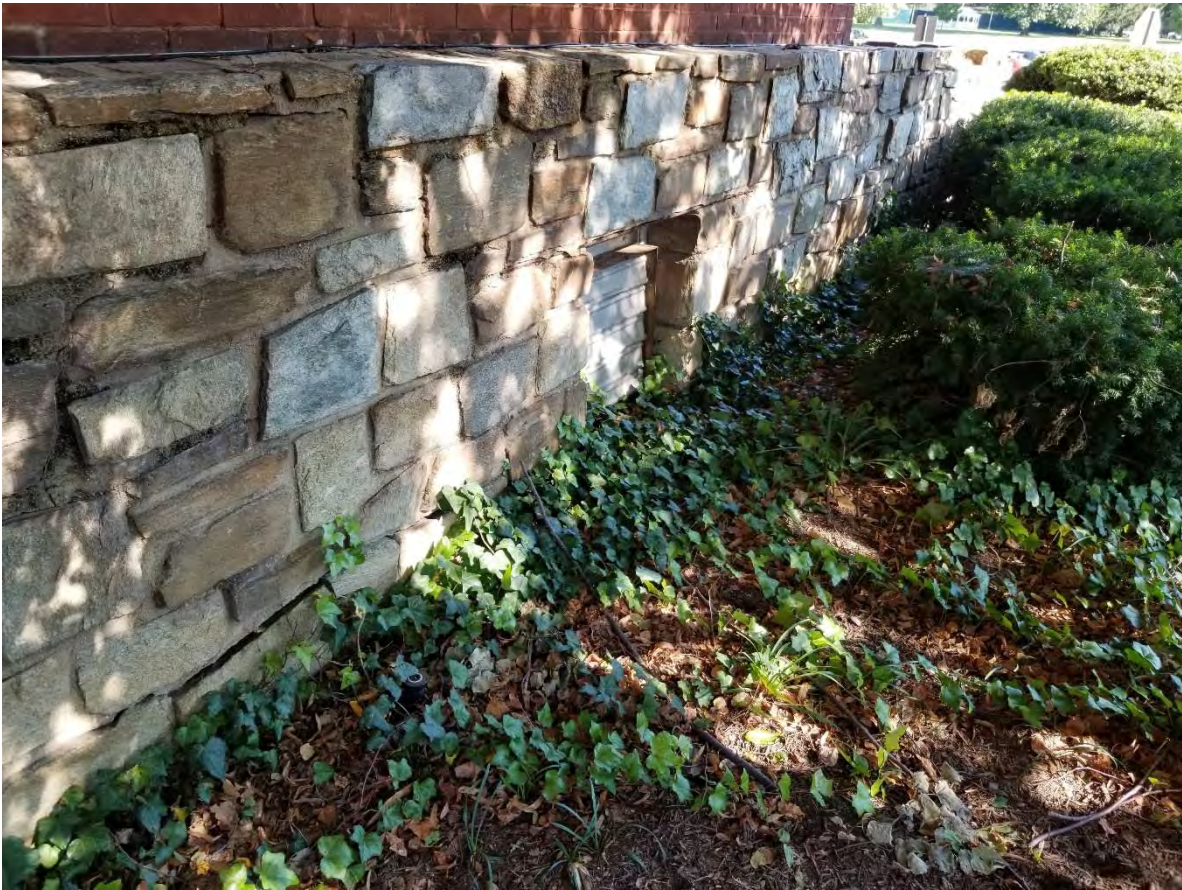
Low air intake

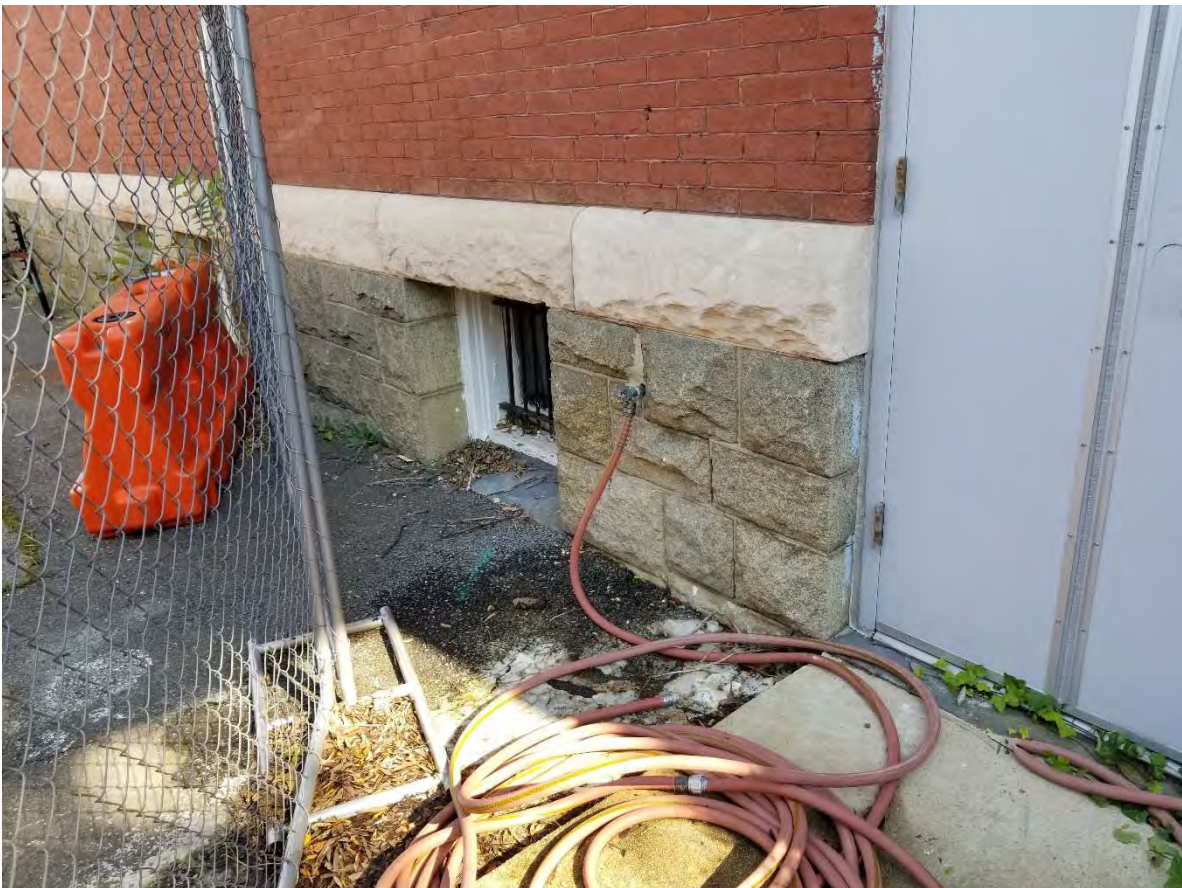
Low window

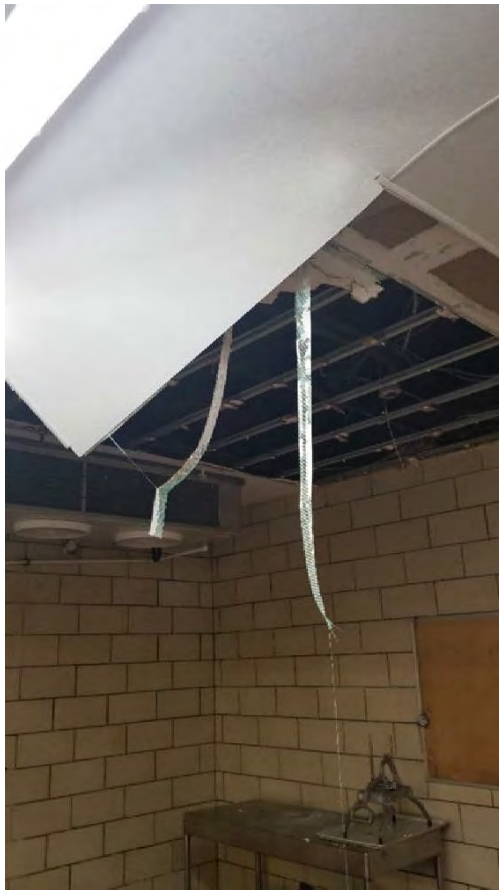
Ceiling water damage

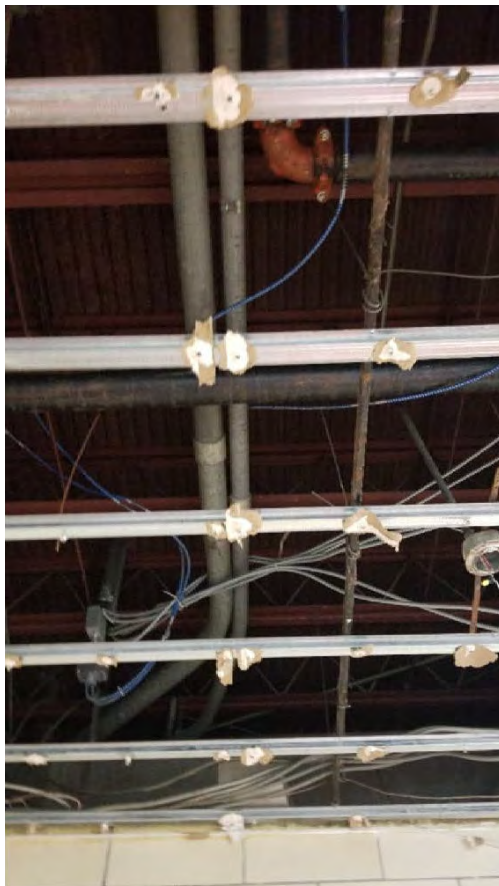
Ceiling water damage

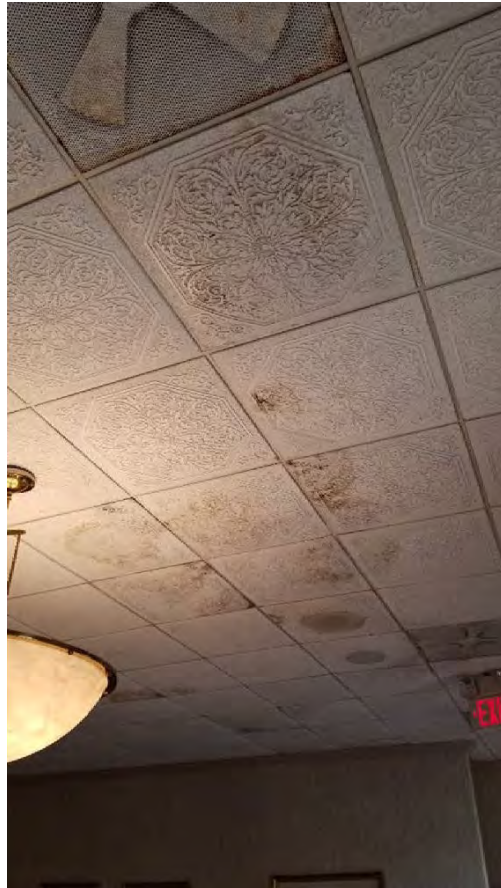
Ceiling water damage

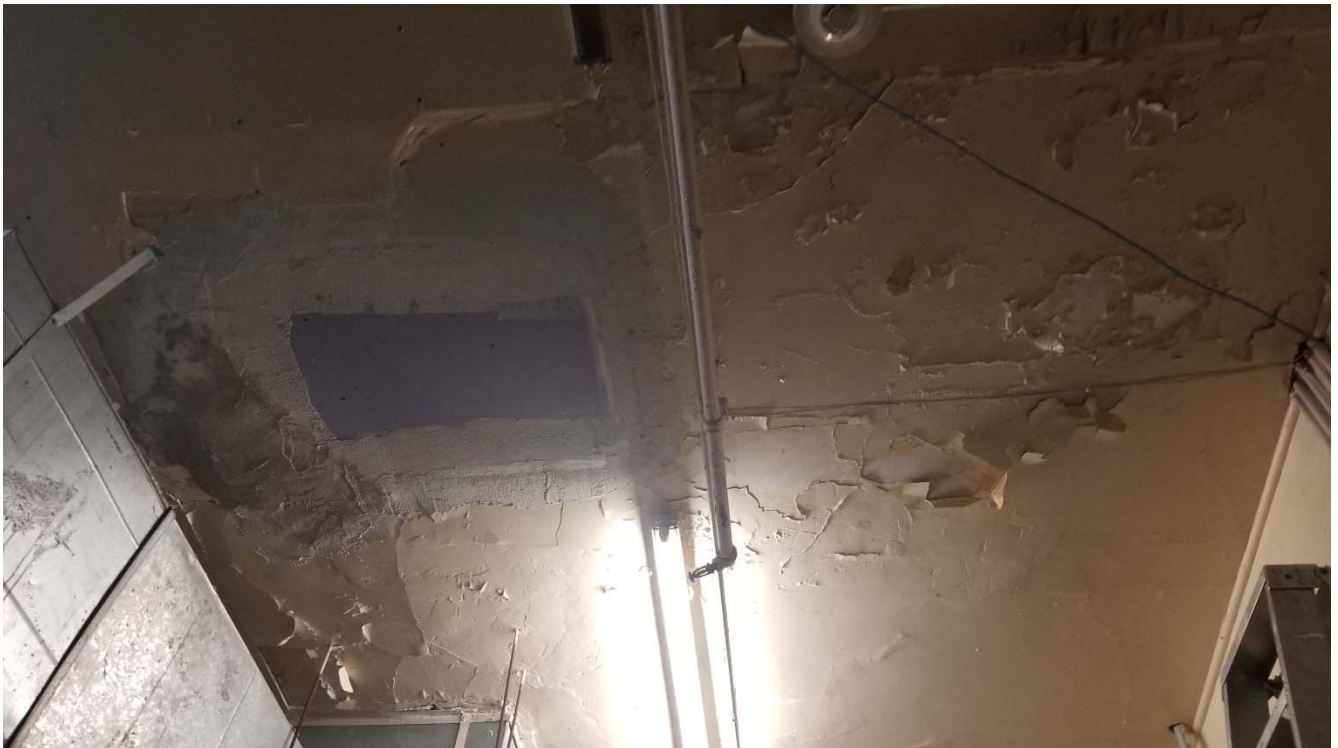
Ceiling water damage

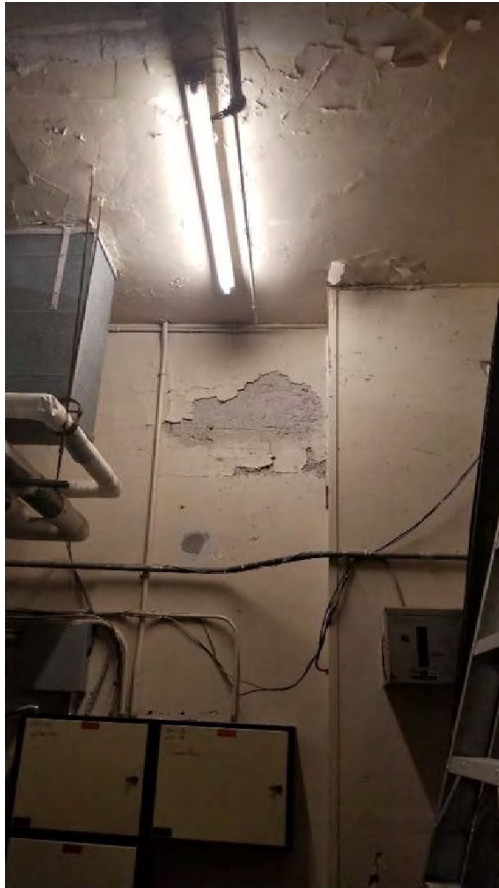
Ceiling/Wall water damage
