**Building 214, Fort Myer**  
77,310 SQFT

## **Attachment A: Photographs**

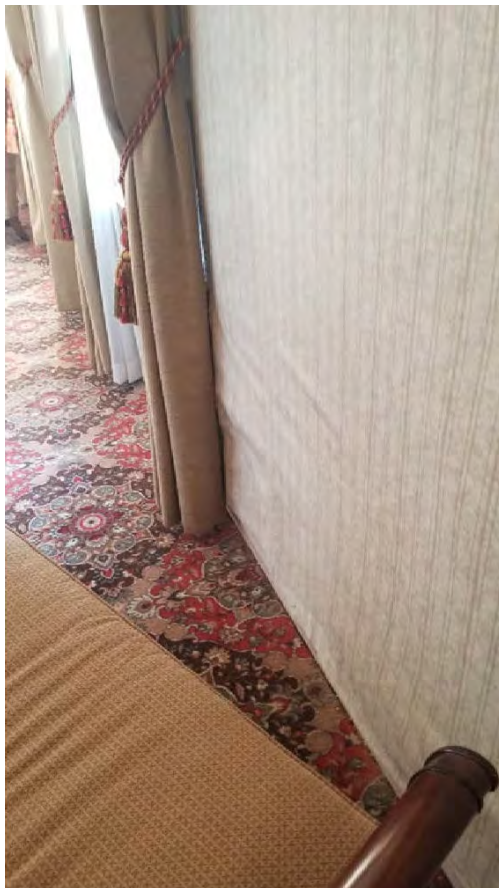
Water damaged wall behind textile

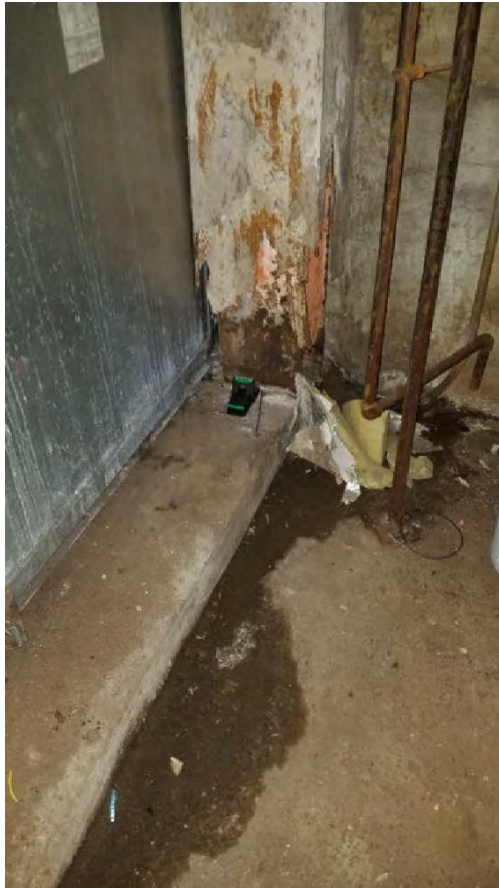
Standing water in mech room

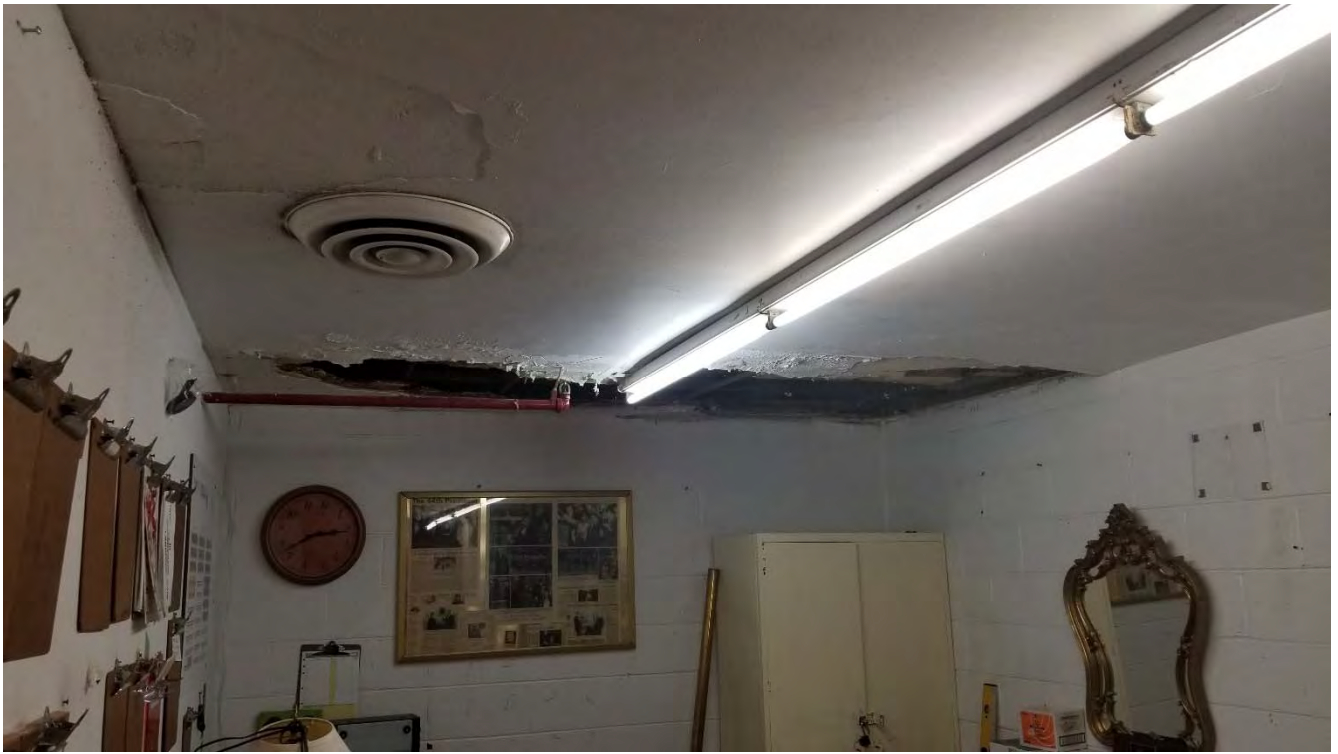
Water damaged ceiling

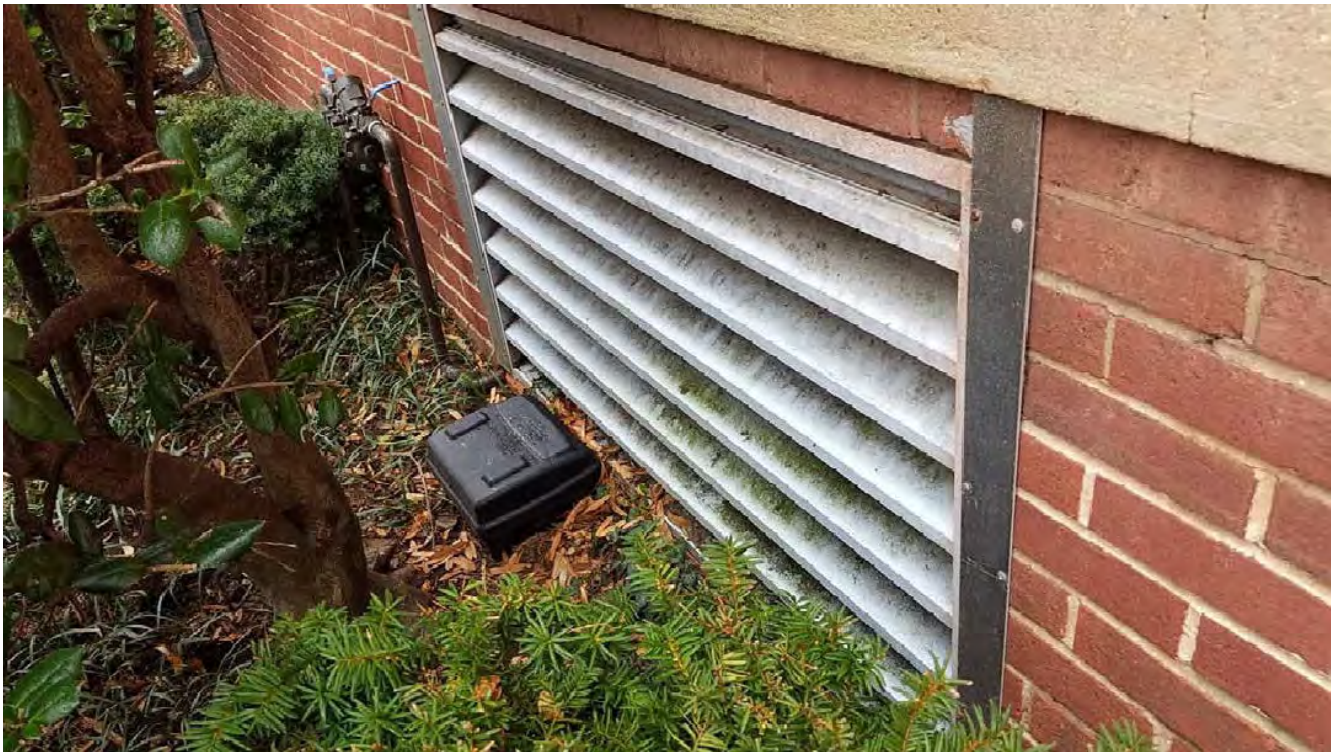
Outside Air Intake at Grade with Rat Trap In Front of It

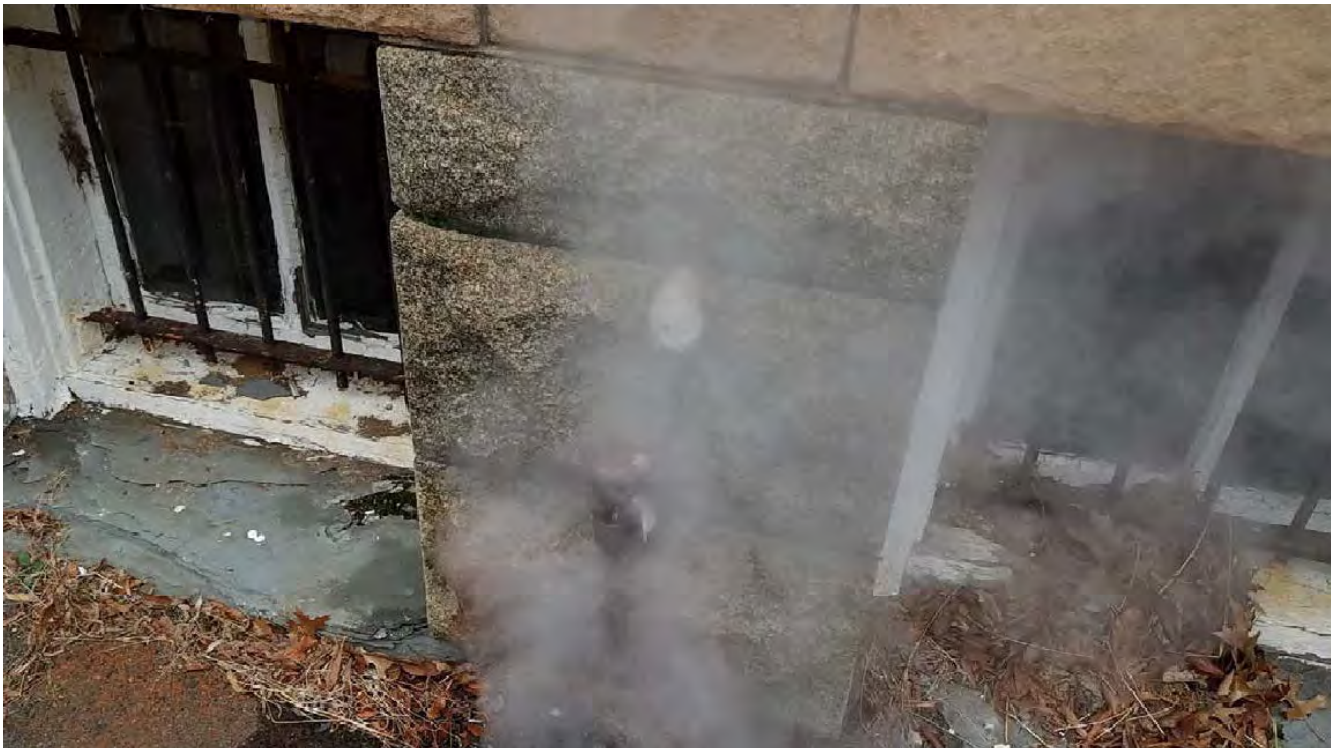
Mechanical Room 1 LPC Lift Station Vent and Window Deterioration

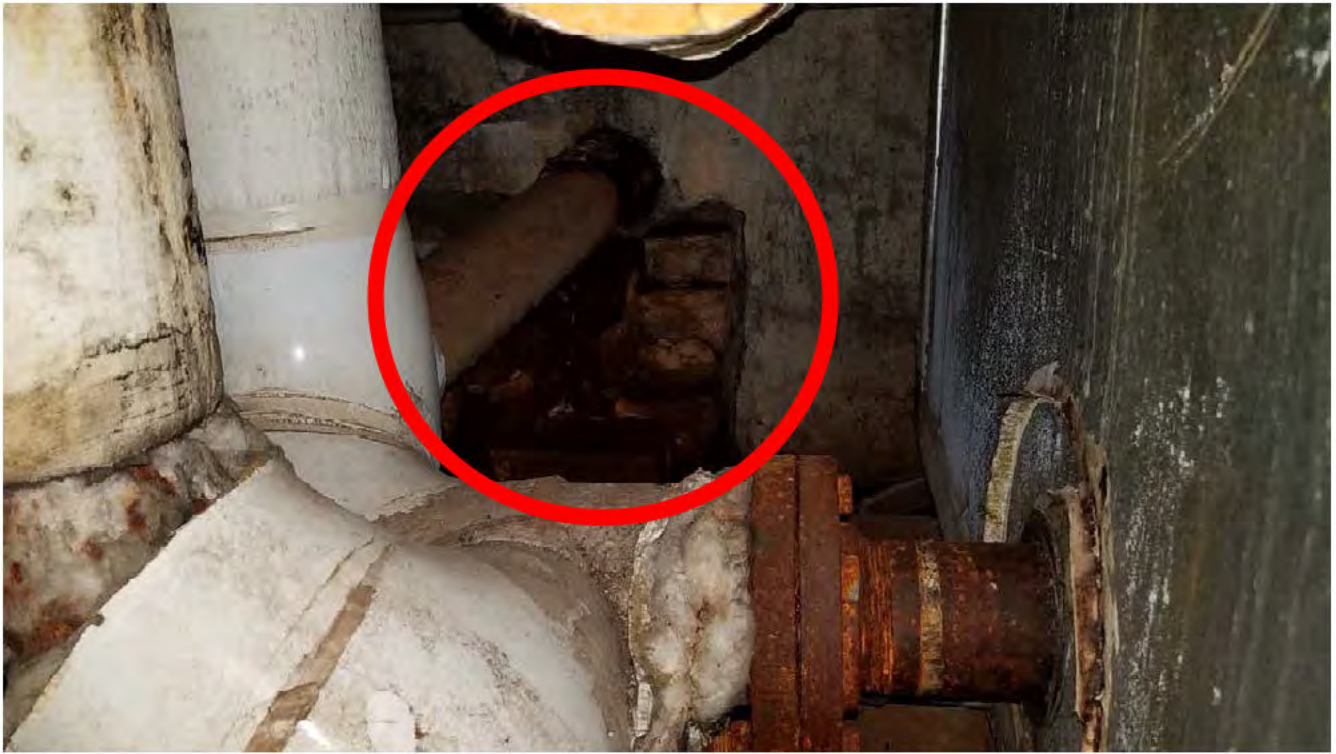
Water Leak Through Mechanical Room 2 Foundation Wall Pipe Penetration

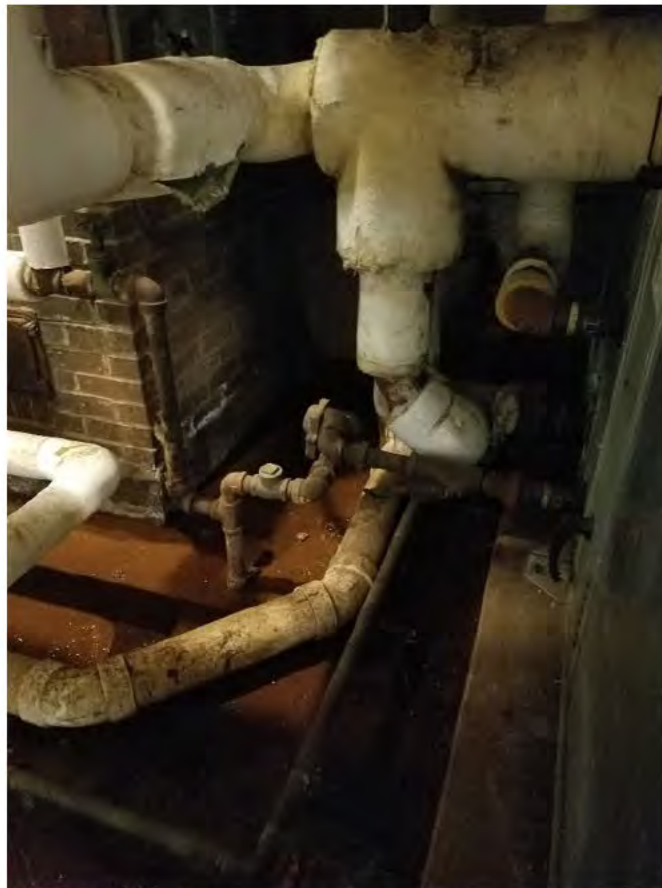
Water Leak Through Mechanical Room 2 Foundation Wall Pipe Penetration

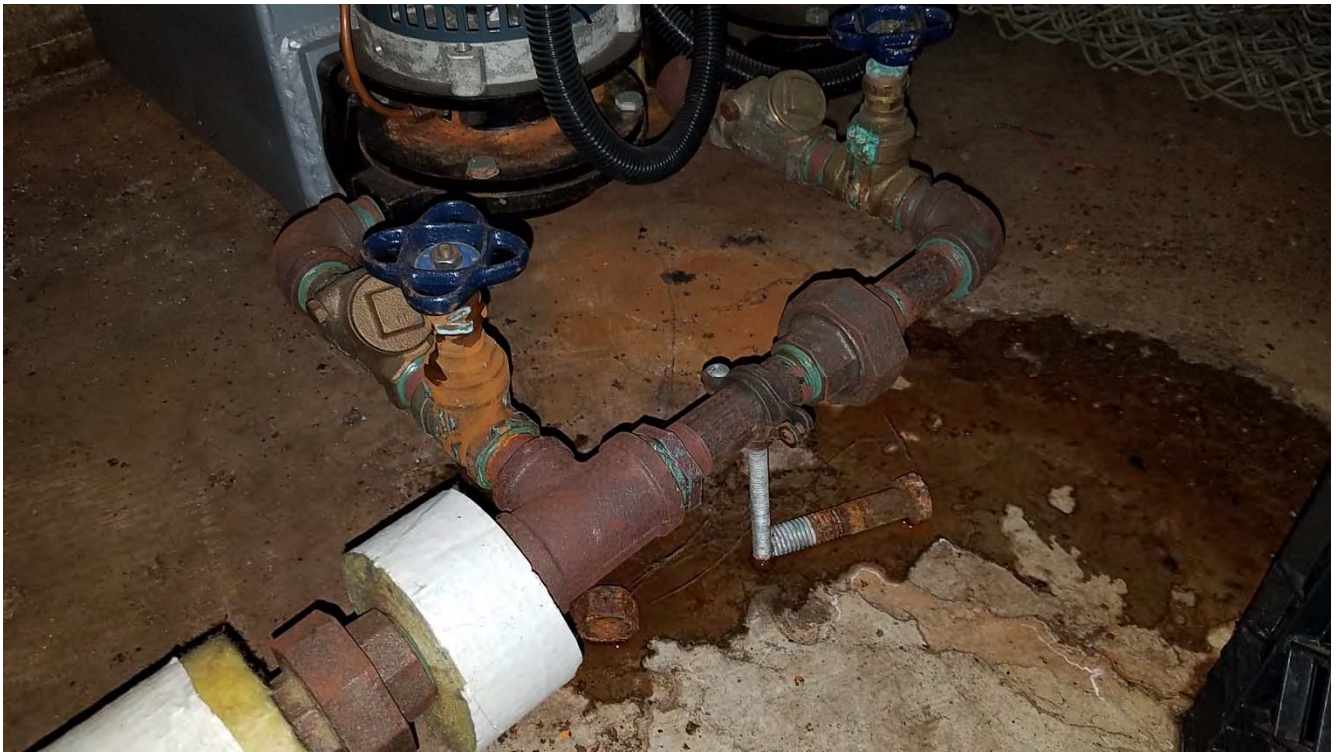
AHU-5 Low Pressure Condensate Lift Station Leaking

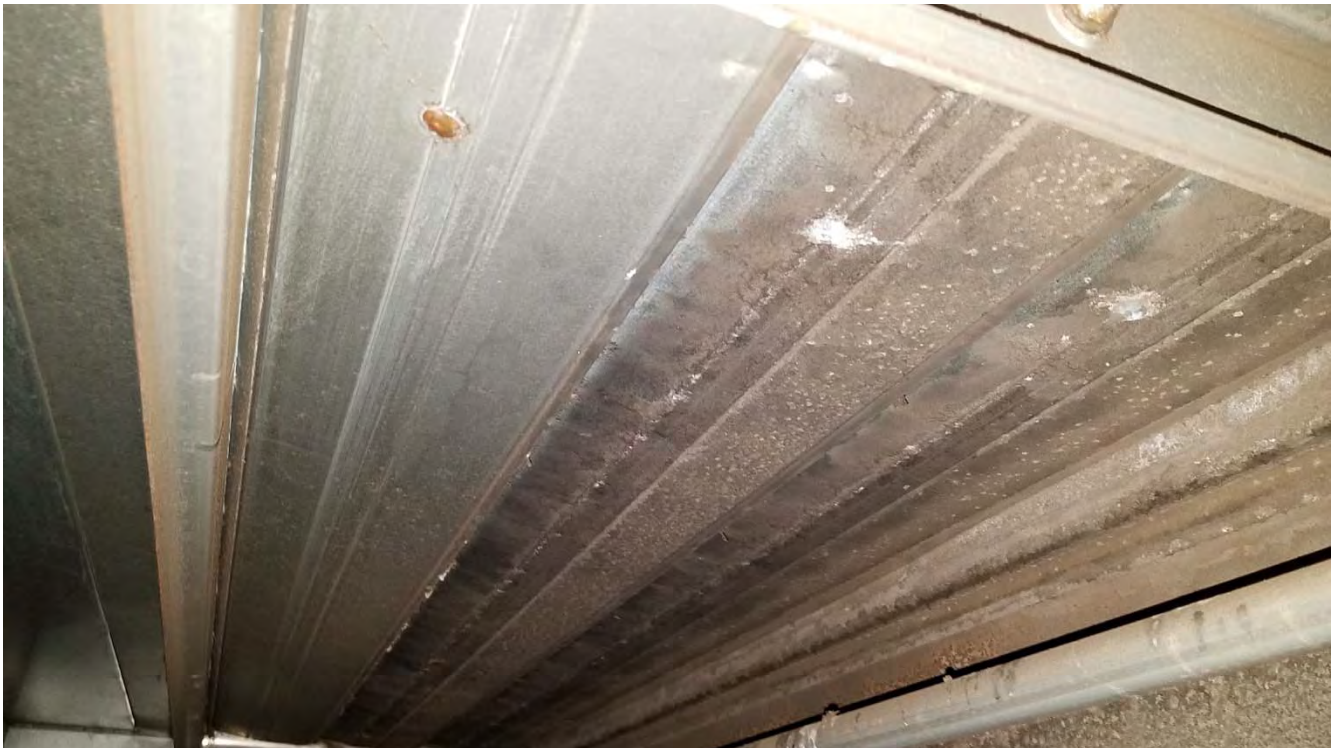
AHU-5 OA Damper in the Closed Position During Occupied Hours

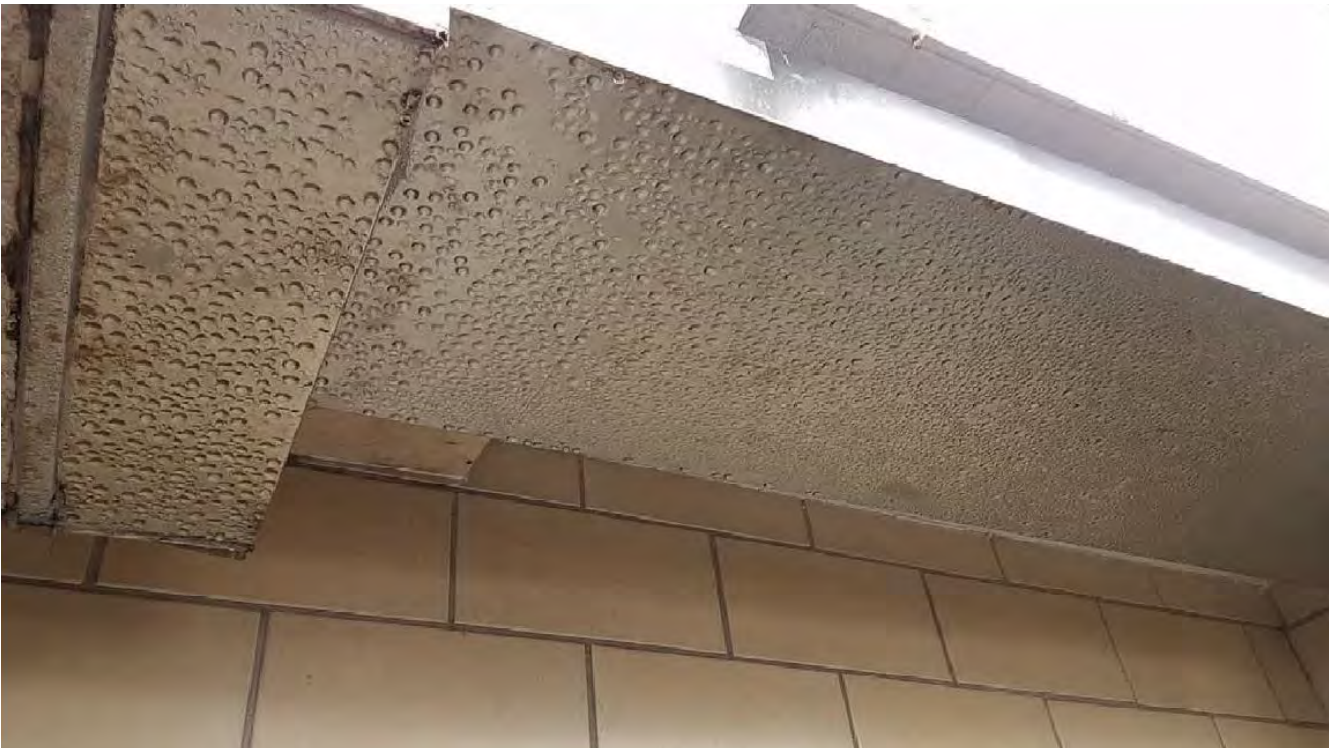
First Floor Kitchen Condensation on Dishwasher Duct – Inadequate Exhaust in Space

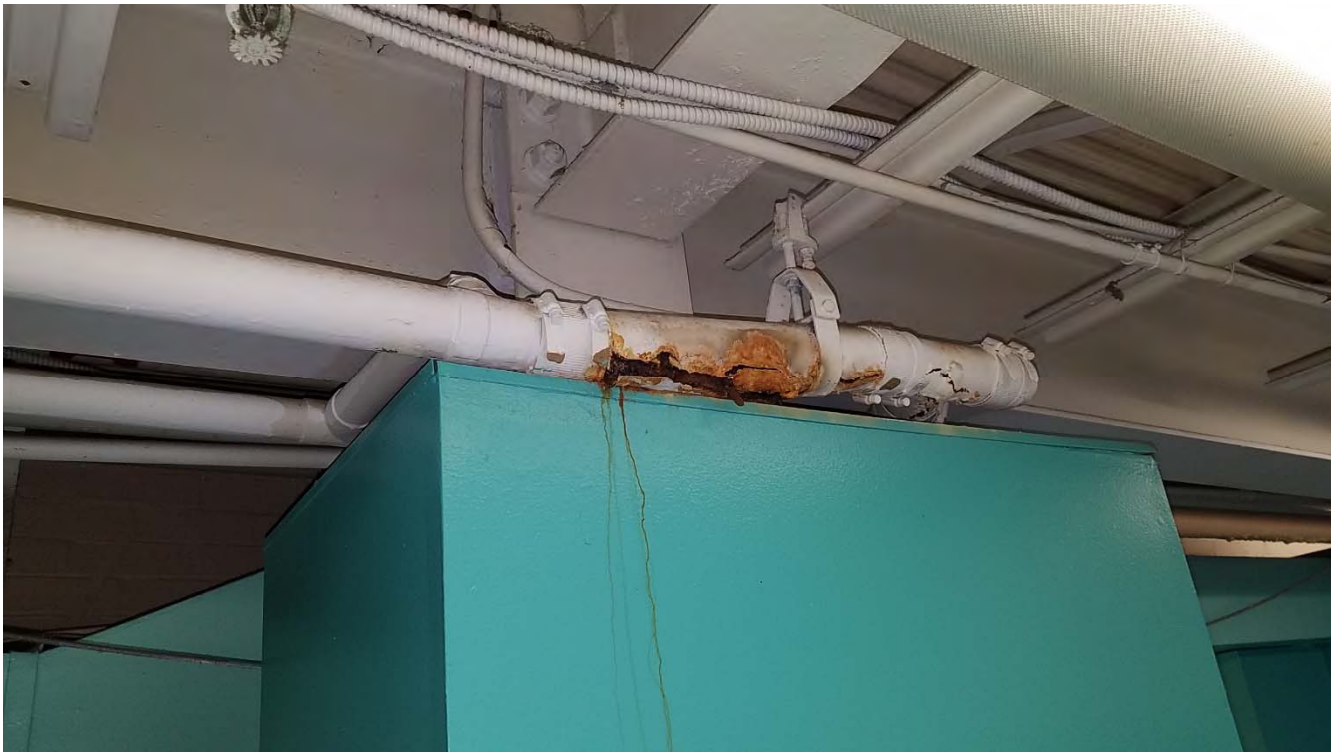
Bathroom Leaking Pipe

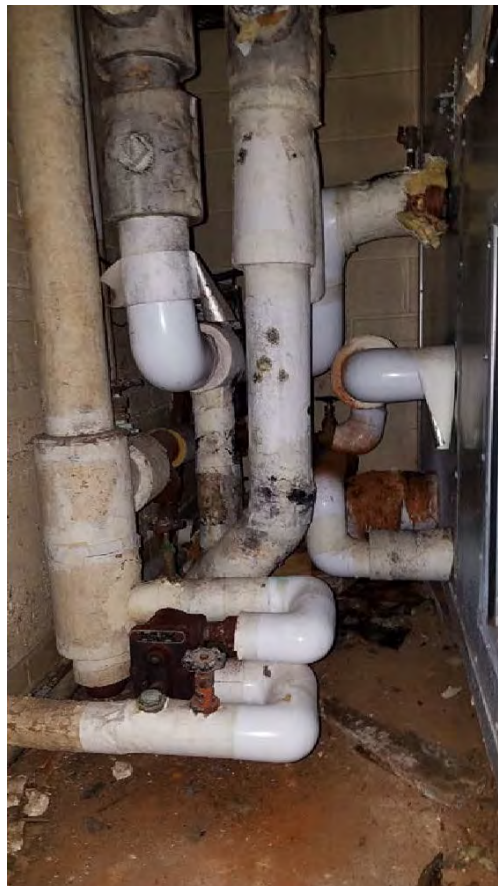
Bathroom AHU Pipe Chase and Mixed Air Plenum

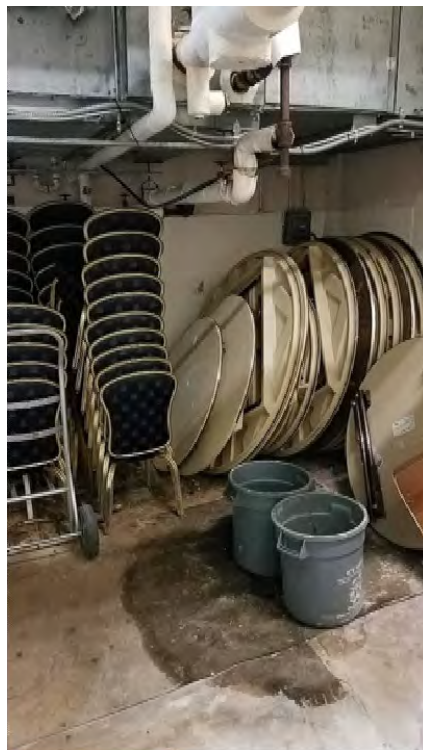
Leaking Low Pressure Condensate Pipe Contributing to Mold Garden in Coat Check Mechanical Room

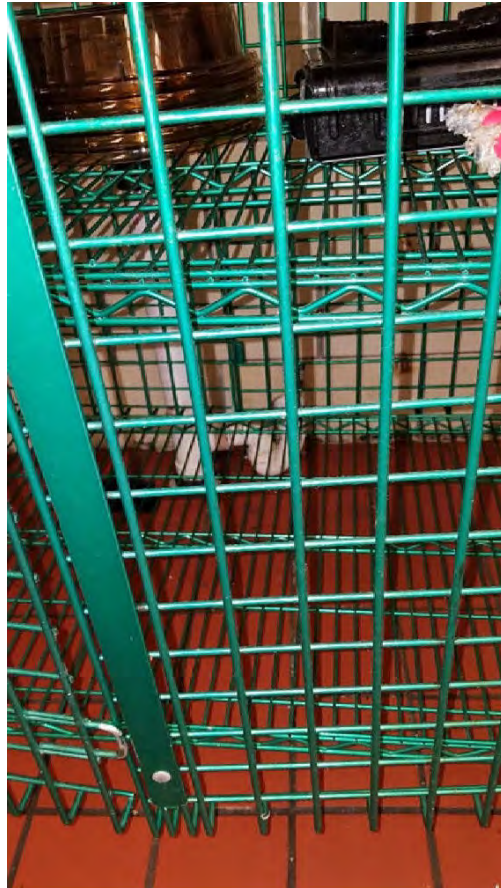
Open Hub P-Trap in Second Floor Kitchen

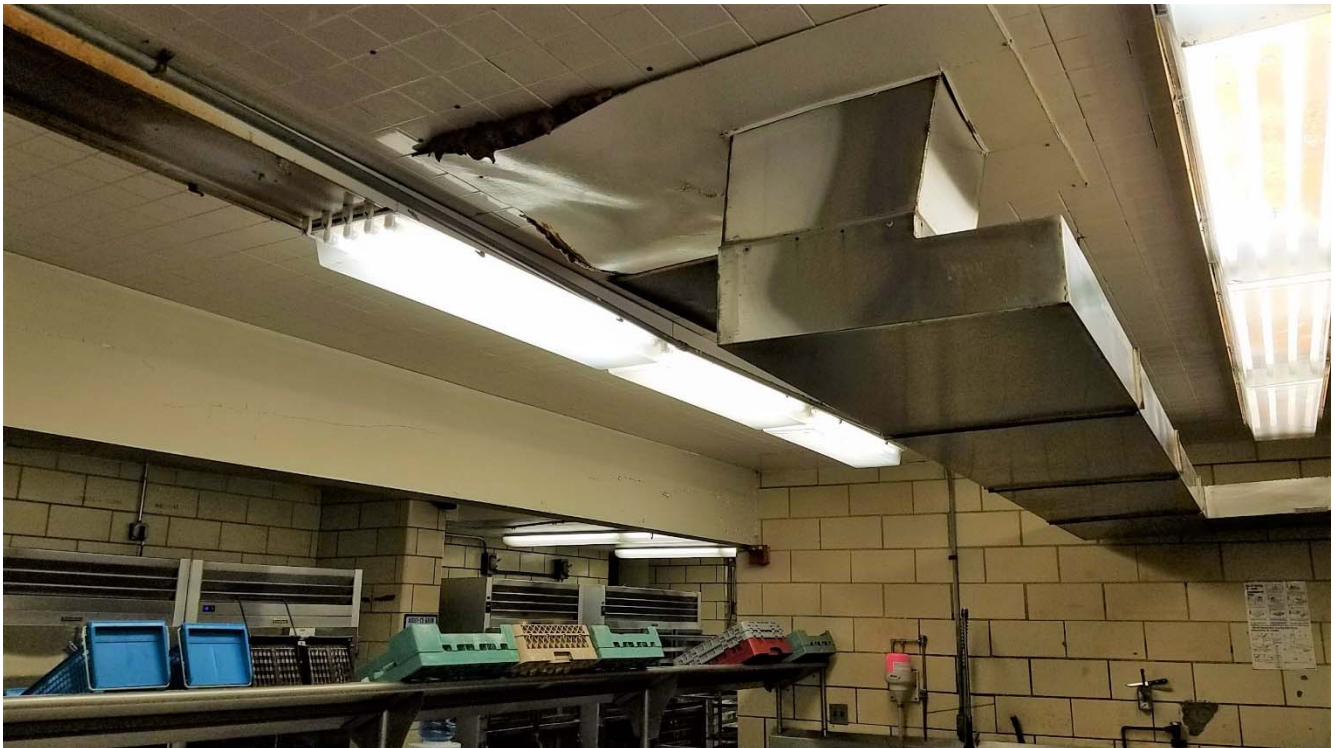
Moisture Laden Insulation at Duct Penetration in Second Floor Kitchen Dishwashing Area

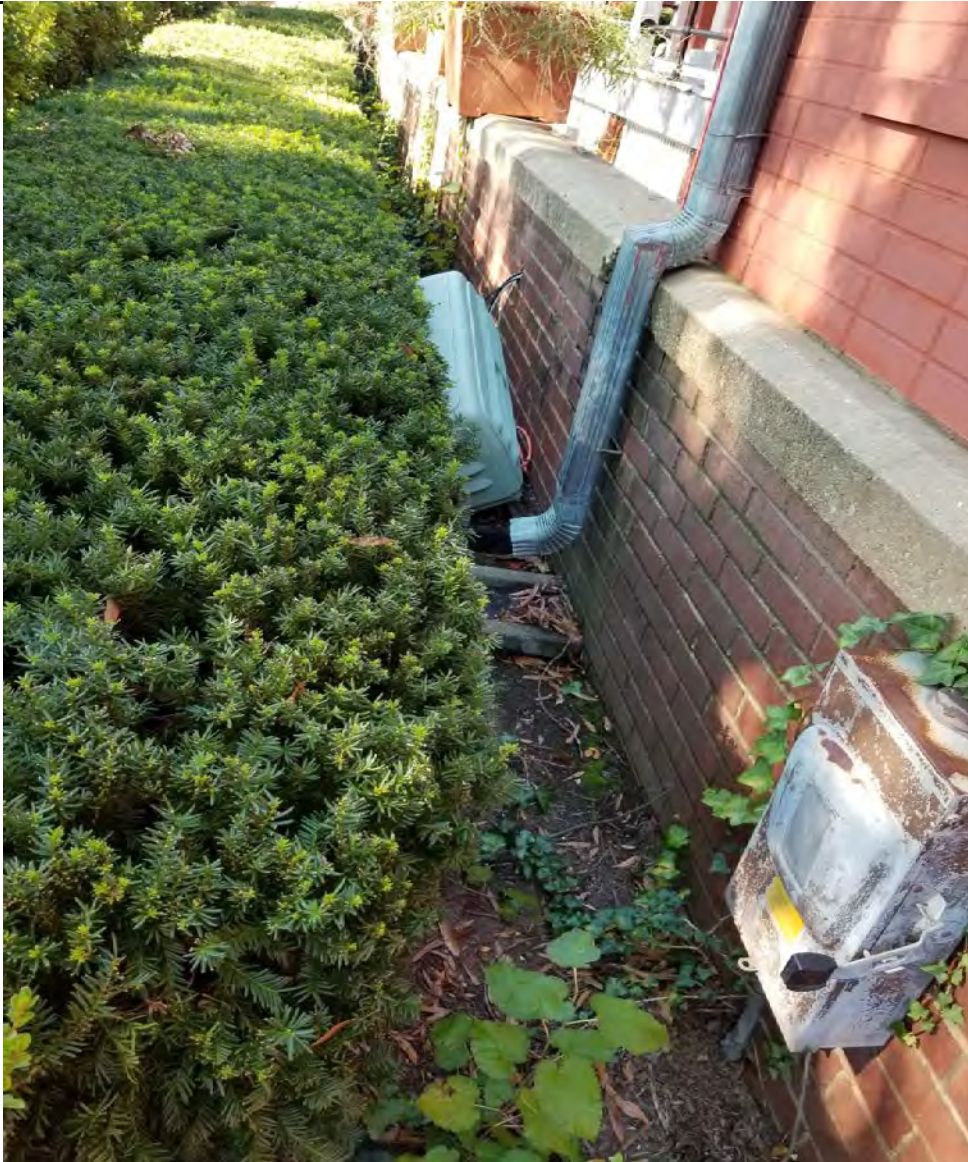
(1) Open electrical / cable box next to downspout.

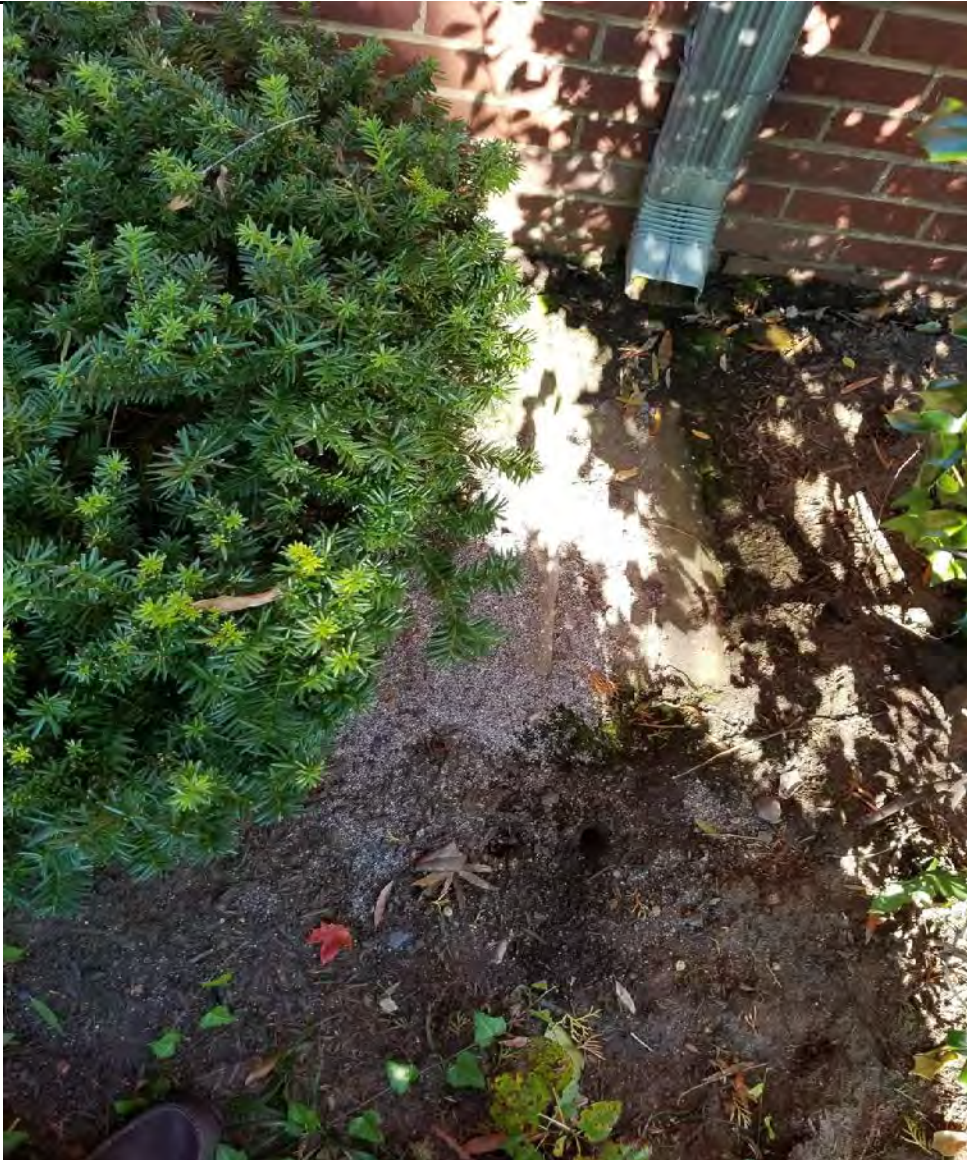
(2) Downspout splash block is covered and blocked by mulch, causing water to pond next to building.

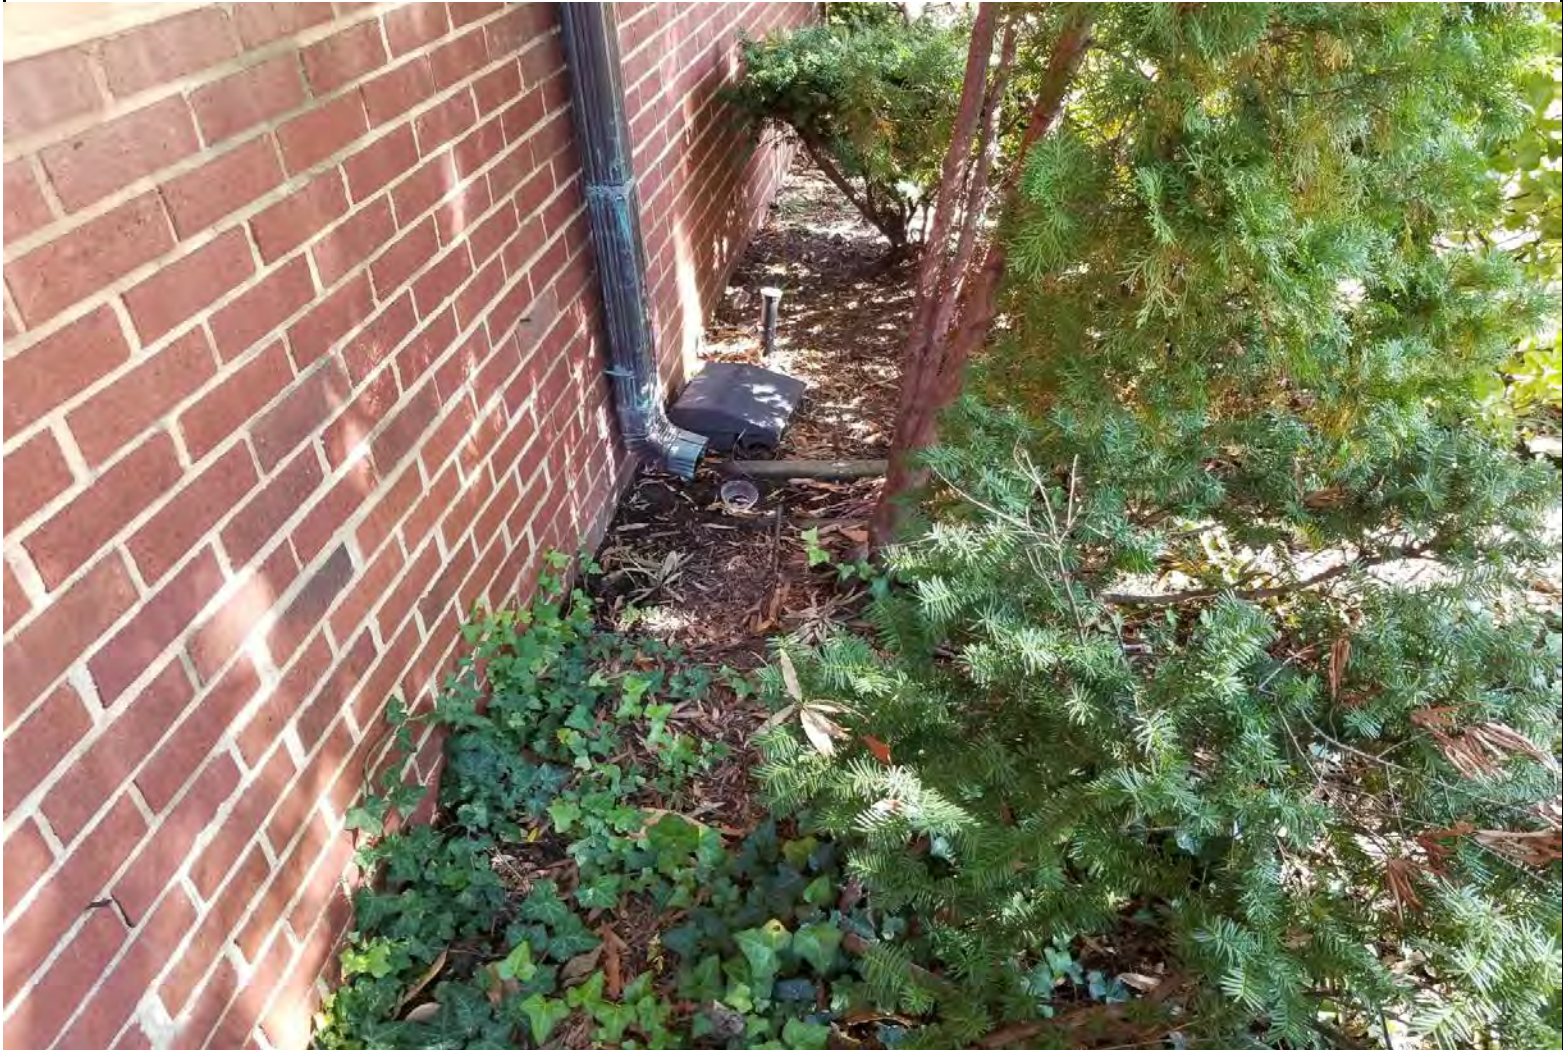
(3) Downspout splash block is flowing backward toward the building and causing water to pond next to the building.

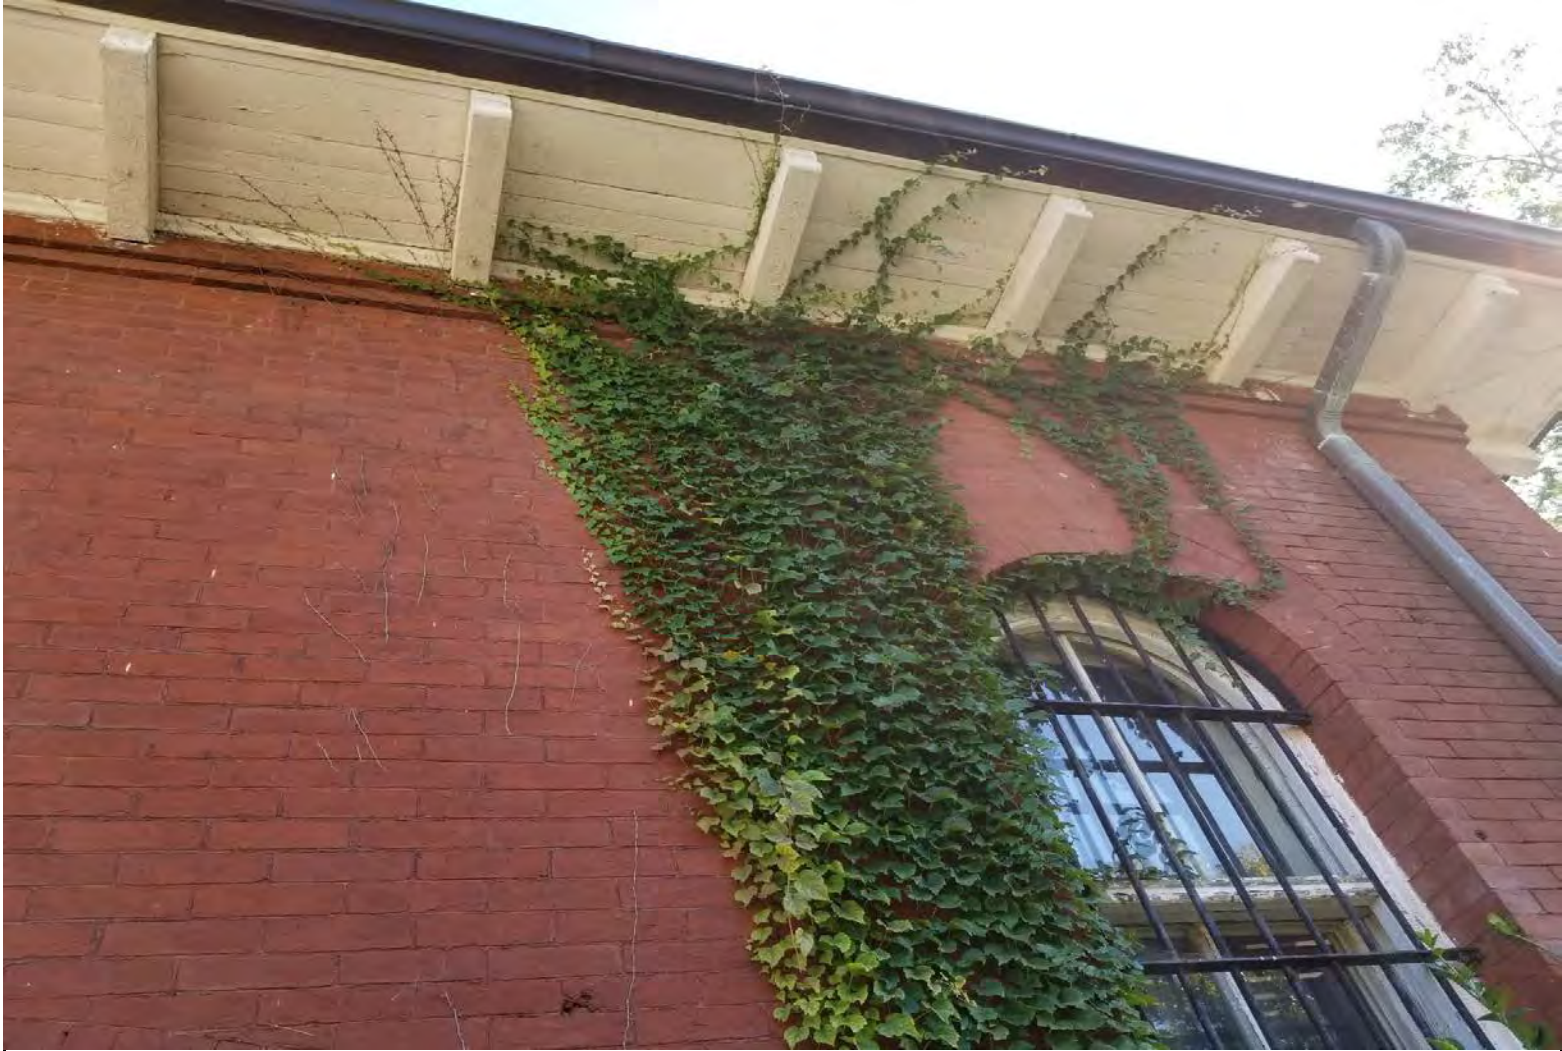
(4) Ivy is growing up the wall. The roots could cause damage to the wall.
