**COMPLETION REPORT
FOR THE
OIL/WATER SEPARATOR
AND
PIPING EVALUATION
FOR THE**

**SOLID WASTE MANAGEMENT UNIT 27F:
3D ENGINEER BRIGADE,
NORTHWEST OF BUILDING 1340 AT
FORT STEWART, GEORGIA**

**U.S. ARMY CORPS OF ENGINEERS
SAVANNAH DISTRICT**

September 2007

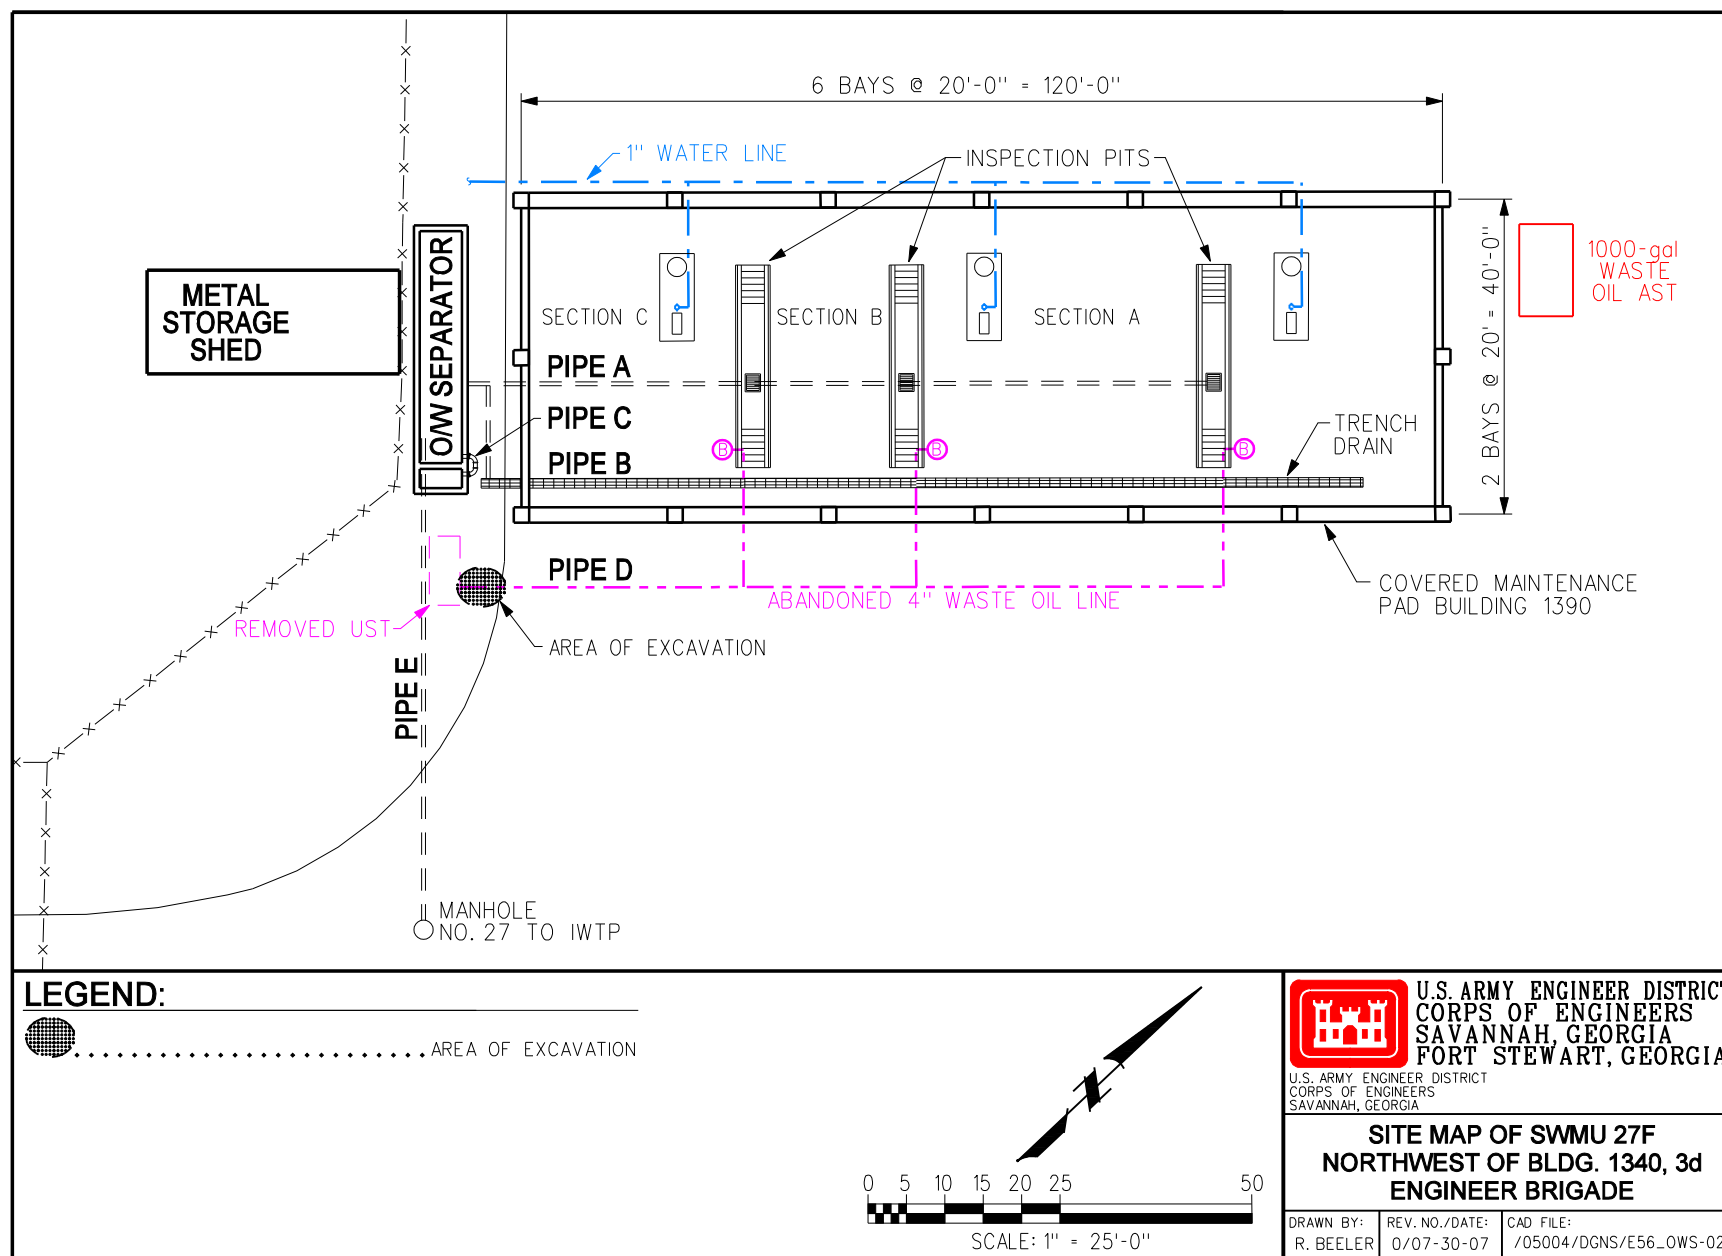
Figure 2. OWS and Piping Layout of Maintenance Pad at SWMU 27F, Northwest of Building 1340

western end of the trench, which then travels parallel along the length of the OWS and ties into the 6-in. PVC pipe (Pipe A on Figure 2) prior to it entering the OWS.

Oil discharged into the main chamber of the OWS is removed by the skimmer and flows (Pipe C on Figure 2) to the smaller holding chamber/reservoir located at the south end of the OWS. Waste oil was routinely pumped out of the holding unit and burned at the Central Energy Plant. The effluent from the OWS (Pipe E) is discharged to a 6-in.-diameter PVC pipe, which discharges to the Industrial Wastewater Treatment Plant (IWTP) by way of Manhole No. 27 (Figure 2).

Inspection Pit Section #C: The western section closest to the OWS indicated a significant longitudinal crack/fracture in the area where the 4-in. drain pipe from the trench drain intercepts (T) and transitions into the 6-in. pipe (Pipe A) from the floor drains in the inspection pits. It should be noted that compacted solids that could not be removed by jet cleaning were located from video count 26 to this point.
