**COMPLETION REPORT  
FOR THE  
OIL/WATER SEPARATOR  
AND  
PIPING EVALUATION  
FOR THE**

**SOLID WASTE MANAGEMENT UNIT 27F:  
3D ENGINEER BRIGADE,  
NORTHWEST OF BUILDING 1340 AT  
FORT STEWART, GEORGIA**

**September 2007**

**COMPLETION REPORT  
FOR THE  
OIL/WATER SEPARATOR  
AND  
PIPING EVALUATION  
FOR THE  
SOLID WASTE MANAGEMENT UNIT 27F:  
3D ENGINEER BRIGADE,  
NORTHWEST OF BUILDING 1340 AT  
FORT STEWART, GEORGIA**

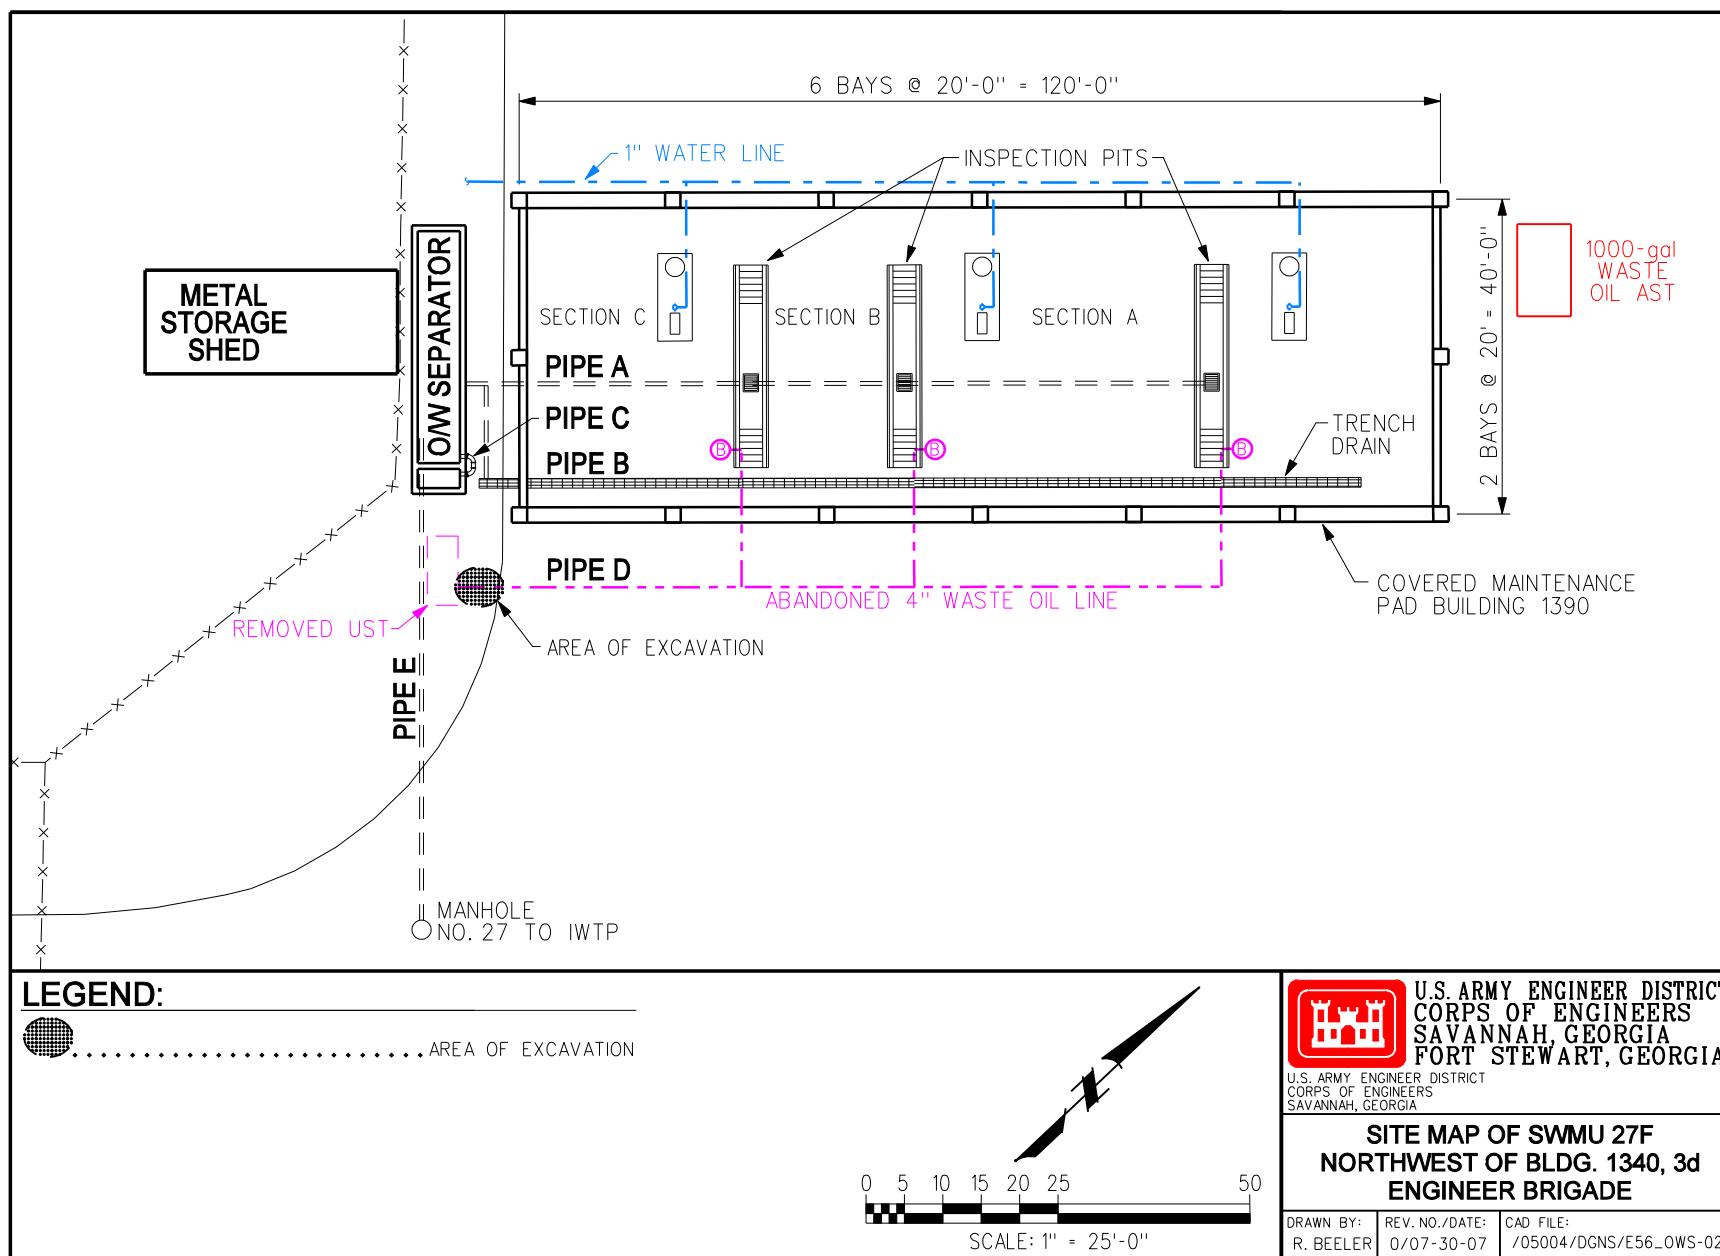
**Figure 2. OWS and Piping Layout of Maintenance Pad at SWMU 27F, Northwest of Building 1340**

western end of the trench, which then travels parallel along the length of the OWS and ties into the 6-in. PVC pipe (Pipe A on Figure 2) prior to it entering the OWS.

Oil discharged into the main chamber of the OWS is removed by the skimmer and flows (Pipe C on Figure 2) to the smaller holding chamber/reservoir located at the south end of the OWS. Waste oil was routinely pumped out of the holding unit and burned at the Central Energy Plant. The effluent from the OWS (Pipe E) is discharged to a 6-in.-diameter PVC pipe, which discharges to the Industrial Wastewater Treatment Plant (IWTP) by way of Manhole No. 27 (Figure 2).

Smoke testing was performed on: (1) the wastewater effluent pipe from the OWS to Manhole No. 27 approximately 60 ft away (Pipe E) and (2) the 6-in.-diameter waste pipe with three floor drains in the bottom of the inspection pits (Pipe B).

**Inspection Pit Section #C:** The western section closest to the OWS indicated a significant longitudinal crack/fracture in the area where the 4-in. drain pipe from the trench drain intercepts (T) and transitions into the 6-in. pipe (Pipe A) from the floor drains in the inspection pits. It should be noted that compacted solids that could not be removed by jet cleaning were located from video count 26 to this point.

The static water test of the OWS system did not indicate any measurable releases to the environment, even given the observed longitudinal fracture in the 6-in. pipe (Pipe A) near where it enters the OWS. However, the low-pressure air test failed on all of the pipes tested. This was probably due to the sensitivity of the test and the connections associated with gravity drain pipes.

Given the present continuing status for emergency use as observed in July 2007, it is recommended that the drains in the inspection pits remain usable to prevent any accumulation of water in the inspection pits, until the entire maintenance pad is either upgraded or removed. This allows any spill to at least be directed to the OWS. The bolted metal covers installed over the inspection pits will prevent easy access to the inspection pits, but still allow the drains to remain open. However, at a minimum, the fracture in the 6-in. pipe as it goes into the OWS needs to be repaired. This would eliminate the potential for release to the environment of potential petroleum sources if a spill or waste material is directed to the drains in the inspection pits. This area needing repair is located in the grassy area between the maintenance pad and the OWS; therefore, it is easily accessed. However, it will require excavating to approximately 6 ft BGS in a narrow area, and shoring of the side walls of the excavation will probably be necessary.

The effluent pipe from the OWS to Manhole No. 27 should receive only petroleum-contaminated wastewater if the OWS is operating properly. This pipe did not test tight by the low-pressure air test. Video inspection indicated three piping transitions and slight misalignment of the piping. This pipe is probably of sufficient quality for a gravity drain sewer line. However, given the petroleum contamination in the subsurface at the site, the potential future remediation efforts to clean up this site, and, to be on the conservative side, if the OWS is to remain operational, this line should probably be repaired and the misaligned joints fixed to prevent any potential for low level leaking of petroleum-contaminated wastewater. In addition, any chemical injection remedial alternative could damage the Fernco couplings connecting the different sections of the drainage pipe.

Proper abandonment of the facility would consist of removal of the OWS and grouting of the remaining pipes.

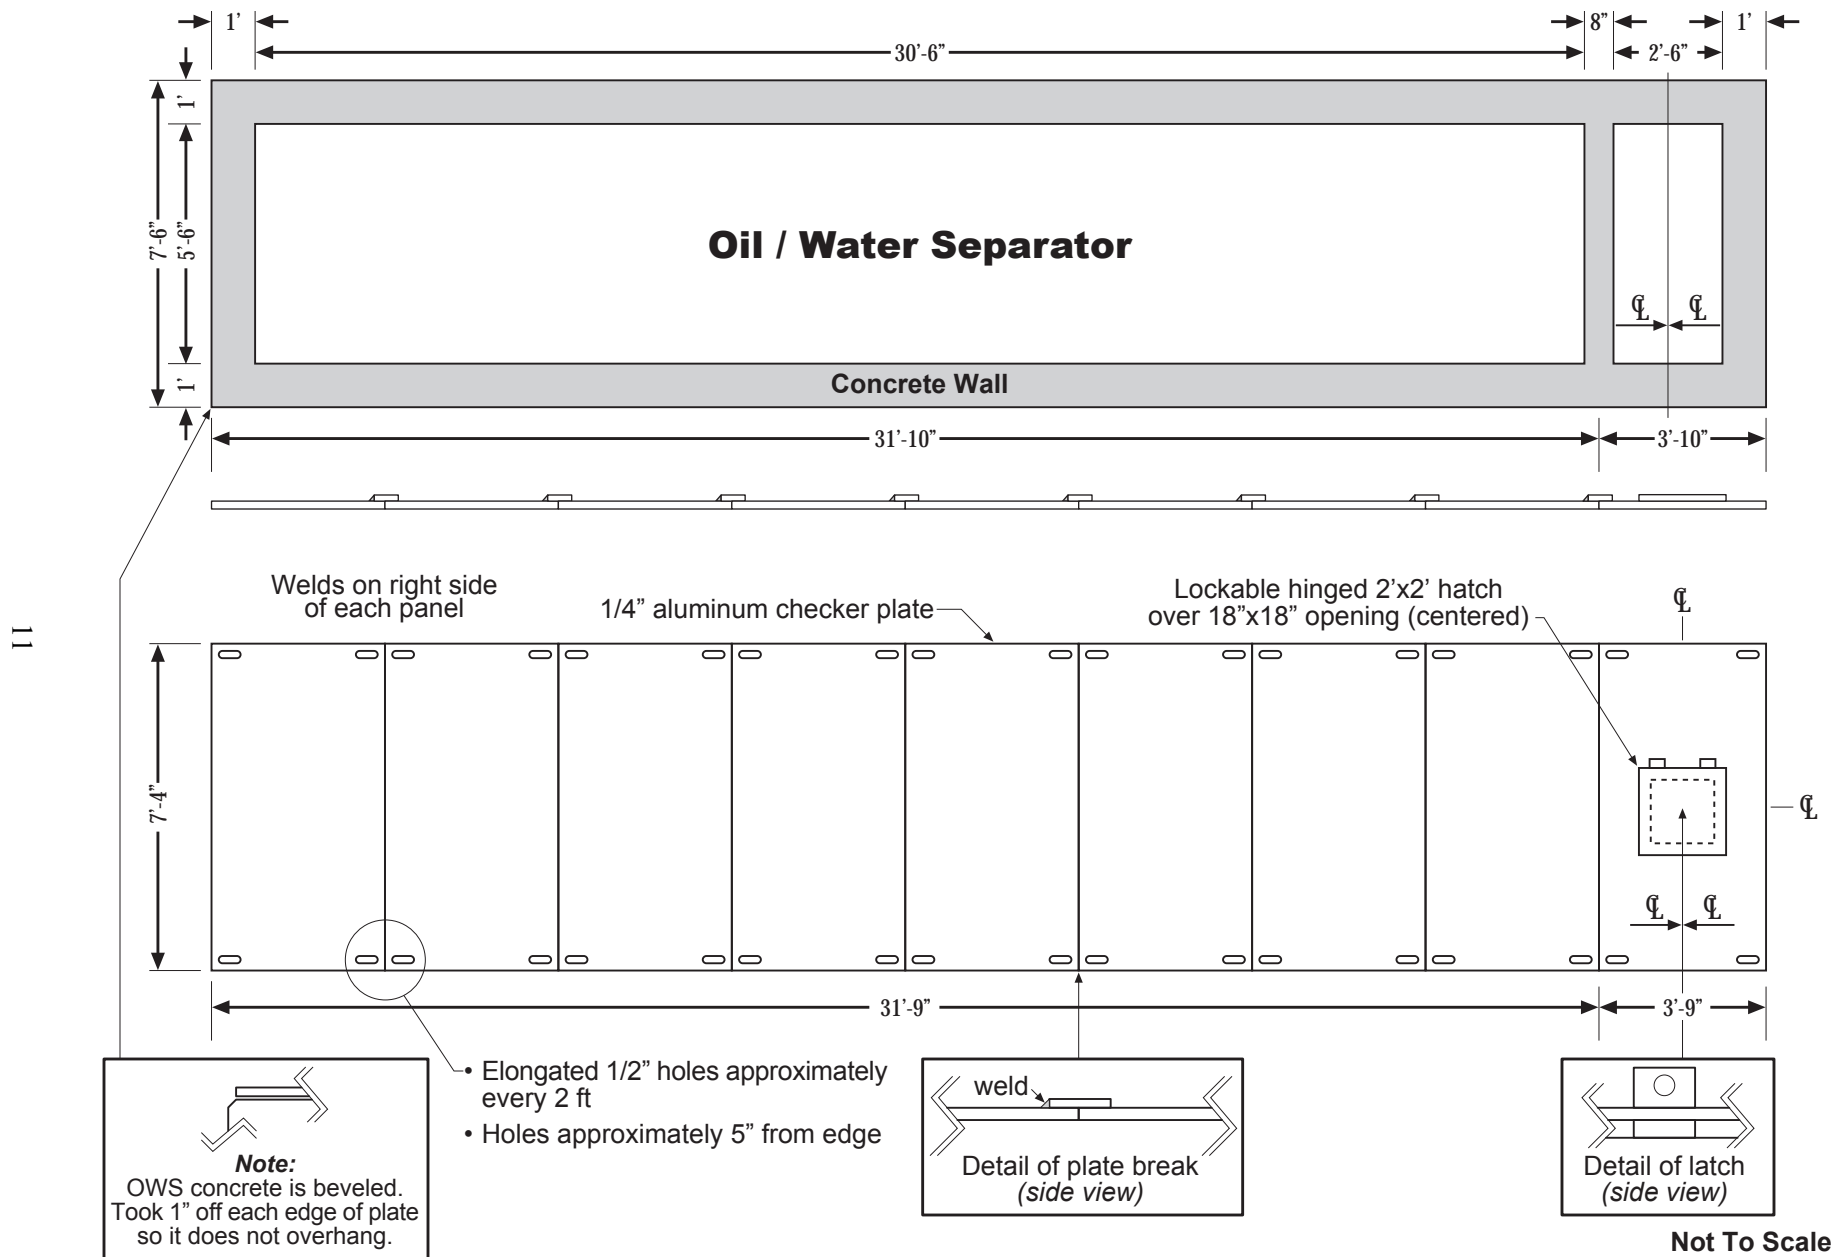
Figure 3. OWS Cover Installation for SWMU 27F, Northwest of Building 1340

A local metal fabrication company, Coastal Precision, manufactured the cover for the OWS. The installation of the cover began on May 15, 2007, and was completed on May 16, 2007. The cover was constructed of eight pieces of 1/4-in. aluminum checker plate with an aluminum flat bar welded at the lap joints, and one piece of 1/4-in. aluminum checker plate with a 2- × 2-ft hinged cover over an 18- × 18-in. access hole (Figure 3). The cover was bolted down to the concrete wall of the OWS using 1/2-in. concrete wedge anchors. A thick bead of clear silicon caulk was placed between the concrete wall and cover and the lap joints of the aluminum sections to minimize rain from entering into the OWS. A lock with two keys was placed on the latch of the manhole. The keys to the locked access hatch were given to Mr. Dale Keifer of Fort Stewart DPW.

An aluminum cover with a locked access hatch was installed over the OWS. This should prevent dumping of oil into the previously open OWS. The only access presently available to the OWS is through the three drains in the inspection pits.

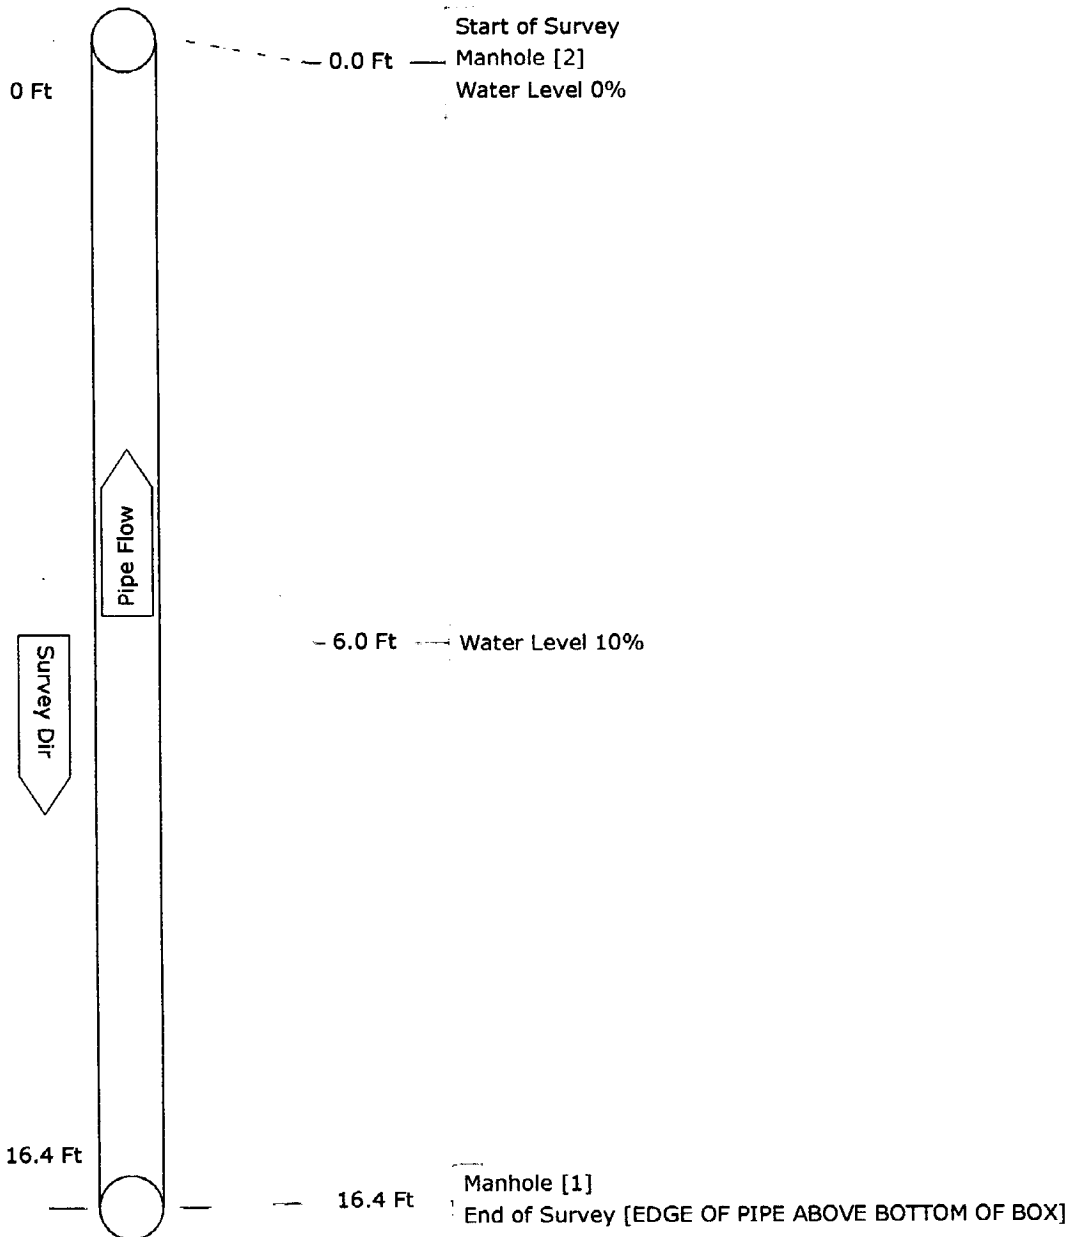
**Tabular Report of PSR 2**
**X**
**for SAIC**

**Inspection Pit Section #B:** The middle, Section B, of the drain piping did not show any cracks or damage.

Count	Video	CD	Code	In1	In2	%	Jnt	Fr	To	ImRef	Remarks
0.0	00000		ST Start of Survey								
0.0	00000		AMH Manhole								2
0.0	00000		MWL Water Level			5					
37.6			AMH Manhole								3
37.6			FH End of Survey

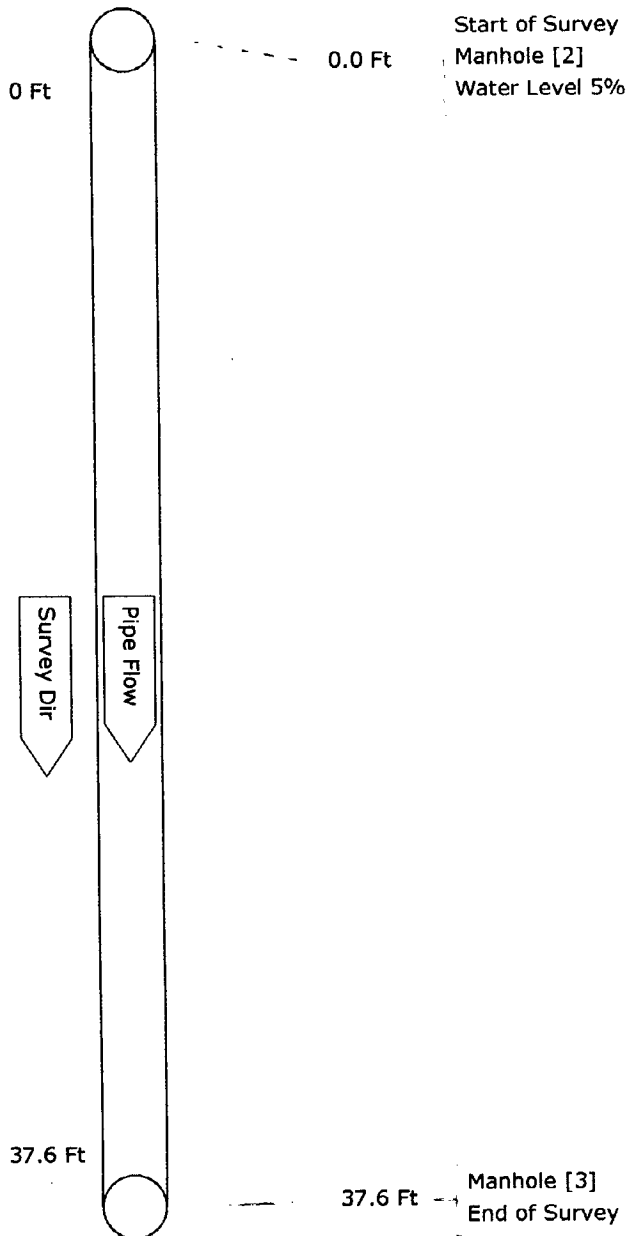
**Tabular Report of PSR 3**
**X**
**for SAIC**

Count	Video	CD	Code	In1	In2	%	Jnt	Fr	To	ImRef	Remarks
0.0	00000		ST Start of Survey								
0.0	00000		AMH Manhole								3
0.0	00000		MWL Water Level			5					
26.0			DSC Deposits Settled Compacted			10		04	06		
33.2			TFA Tap Factory Active	06				12			
33.6			FL Fracture Longitudinal					12			
33.7			MSA Abandoned Survey								CAMERA WILL NOT PASS TAP WITH

<b>Structural:</b>	<b>Total</b> 3	<b>Mean Defect</b> 3	<b>Peak</b> 3	<b>Mean Pipe</b> 0.1
<b>Service:</b>	<b>Total</b> 6	<b>Mean Defect</b> 1	<b>Peak</b> 4	<b>Mean Pipe</b> 0.2
