**ELIGIBILITY ASSESSMENT OF THE DURRETT HOUSE  
BUILDING 1541, FT. CAMPBELL, KENTUCKY**

**Prepared for:  
USACE Louisville District  
600 Martin Luther King Drive  
Louisville, Kentucky 40202-2232**

**Prepared by:  
Samiran Chanchani, Ph.D.  
Principal Investigator  
BHE Environmental, Inc.  
11733 Chesterdale Road  
Cincinnati Ohio 45246-3405  
513-326-1500  
[www.bheenv.com](http://www.bheenv.com)**

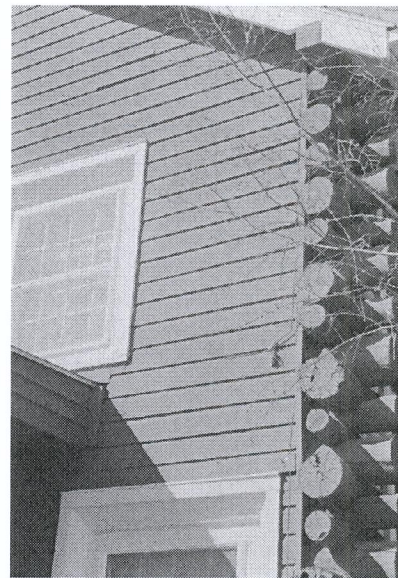
15

There is mention in the OAHF inventory of damage to the building from nearby blasting activity in the 1940s. The Inventory states "3 walls replaced with frame" (Fig. 15). Due to the presence of siding in these areas, our team was unable to evaluate the present condition or extent of remaining and damaged original material on these walls. What was clear, however, is that the logs have been left in place and a system of deep furring and siding have been applied over them,

much like a cladding. The void spaces between the logs and the applied siding have become home to squirrels – one was observed during the survey - and by the looks of the attic HVAC equipment, these vermin have managed to find their way into the structure. The potential environmental hazard and structural damage from this infestation and cladding condition is high enough to justify a more thorough investigation of these walls. Preservation technology has advanced greatly since the 1940's. New restoration materials and procedures offer excellent and reliable long-term solutions for rehabilitation of wood and timber structures. It is now feasible to reconstitute efficiently damaged log and timber components to their original condition. The permanent removal of the siding and framing materials will enable future maintenance and protection of the building structure, thus extending its life expectancy and offering a look that is more consistent with what its designer intended.

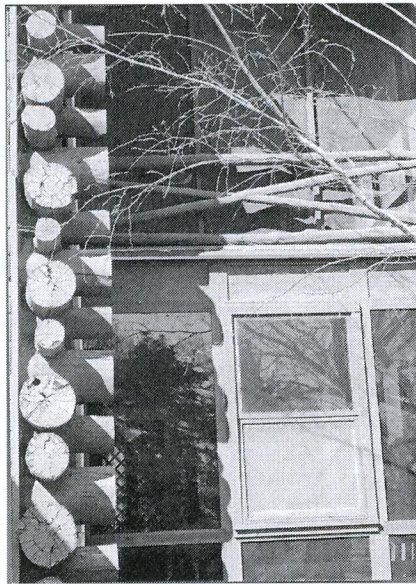
16

Absorbed moisture is more likely introduced into the log axially than it is transversely. This is because the timber has a pattern of fluid transmission from the roots to the branches. Therefore, log ends will conduct moisture into the shaft of the timber more readily than will exposed portions of the timber girth. Many exposed log ends, especially the lower units, reveal substantial deterioration from exposure to weather (Fig. 16).

Fig 16: View of log junction detail at the front porch, looking west.  
 Fig. 17: View of basement water damage, looking south at the south wall.  
 Fig. 18: View of the living room showing logs with protective coating, looking northwest.

The extent of deterioration and damage behind the siding panels needs to be determined without delay. The invading vermin need to be removed and, after assessment of the condition of the logs, prevented from re-infesting the panels. Refer to National Park Service Preservation Brief # 26, *The Preservation and Repair of Historic Log Buildings*, for more complete information on the types and features of log structures and for the conditions noted in this report.

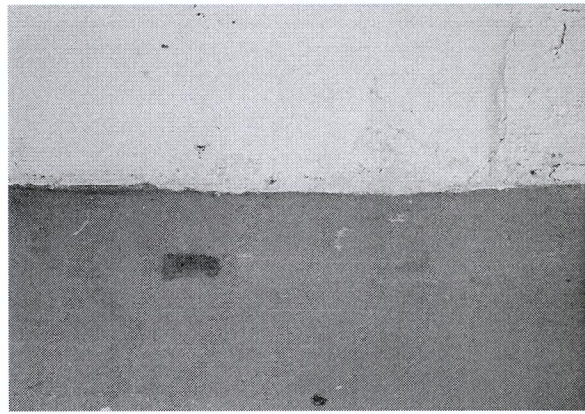
17

An area of concern exists in the lower level where a utility shower exists (Fig. 17). There is substantial evidence of long-term leakage from the shower walls and floor into the cavity space of the enclosing partition. Prolonged moisture entrapment in these concealed spaces can attract and sustain cellulose fiber-consuming parasites, microbes, and mold growth. The source of this leakage needs to be determined and the shower assembly re-designed to prevent future leakage. The surrounding materials should be removed and replaced with new assemblies, preferably composed of non-absorptive or waterproof materials.

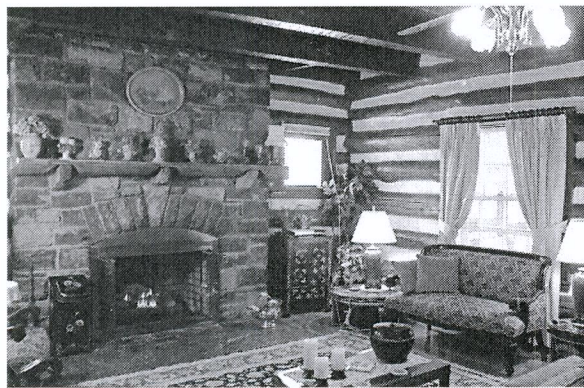
18

Exposed interior log surfaces show evidence of past applications of some type of protective coating (Fig. 18). A chemical analysis of the interior surfaces of log walls should be completed to determine the exact chemical composition of any previous applications. Sealer such as polyurethane can accelerate internal deterioration. Only breathable coating (interior and exterior) will support extended life of timber products.
