**APPENDIX I:**  
**Stream Assessment for Paint Branch and**  
**Associated Tributaries on ALC**

## **Stream Assessment for Paint Branch and Associated Tributaries on Adelphi Laboratory Center**

**U.S. Army Garrison Adelphi Laboratory Center,  
Montgomery and Prince Georges County, Maryland**

January 2019

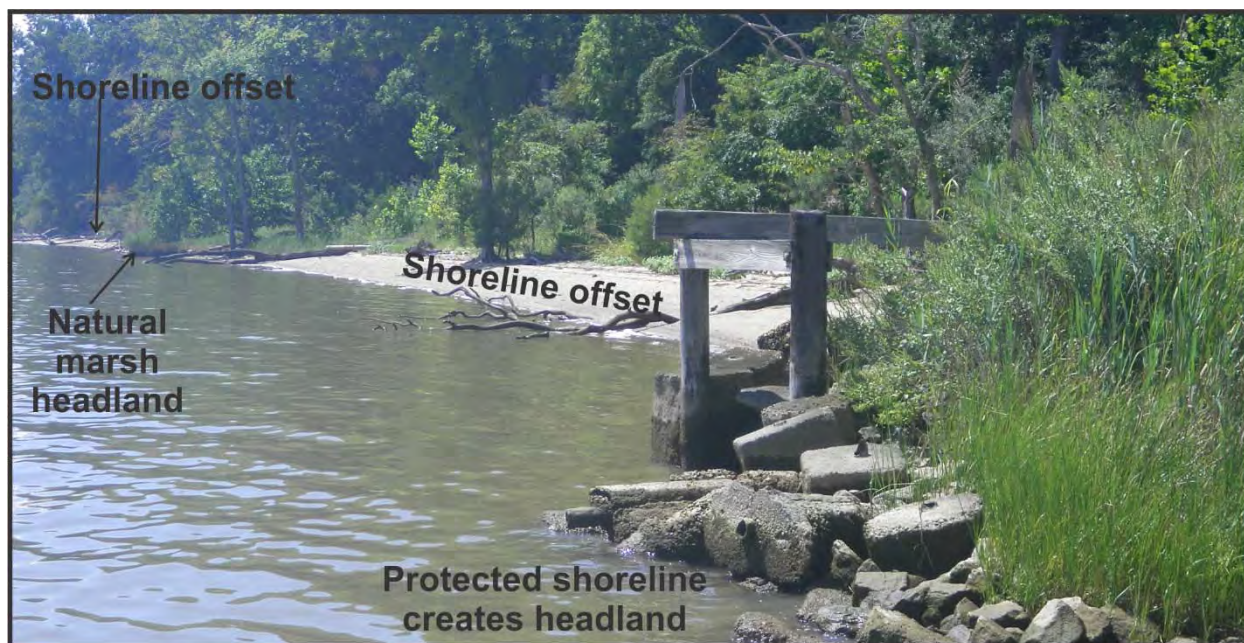
Figure 3-2. Photo of Blossom Point showing how natural and man-made headlands impact the shoreline morphology by creating offsets along the shore. These headlands impact sediment transport along the reach as well.

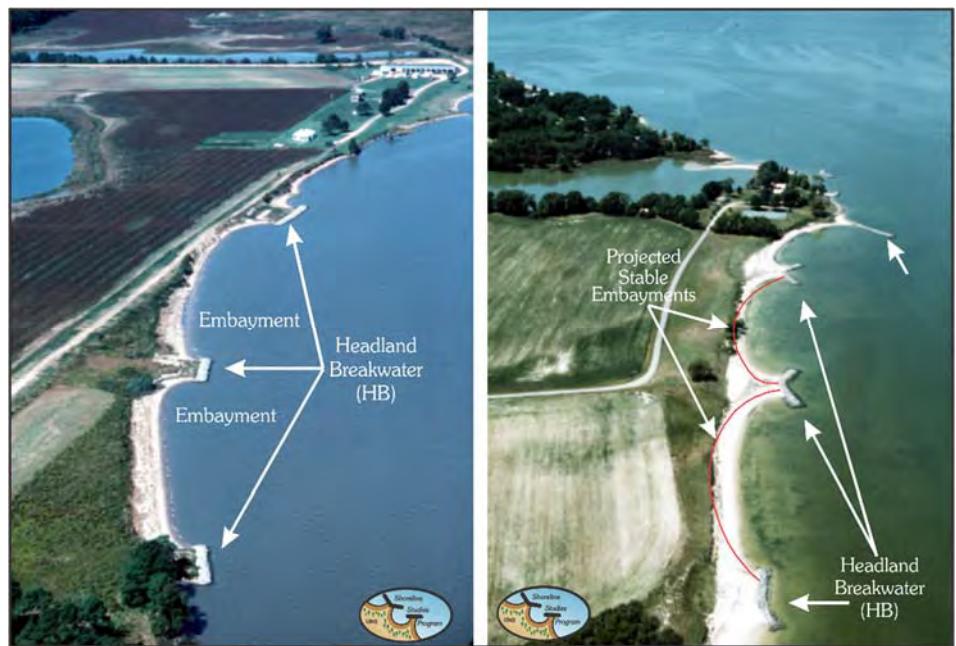
Figure 4-4. Examples of headland breakwaters spaced widely apart to allow adjacent shoreline to erode toward a dynamic equilibrium. This is a cost-effective shoreline management strategy when infrastructure is not threatened by the upland erosion between the structures. From Hardaway and Byrne (1999).

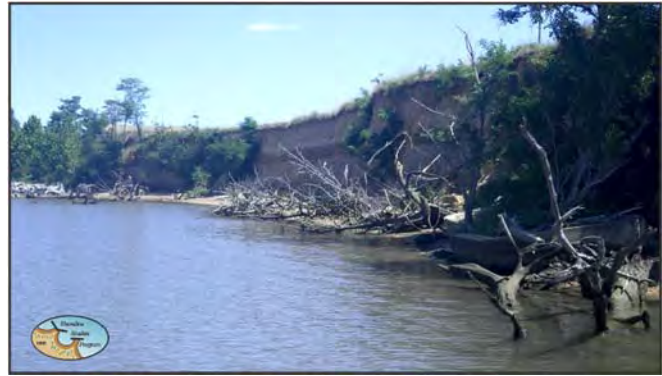
Figure 5-6. Photo showing vertical, eroding banks along Reach ID.

reach has been designated Critical Area #1 because of a building close to the eroding bank. Along this shore, broken concrete has been placed along the shoreline (Figure 5-7). The upland continues to be erosive as it transitions to the low sandy spit that marks Blossom Point and the boundary between Reach I and Reach II. The spit has evolved over time as eroding bank sediment are transported from Reach I and Reach II and accumulate. Wetlands vegetation and a semi-tidal pond occupies the bulk of spit (Figure 5-7).

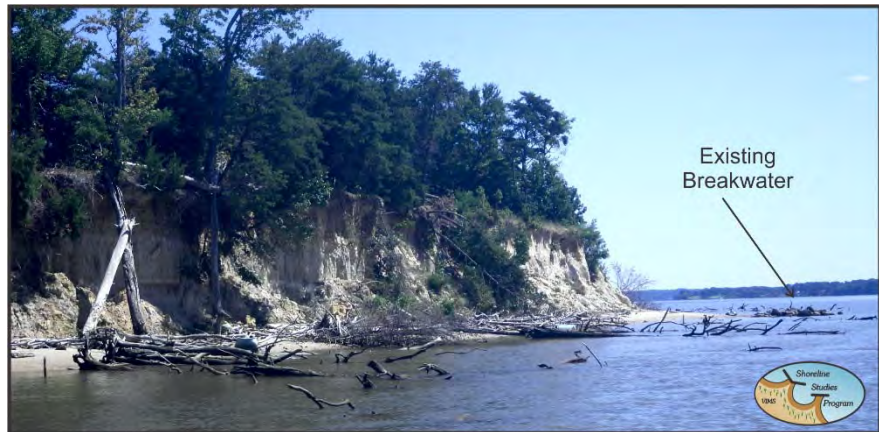
Figure 6-4. Photo of the Reach IIB shoreline with exposed banks, fallen trees and an existing broken concrete breakwater.

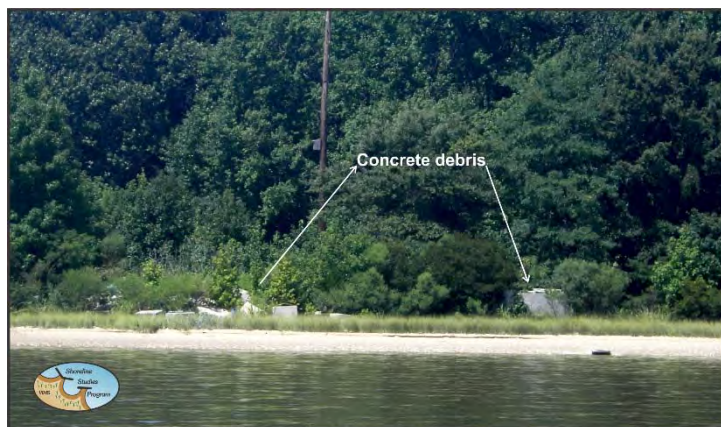
Figure 7-3. Low beach and marsh fronting a wooded upland along Reach IIIB with concrete debris along the shoreline.
