Originating Office: DPW-ENRD		Review Frequency: As required
Document Title: Final Fort AP Hill PFAS PA/SI Report  Document No: FW-SEMS-003		
Document Organization Owner: DPW – ENRD	Prepared By: Contract-ARCADIS USACE - Baltimore	Revision Date: June 2022
Contact Name: Gef Fisher George.e.fisher24.civ@army.mil	Distribution: External	Original Date: June 2022

# FINAL PRELIMINARY ASSESSMENT AND SITE INSPECTION OF PER- AND POLYFLUOROALKYL SUBSTANCES

**Fort A.P. Hill, Virginia**

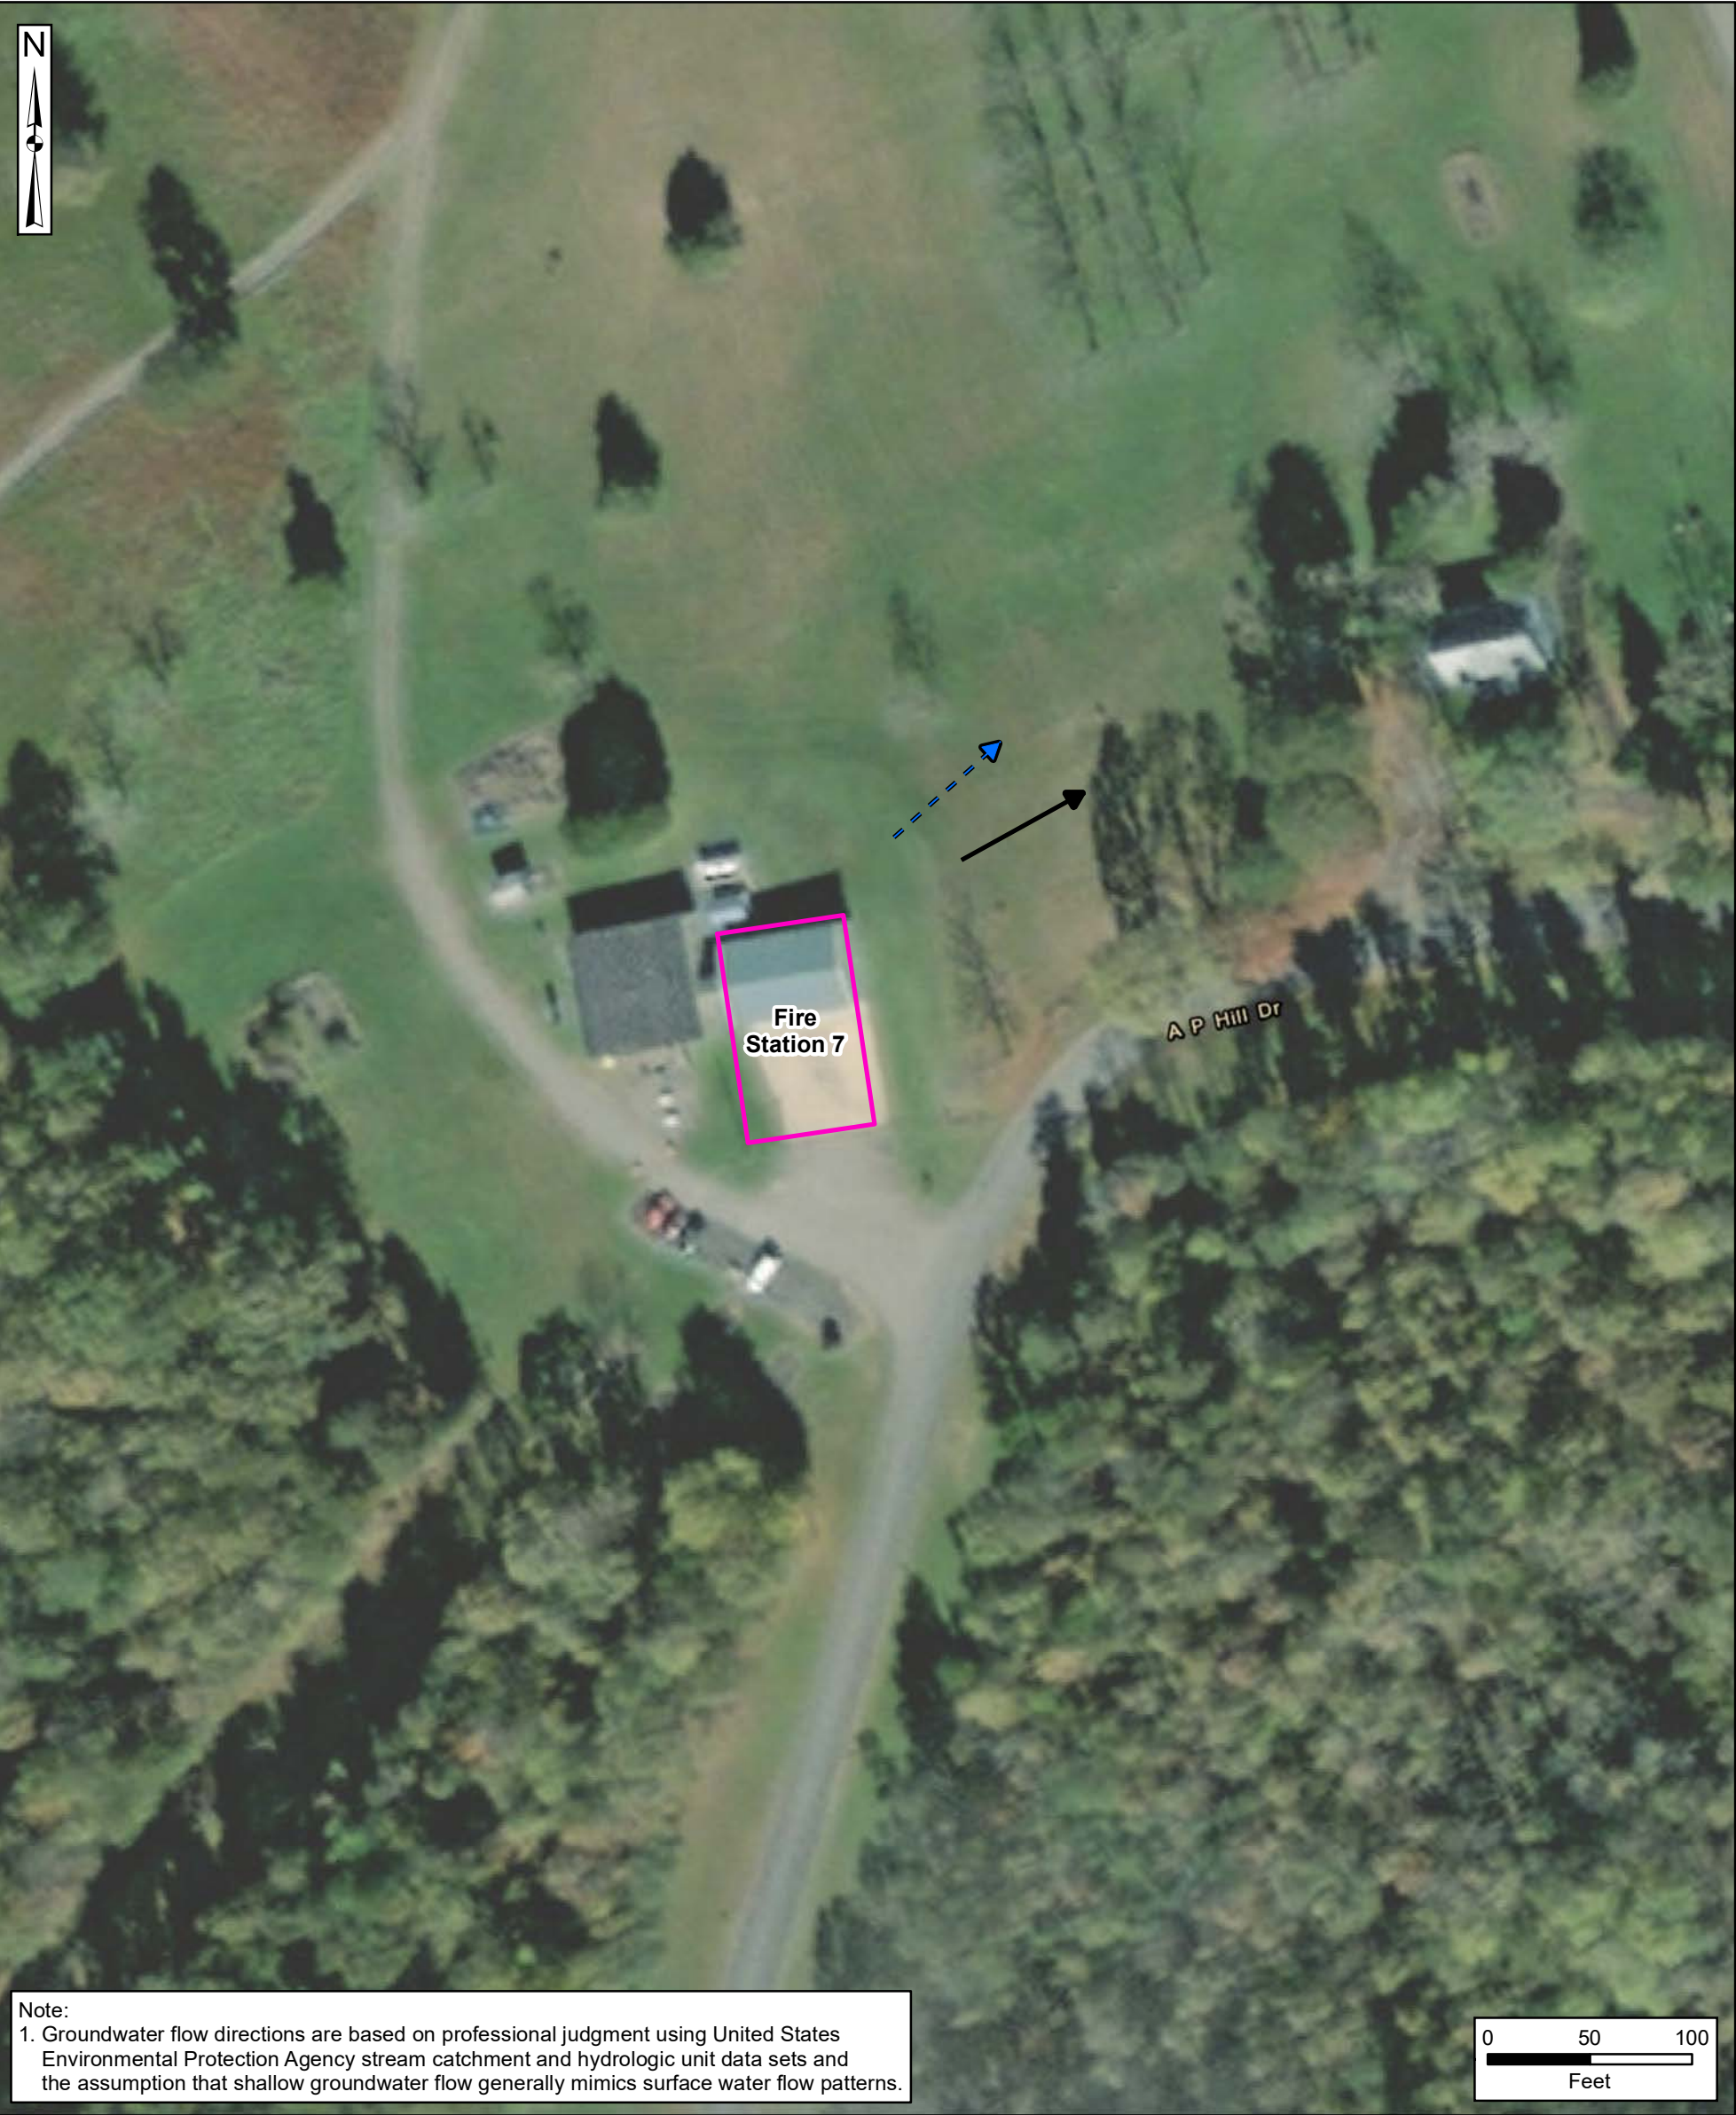
Figure 5-3  
Aerial Photo of  
Fire Station 7 AOPI

Fire Station 7 (**Figure 5-3**) is identified as an AOPI following records review, personnel interviews, and site reconnaissance due to the possibility of incidental spills or leaks while transferring AFFF, washing fire engines, or additional regular fire department practices. The fire station has been in use since 2008. AFFF is transferred into fire engines regularly; however, no spills or incidents involving AFFF have been recorded. The facility contains a drain that goes to the Central WWTP.

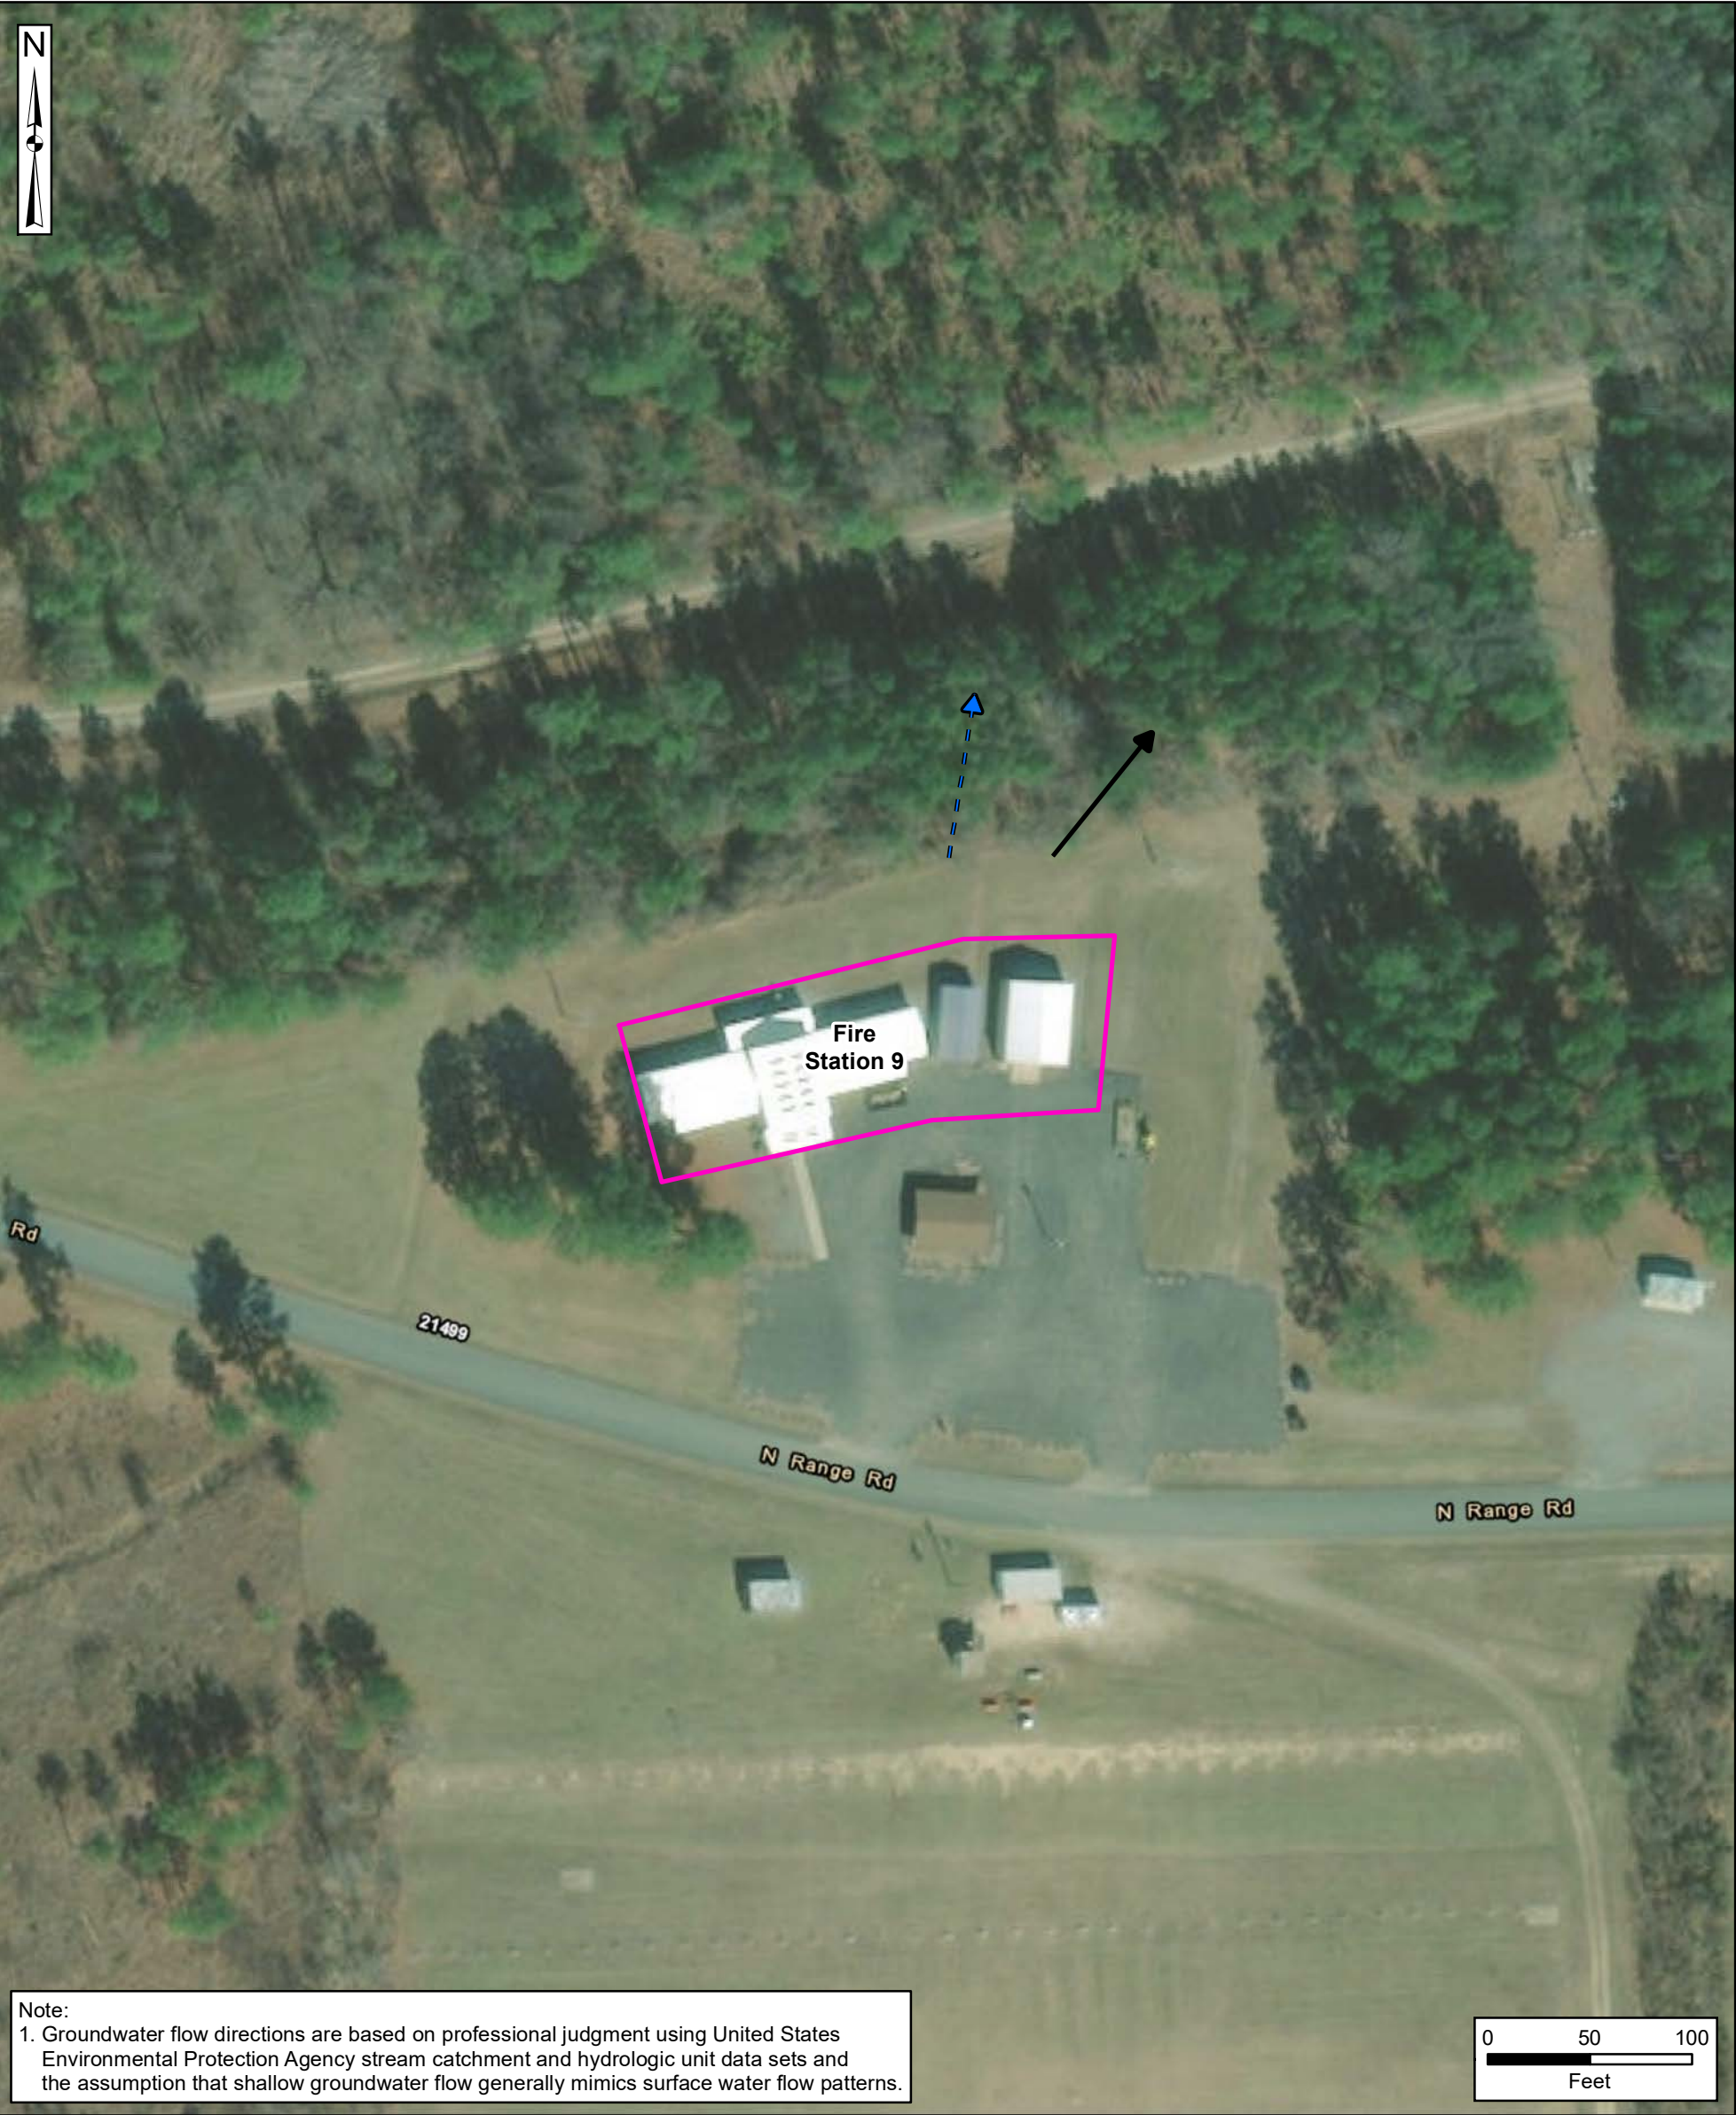
Figure 5-5  
Aerial Photo of  
Fire Station 9 AOPI

Fire Station 9 (**Figure 5-5**) is identified as an AOPI following records review, personnel interviews, and site reconnaissance due to the possibility of incidental spills or leaks while transferring AFFF, washing fire engines, or additional regular fire department practices. Fire Station 9 has been in use since 2013 and includes a storage warehouse. AFFF is stored in 5-gallon buckets in a storage locker at the site. AFFF is

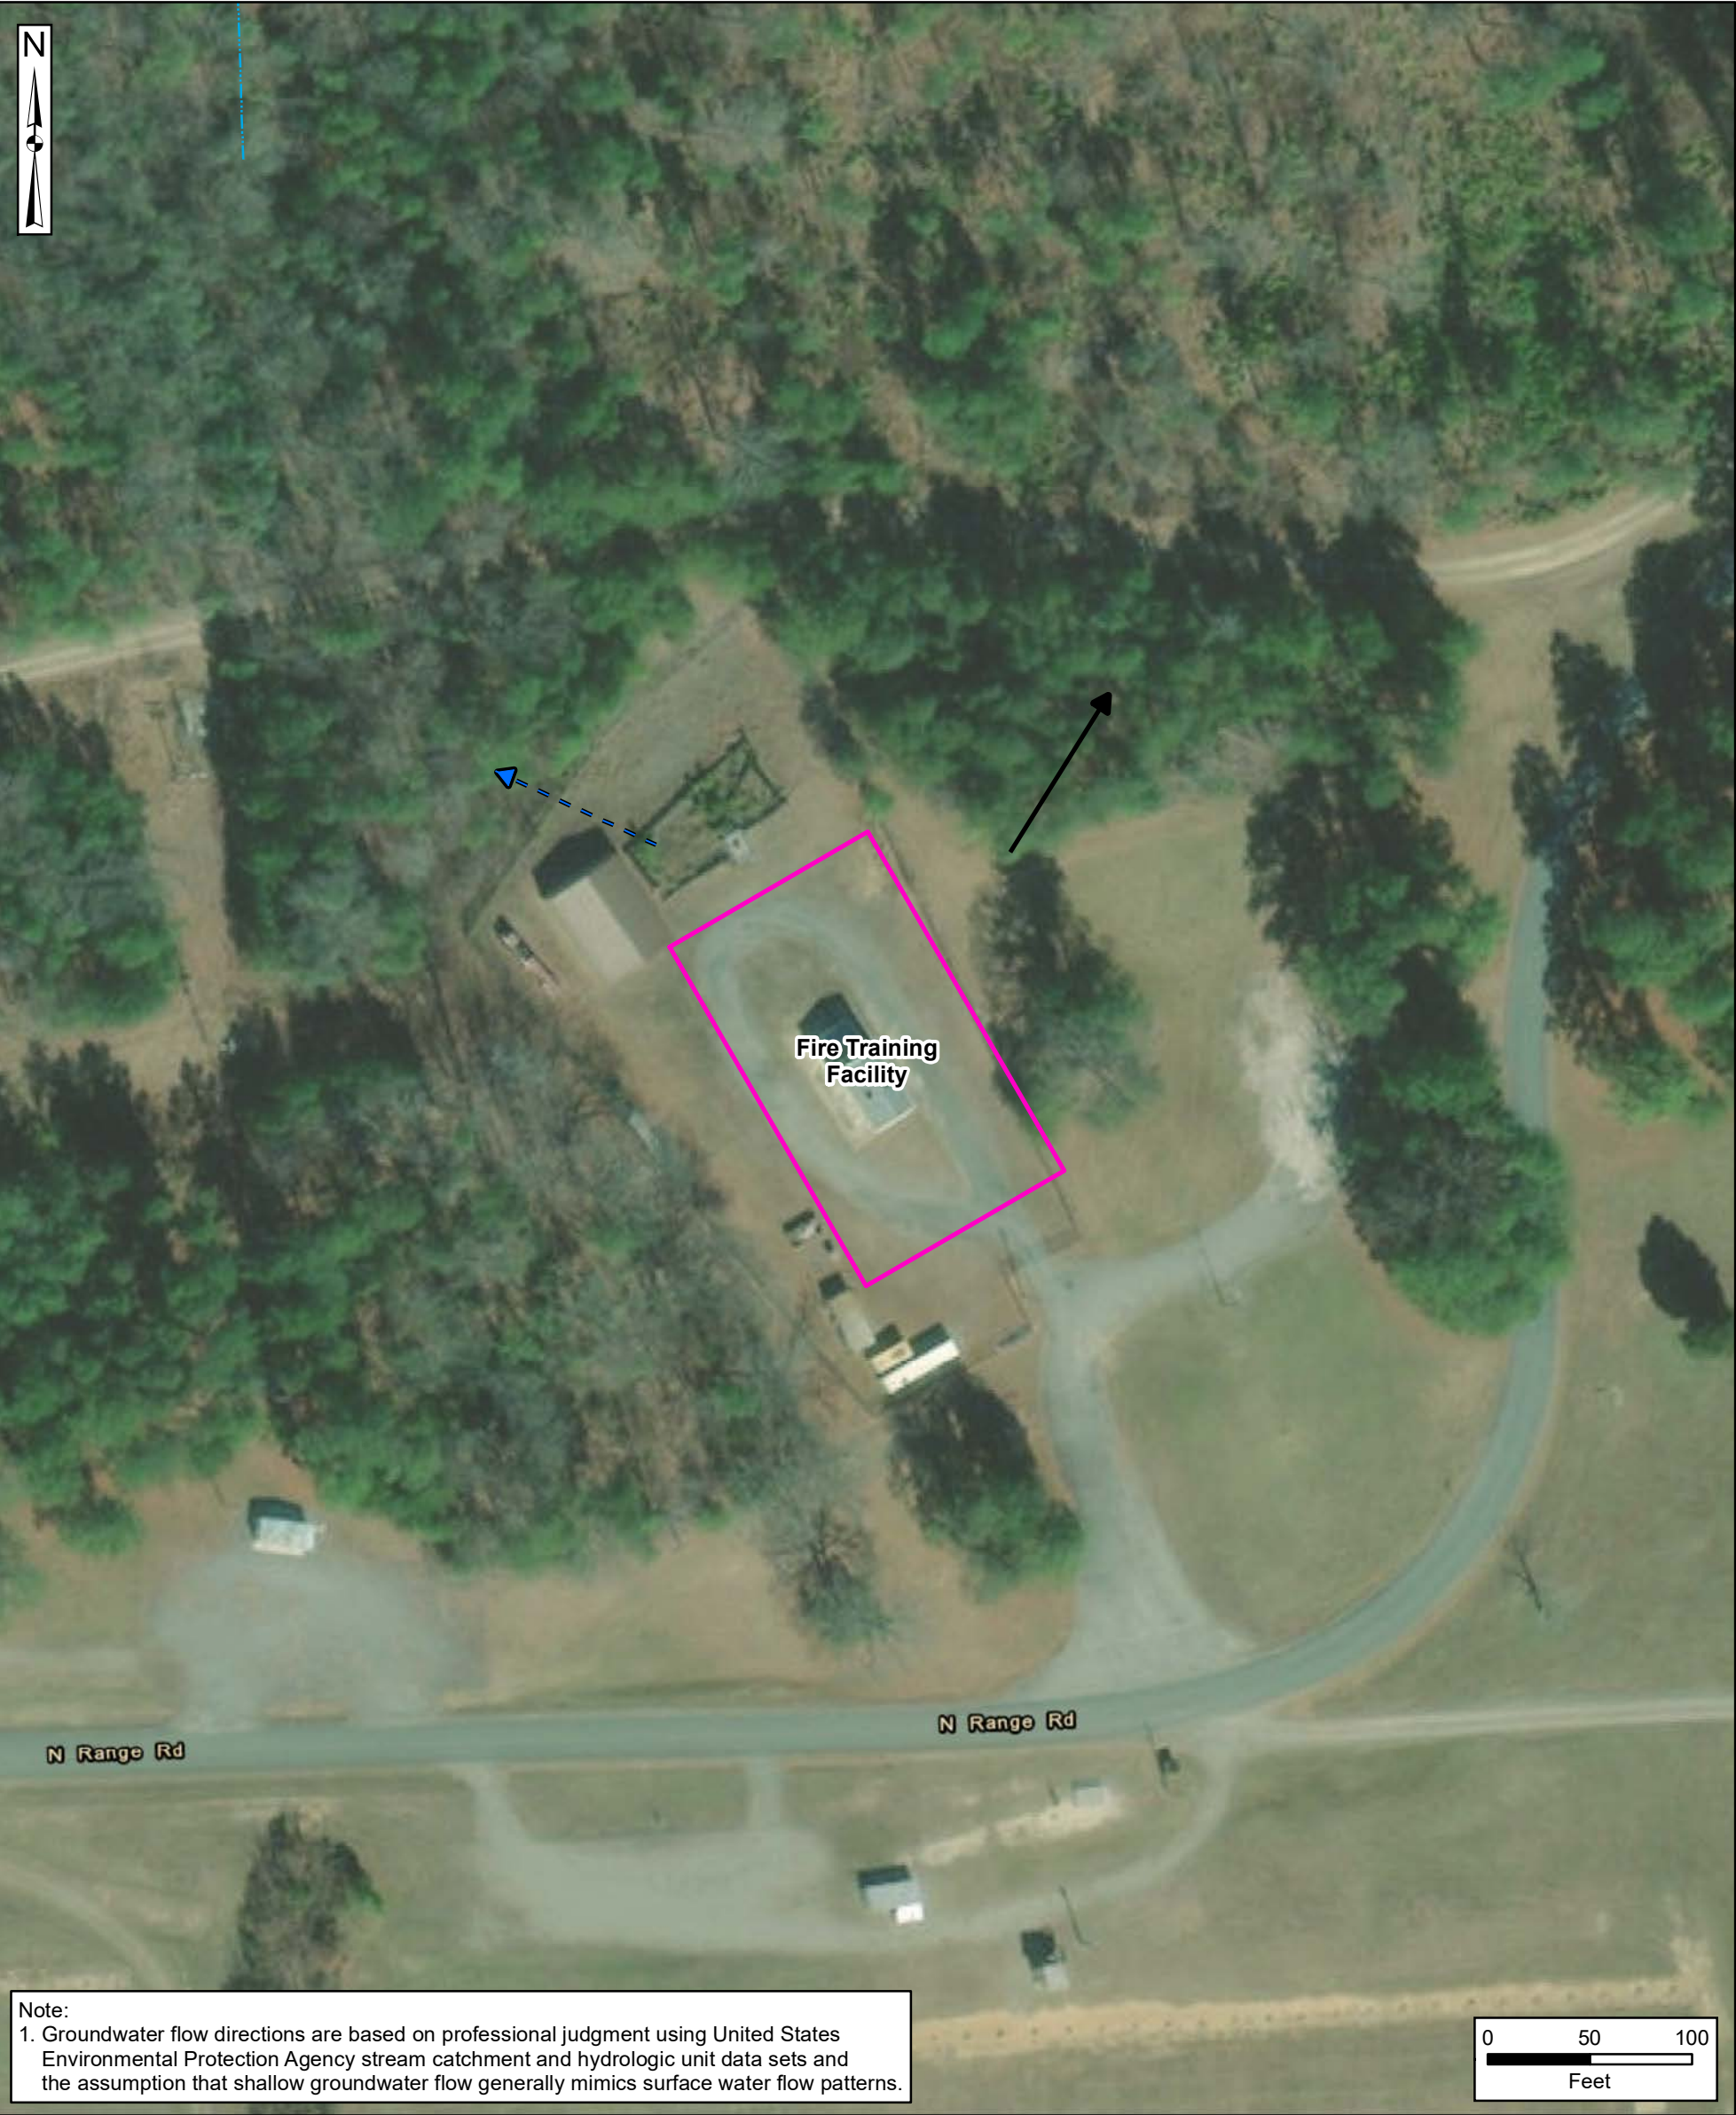
Figure 5-6  
Aerial Photo of  
Fire Training Facility AOPI

The Fire Training Facility (**Figure 5-6**) is identified as an AOPI following records review, personnel interviews, and site reconnaissance due to residual AFFF that may have been released with water used for training. The Fire Training Facility has been in use by the fire department for hazardous material training since the early 2000s. Class A materials, such as wood pallets and bales of straw, are burned in the building and disposed of in a nearby dumpster. A metal aircraft is also on site and used for fire department training. No AFFF has been used in this area; only water is used for training. Despite this, there is a high possibility of release of residual AFFF from nozzles during training at this facility because AFFF is frequently used in the same fire engines to extinguish fires at other areas of the installation.

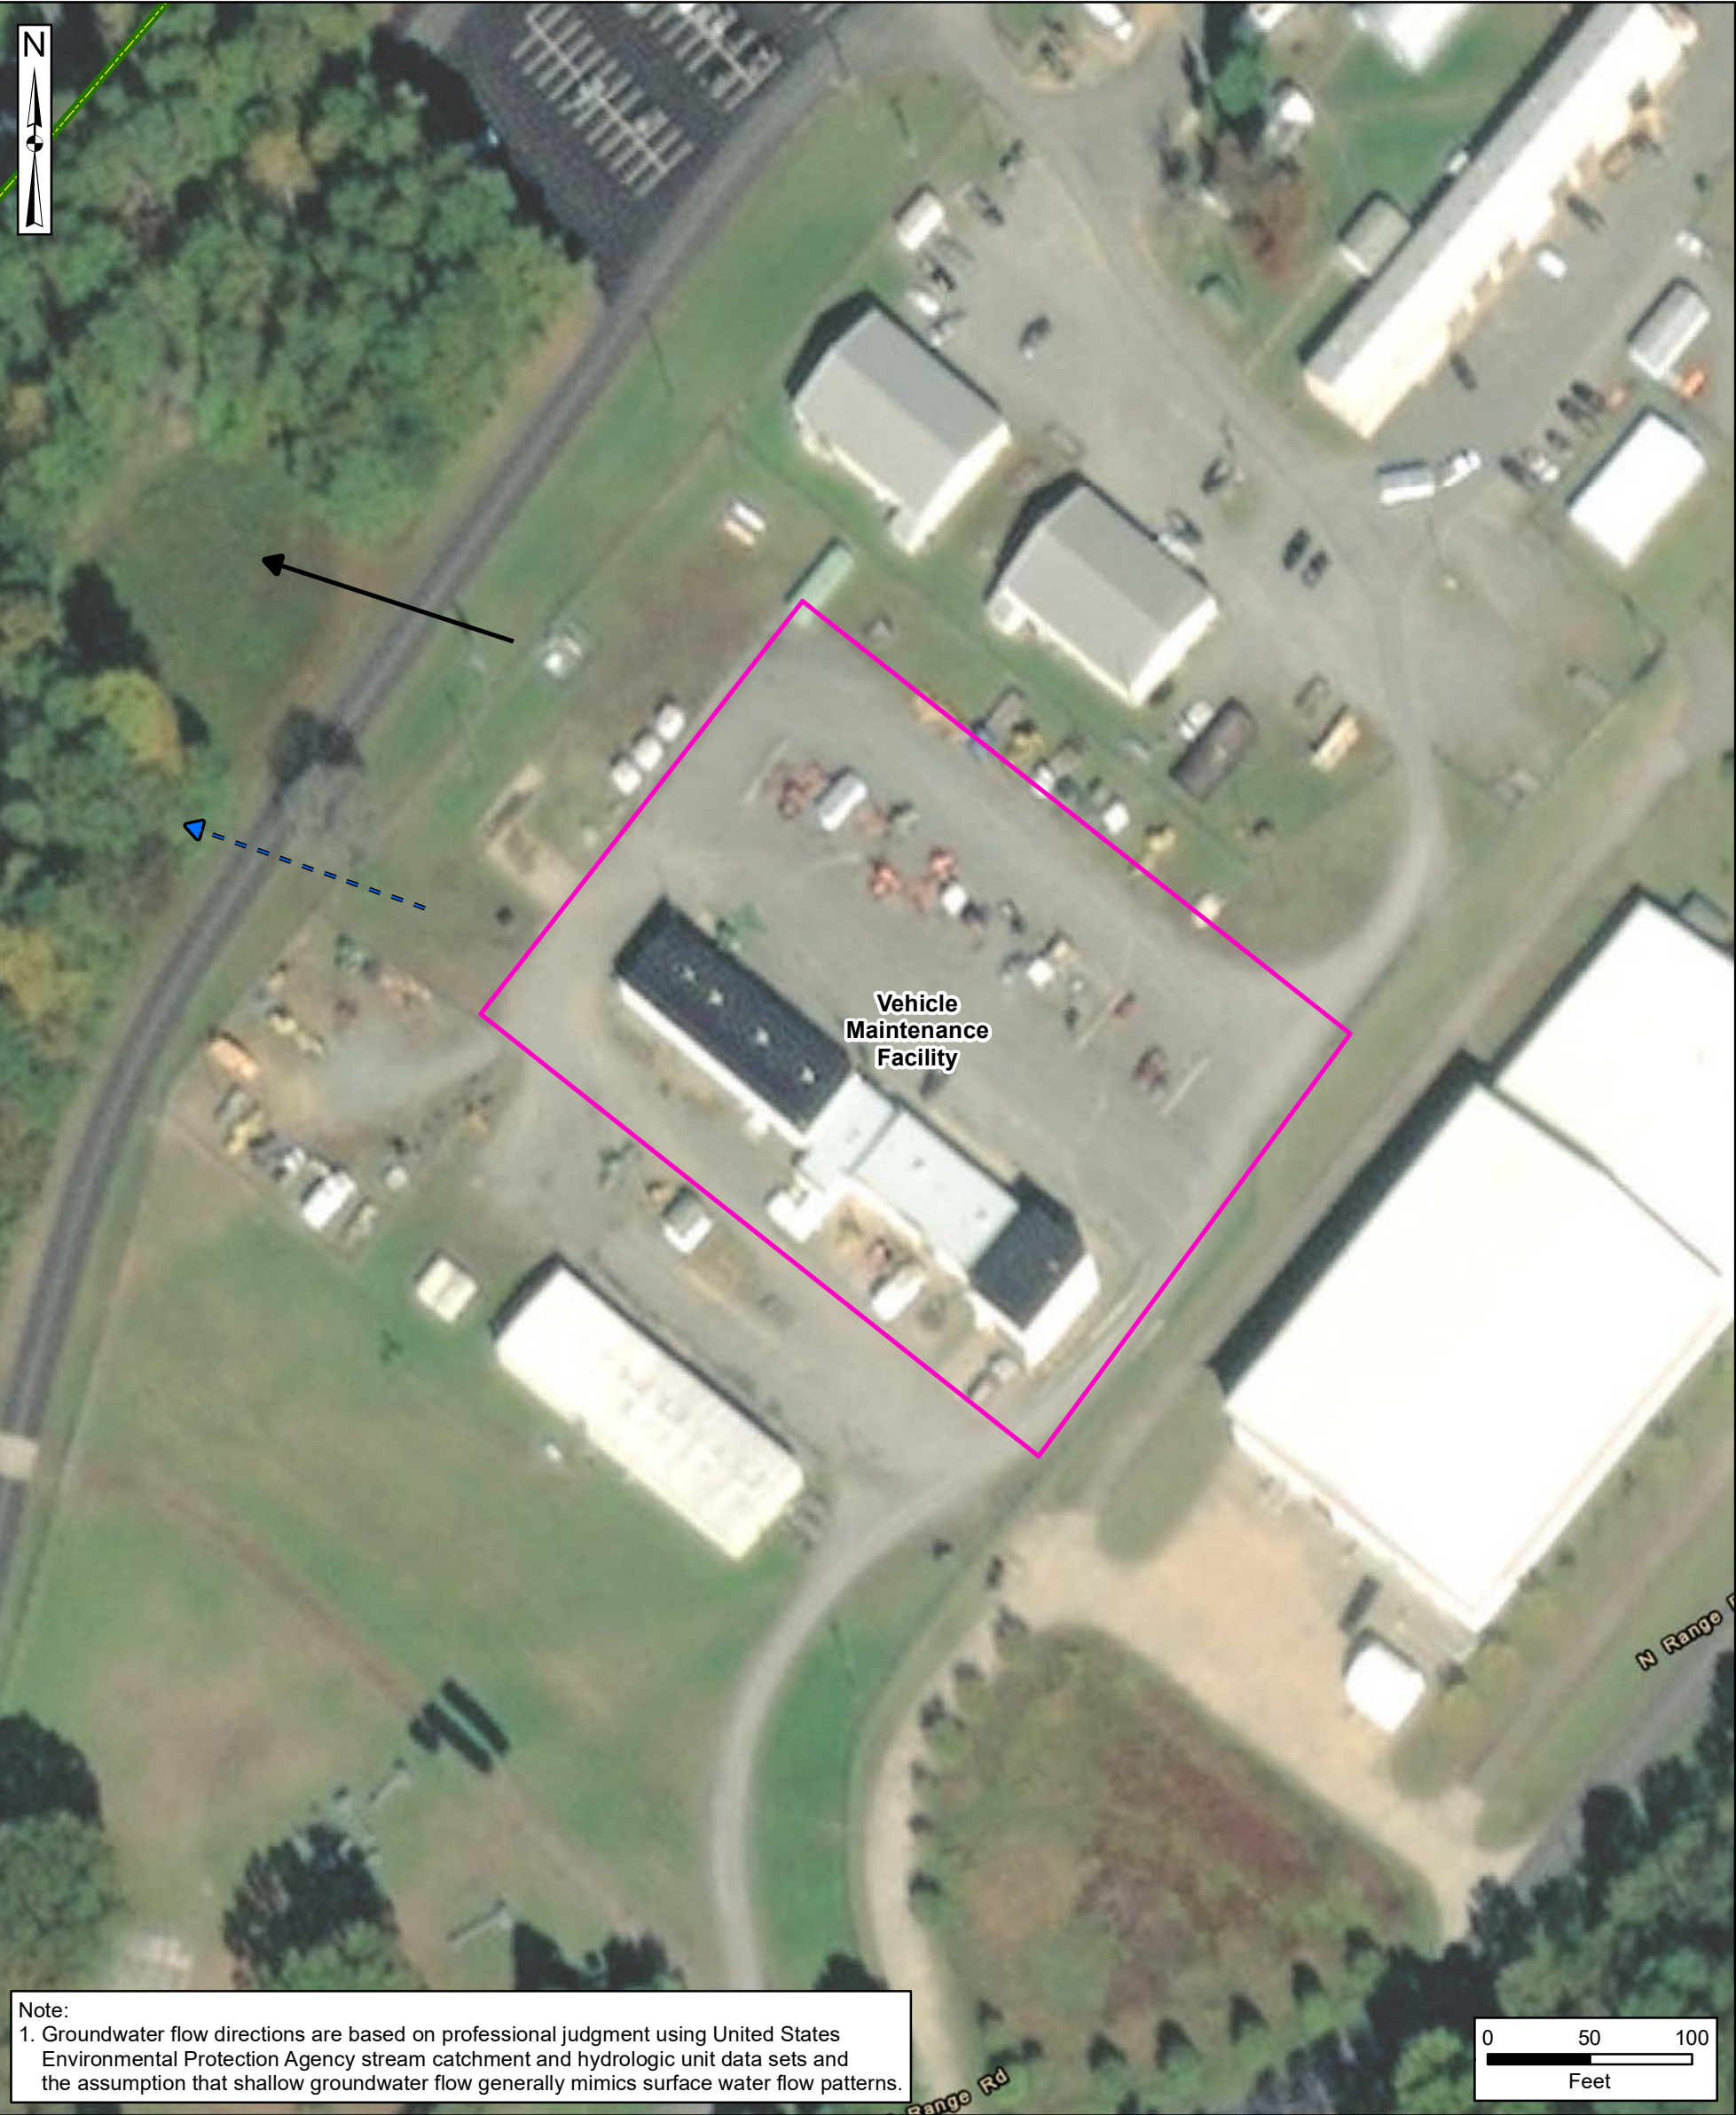
Figure 5-9  
Aerial Photo of  
Vehicle Maintenance Facility AOP

The Vehicle Maintenance Facility (**Figure 5-9**) is identified as an AOPI following records review, personnel interviews, and site reconnaissance due to potential drainage of AFFF from the 20 June 2012 spill at Fire Station 8. The facility has been in operation since in 1972. Some fire engine maintenance occurs at the Vehicle Maintenance Facility, but most engines are sent to Fort Belvoir for maintenance. The engine's AFFF reservoir from the spill at Fire Station 8 after draining was sent to the maintenance facility to be decommissioned. At this point AFFF could have been released at the facility. Additionally, the Vehicle Maintenance Facility is included as an AOPI for other historical leaks, spills, or releases to the drain field.

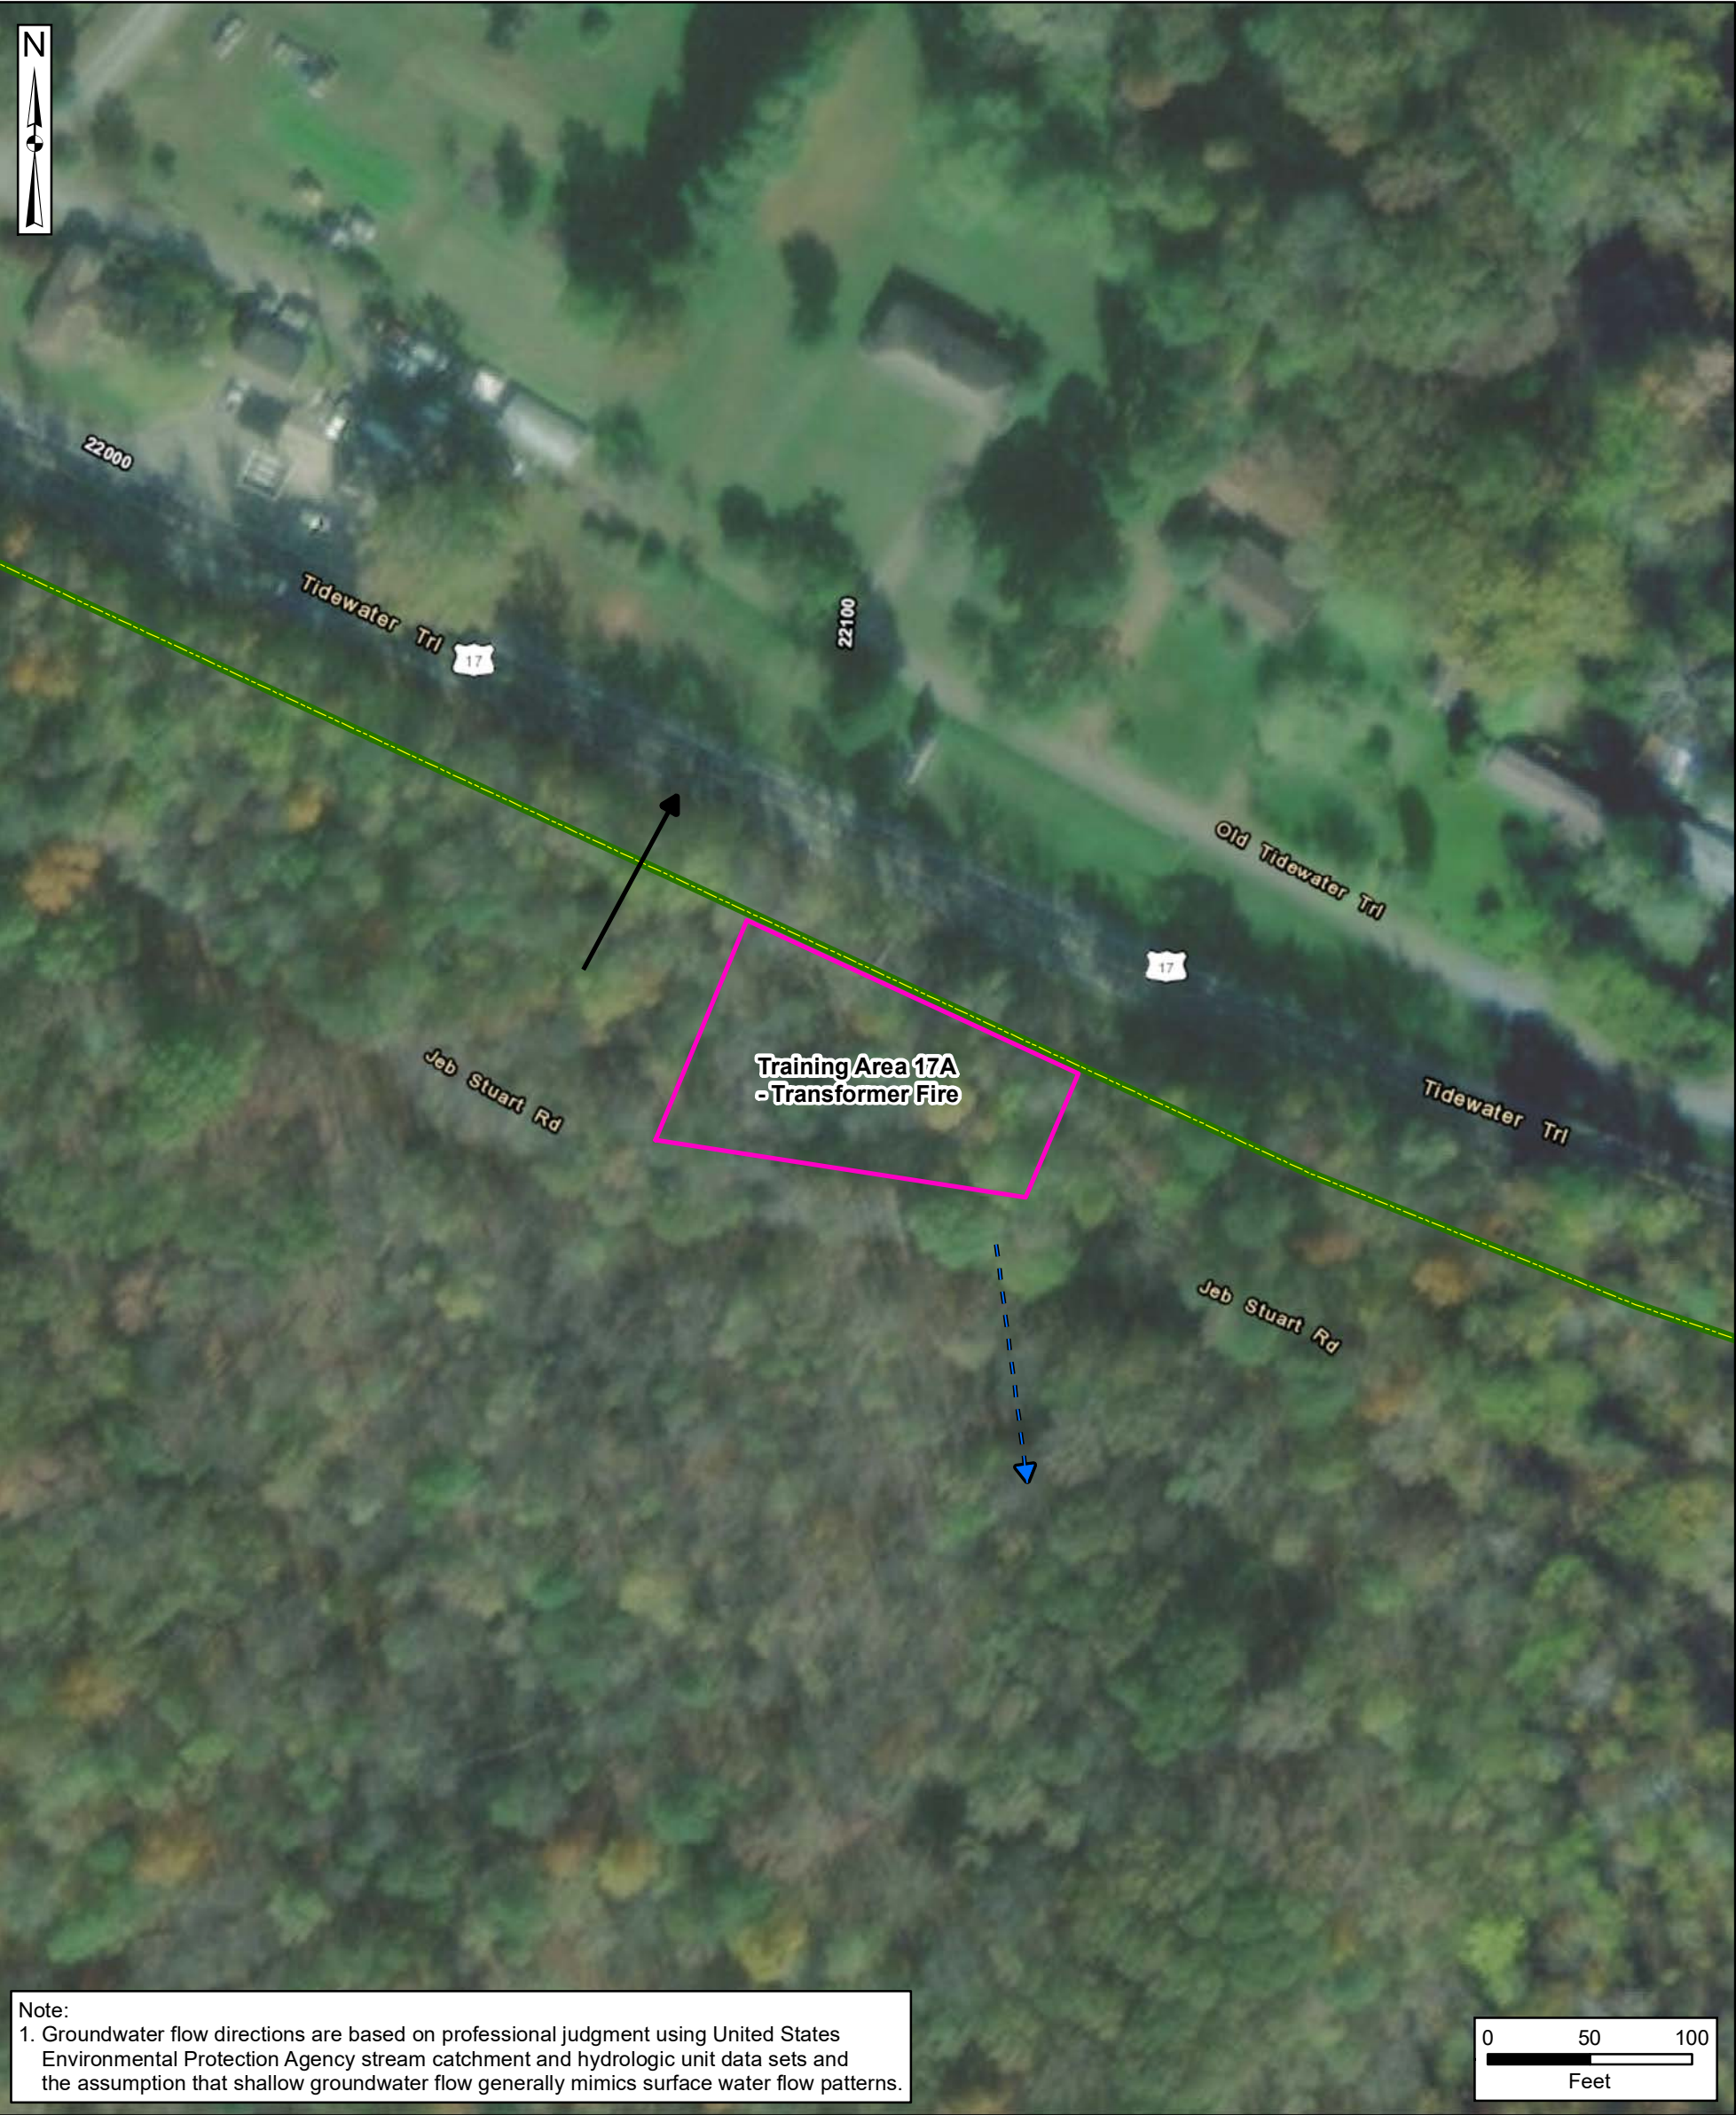
Figure 5-10  
Aerial Photo of  
Training Area 17A - Transformer Fire AOPI

Training Area 17A – Transformer Fire (**Figure 5-10**) is identified as an AOPI following records review, personnel interviews, and site reconnaissance due to the use of AFFF to extinguish a fire. Training Area 17A – Transformer Fire is a laser range adjacent to the installation's northern boundary. On 14 April 2018, a downed power line caused a transformer fire. About 5 gallons of AFFF was used to spot treat logs over an area measuring about 400 square feet. The use of AFFF was required to keep the fire from migrating off-post to a residential area with known drinking water supply wells about 100 yards north of the installation boundary.
