Originating Office: DPW-ENRD		Review Frequency: As required
Document Title: Final Fort AP Hill PFAS PA/SI Report  Document No: FW-SEMS-003		
Document Organization Owner: DPW – ENRD	Prepared By: Contract-ARCADIS USACE - Baltimore	Revision Date: June 2022
Contact Name: Gef Fisher George.e.fisher24.civ@army.mil	Distribution: External	Original Date: June 2022

# FINAL PRELIMINARY ASSESSMENT AND SITE INSPECTION OF PER- AND POLYFLUOROALKYL SUBSTANCES

**Fort A.P. Hill, Virginia**

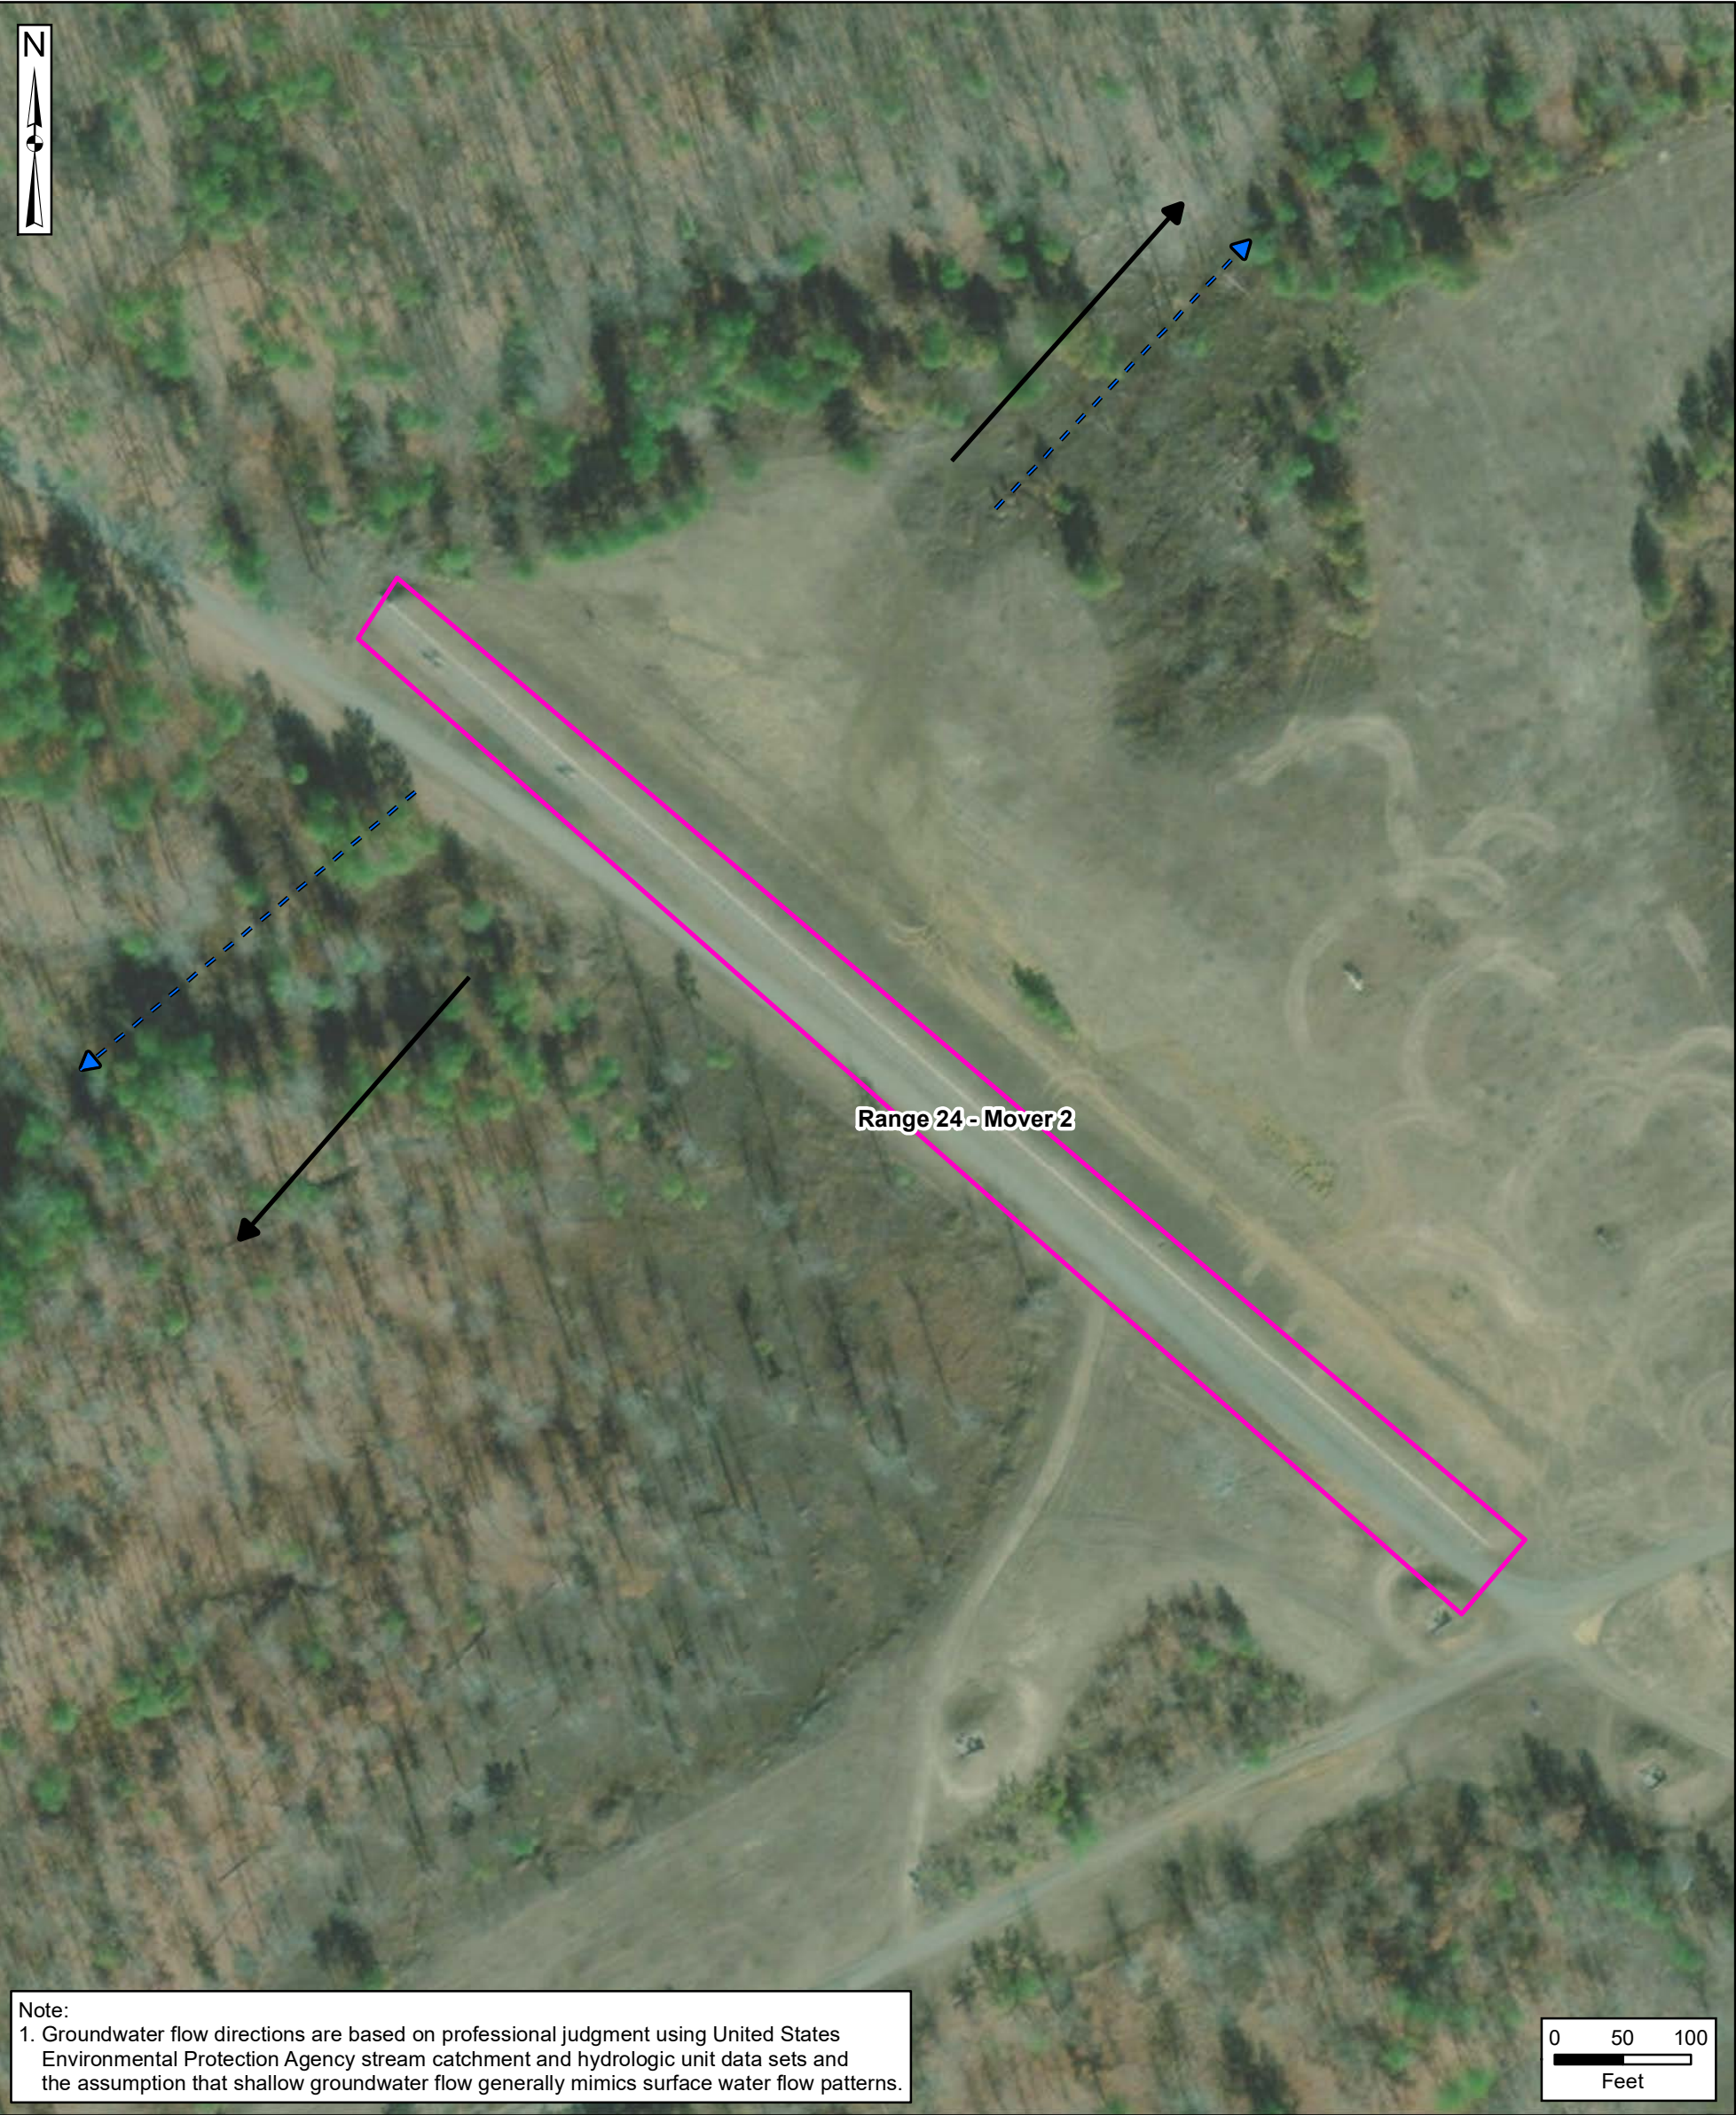
Figure 5-12  
Aerial Photo of  
Range 24 - Mover 2 AOPI

Range 24 – Mover 2 (**Figure 5-12**) is identified as an AOPI following records review, personnel interviews, and site reconnaissance due to the use of AFFF to control a fire. Range 24 is utilized for pre-deployment training. Two mover targets (not co-located) consist of an approximately 200-foot long, 8-foot-high concrete wall backed by a soil berm. The walls were previously built from creosote timbers. Around 2005 at least one large fire occurred on the creosote timbers at each mover target. AFFF was used at these mover targets to control a large fire by completely covering the entire wall with AFFF. Incidental AFFF contact with soil would have occurred, as well as, leaching from residual AFFF on the creosote timbers. The creosote timbers were removed and disposed off-post when the concrete walls were built.

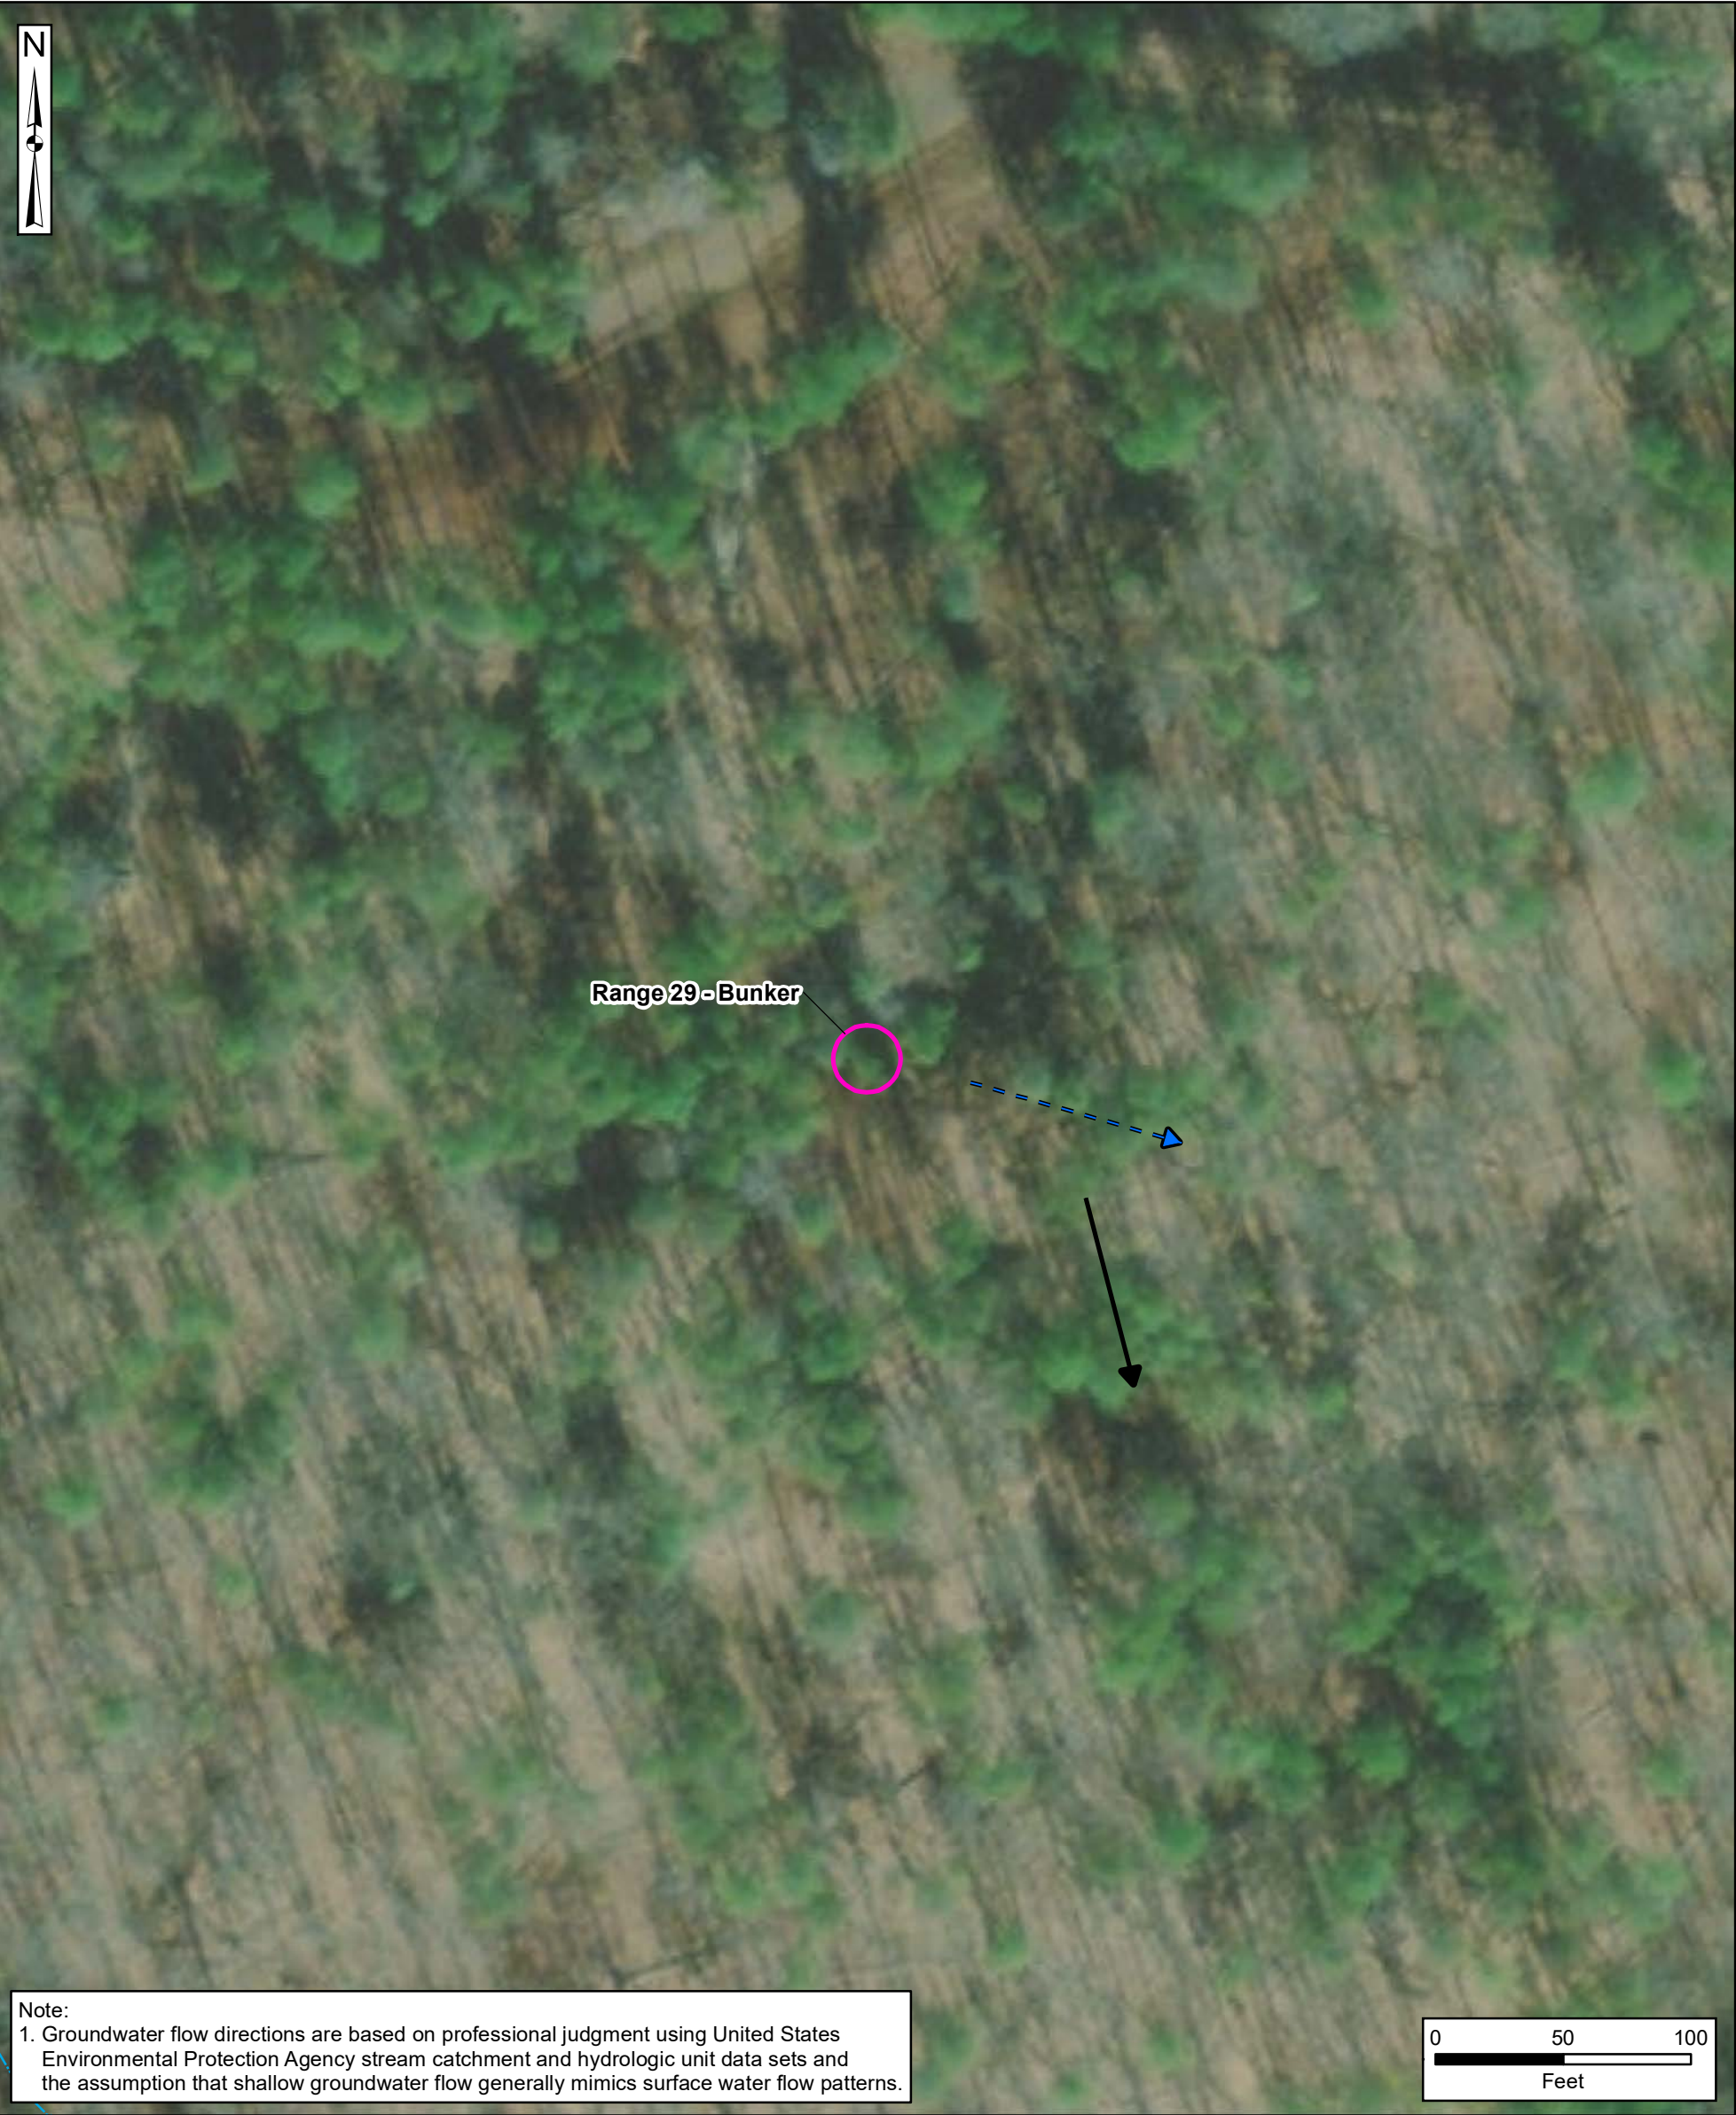
Figure 5-14  
Aerial Photo of  
Range 29 - Bunker AOPi

Range 29 – Bunker (**Figure 5-14**) is identified as an AOPI following records review, personnel interviews, and site reconnaissance due to the use of AFFF to extinguish a fire. Range 29, the Infantry Platoon Battle Course, is a heavily forested area. AFFF was used to extinguish a fire at a wooden turret sometime between 2010 and 2019. The turret has been removed and is now a large depression in the ground. Soil in place when the turret existed remains on site.

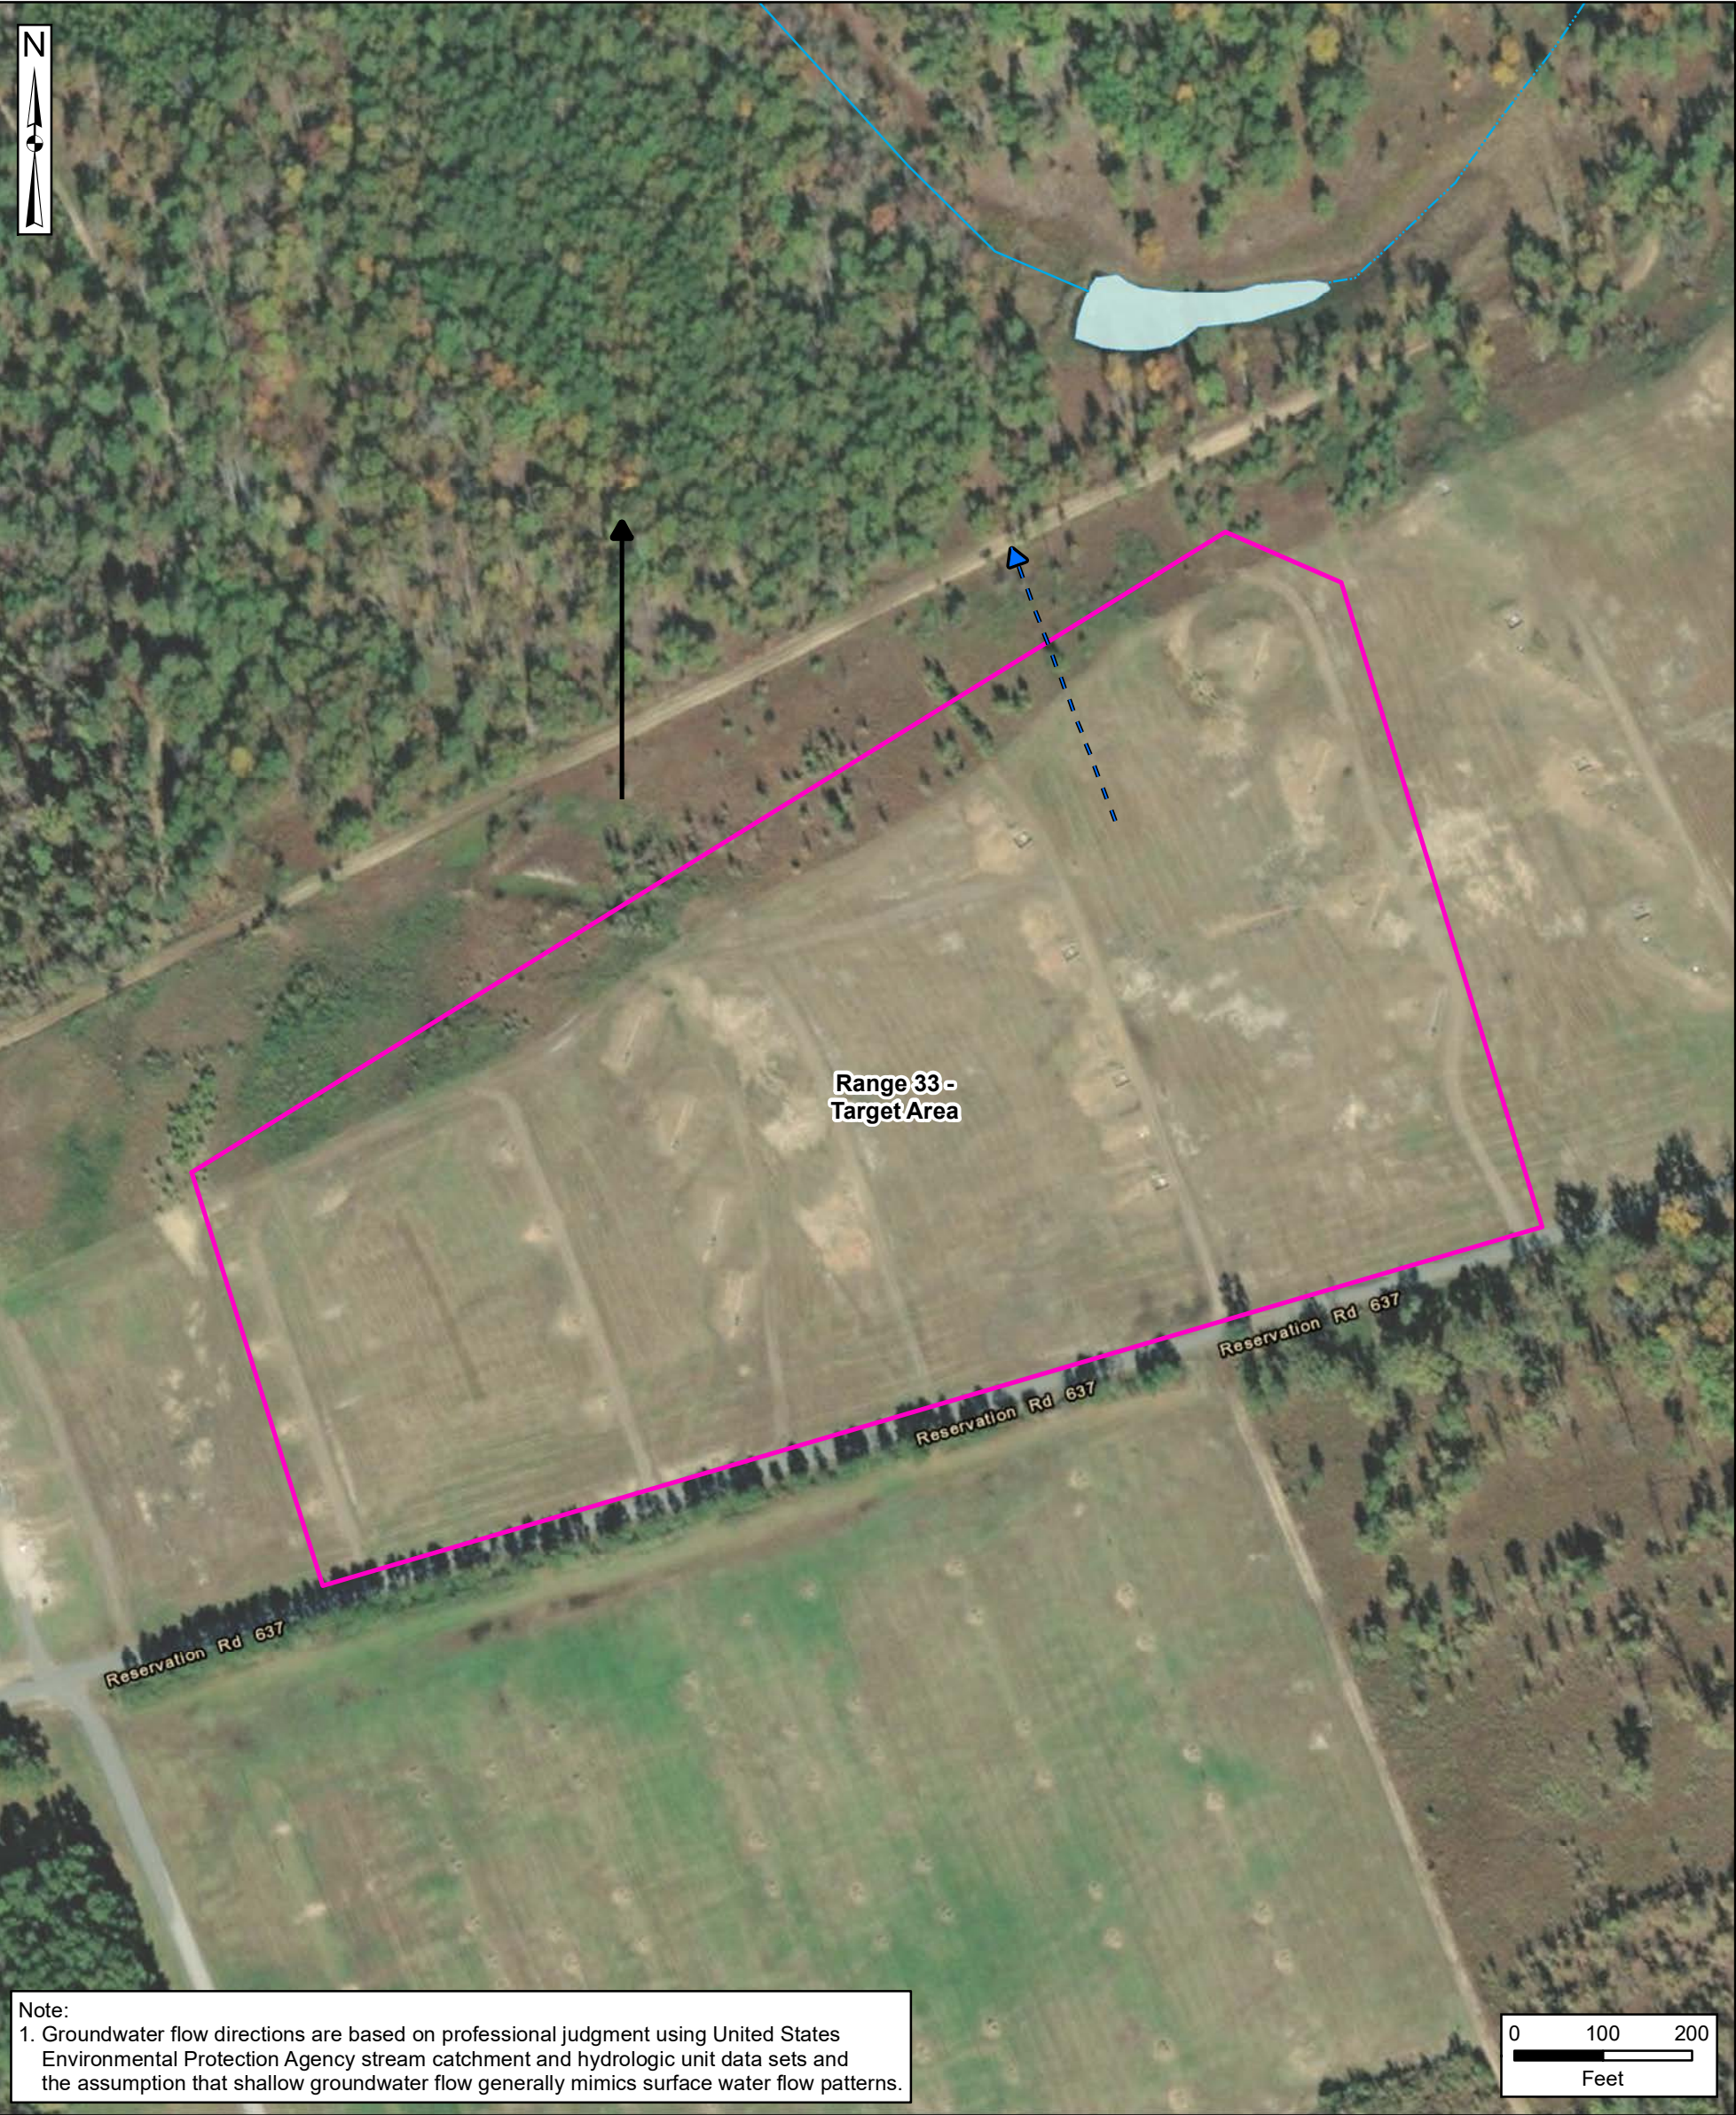
Figure 5-15  
Aerial Photo of  
Range 33 - Target Area AOPI

Range 33 – Target Area (**Figure 5-15**) is identified as an AOPI following records review, personnel interviews, and site reconnaissance due to the use of AFFF to extinguish fires at the site. Range 33 is a small arms shooting range made up of approximately 50 targets. Tracers at this range have previously caught fire and ignited creosote timbers at multiple targets. The targets have one creosote timber each that function as target protection. AFFF has been used to extinguish fires at these creosote timbers several times; however, the fire department was unable pinpoint exact locations or time frames.

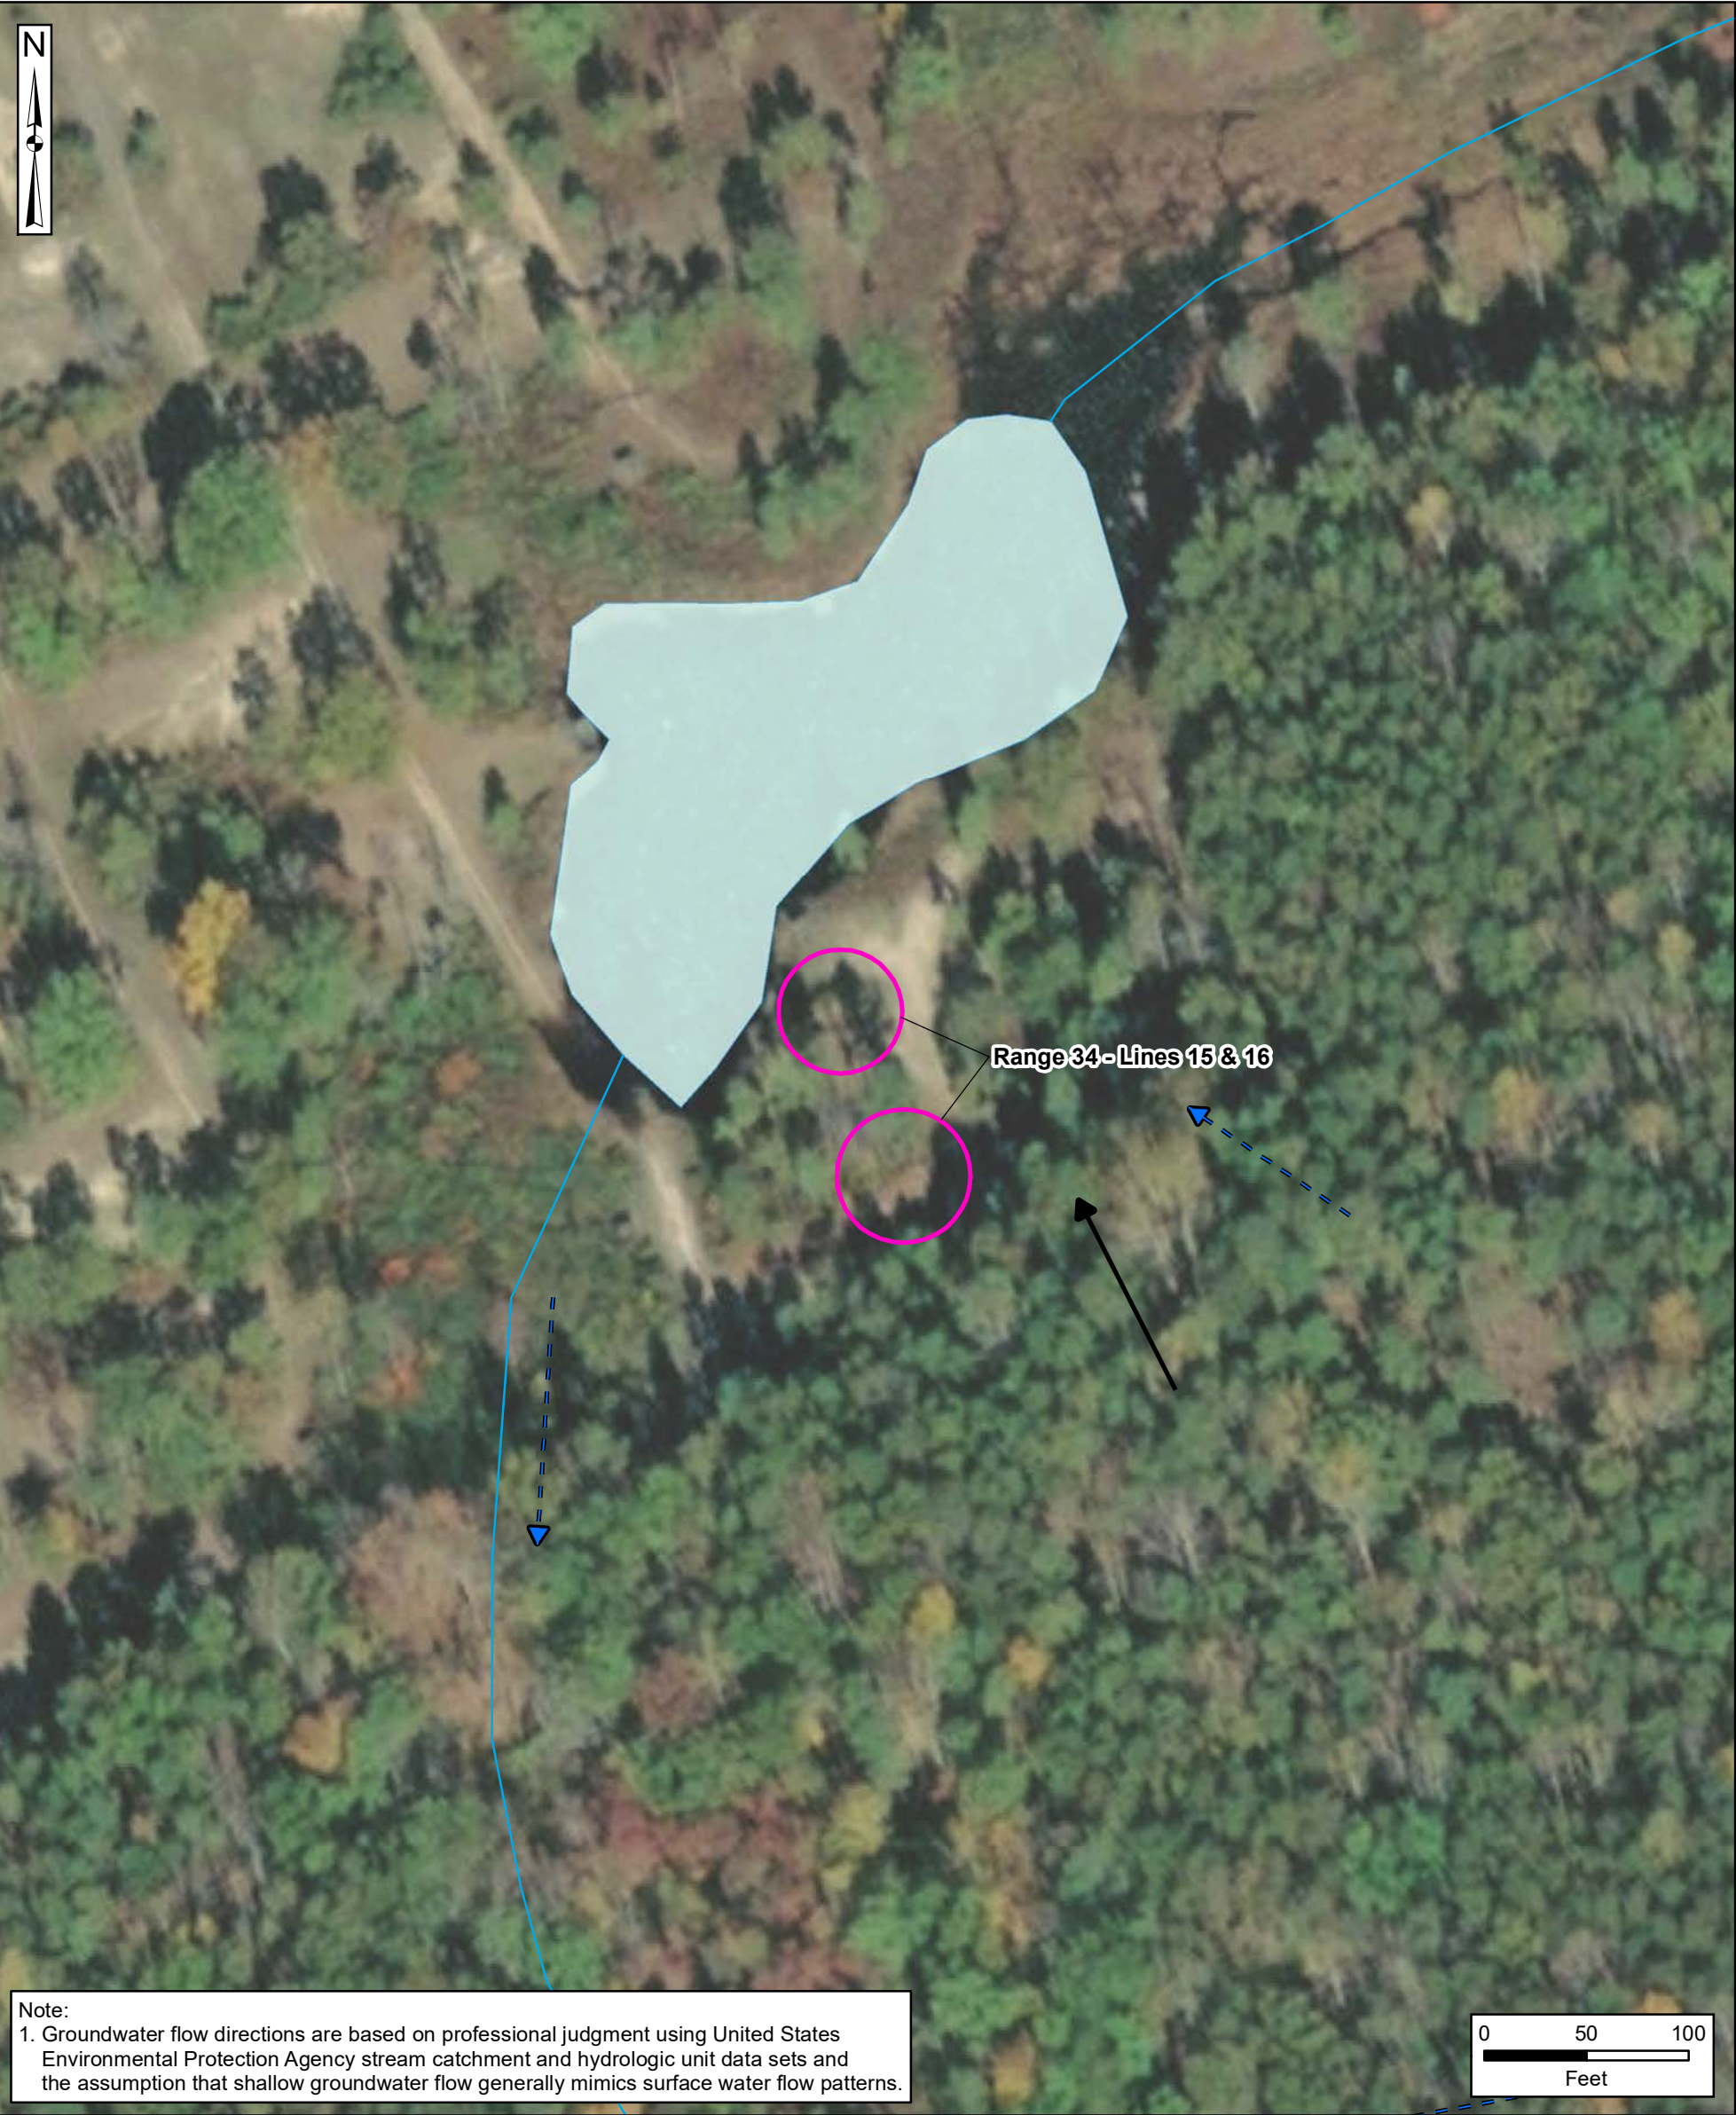
Figure 5-16  
Aerial Photo of  
Range 34 - Lines 15 & 16 AOPI

Range 34 Lines 15 & 16 (**Figure 5-16**) is identified as an AOPI following records review, personnel interviews, and site reconnaissance due to the use of AFFF to extinguish fires at the site. Range 34 is a small arms shooting range with targets in wooded areas. Wildfires have previously occurred at this range, which caused creosote timbers at Lines 15 & 16 to catch fire. AFFF was used to extinguish the fires. Fires may have occurred at additional timbers but were unknown by current fire department personnel at the time of the PA.

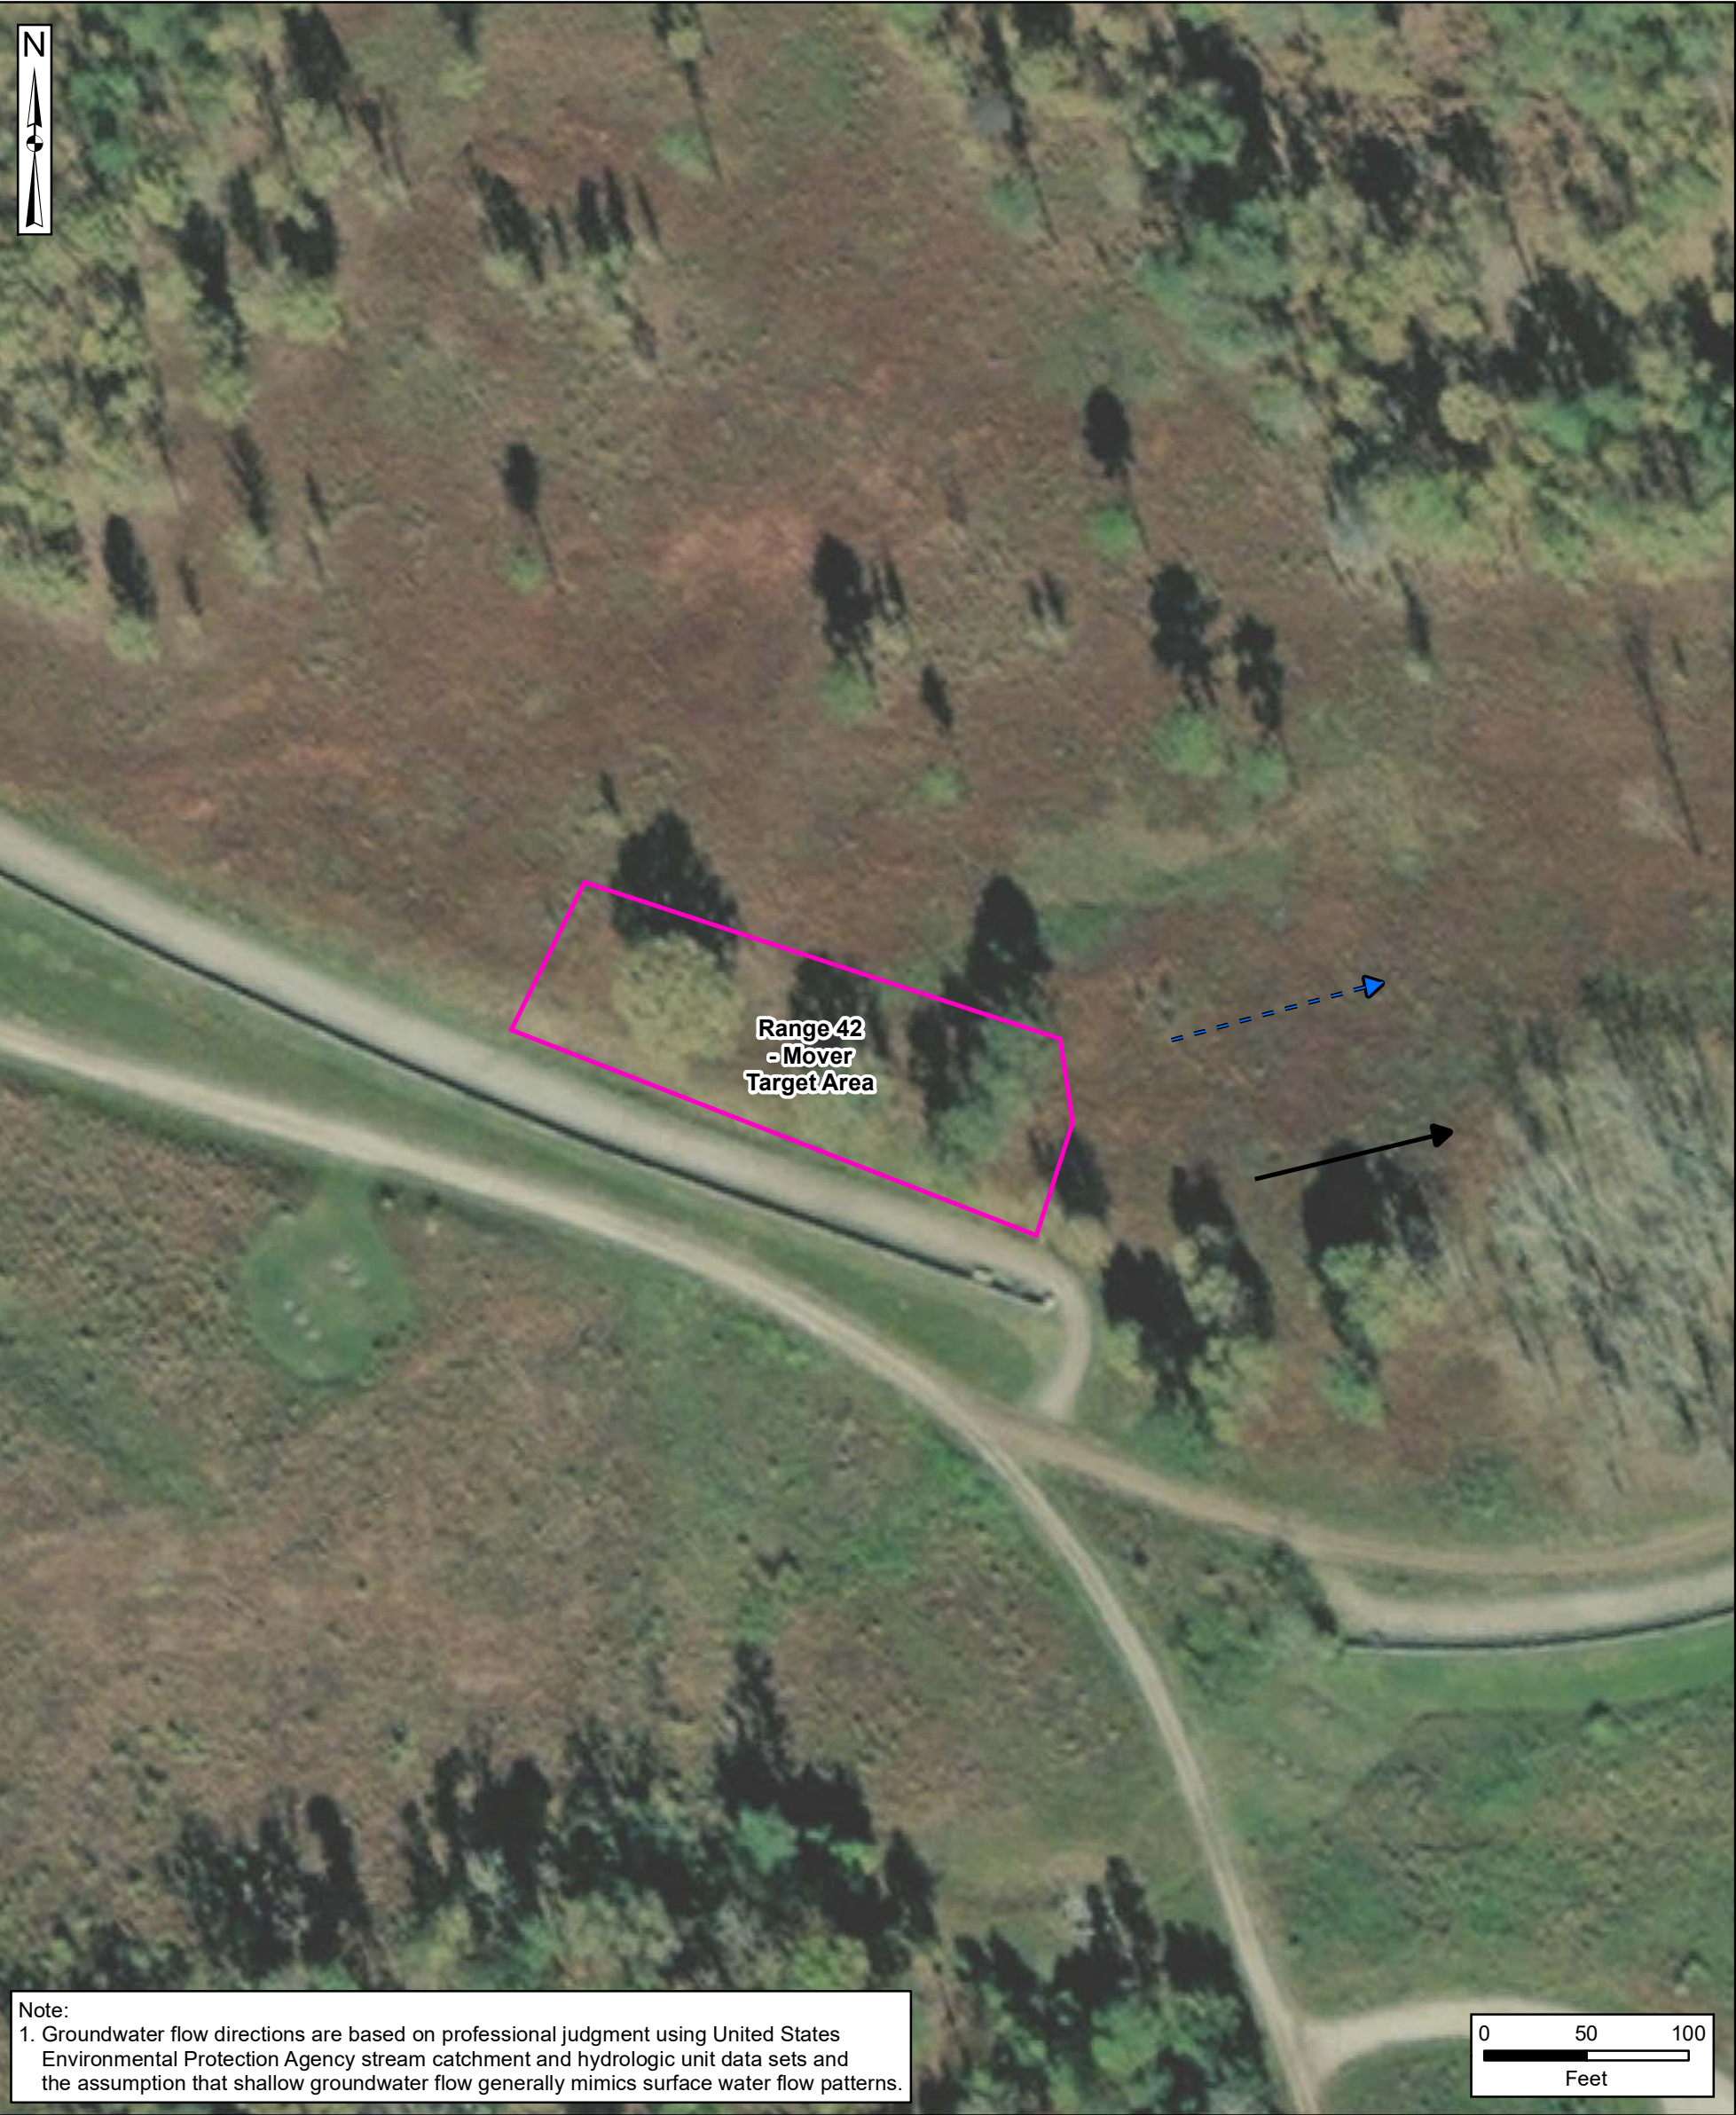
Figure 5-17  
Aerial Photo of  
Range 42 - Mover Target Area AOPI

Range 42 – Mover Target Area (**Figure 5-17**) is identified as an AOPI following records review, personnel interviews, and site reconnaissance due to the use of AFFF to prevent the destruction of large trees. Range 42 is operated by the Asymmetric Warfare Group and is used for survival, leadership, and medical training. Prescribed burns have previously occurred at this range adjacent to the back road and mover target. AFFF would have been used at the base of larger trees to prevent the trees from falling and causing damage to expensive targets. Fire department personnel with experience assisting with prescribed burns pointed out several trees as examples during the PA site reconnaissance, but exact locations of AFFF use are unknown.
