Originating Office: DPW-ENRD		Review Frequency: As required
Document Title: Final Fort AP Hill PFAS PA/SI Report  Document No: FW-SEMS-003		
Document Organization Owner: DPW – ENRD	Prepared By: Contract-ARCADIS USACE - Baltimore	Revision Date: June 2022
Contact Name: Gef Fisher George.e.fisher24.civ@army.mil	Distribution: External	Original Date: June 2022

# FINAL PRELIMINARY ASSESSMENT AND SITE INSPECTION OF PER- AND POLYFLUOROALKYL SUBSTANCES

**Fort A.P. Hill, Virginia**

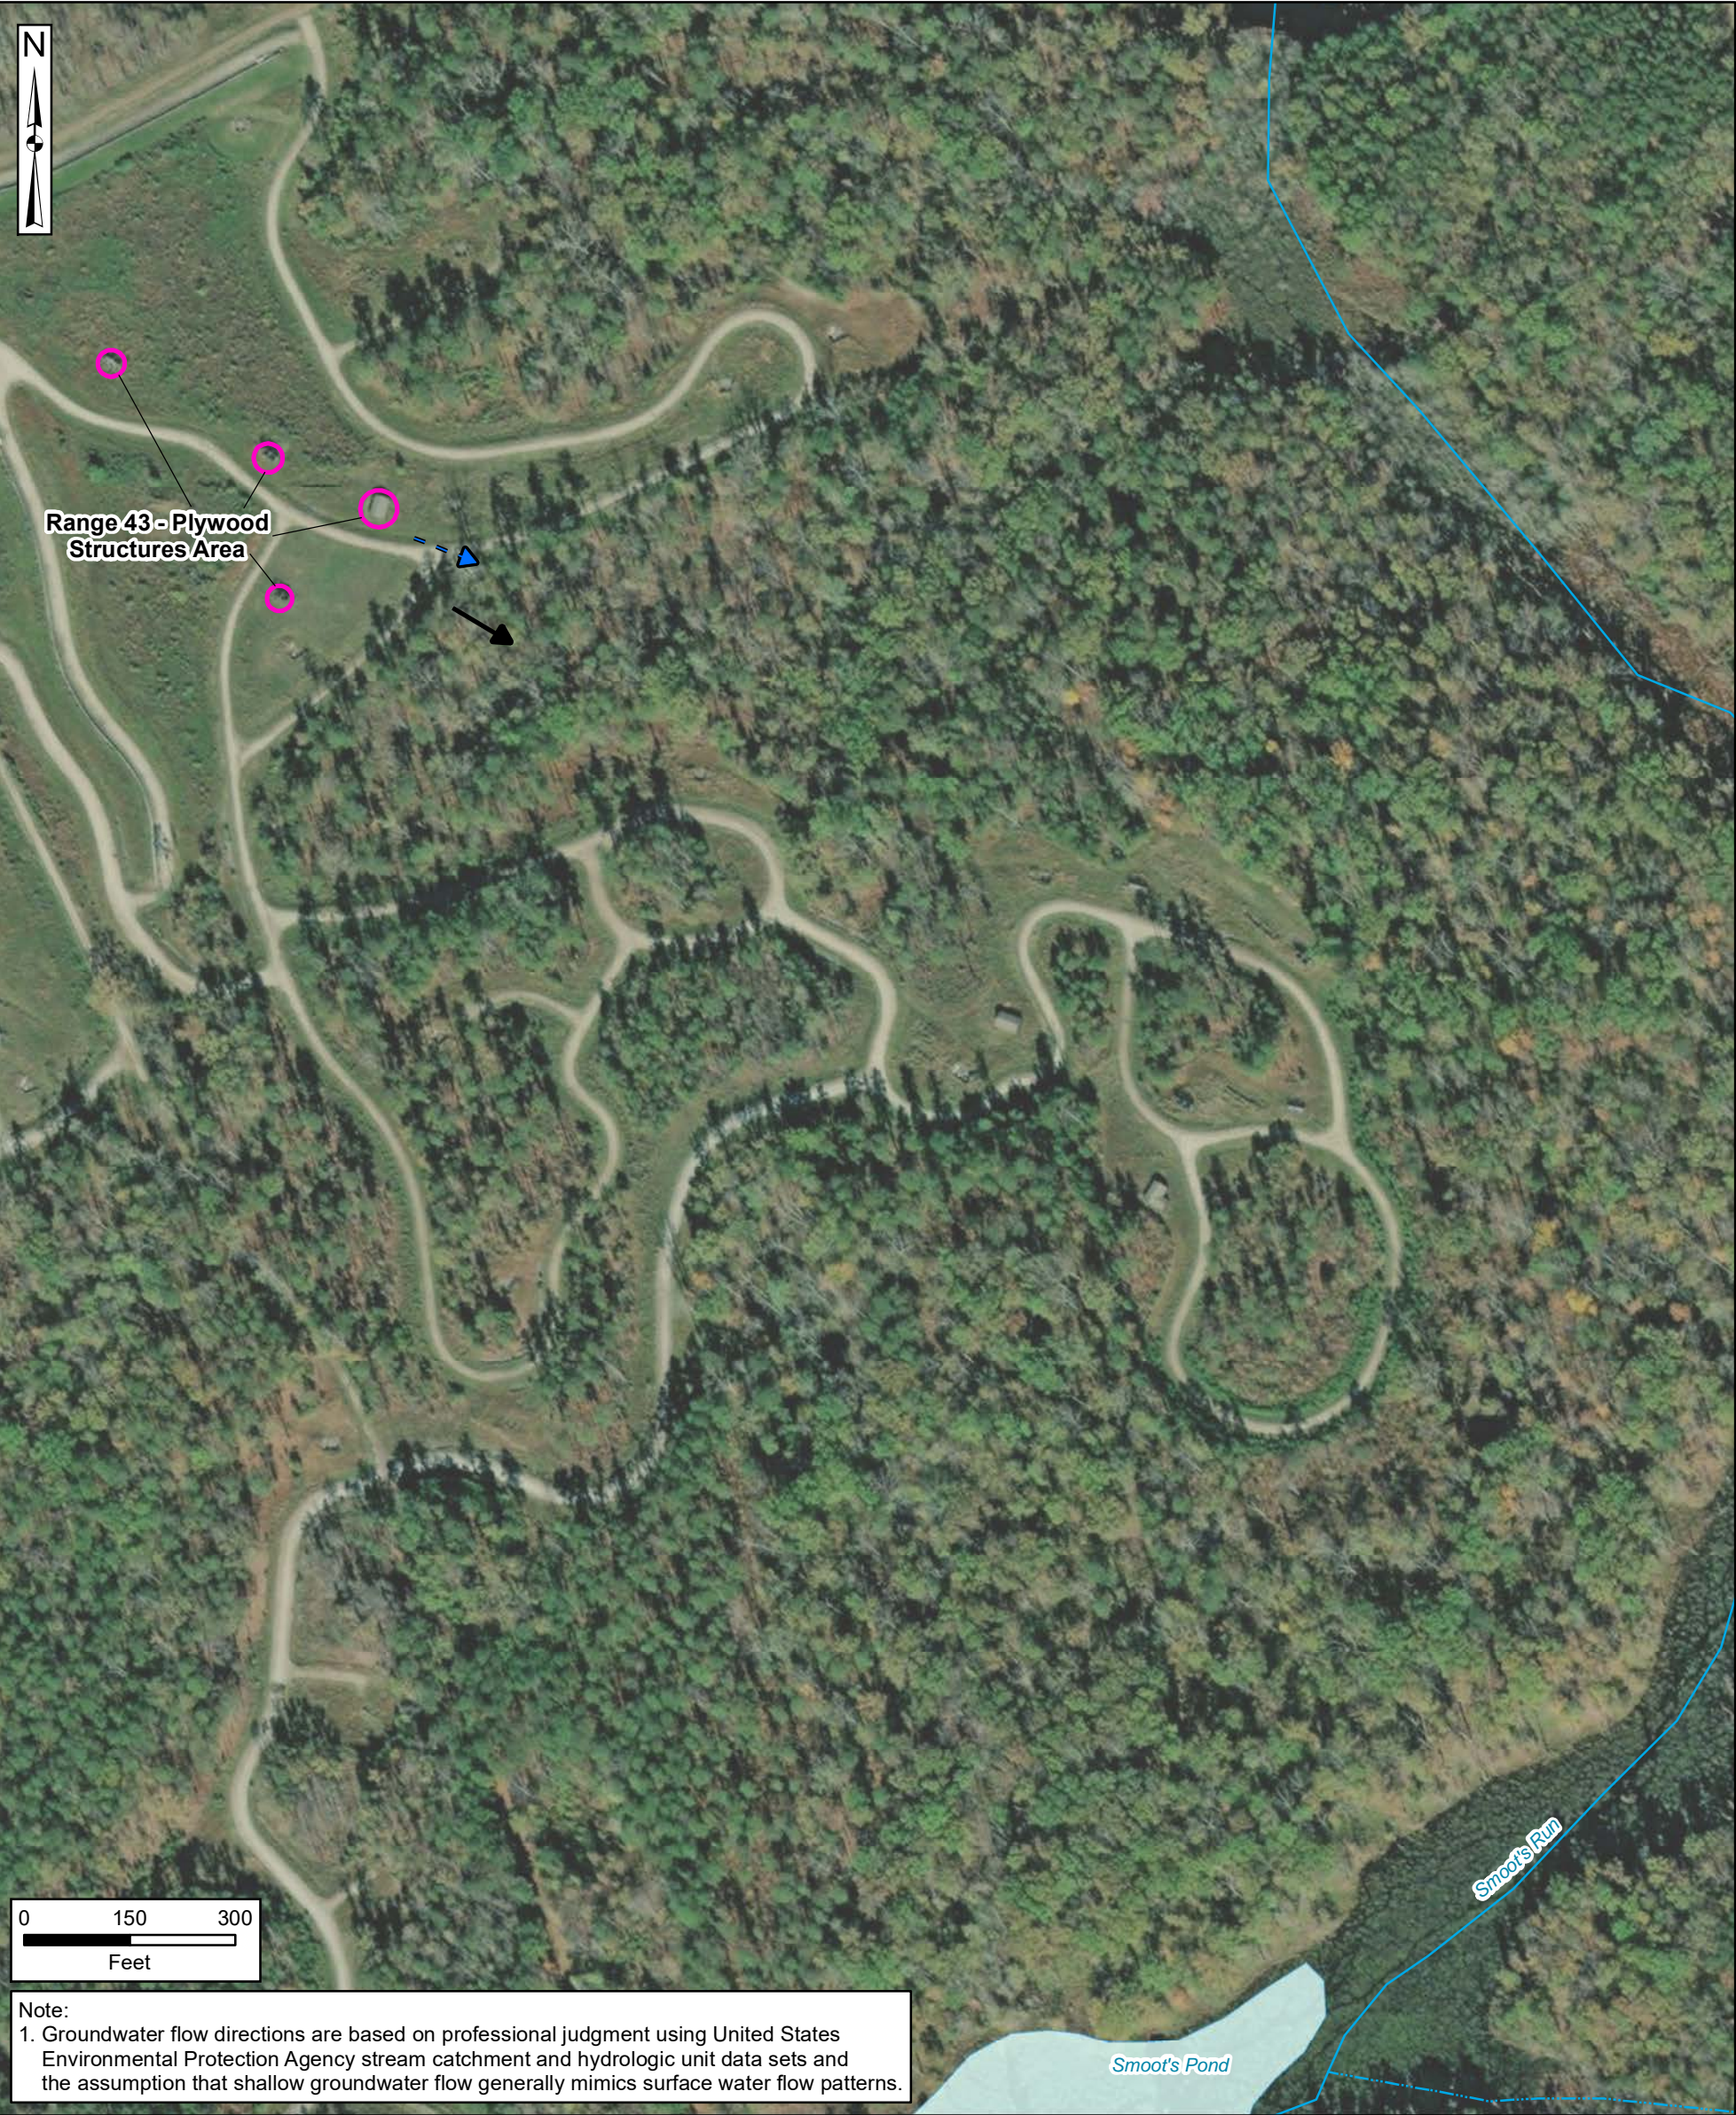
Figure 5-18  
Aerial Photo of  
Range 43 - Plywood Structures Area AOPI

Range 43 – Plywood Structures Area (**Figure 5-18**) is identified as an AOPI following records review, personnel interviews, and site reconnaissance due to the preventive use of AFFF. Range 43 is also operated by the Asymmetric Warfare Group and contains many plywood structures (e.g., small houses, turrets). AFFF has been sprayed around the base of some of these structures for protection before

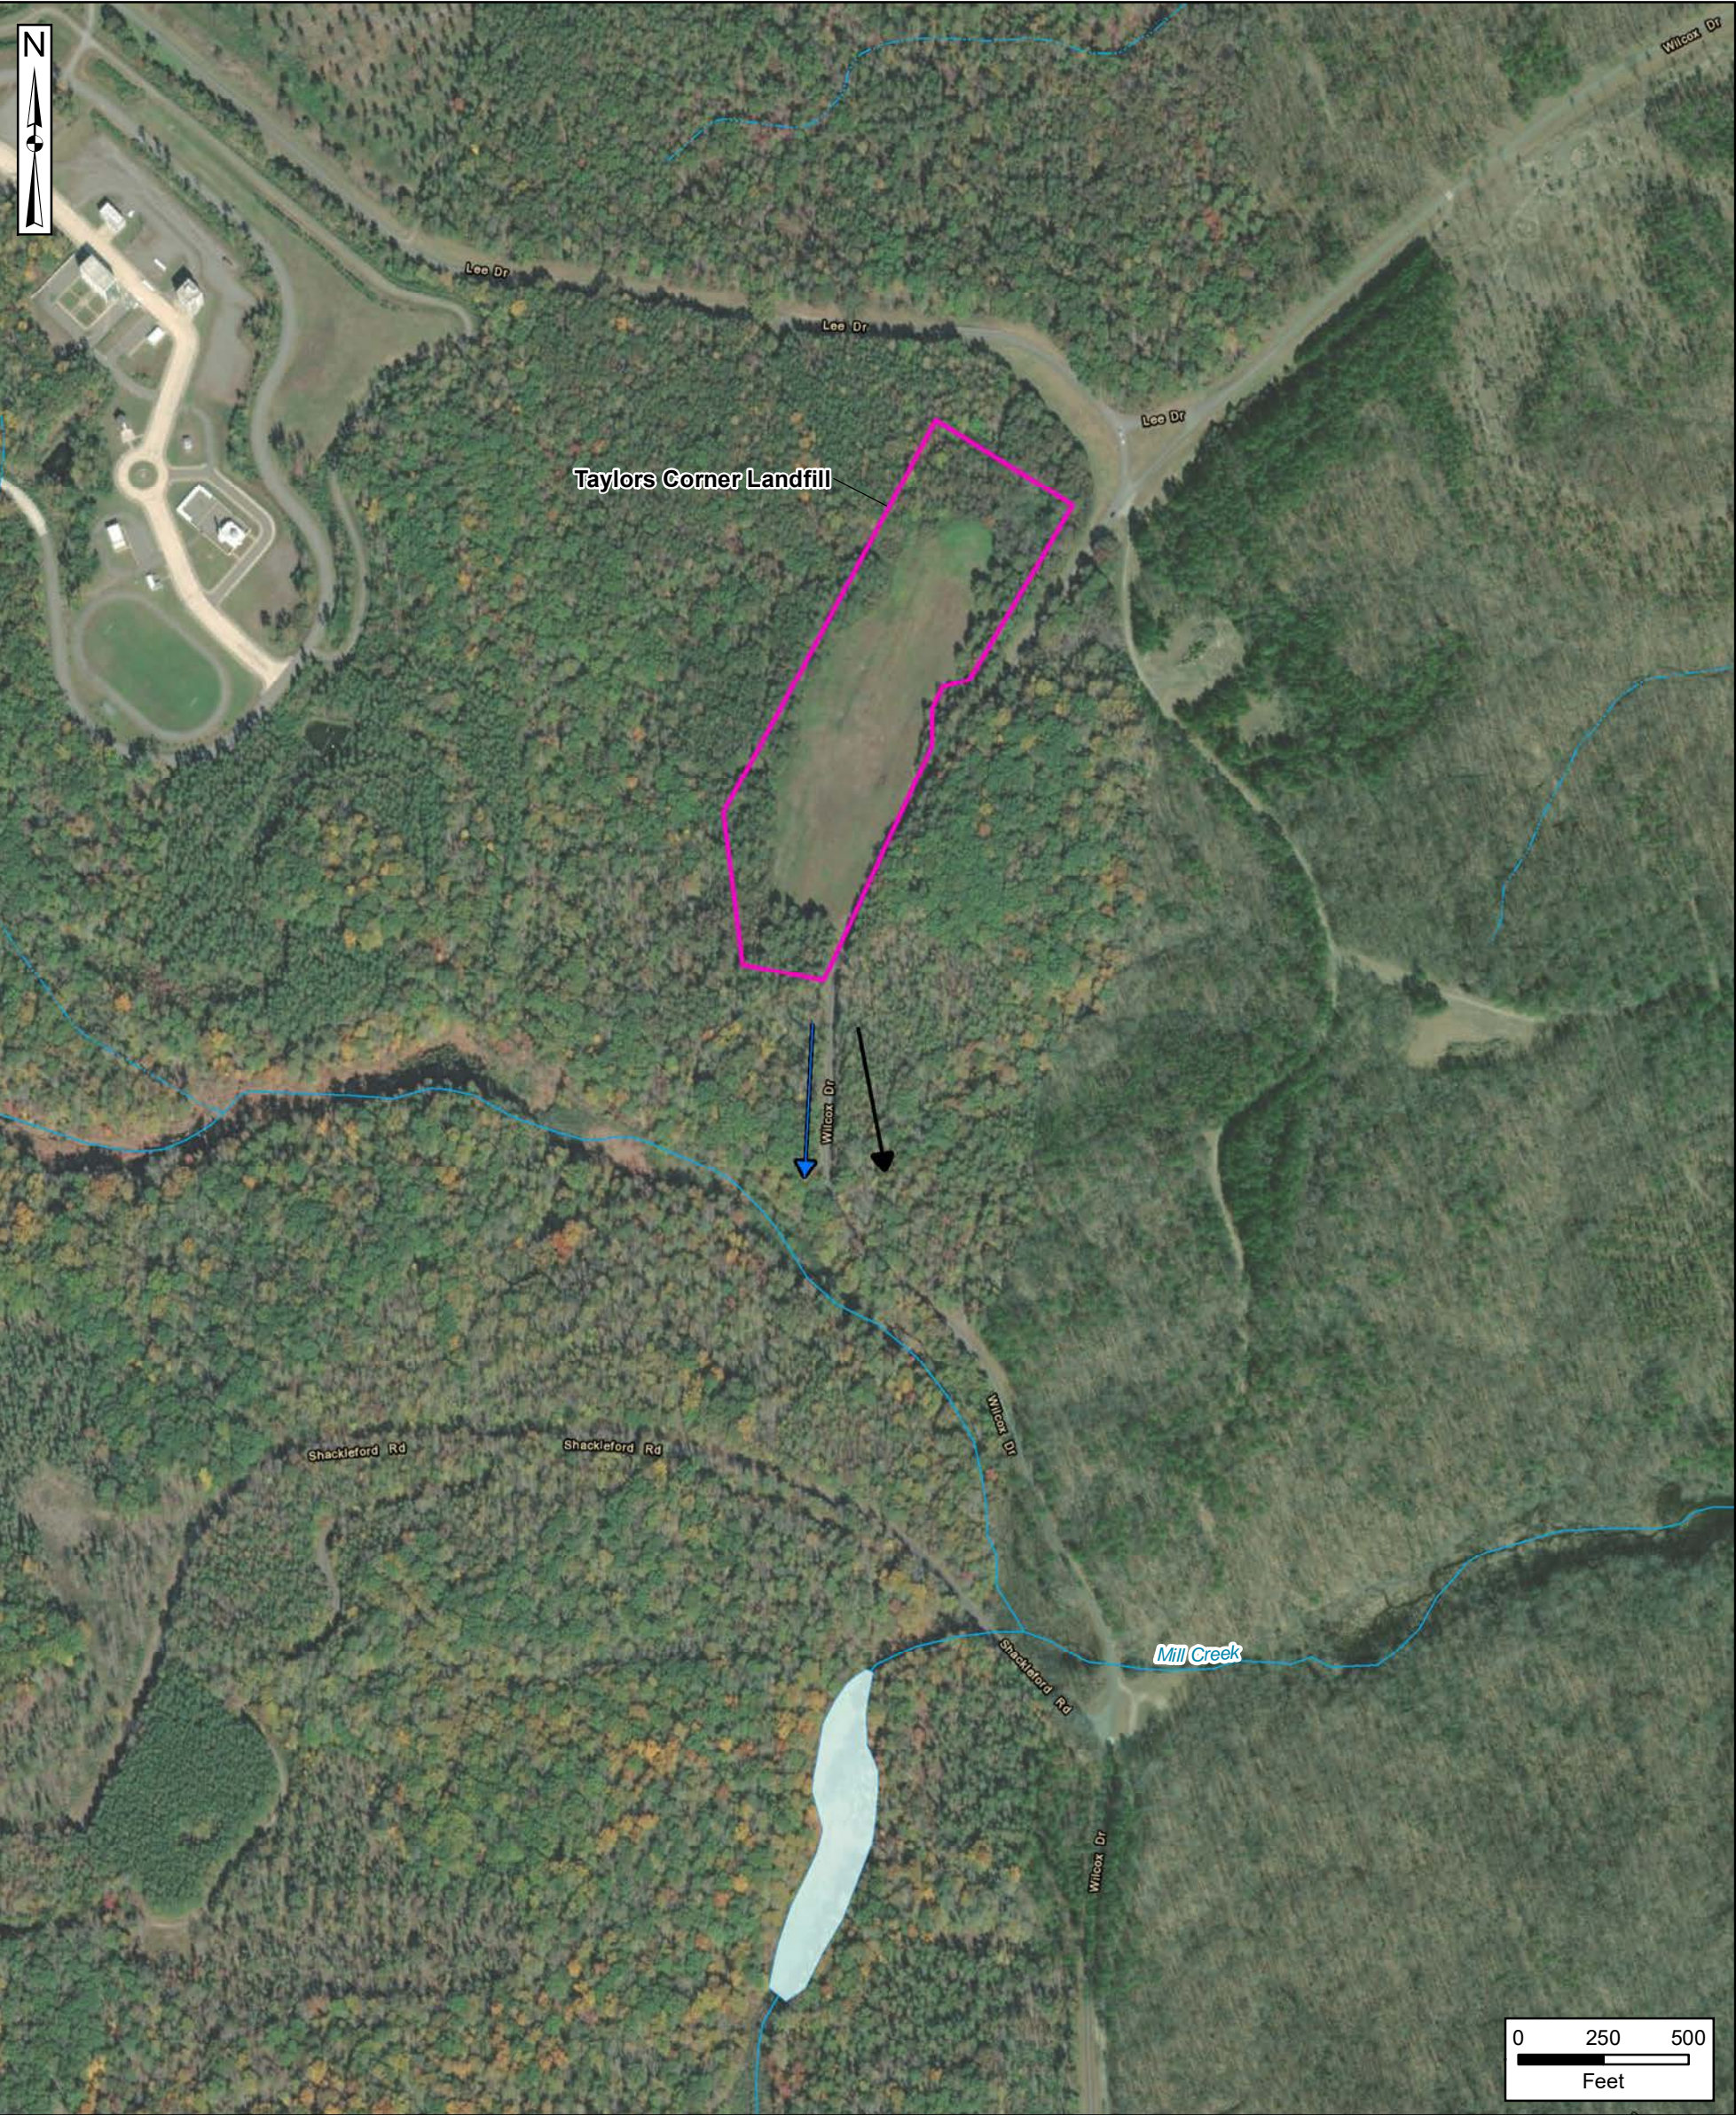
Figure 5-19  
Aerial Photo of  
Taylors Corner Landfill AOPI

During a 1982 Installation Assessment (USATHAMA 1982), the Taylor's Corner Landfill was noted as the primary sanitary landfill for Fort A.P. Hill prior to the Wilcox Landfill. Taylor's Corner Landfill began operation in 1968 and ended prior to 1988. Taylor's Corner Landfill is located to the west of Wilcox Drive in the northern/central portion of the installation. Soil, groundwater, surface water, and sediment were investigated throughout 2001 to 2002 and 2006 to 2007 to evaluate constituents in the environment from landfill operations. Based on the investigation results, no further assessment was required, and the landfill utilizes institutional controls (i.e., signs).

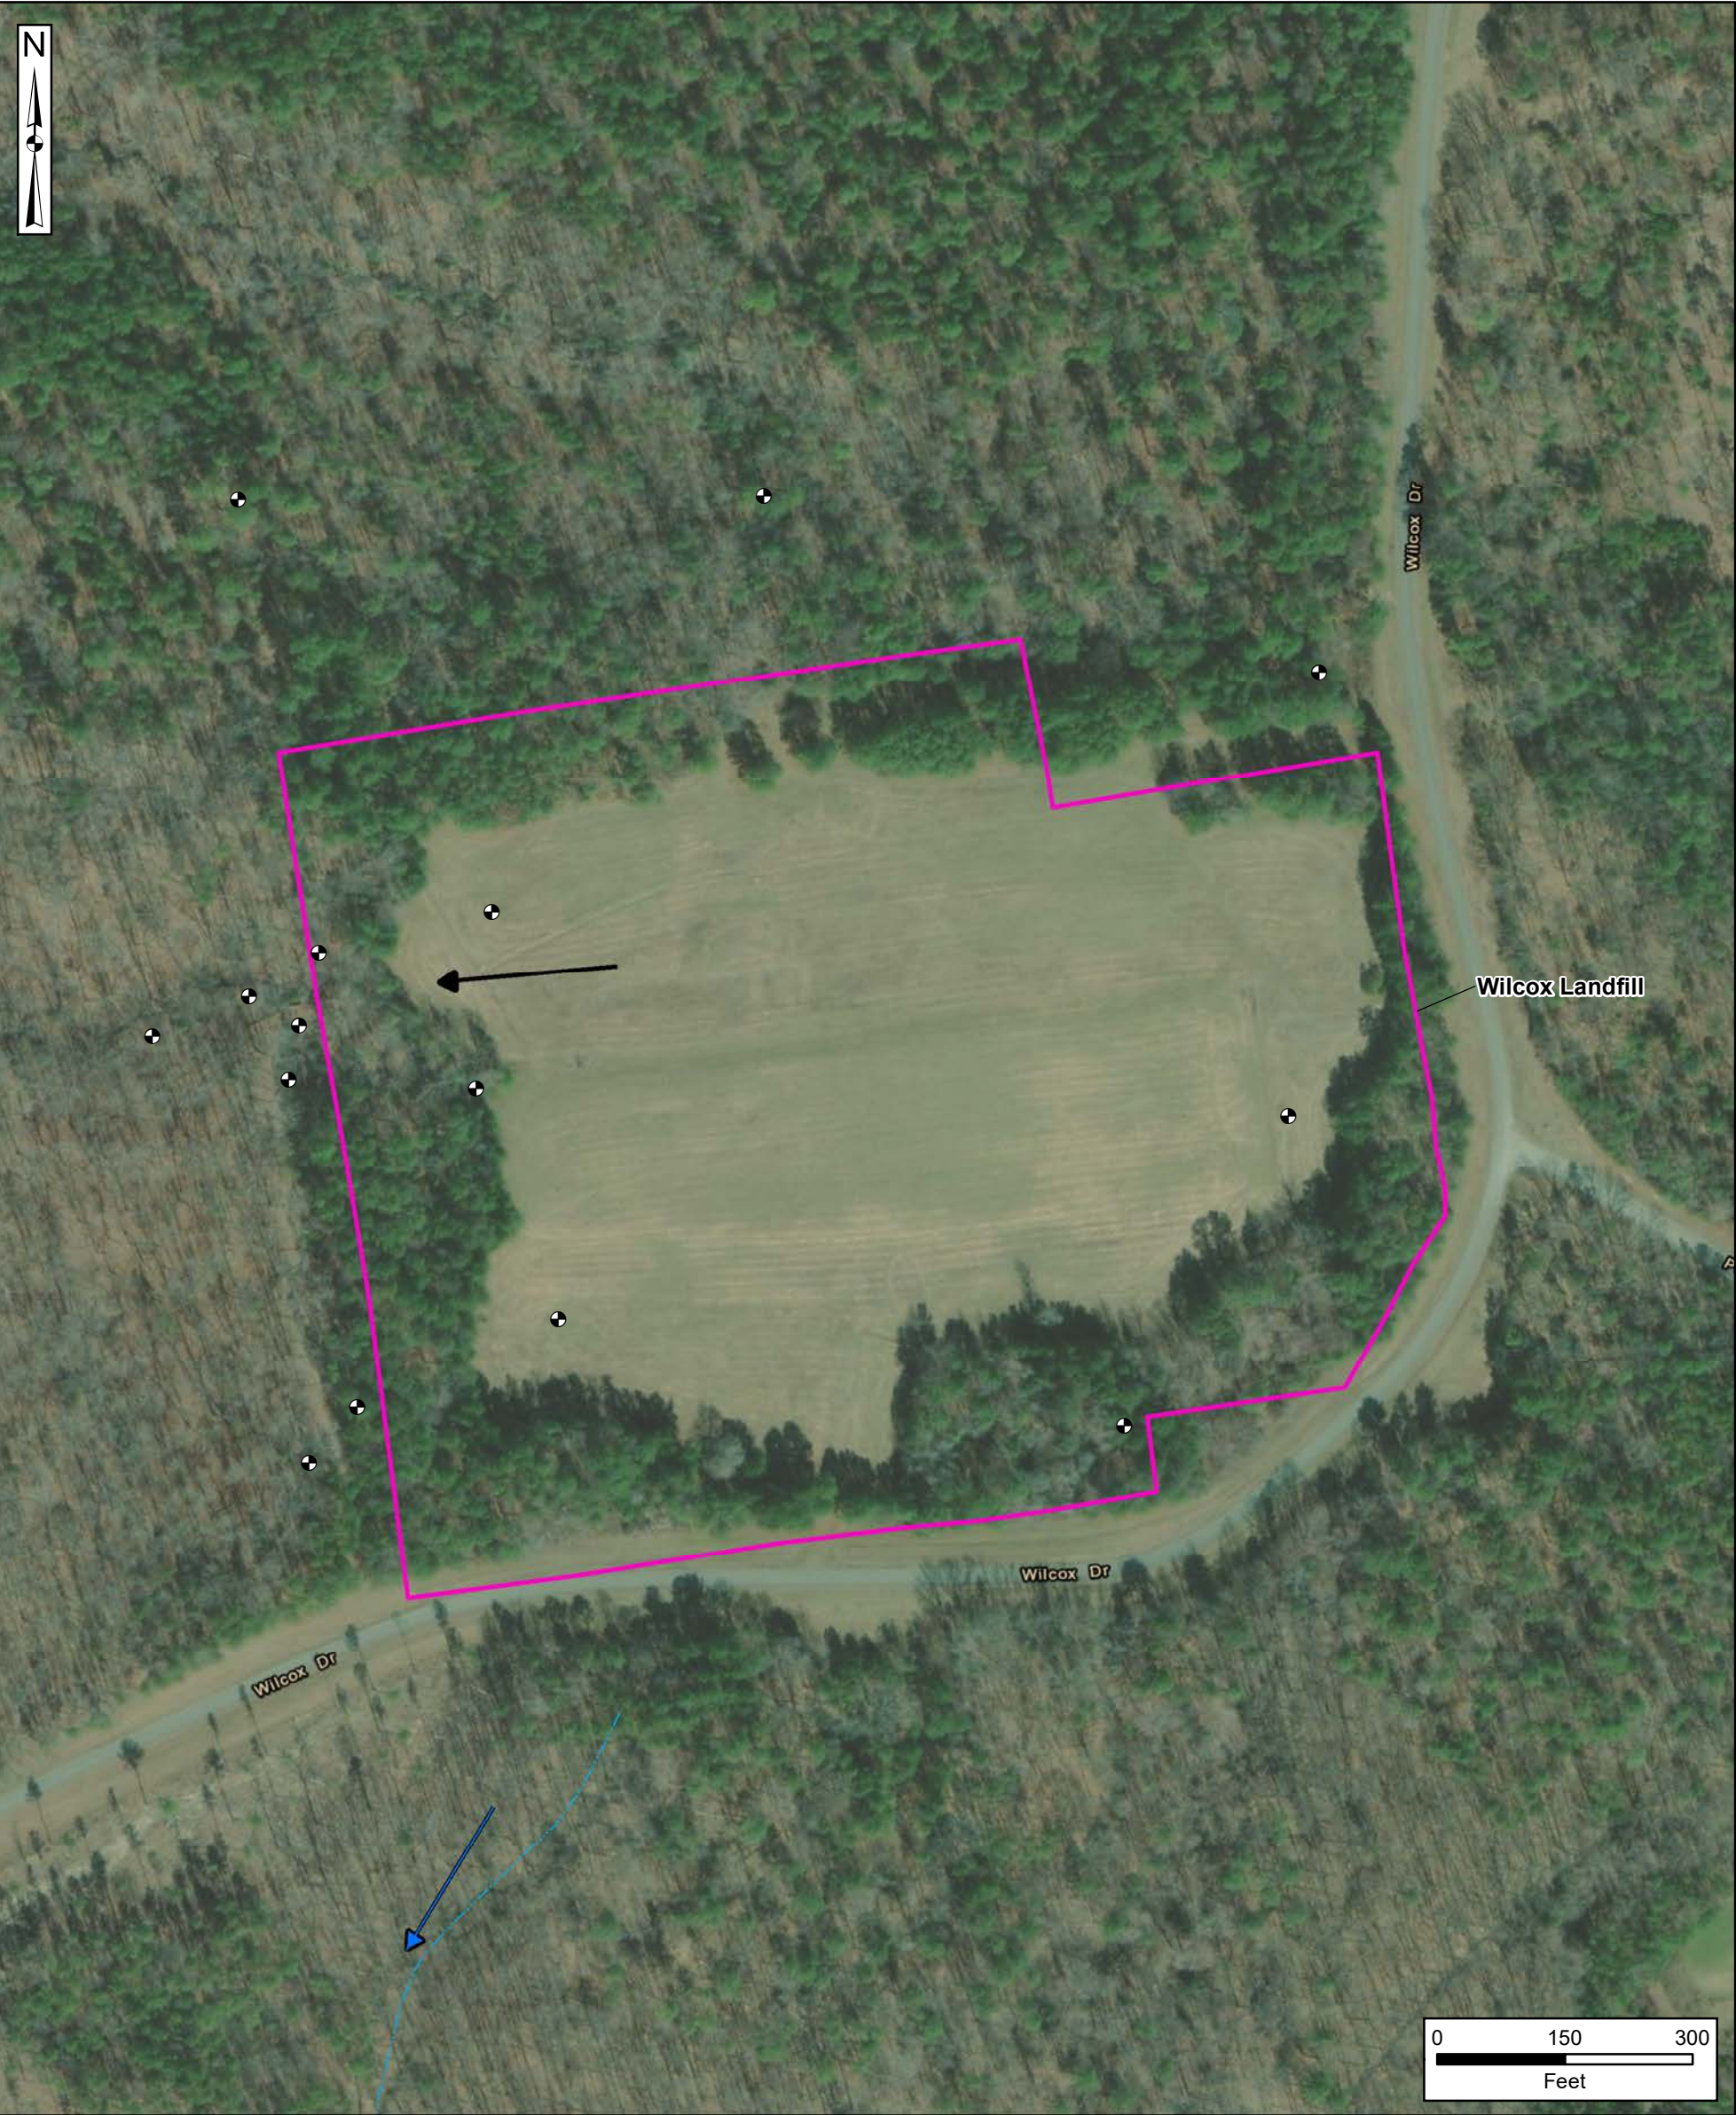
Figure 5-20  
Aerial Photo of  
Wilcox Landfill AOPi

Wilcox Landfill (**Figure 5-20**) is identified as an AOPI following records review due to the possible disposal of PFAS-containing materials. Wilcox Landfill was historically used as a sanitary landfill at Fort A.P. Hill and possibly received sludge wastes from the Old Headquarters WWTP. The Old Headquarters WWTP received sanitary wastes from the Fire Station 8 bay drains, where AFFF drained (**Section 5.2.5**).

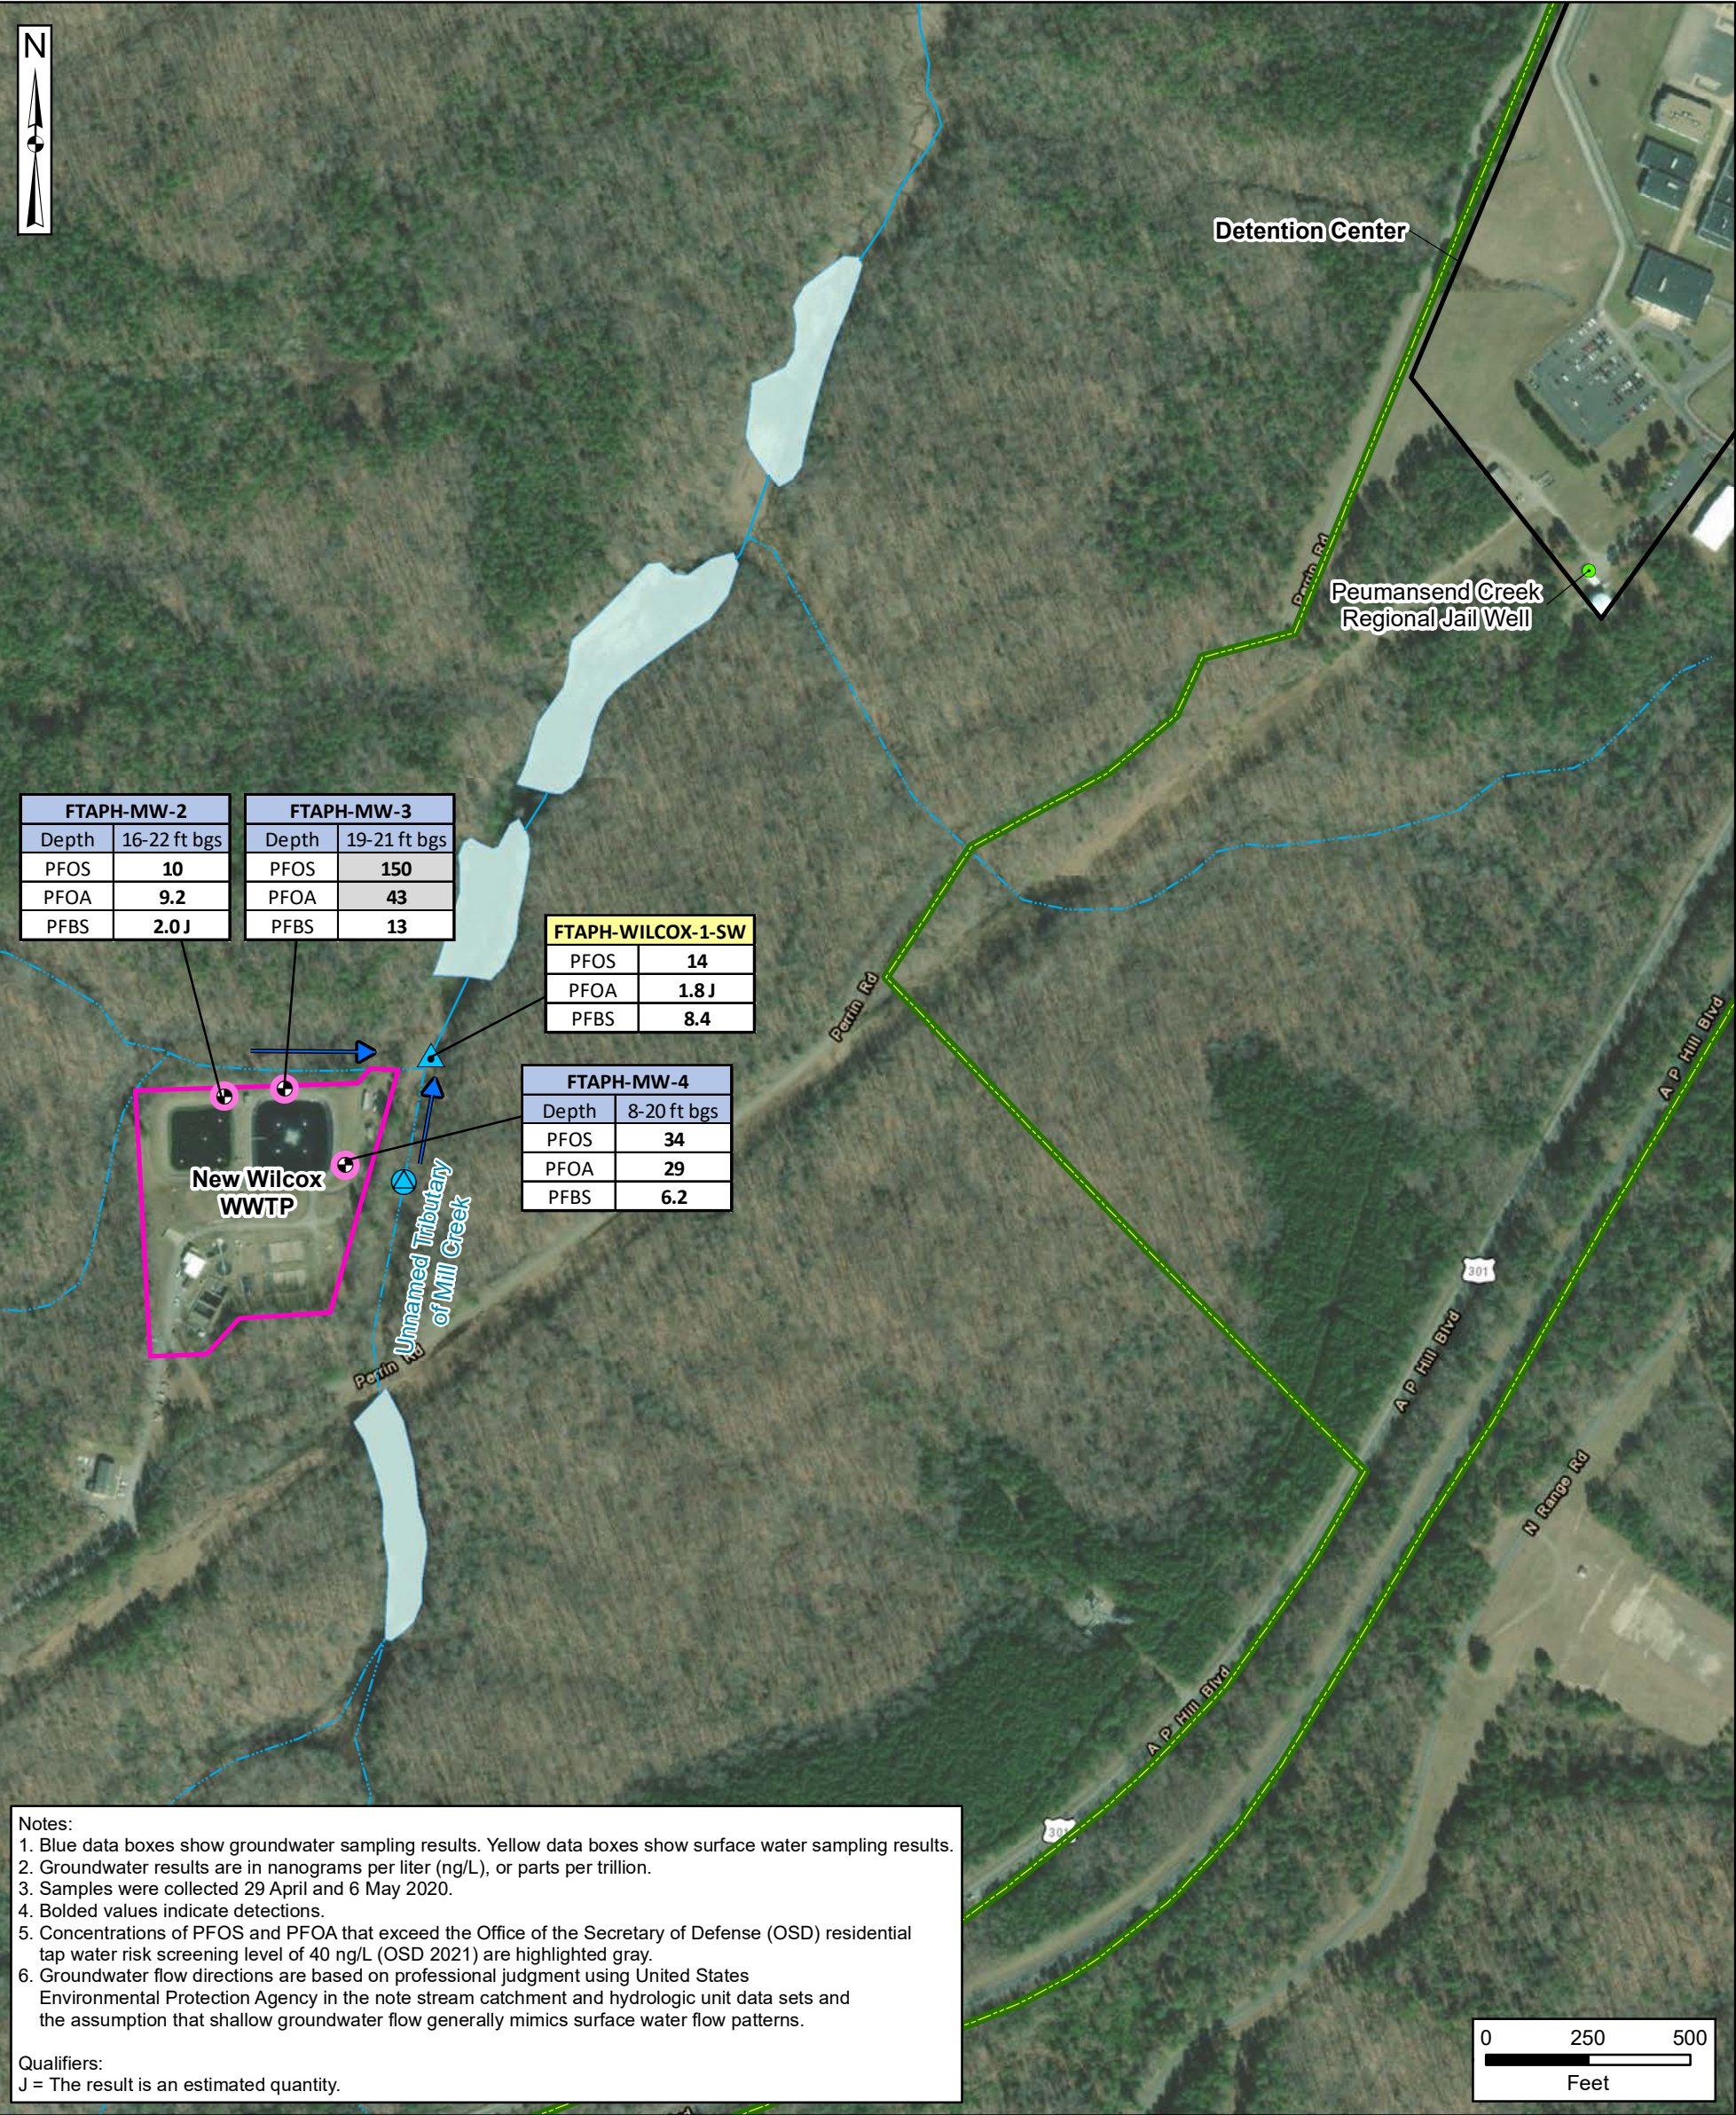
Figure 7-7  
New Wilcox WWTP AOPI  
PFOS, PFOA, and PFBS Analytical Results

Groundwater sampling at New Wilcox WWTP occurred on 6 March 2020. Groundwater samples were collected from monitoring wells MW-2, MW-3, and MW-4, for a total of three groundwater samples. FTAPH-MW-2 and FTAPH-MW-3 are located on the northern edge of the New Wilcox WWTP, and FTAPH-MW-4 is located on the northeastern edge of the New Wilcox WWTP (**Figure 7-7**).

Surface water sampling at New Wilcox WWTP occurred on 29 April 2020. One sample, FTAPH-WILCOX-1-SW, was collected at the confluence of the two streams adjacent to the New Wilcox WWTP to evaluate potential groundwater discharge to surface water (**Figure 7-7**).

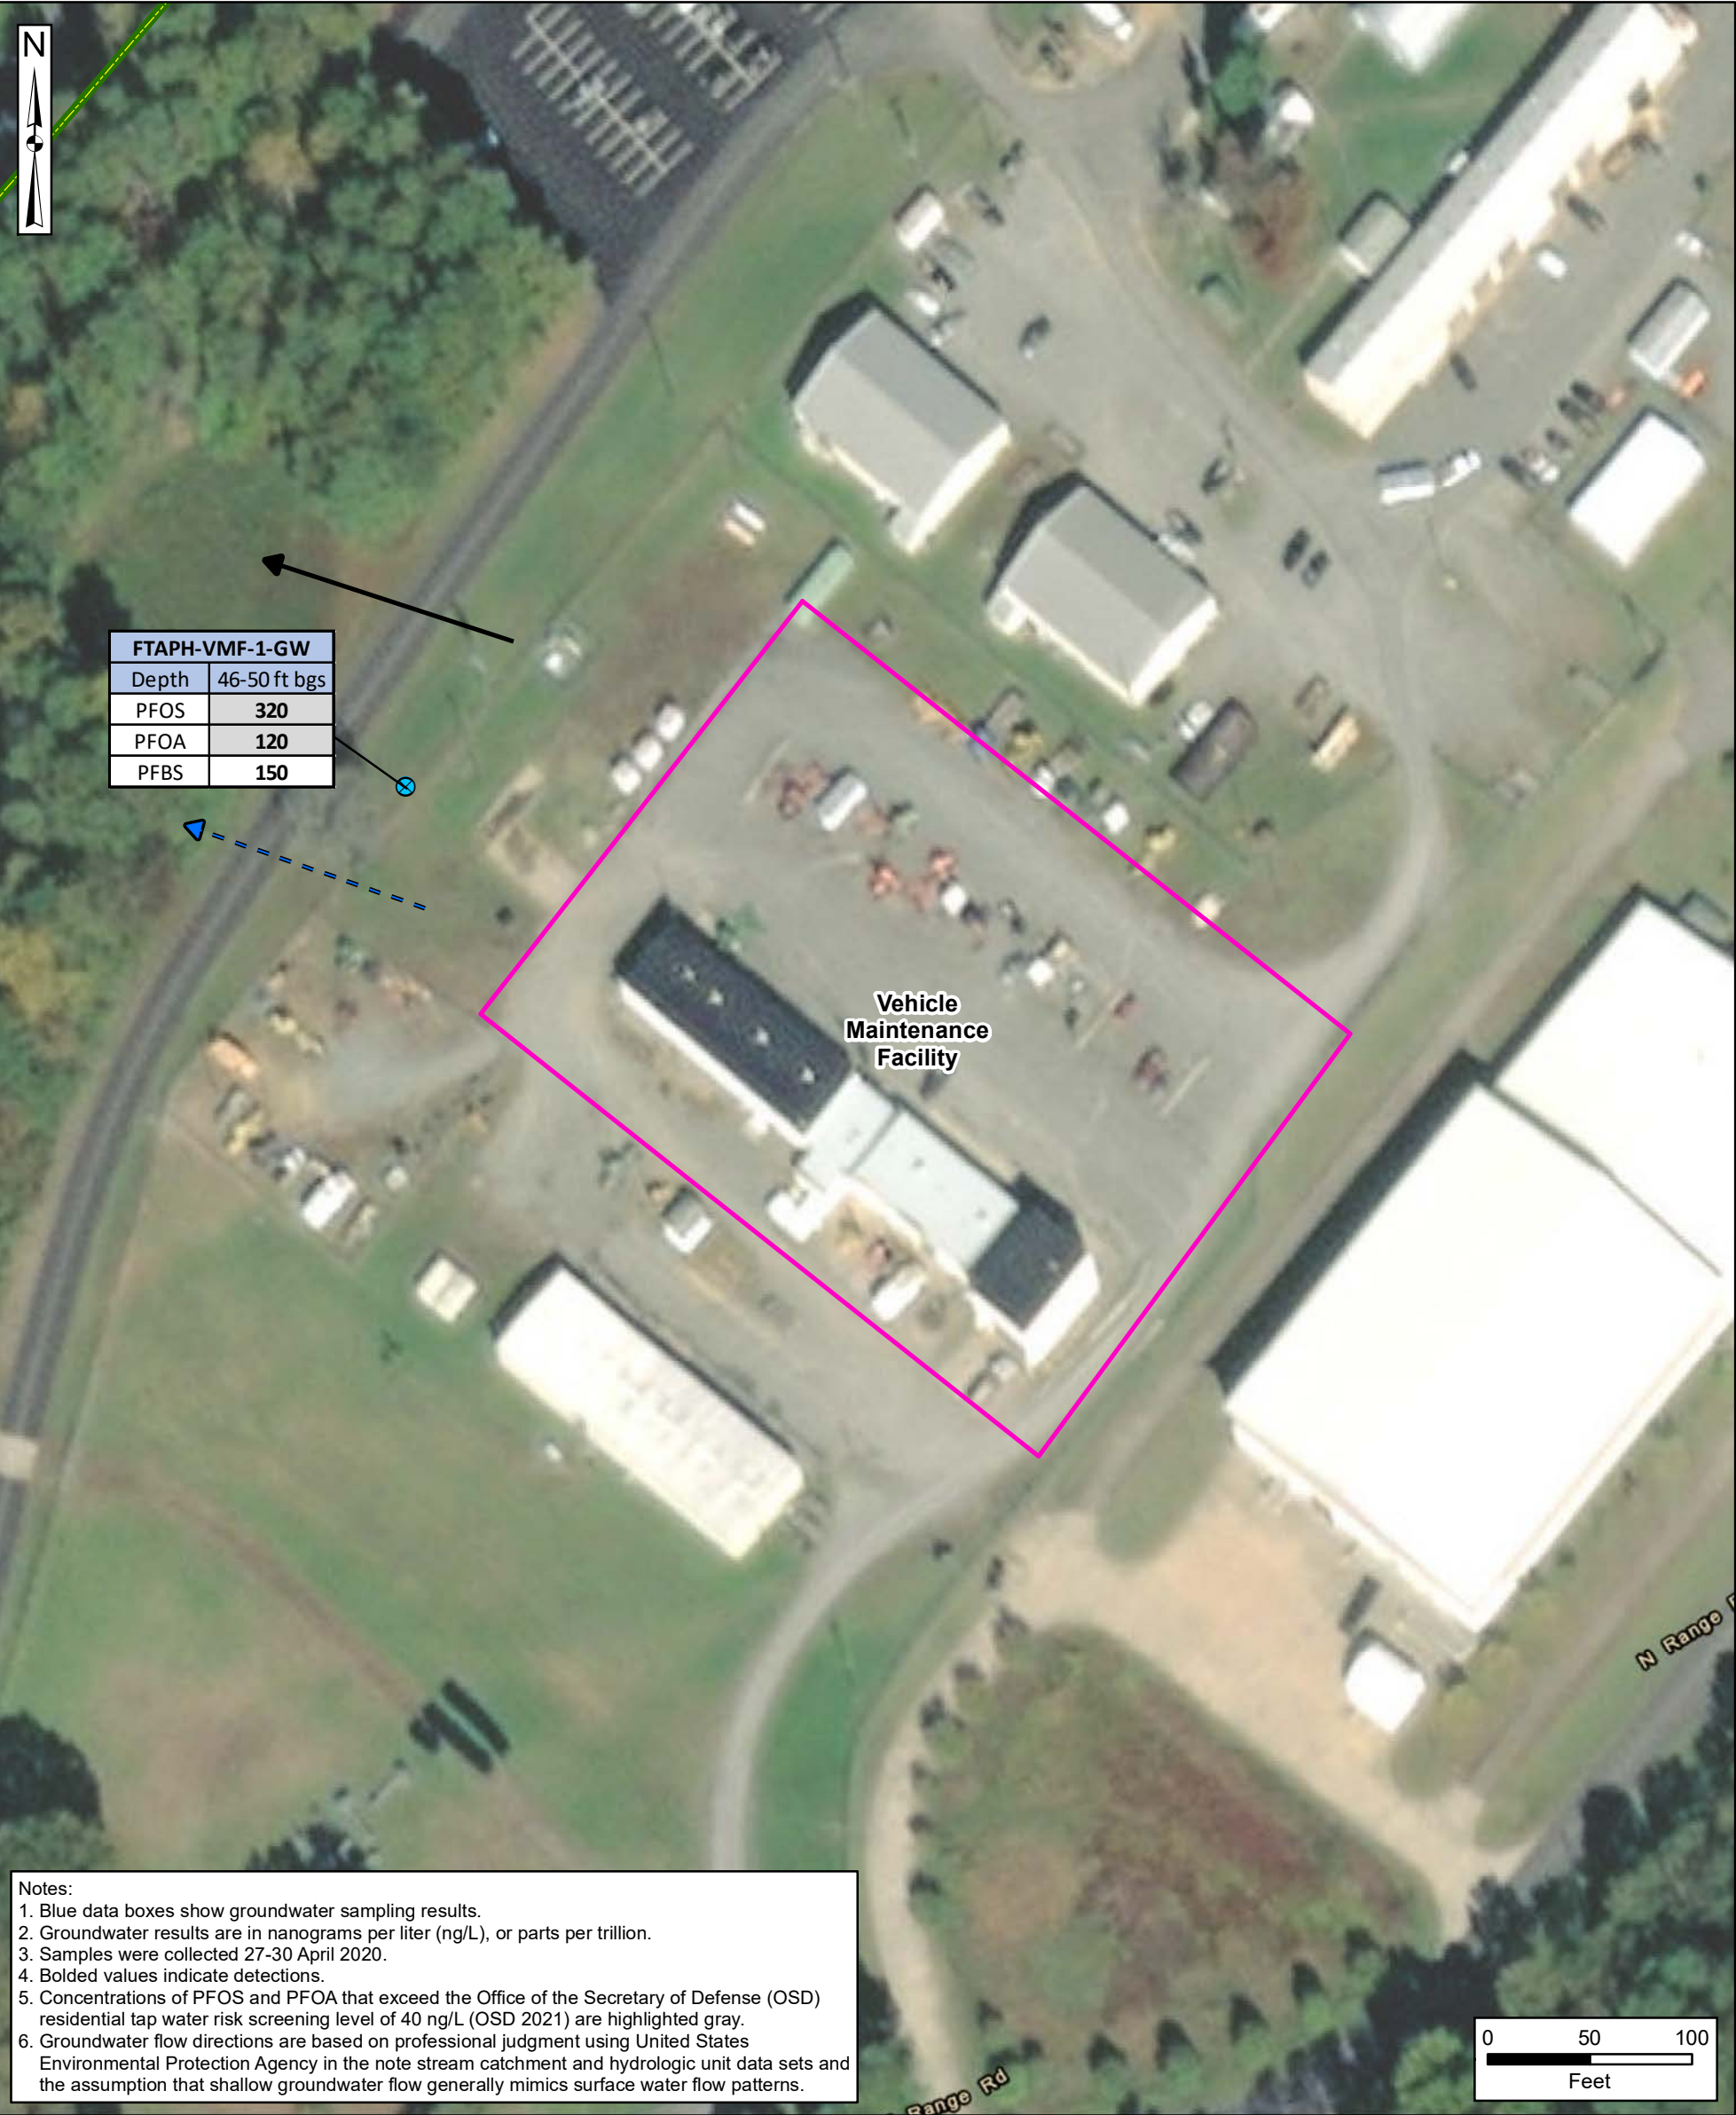
Figure 7-8  
Vehicle Maintenance Facility AOP  
PFOS, PFOA, and PFBS Analytical Results

Groundwater sampling at Vehicle Maintenance Facility occurred on 29 April 2020. One groundwater sample, FTAPH-VMF-1-GW, was collected in the inferred downgradient groundwater flow direction of the possible AFFF spill area (**Figure 7-8**).
