FINAL
Third Five-Year Review Report
Fort Belvoir
Fairfax County, Virginia

**Third Five-Year Review Report
Fort Belvoir
Fairfax County, Virginia**

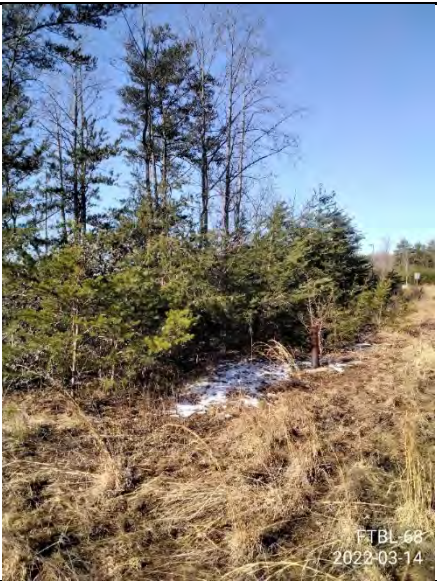
Photo 2	SITE ID: FTBL-68	SITE NAME: M-26 Hydrocarbon Spill Area	DATE: 3/14/2022	DIRECTION: SE	COMMENTS: Fairfax County Parkway interchange present at the site.

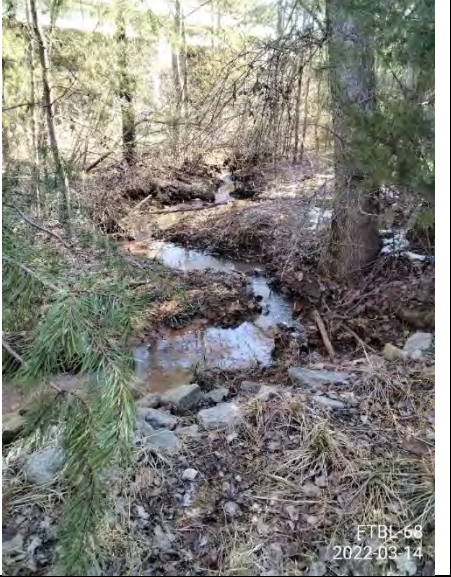
Photo 4	SITE ID: FTBL-68	SITE NAME: M-26 Hydrocarbon Spill Area	DATE: 3/14/2022	DIRECTION: SE	COMMENTS: Small unnamed stream observed at the site.

A photograph showing a small, shallow stream flowing through a wooded area. The water is clear and reflects the surrounding trees. The stream is surrounded by rocks and fallen branches. The trees are mostly bare, suggesting a winter or early spring setting. The photo is taken from a low angle, looking down the stream.
Photo 5	SITE ID: FTBL-69	SITE NAME: M-27 Waste Ordnance Pit at Range 1	DATE: 3/14/2022	DIRECTION: W	COMMENTS: Site access path was well maintained. Moderate vegetation was observed throughout site.

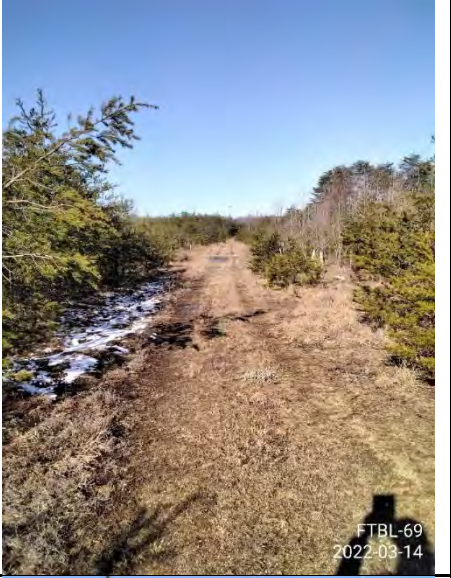
A photograph showing a dirt access path leading through a field of dry grass and trees. The path is well-maintained and leads towards a line of trees in the distance. The sky is clear and blue. The photo is taken from a low angle, looking down the path.

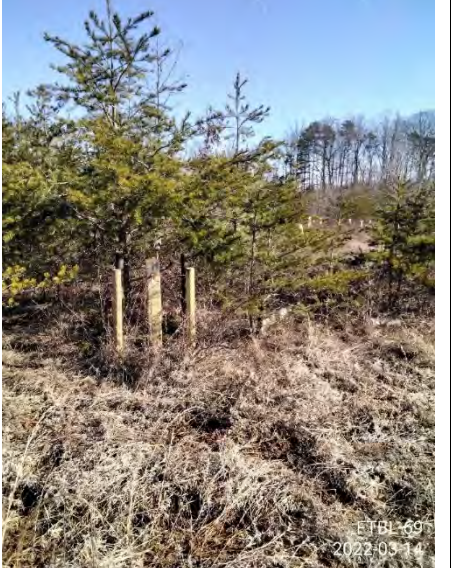
Photo 6	SITE ID: FTBL-69	SITE NAME: M-27 Waste Ordnance Pit at Range 1	DATE: 3/14/2022	DIRECTION: N	COMMENTS: Monitoring wells were secured and appear to be well maintained. Moderate vegetation was observed throughout site.

A photograph showing a dirt access path leading through a field of dry grass and trees. In the foreground, there are several wooden posts or markers, likely for monitoring wells. The path leads towards a line of trees in the distance. The sky is clear and blue. The photo is taken from a low angle, looking down the path.

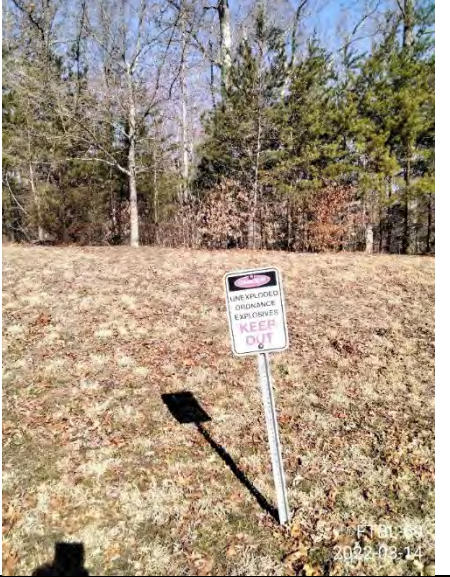
Photo 7	SITE ID: FTBL-69	SITE NAME: M-27 Waste Ordnance Pit at Range 1	DATE: 3/14/2022	DIRECTION: NW	COMMENTS: Signage was posted and well maintained.

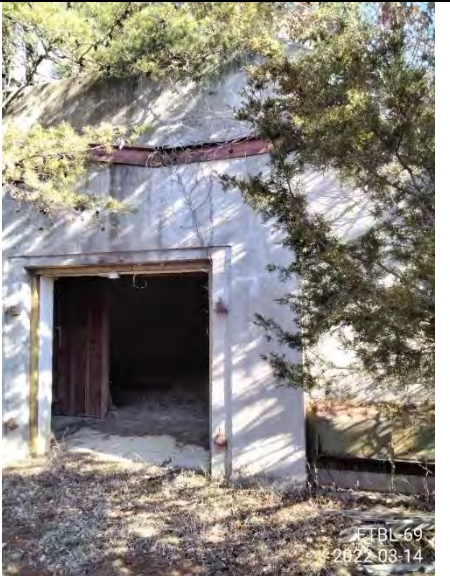
Photo 9	SITE ID: FTBL-69	SITE NAME: M-27 Waste Ordnance Pit at Range 1	DATE: 3/14/2022	DIRECTION: NW	COMMENTS: Concrete debris (traffic barriers) observed at the site.

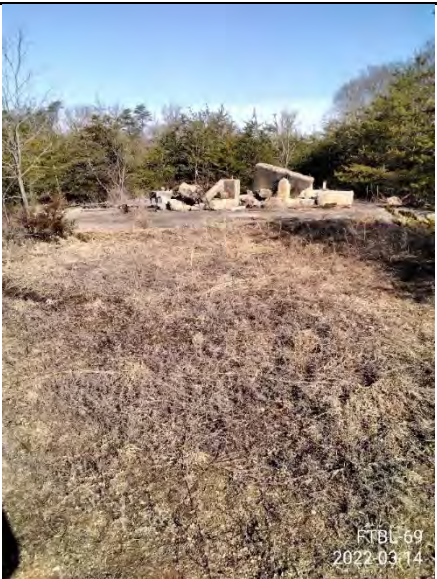
Photo 10	SITE ID: FTBL-69	SITE NAME: M-27 Waste Ordnance Pit at Range 1	DATE: 3/14/2022	DIRECTION: NW	COMMENTS: Concrete pad and debris observed at the site.

A photograph showing a concrete pad and debris in a field. The pad is surrounded by dry grass and some trees in the background. The text "FTBL-69 2022-03-14" is visible in the bottom right corner of the photo.
Photo 11	SITE ID: FTBL-001-R-02	SITE NAME: Infiltration Course	DATE: 3/14/2022	DIRECTION: NW	COMMENTS: Warning sign at access path to site. Access path is a recreational trail accessible to the public. Signage and access path were well maintained.

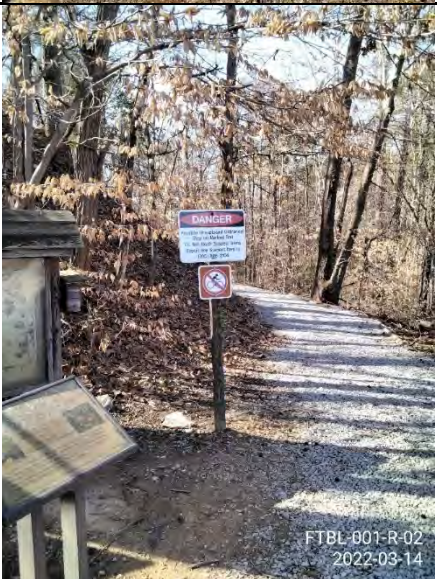
A photograph of a warning sign at an access path. The sign is a "DANGER" sign with text about a deep excavation. The path is a gravel trail leading into a wooded area. The text "FTBL-001-R-02 2022-03-14" is visible in the bottom right corner of the photo.
Photo 12	SITE ID: FTBL-001-R-02	SITE NAME: Infiltration Course	DATE: 3/14/2022	DIRECTION: W	COMMENTS: Heavy vegetation observed at the site. No signs of soil disturbing activities were observed.

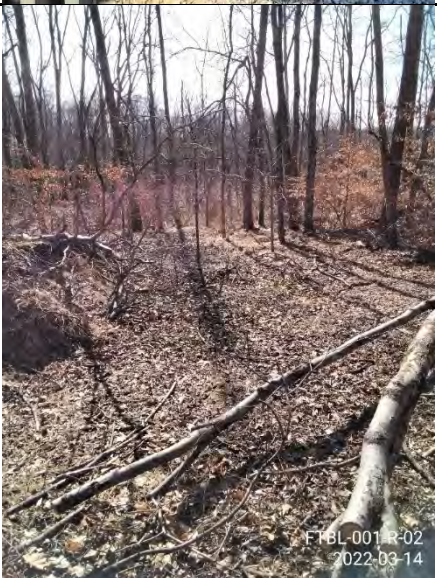
A photograph showing heavy vegetation in a wooded area. The ground is covered with dry leaves and branches. The text "FTBL-001-R-02 2022-03-14" is visible in the bottom right corner of the photo.

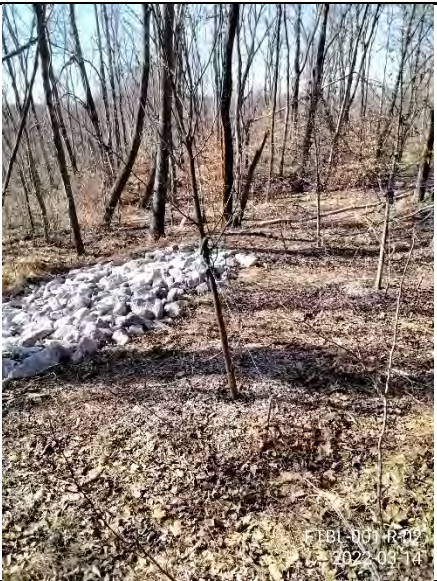
Photo 13	SITE ID: FTBL-001-R-02	SITE NAME: Combat Range Complex	DATE: 3/14/2022	DIRECTION: W	COMMENTS: Trees mitigation on site and riprap installed on side slope.

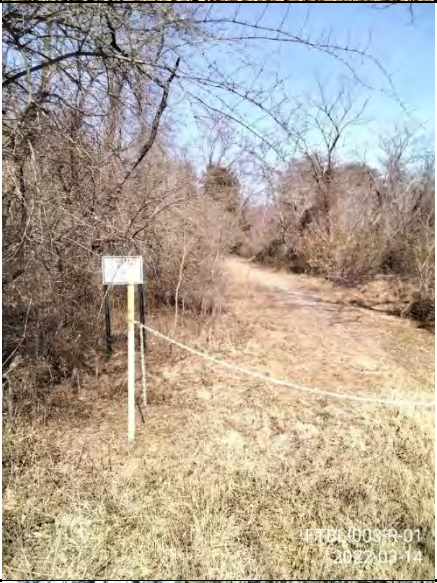
Photo 14	SITE ID: FTBL-003-R-01	SITE NAME: Combat Range Complex	DATE: 3/14/2022	DIRECTION: SE	COMMENTS: Warning signage posted at access point to site from unnamed road. Vehicle access was restricted by a secured chain.

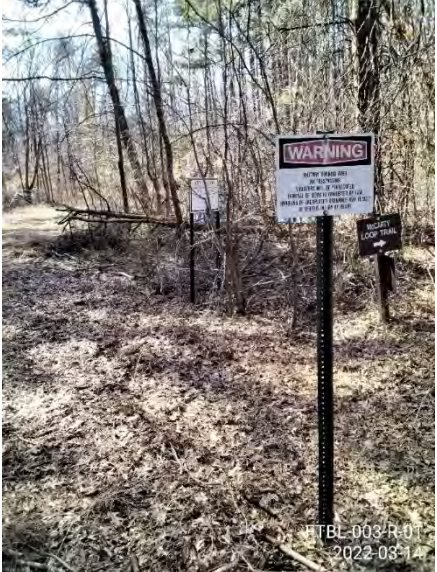
Photo 15	SITE ID: FTBL-003-R-01	SITE NAME: Combat Range Complex	DATE: 3/14/2022	DIRECTION: S	COMMENTS: Warning signage was posted and well maintained at the site. Signs for recreational trails were also observed.

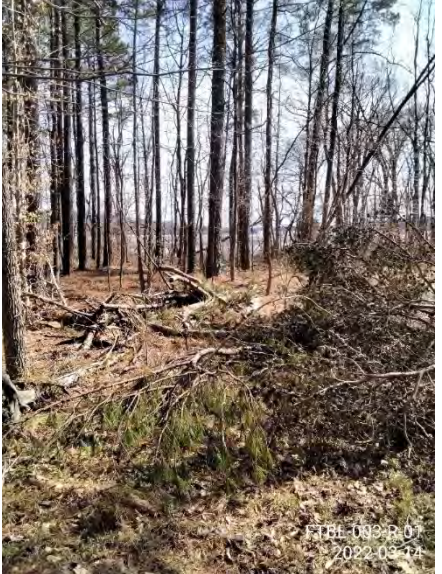
Photo 16	SITE ID: FTBL-003-R-01	SITE NAME: Combat Range Complex	DATE: 3/14/2022	DIRECTION: S	COMMENTS: Heavy vegetation observed at the site.

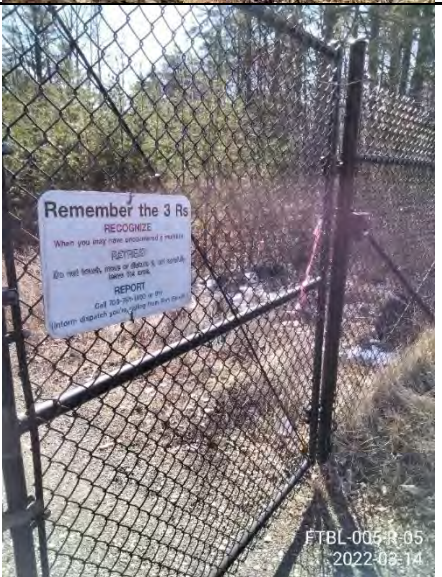
Photo 17	SITE ID: FTBL-005-R-05 & FTBL-005-R-08	SITE NAME: Inert Mine Testing Area at Range 5 & Range 5 (Building 5091)	DATE: 3/14/2022	DIRECTION: E	COMMENTS: Access gate off Rolling Road was secured and well maintained. Educational signage was posted on the gate.

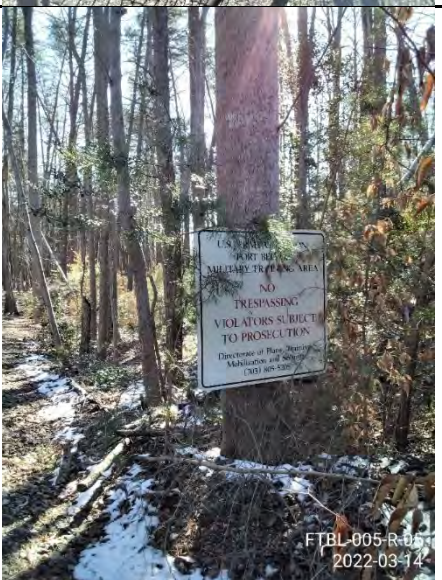
Photo 18	SITE ID: FTBL-005-R-05 & FTBL-005-R-08	SITE NAME: Inert Mine Testing Area at Range 5 & Range 5 (Building 5091)	DATE: 3/14/2022	DIRECTION: E	COMMENTS: No Trespassing sign posted on tree near site access gate. Site is heavily vegetated.

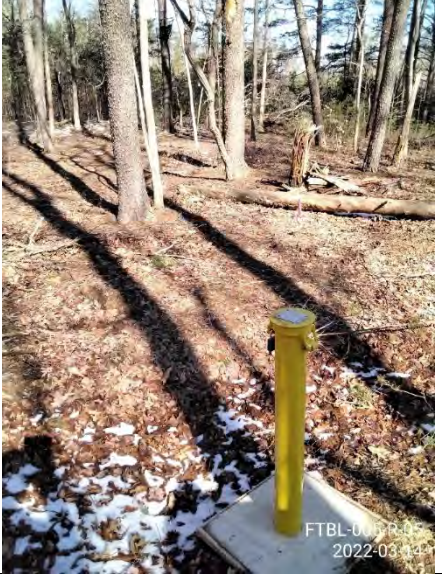
Photo 19	SITE ID: FTBL-005-R-05 & FTBL-005-R-08	SITE NAME: Inert Mine Testing Area at Range 5 & Range 5 (Building 5091)	DATE: 3/14/2022	DIRECTION: W	COMMENTS: Monitoring wells were secured and appear to be well maintained.

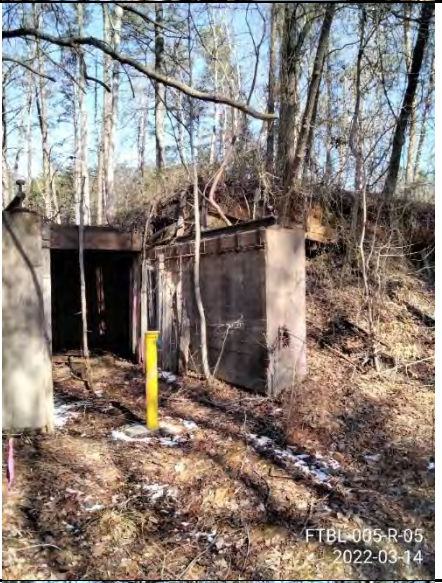
<p>FTBL-005-R-05 2022-03-14</p>
Photo 20	SITE ID: FTBL-005-R-05 & FTBL-005-R-08	SITE NAME: Inert Mine Testing Area at Range 5 & Range 5 (Building 5091)	DATE: 3/14/2022	DIRECTION: NW	COMMENTS: Monitoring well M32-MW02 adjacent to the former bunker (Building 2091).

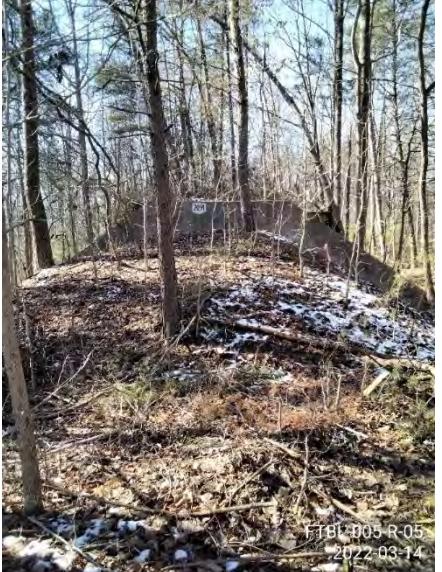
<p>FTBL-005-R-05 2022-03-14</p>
Photo 21	SITE ID: FTBL-005-R-05 & FTBL-005-R-08	SITE NAME: Inert Mine Testing Area at Range 5 & Range 5 (Building 5091)	DATE: 3/14/2022	DIRECTION: SW	COMMENTS: Heavy vegetation observed at the site near the former bunker (Building 2091).

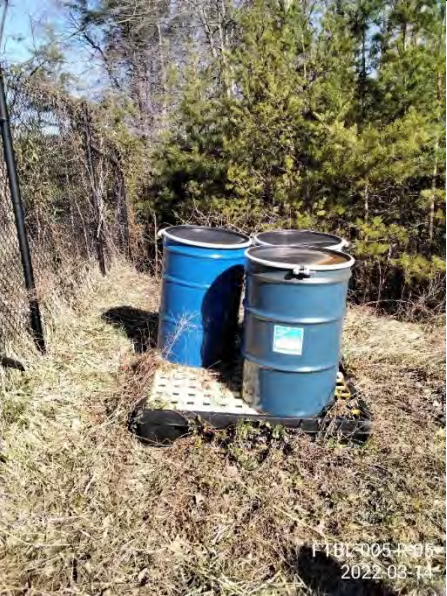
Photo 22	SITE ID: FTBL-005-R-05 & FTBL-005-R-08	SITE NAME: Inert Mine Testing Area at Range 5 & Range 5 (Building 5091)	DATE: 3/14/2022	DIRECTION: N	COMMENTS: Investigation-derived waste (IDW) drums and secondary containment pad associated with groundwater monitoring activities at the site.

A photograph showing two blue drums placed on a white secondary containment pad in a wooded area. The drums are surrounded by dry grass and trees. A timestamp in the bottom right corner reads 'FTBL-005-R-05 2022-03-14'.
Photo 23	SITE ID: FTBL-005-R-05 & FTBL-005-R-08	SITE NAME: Inert Mine Testing Area at Range 5 & Range 5 (Building 5091)	DATE: 3/14/2022	DIRECTION: SE	COMMENTS: Unlabeled drum observed near the former bunker (Building 2091).

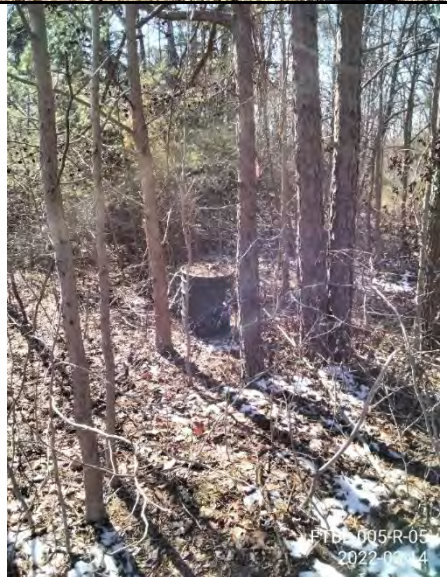
A photograph of an unlabeled drum in a wooded area. The drum is dark and partially obscured by trees and snow on the ground. A timestamp in the bottom right corner reads 'FTBL-005-R-05 2022-03-14'.

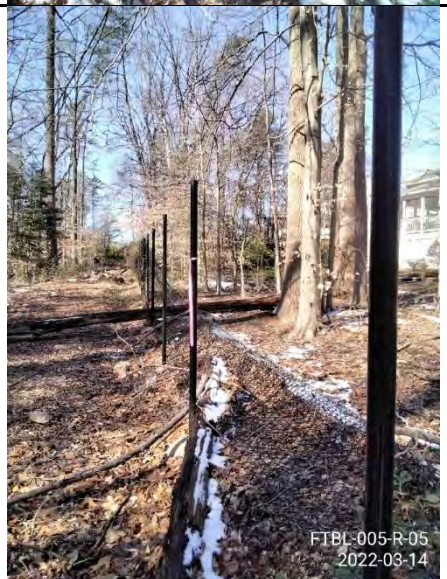
Photo 24	SITE ID: FTBL-005-R-05 & FTBL-005-R-08	SITE NAME: Inert Mine Testing Area at Range 5 & Range 5 (Building 5091)	DATE: 3/14/2022	DIRECTION: SW	COMMENTS: Fort Belvoir North Area northern installation boundary fencing damaged by fallen trees near the site.

A photograph showing a section of boundary fencing that has been damaged by fallen trees. The fence is made of metal posts and wire, and the surrounding area is wooded with snow on the ground. A timestamp in the bottom right corner reads 'FTBL-005-R-05 2022-03-14'.

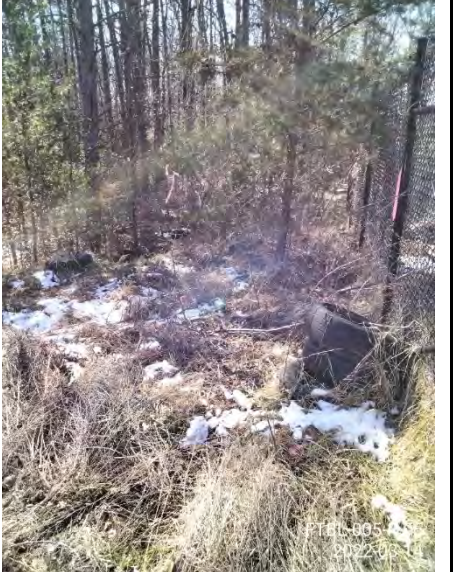
Photo 25	SITE ID: FTBL-005-R-05 & FTBL-005-R-08	SITE NAME: Inert Mine Testing Area at Range 5 & Range 5 (Building 5091)	DATE: 3/14/2022	DIRECTION: S	COMMENTS: Waste tires observed near site access gate indicative of illegal dumping activities.

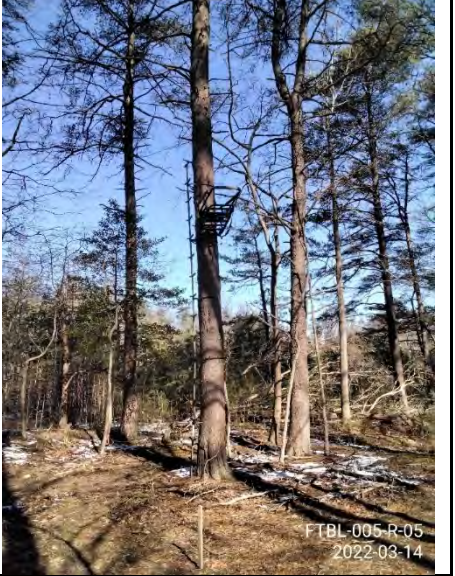
FTBL-005-R-05 2022-03-14
Photo 26	SITE ID: FTBL-005-R-05 & FTBL-005-R-08	SITE NAME: Inert Mine Testing Area at Range 5 & Range 5 (Building 5091)	DATE: 3/14/2022	DIRECTION: E	COMMENTS: Tree stand indicative of recreational use of the site.

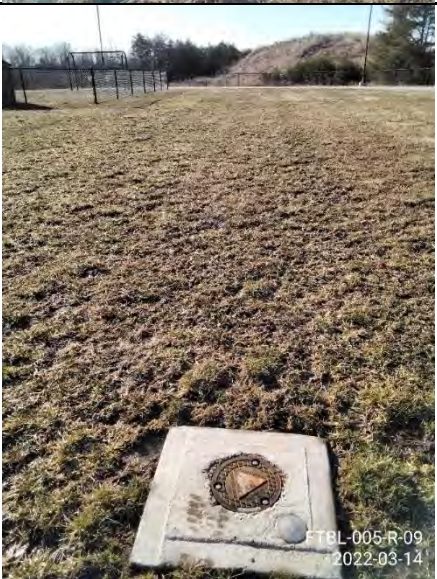
A photograph of a flush-mount monitoring well, which is a concrete square with a circular metal cover, situated in a field of dry grass. A fence and trees are visible in the background. A timestamp in the bottom right corner reads "FTBL-005-R-09 2022-03-14".
Photo 30	SITE ID: FTBL-007-R-01	SITE NAME: Grenade Court	DATE: 3/14/2022	DIRECTION: NE	COMMENTS: Site access road (Poe Road) was well maintained. Heavy vegetation was observed at the site.

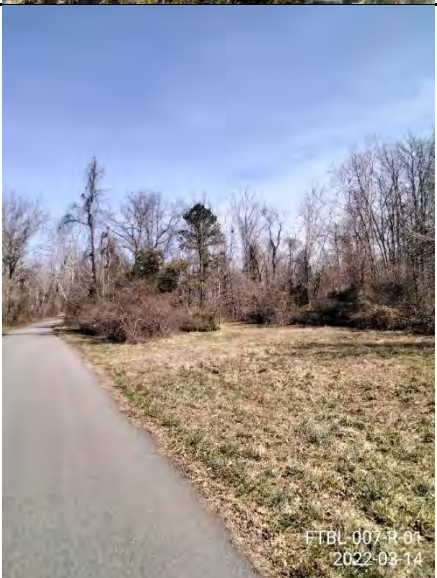
A photograph of a paved site access road (Poe Road) next to a field of dry grass and brush. Trees are visible in the background under a clear blue sky. A timestamp in the bottom right corner reads "FTBL-007-R-01 2022-03-14".

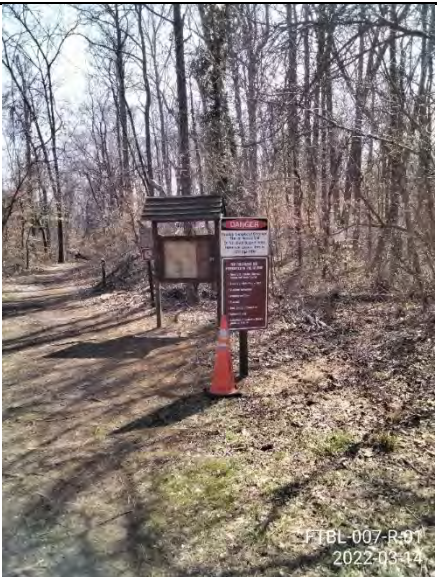
Photo 31	SITE ID: FTBL-007-R-01	SITE NAME: Grenade Court	DATE: 3/14/2022	DIRECTION: SE	COMMENTS: Warning sign posted at the site near recreational trail accessible to the public.

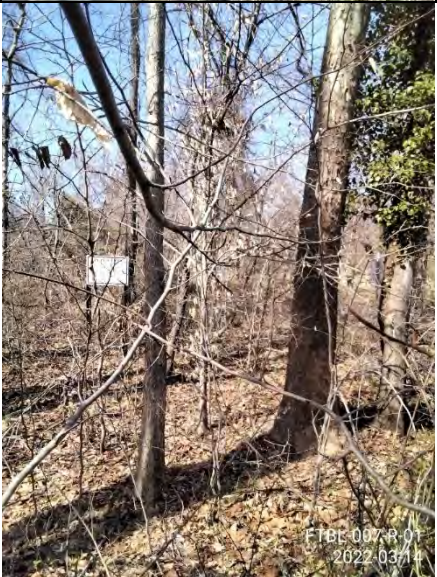
<p style="text-align: right;">FTBL-007-R-01 2022-03-14</p>
Photo 32	SITE ID: FTBL-007-R-01	SITE NAME: Grenade Court	DATE: 3/14/2022	DIRECTION: E	COMMENTS: Signage was posted and well maintained.

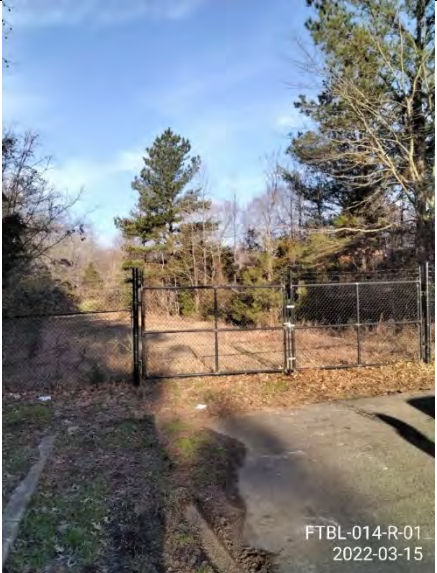
<p style="text-align: right;">FTBL-007-R-01 2022-03-14</p>
Photo 33	SITE ID: FTBL-014-R-01	SITE NAME: Tracy Road Range	DATE: 3/15/2022	DIRECTION: W	COMMENTS: Access gate off Tracy Loop was secured and well maintained.

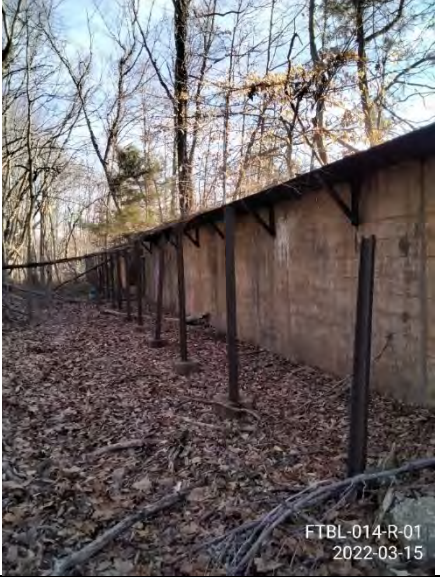
Photo 34	SITE ID: FTBL-014-R-01	SITE NAME: Tracy Road Range	DATE: 3/15/2022	DIRECTION: NE	COMMENTS: Concrete wall backstop associated with the historical western berm.

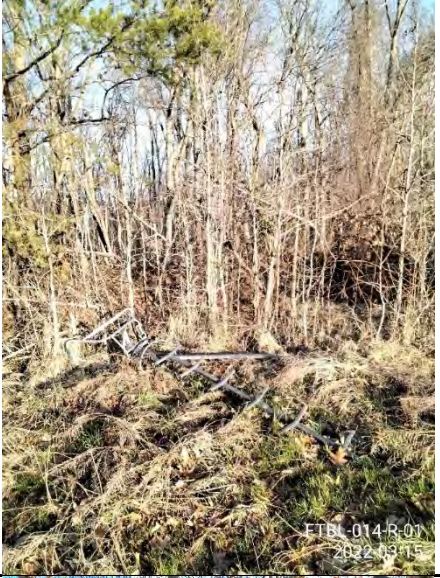
Photo 35	SITE ID: FTBL-014-R-01	SITE NAME: Tracy Road Range	DATE: 3/15/2022	DIRECTION: W	COMMENTS: Tree stand indicative of recreational use of the site.

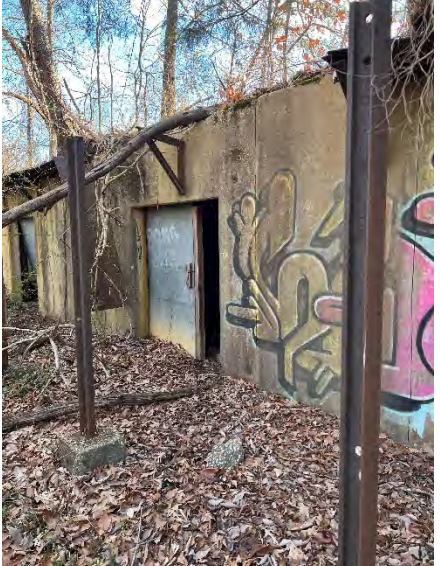
Photo 36	SITE ID: FTBL-014-R-01	SITE NAME: Tracy Road Range	DATE: 3/15/2022	DIRECTION: NE	COMMENTS: Western concrete wall.

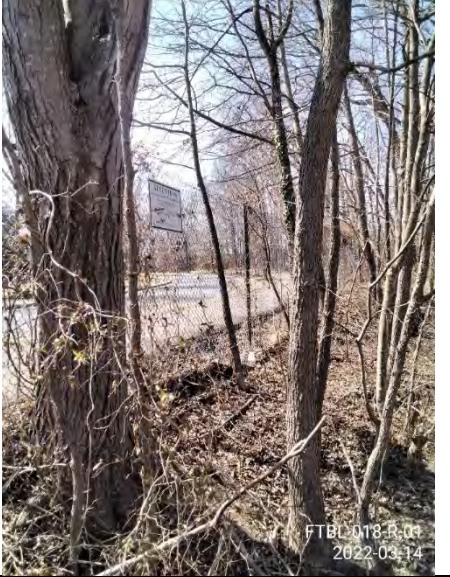
Photo 37	SITE ID: FTBL-018- R-01	SITE NAME: Demolition Area - 01	DATE: 3/14/2022	DIRECTION: S	COMMENTS: Signage posted on fencing on Plantation Drive.

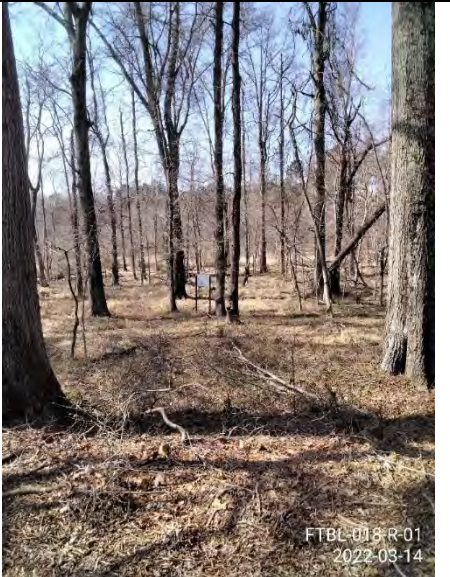
Photo 38	SITE ID: FTBL-018- R-01	SITE NAME: Demolition Area - 01	DATE: 3/14/2022	DIRECTION: NW	COMMENTS: Signage posted near Dogue Creek. Site is heavily vegetated.

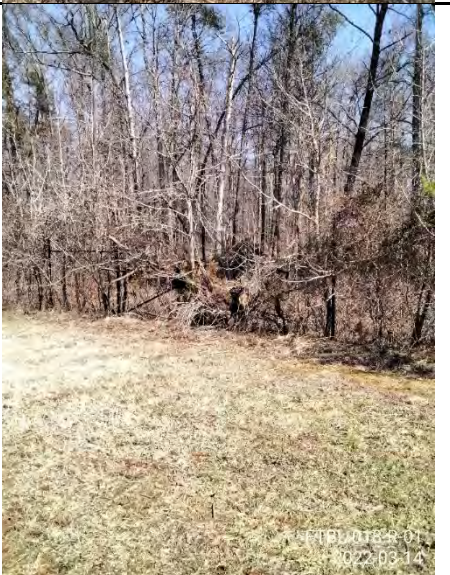
Photo 39	SITE ID: FTBL-018- R-01	SITE NAME: Demolition Area - 01	DATE: 3/14/2022	DIRECTION: NE	COMMENTS: Fencing damaged by fallen trees along Plantation Drive.

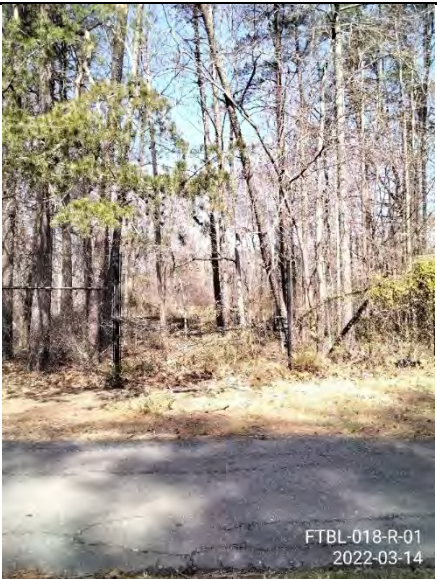
Photo 40	SITE ID: FTBL-018-R-01	SITE NAME: Demolition Area - 01	DATE: 3/14/2022	DIRECTION: N	COMMENTS: Fencing damaged by fallen trees and recreation trail along Plantation Drive.

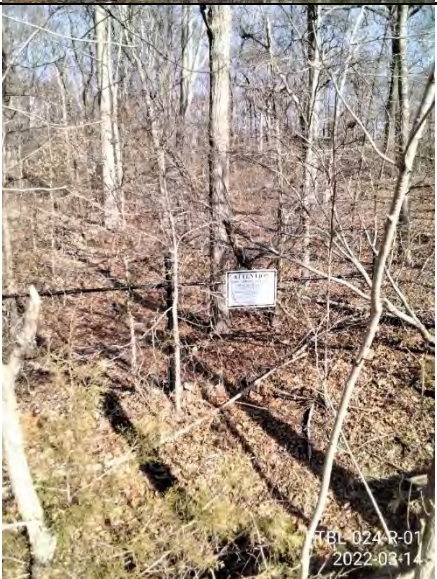
FTBL-018-R-01 2022-03-14
Photo 41	SITE ID: FTBL-024-R-01	SITE NAME: Booby Trap Site	DATE: 3/14/2022	DIRECTION: NE	COMMENTS: Signage posted and well maintained on fencing along Johnston Road.

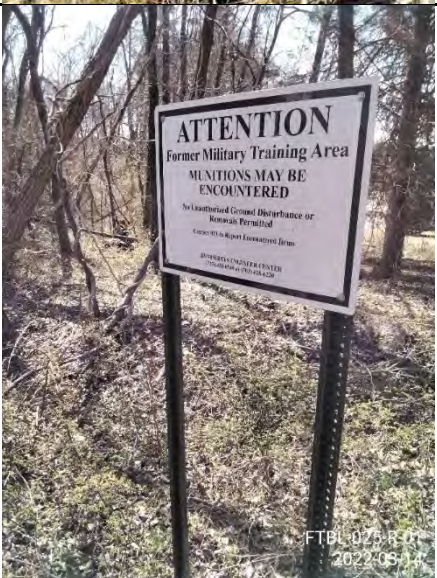
FTBL-024-R-01 2022-03-14
Photo 42	SITE ID: FTBL-025-R-01	SITE NAME: Demolition Area - USACE	DATE: 3/14/2022	DIRECTION: NE	COMMENTS: Signage was posted and well maintained near Kingman Road.

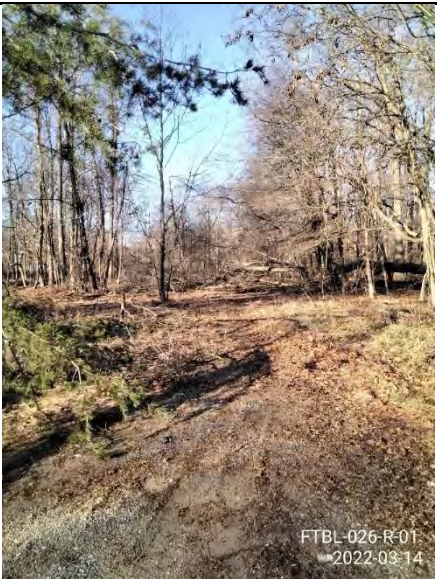
Photo 44	SITE ID: FTBL-026- R-01	SITE NAME: Mines and Booby Trap Area	DATE: 3/14/2022	DIRECTION: NW	COMMENTS: Heavy vegetation and concrete debris observed at the site.

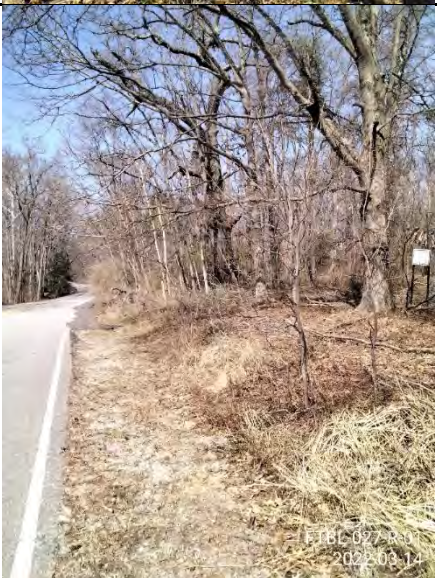
Photo 45	SITE ID: FTBL-027- R-01	SITE NAME: T-16	DATE: 3/14/2022	DIRECTION: N	COMMENTS: Signage posted adjacent to Woodlawn Road.

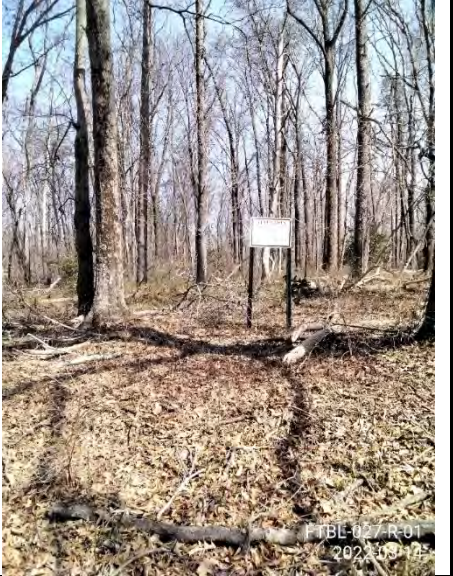
SITE ID:	SITE NAME:	DATE:	DIRECTION:	COMMENTS:	
Photo 46	FTBL-027- R-01	T-16	3/14/2022	E	Signage posted and well maintained. Site is heavily vegetated.
