# **FORT BLISS Restoration Advisory Board (RAB)**

# PRELIMINARY ASSESSMENT SNAKE PIT SITE

# **RAB Meeting Fort Bliss**

# Closed Castner Firing Range Remedial Investigation

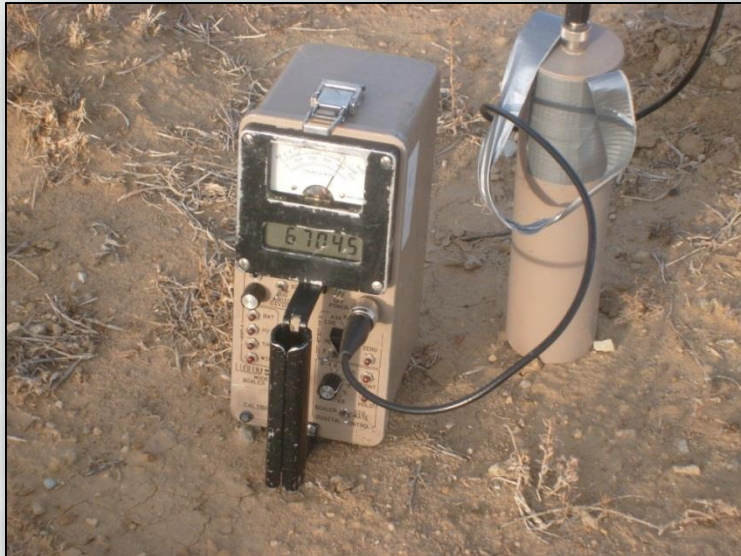
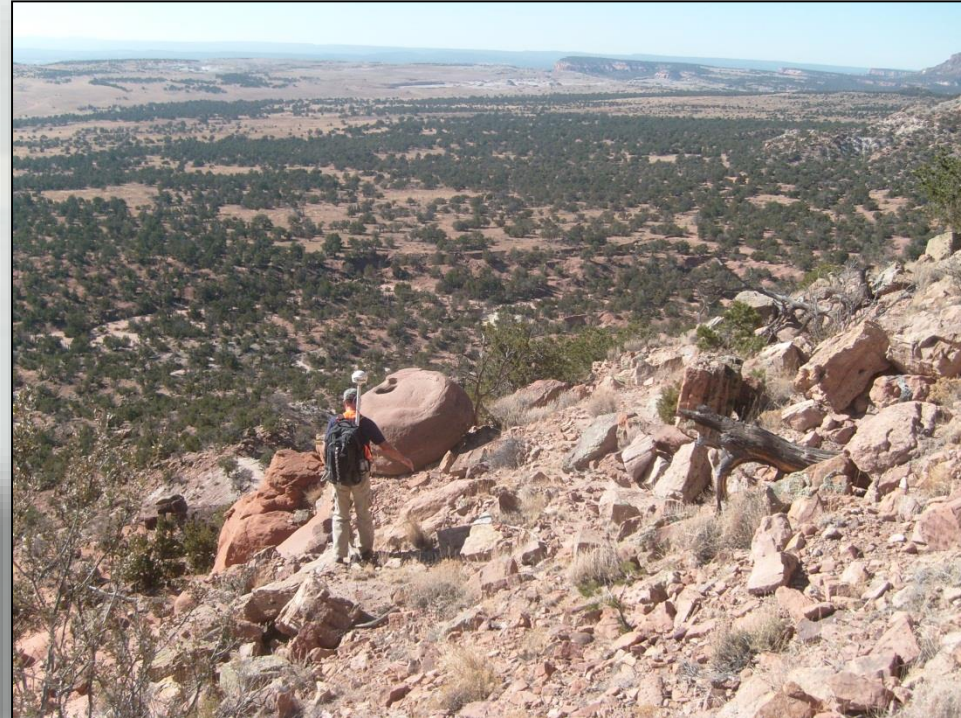
- 10 ft spaced transect survey used Ludlum 44-10 sodium iodide detector integrated with a Trimble GPS backpack unit and data logger
- 24 – 36 inches above the ground surface

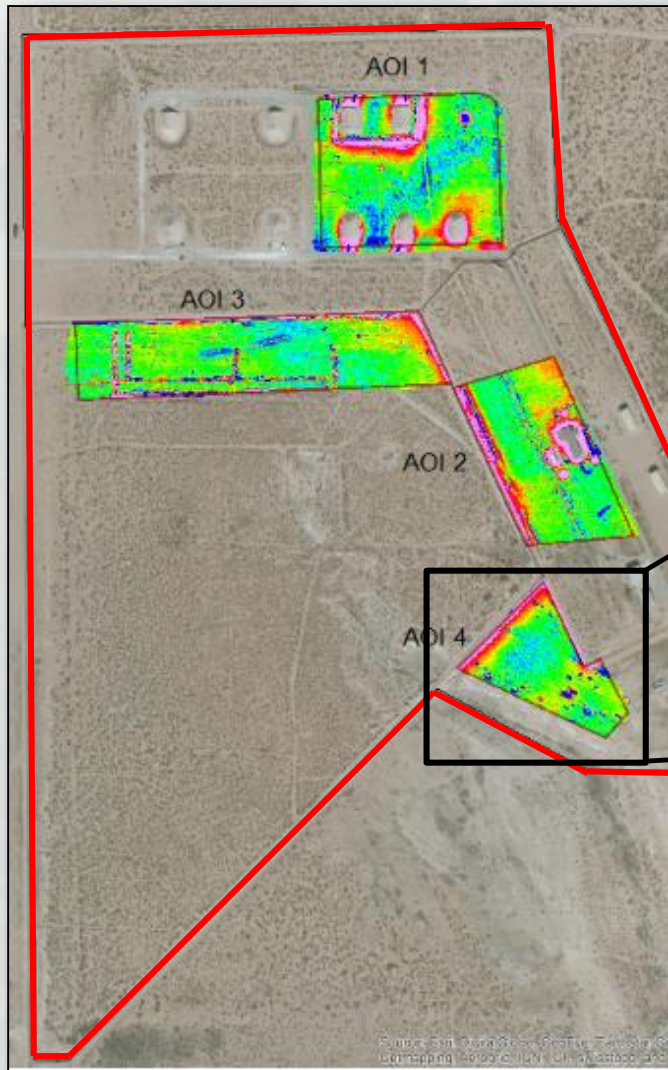
## Investigation Results (EM31 and GPR) (AOI-4 Example)

AOI-4-04	Strong inphase response with slight corresponding change in quadrature response; near drainage swale
	AOI-4-05	Both components display good variance from background, potential buried metal; no cultural features identified
	AOI-4-06	Linear feature on quadrature; some slightly low values on inphase; no cultural features identified; within site of guard shack
	AOI-4-07	Quadrature component significantly different from background; changes of soil properties; isolated inphase responses characteristic of buried small metal
	AOI-4-08	Isolated inphase responses characteristic of smaller buried metal objects
	AOI-4-09	Isolated inphase responses within the zone of quadrature zone that is significantly different from background; within site of guard shack
	AOI-4-10	Quadrature component significantly different from background; changes of soil properties; isolated inphase responses characteristic of buried metal; within site of guard shack

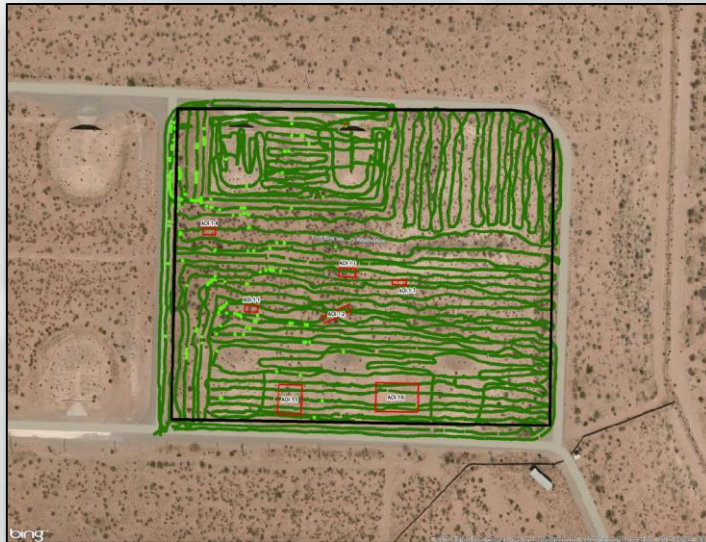
AOI-1

# Investigation Results (Surface Gamma Survey)

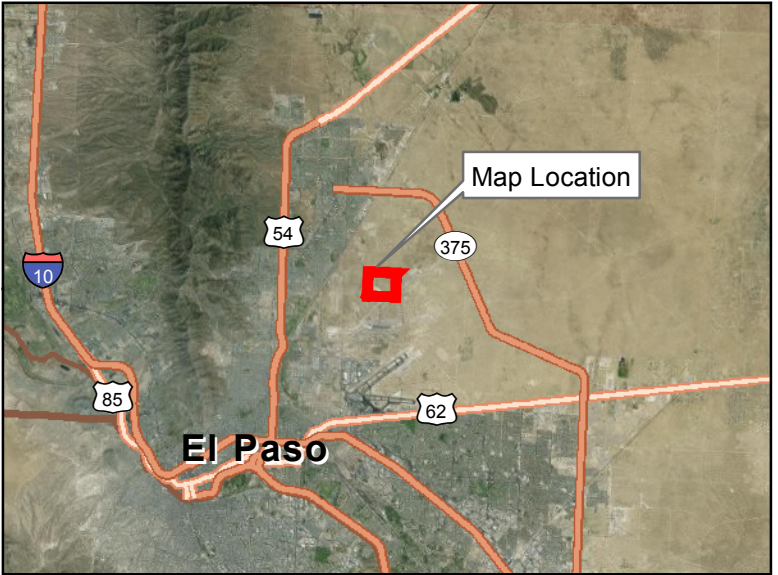
- MD observed
- Possible Pit or Trench
- Mound
- Site Boundary
- Expanded Investigation Area
- 25 ft Spaced Parallel DGM Transect
- Radial DGM Transect

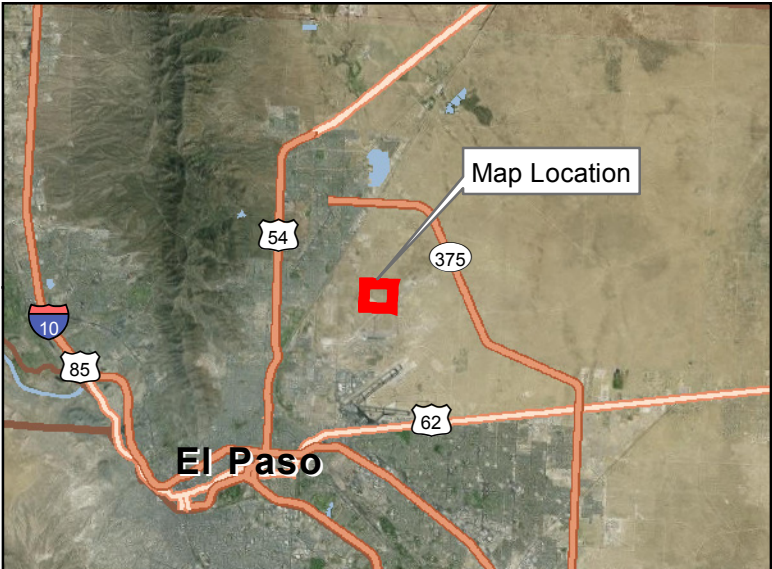
- MD observed
- Possible Pit or Trench
- Mound
- Site Boundary
- Expanded Investigation Area
- Sampling Unit

U.S. Army Environmental Command	
DESIGNED BY: GP	<b>Remedial Investigation Biggs OB/OD Site I, Ft. Bliss, El Paso, Texas</b>		
DRAWN BY: GP			
CHECKED BY: JS	SCALE: As Shown	CONTRACT NUMBER:	
SUBMITTED BY: JS	DATE: September 2015	PAGE NUMBER:

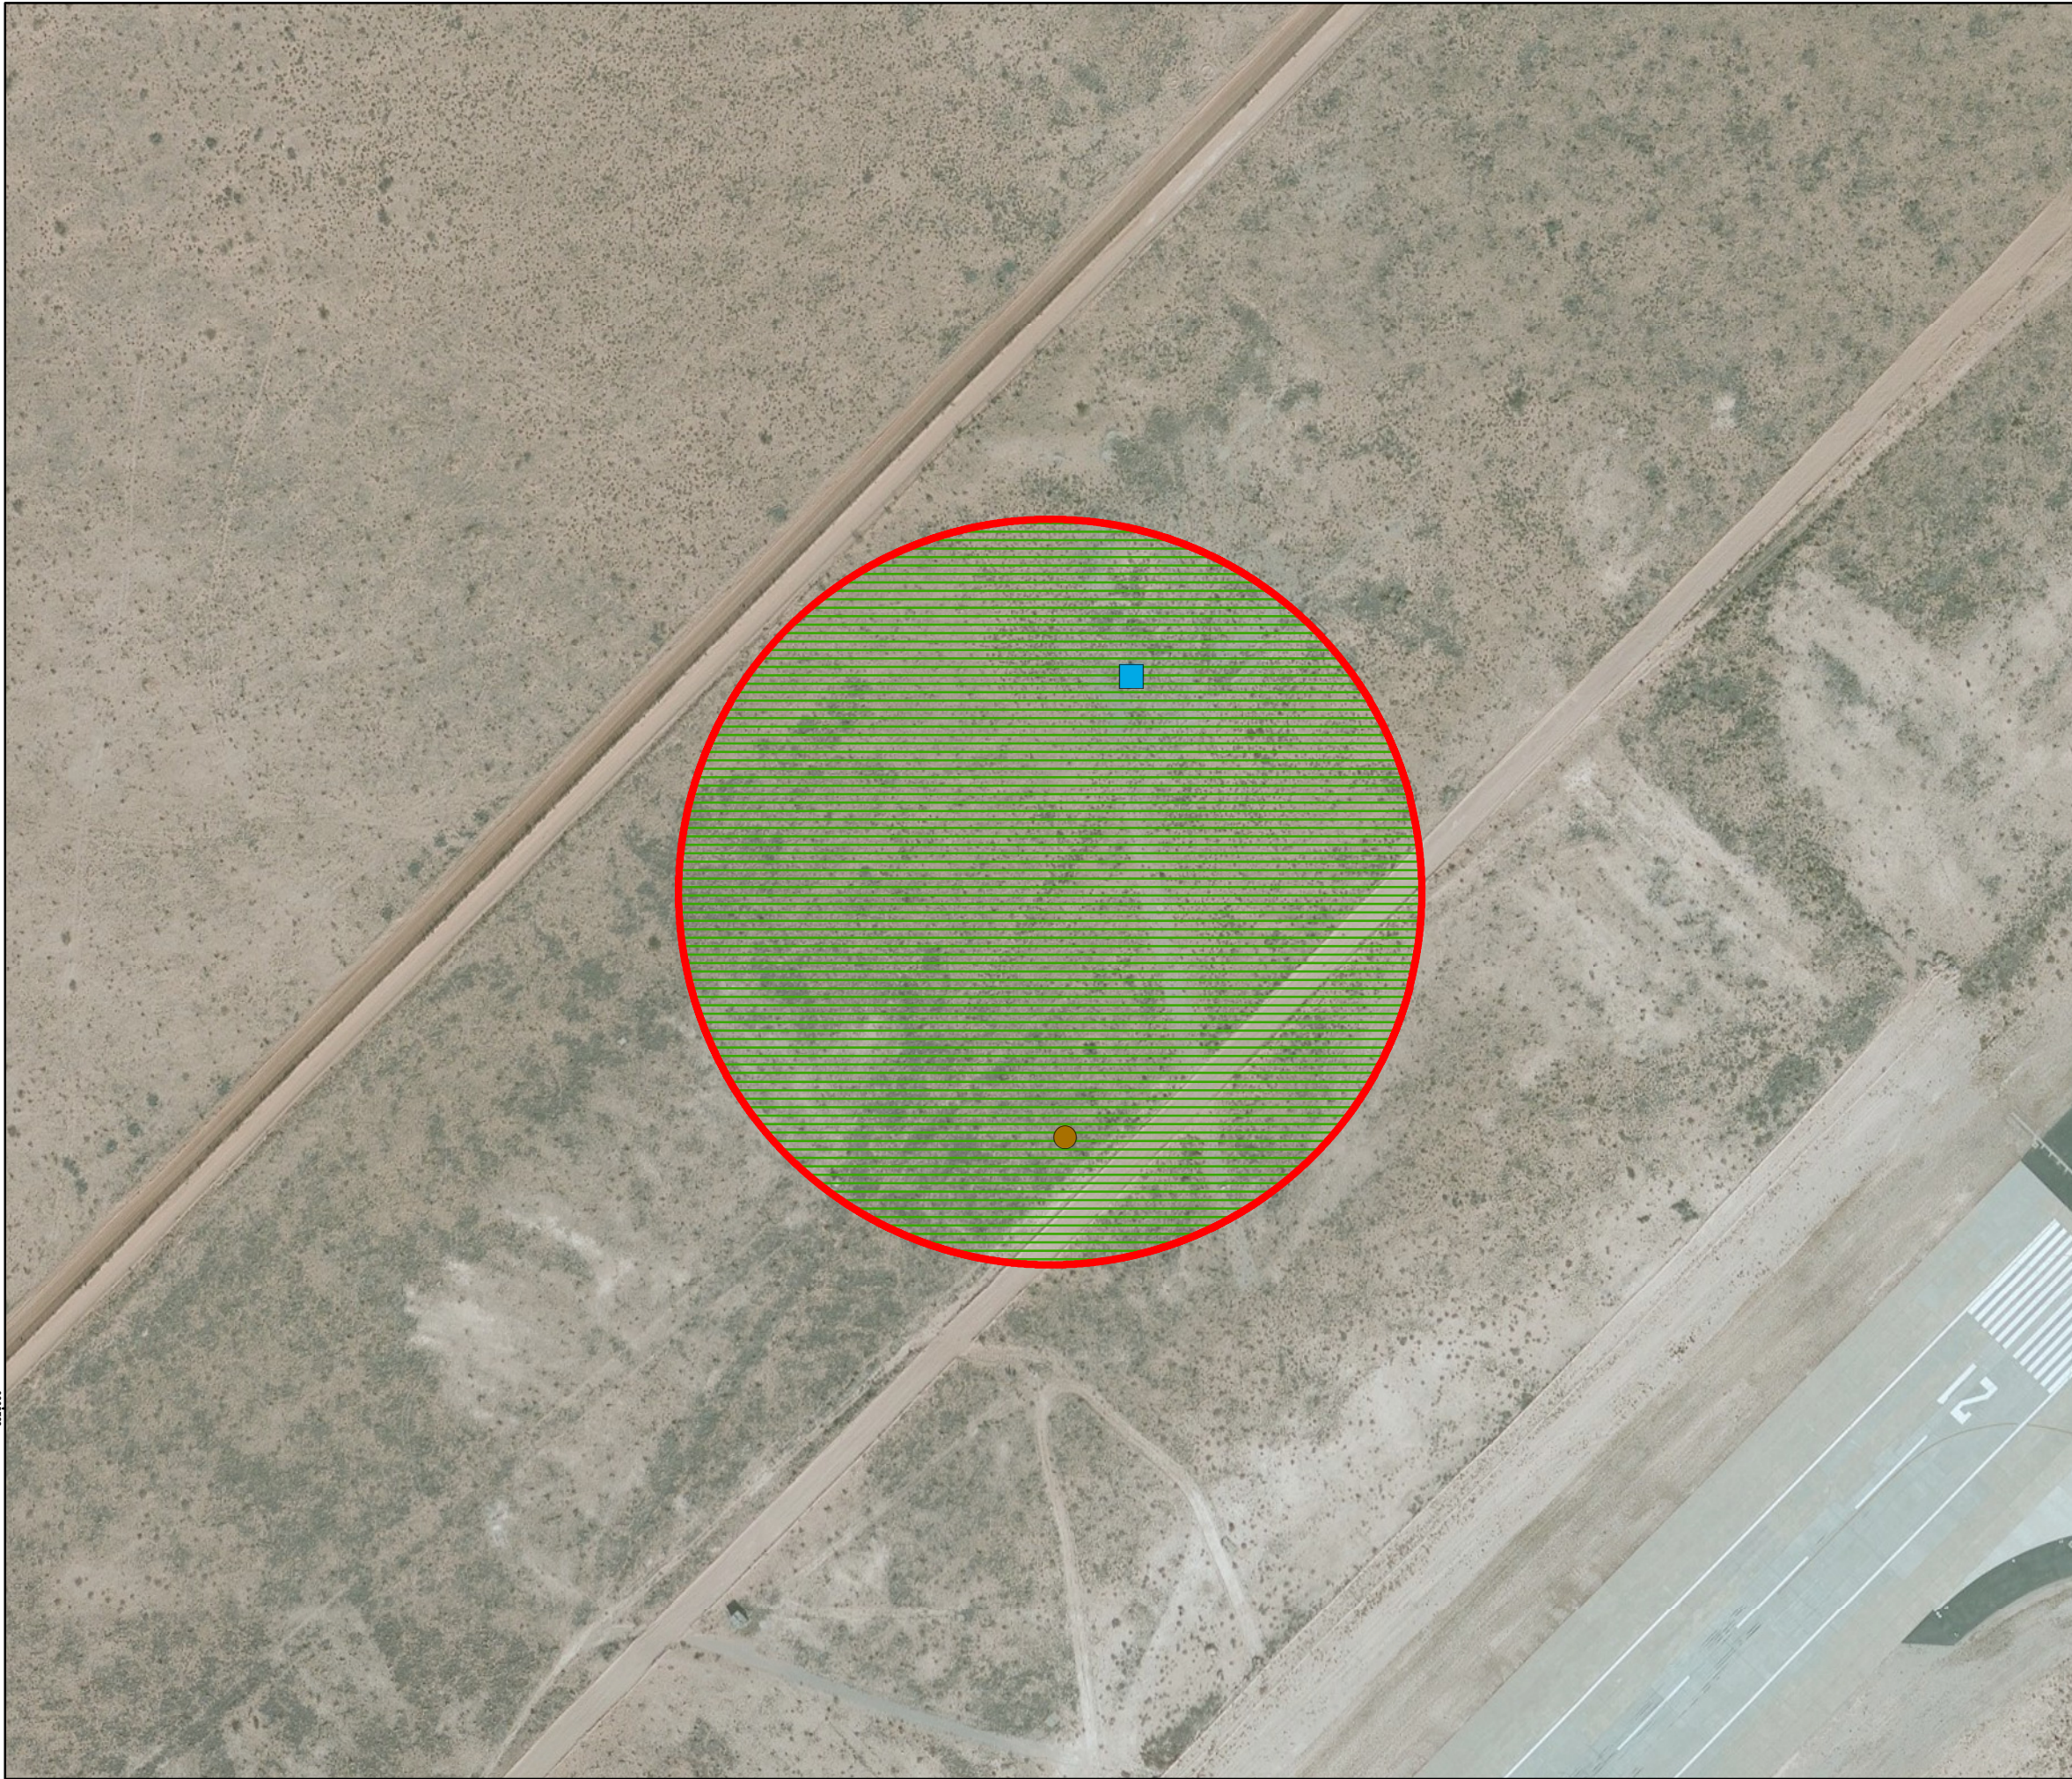
Figure 17-1

**Biggs OB Site II**  
**MEC Investigation Approach**

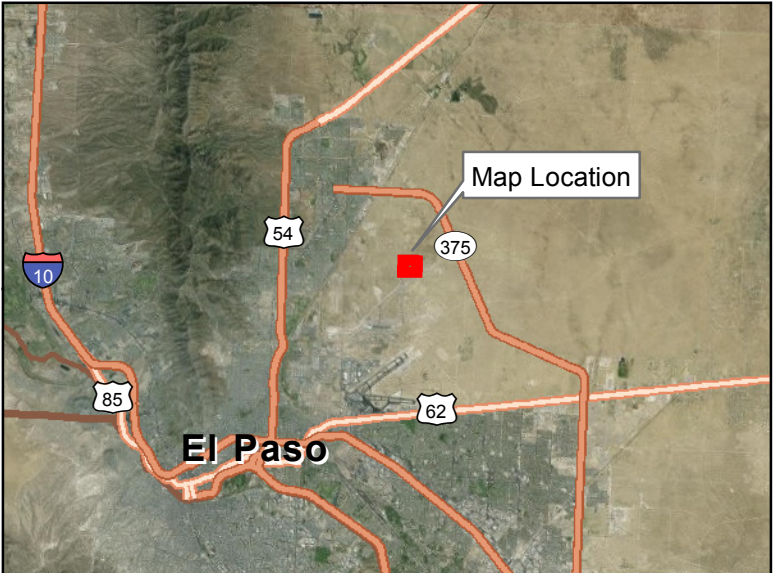
10 ft Spaced Parallel DGM Transect

DESIGNED BY: GP	<b>Site Inspection</b> <b>Biggs OB Site II,</b> <b>Ft. Bliss, El Paso, Texas</b>		
DRAWN BY: GP			
CHECKED BY: JS	SCALE: As Shown	CONTRACT NUMBER:	
SUBMITTED BY: JS	DATE: September 2015	PAGE NUMBER:

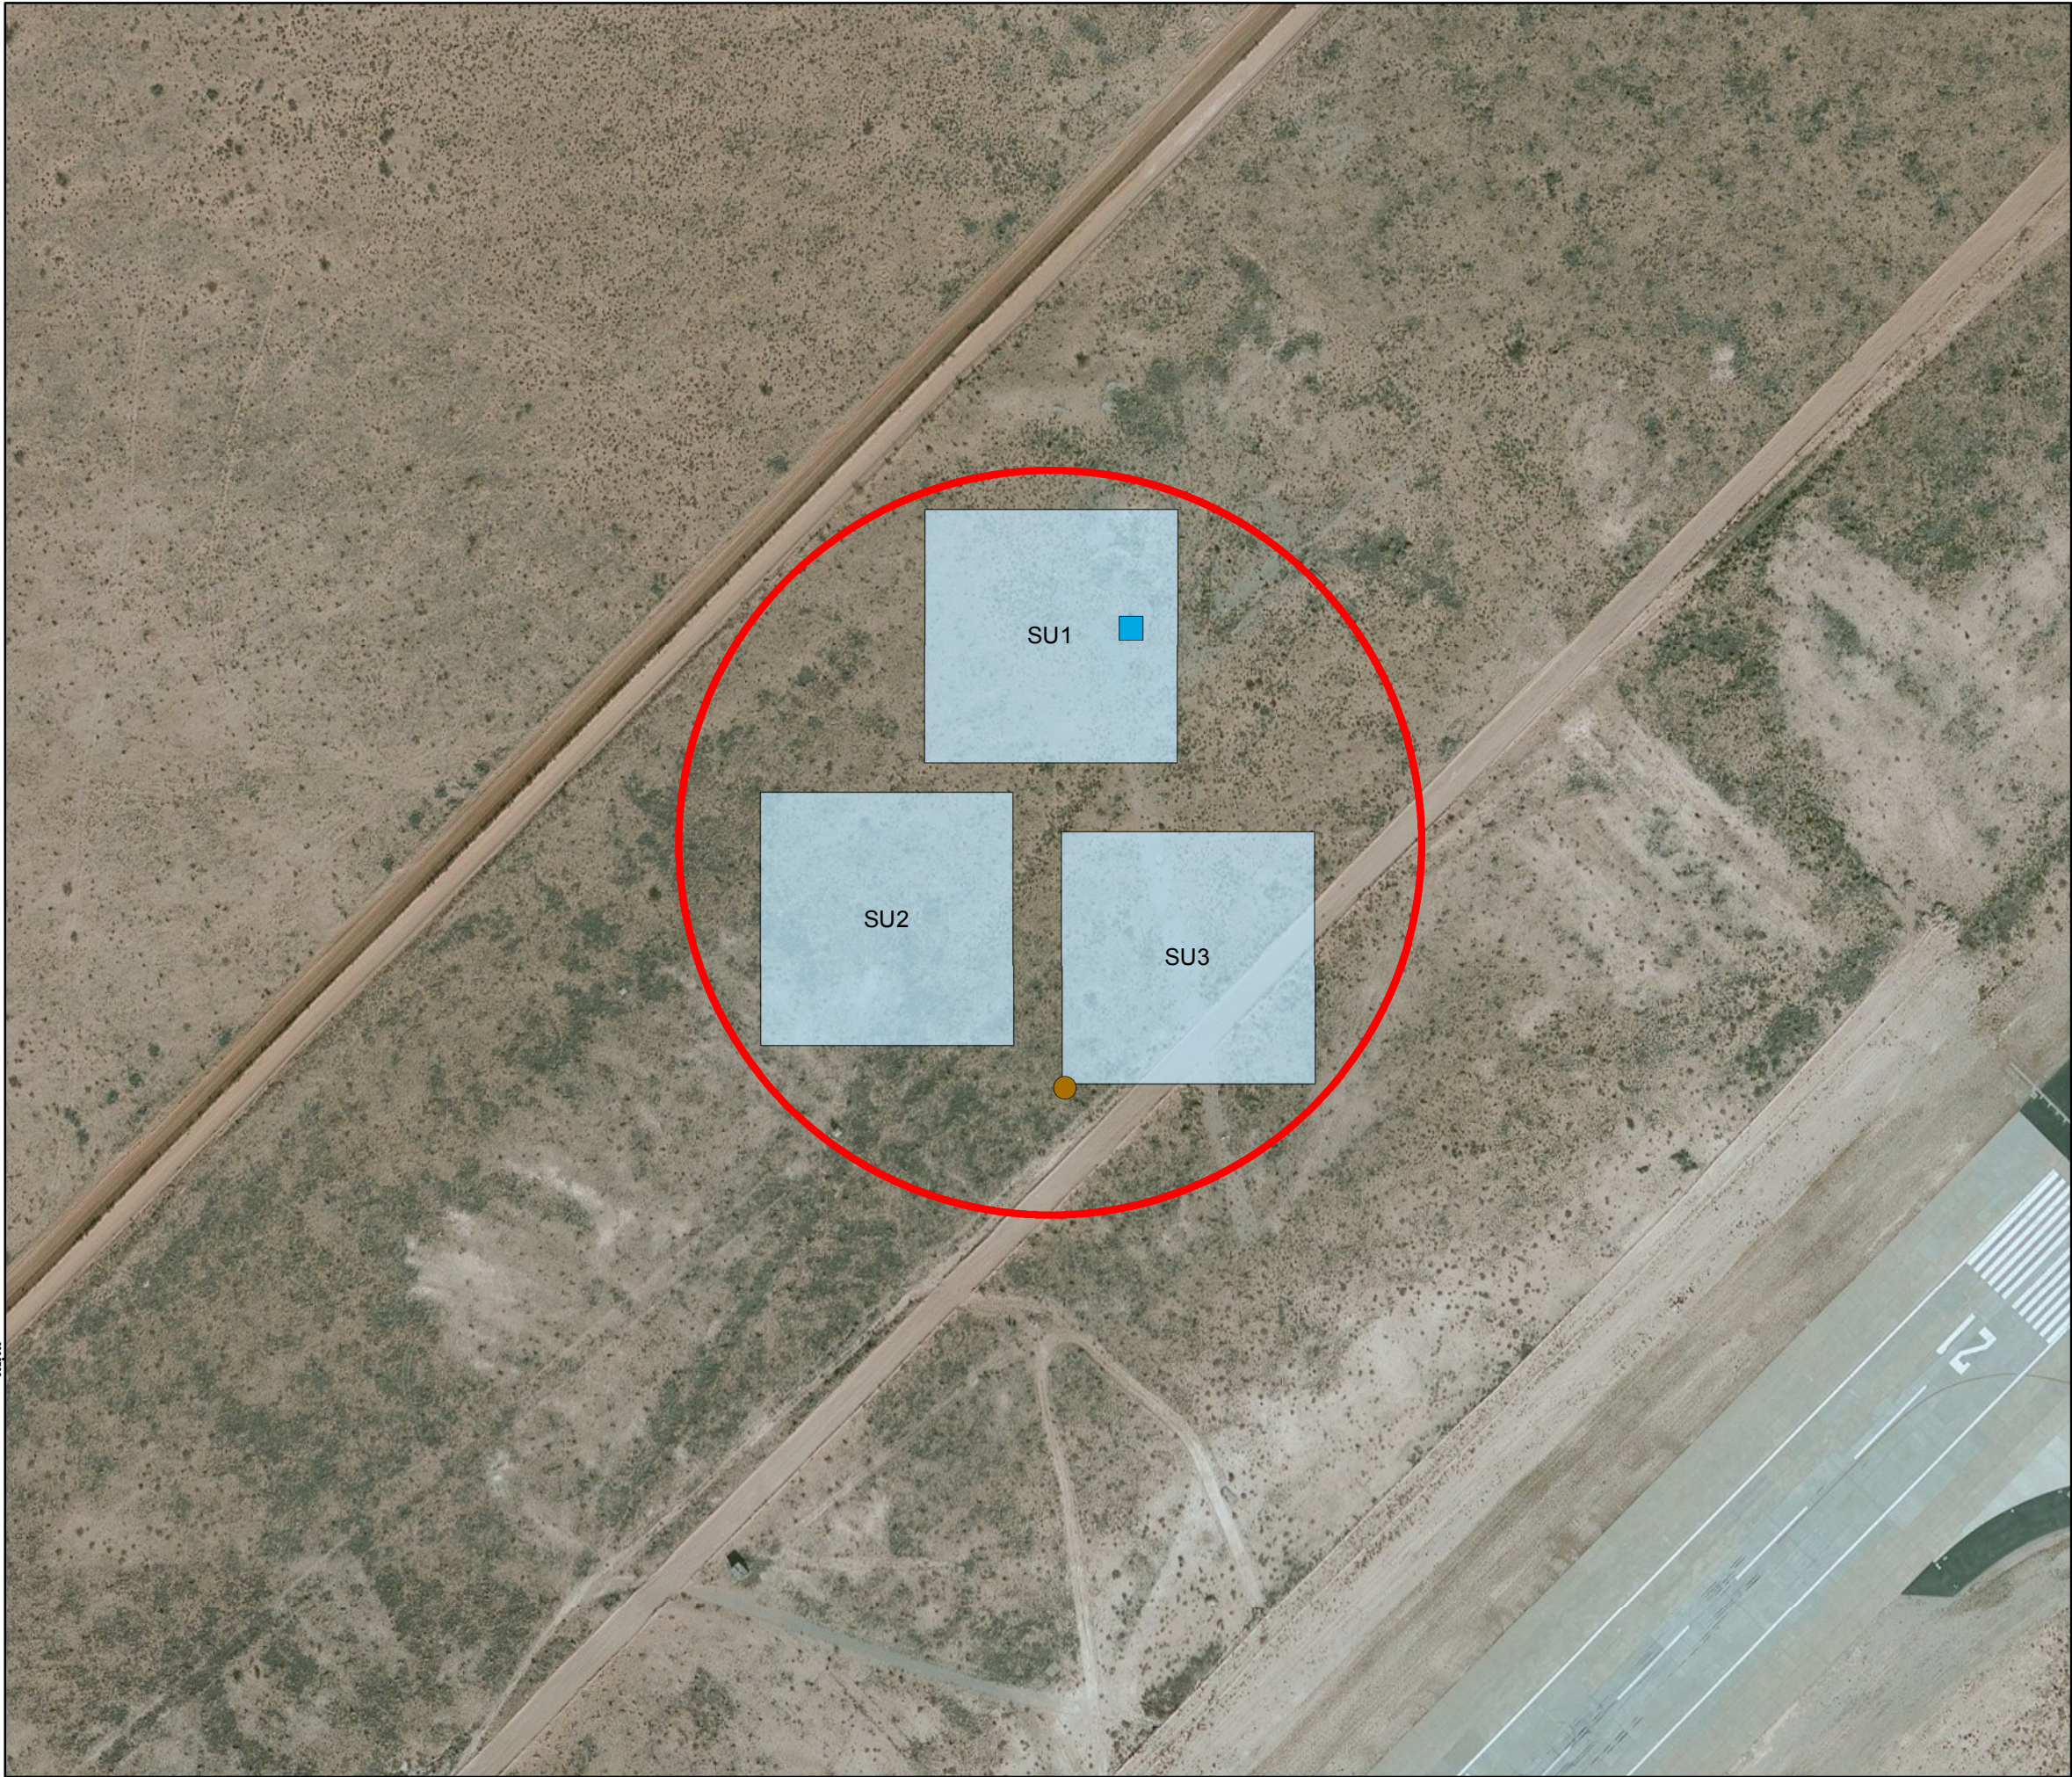
Figure 17-2

**Biggs OB Site II**  
**MC Investigation Approach**

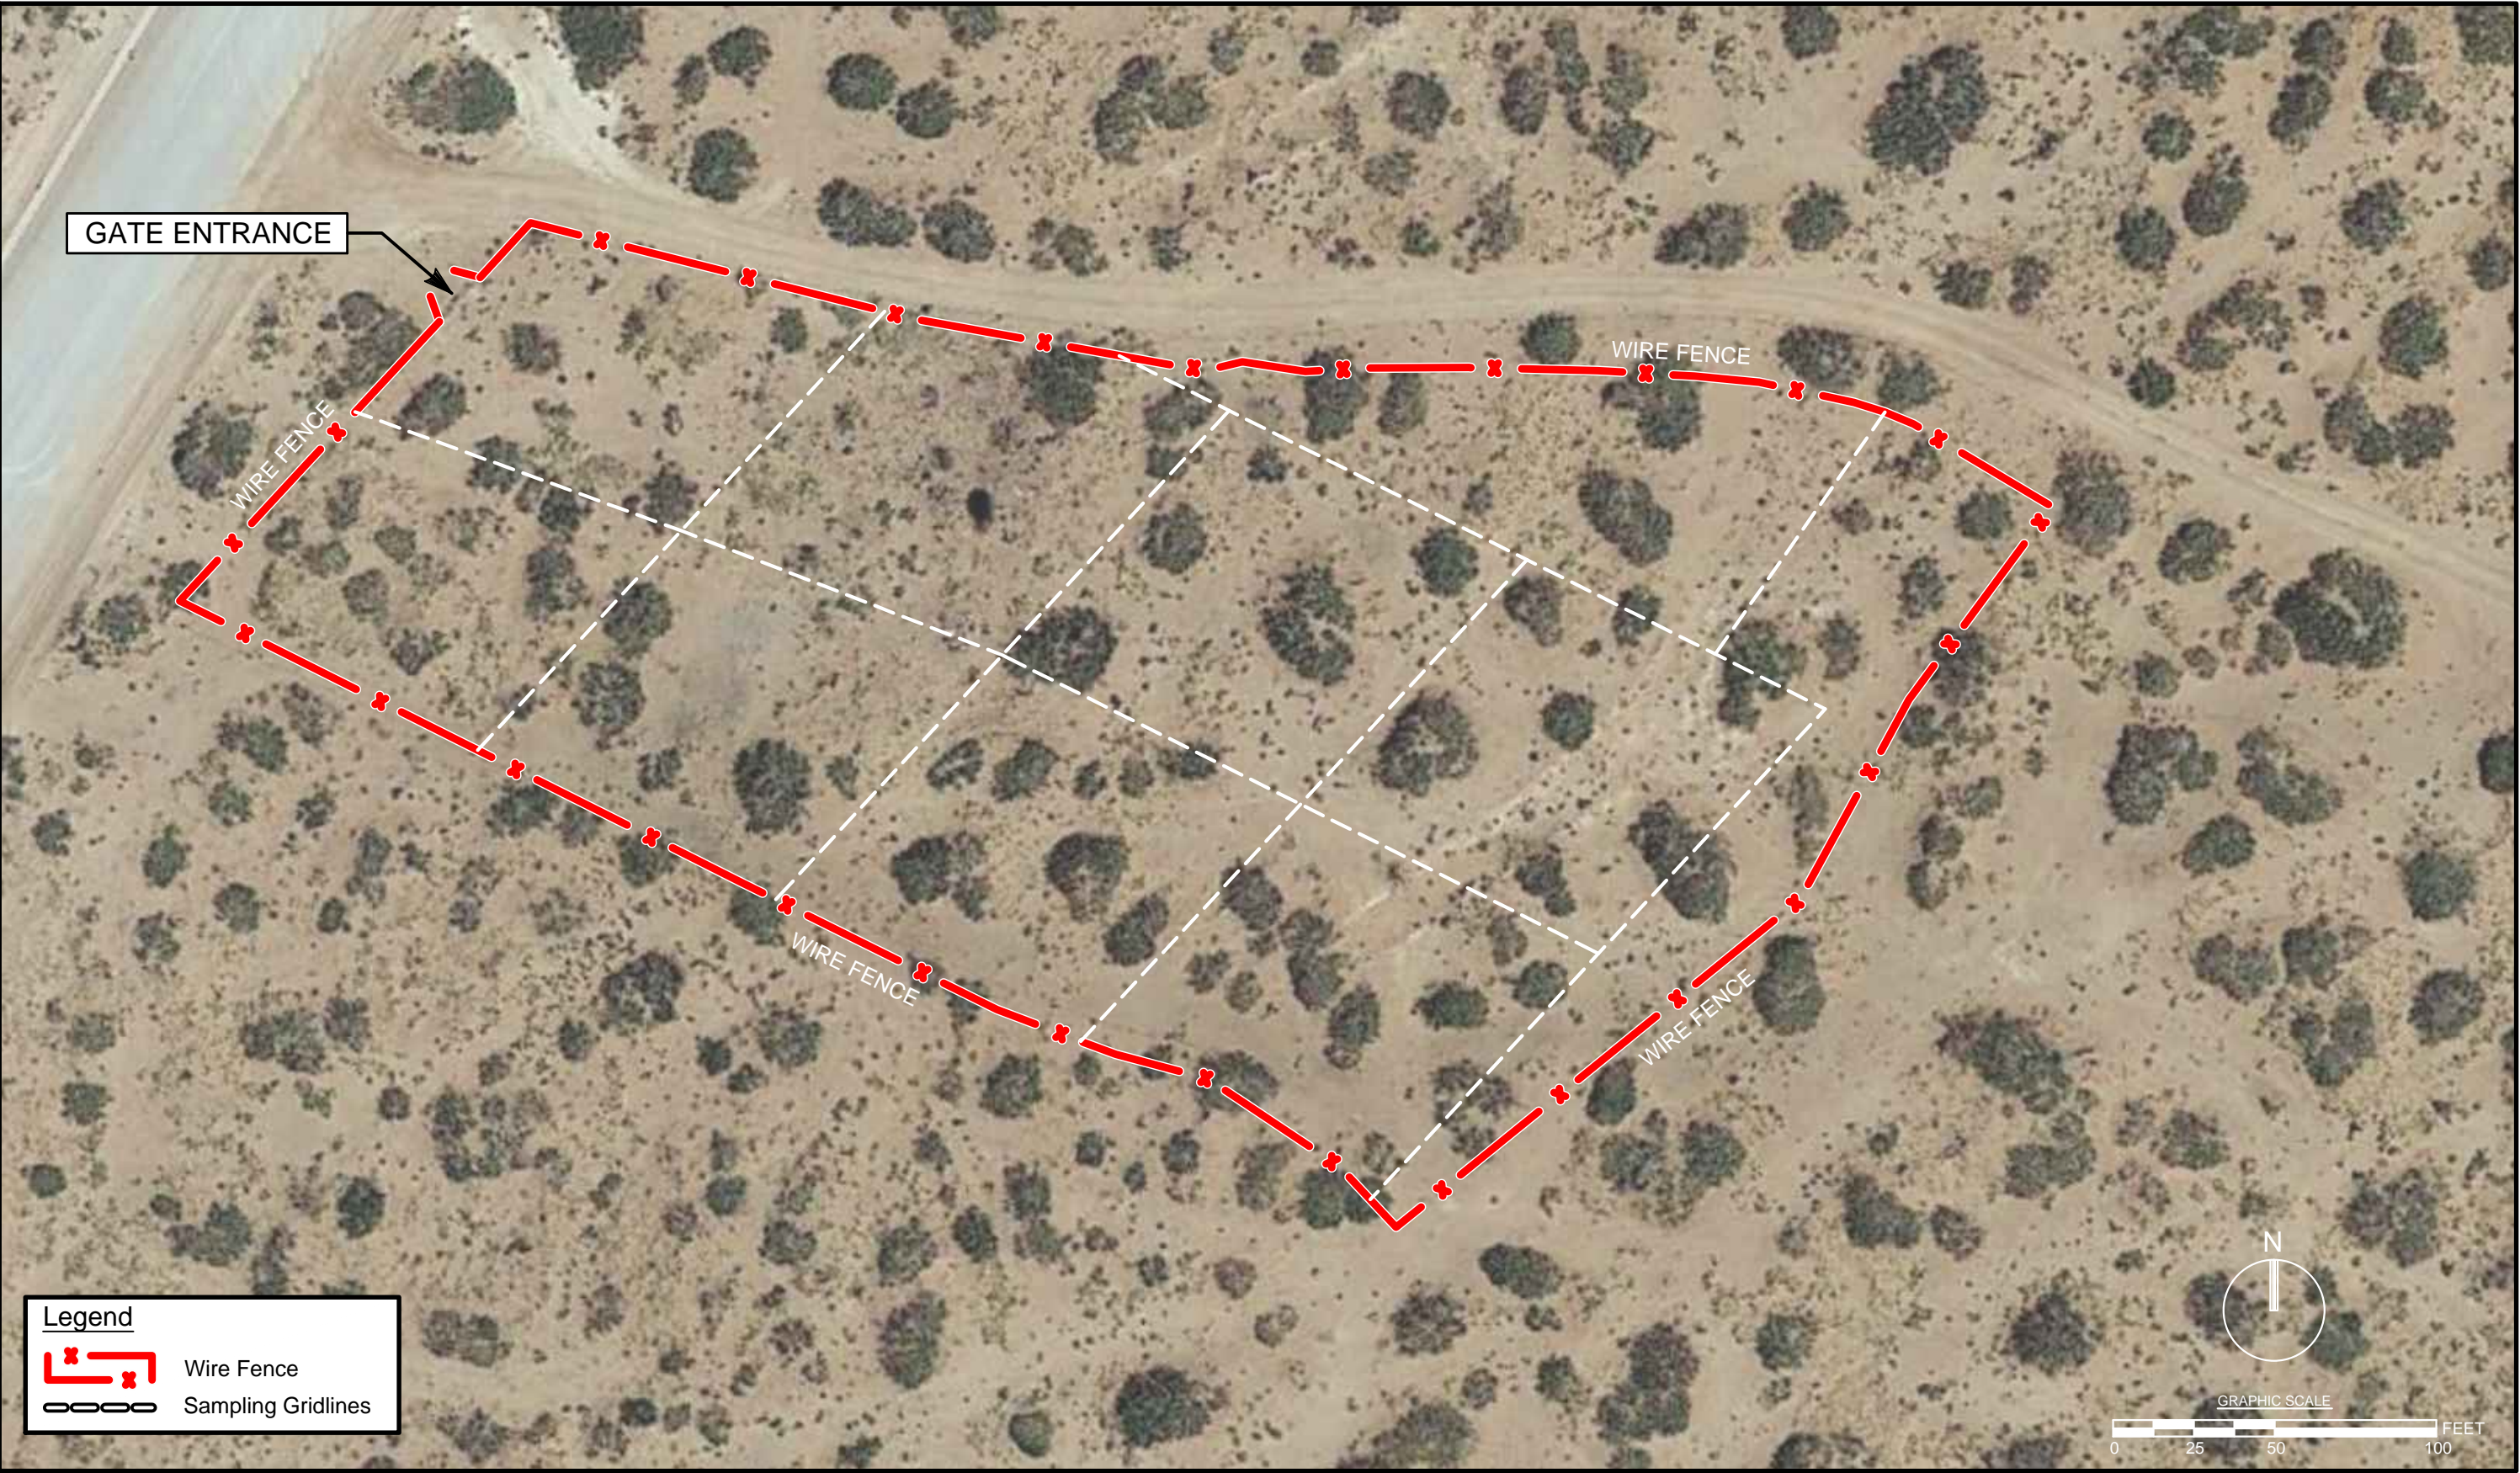
SHEET NUMBER:  
**FIGURE 17-2**

SHEET TITLE  
SITE MAP AND SAMPLING GRIDLINES  
ILLEGAL DUMPING SITE IN FAR EAST FORT BLISS

- **RI Approach, cont.**
  - Site activities will include collecting soil samples from the surface and from 2-3 feet below ground surface in a phased approach.
  - Additional samples will be collected if needed to delineate the waste extents with the initial sampling.
  - A visual survey of the site will be performed to determine if wastes are observed outside the fenced area. Based on analytical results and field observations, CAPE will define the extent, distribution, and concentration of contamination at the site.

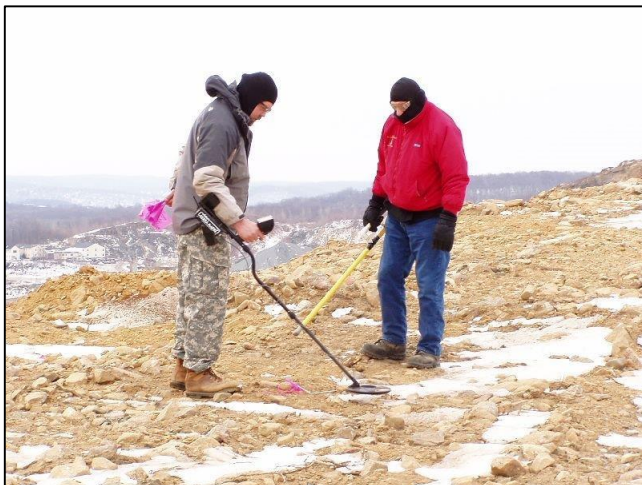
- **Visual Surveys**
  - Conducted in mountainous areas; meandering path surveys
- **Intrusive Investigation**
  - Investigation of existing anomalies\* – flatter terrain areas
    - 1750 100-foot transect segments selected
  - Analog (“mag and dig”) transects – moderate terrain areas
    - 452 randomly placed 100-foot transect segments
- **DGM Grids**
  - DGM surveys of 22 grids (100 feet x 100 feet) with highly accurate GPS positioning
  - Data recorded electronically, then processed by computer to select anomalies for investigation

*Handheld Metal Detector*

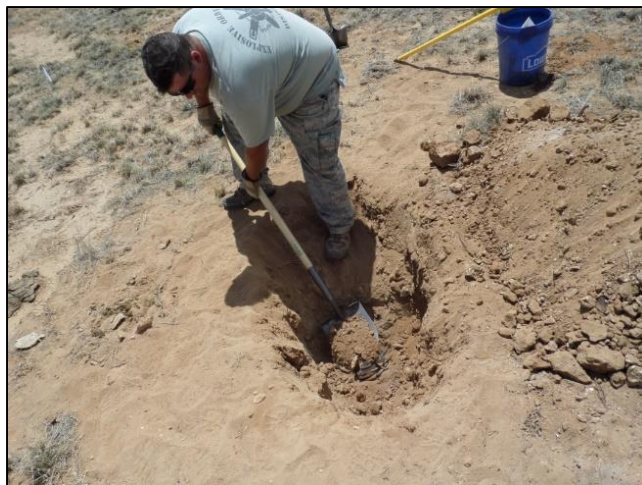
*Intrusive Investigation*

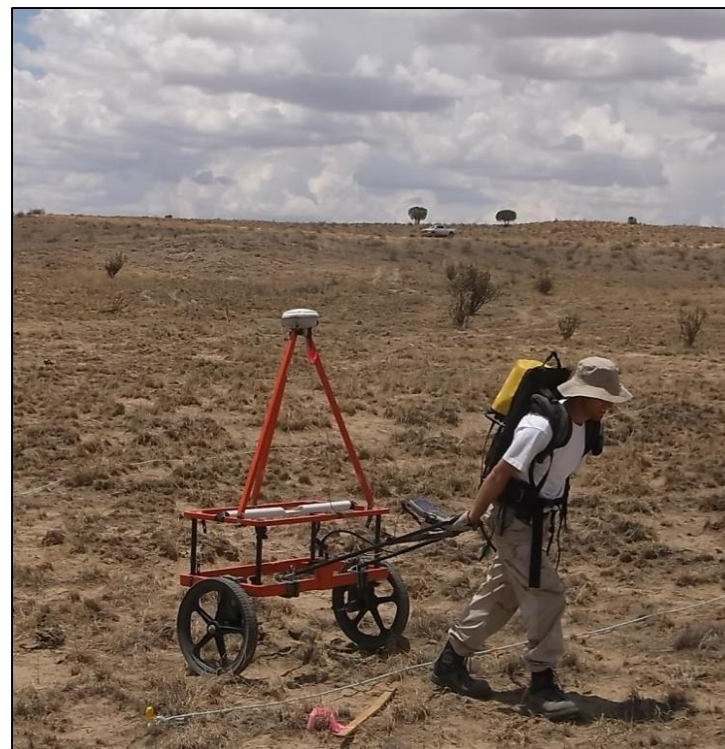
*DGM Data Collection*
