Photograph Log

Fort Bliss
Limits of Waste Investigation
30056989

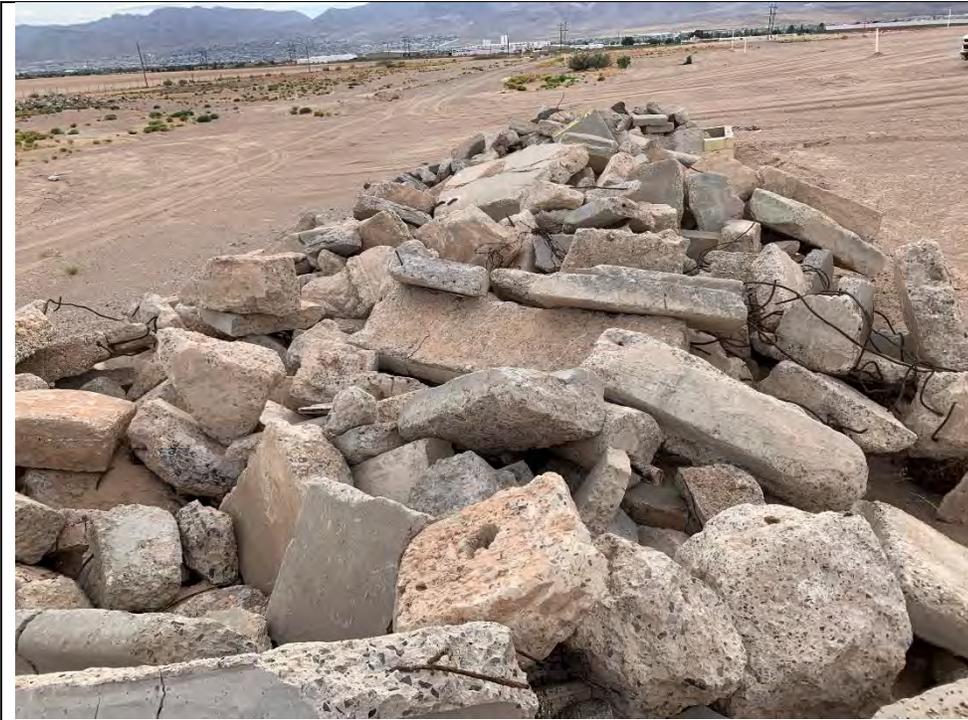
Photograph: CP-11-4

Description: Top view of concrete pile. Visible are some street curb concrete pieces.

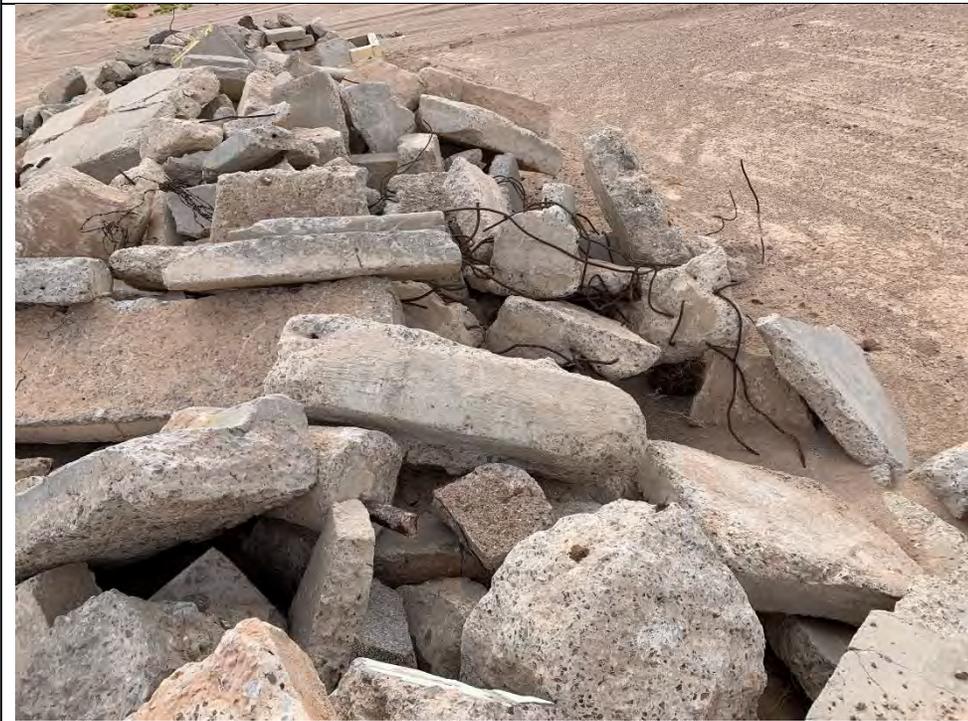
Photograph: CP-11-5

Description: Some visible rebar steel wire within the concrete pile.

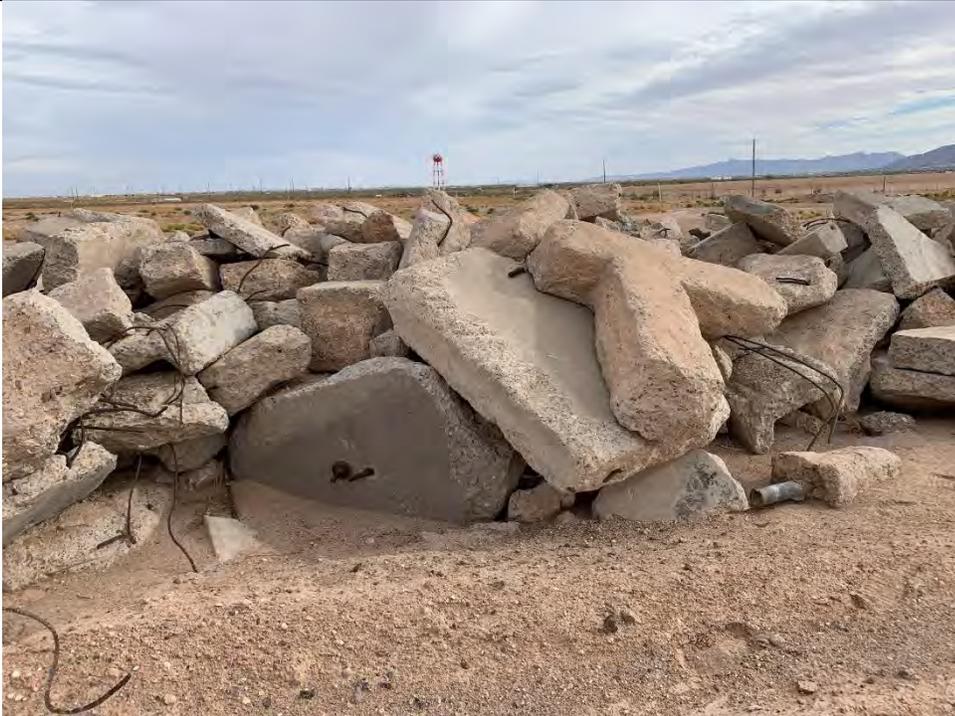
Photograph: CP-11-6

Description: Large pieces of concrete some measuring up to 5 feet in length visible in the concrete pile along with steel pipes and steel rebar wire.

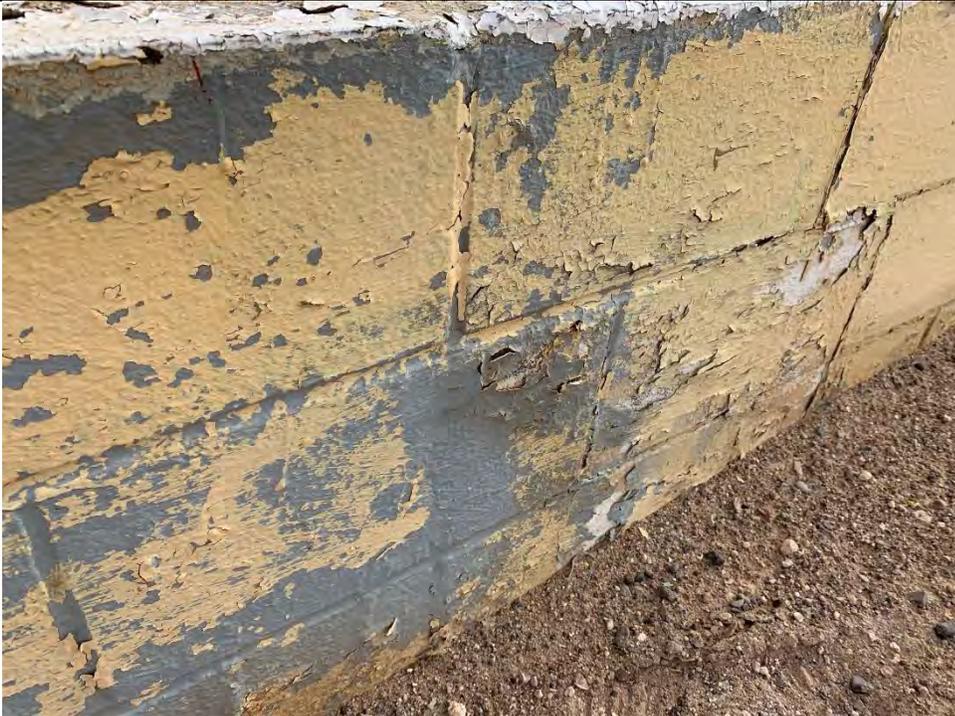
Photograph: CP-11-7

Description: Possible lead-based paint chipping from a cinder block wall near pile of broken up concrete.

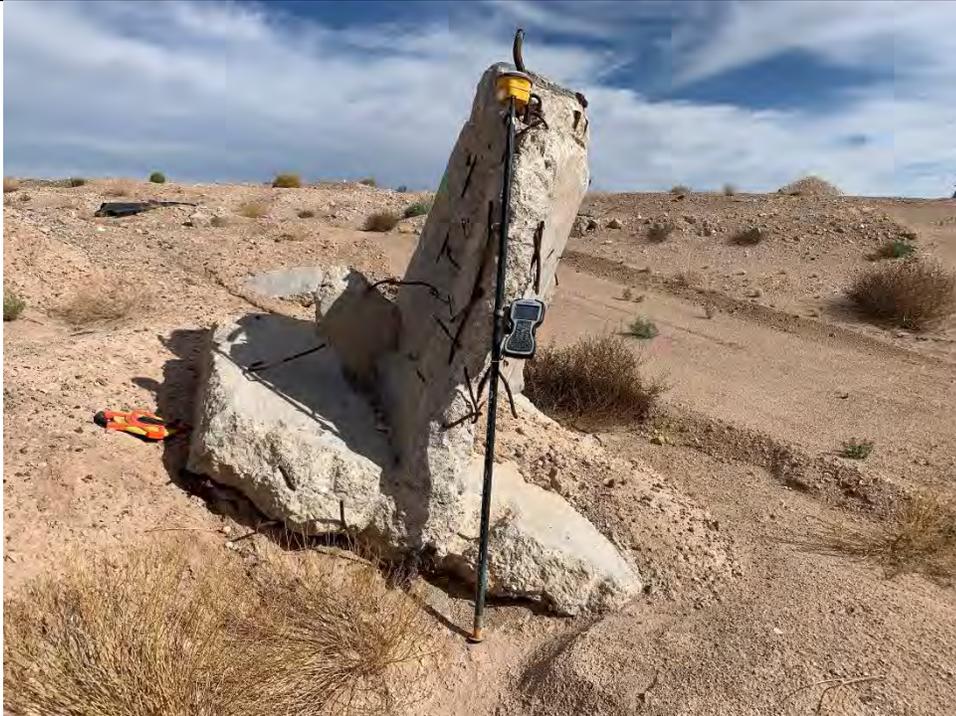
Photograph: CP-12-1

Description: Large concrete structure found on north side of landfill. Vertical height of about 6 feet.

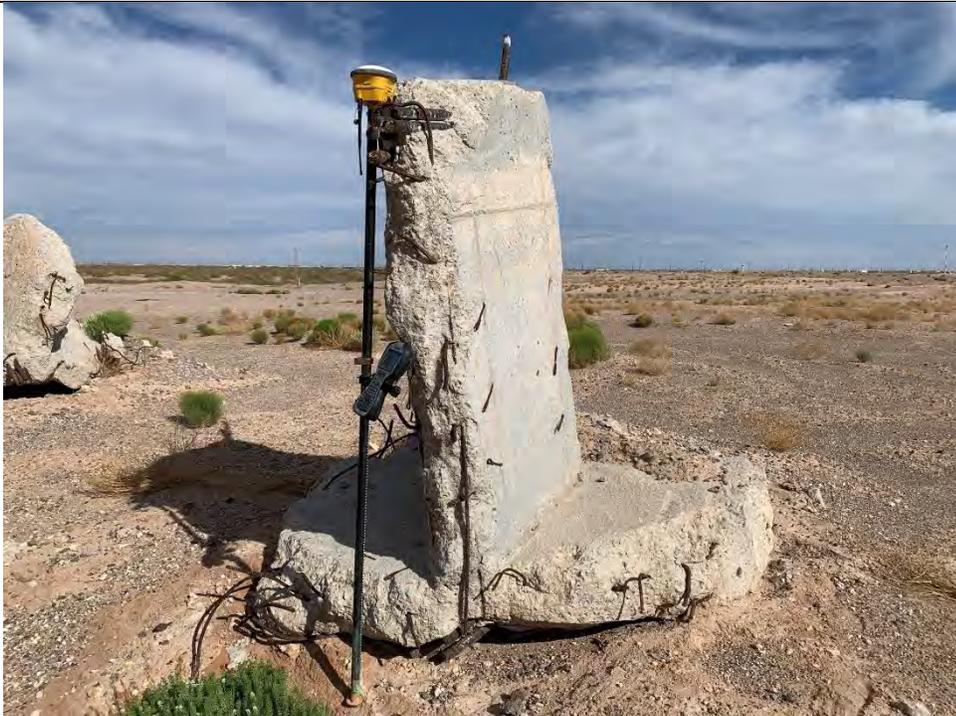
Photograph: CP-12-2

Description: Concrete Structure approximately 20 feet away from another concrete structure that measures about 6 feet tall.

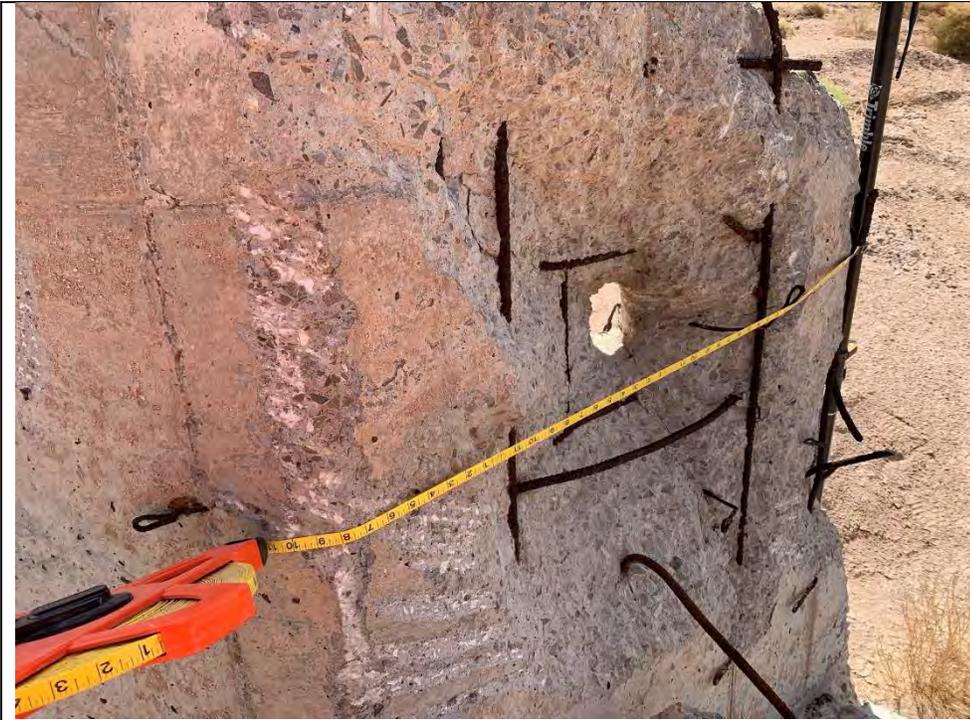
Photograph: CP-13-1

Description: Large concrete structure similar as CP-12-1 but measuring a width of about 4 feet.

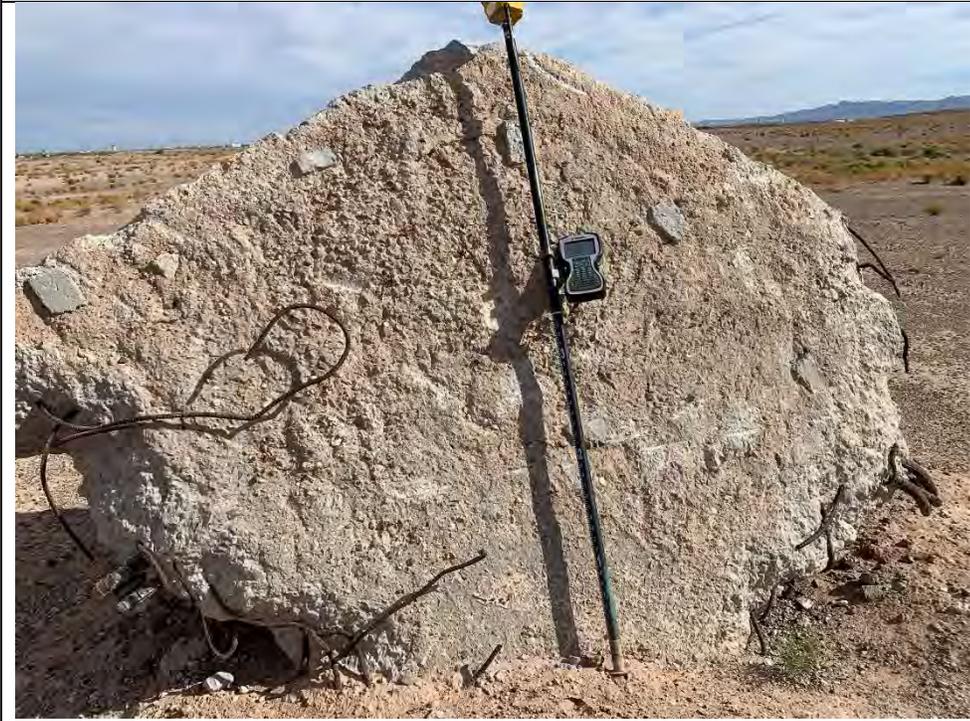
Photograph: CP-13-2

Description: Concrete structure measuring about 6 feet tall.

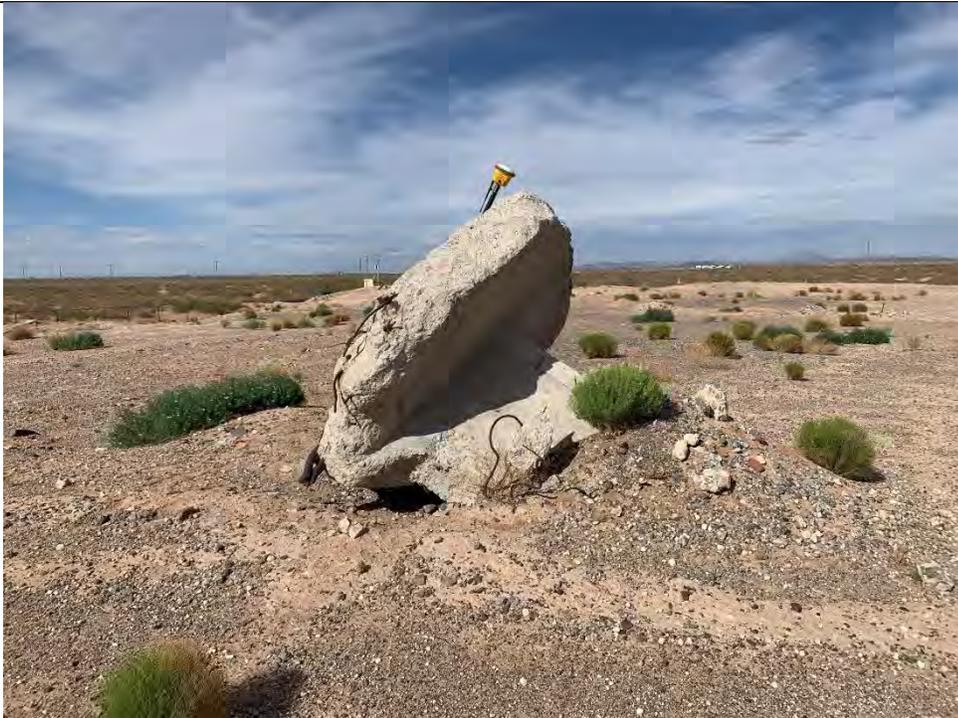
Photograph: CP-13-3

Description: Looking northeast at side of concrete structure.

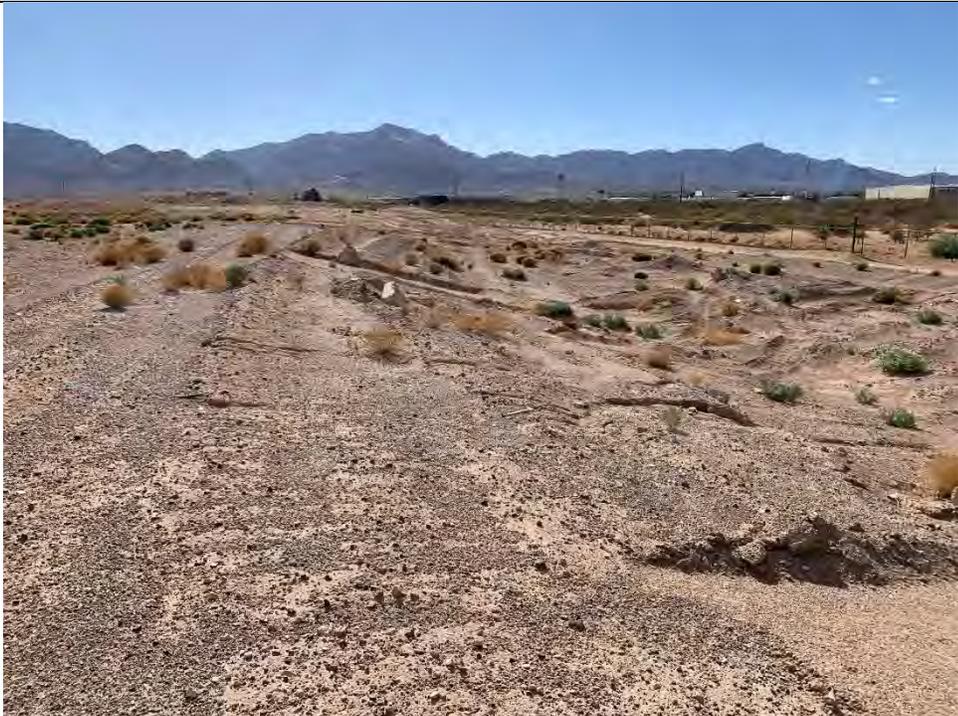
Photograph: CP-14-1

Description: Visible small pieces of concrete thrown across the northeastern portion of the landfill.

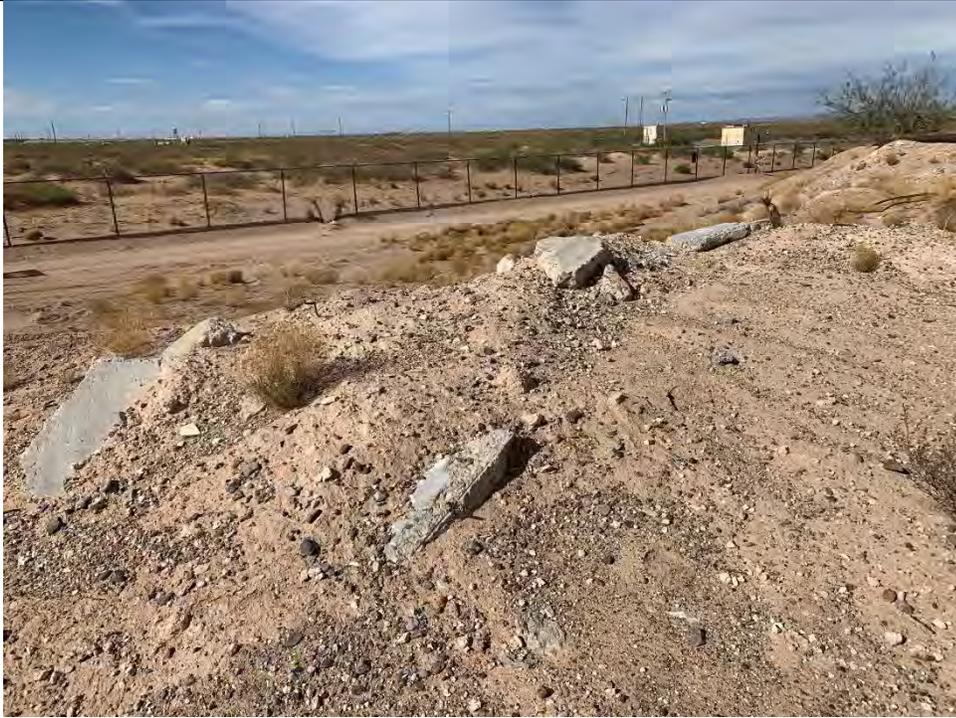
Photograph: CP-14-2

Description: More visible pieces of concrete measuring up to 3 feet thrown across the northeastern portion of the landfill.

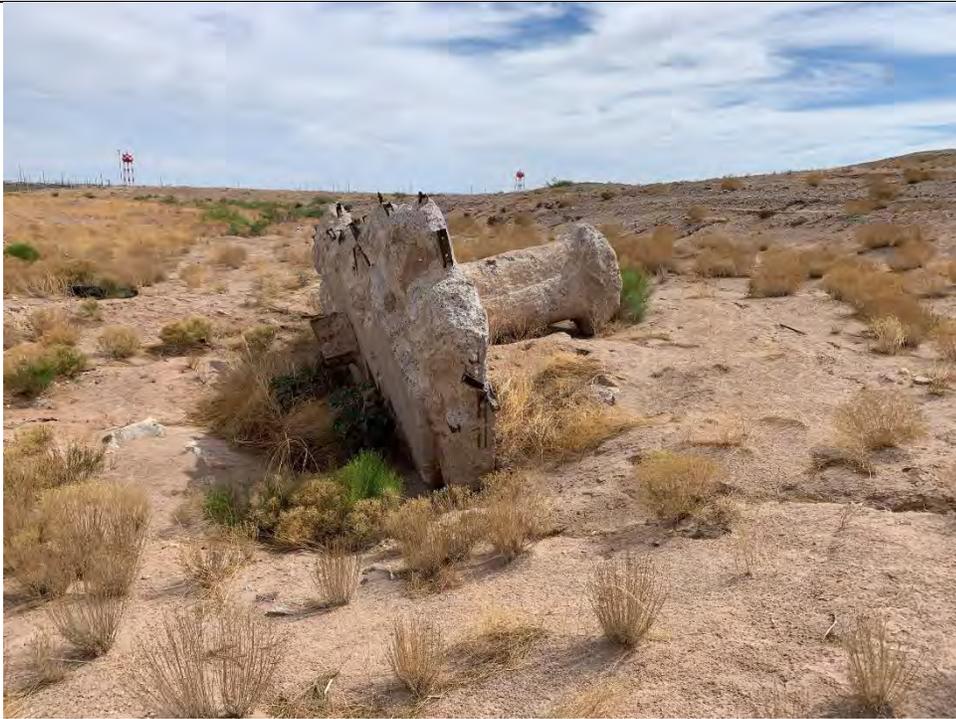
Photograph: CP-15-1

Description: Massive concrete structure, possible a foundation for a column at one point.

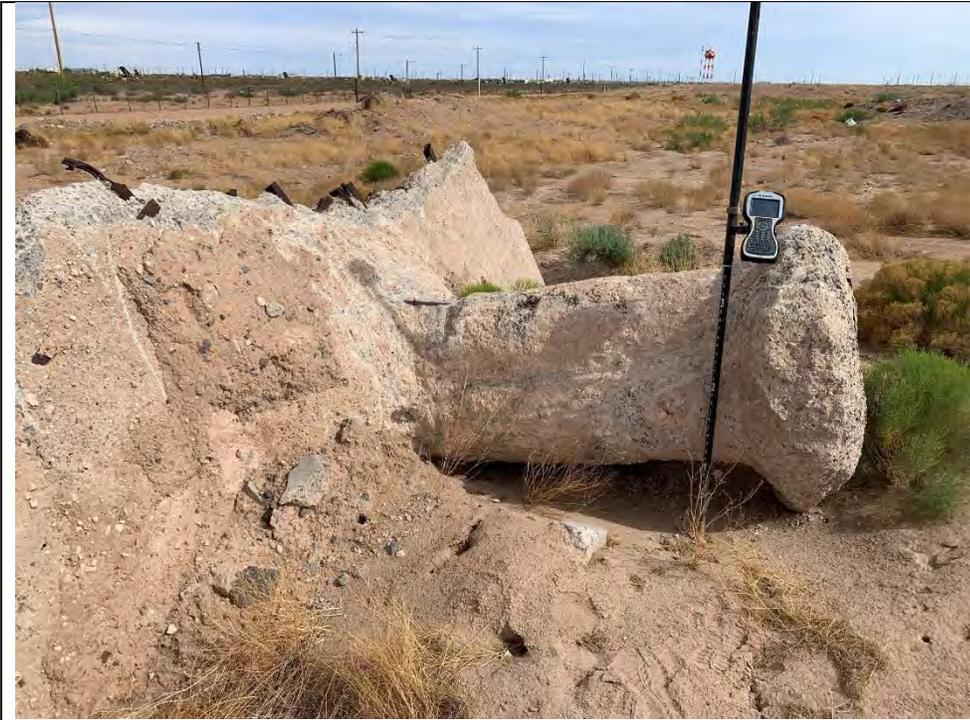
Photograph: CP-15-2

Description: The center piece of the massive structure is about 3 feet in diameter.

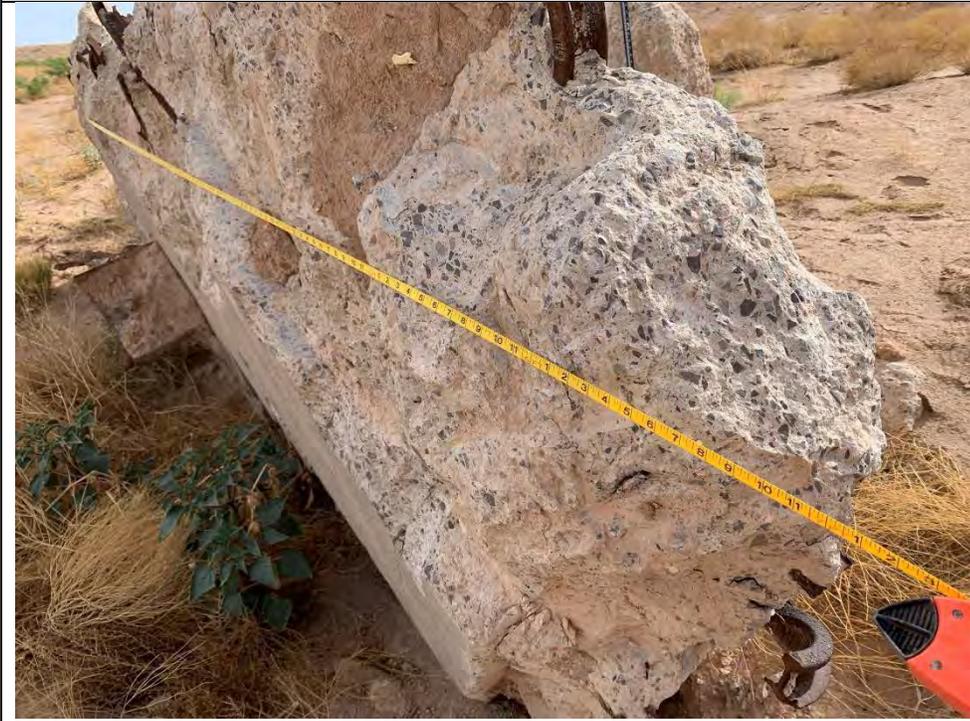
Photograph: CP-15-3

Description: Same concrete structure as previous photo with measuring up to 8 feet wide.

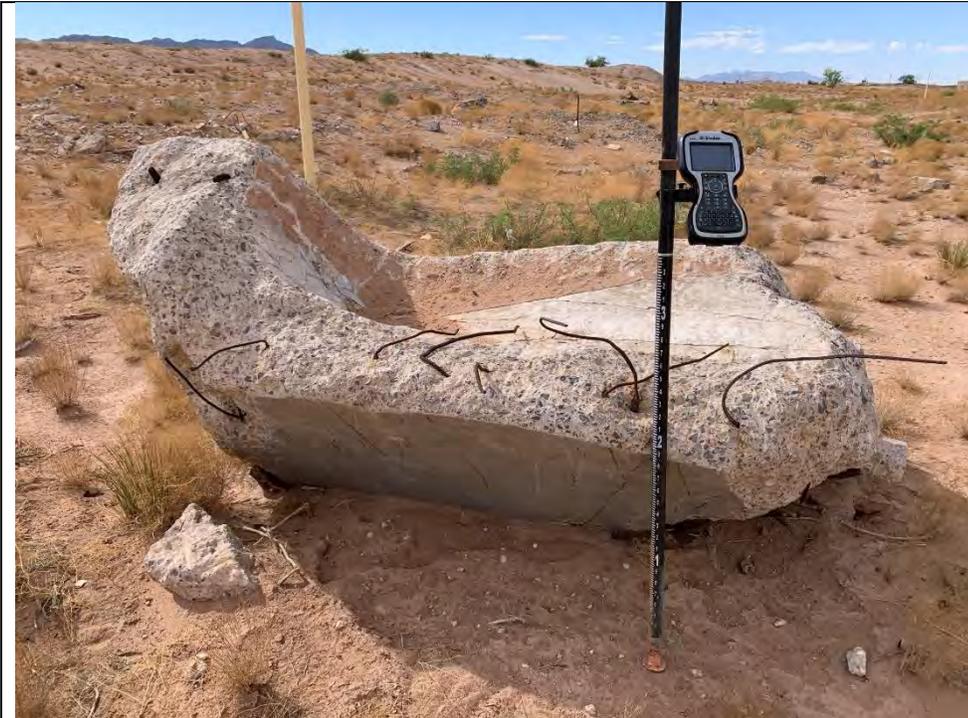
Photograph: CP-16-1

Description: Concrete structure with steel wire measuring about 2.5 feet tall.

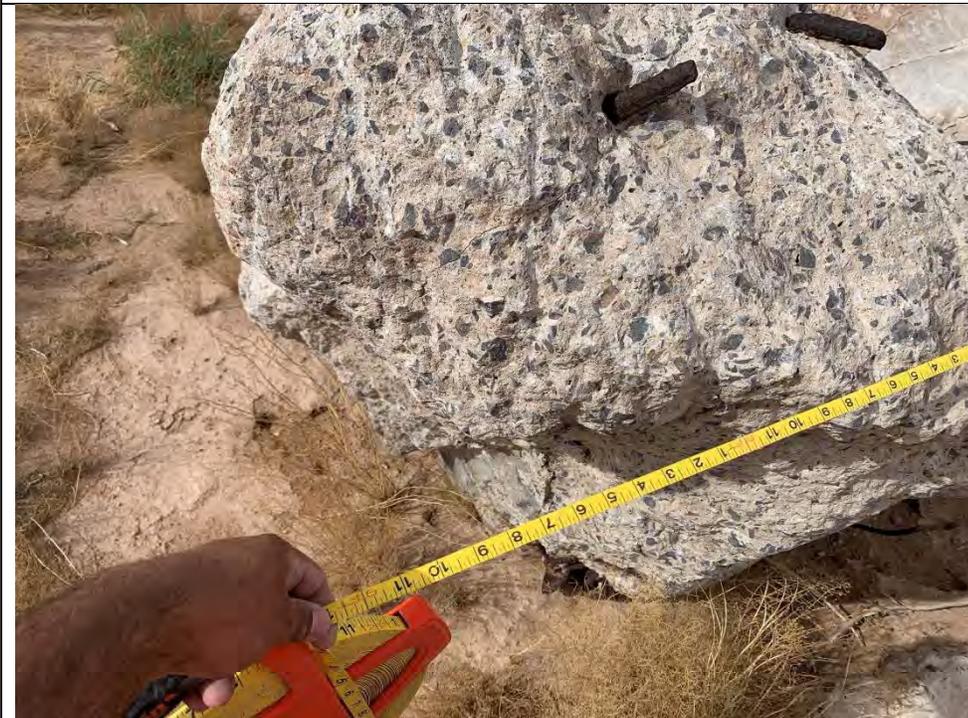
Photograph: CP-16-2

Description: Same concrete structure as previous photo with measuring up to 8 feet wide.

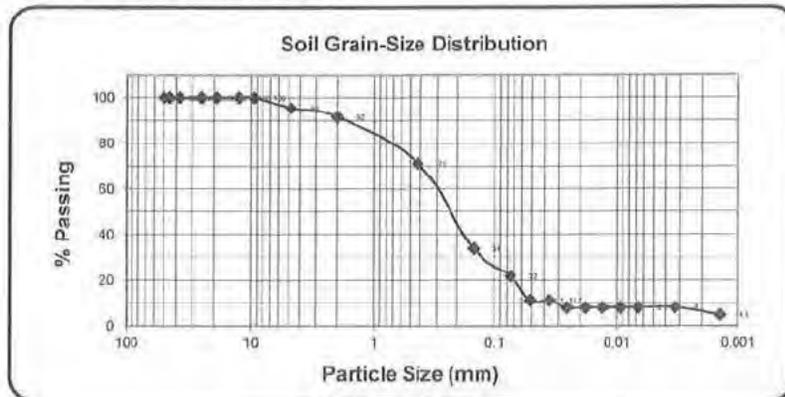
Sieve Analysis Test: ASTM C 136, D 6913

D10= 0.03
D30= 0.13
D60= 0.34
Cc= 1.35
Cu= 9.97

Test Method: ASTM D 2487 - Soil Class: SM

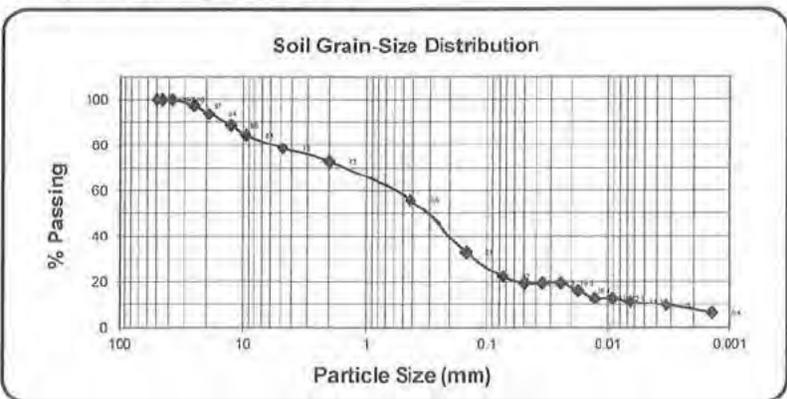
Sieve Analysis Test: ASTM C 136, D 6913

D10= 0.03
D30= 0.13
D60= 0.80
Cc= 0.62
Cu= 23.90

Test Method: ASTM D 2487 - Soil Class: SC

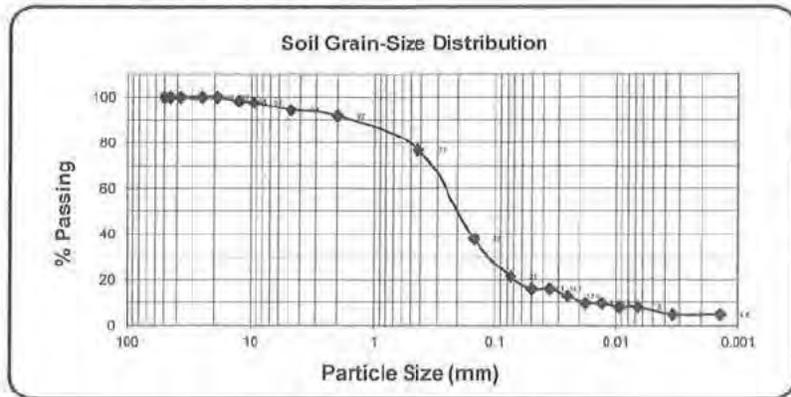
Sieve Analysis Test: ASTM C 136, D 6913

D10= 0.04
D30= 0.11
D60= 0.31
Cc= 1.21
Cu= 8.69

Test Method: ASTM D 2487 -- Soil Class: SM

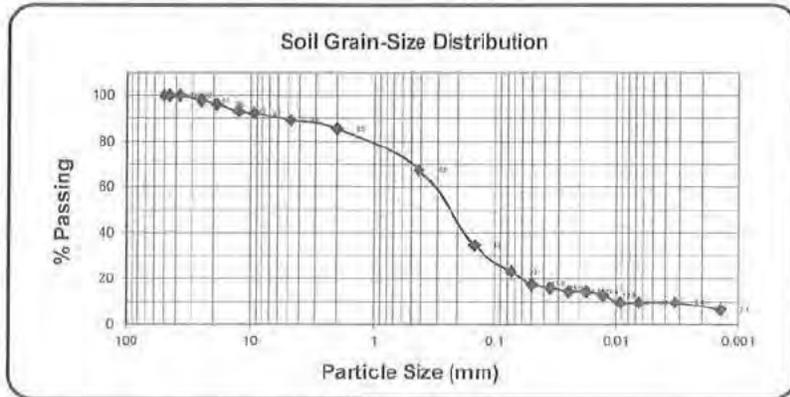
Sieve Analysis Test: ASTM C 136, D 6913

Test Method: ASTM D 2487 - Soil Class: SC

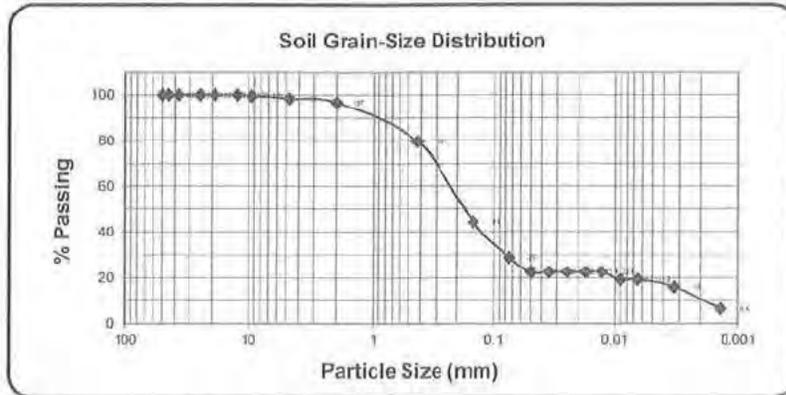
Sieve Analysis Test: ASTM C 136, D 6913

D10= 0.03
D30= 0.08
D60= 0.27
Cc= 0.92
Cu= 10.43

Test Method: ASTM D 2487 - Soil Class: SC

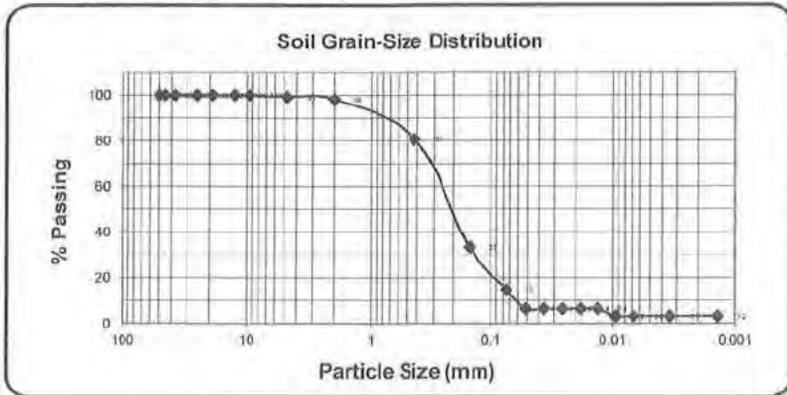
Sieve Analysis Test: ASTM C 136, D 6913

D10= 0.05
D30= 0.14
D60= 0.30
Cc= 1.21
Cu= 6.04

Test Method: ASTM D 2487 - Soil Class: SM

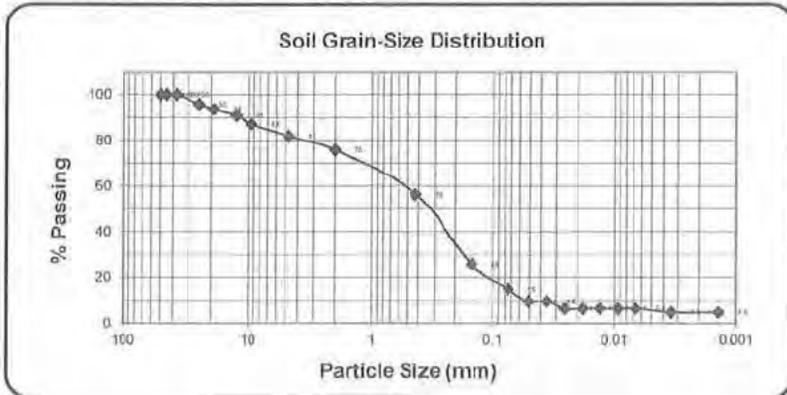
Sieve Analysis Test: ASTM C 136, D 6913

D10= 0.05
D30= 0.19
D60= 0.71
Cc= 0.97
Cu= 14.18

Test Method: ASTM D 2487 - Soil Class: SM
