# Photograph Log

Fort Bliss  
Limits of Waste Investigation  
30056989

## **Appendix C – Laboratory Report**

**PROJECT ASTM SOIL CLASSIFICATION REPORT  
SOIL SIEVE ANALYSIS, HYDROMETER ANALYSIS  
ATTERBERG LIMITS, SOIL CLASSIFICATION  
TEST RESULTS**

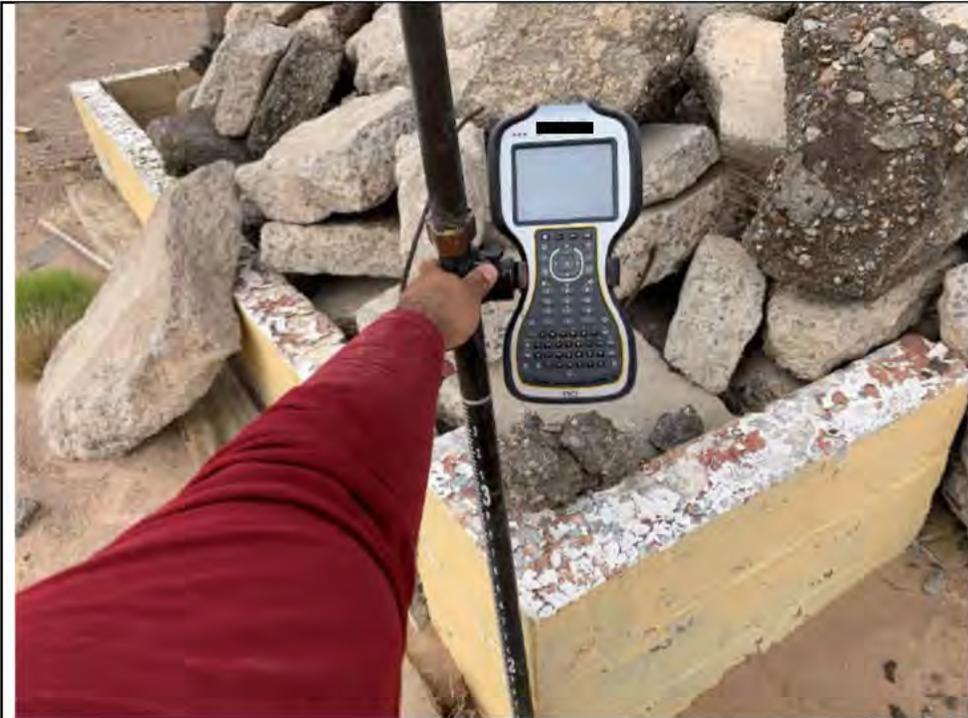
**Photograph: CP-11-2**

**Description:** Cinder block wall measuring up to 2.5 feet. Possible paint can be lead-based paint.

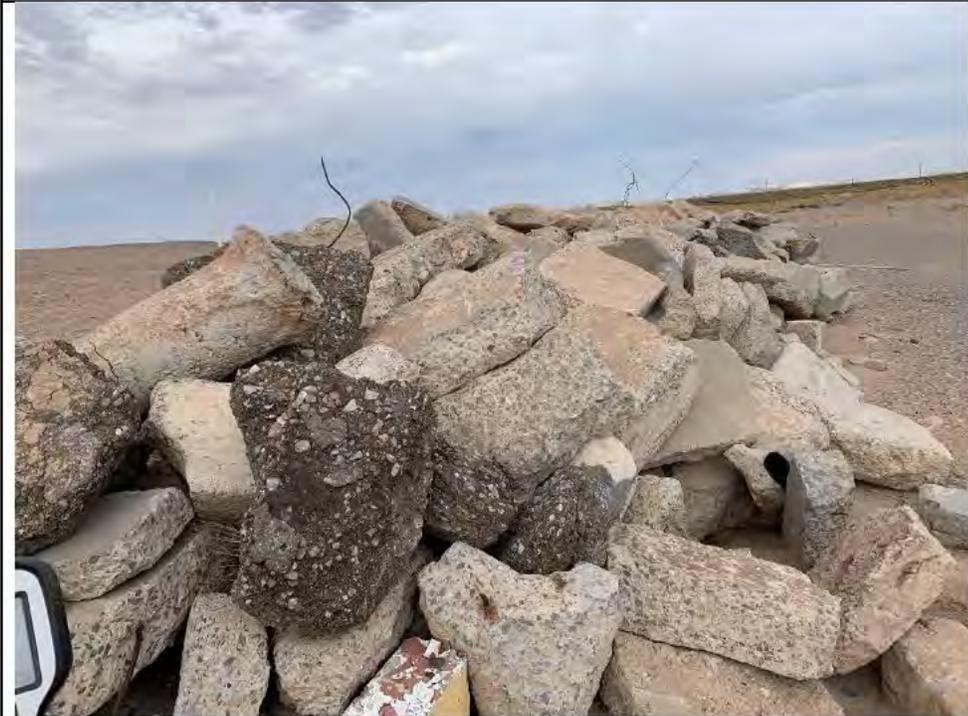
**Photograph: CP-11-3**

**Description:** Some asphalt mixed within the concrete pile along with rebar and/or steel wires.

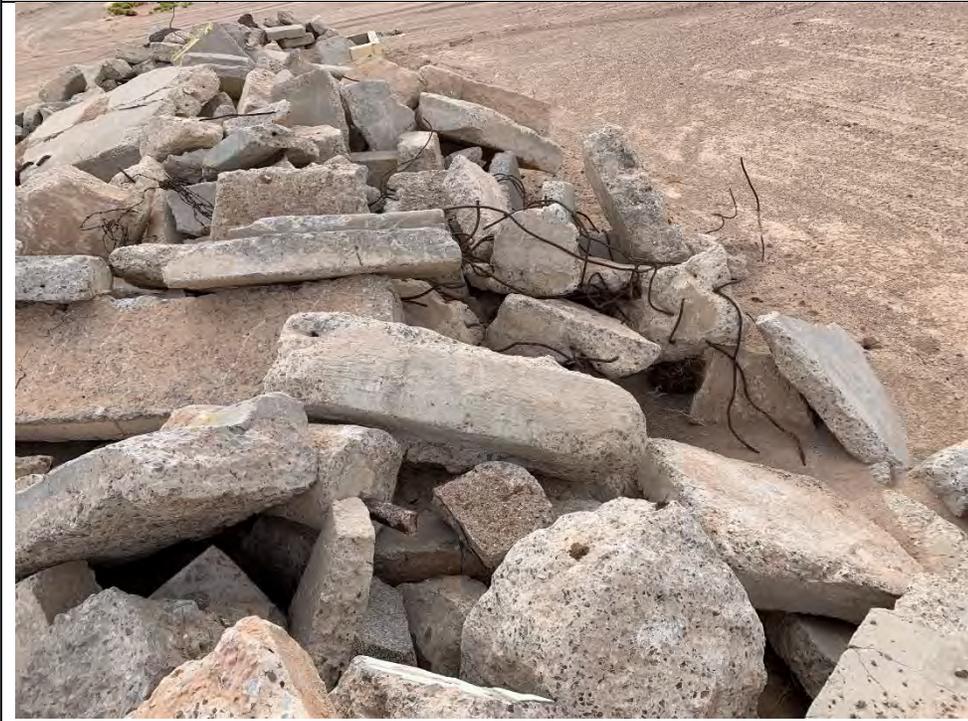
**Photograph: CP-11-5**

**Description:** Some visible rebar steel wire within the concrete pile.

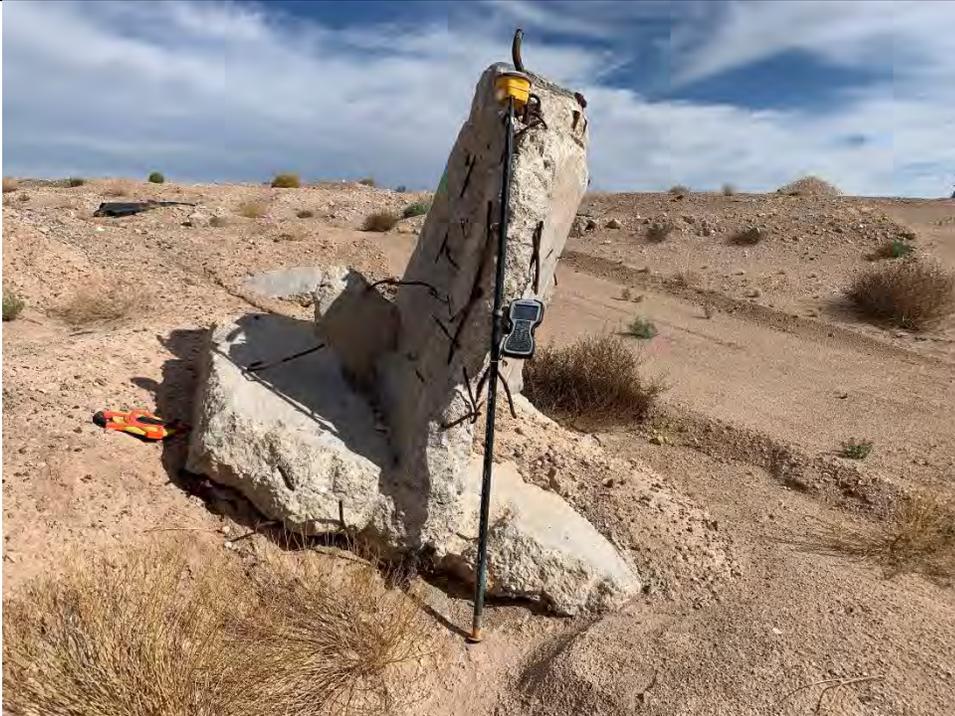
**Photograph: CP-12-1**

**Description:** Large concrete structure found on north side of landfill. Vertical height of about 6 feet.

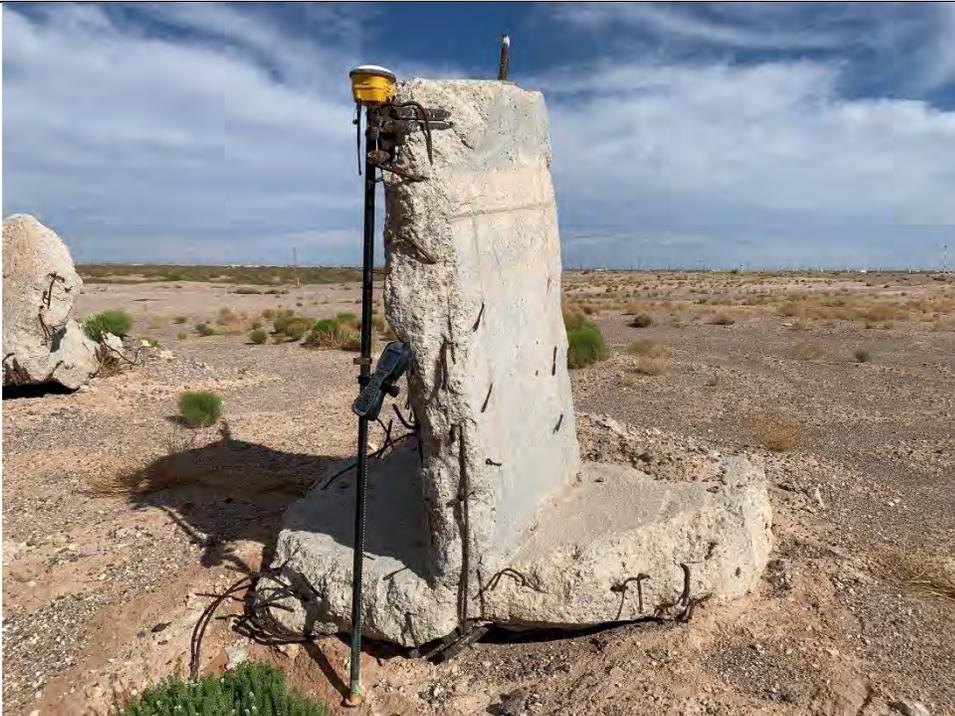
**Photograph: CP-12-2**

**Description:** Concrete Structure approximately 20 feet away from another concrete structure that measures about 6 feet tall.

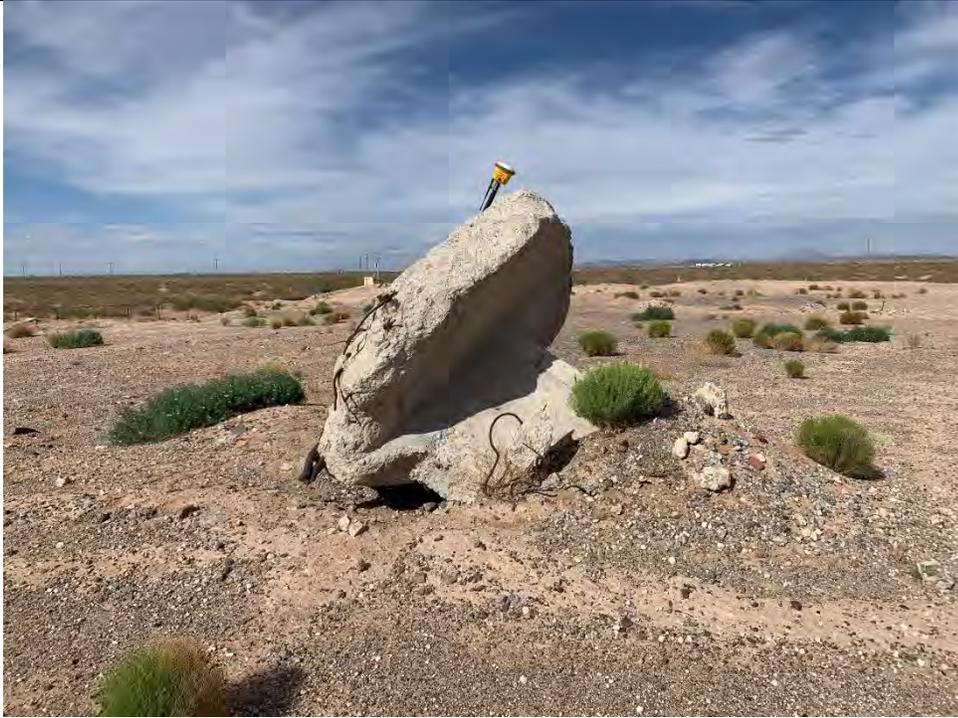
**Photograph: CP-13-3**

**Description:** Looking northeast at side of concrete structure.

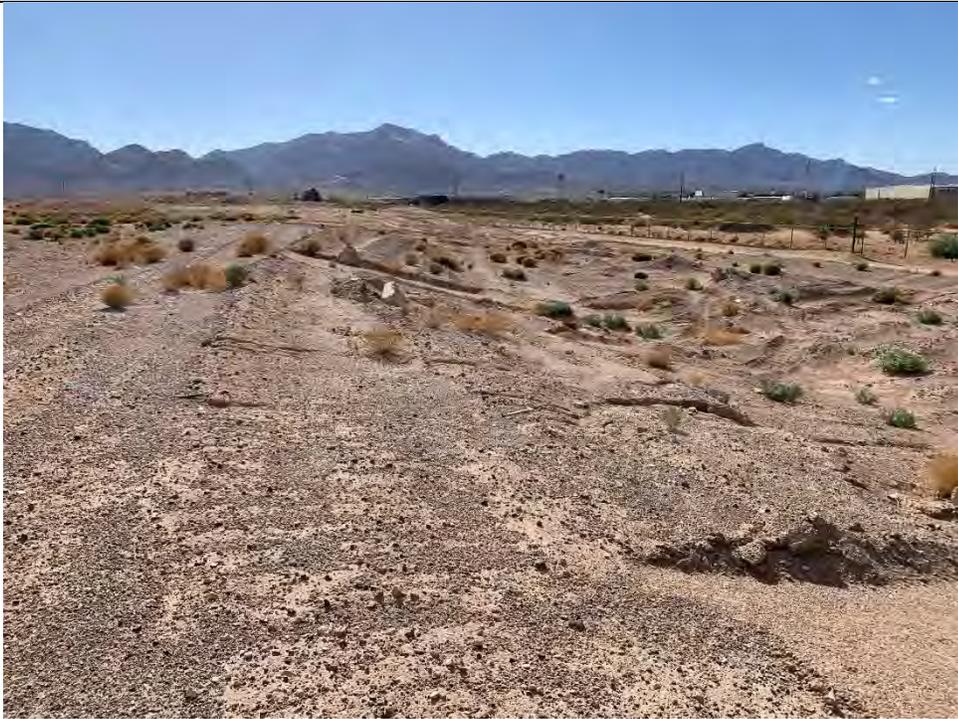
**Photograph: CP-14-1**

**Description:** Visible small pieces of concrete thrown across the northeastern portion of the landfill.

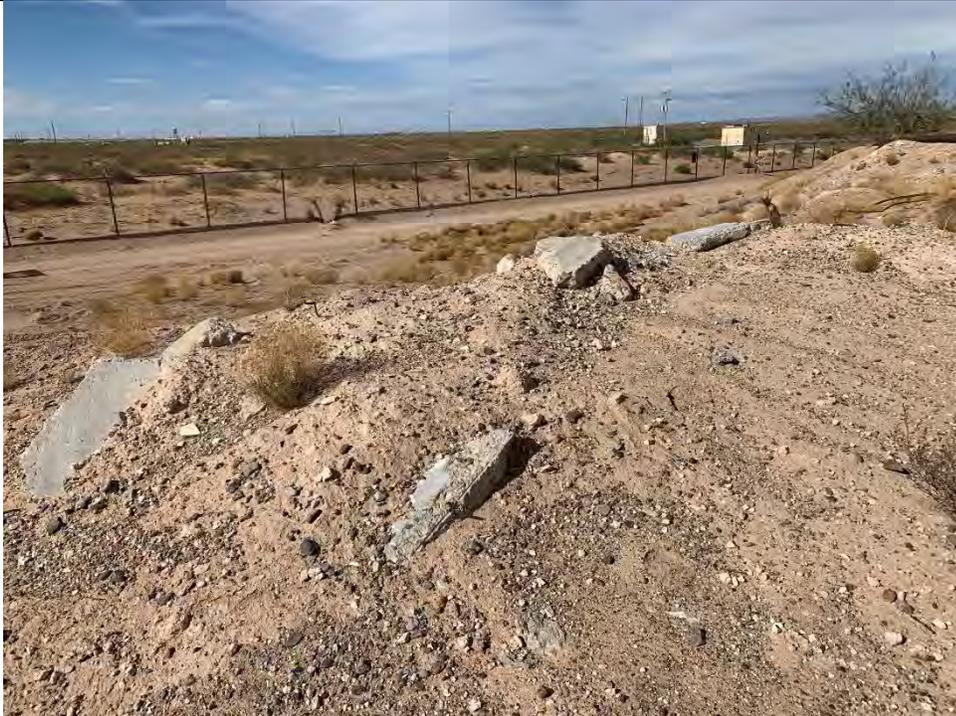
**Photograph: CP-14-2**  
**Description:** More visible pieces of concrete measuring up to 3 feet thrown across the northeastern portion of the landfill.

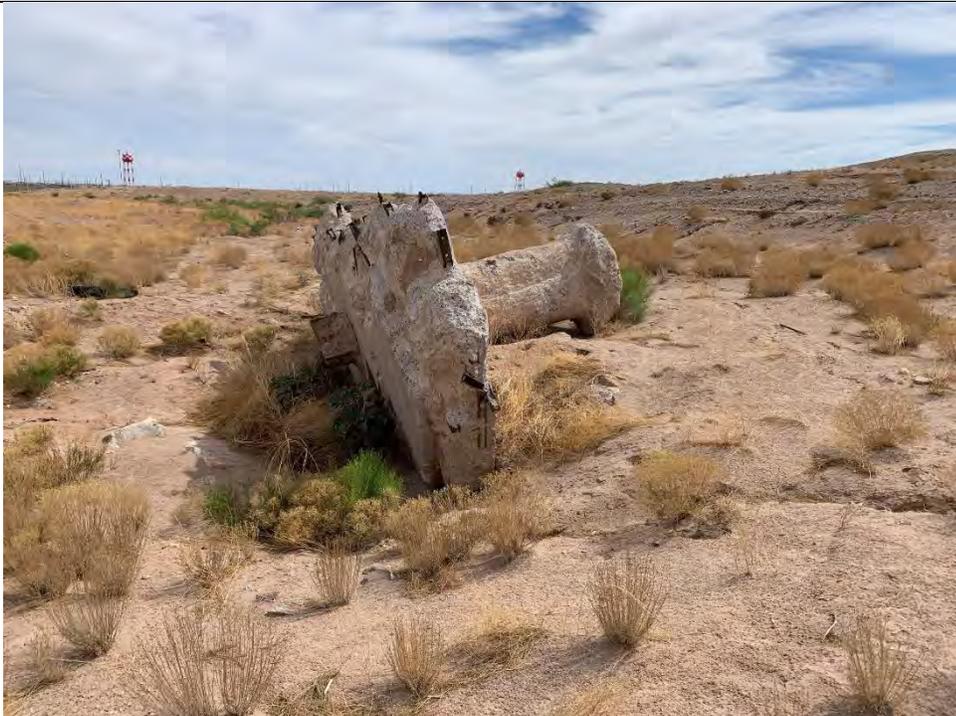
**Photograph: CP-15-1**  
**Description:** Massive concrete structure, possible a foundation for a column at one point.

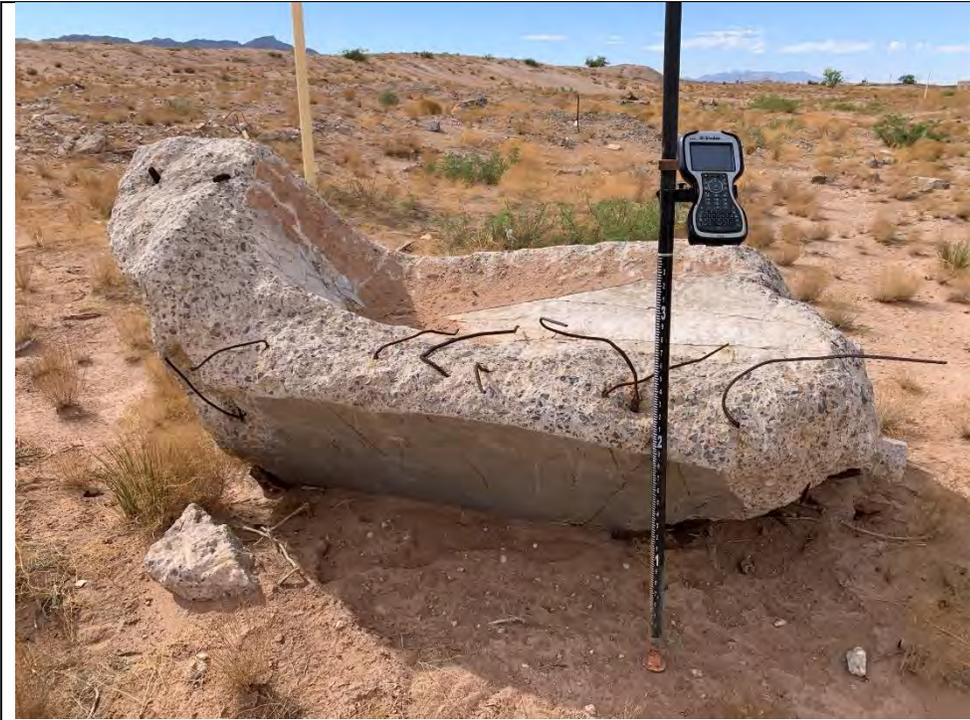
**Photograph: CP-16-1**

**Description:** Concrete structure with steel wire measuring about 2.5 feet tall.

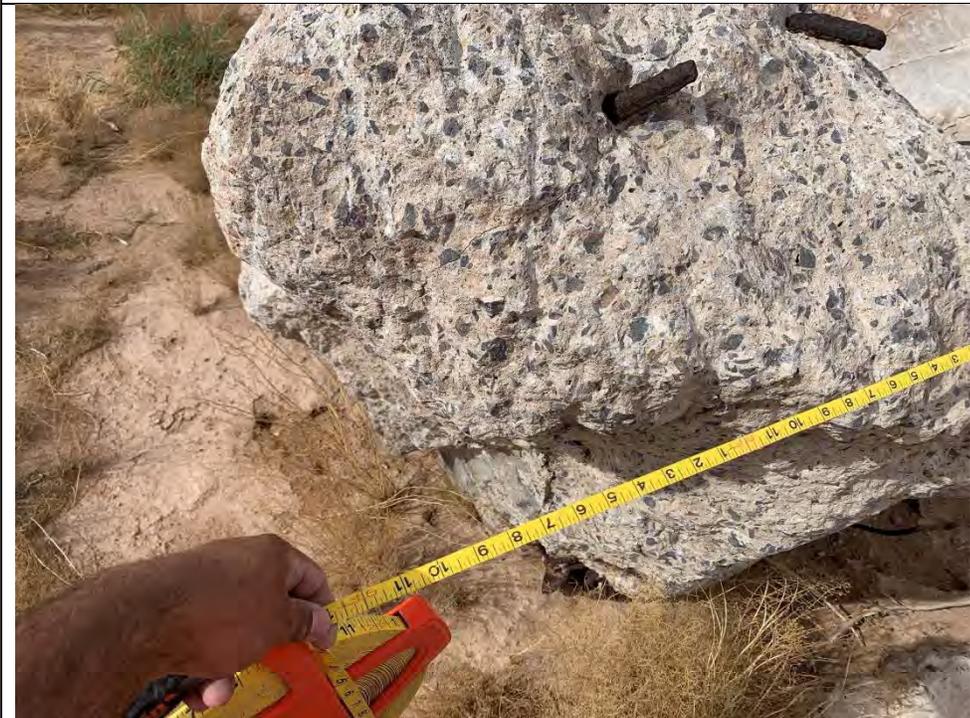
**Photograph: CP-16-2**

**Description:** Same concrete structure as previous photo with measuring up to 8 feet wide.

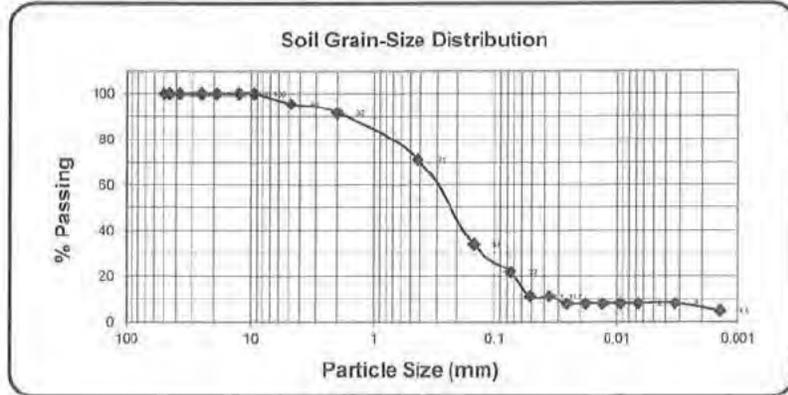
Sieve Size/No.	Percent Retained	Percent Passing	Fill Material Specification % Passing
3"	0	100	*
1 1/2"	0	100	*
1"	0	100	*
3/4"	0	100	*
1/2"	0	100	*
3/8"	0	100	*
#4	4	96	*
#10	8	92	*
#40	29	71	*
#100	66	34	*
#200	78.2	21.8	*

D10= 0.03  
D30= 0.13  
D60= 0.34  
Cc= 1.35  
Cu= 9.97

Test Method: ASTM D 2487 - Soil Class: SM

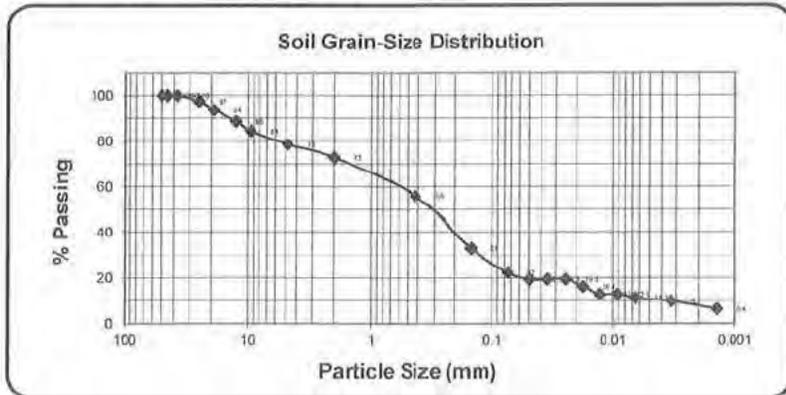
Sieve Size/No.	Percent Retained	Percent Passing	Fill Material Specification % Passing
3"	0	100	*
1 1/2"	0	100	*
1"	3	97	*
3/4"	6	94	*
1/2"	11	89	*
3/8"	16	84	*
#4	21	79	*
#10	27	73	*
#40	44	56	*
#100	67	33	*
#200	77.7	22.3	*

D10= 0.03  
D30= 0.13  
D60= 0.80  
Cc= 0.62  
Cu= 23.90

Test Method: ASTM D 2487 - Soil Class: SC

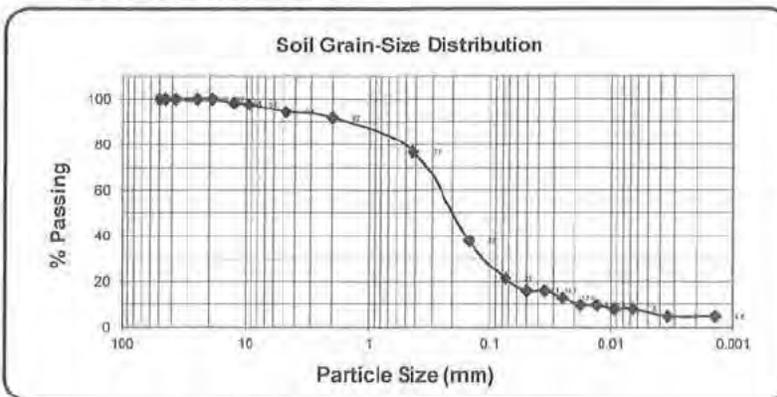
Sieve Size/No.	Percent Retained	Percent Passing	Fill Material Specification % Passing
3"	0	100	*
1 1/2"	0	100	*
1"	0	100	*
3/4"	0	100	*
1/2"	2	98	*
3/8"	2	98	*
#4	6	94	*
#10	8	92	*
#40	23	77	*
#100	62	38	*
#200	78.7	21.3	*

D10= 0.04  
D30= 0.11  
D60= 0.31  
Cc= 1.21  
Cu= 8.69

Test Method: ASTM D 2487 - Soil Class: SM
