**INVENTORY AND ELIGIBILITY EVALUATION OF
ENOCH TANNER WICKHAM MEMORIAL SCULPTURE,
FT. CAMPBELL, MONTGOMERY COUNTY, TN**

**Prepared for:
USACE Louisville District
600 Martin Luther King Drive
Louisville, Kentucky 40202-2232**

**Prepared by:
Samiran Chanchani, Ph.D.
Principal Investigator
BHE Environmental, Inc.
11733 Chesterdale Road
Cincinnati OH
513-326-1500
www.bheenv.com**

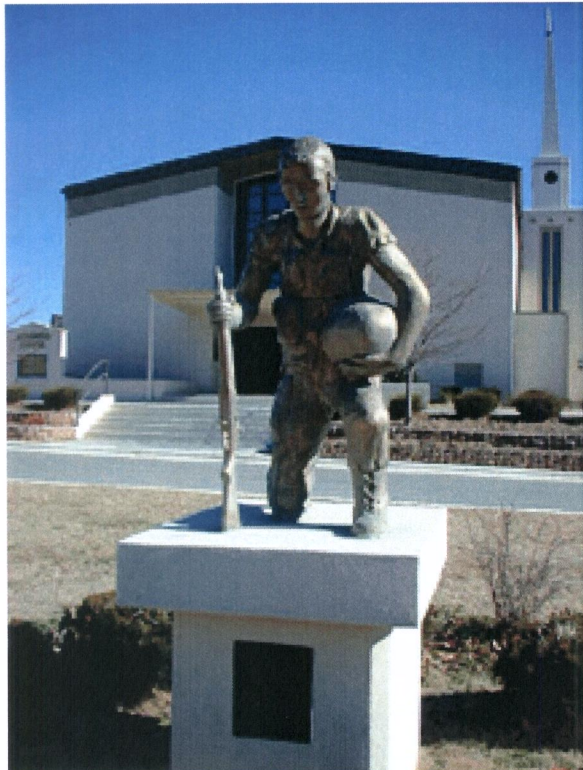
Standing on a square, concrete base, the life-size sculpture depicts a soldier in combat gear kneeling down, holding a gun in his right hand, a helmet in his left, and a knapsack across his back. His posture is one of deference or prayer – eyes shut, head bowed, helmet in hand, and kneeling with one knee to the ground. His features do not cast a deep relief, nor are the details of

Fig. 2: Soldier's Memorial Statue with Soldier's Chapel in background (left); Fig. 3: Soldier's Memorial, looking North, Medical Clinic and parking lot in the background (right)

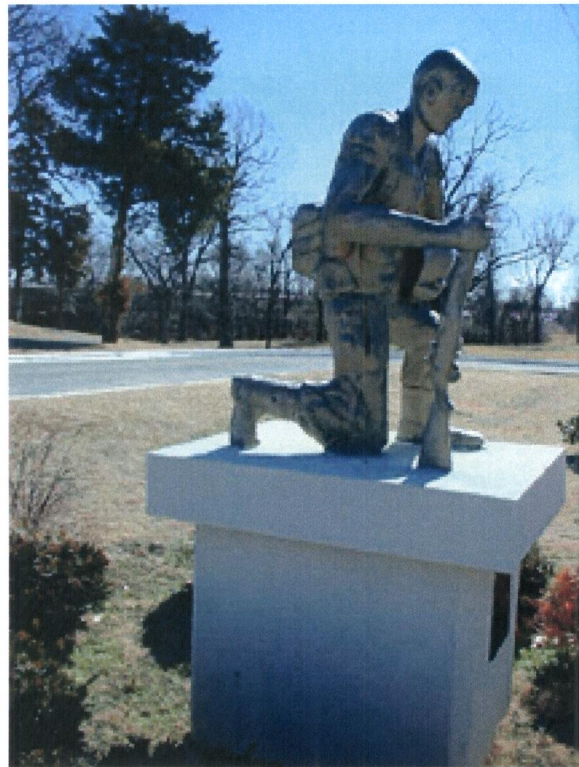
Fig.4: Soldier's Memorial Statue looking South (left); Fig. 5: Soldier's Memorial, looking West, Korean War era billet in background (right)
