Table 4.0-3. RMA Remedial Project Status as of March 31, 2020

**ROCKY MOUNTAIN ARSENAL
COMMERCE CITY, COLORADO**

PROJECT NAME
**2020
FIVE-YEAR REVIEW REPORT**

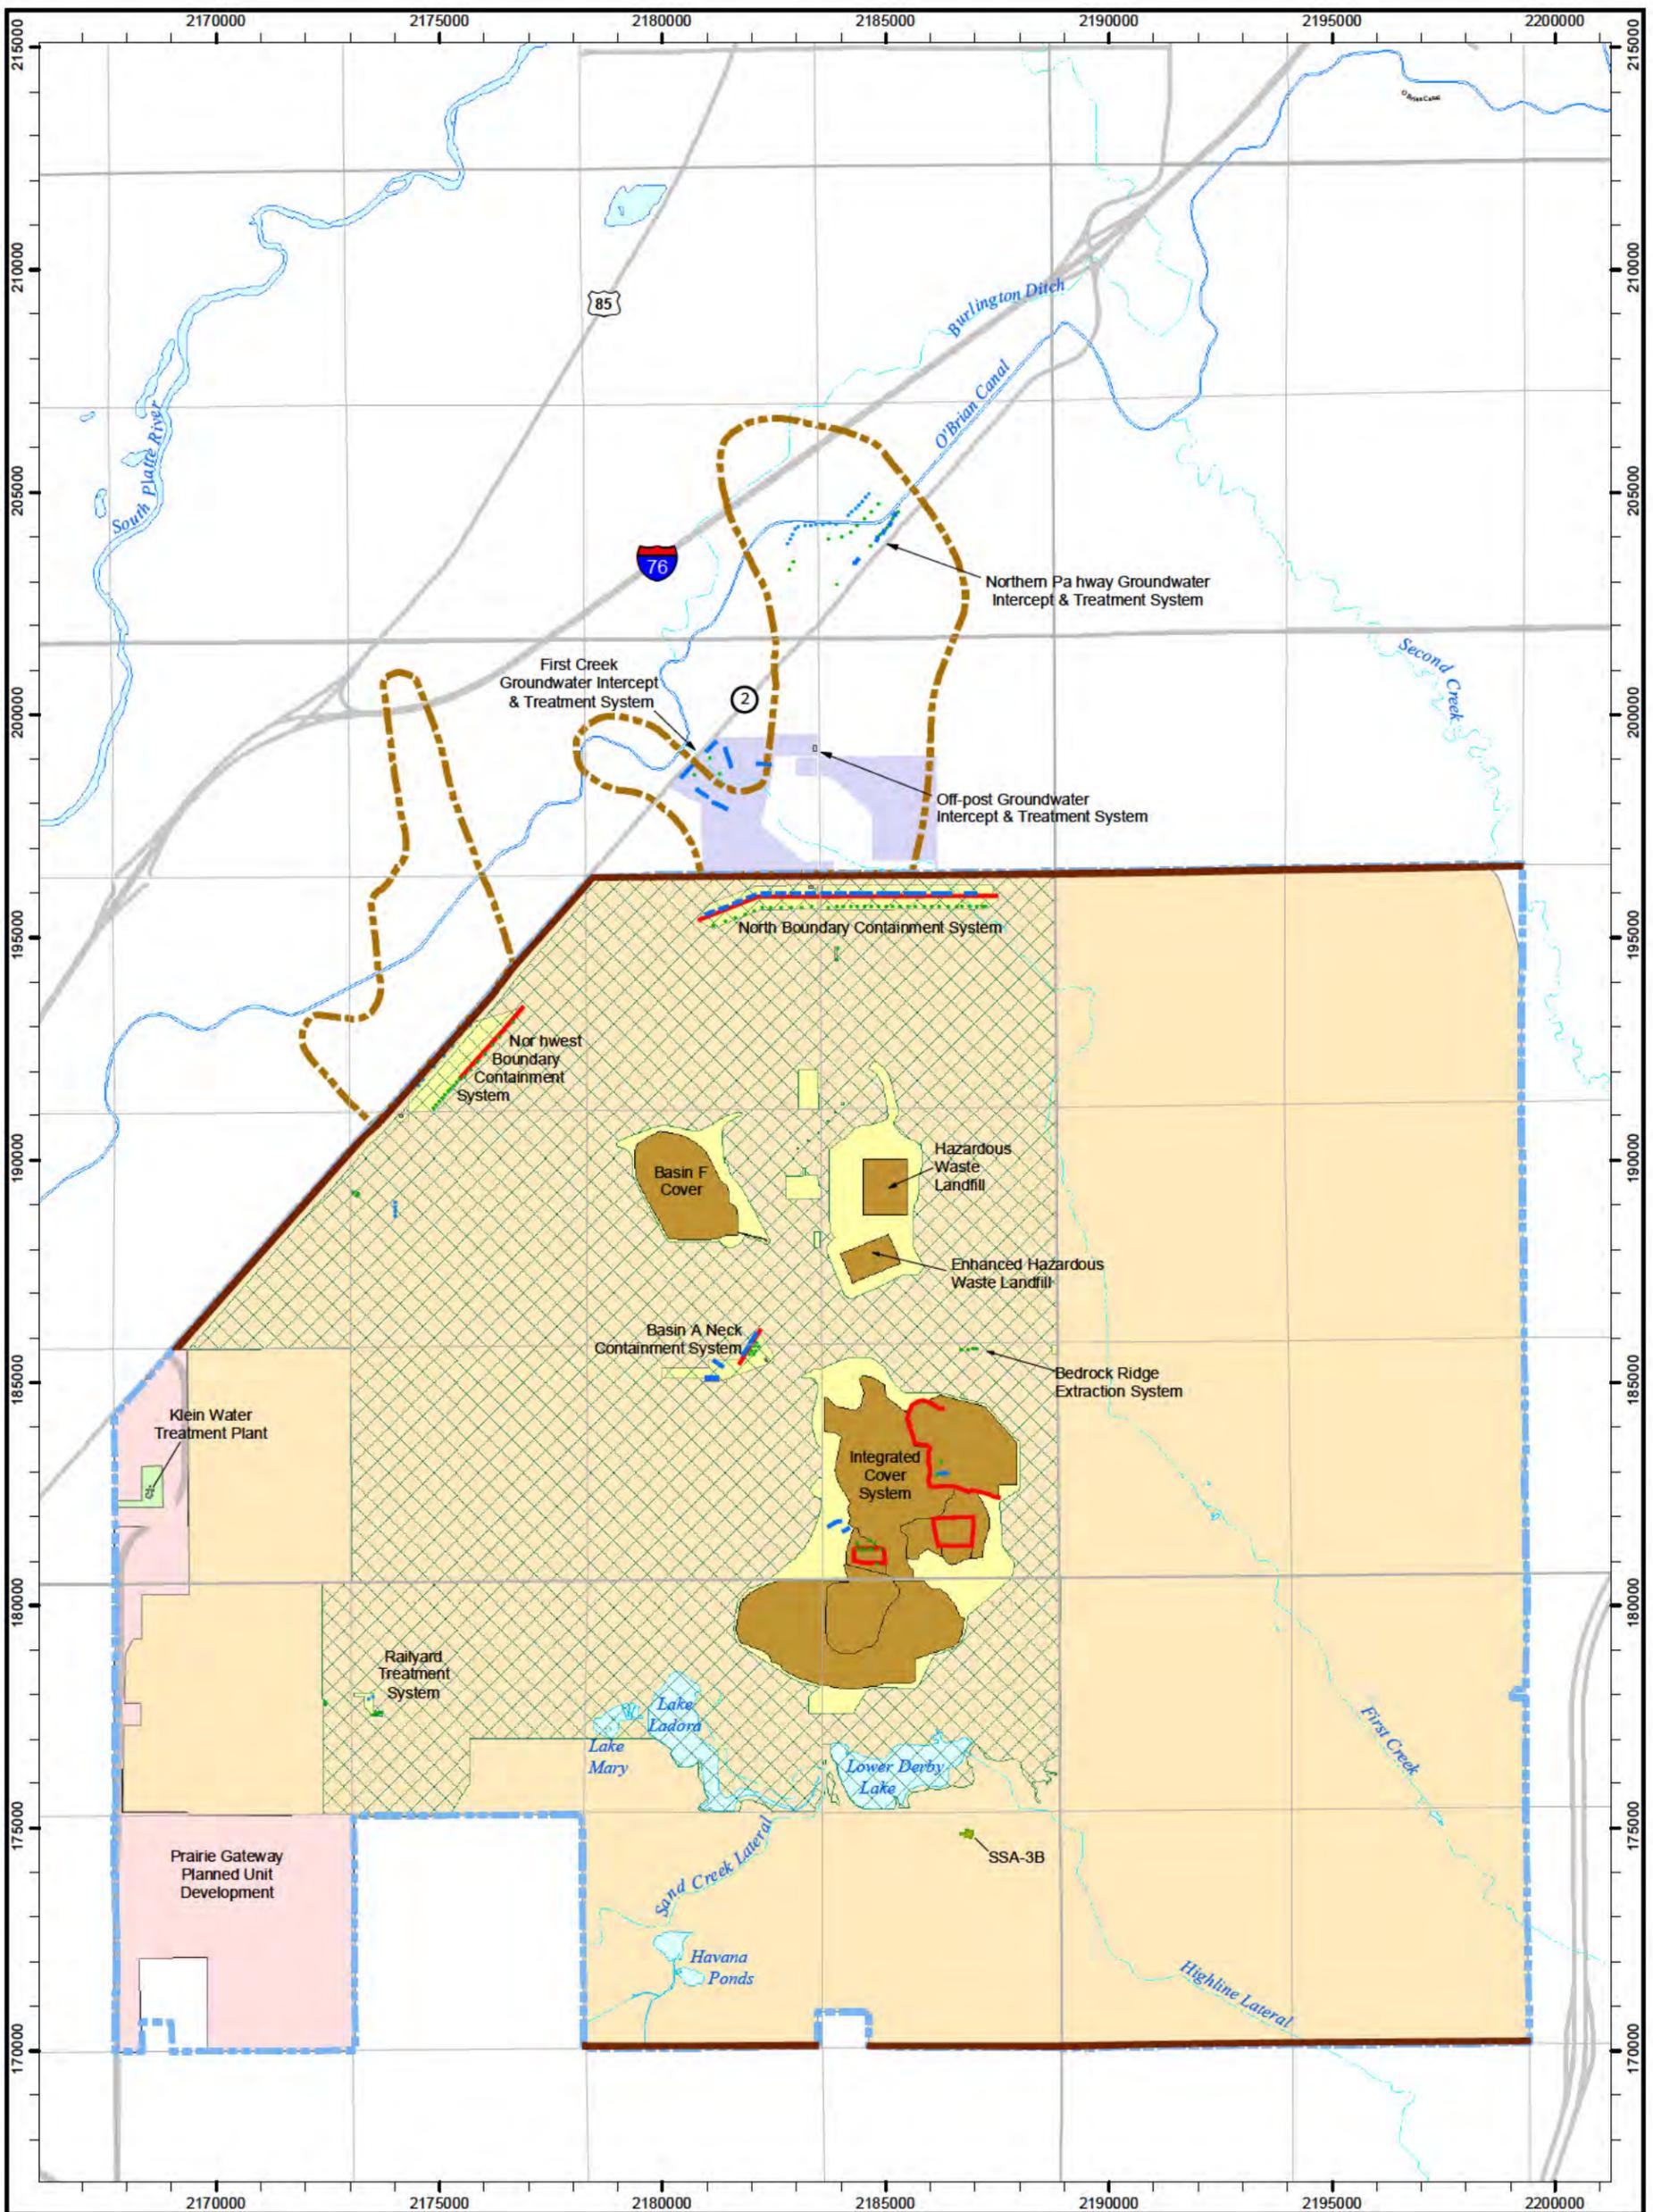
Figure 3.0-1

Note: Monitoring wells not shown for clarity. Location of monitoring wells is provided in the Long-Term Monitoring Plan for Groundwater and Surface Water (TIEC & URS 2010)

RMA Details

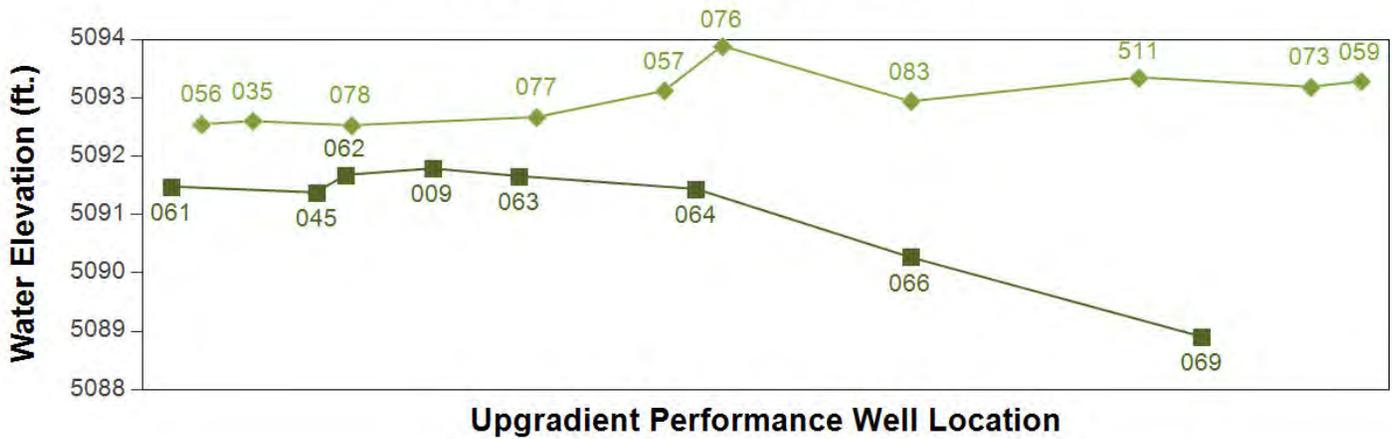
Northwest Boundary Water Levels

Third Quarter FY2019: 2019-04-01 to 2019-06-30

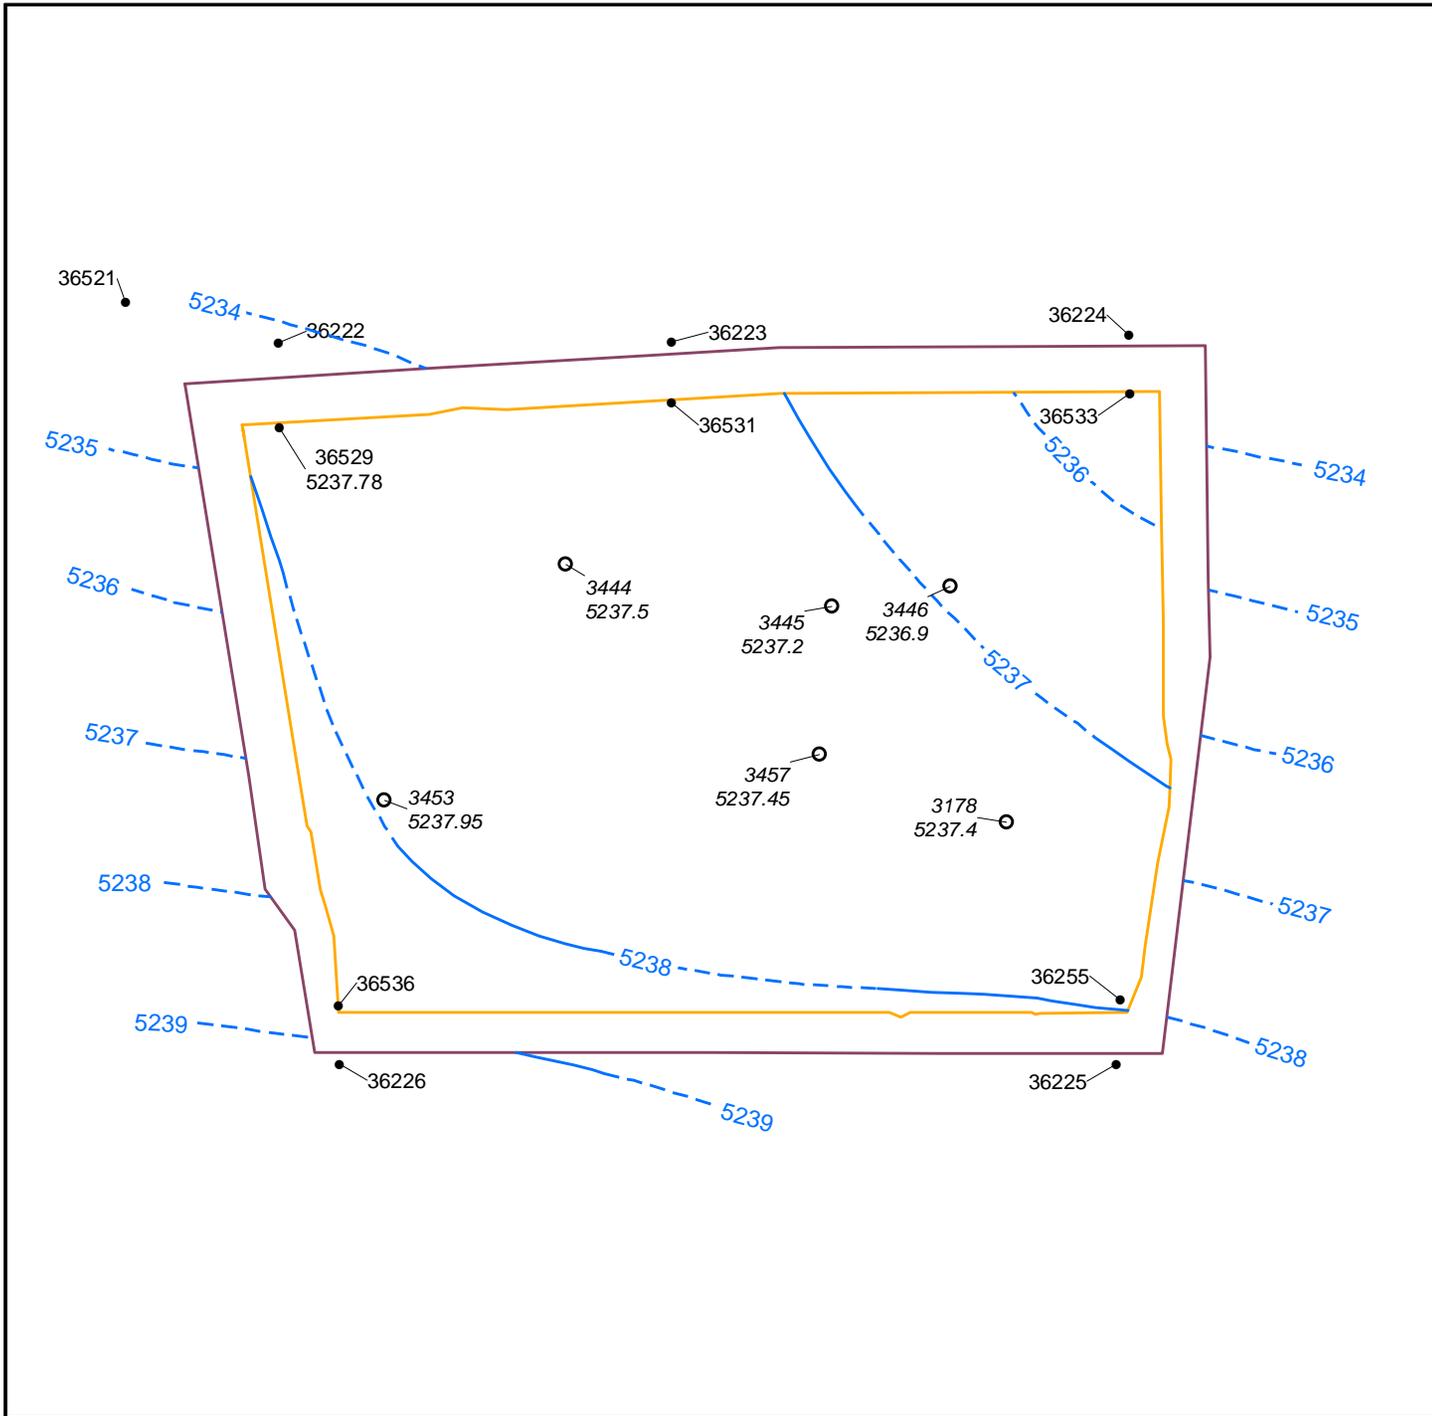
Figure 6.3-42
FY19 Shell Disposal Trenches Well and Borehole Locations and Potentiometric Surface

- Water elevation contours - 1 foot intervals
- - - Inferred water elevation contours
- ROD Slurry Wall
- IRA Slurry Wall
- Boreholes with Site ID and Water Elevation in Feet (Italics)
- Monitoring Wells with Site ID and Water Elevation in Feet

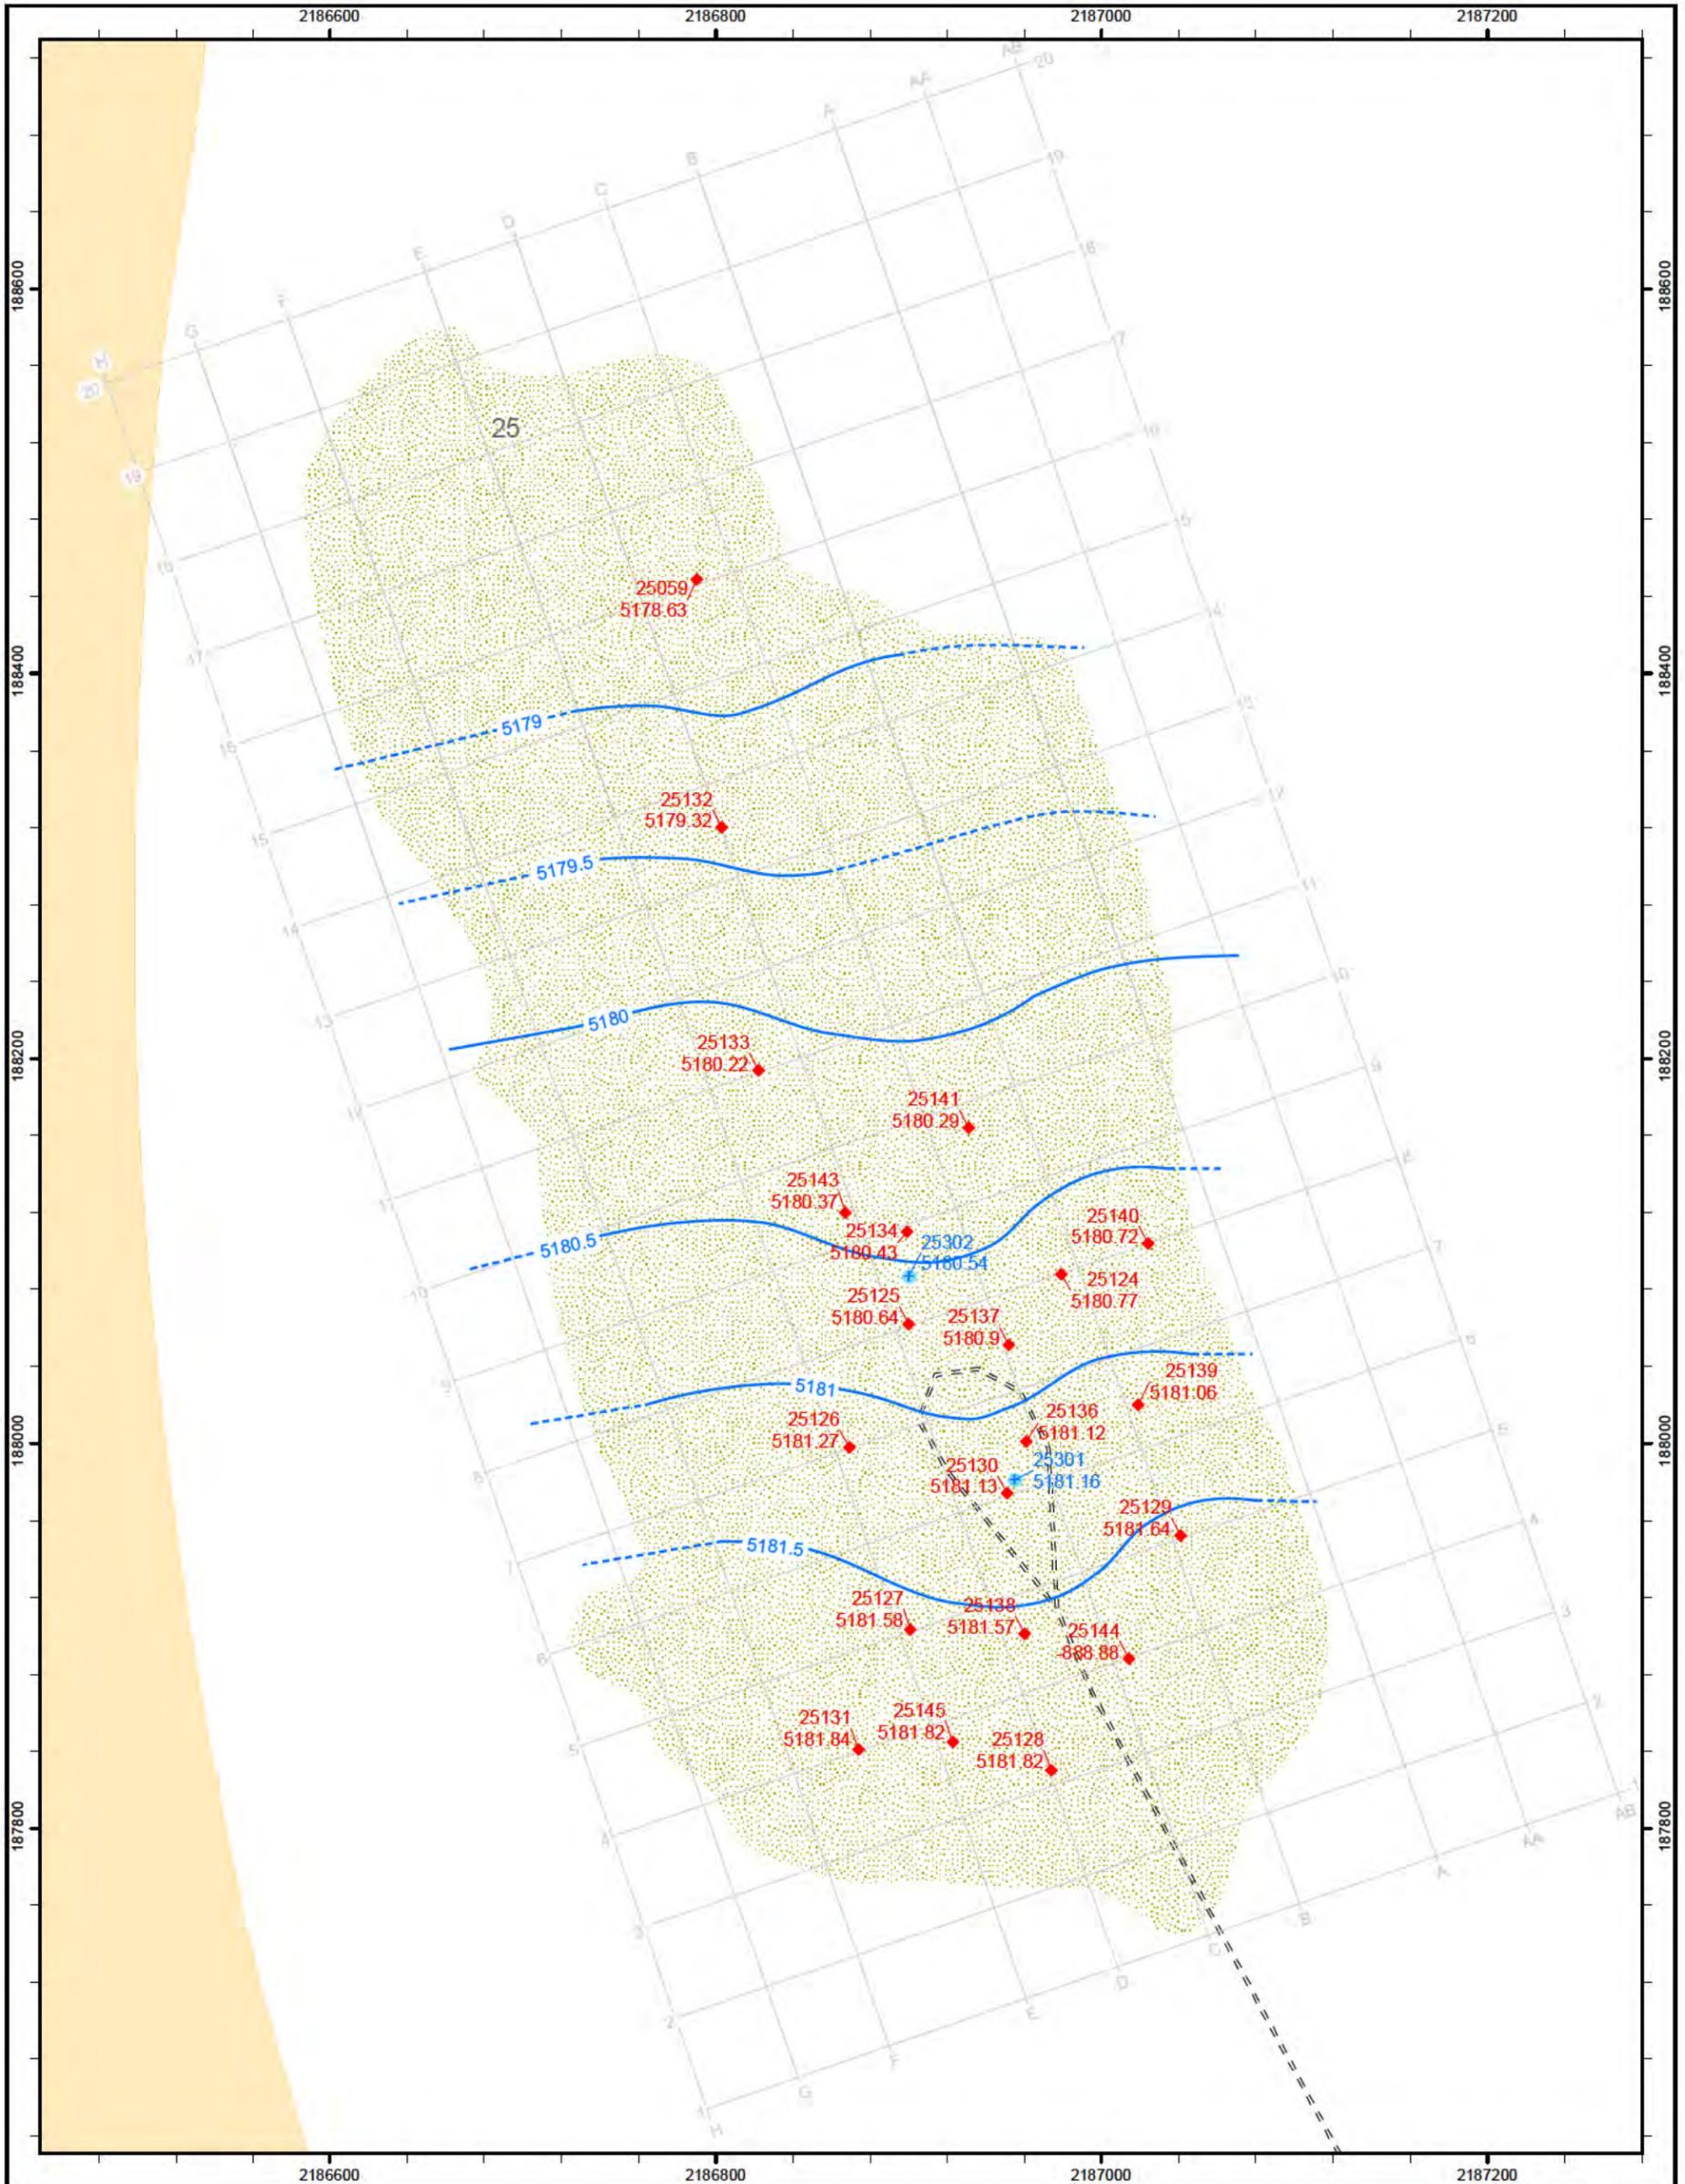
**North Plants LNAPL Recovery Wells
Water Elevations and LNAPL Thickness**

- Unsaturated Alluvium
- Historically stained and/or contaminated soil
- Water elevation contour - 1 foot interval
- Inferred water elevation contour
- Unpaved Roads
- Piezometer
- Recovery Well

Notes: Water levels were measured in FY19 Quarter 2.
Water level in well 25144 could not be measured due to a damaged casing.

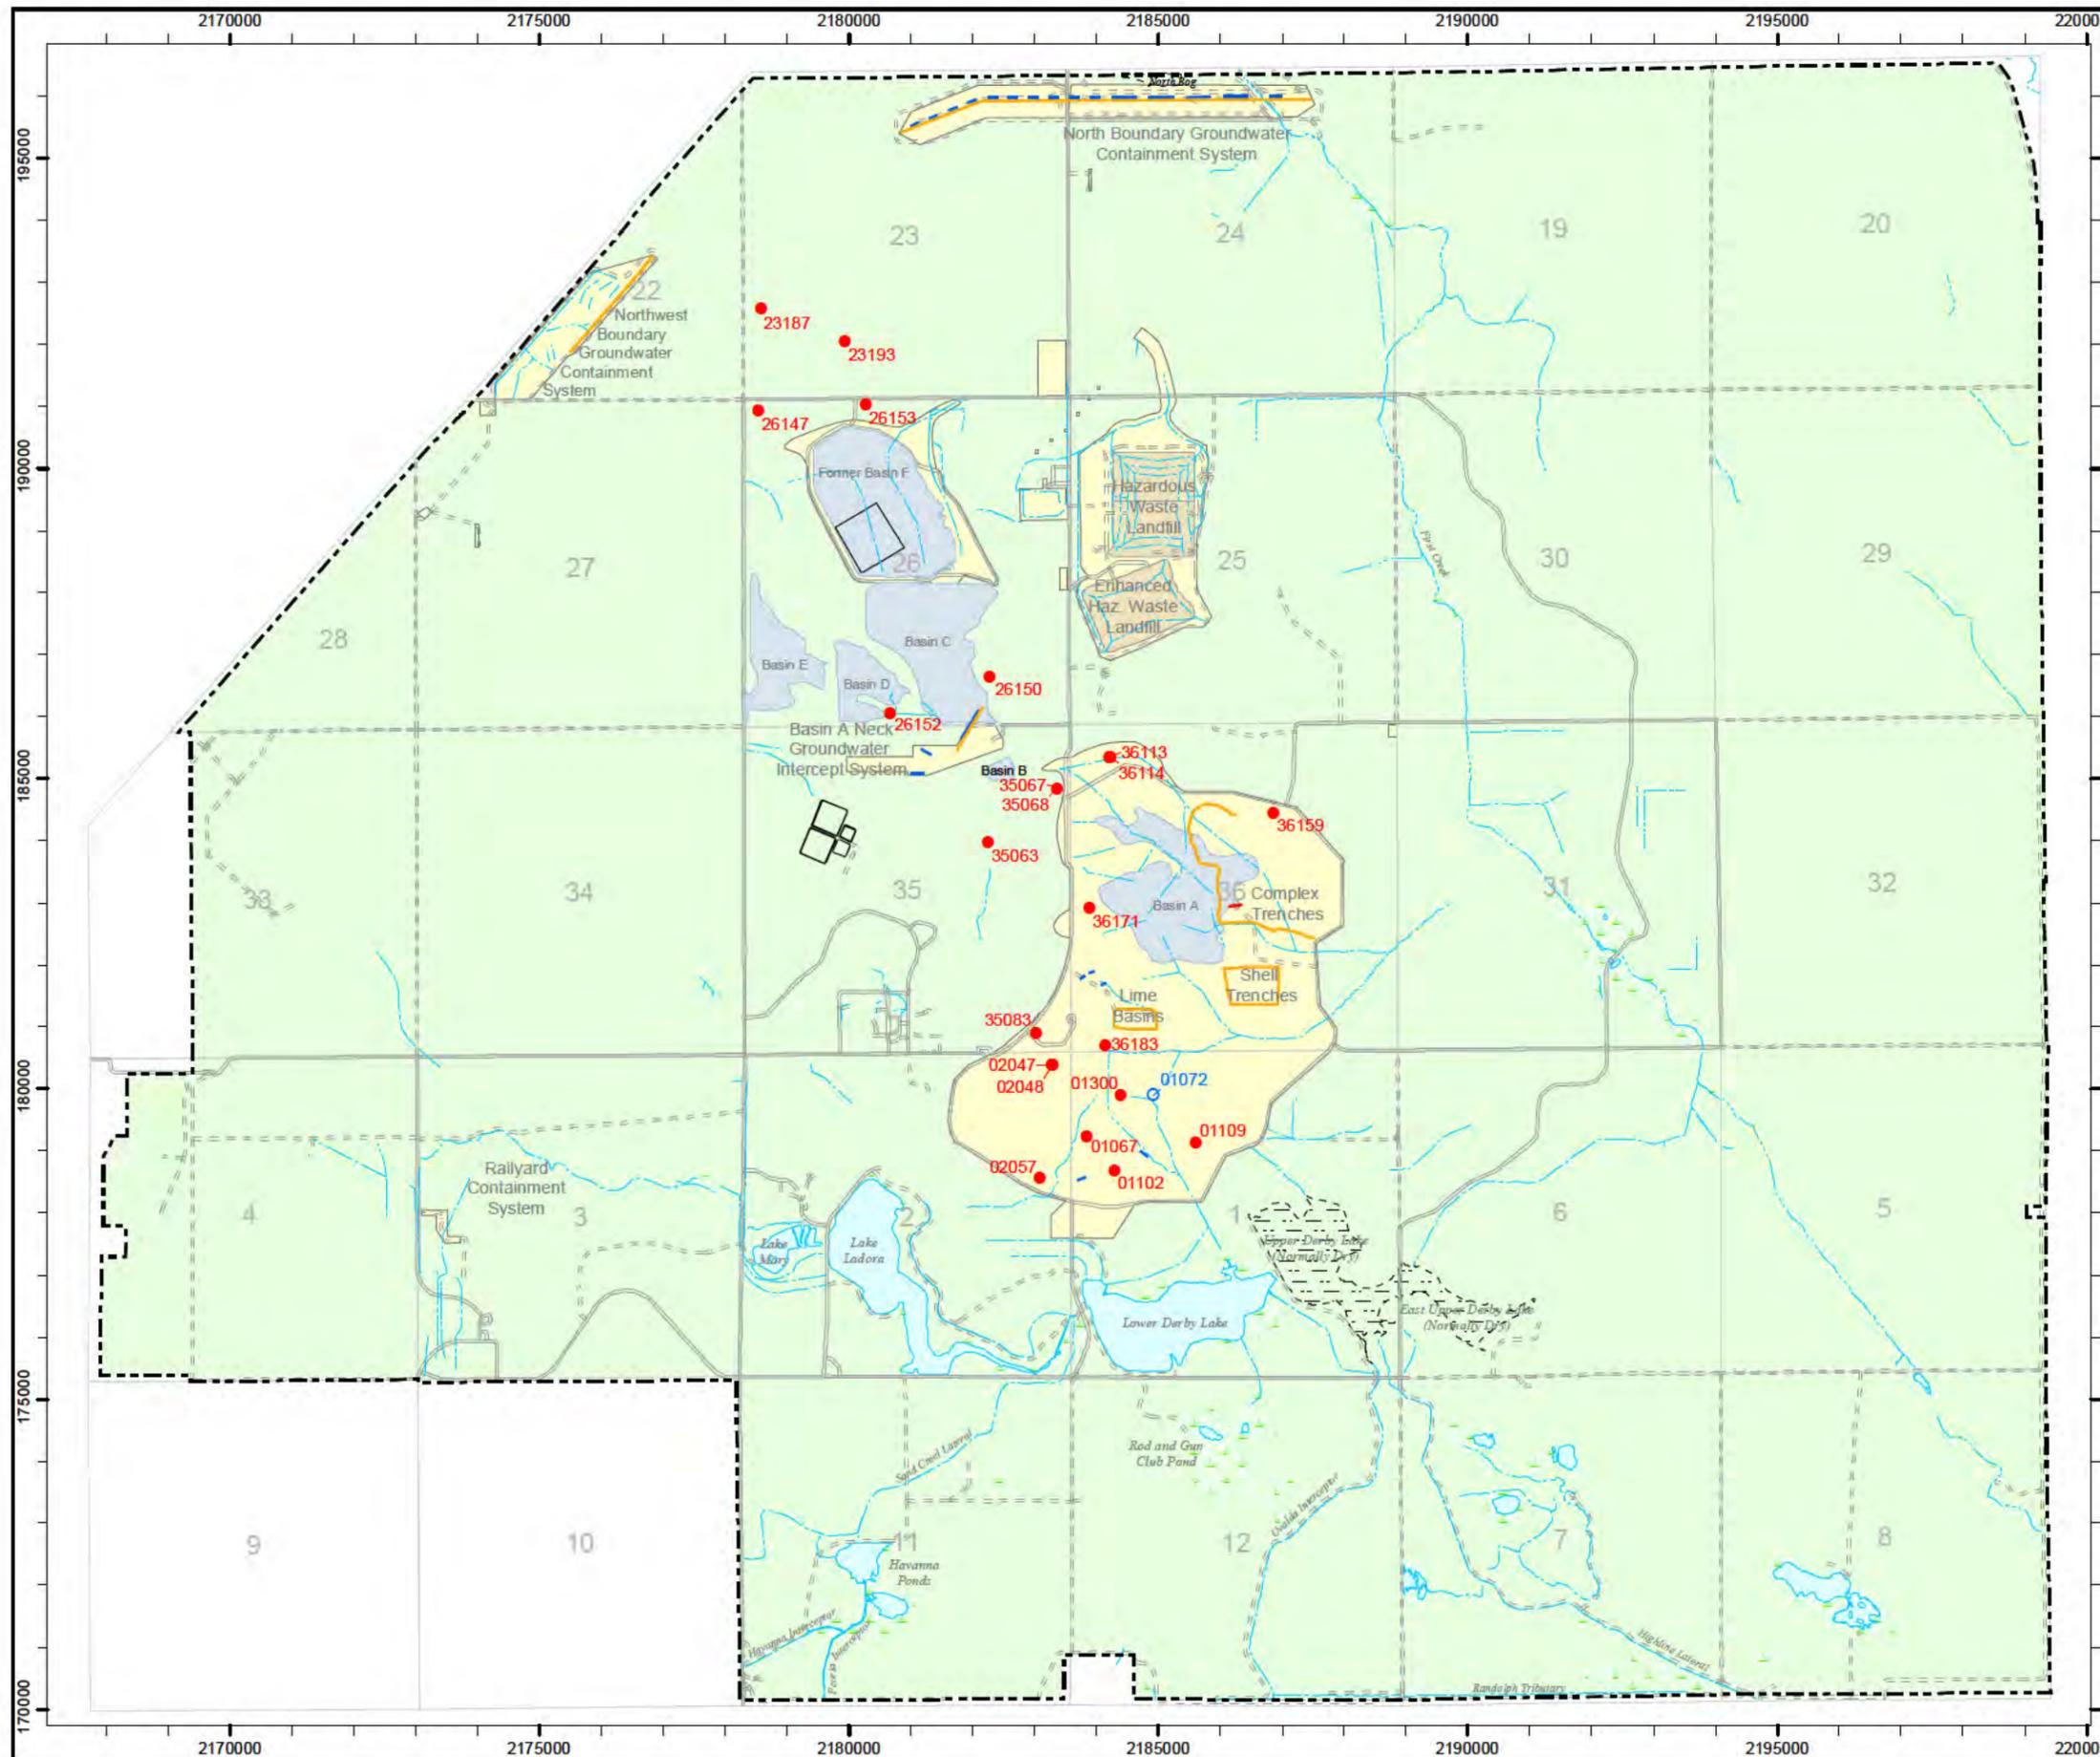
Figure 6.3-55
Rocky Mountain Arsenal
Confined Flow System
Water Quality Wells

- ### Legend
- USFWS Managed
 - Army Maintained
 - Hazardous Waste Landfill, & Enhanced Hazardous Waste Landfill
 - Historic Basins
 - Section Lines
 - Lakes and Ponds
 - Dry Lakes/Ponds
 - Wetlands
 - Intermittent Streams
 - Ditches, Canals
 - Slurry Walls
 - Recharge Trenches
 - Extraction Trenches
 - Paved Roads
 - Unimproved Roads
 - Confined Flow System Water Quality Wells (Sampled Twice in 5 Years)
 - Alternate Confined Flow System Water Quality Wells

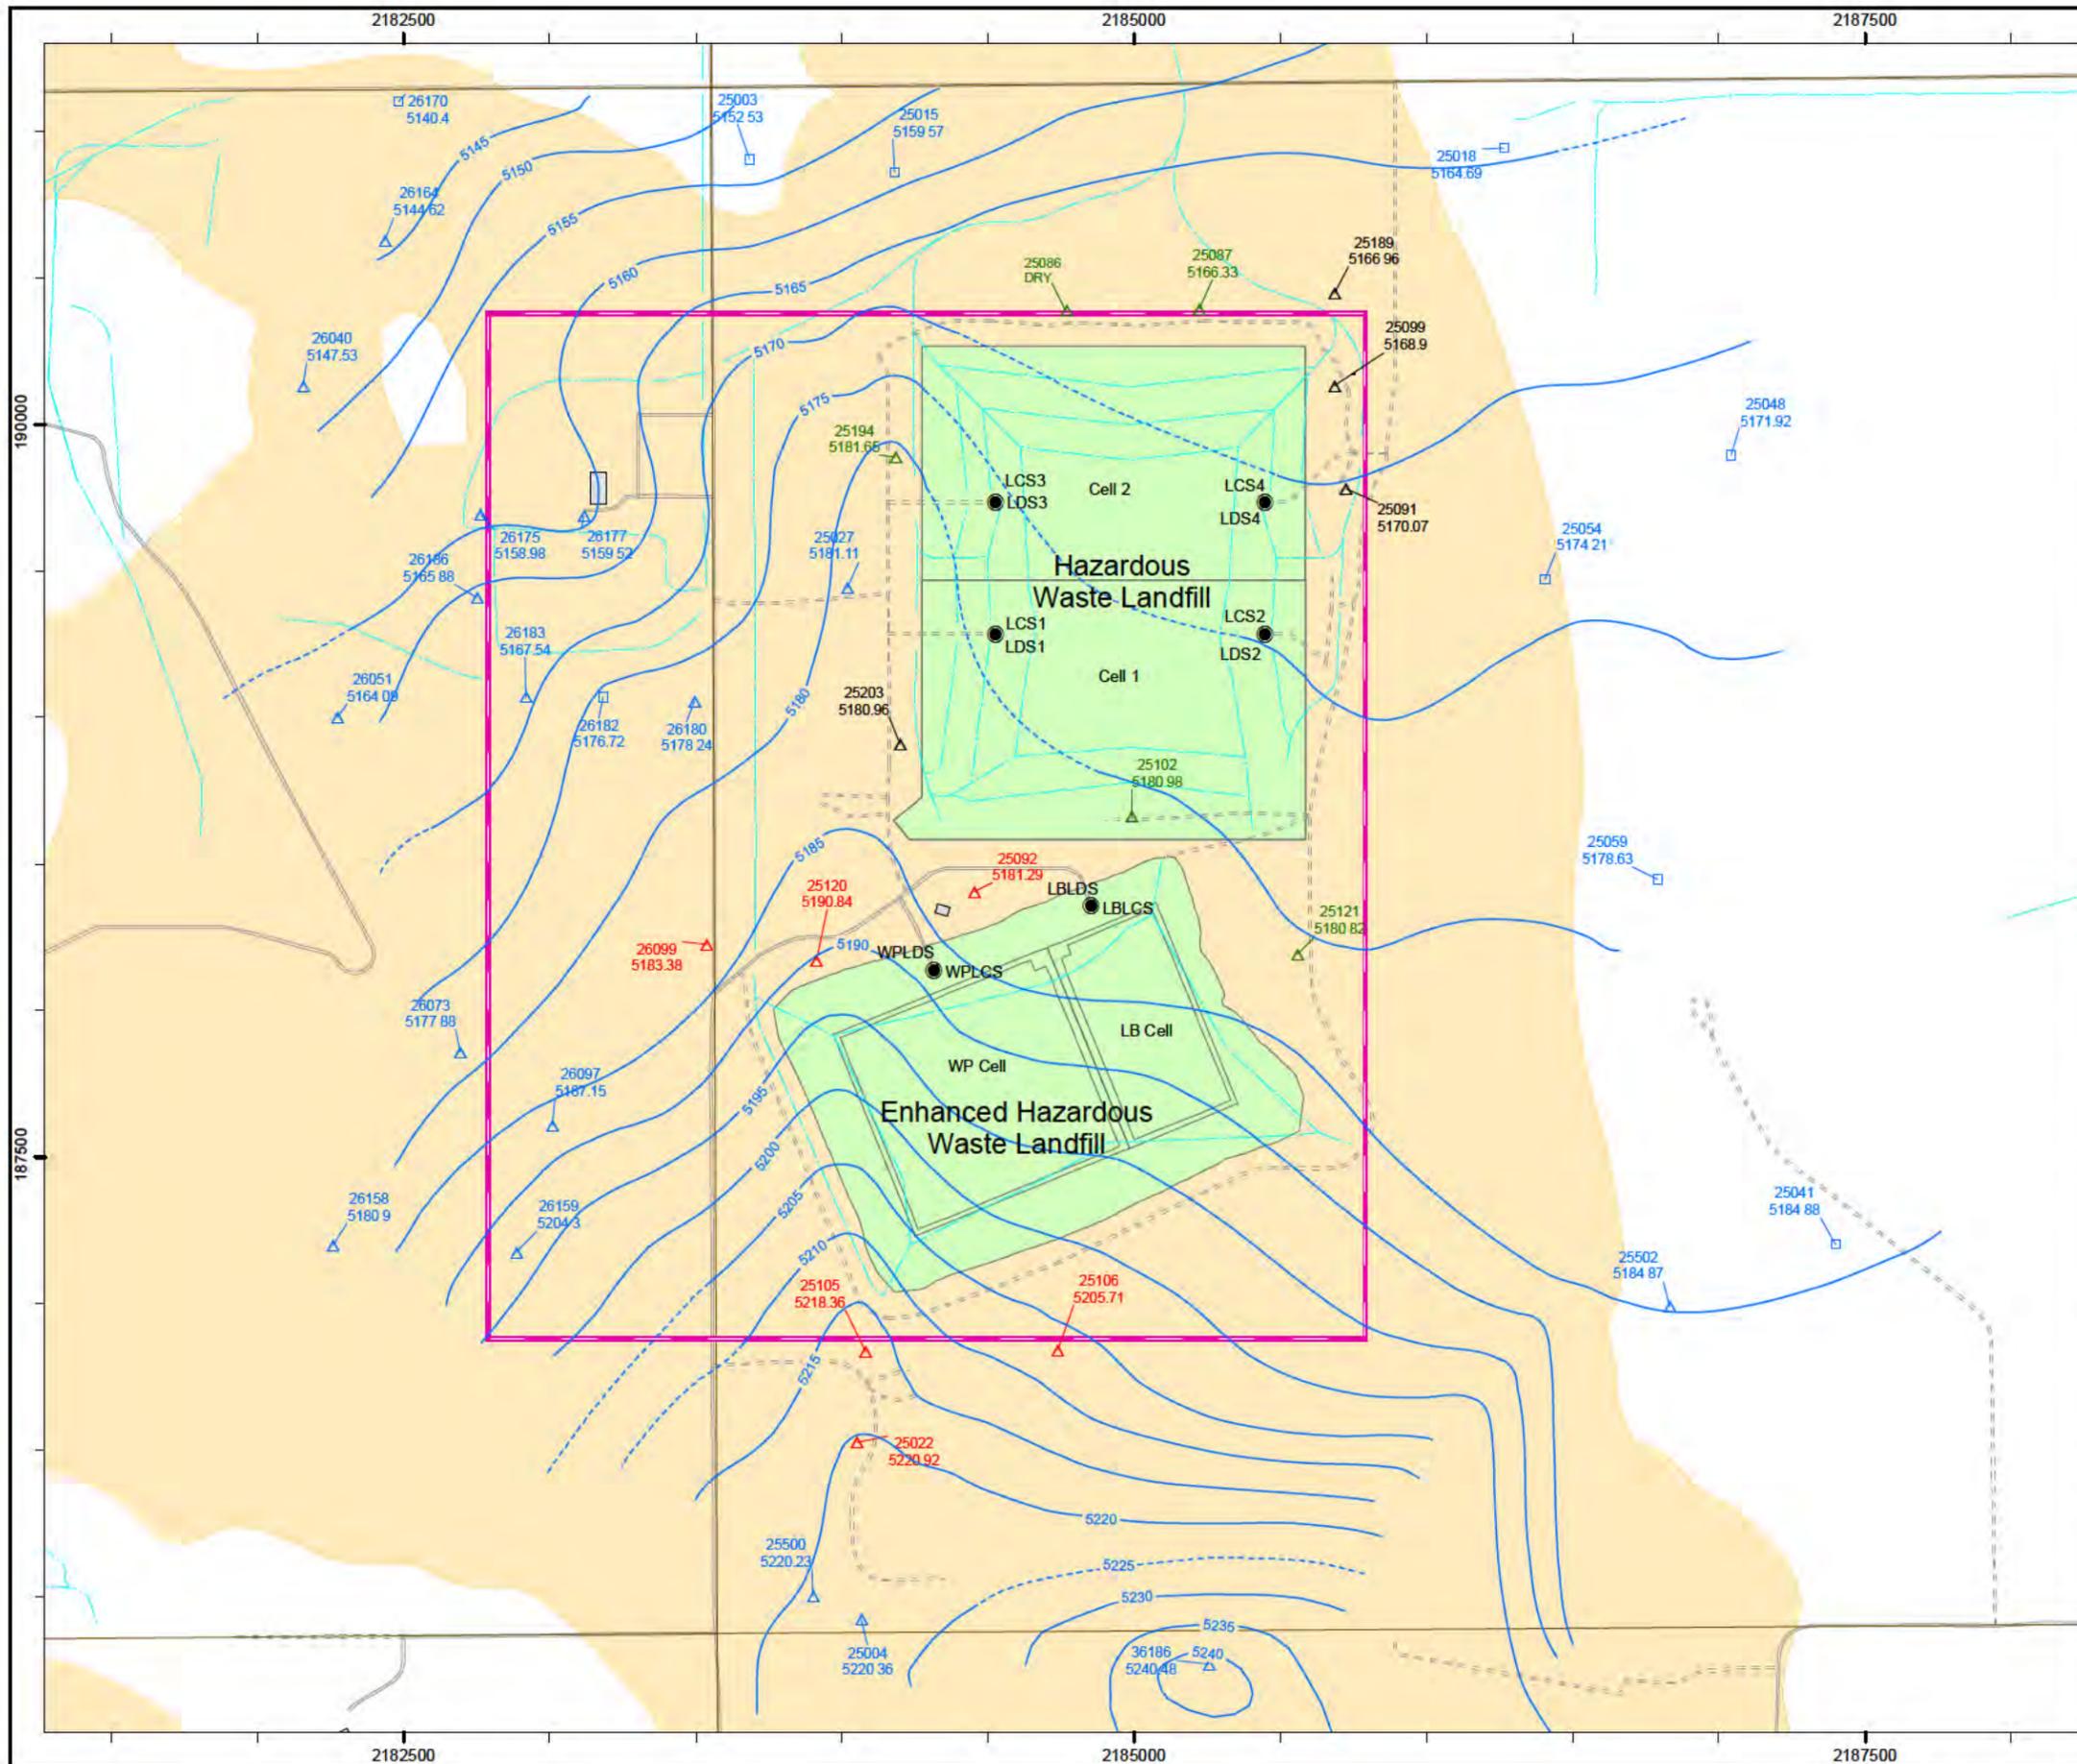
Figure 6.3-68
Potentiometric Surface of the Unconfined Flow System, Hazardous Waste and Enhanced Hazardous Waste Landfills

Monitoring Well Network	Flow System/Aquifer	
	Unconfined Alluvial	Unconfined Denver
Hazardous Waste Landfill (HWL)		▲
HWL Supplemental Operations		▲
Enhanced Hazardous Waste Landfill (ELF)		▲
Water Level Only	□	▲

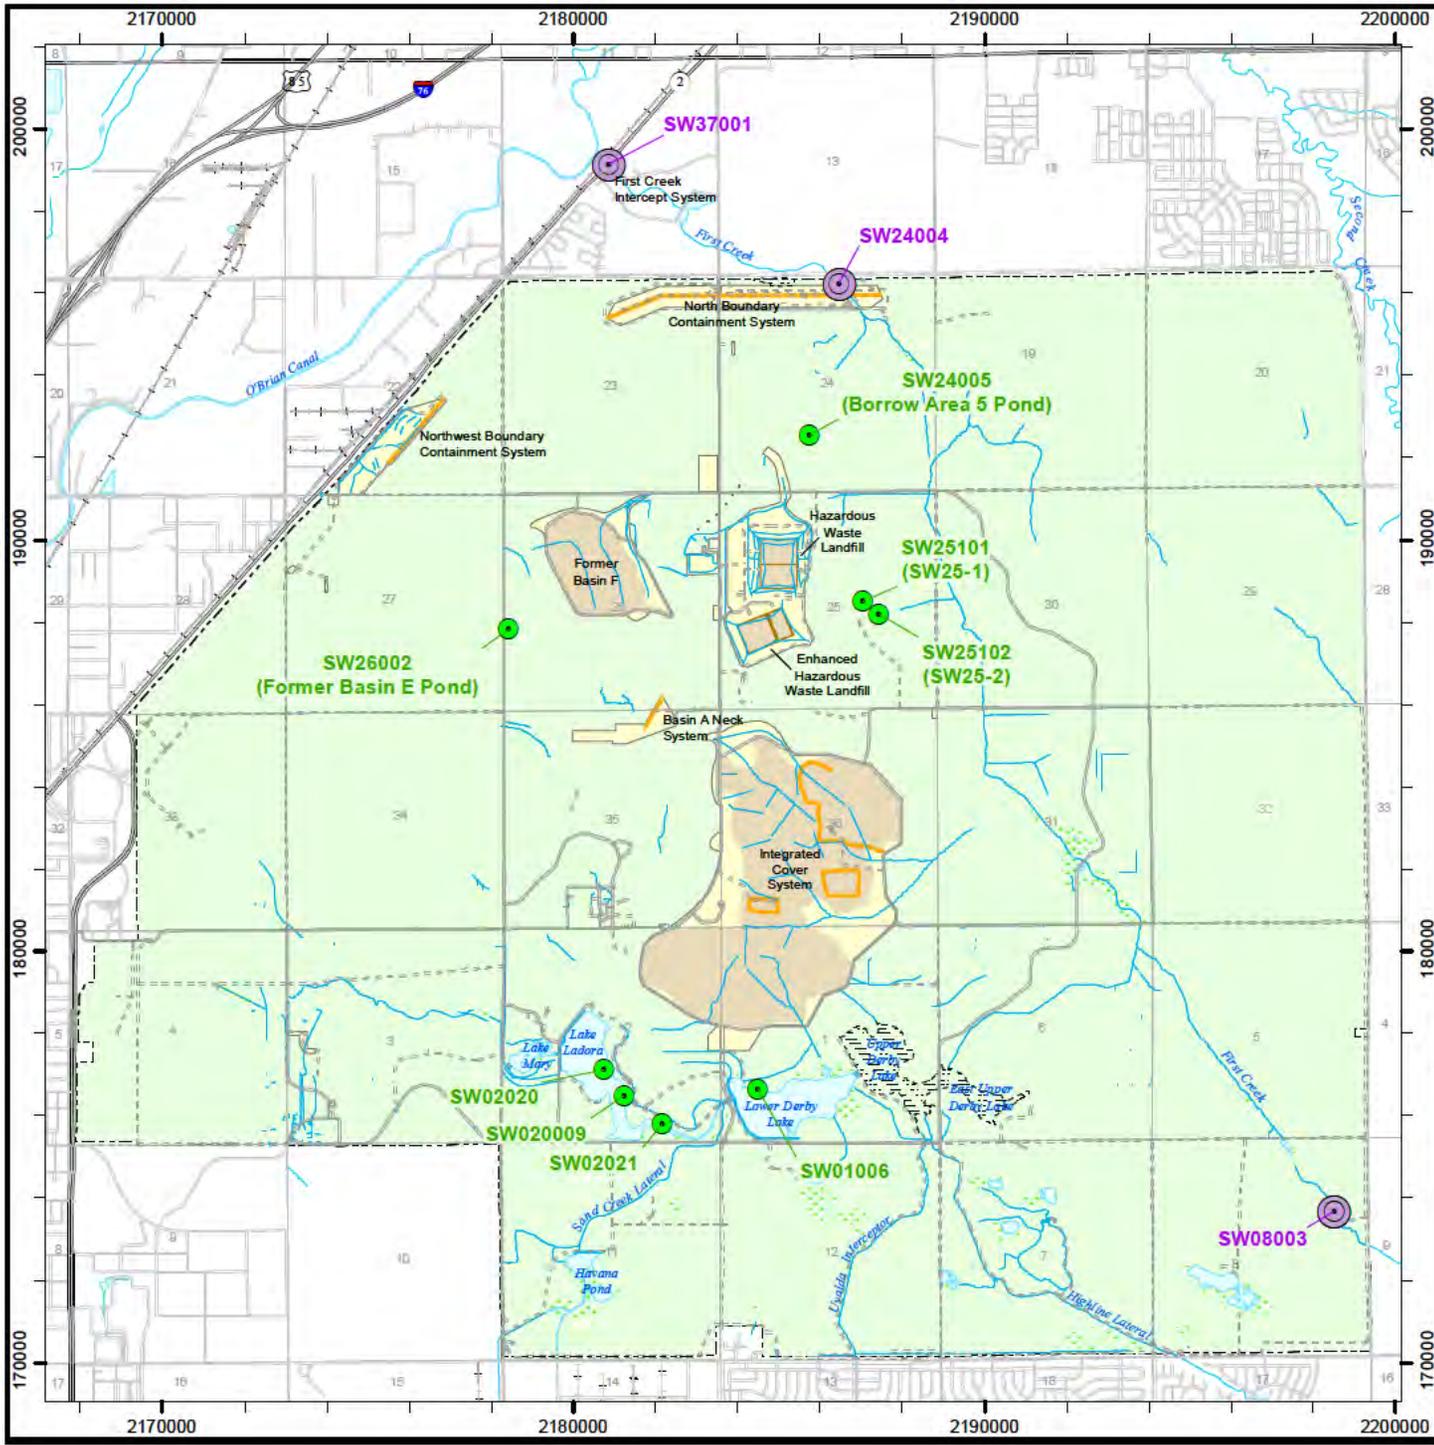
Figure 6.3-77
Rocky Mountain Arsenal
Surface Water
Monitoring Locations

- ### Legend
- RMA Boundary
 - Army Maintained
 - Soil Caps and Covers
 - Dry Lake or Pond
 - Lake, Pond, Ditch or Canal
 - Wetland, Marsh, Swamp, or Bog
 - Intermittent Streams
 - Ditch or Spillway
 - Culvert
 - Dam
 - Flume, Siphon, Sluice, or Weir
 - Slurry Wall
- Surface water Monitoring Locations
- Short-Term Locations
 - LTMP Locations
