Table 4.0-3. RMA Remedial Project Status as of March 31, 2020

**ROCKY MOUNTAIN ARSENAL
COMMERCE CITY, COLORADO**

PROJECT NAME
**2020
FIVE-YEAR REVIEW REPORT**

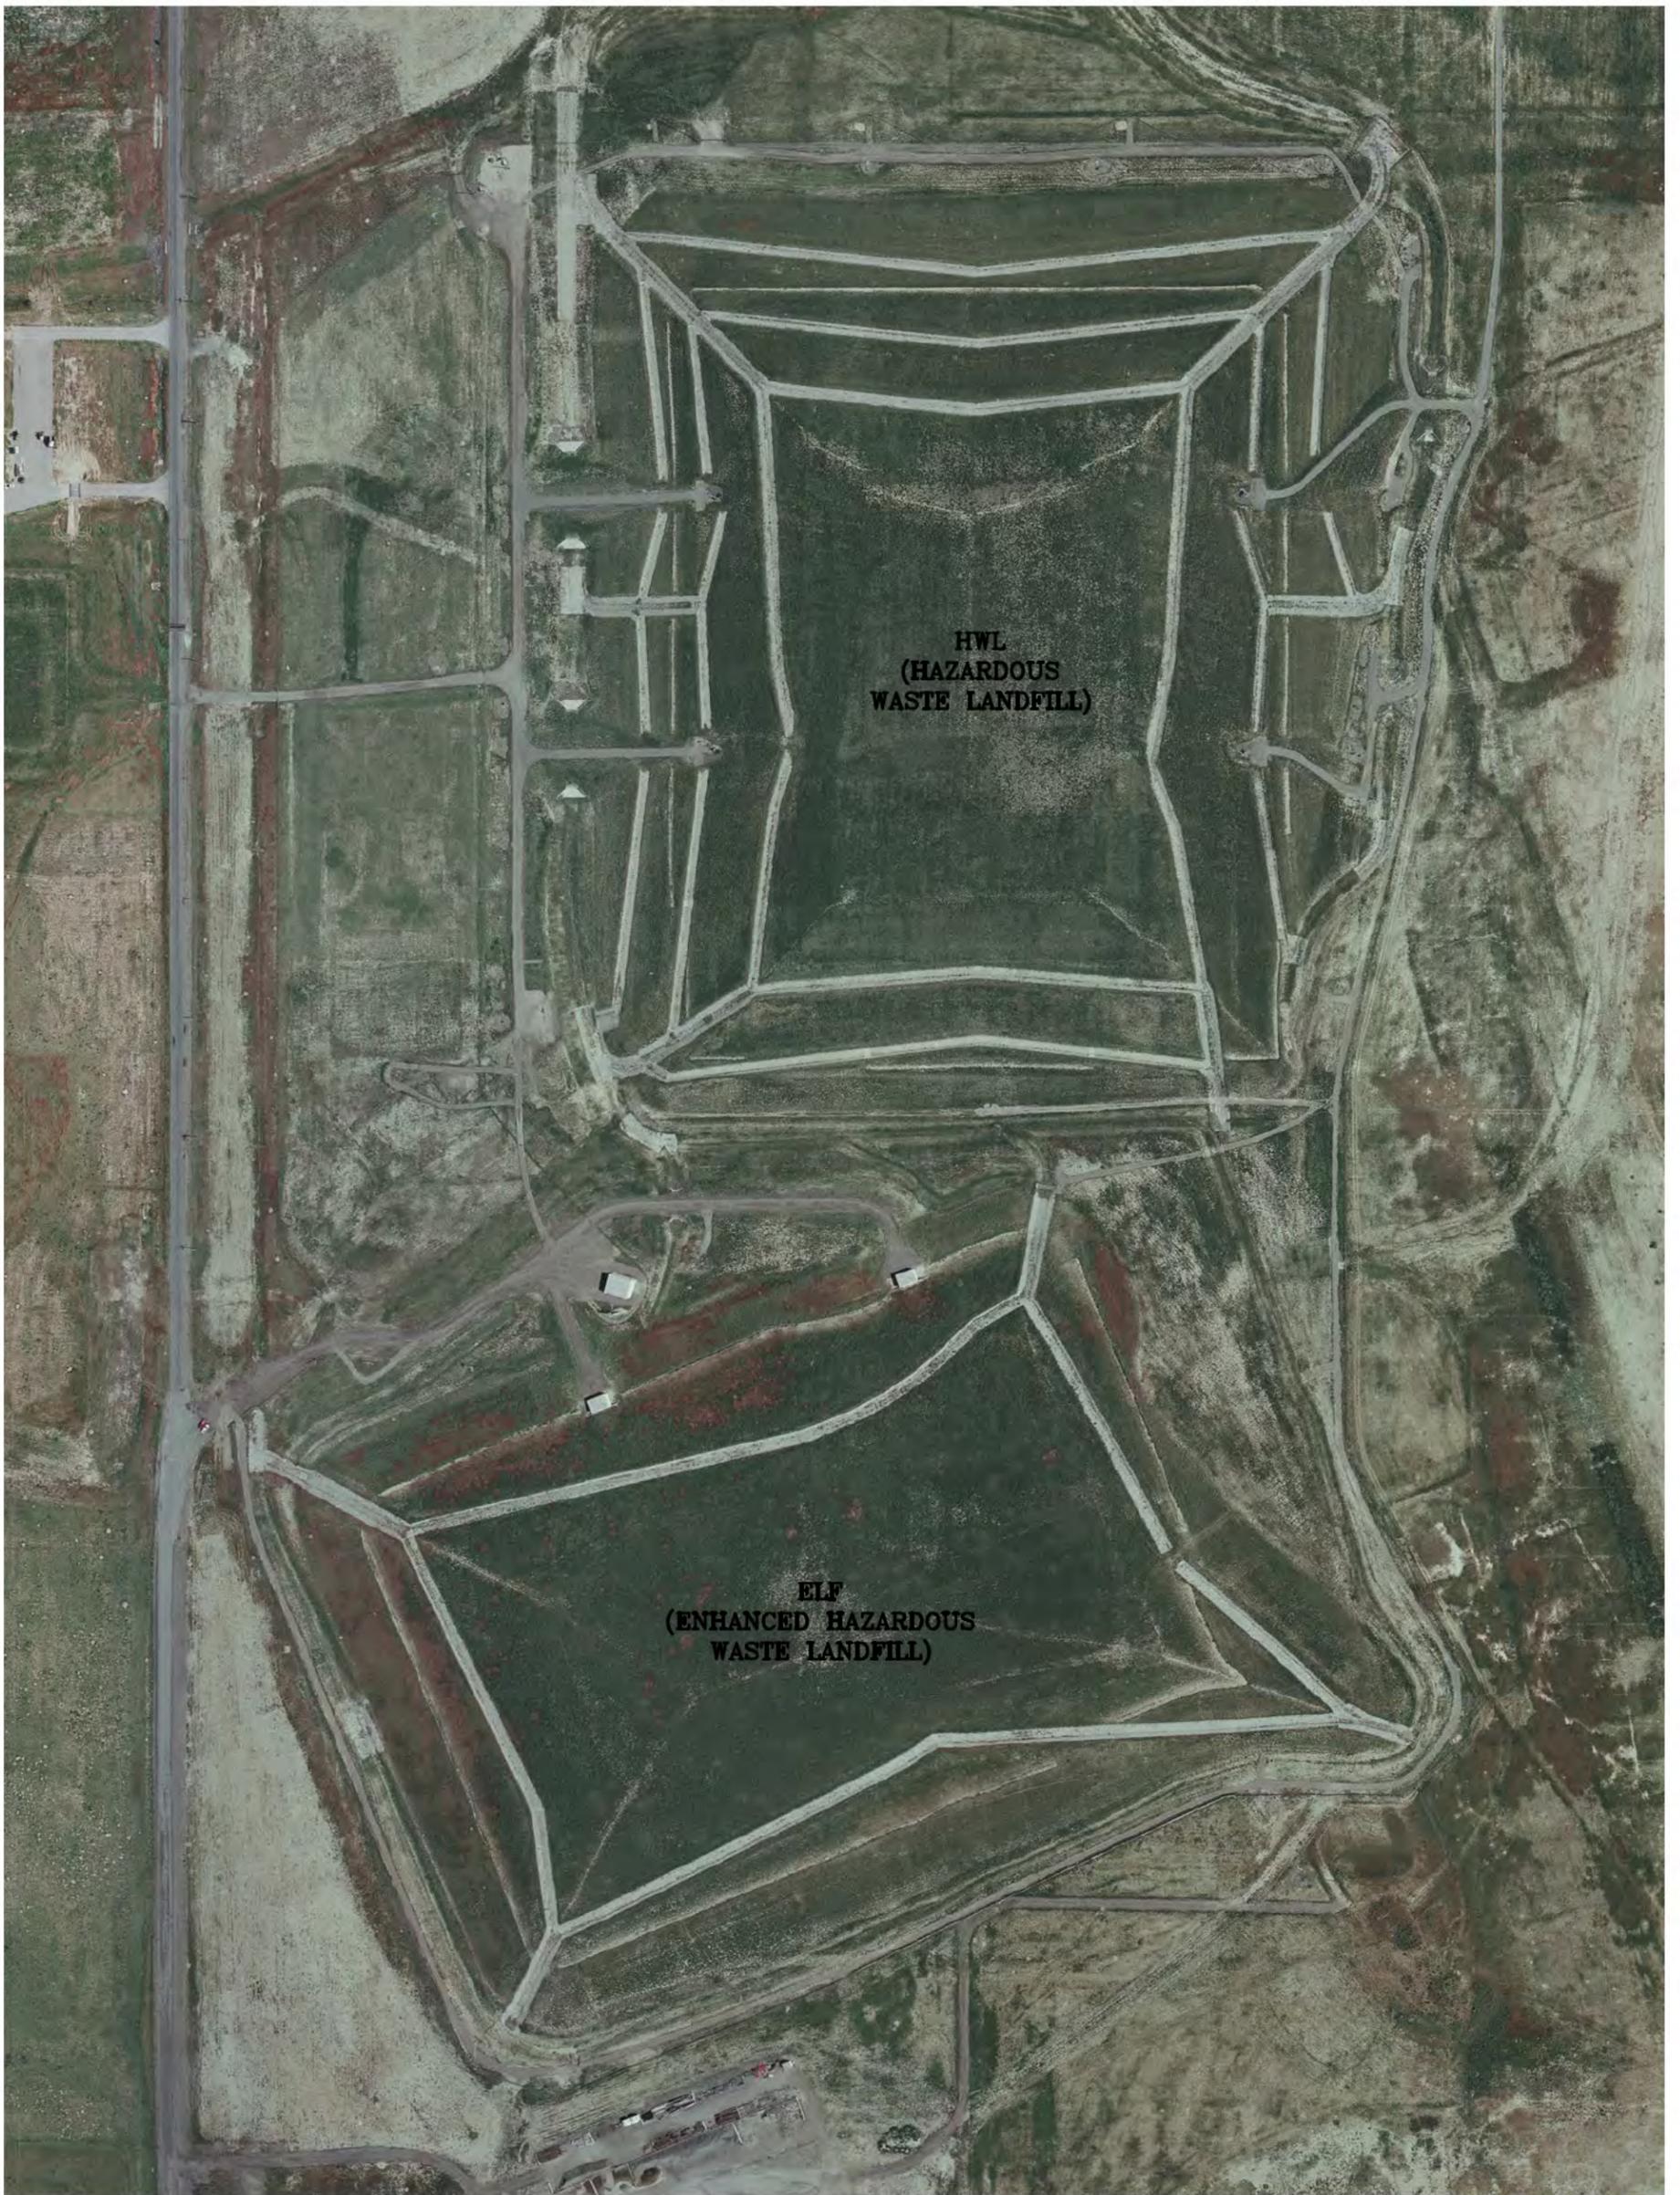
ROCKY MOUNTAIN ARSENAL COMMERCE CITY, COLORADO		
NAVARRO Research and Engineering, Inc.		
PROJECT NAME 2020 FIVE-YEAR REVIEW REPORT		
TITLE HAZARDOUS WASTE LANDFILL AND ENHANCED HAZARDOUS WASTE LANDFILL RCRA-CAPS DETAILS (SHEET 1 OF 2)		
DRAWN BY SMG	DATE 08.26.20	FIGURE NUMBER 6.3-79

NOTE: AERIAL IMAGE SHOWN IS FROM 2014.

**SEE FIGURE 6.3-79 HAZARDOUS WASTE LANDFILL AND ENHANCED HAZARDOUS WASTE LANDFILL RCRA-CAPS DETAILS (SHEET 1 OF 2) FOR AREA DETAILS.

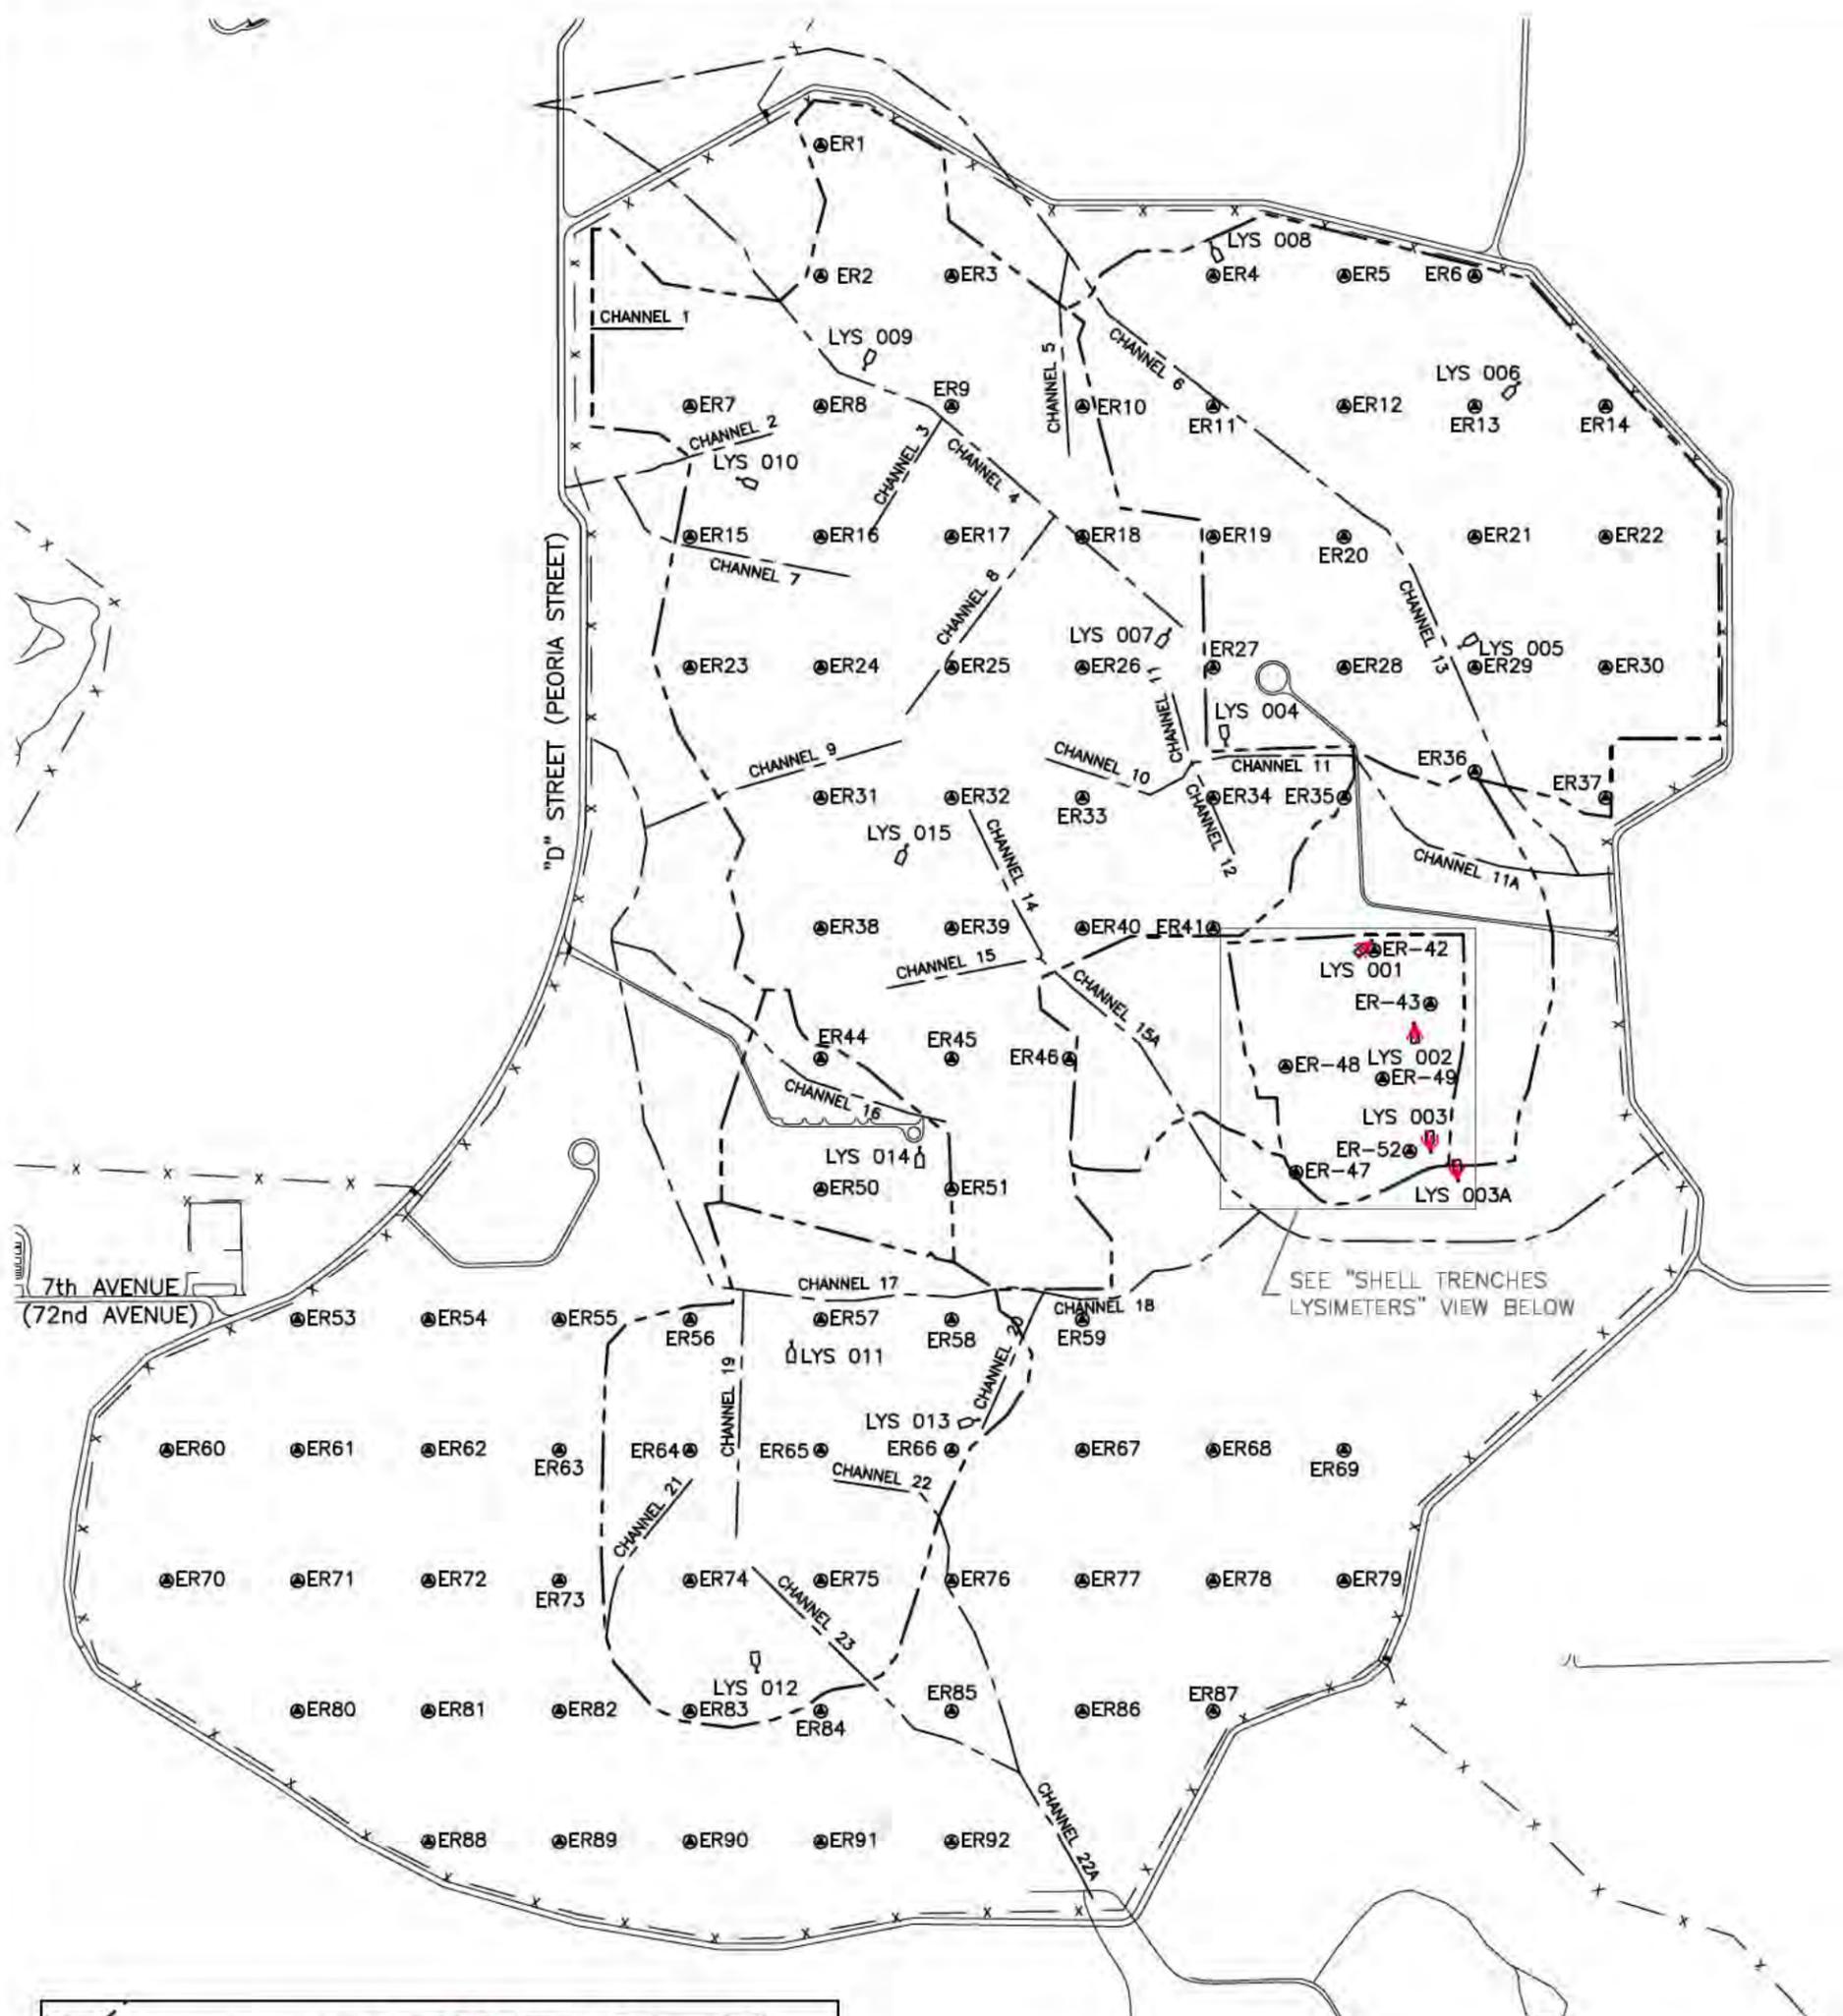
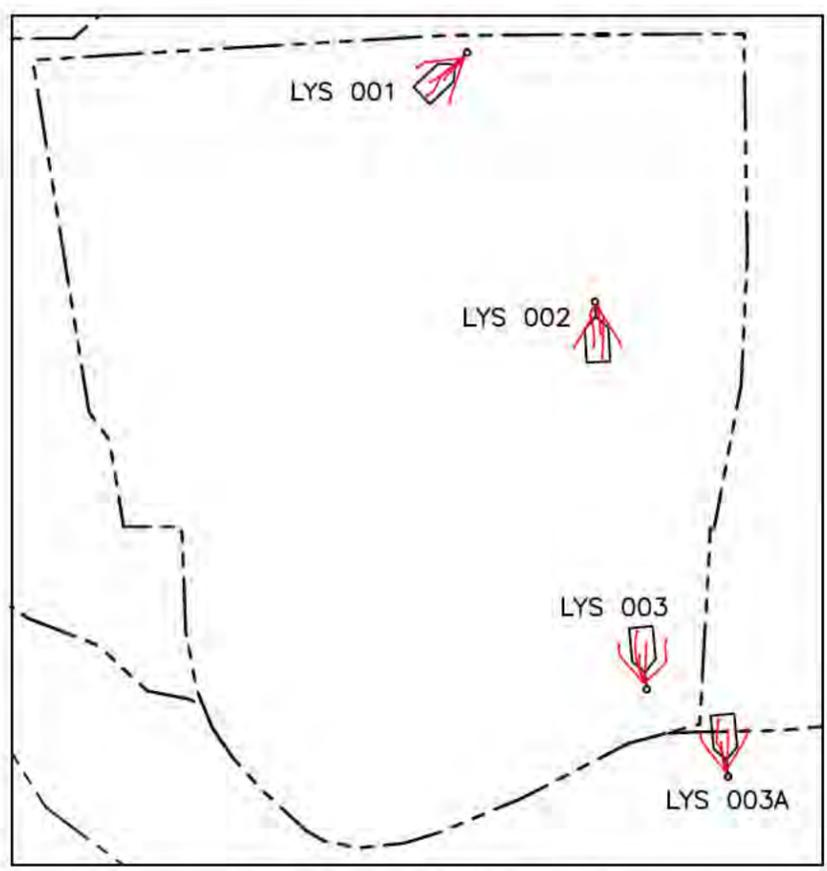
ROCKY MOUNTAIN ARSENAL COMMERCE CITY, COLORADO		
 NAVARRO Research and Engineering, Inc.		
PROJECT NAME 2020 FIVE-YEAR REVIEW REPORT		
TITLE INTEGRATED COVER SYSTEM DETAILS (SHEET 1 OF 2)		
DRAWN BY: SMG	DATE 08.26.20	FIGURE NUMBER 6.3-80

SHELL TRENCHES LYSIMETERS

- LEGEND**
- RCRA-EQUIVALENT COVER LIMITS
 - ROAD
 - FENCE
 - DRAINAGE CHANNEL
 - LYSIMETER/FORMER MOISTURE PROBE SYSTEM
 - COVER EROSION/SETTLEMENT MONUMENT

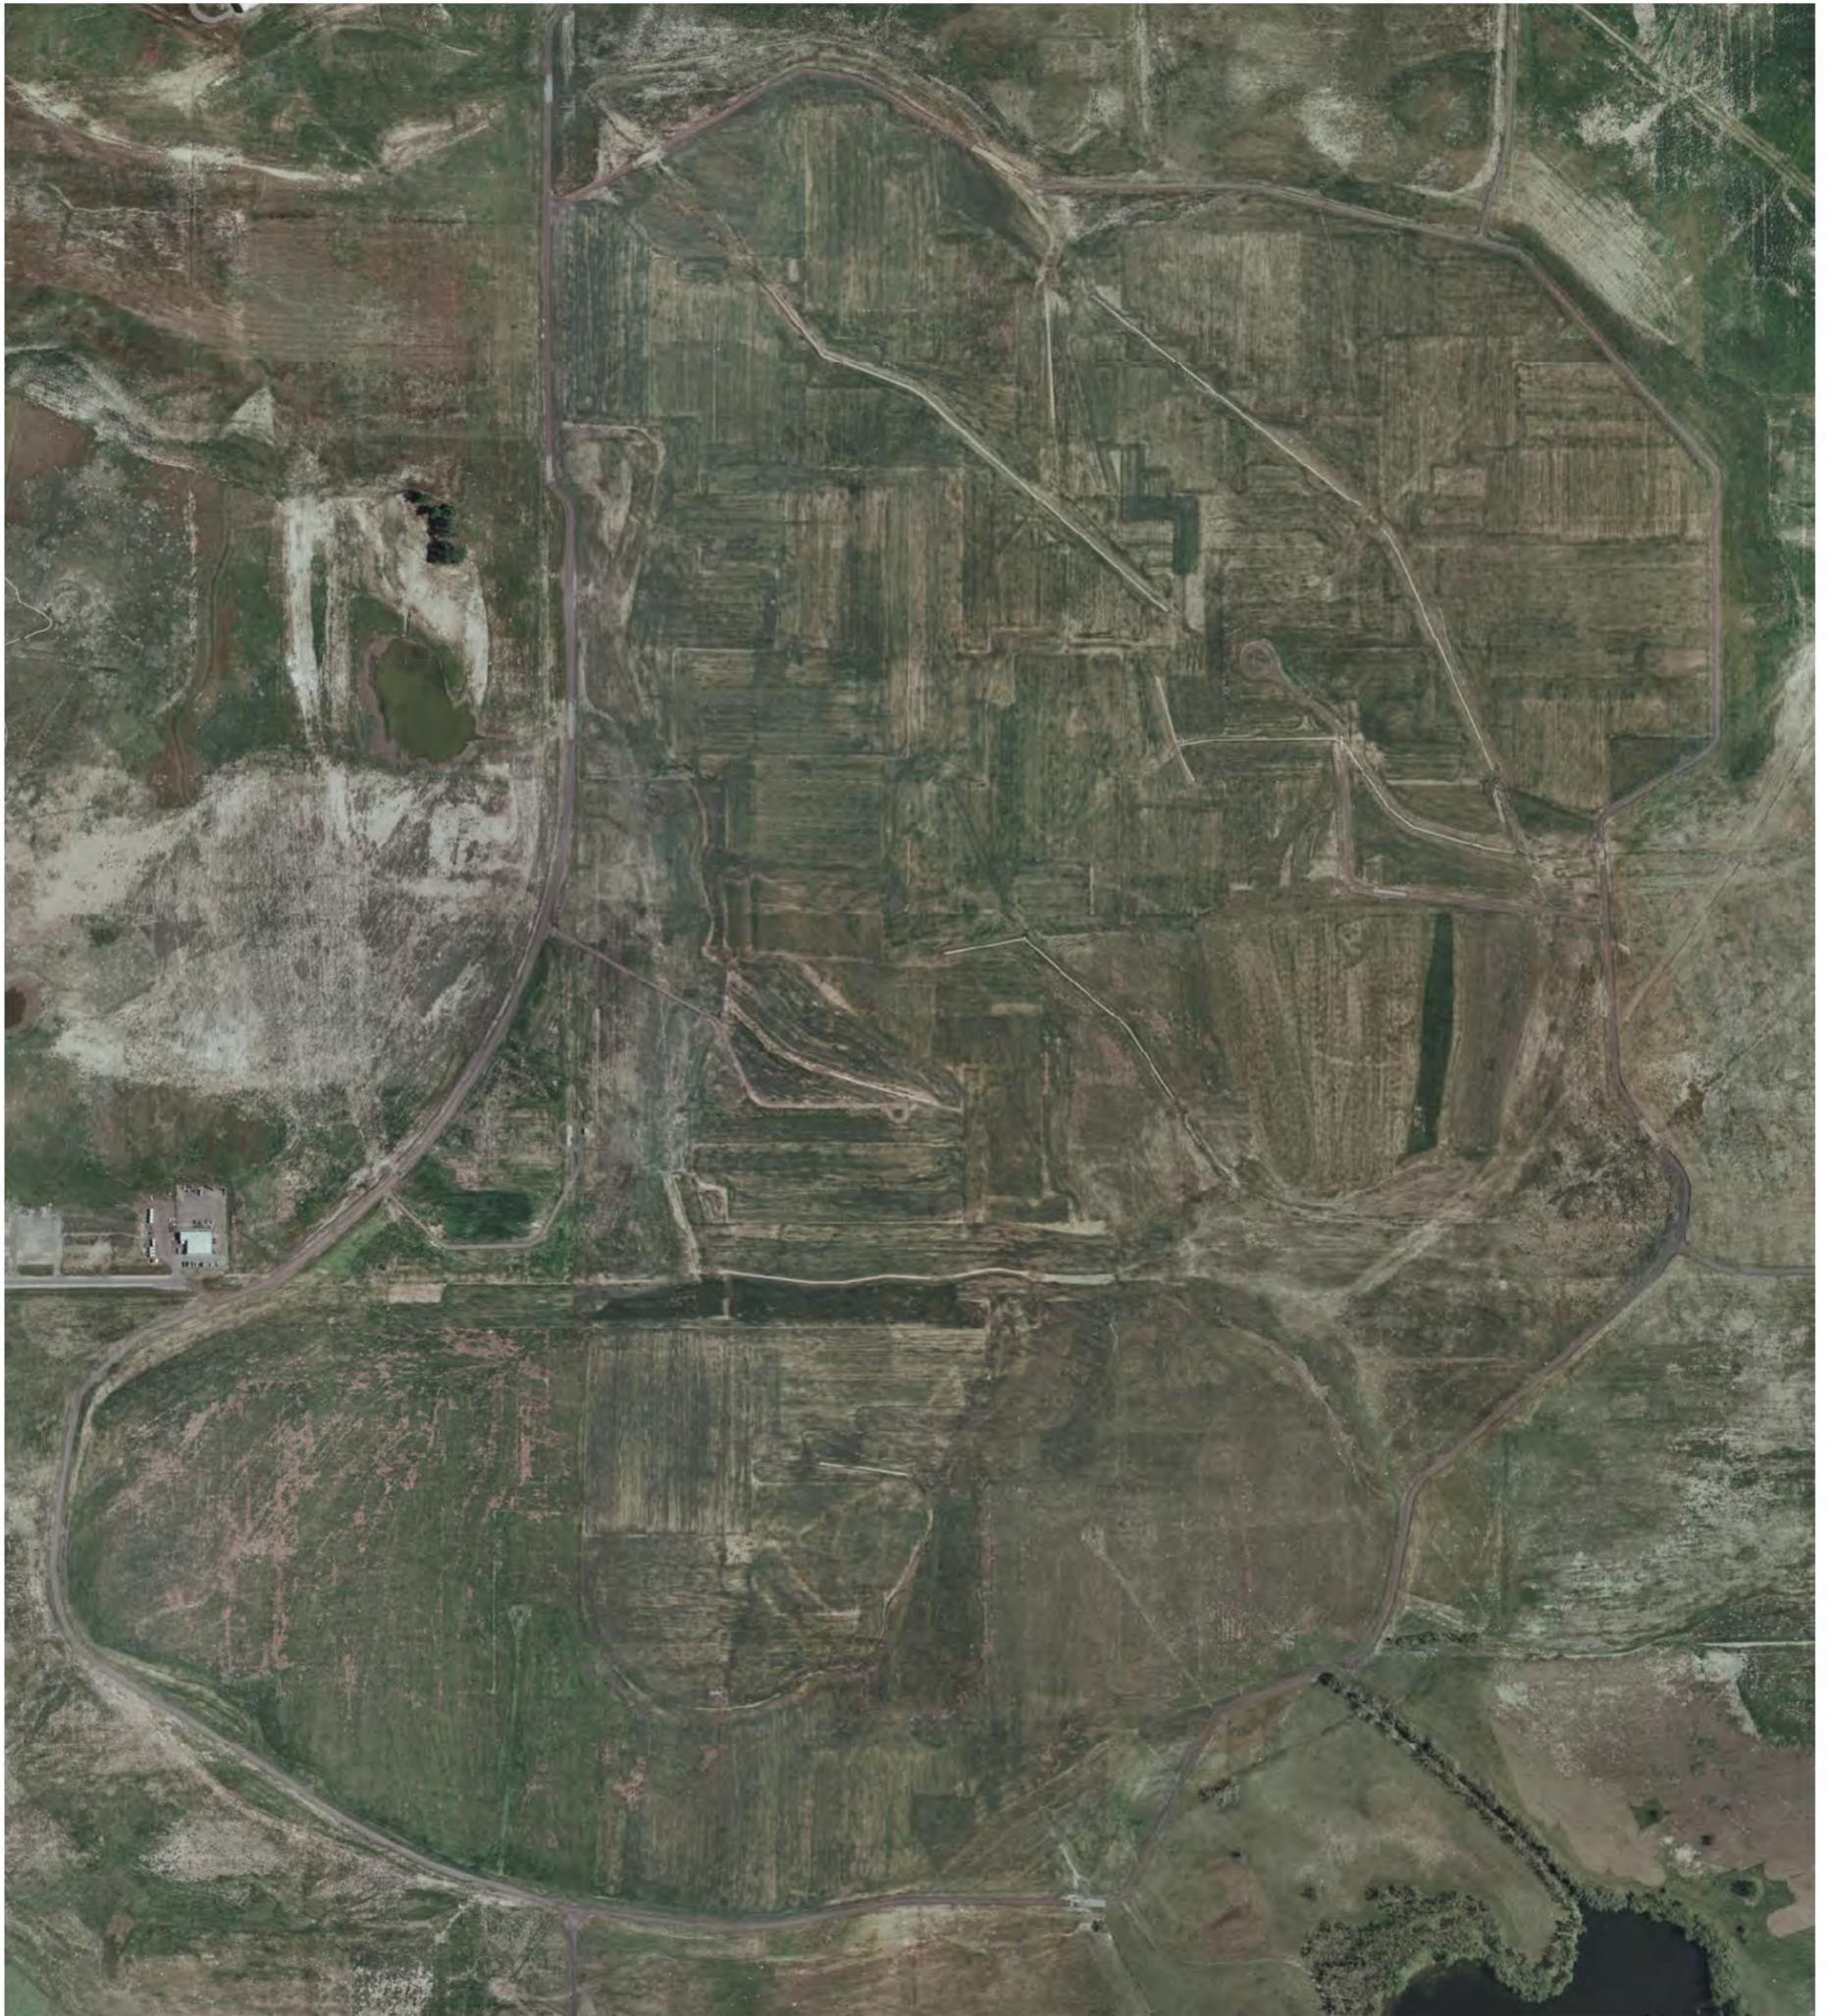
NOTE: AERIAL IMAGE SHOWN IS FROM 2014.

**SEE FIGURE 6.3-80 INTEGRATED COVER SYSTEM DETAILS (SHEET 1 OF 2) FOR AREA DETAILS.

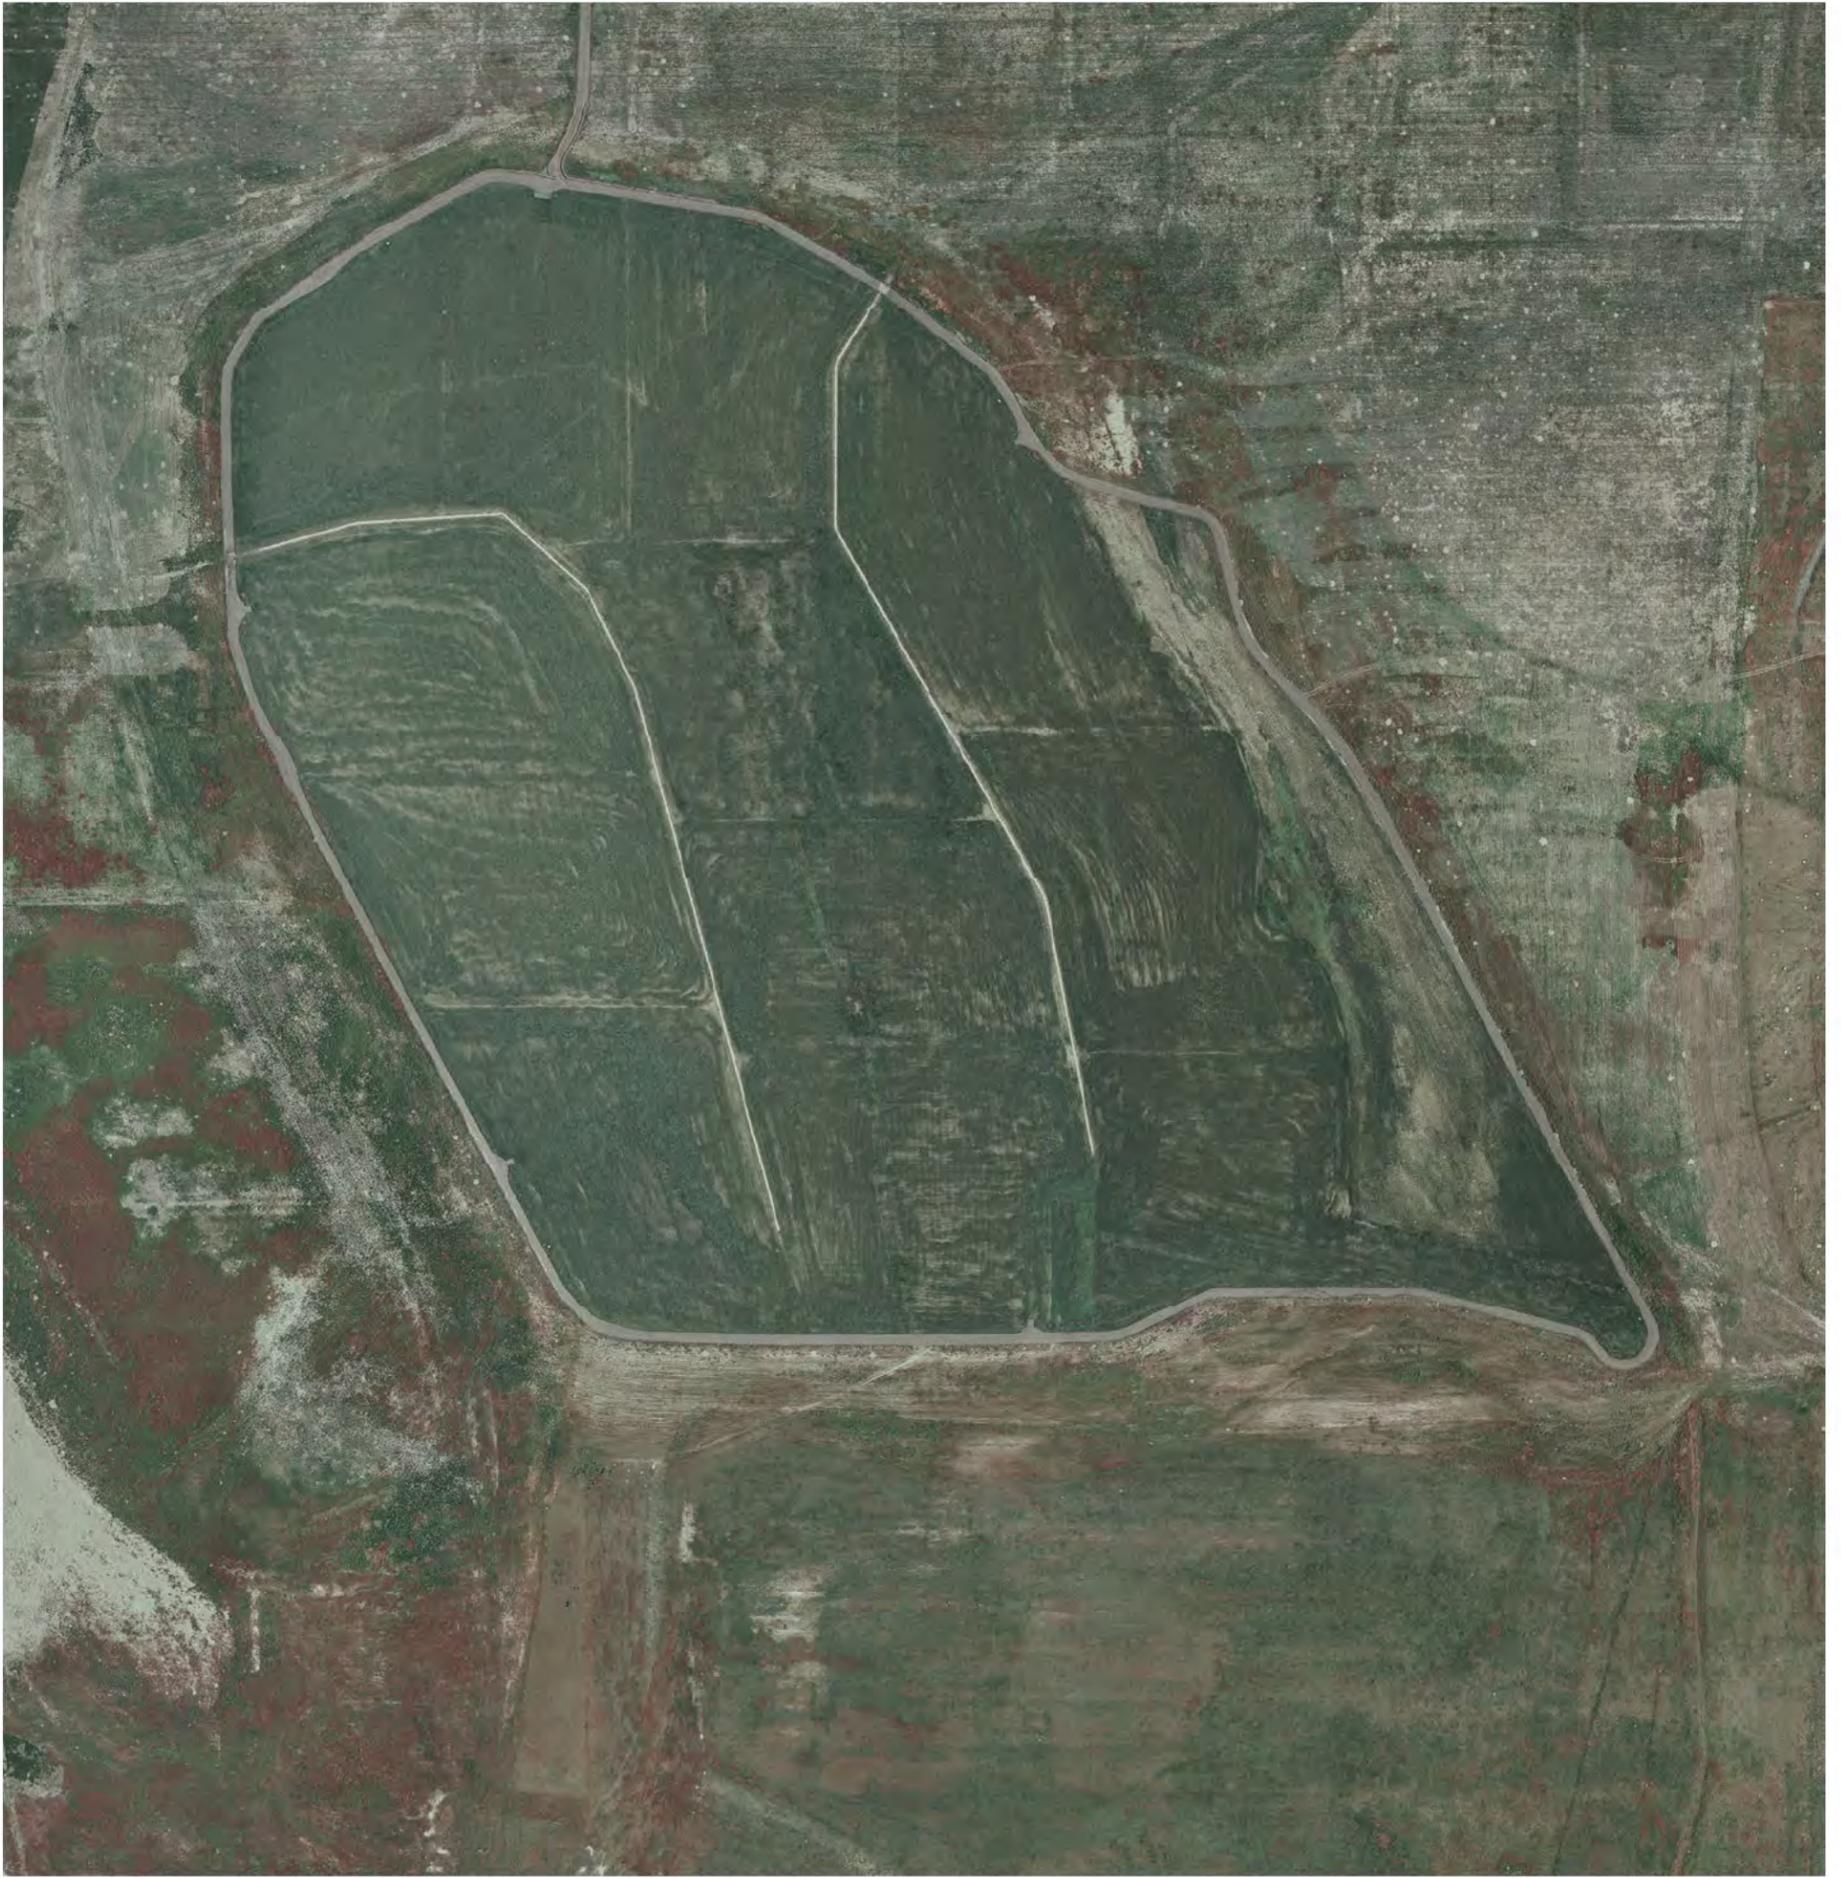
NAVARRO Research and Engineering, Inc.		
PROJECT NAME 2020 FIVE-YEAR REVIEW REPORT		
TITLE BASIN F RCRA-EQUIVALENT COVER DETAILS (SHEET 1 OF 2)		
DRAWN BY SMG	DATE 08.26.20	FIGURE NUMBER 6.3-81

NOTE: AERIAL IMAGE SHOWN IS FROM 2014.

**SEE FIGURE 6.3-81 BASIN F RCRA-EQUIVALENT COVER DETAILS (SHEET 1 OF 2) FOR AREA DETAILS.
