ROCKY MOUNTAIN ARSENAL

ANNUAL COVERS REPORT FOR INTEGRATED COVER SYSTEM 2024

November 19, 2024

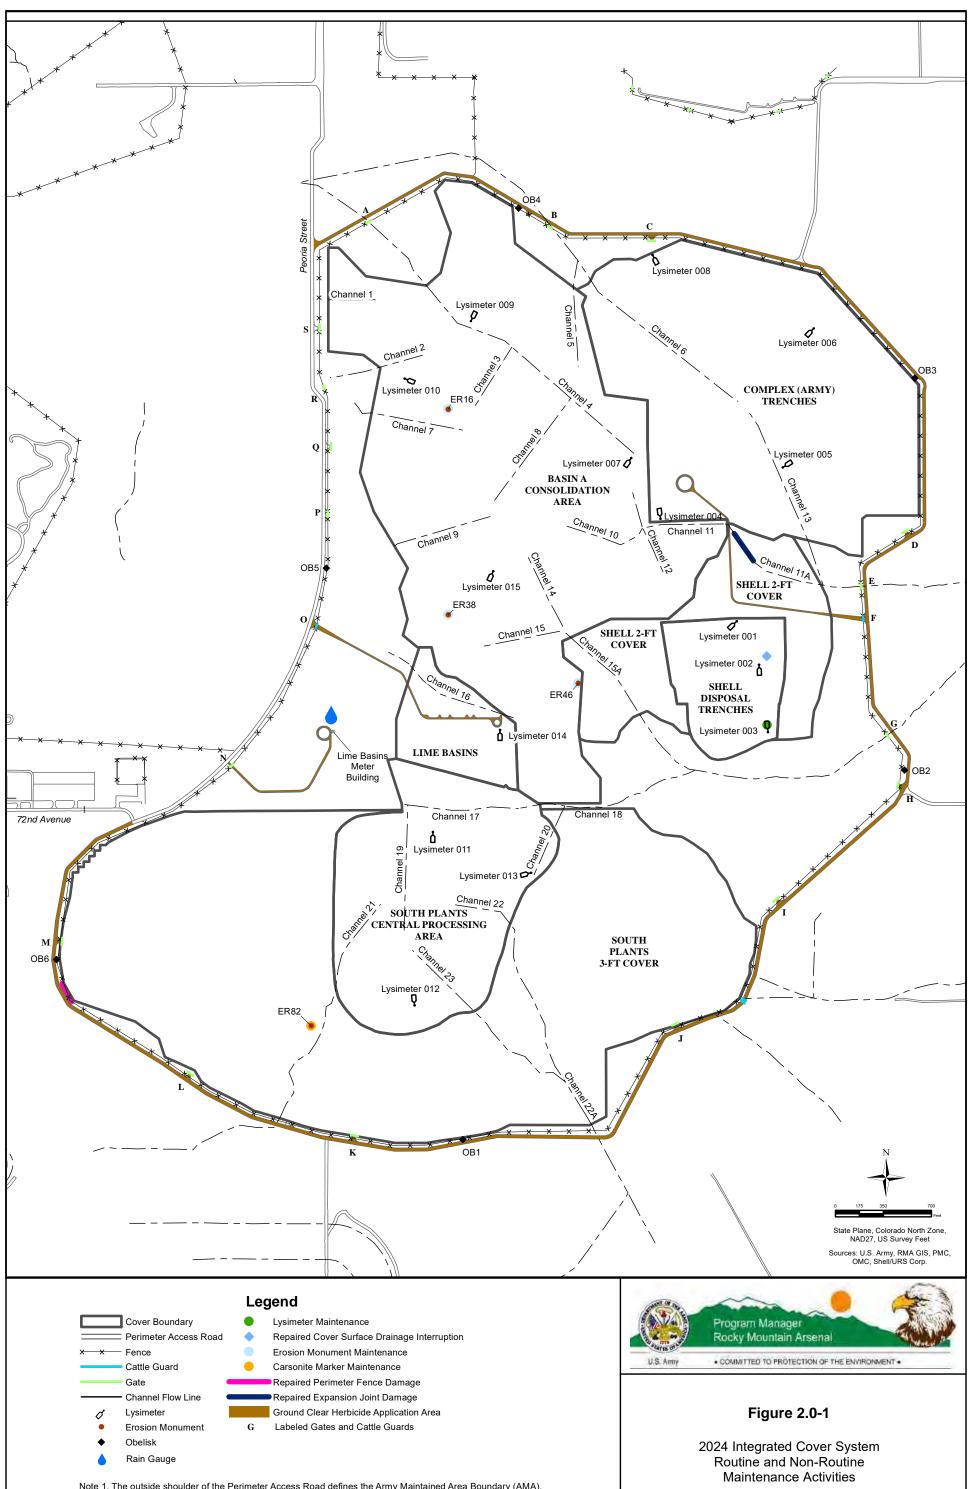
Note 1. The outside shoulder of the Perimeter Access Road defines the Army Maintained Area Boundary (AMA). Note 2. The ICS Perimeter Road was maintained by a motor grader as needed.

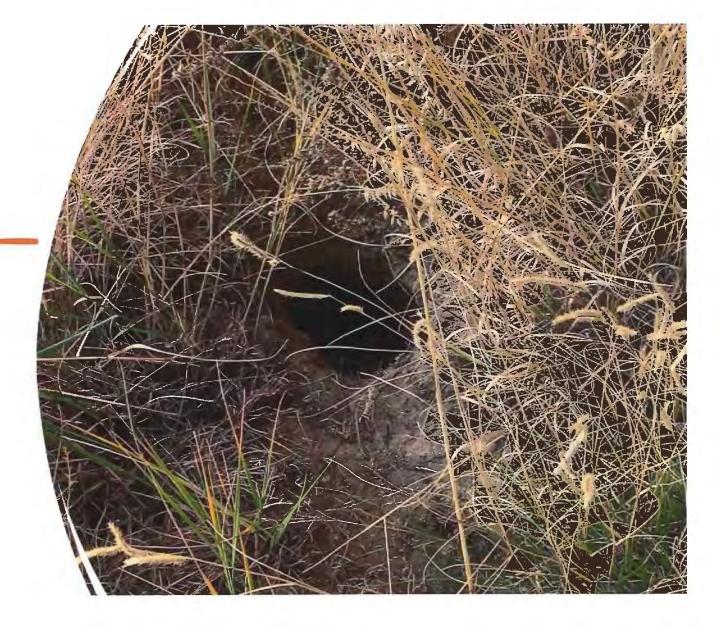
Inspection Item	Observation	Action
Erosion rills, gullies, or sheet erosion	None	N/A
Conditions that could interrupt cover surface drainage (ponding areas, ruts, holes greater than 3" in diameter)	A hole greater than 3" was identified on the SDT cover. (Inspection Form: 10/12/23)	Repaired in November 2023.
Excessive animal trails	None	N/A
Widespread burrowing animal holes	None	N/A
Extensive linear cracks	None	N/A
Vandalism, or intrusive damage such as unplanned excavation, drilling, grading, damage to engineering or access controls	None	N/A
Bare area or areas of poor growth greater than 100 square feet	None	N/A
Areas of vegetation stress greater than 100 square feet (over grazing, discoloration, pedestalling)	None	N/A
Deep rooted, noxious, or undesirable weedy species	Cheatgrass observed around Monument ER39. (Inspection Form: 4/3/24)	Not addressed during this reporting period.
Excessive litter accumulation	None	N/A

• Photo #1: Hole identified on the SDT Cover

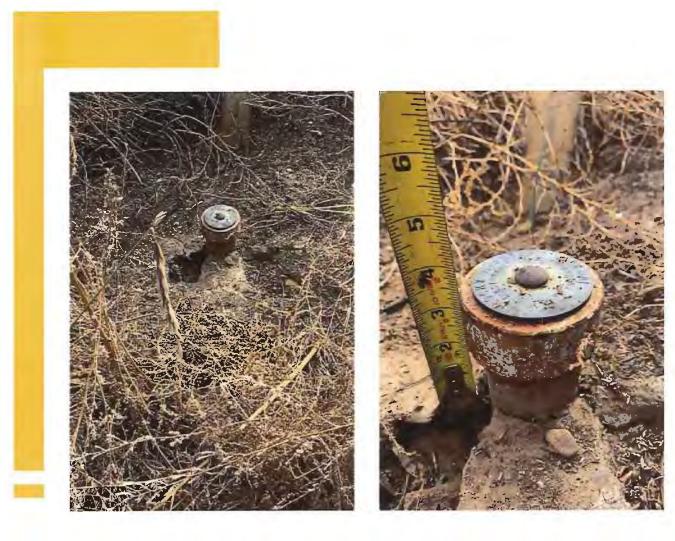
Photo #2: ICS ER 46

Monument ER46 exceeded the non-routine action trigger level during the fall 2023 Type I inspection and prompted the preparation of NRAP-2023-004. In February 2024, the cover was repaired around Monument ER46 in accordance with the approved NRAP.

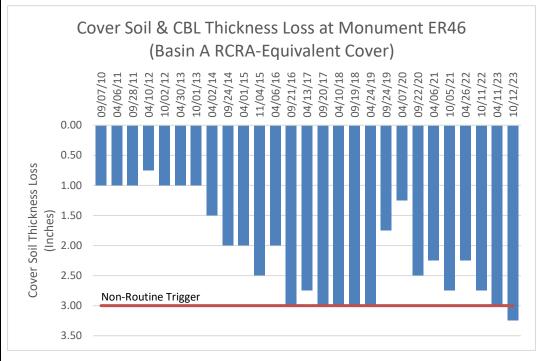
Soil Thickness Loss Measurements at ER46

Since cover construction was completed in 2010 soil loss measurements at ER46 have varied from 0.75 inches, up to 3.0 inches, as shown on the chart below. The measurement collected in October of 2023 was the first that exceeded 3.0 inches. Tabulated soil thickness loss data are provided in Table 1.

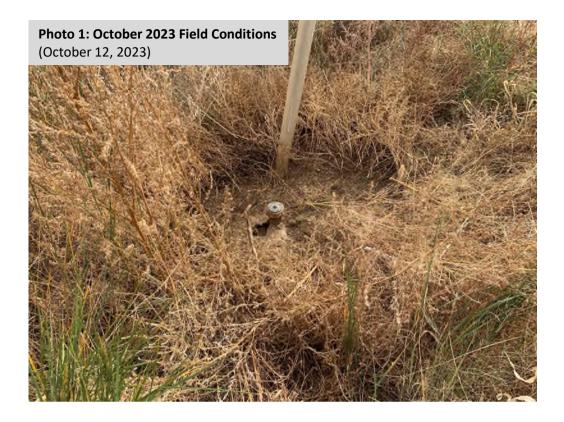
Field conditions around monument ER46 were evaluated by the Army on October 12 and 24, and November 13 and 14, 2023. Photos 1 and 2 show the condition of the area surrounding ER46 in October of 2023 when the non-routine trigger level was exceeded. The vegetation in the area was thick and composed of a combination of perennial grasses and annual weedy species. Some local settlement was evident adjacent to the monument, but there was no evidence of cracking or soil erosion, either caused by wind or precipitation.
