# FINAL PRELIMINARY ASSESSMENT AND SITE INSPECTION OF PER- AND POLYFLUOROALKYL SUBSTANCES

## **Joint Base Myer-Henderson Hall, Virginia**

PRELIMINARY ASSESSMENT/SITE INSPECTION OF PFAS AT JOINT BASE MYER-HENDERSON  
HALL, VIRGINIA

**Preliminary  
Assessment and Site  
Inspection of Per- and  
Polyfluoroalkyl  
Substances**

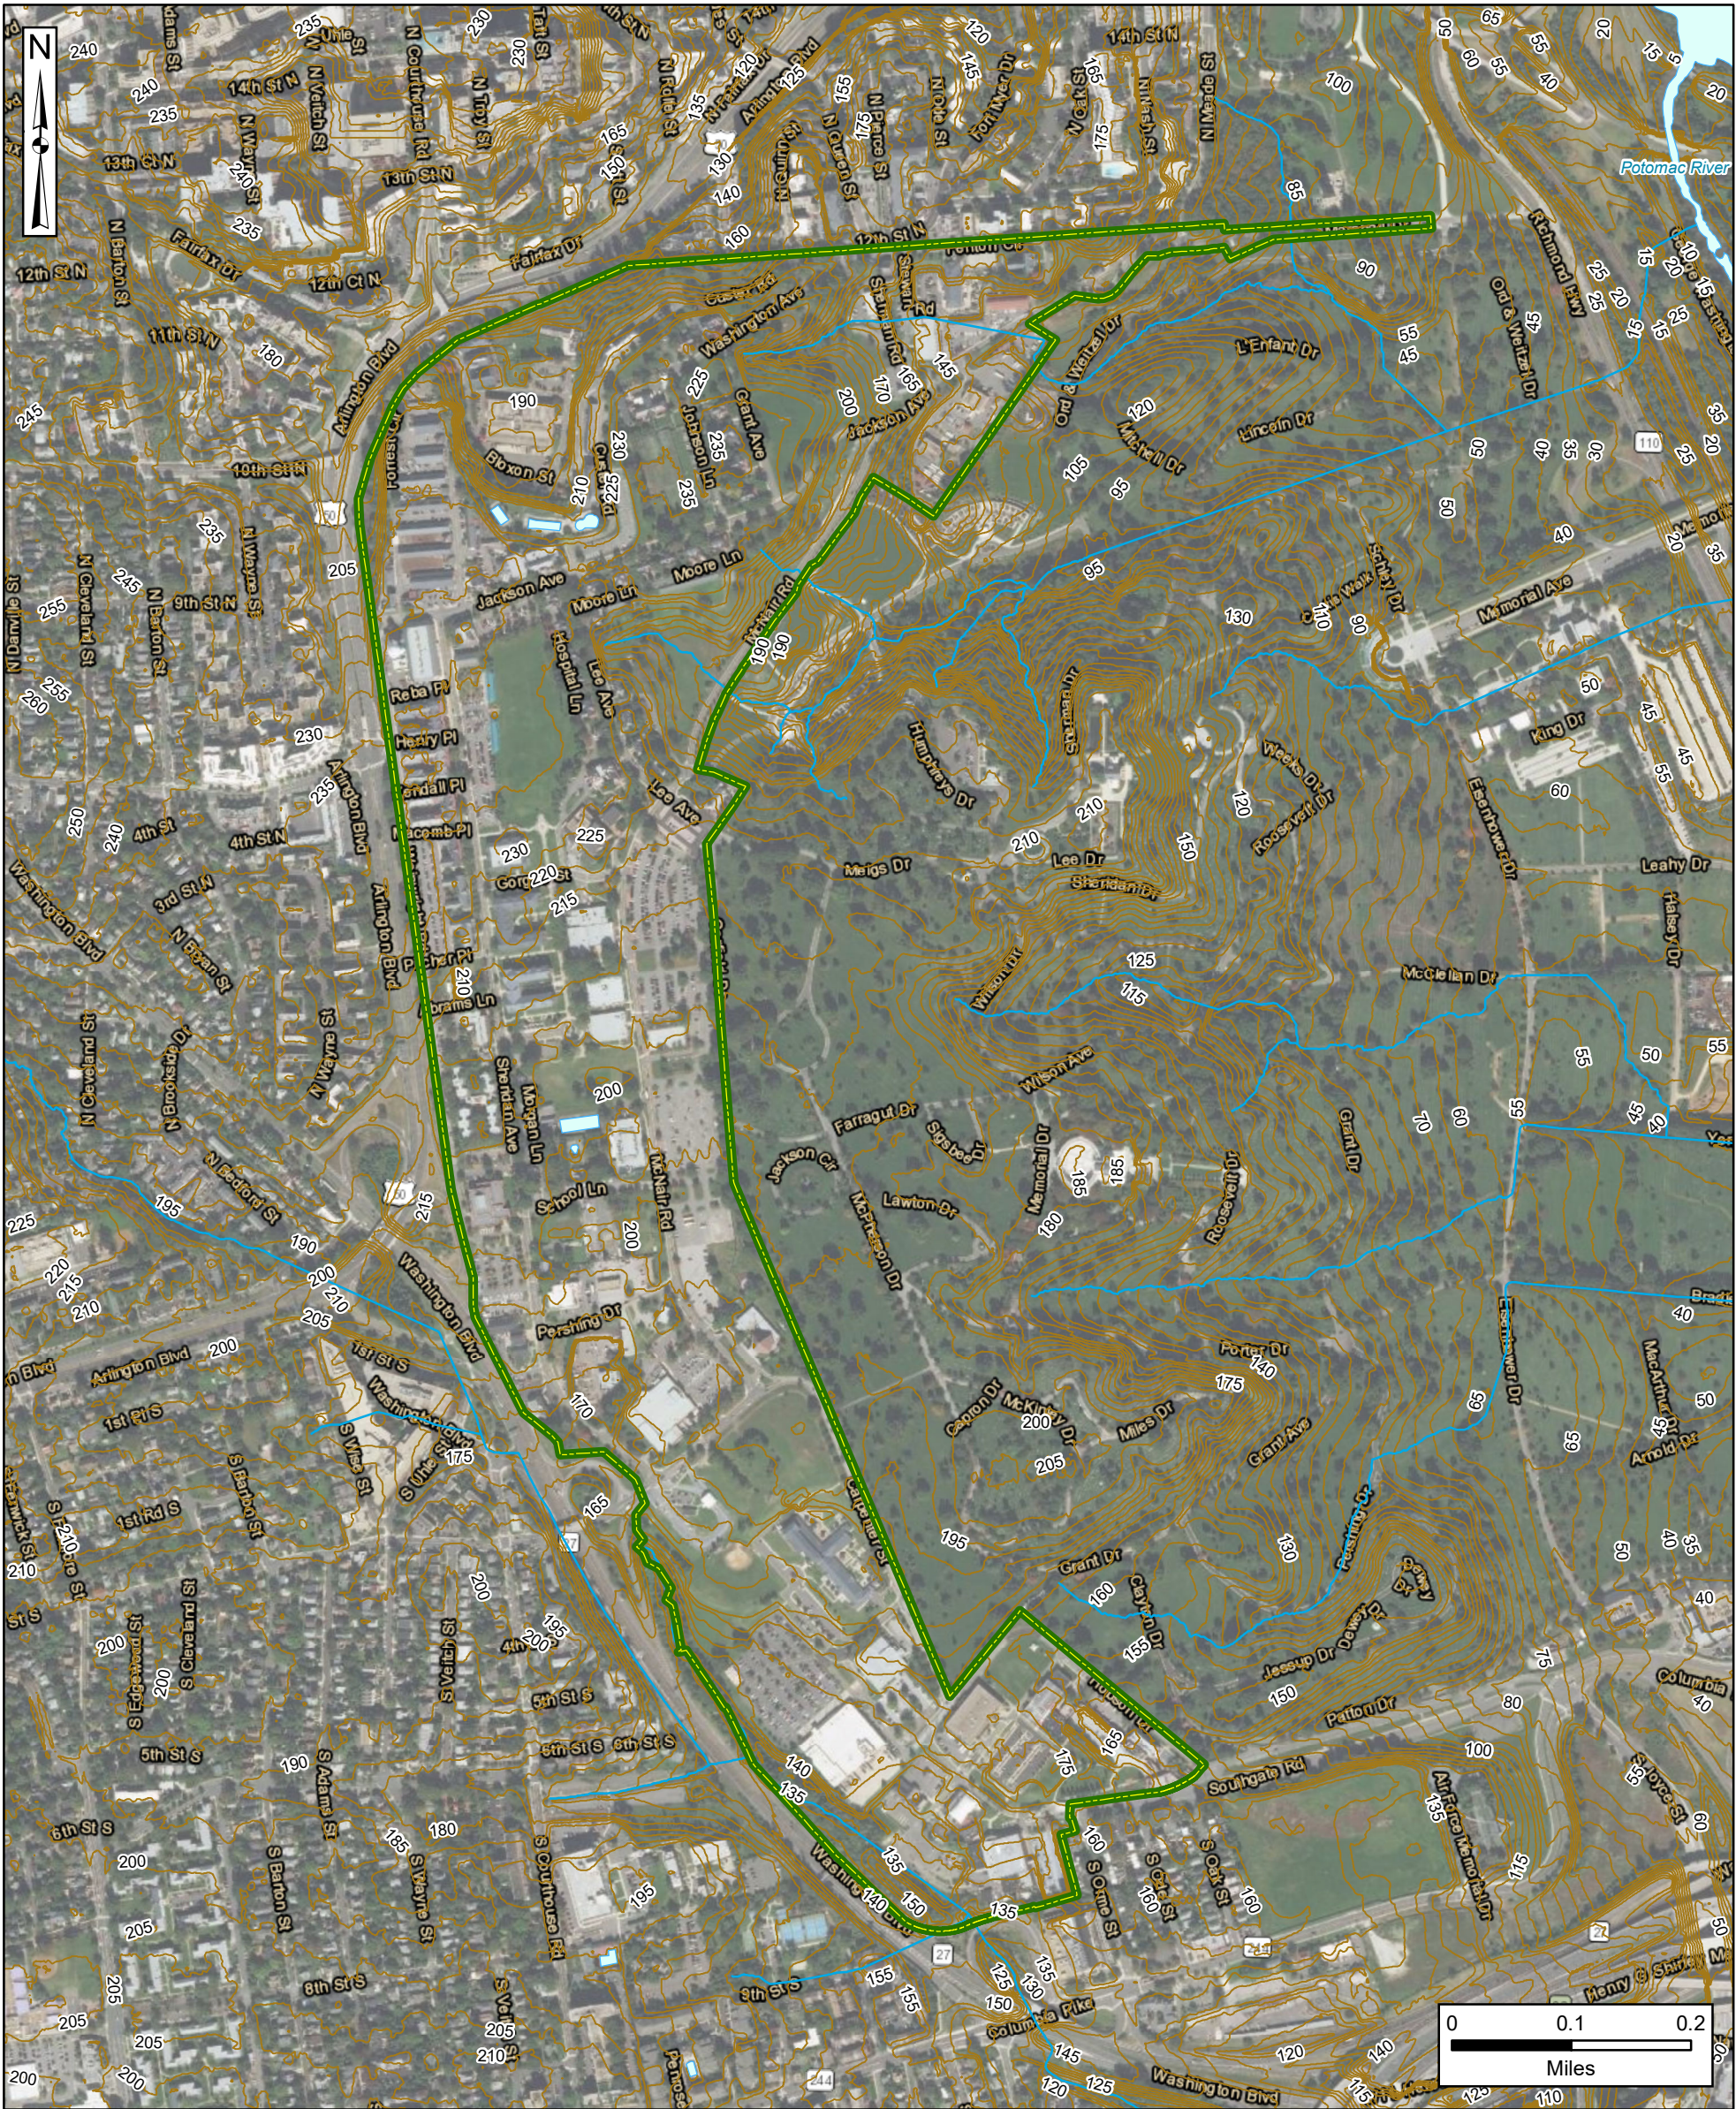
Figure 2-3  
Topographic Map of Fort Myer

- Installation Boundary
- River/Stream
- Water Body
- Elevation Contour (feet)

The topography of Fort Myer consists of mostly flat terrain. Elevations range from a low of approximately 100 feet above mean sea level (amsl) to a high of approximately 240 feet amsl (**Figure 2-3**). Fort Myer resides within the Rock Creek subwatershed, a subwatershed of the Potomac River Watershed, which drains to the Potomac River (Alliance 2018).

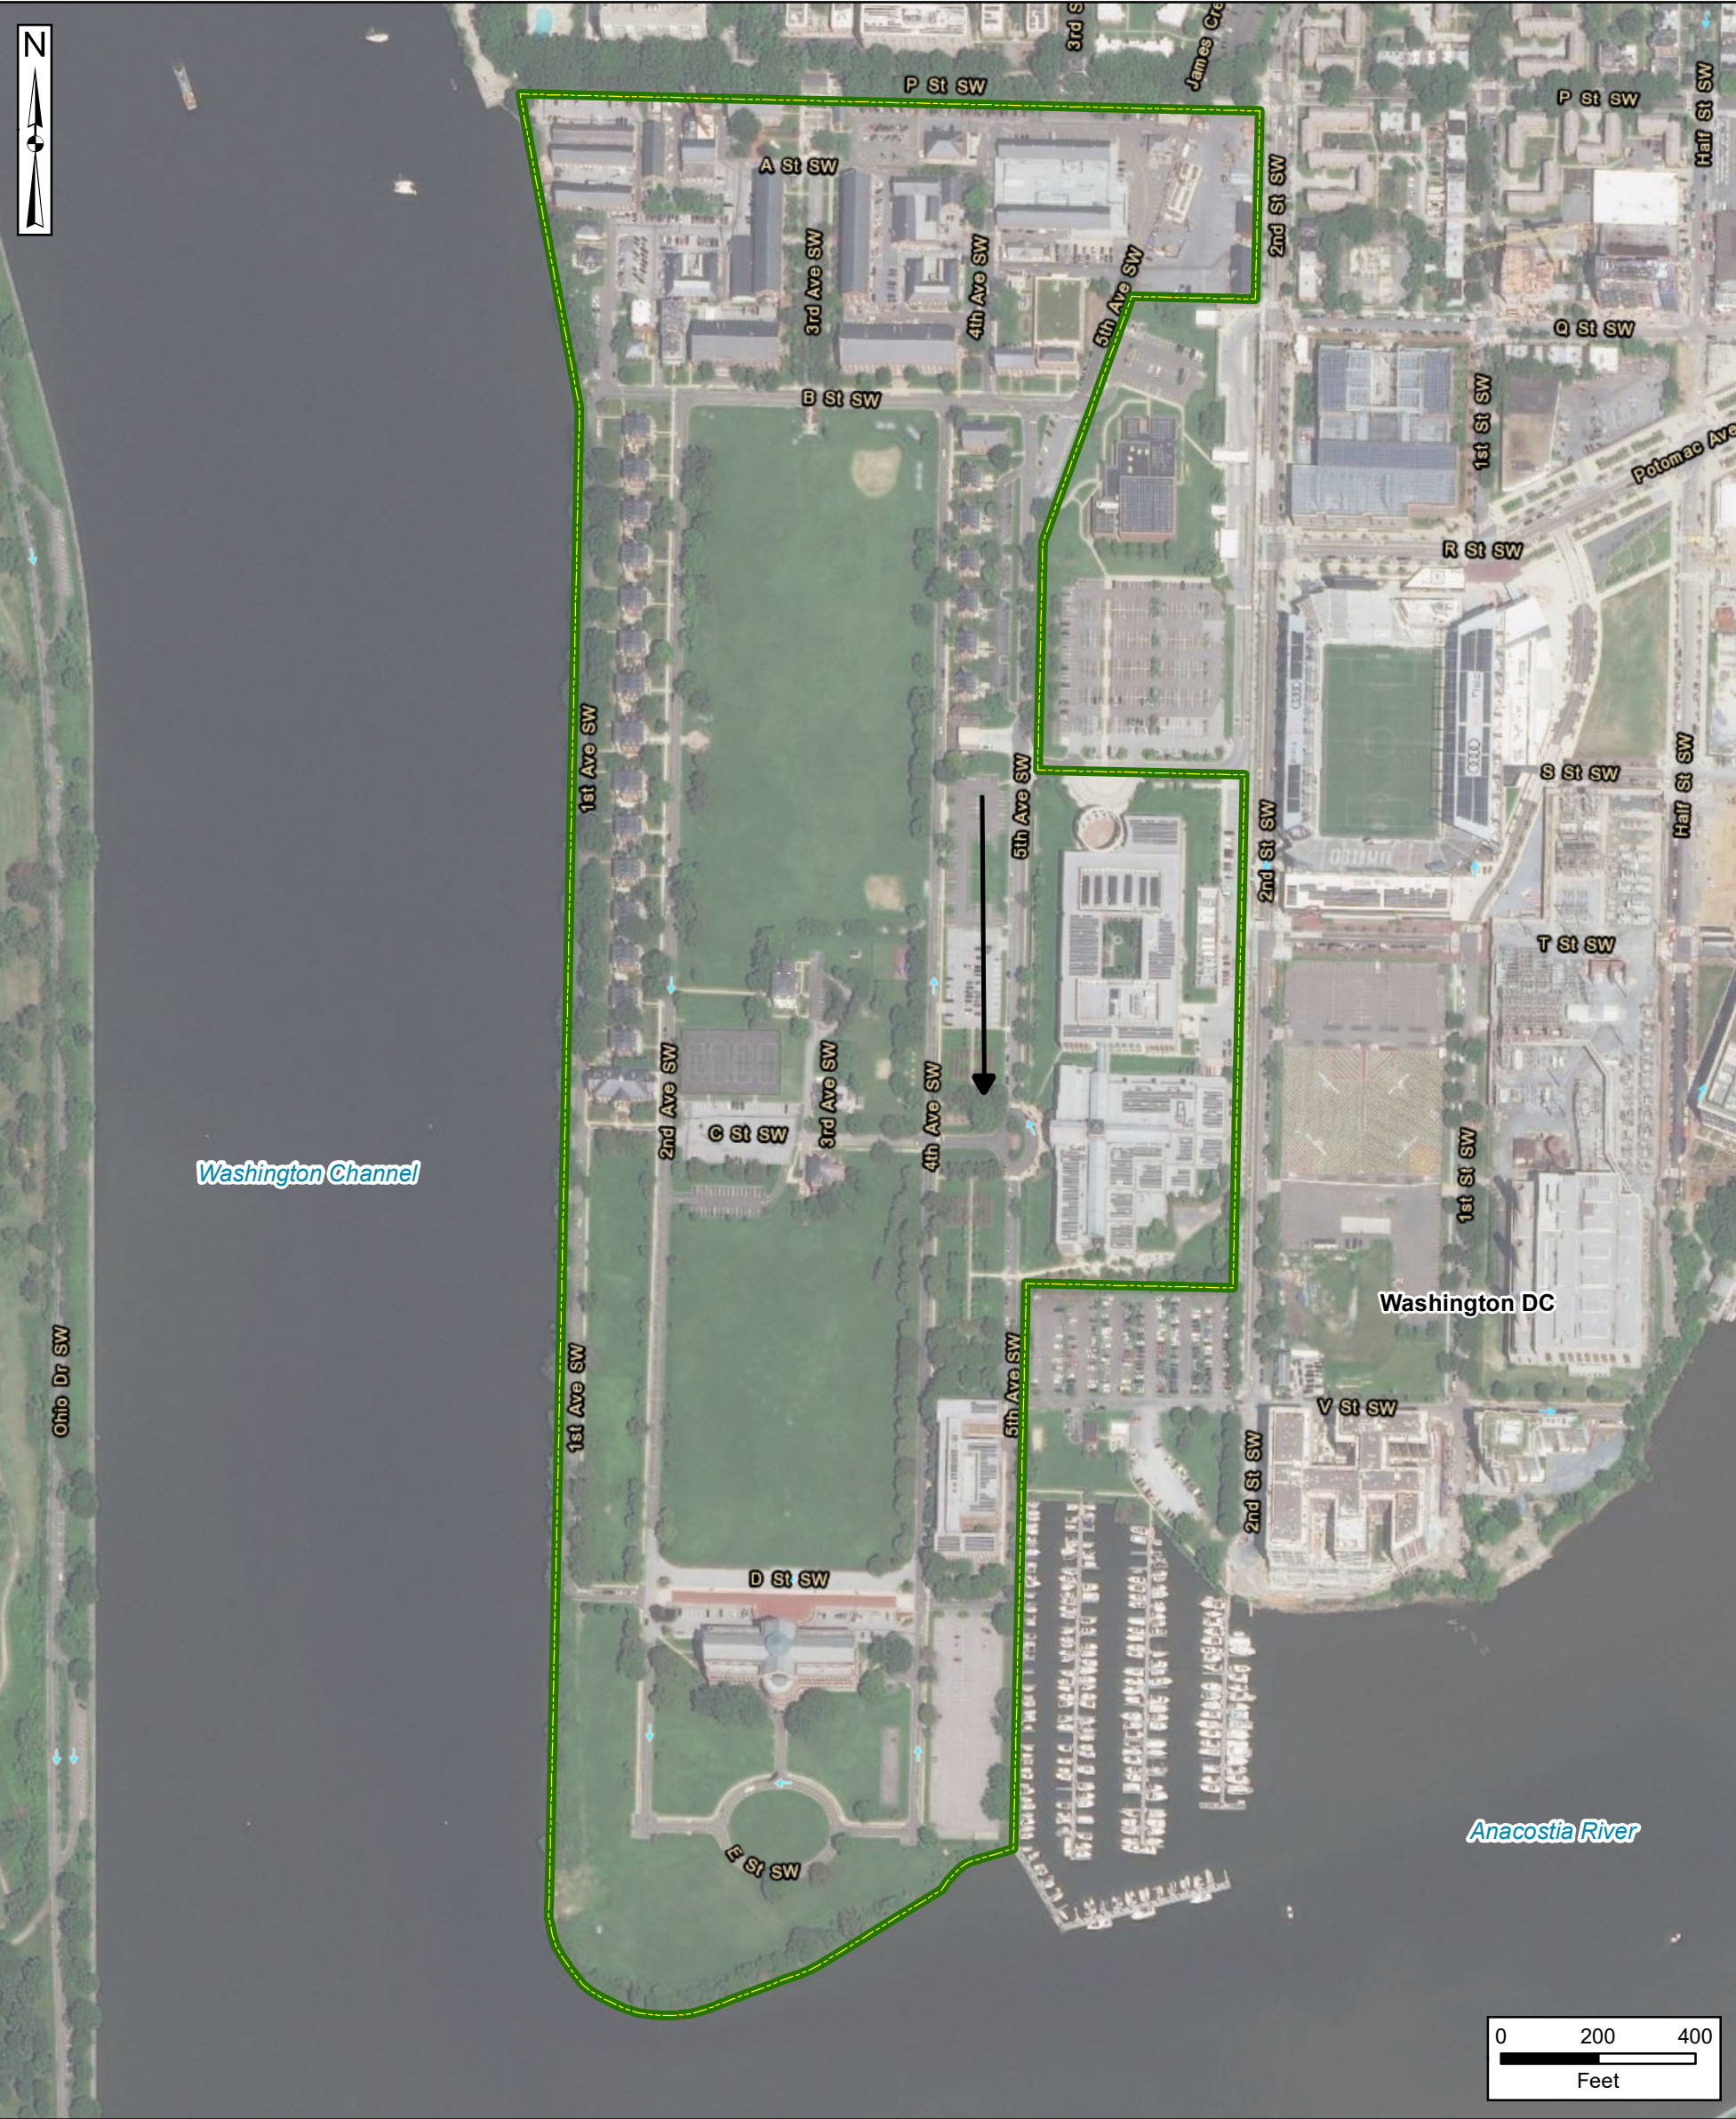
Figure 2-4  
Site Layout of Fort McNair

- Installation Boundary
- Groundwater Flow Direction

JBM-HH is a Joint Base of the U.S. military made up of Fort Myer, Fort McNair, and Henderson Hall (**Figure 2-1**). Fort McNair is in the southern region of Washington, D.C., where the Potomac and Anacostia rivers converge (**Figure 2-4**). Fort McNair, established in 1791, occupies approximately 112 acres (JBM-HH 2017), where it is home to the U.S. Army Military District of Washington (MDW) and National Defense University (NDU).

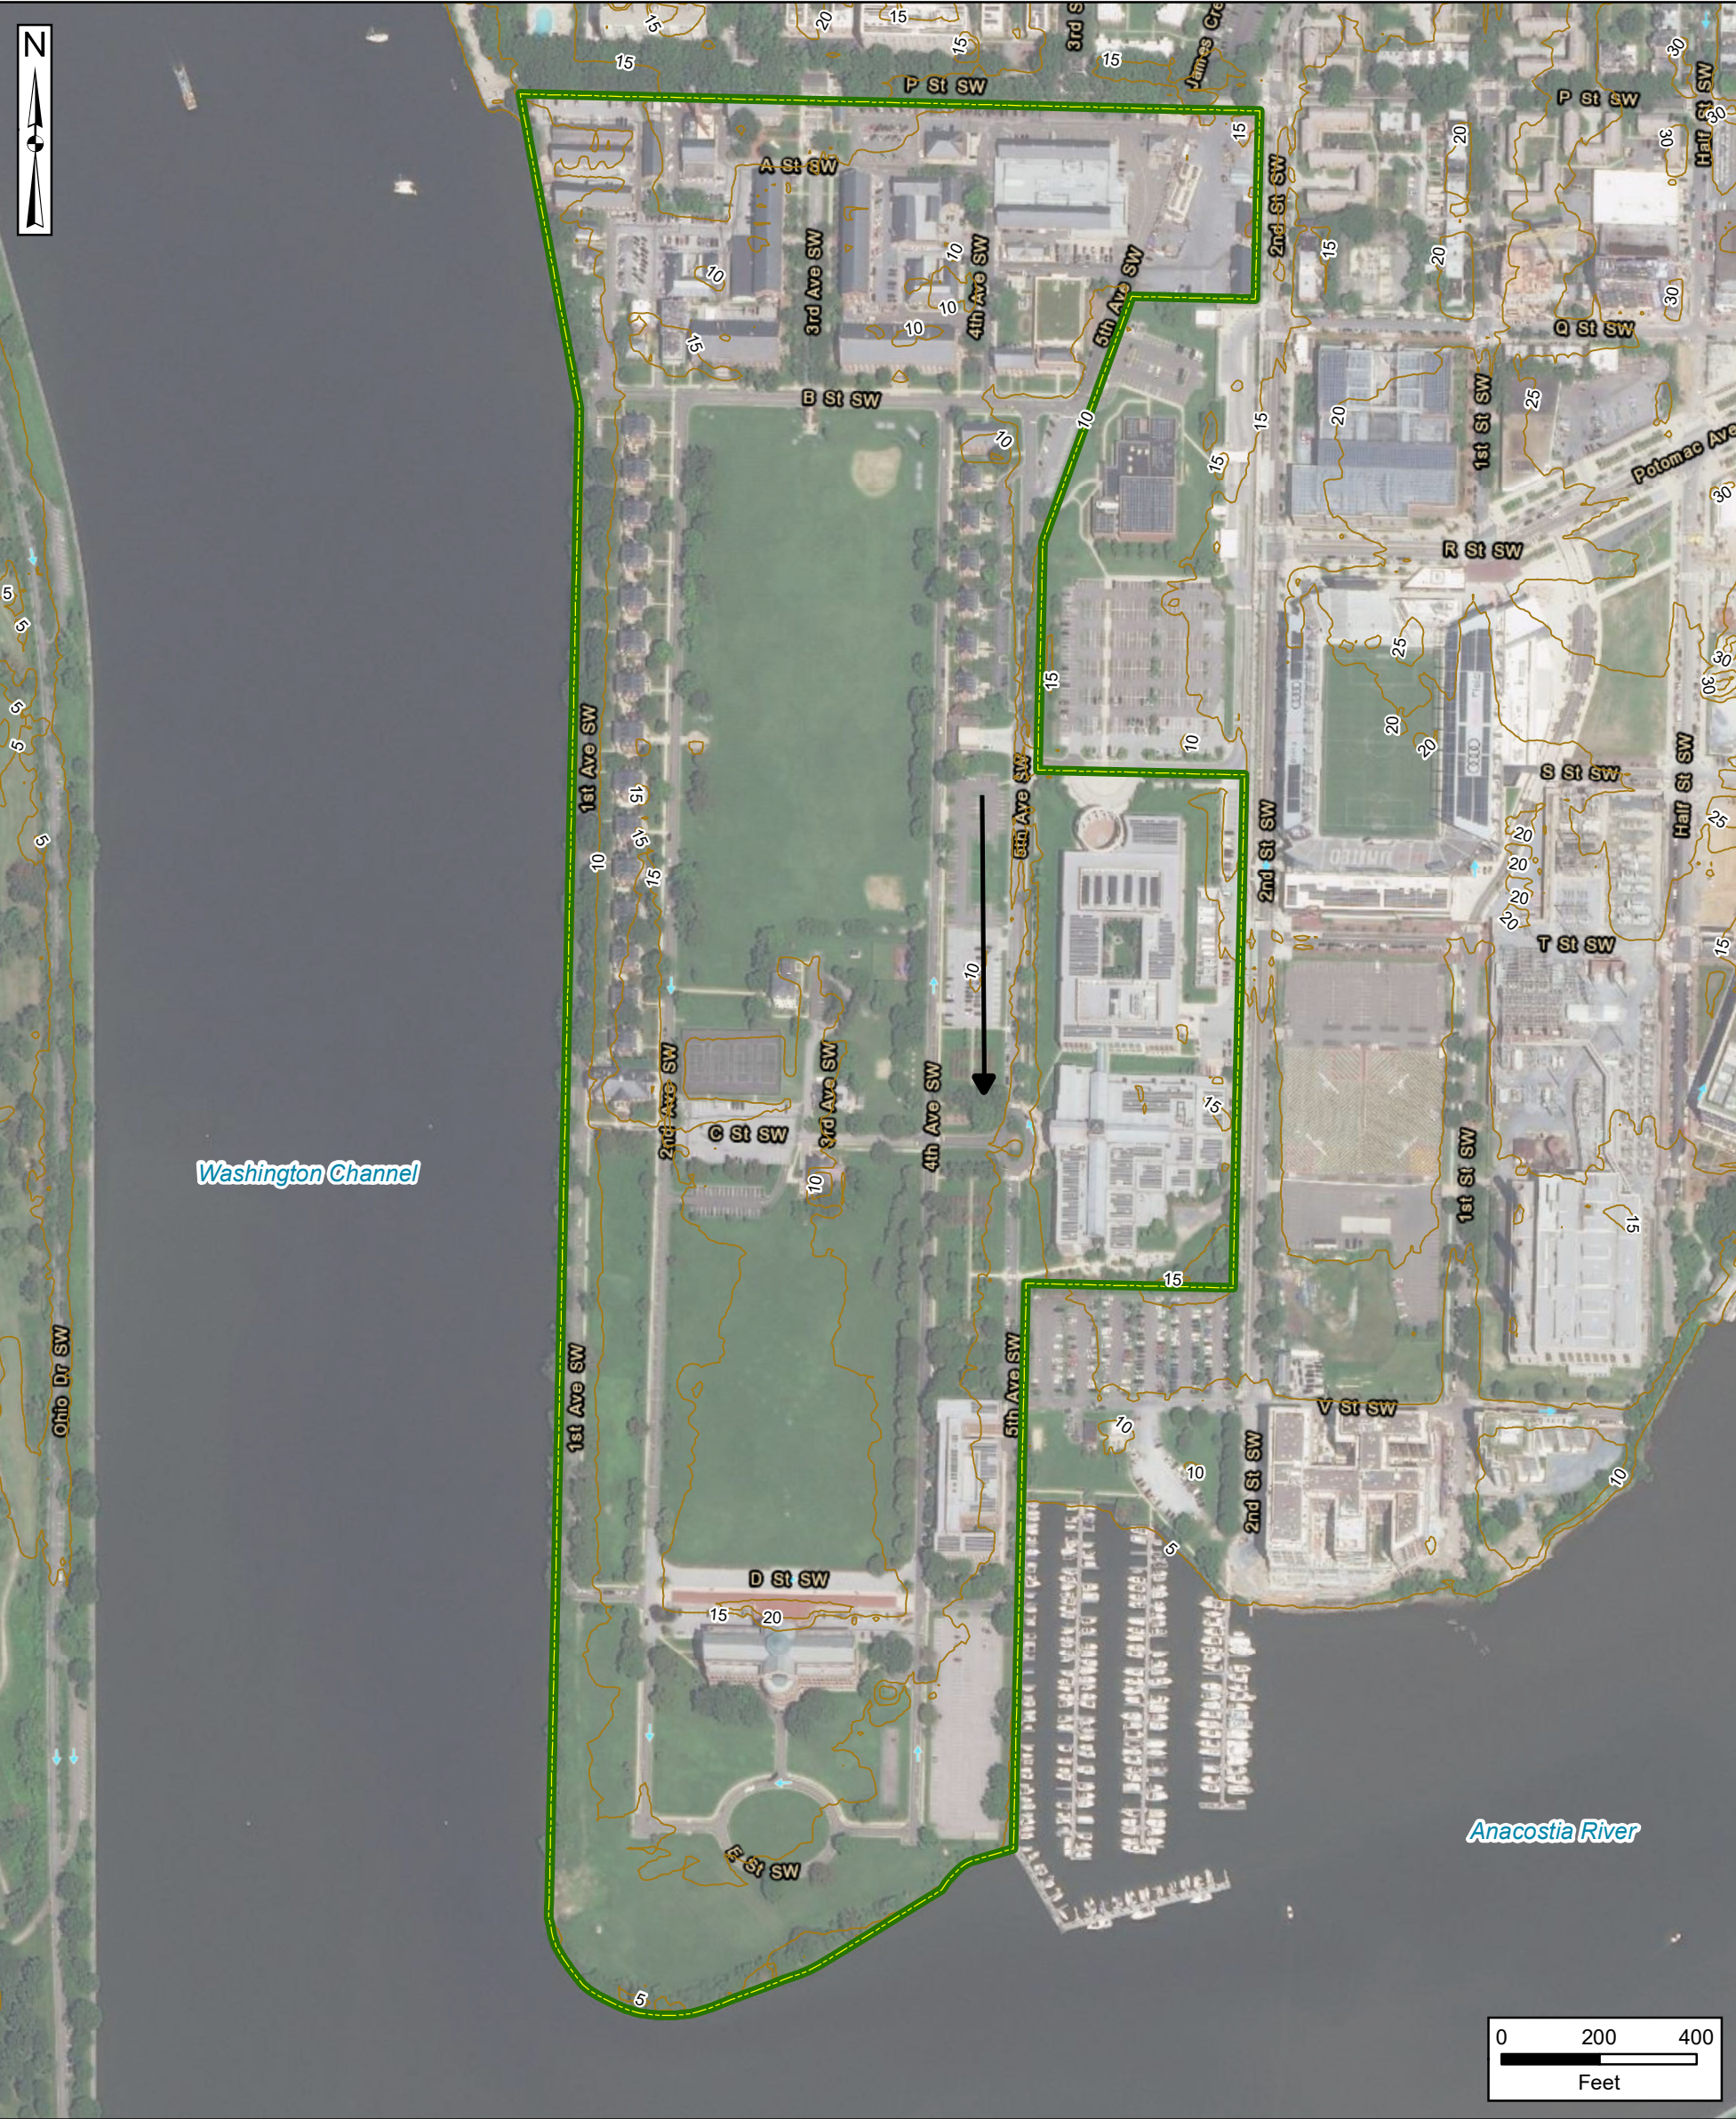
Figure 2-5  
Topographic Map of Fort McNair

- Fort McNair Installation Boundary
- Groundwater Flow Direction

The topography of Fort McNair consists of mostly flat terrain, sloping southeast toward the Anacostia River. Elevations range from a low of approximately 0.0 feet amsl to a high of approximately 20 feet amsl (**Figure 2-5**). Fort McNair resides within the Rock Creek – Potomac River and Anacostia River Watersheds.

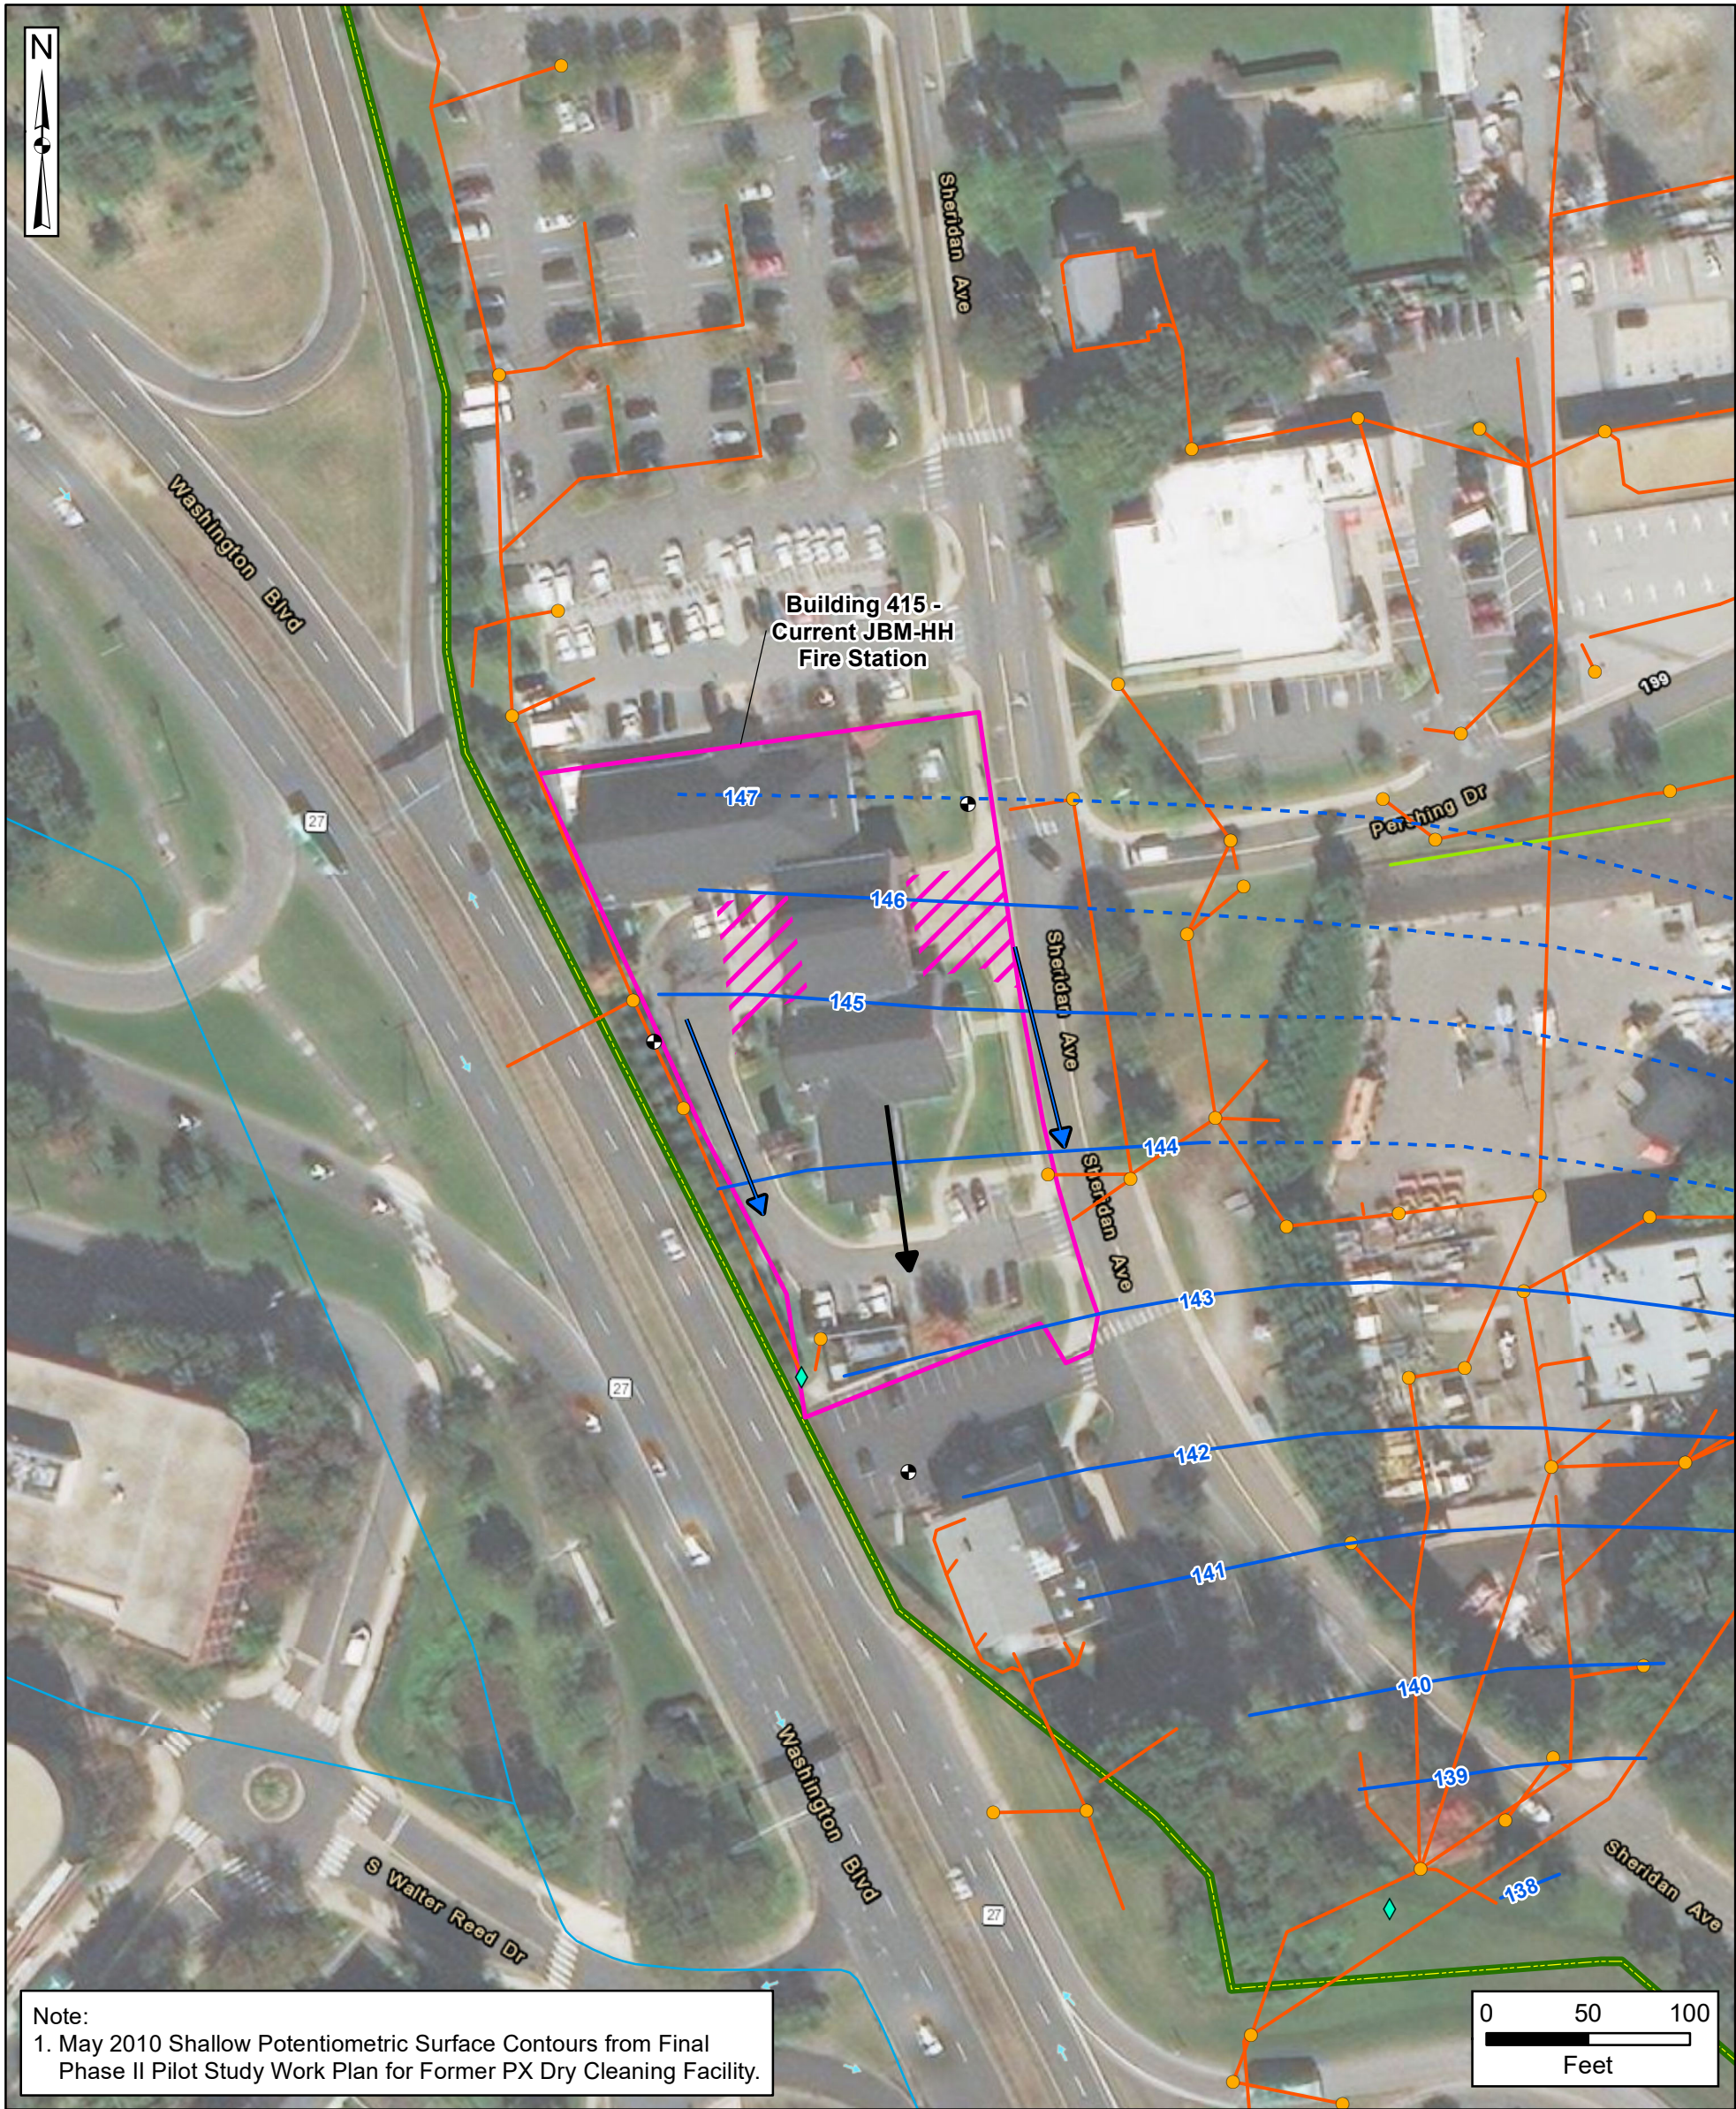
Figure 5-3  
Aerial Photo of Building 415 -  
Current JBM-HH Fire Station AOP

- Installation Boundary
- River/Stream
- Surface Water Runoff Flow Direction
- Groundwater Flow Direction
- Shallow Potentiometric Surface Contour (May 2010)
- Estimated Shallow Potentiometric Surface Contour (May 2010)
- Approximate Area of AFFF Release

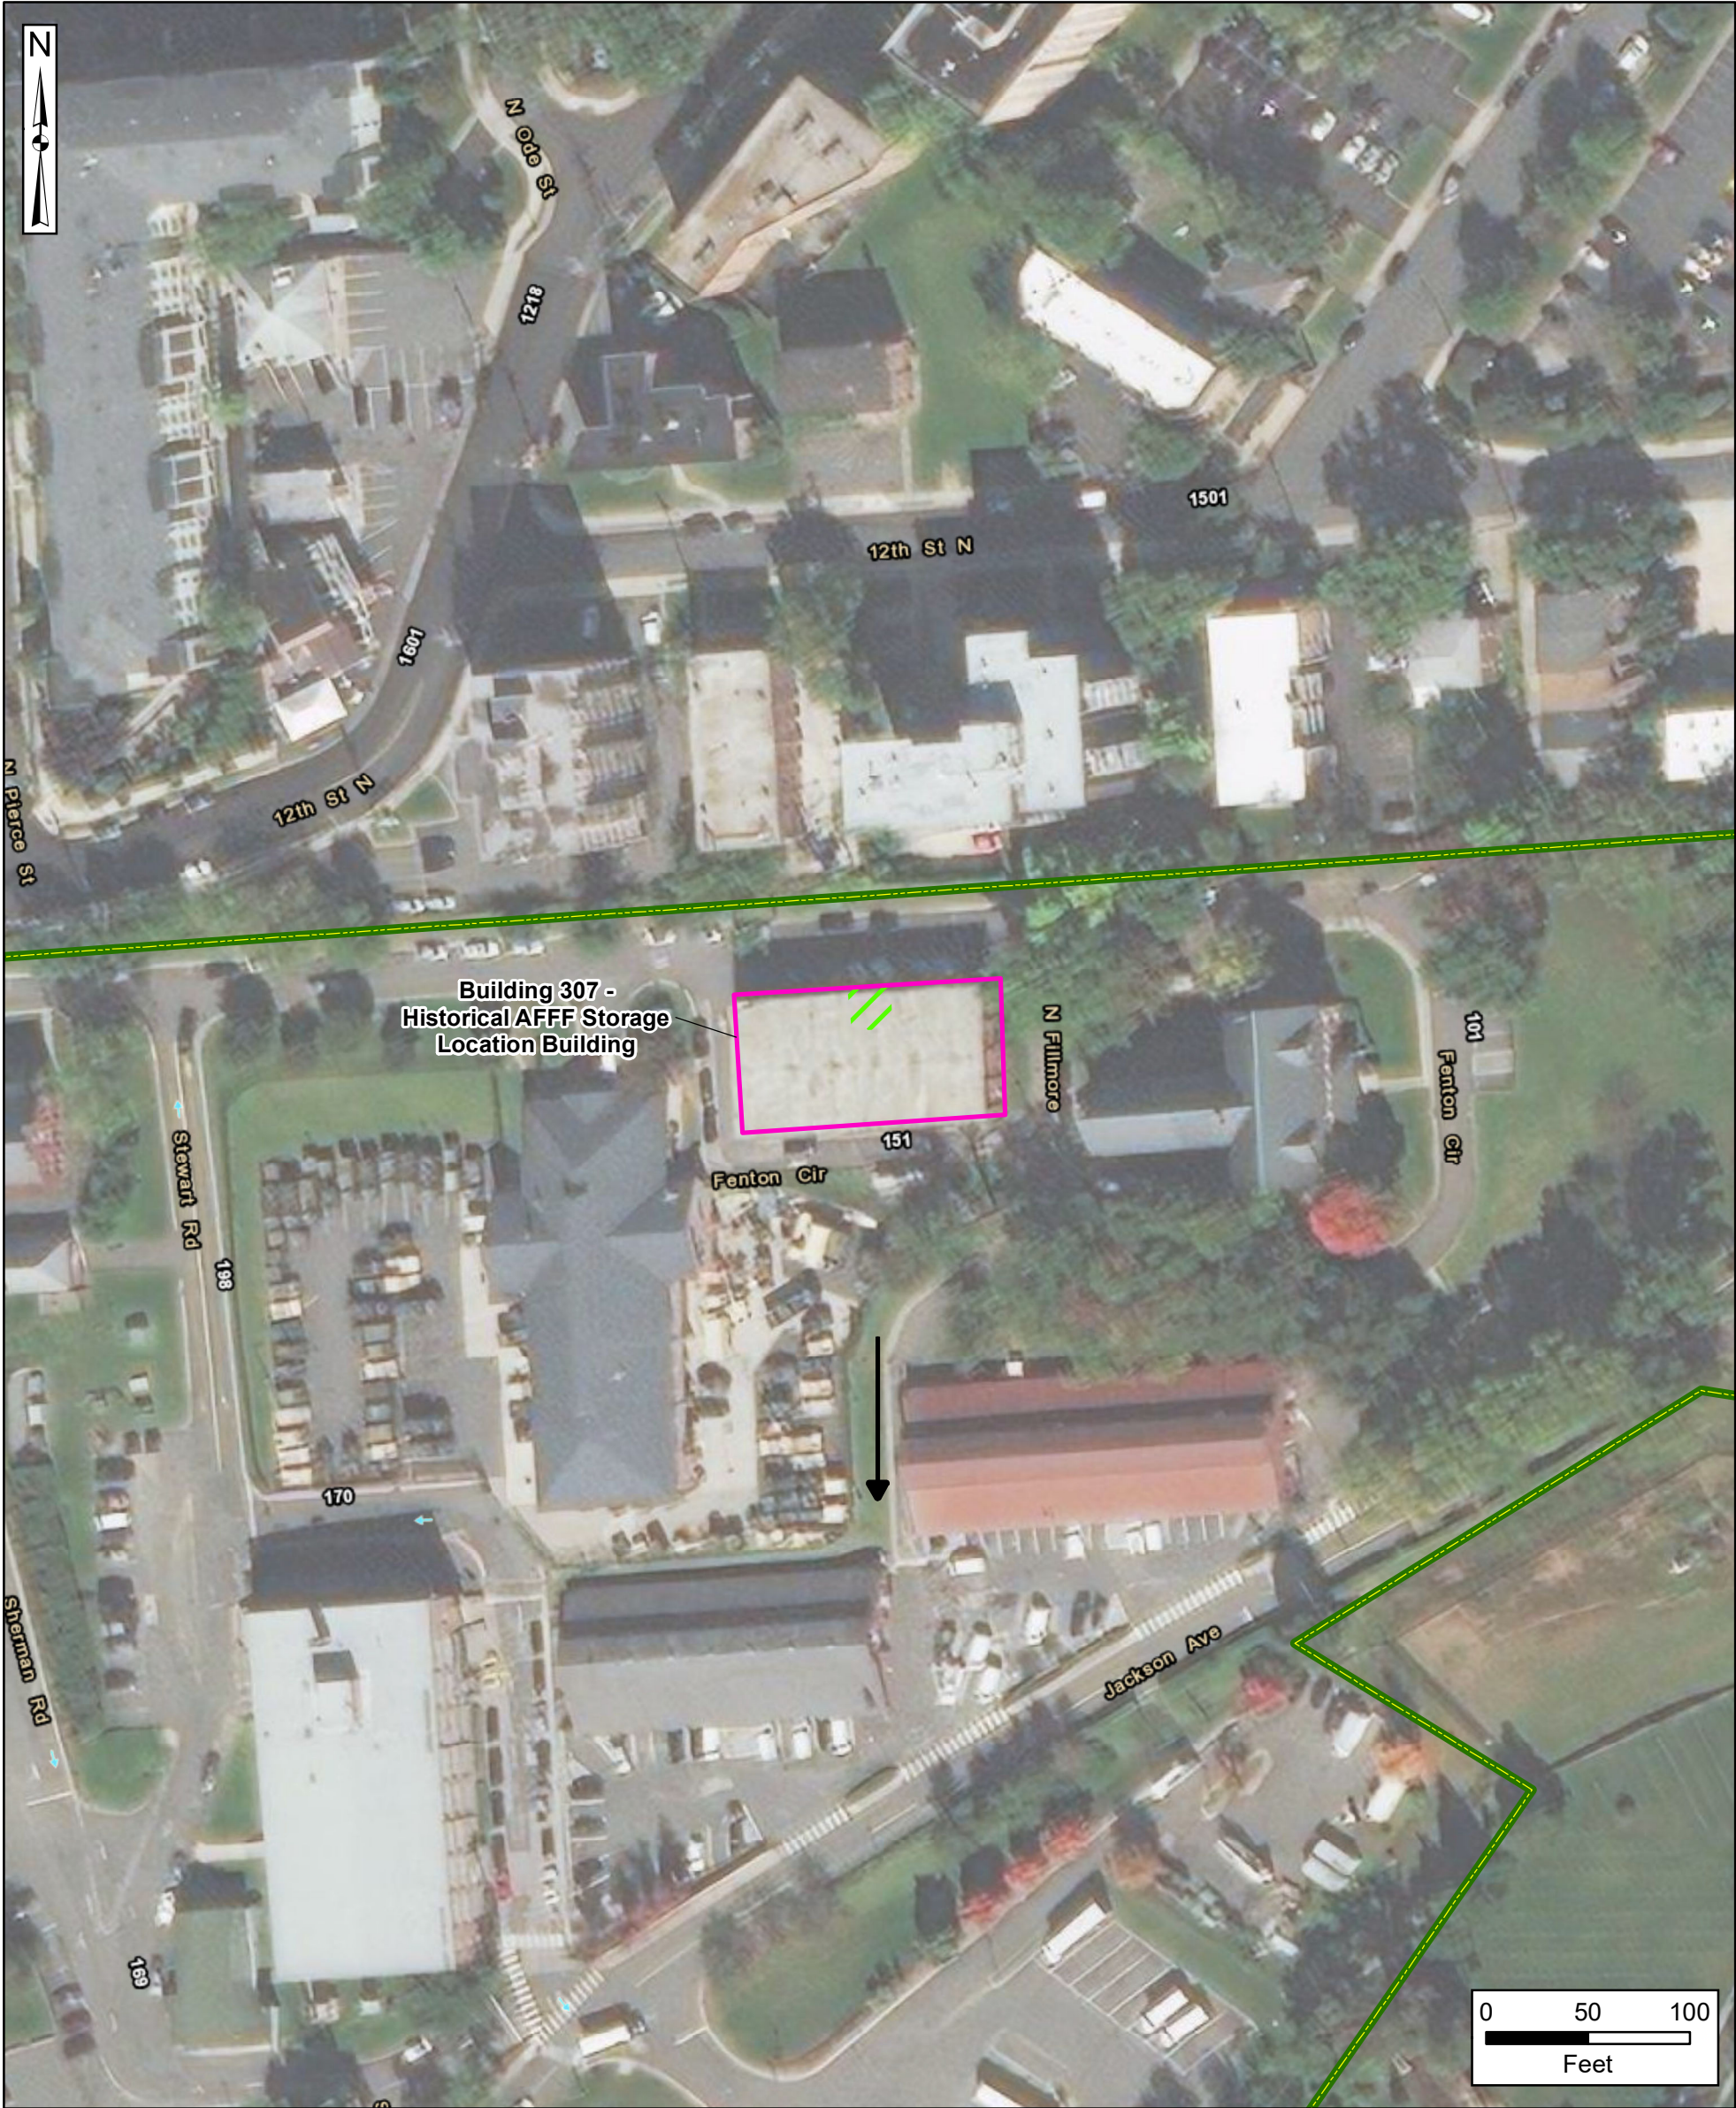
Figure 5-5  
Aerial Photo of Building 307 -  
Historical AFFF Storage Location AOPI

An interview with a retired JBM-HH Assistant Fire Chief stated that Building 307 was used as a storage space for Fire Department equipment and materials from the mid-2000s to 2015. AFFF was reportedly stored at this location before being disposed of through the JBM-HH Hazardous Waste Program in 2015.

- Installation Boundary
- Groundwater Flow Direction
- AOPI
- Location of AFFF Storage Area in Building 307

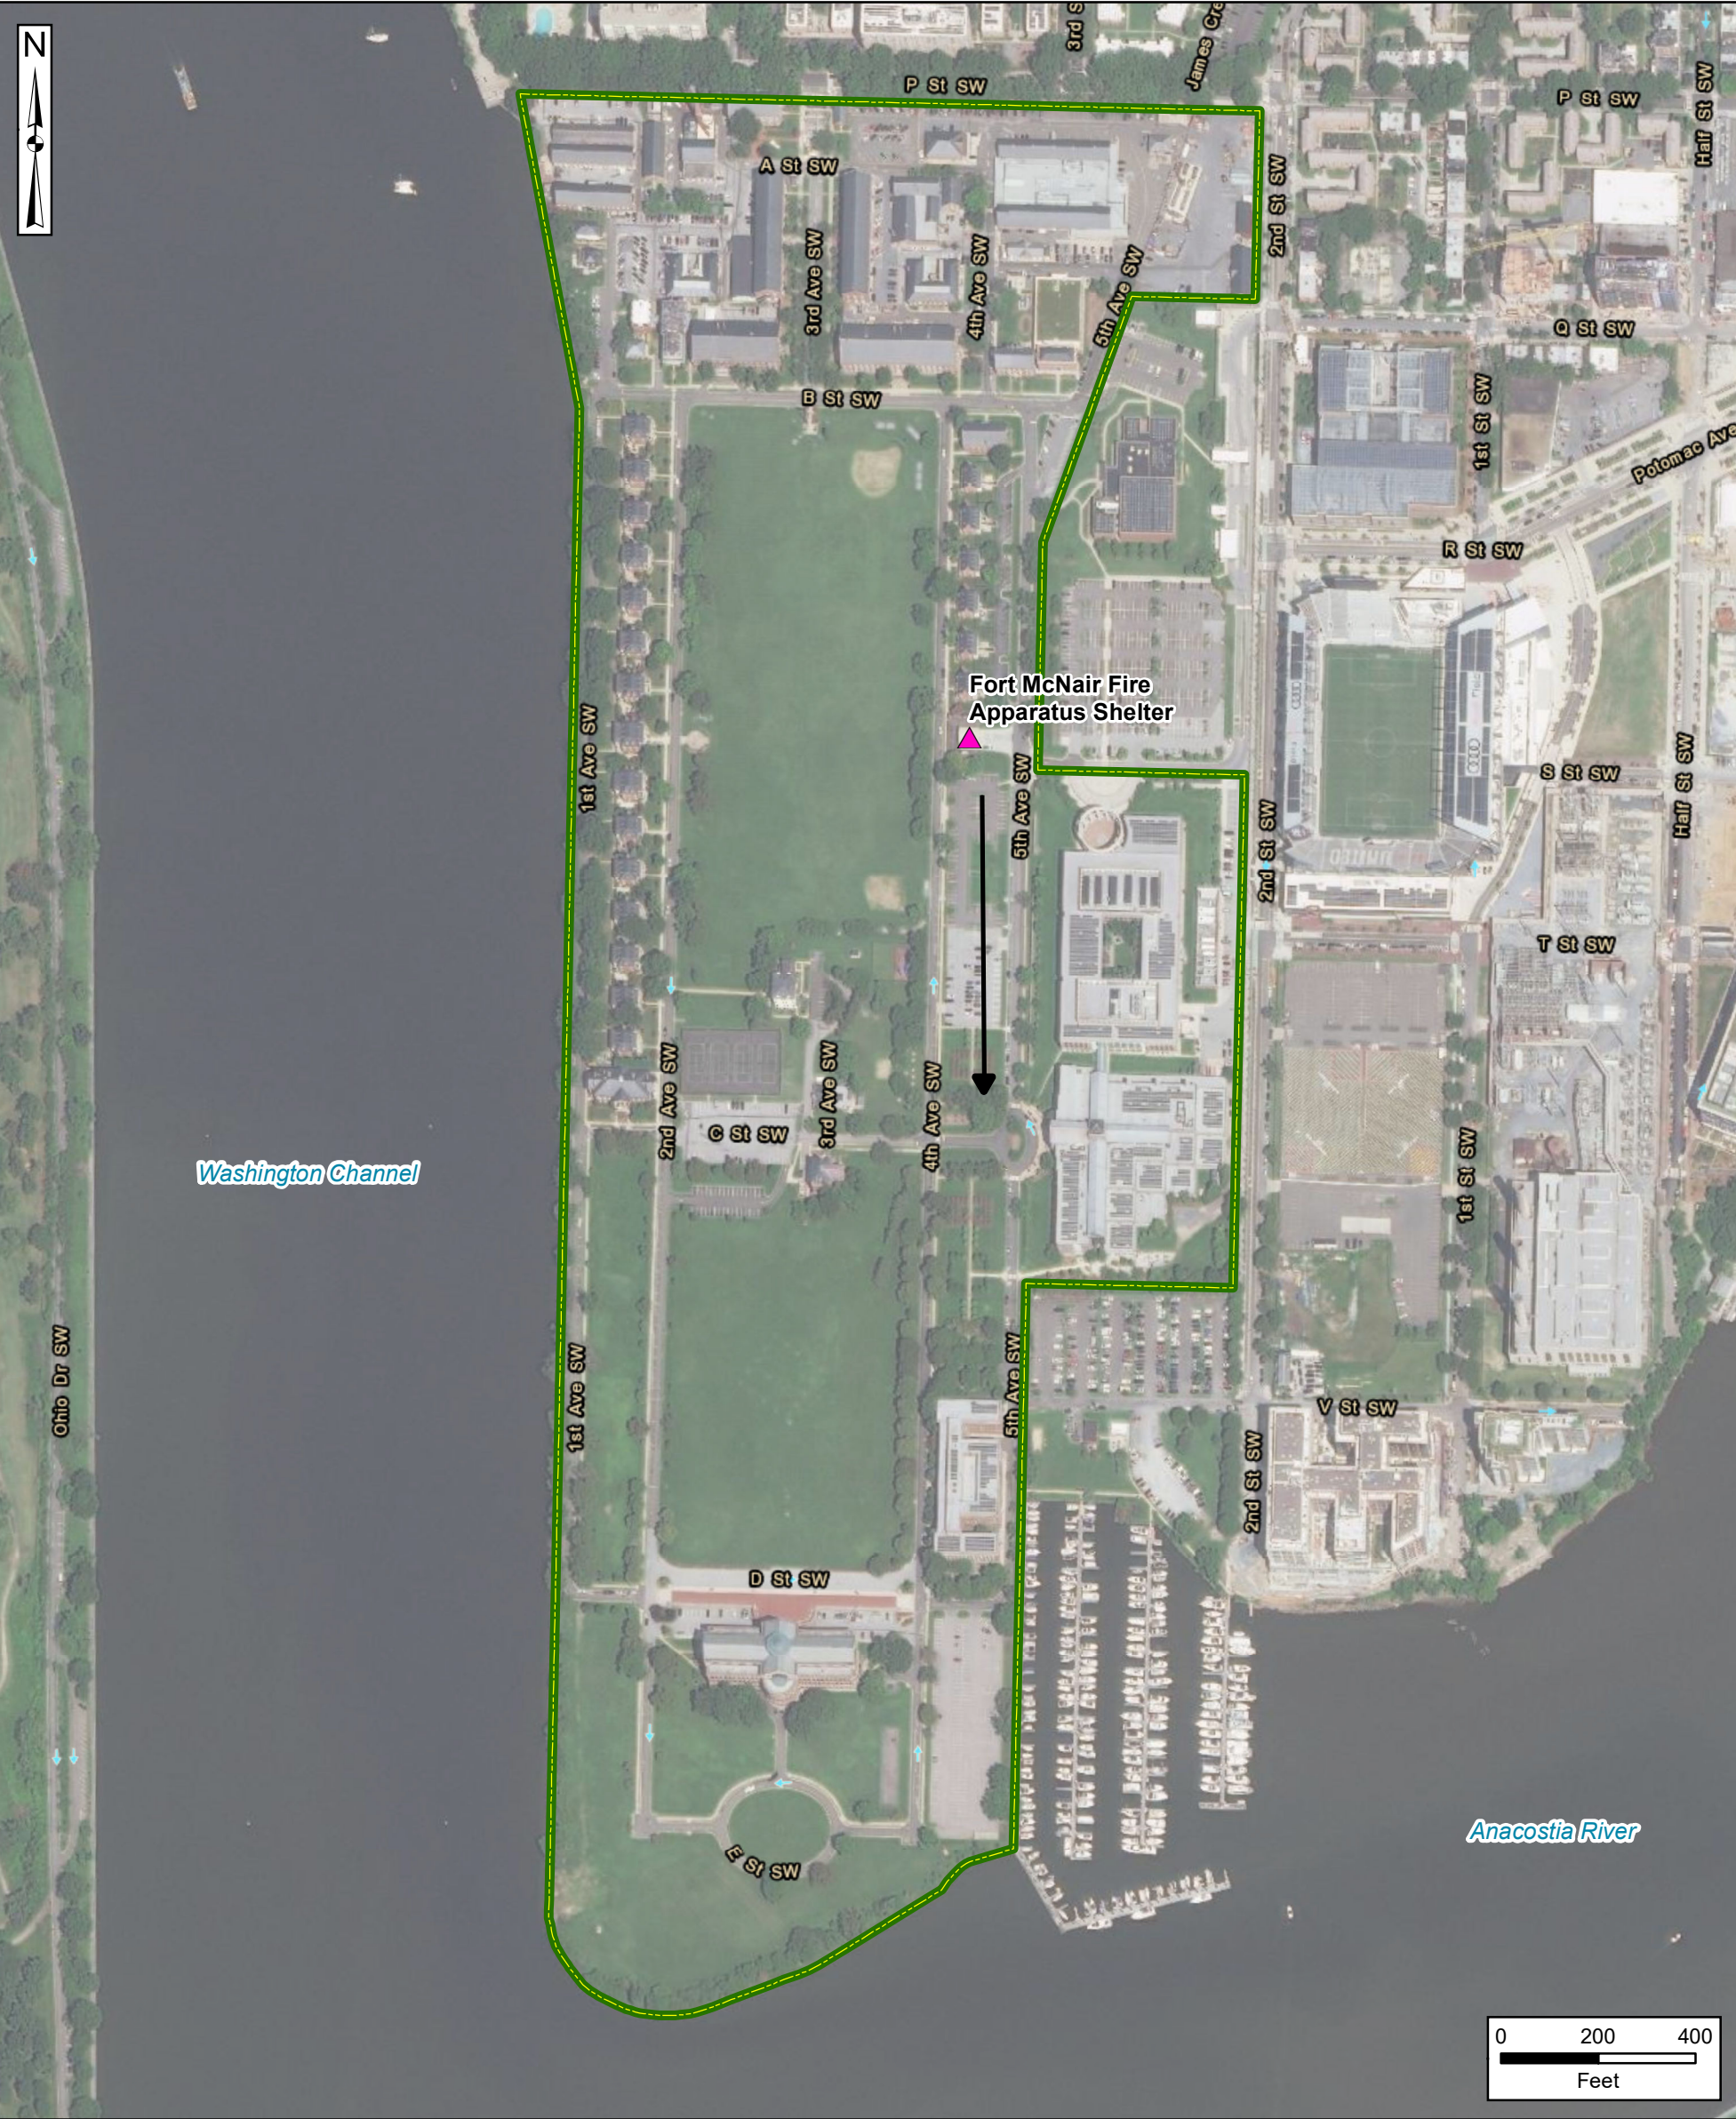
Figure 5-6  
AOPI Locations at Fort McNair

- Installation Boundary
- Groundwater Flow Direction
- AOPI

The AOPI location is shown on **Figure 5-6**. An aerial photograph that shows the AOPI and the approximate extent of AFFF release at the AOPI is presented on **Figure 5-7**.
