# FINAL PRELIMINARY ASSESSMENT AND SITE INSPECTION OF PER- AND POLYFLUOROALKYL SUBSTANCES

## **Joint Base Myer-Henderson Hall, Virginia**

PRELIMINARY ASSESSMENT/SITE INSPECTION OF PFAS AT JOINT BASE MYER-HENDERSON  
HALL, VIRGINIA

**Preliminary  
Assessment and Site  
Inspection of Per- and  
Polyfluoroalkyl  
Substances**

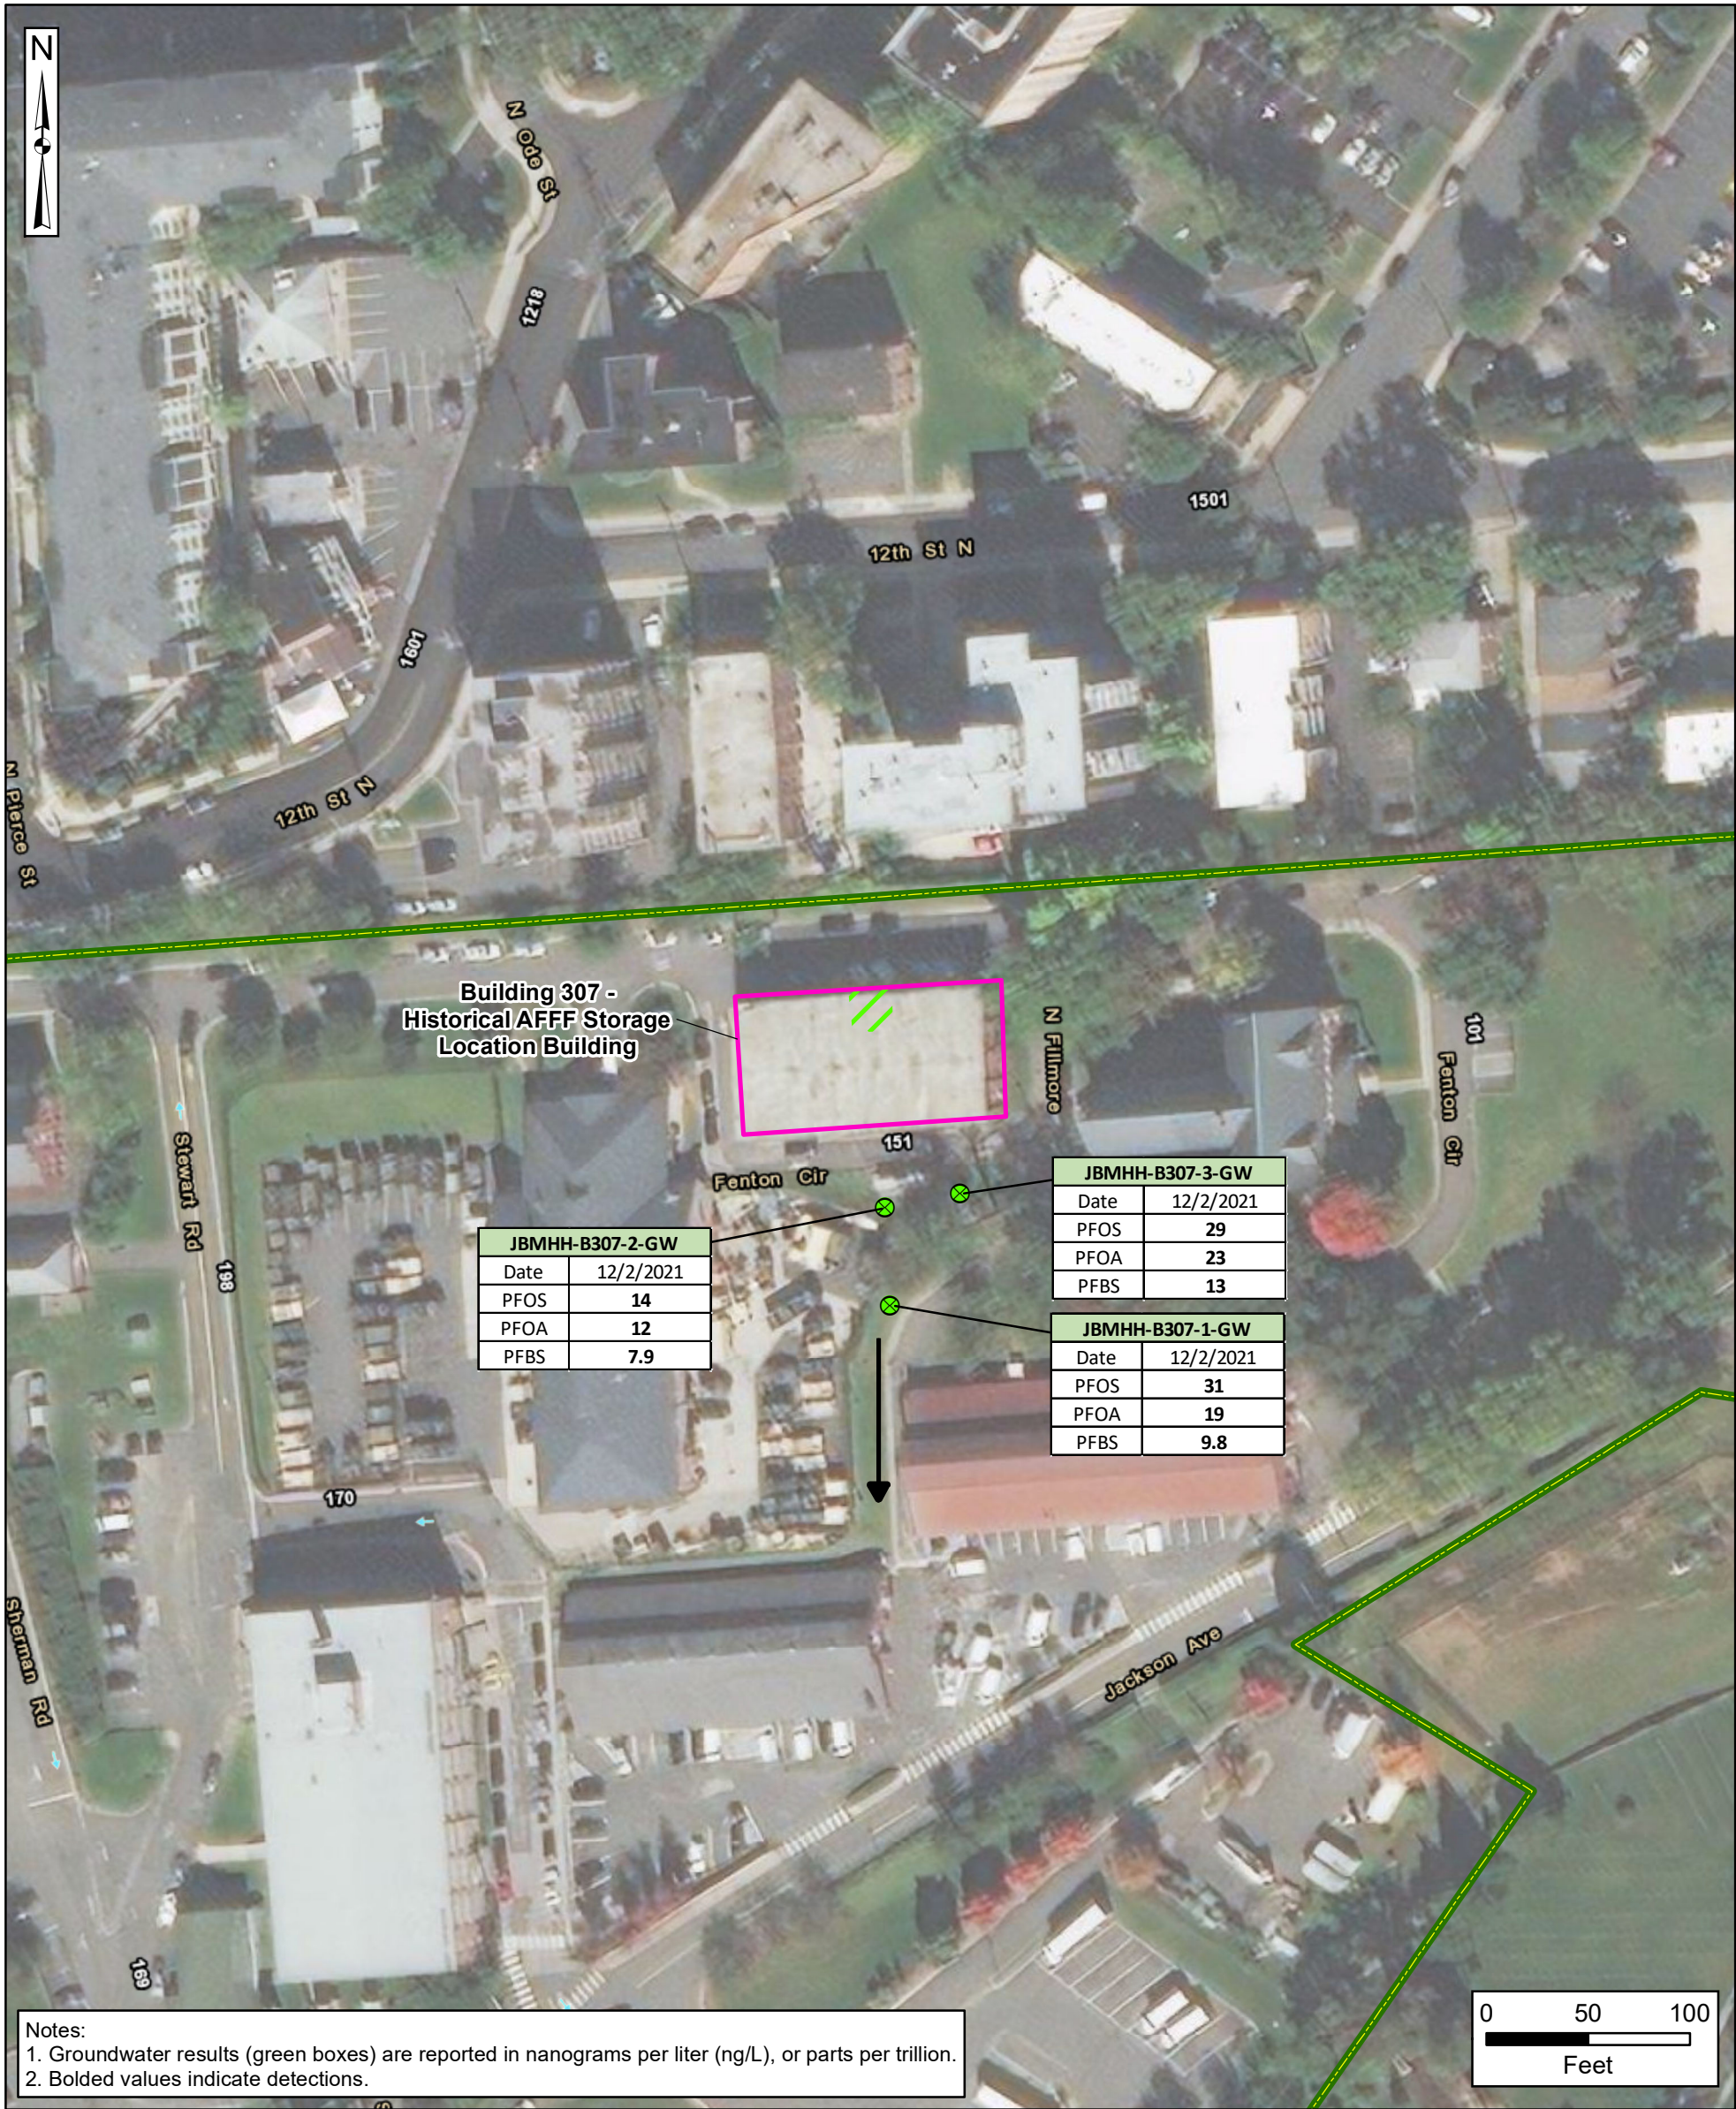
Figure 7-4  
Building 307 – Historical AFFF Storage Location  
PFOS, PFOA, and PFBS Analytical Results

- Installation Boundary
- Groundwater Flow Direction
- AOPF
- Location of AFFF Storage Area in Building 307
- Groundwater Sampling Location
- AFFF = aqueous film-forming foam
- AOPF = area of potential interest
- PFBS = perfluorobutanesulfonic acid
- PFOA = perfluorooctanoic acid
- PFOS = perfluorooctane sulfonate
