Site Management Plan

2023

Fort George G. Meade, MD

June 2023

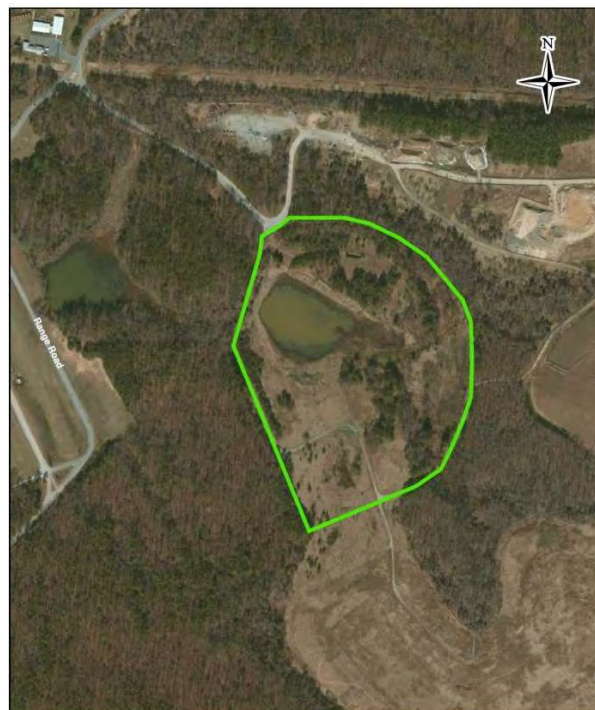
FGGM 08 - Comp Ammunition Supply Point No. 1 (OU-7)
0 200 400 800
Feet

One surface and one subsurface soil sample were collected from each of the six former magazine locations in the former ASP area to assess the potential for soil contamination due to spills or leaks. Based on a risk analysis of the analytical results, concentrations are below site-specific action levels.

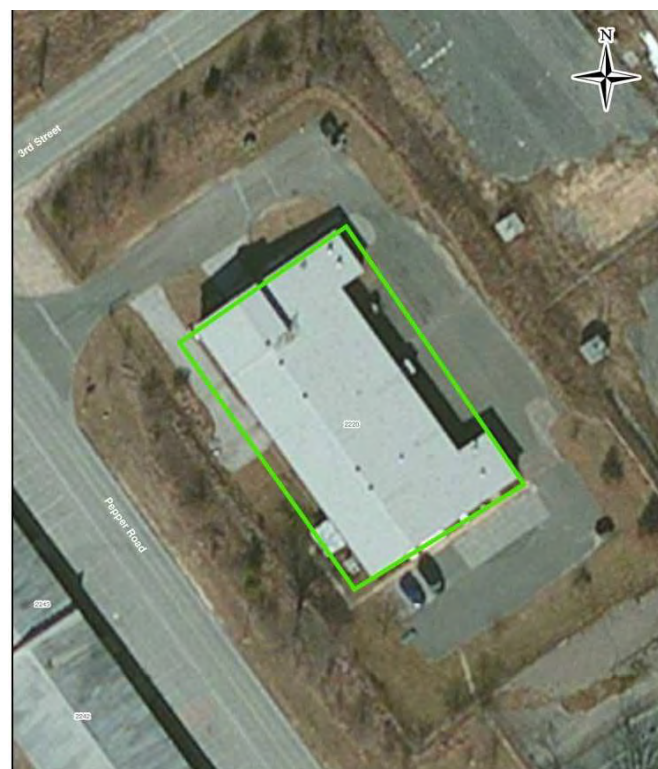
FGGM 45 - Building 2220 - Calibration Laboratory

Site Description: Building 2220 (SWMU 42) was constructed in the late 1950s or early 1960s and was used as a warehouse and troop training center. This site was used in the late 1960s as a missile repair shop, using solvents and producing solvent waste. Small amounts of cleaning solvent and gasoline were formerly stored in a shed outside the building. Two fuel oil USTs were formerly located at the south side of the building; one removed in 1992, and the other removed and replaced in 1988 then removed in 1997. During the 1988 UST removal, corrosion holes were noted at the end of the tank. Building 2220 is also identified as FGGM-91, Former Missile Repair Shop groundwater.

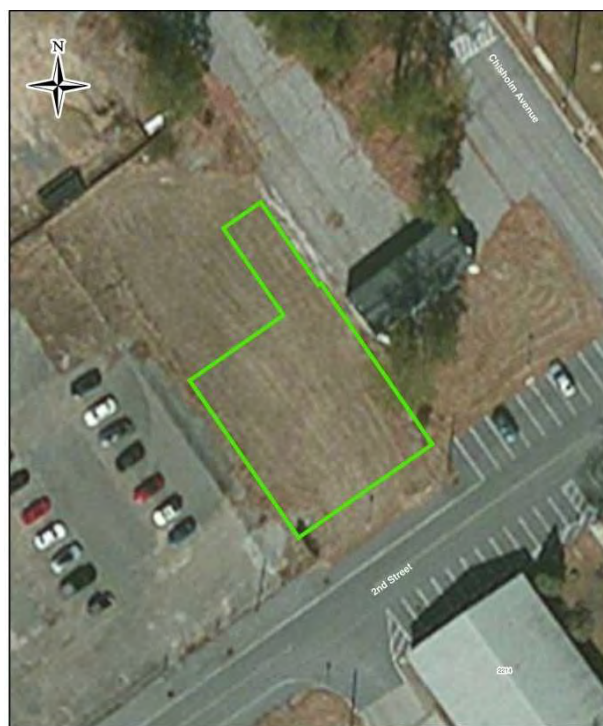
FGGM 51 (OU-24) – Building 2217 (Spill Site)

Site Description: Two heating oil USTs were near Building 2217. UST #2217A was installed 1 June 1970 and removed 14 July 1988; UST #2217B was a 1,000-gallon capacity steel UST installed 3 August 1988 and removed 11 December 1997 (FGGM 2010; Horne 1994). The first tank was removed due to corrosion; there were holes at the tank end (FGGM 2010). Free product was observed, the saturated soils were removed, and the soil removal project stopped upon finding a clay area (FGGM 2010).

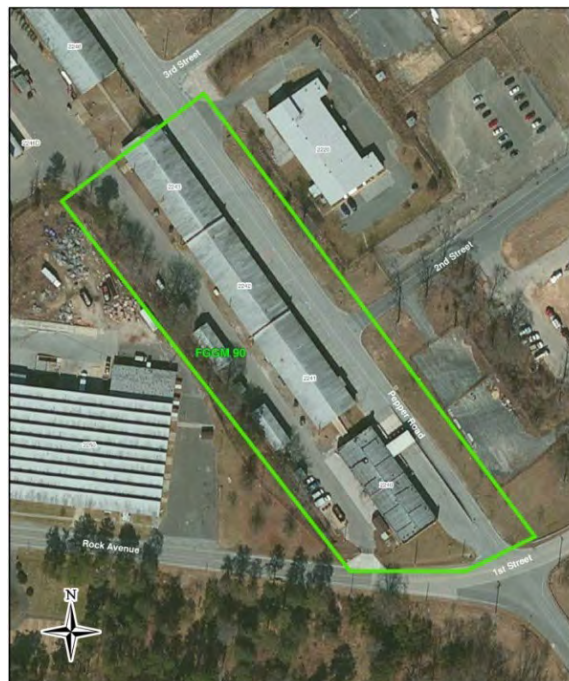
FGGM 90 - Former Tank Cleaning Supply Warehouse

Current Use: Building 2240 has been used as a storage and supply facility since its construction in 1934. Buildings 2241 and 2242 were constructed in 1918 and have always been used for receiving and short-term storage of supplies and materials before shipping. Buildings 2247, 2248, and 2249 are currently being used for assorted military administrative, commercial, and storage activities.

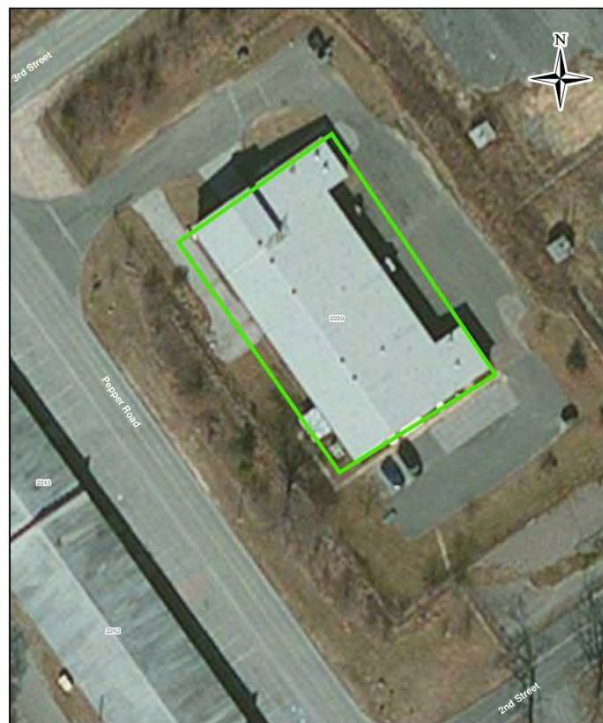
FGGM 91 - Former Missile Repair Shop
0 25 50 100 Feet

Site Description: Building 2220 (SWMU 42) is currently used for an electronic maintenance and calibration shop; but in the 1960s, it was used as a missile repair shop, warehouse, and troop training center. Building 2220 is designated as FGGM-45 and is discussed separately. The FGGM-45 designation is for the building, while FGGM-91 is the groundwater at the site. Solvents, mineral spirits, cleaners, and lubricants were stored and used at the facility in the past. The site had two fuel oil USTs; one was removed in 1992, the other replaced in 1988 then removed in 1997. A 1-gallon spill of fuel oil reportedly occurred in 1993.

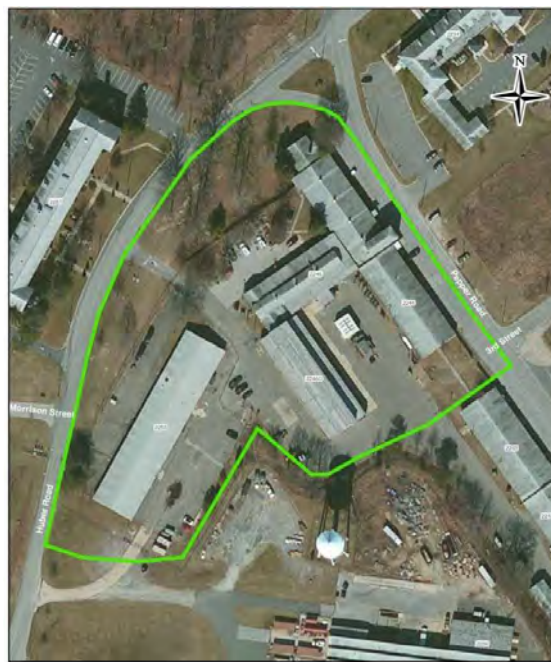
FGGM-92 - Former Heavy Gun Cleaning and Repair Shop

Site Description: FGGM-92 is currently the DOL Tactical and Support Vehicle/Heavy Equipment Maintenance Facility and includes Building 2246/2246D (SWMUs 55–58), Building 2253 (SWMUs 61–62), and two storage sheds (Buildings 2244 and 2245). Building 2246 was used as a heavy gun repair shop from 1934 until the mid-1980s, and a military tank repair shop in the past. Since 1992, the Director of Community Activities has used the facility for storage and maintenance of grounds-keeping equipment and supplies. Building 2253, constructed in 1934, and has been used for vehicle maintenance in the past. Prior to 1992, it was used by the DOL as a warehouse.

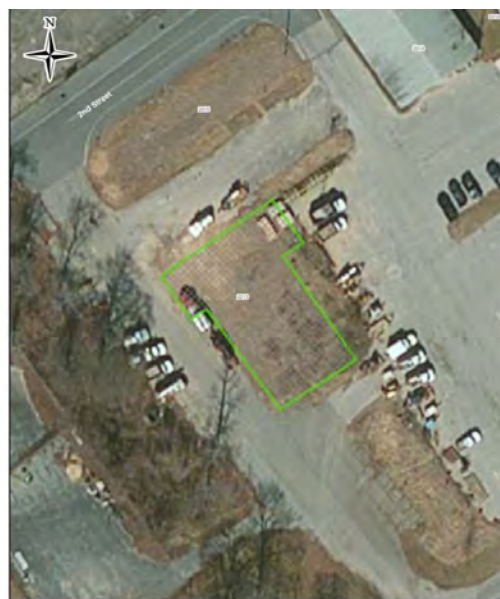
Building 2213 - Sheet Metal and Sign Fabrication Shop

Building 2213 was used to store small quantities of paints, lubricants, cleaners, and mineral spirits. The building also served as a drop-off point for oil-based and latex paints (unused and waste). The oil-based paints were stored in a hazardous waste locker on the northern side of the building. Latex paints were bulked into a 55-gallon drum and processed as non-regulated waste. Two 550-gallon heating oil USTs, formerly located along the southeast exterior wall, were removed in 1997.

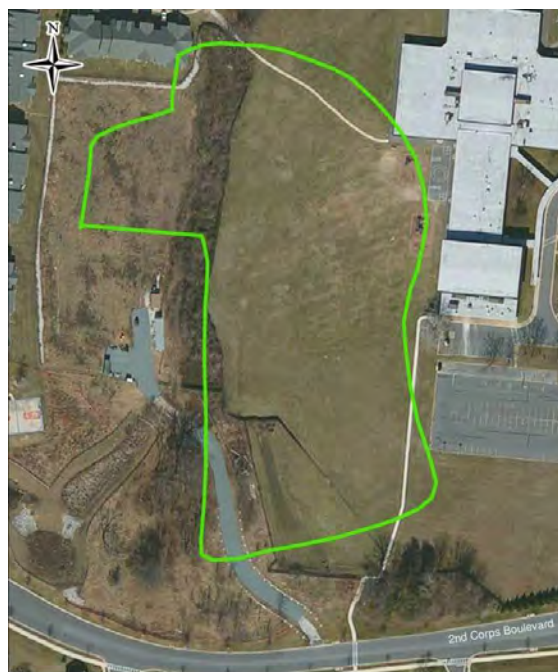
FGGM 93 - Manor View Dump
0 60 120 240 Feet

The area of buried waste was temporarily fenced with barricade safety fencing, which was replaced with chain-link fence when the landfill gas migration control system was installed in August 2005 (Plexus 2008). A passive vent trench was installed and later upgraded to a soil vapor extraction system with a blower to enhance vapor capture (Plexus 2006). An NTCRA to remove 27,700 tons of nonhazardous methane-generating waste was completed in the summer of 2012, and the extraction system was turned off in August 2012. A revised HHRA, and FS were finalized in June 2014.

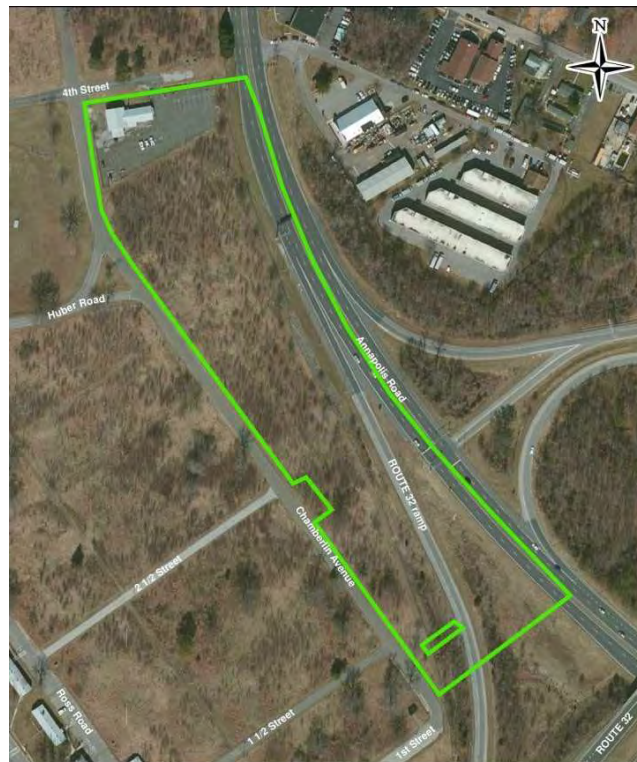
MP-7 and WR-6
 0 100 200 400
 Feet

As part of the PA/SI, six surface soil samples were collected and analyzed for VOCs, SVOCs, TPH-DRO, TPH-GRO, and metals; two subsurface soil samples were collected and analyzed for metals; six groundwater monitoring wells were installed, and groundwater samples were collected and analyzed for VOCs, TPH-DRO, TPH-GRO, total metals, and dissolved metals. Soil does not pose a risk at this AOI. The concentrations of chromium, cobalt, thallium, arsenic, iron, manganese, nickel, aluminum, and cadmium in groundwater cause excess risk at this AOI.

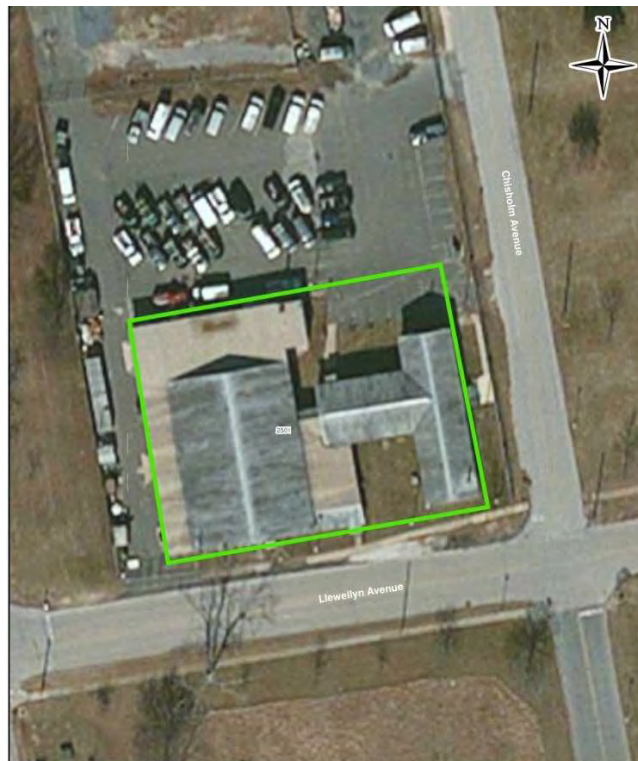
Building 2501 - Shipping and Receiving
0 25 50 100 Feet

As part of the PA/SI, one subsurface soil sample was collected, and one groundwater monitoring well was installed and sampled. All samples were analyzed for VOCs, SVOCs, metals, TPH-DRO, TPH-GRO, and cyanide. Soil does not pose a risk at this AOI. The concentrations of chromium, arsenic, cobalt, mercury, beryllium, nickel, thallium, and aluminum in groundwater cause excess risk at this AOI.

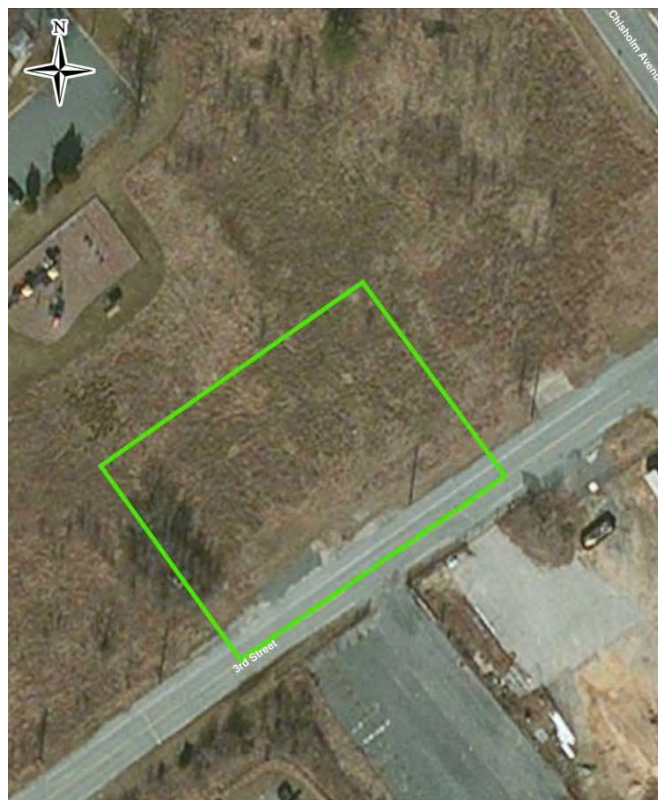
Stained Soils along 3rd Street

The PA/SI included collecting five subsurface soil samples, installing three groundwater monitoring wells and collecting groundwater samples. Soil and groundwater samples were analyzed for VOCs, SVOCs, TPH-DRO, TPH-GRO, and metals. The concentrations of bis(2-ethylhexyl) phthalate and arsenic in soil and chromium, arsenic, CCl₄, cobalt, manganese, thallium, and nickel in groundwater cause excess risk at this AOI.

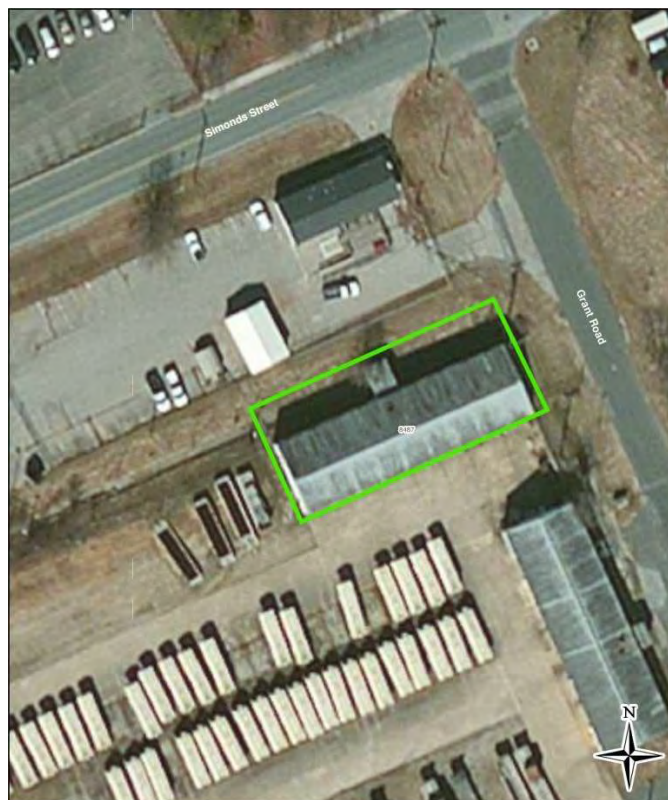
Building 8487 - Motor Pool

Contaminants of Potential Concern: TPH, VOCs, and SVOCs**Media of Concern:** Soil and groundwater**Site Location:** Grid F5, in the southwestern portion of the installation, southwest of the intersection of O'Brien Road and Simonds Street.**Site Description:** Building 8487 (SWMUs 119 and 120) was used as an MP for conducting maintenance checks on military vehicles, including oil changes. This AOI also contains five sheds west of Building 8487 that used to store paints, oils, antifreeze, and waste oil. Building 8487 stores acetylene and argon for welding.**Previous Studies:** Over the course of previous investigations at this site, two surface soil samples and eight subsurface soil samples were collected from eight different borings around Building 8487. Based on a risk analysis of the analytical results, the risk numbers are below site-specific action levels.**Current Use:** Administrative**Current Status:** EPA approved NFA for this AOI on 5 October 2011.

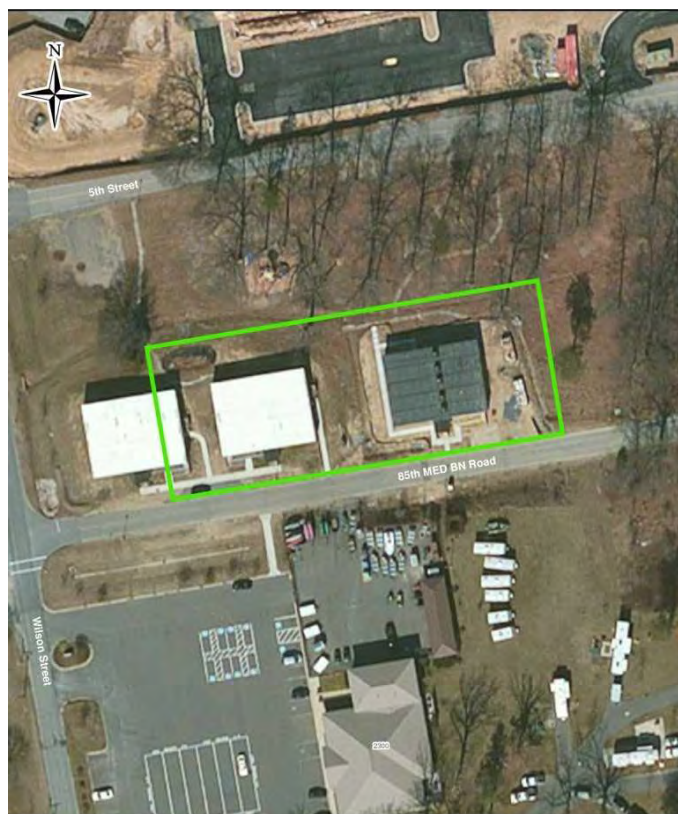
Former Buildings 2454, 2455, 2456, and 2457
0 40 80 160 Feet

Previous Studies: No soil or groundwater samples have been collected at this AOI. The 1996 SWMU study did not identify these AOI as SWMUs (non-SMWU 1–4), and it recommended NFA. The Fort Meade Environmental Partnership approved this AOI for NFA in 1999. There are no recent or historical indications of releases or contamination at these AOI (BCM 1996). There is no evidence of scarring, staining, or disturbance in any of the historical aerial photographs (EPA 1996).

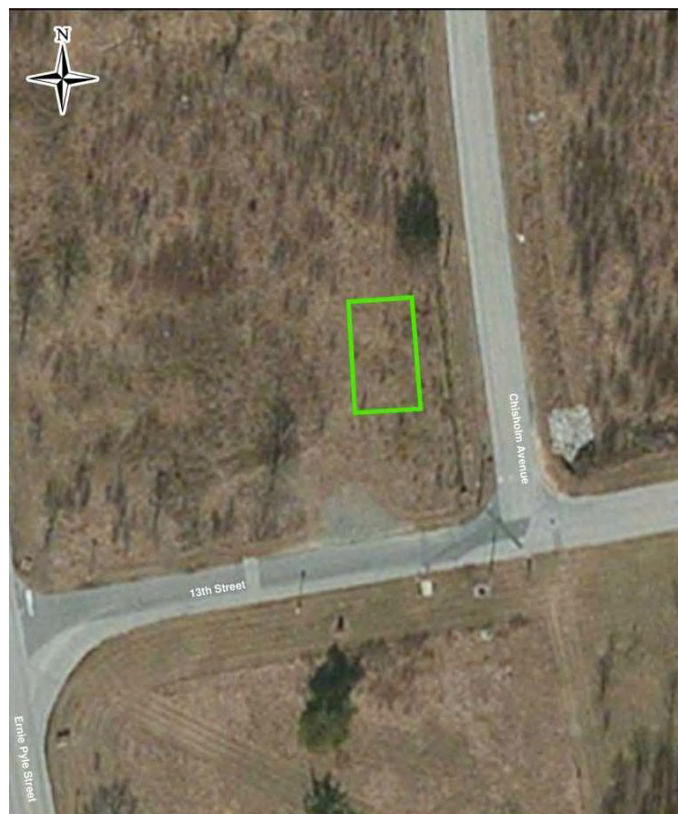
Building 2801 -- Former Research/Administration
0 25 50 100 Feet

Building 2801 was not identified as an SWMU in the 1996 SWMU study (BCM 1996). The SWMU study recommended NFA for this AOI (BCM 1996). There are no recent or historical indications of releases or contamination at this AOI. There is no evidence of scarring, staining, or disturbance in any of the historical aerial photographs (EPA 1996).

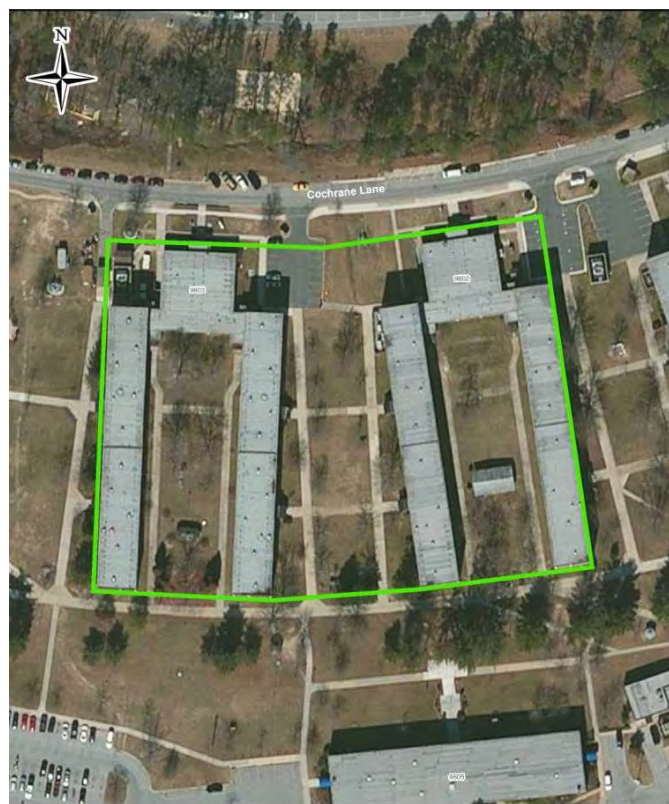
Buildings 9802 and 9803 -- Troop Housing
0 50 100 200 Feet

Previous Studies: Over the course of previous investigations at this site, personnel knowledgeable about the buildings were interviewed and historical aerial photographs were reviewed. In both cases, no evidence of a release of hazardous substances resulting in contamination to soil, groundwater, or surface water was found. There is no evidence of scarring, staining, or disturbance in any of the historical aerial photographs (EPA 1996).

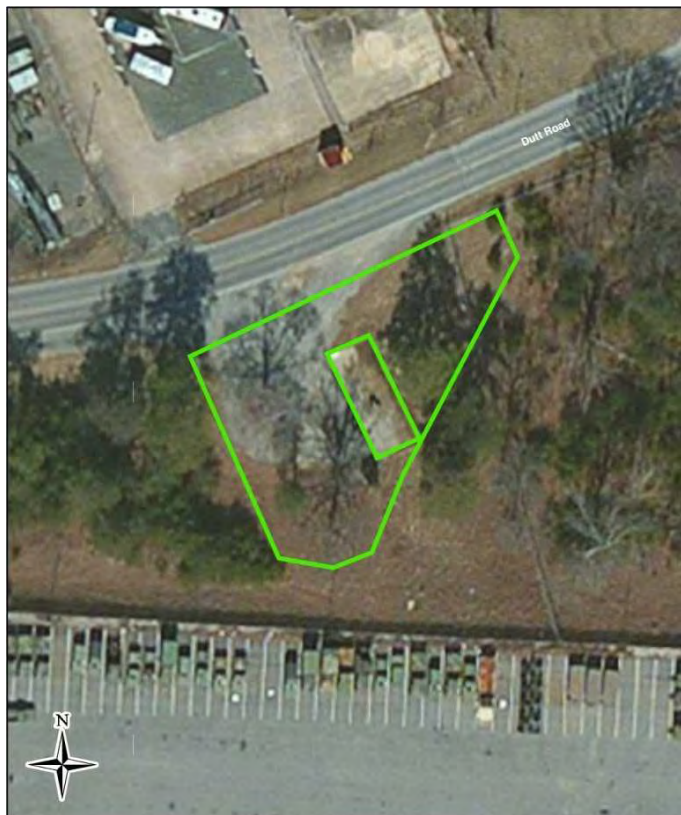
SWMUs 141 and 142 - Privately Owned Vehicles Wash Rack

Contaminants of Potential Concern: None identified**Media of Concern:** None identified**Site Location:** Grid F5, SWMUs 141 and 142 are located in the southern portion of the installation, southeast of Dutt Road.**Site Description:** The WR system located southeast of Dutt Road is not associated with any building. The system was identified as two SWMUs during a 1996 SWMU study because it routinely discharged wash water from the WR (SWMU 142) to the OWS (SWMU 141) (BCM 1996). The WR was in use during the 1999 RFA for washing privately owned vehicles. Its construction date is unknown, but buildings occupied the AOI from the early 1940s through the 1960s. This AOI was not identified in the EPA (1996) review of historical aerial photographs of the installation; no stains, stressed vegetation, standing liquid, or other environmental concerns were identified at this location.**Previous Studies:** Over the course of previous investigations at this AOI, six subsurface soil samples were collected and analyzed.**Current Use:** Grass and trees**Current Status:** EPA approved NFA for this AOI on 15 June 2011.

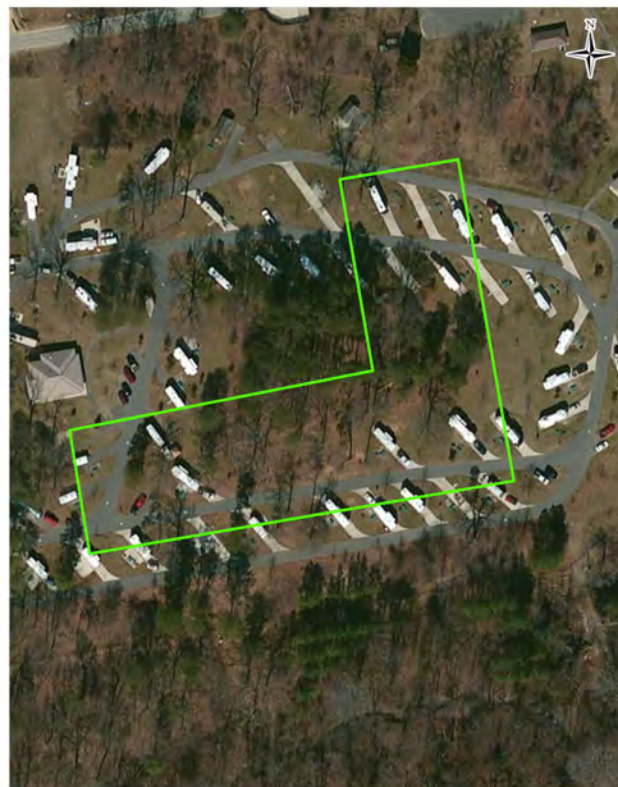
SWMUs 143 and 144 - Wash Rack and Oil/Water Separator

Over the course of previous investigations at this AOI, six surface soil samples (plus one duplicate sample), five subsurface soil samples, and two groundwater samples (plus one duplicate sample) were collected and submitted for laboratory analysis. Based on a risk analysis of the analytical results, the risk numbers are below site-specific action levels.

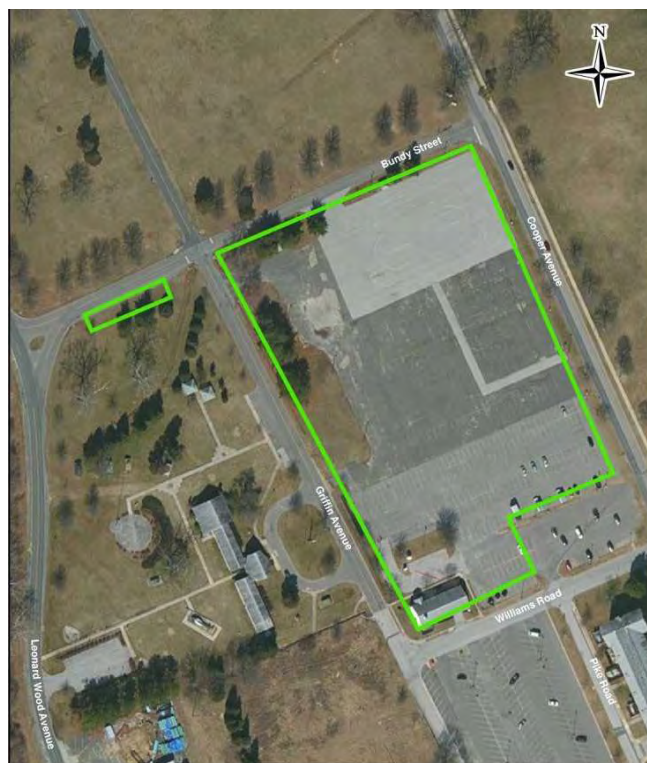
MP-1 and WR-4
0 75 150 300 Feet

Contaminants of Potential Concern: VOCs, SVOCs, and metals**Media of Concern:** Soil**Site Location:** Grid G4, in the south-central portion of the installation, west of Cooper Avenue, east of Griffin Avenue, south of Bundy Street, and north of Williams Road.**Site Description:** MP-1/WR-4 was identified as an AOI because they were identified on the circa 1952 land use map (Anon. 1952). The EPA (1996) study identified a vehicle service and storage area at this location on the 1963 and 1970 aerial photographs. The write-up for the 1975 aerial photograph specifically states “No Longer a Vehicle Service and Storage Area, Now a Parking Lot” for this location.**Previous Studies:** Potential environmental concerns were not cited for this location in the EPA report. There are no recent or historical indications of releases or contamination at this AOI. Also, there is no evidence of scarring, staining, or disturbance in any of the historical aerial photographs. This site may have been used as a parking lot for an MP and for washing cars (WR) for a limited time. It is unknown if vehicles were serviced at any of the former buildings at this AOI. Three of the four buildings have been removed, and most likely the soil has been graded. No stains or stressed vegetation was observed on any of the historical aerial photographs of this location.

There has been no previous environmental sampling at MP-1/WR-4. As part of the PA/SI, 14 surface soil samples were collected and analyzed for VOCs, SVOCs, and metals. The concentrations of PAHs (Benzo(a)pyrene, Benzo(a)fluoranthene, Benzo(a)anthracene) in surface soil cause excess risk at this AOI.

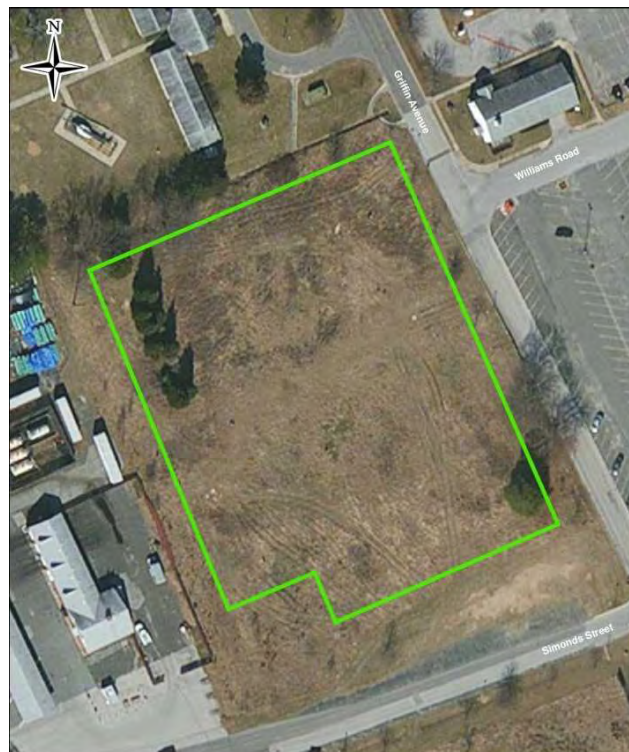
MP-2
0 40 80 160
Feet

The soil and groundwater quality investigation (United States Army Center for Health Promotion and Preventive Medicine [USACHPPM] 2009) concluded that the results of the soil and groundwater analytical data suggest there has not been a contaminant release at the Former MP-2 area. However, the four areas of historical surficial staining have not been fully evaluated.

As part of the PA/SI, four subsurface soil samples were collected, and four groundwater monitoring wells were installed and sampled. All samples were analyzed for VOCs, SVOCs, TPH-GRO, TPH-DRO, and metals. Soil does not pose a risk at this AOI. The concentrations of benzo(a)pyrene and chromium in groundwater cause excess risk at this AOI.

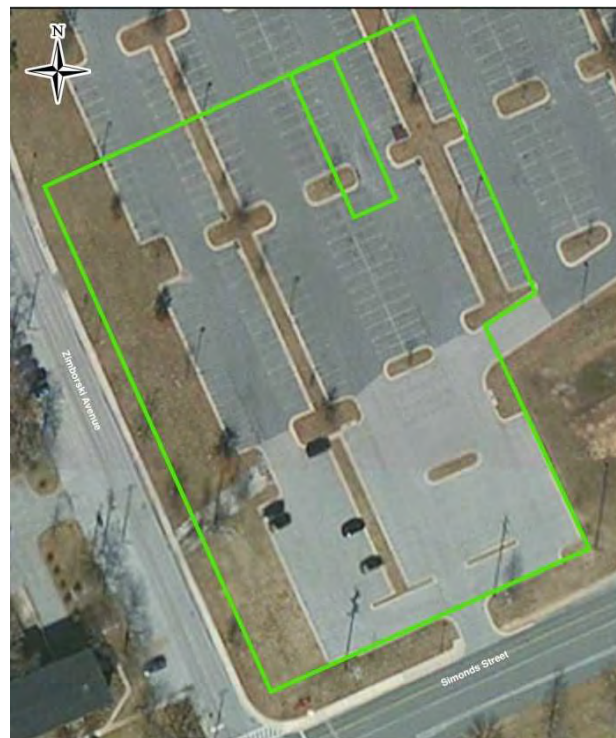
MP-3 and WR-2
0 30 60 120 Feet

Site Description: MP-3/WR-2 was identified as an AOI because it was listed as an MP on the circa 1952 land use map (Anon. 1952). The EPA (1996) report shows a vehicle service and storage area at this location on the 1963, 1970, 1975, and 1988 aerial photographs. The write-up for the 1995 aerial photograph specifically states “Former Vehicle Service and Storage Area” for this location. The EPA study did not report any environmental conditions for this location. There are no recent or historical indications of releases or contamination at this AOI. Also, there is no evidence of scarring, staining, or disturbance in any of the historical aerial photographs. This site may have been used as a parking lot (MP) and for washing cars (WR) for a limited time. The potential for contamination in this area is minimal. It is unknown if vehicles were serviced at any of the former buildings in this AOI. All buildings have been removed, and the soil has been excavated and graded.

Previous Studies: As part of the PA/SI, surface soil samples were collected and analyzed for VOCs, SVOCs, and metals.

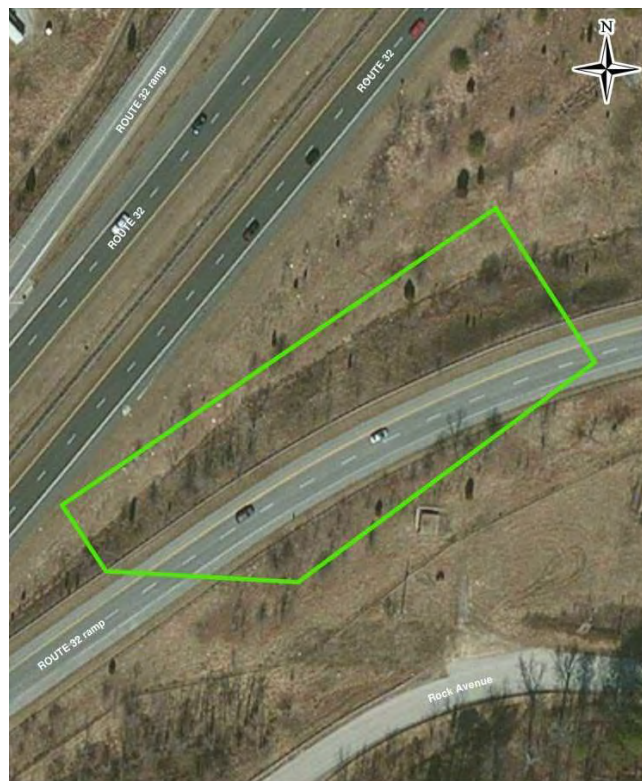
MP-6
0 40 80 160
Feet

Site Description: MP-6 was identified as an AOI because it was listed as an MP on the circa 1952 land use map (Anon. 1952). According to the 1952 map, there are no buildings within the outline of this MP. This AOI was not identified in the EPA (1996) historical aerial photograph study of the installation. Since there were no former buildings at this AOI, it is unlikely that vehicles were serviced at this AOI. All surrounding buildings were removed by 1993, and the soil has been excavated and graded. No stains or stressed vegetation was observed on any of the historical aerial photographs of this location. The buildings were gone at the time of the 1996 SWMU study (BCM 1996), so the SWMU study did not cover this portion of the installation.

Previous Studies: There were no previous samples collected at this AOI. As part of the PA/SI, two subsurface soil samples were collected and analyzed for VOCs, SVOCs, and metals. The Final PA/SI Report recommended an SSI be conducted for soils for chromium speciation for this AOL.

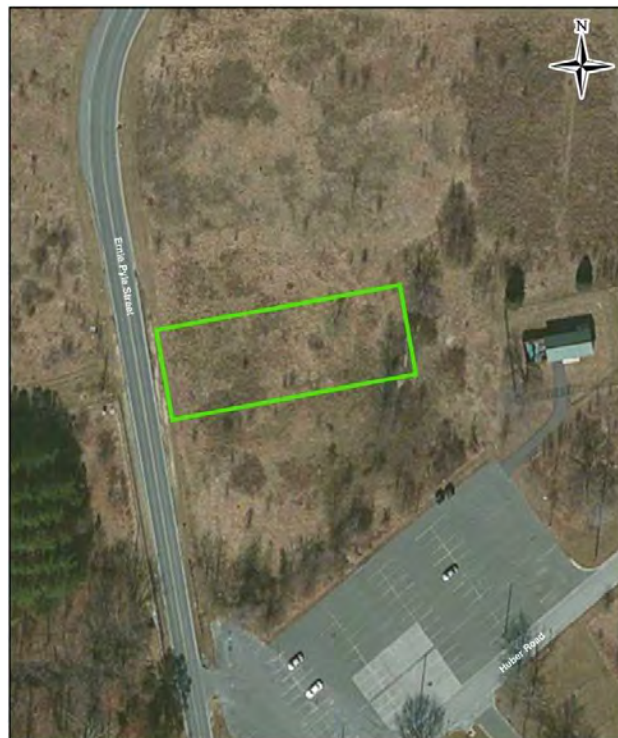
MP-8
0 40 80 160 Feet

Contaminants of Potential Concern: VOCs, SVOCs, metals, TPH-DRO, and TPH-GRO**Media of Concern:** Soil and groundwater**Site Location:** Grid H4, in the southeastern portion of the installation, east of Ernie Pyle Street, west of Chisholm Road, south of 4th Street, and north of Huber Road.**Site Description:** MP-8 was identified as an AOI because it was listed as an MP on the circa 1952 land use map (Anon. 1952). The EPA (1996) study shows a vehicle service and storage area at this location on aerial photographs from 1943, 1952, and 1957. This area is not shown in the 1947 aerial photograph. The 1952 land use map (Anon., 1952) identifies MP-8 in the southwestern portion of the AOI outlined in the EPA study (1996).**Previous Studies:** There were no previous samples collected at this AOI. As part of the PA/SI, two subsurface soil samples were collected, and one groundwater monitoring well was installed and sampled. All samples were analyzed for VOCs, SVOCs, TPH-DRO, TPH-GRO, and metals. Soil does not pose a risk at this AOI. The concentrations of chromium, manganese, cobalt, and thallium in groundwater cause excess risk at this AOI. The Final PA/SI Report recommended NFA for soils and an SSI be conducted for groundwater for total and dissolved metals, including hexavalent and trivalent chromium speciation.**Current Use:** Grass field

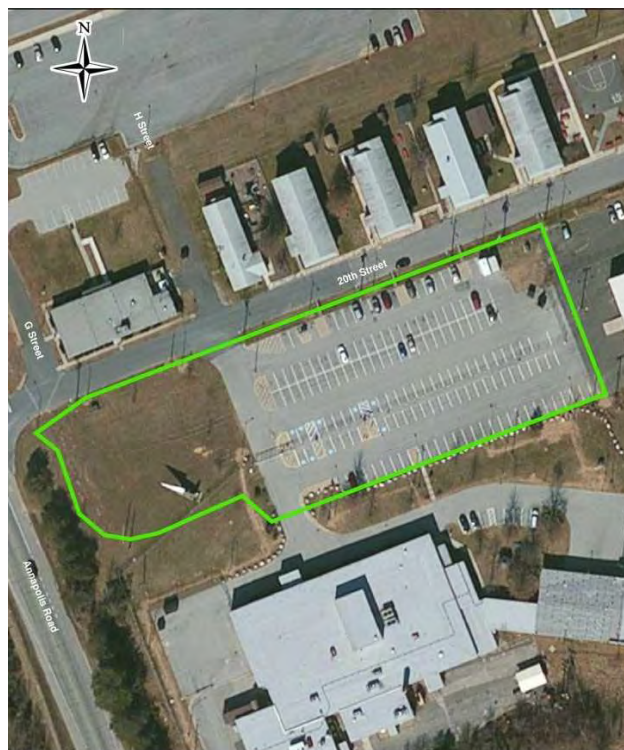
MP-14
0 45 90 180 Feet

Site Description: MP-14 was identified as an AOI because it was listed as an MP on the circa 1952 land use map (Anon. 1952). The AOI is also identified in the EPA (1996) historical aerial photograph study of the installation, which shows a vehicle service and storage area at this location on the 1943, 1947, 1952, 1957, 1963, 1970, and 1975 aerial photographs. Five sumps are shown in the southern and eastern portions of this area on the 1957 aerial photograph (EPA 1996). The sumps, or the area around them, were not discolored or stained. A stain is visible in the southwestern portion of this area in the 1963 aerial photograph, but not in subsequent aerial photographs.

Previous Studies: There were no previous samples collected at this AOI. As part of the PA/SI, one subsurface soil sample was collected and analyzed for VOCs, SVOCs, TPH-DRO, TPH- GRO, and metals.

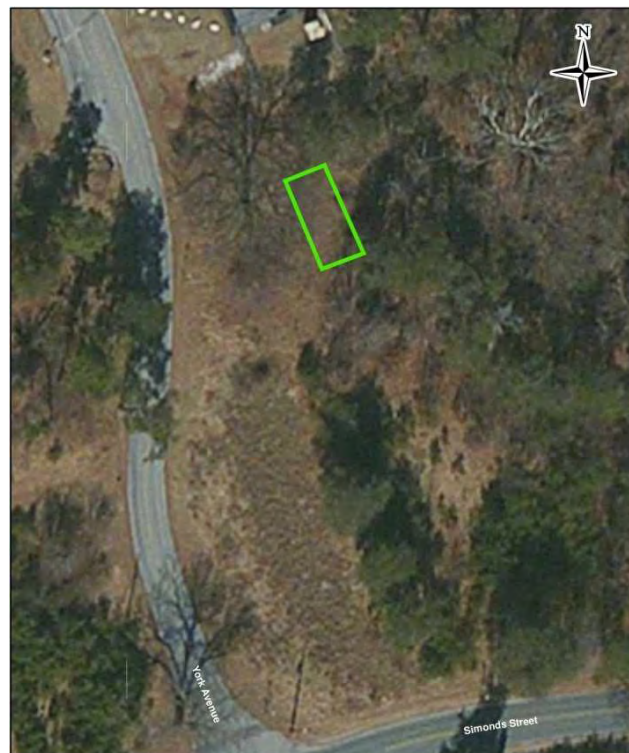
Wash Rack 3

Contaminants of Potential Concern: VOCs, SVOCs, and metals**Media of Concern:** Soil**Site Location:** Grid F4, in the southern portion of the installation, north of Simonds Street and east of York Avenue.**Site Description:** This WR was probably used for washing cars. Chemicals potentially used at this WR may have included soap and car wax. Neither this WR nor nearby Building 6507 were identified as SWMUs during the SWMU study (BCM 1996), so there are no reports of hazardous chemicals being used or stored at the building or the WR. Access to WR-3 appears to be from York Avenue or along a path leading from Building 6507.**Previous Studies:** The WR first appears on the 1943 aerial and is last seen on the 1977 aerial. By 1984, it is no longer visible. The EPA (1996) review of historical aerial photographs did not identify potential concerns at this area. No stained soils or stressed vegetation was identified on any aerial photographs.

As part of the PA/SI, four surface soil samples were collected and analyzed for VOCs, SVOCs, and metals.

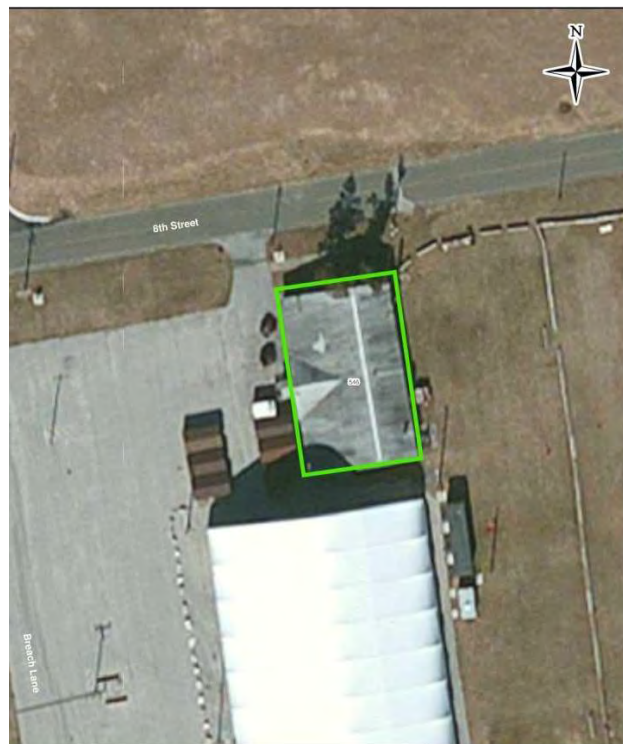
Building 546 - Photography Laboratory
0 25 50 100 Feet

Contaminants of Potential Concern: SVOCs and metals**Media of Concern:** Soil and groundwater**Site Location:** Grid H4, in the eastern portion of the installation, on 8th Street between Chamberlin and Chisholm Avenues.**Site Description:** Building 546 (SWMU 011) was identified as an SWMU because of routine discharge of water from a silver recovery unit (BCM 1996). The discharge point was the Fort Meade sanitary sewer system. There were no spills or reported releases identified during the SWMU study (BCM 1996). Prior to 1985, the building was used as a visual information training center, and since 1985 it has been used as a full-service photographic laboratory, offices, and graphic arts department.**Previous Studies:** Over the course of previous investigations at this AOI, 12 subsurface soil samples (plus 1 duplicate subsurface soil sample) and 12 groundwater samples (plus 1 duplicate groundwater sample) were collected and submitted for laboratory analysis. Based on a risk analysis of the analytical results, arsenic, copper, mercury, and chromium elevate the risk numbers above the site-specific action levels.

As part of the PA/SI, three groundwater monitoring wells were installed and sampled for SVOCs and metals. Soil does not pose a risk at this AOI. The concentrations of chromium, arsenic, thallium, mercury, copper, cobalt, and cadmium in groundwater cause excess risk at this AOI. The Final PA/SI Report recommended NFA for soil and an SSI be conducted for groundwater for bis(2-ethylhexyl)phthalate, polyfluorinated chemicals, and total and dissolved metals, including hexavalent and trivalent chromium speciation for this AOI.

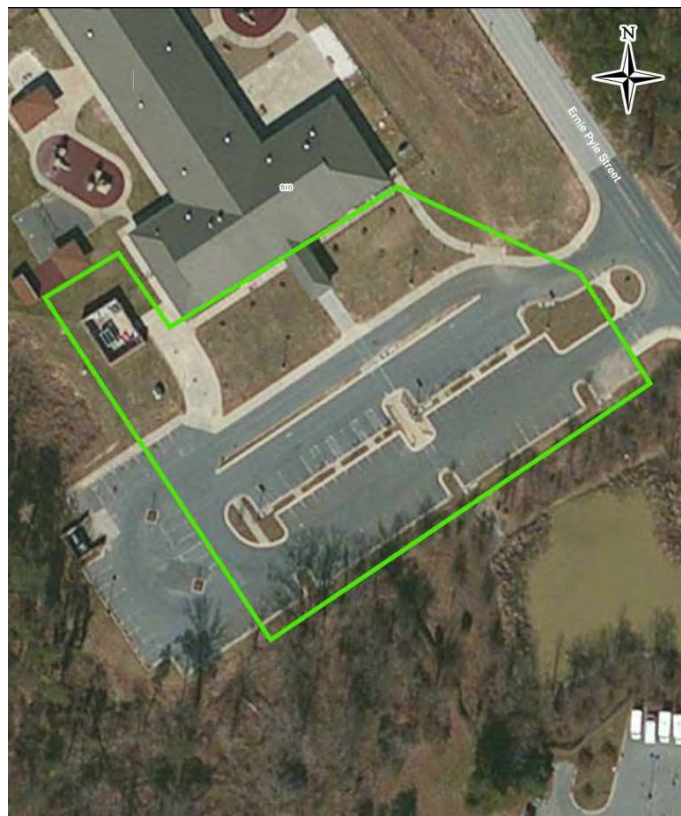
Building 940 - Motor Pool, Wash Rack and Oil/Water Separator

Previous Studies: Over the course of previous investigations at this AOI, 4 surface soil samples (plus 1 duplicate surface soil sample), 14 subsurface soil samples (plus 1 duplicate subsurface soil sample), and 6 groundwater samples (plus 2 duplicate groundwater samples) were collected and submitted for laboratory analysis. Based on a risk analysis of the analytical results, arsenic, cobalt, iron, aluminum, and chromium elevate the risk numbers above the site-specific action levels.

As part of the PA/SI, two groundwater monitoring wells were installed and sampled for metals. Arsenic, beta-BHC, chromium, and thallium were listed as contaminants of potential concern. The Final PA/SI Report recommends NFA for soils and an SSI be conducted for groundwater for TPH-DRO, TPH-GRO, and chromium speciation.

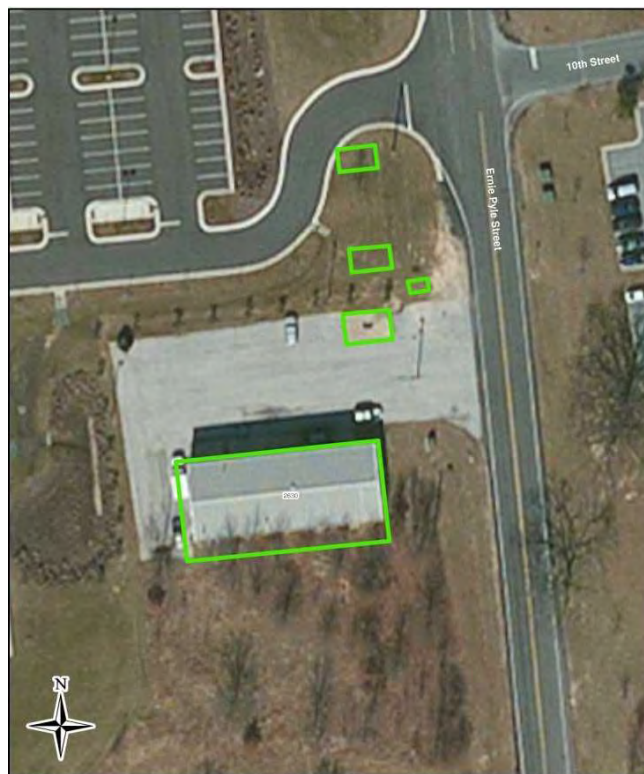
Building 2630 - Dispatch, Storage, and
Parking Area for Emergency Medical Units Wash Rack

As part of the PA/SI, two surface soil samples were collected and analyzed for herbicides, and two groundwater monitoring wells were installed and sampled for VOCs, SVOCs, TPH-DRO, TPH-GRO, metals, herbicides, and pesticides. Soil does not pose a risk at this AOI. The concentrations of chromium, cobalt, and thallium in groundwater cause excess risk at this AOI. The Final PA/SI Report recommends NFA for soils and an SSI be conducted for groundwater for total dissolved metals, including hexavalent and trivalent chromium speciation.

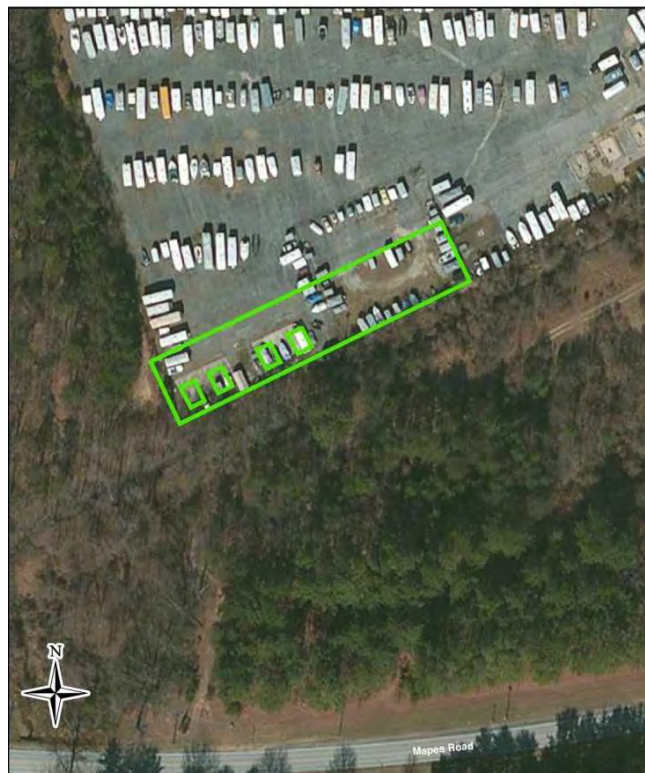
Building 2728 - Out of Service Wash Racks,
Recreational Equipment and Storage

Site Description: Building 2728 (SWMU 148) was built in the 1950s and was formerly used as a military vehicle and equipment maintenance facility. It stored relatively small quantities of hazardous chemicals (motor and lubricating oil, antifreeze, used oil, degreasers, and batteries).

Previous Studies: Over the course of previous investigations at this site, 20 direct-push borings were completed; 4 surface soil, 20 subsurface soil, and 10 groundwater samples were collected and submitted for analysis. Based on a risk analysis of the analytical results, 2-methyl-4-chlorophenoxyacetic acid (MCPA), MCPP, chloroform, and bromodichloromethane elevate the risk numbers above the site-specific action levels.

As part of the 2013 PA/SI, two surface soil samples were collected and analyzed for herbicides and two groundwater monitoring wells were installed and sampled for VOCs and metals. Soil does not pose a risk at this AOI. The concentrations of chloroform, chromium, manganese, and thallium in groundwater cause excess risk at this AOI.

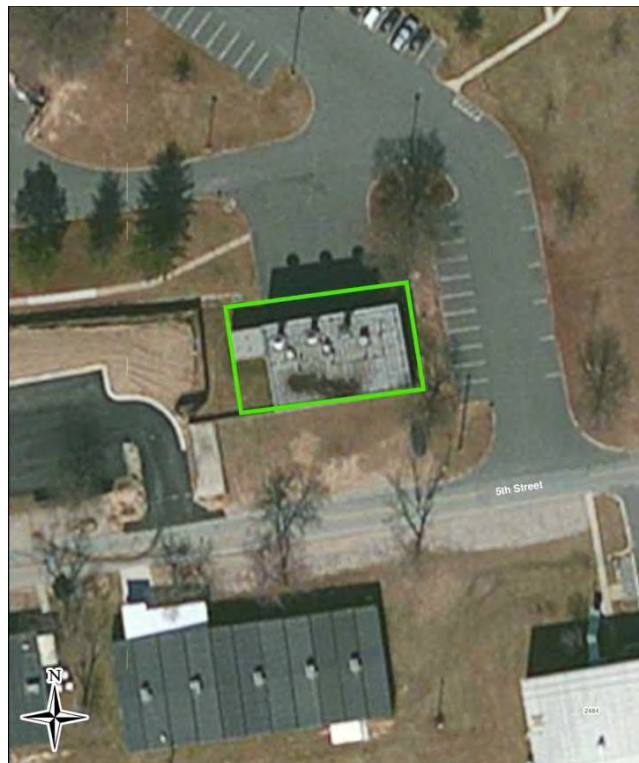
Building 2482 - Used Oil Recycling Tank at Hospital Boiler Plant

As part of the PA/SI, four surface soil samples were collected and analyzed for PCBs and dioxins; one subsurface soil sample was collected and analyzed for SVOCs; and one groundwater monitoring well was installed and sampled for metals and SVOCs.

The concentrations of benzo(a)pyrene and thallium in soil and chromium, arsenic, benzo(a)pyrene, naphthalene, and dibenzo(a,h)anthracene, cobalt, arsenic, naphthalene, iron, manganese, chromium, 2-methylnaphthalene, thallium, and vanadium in groundwater cause excess risk at this AOI.

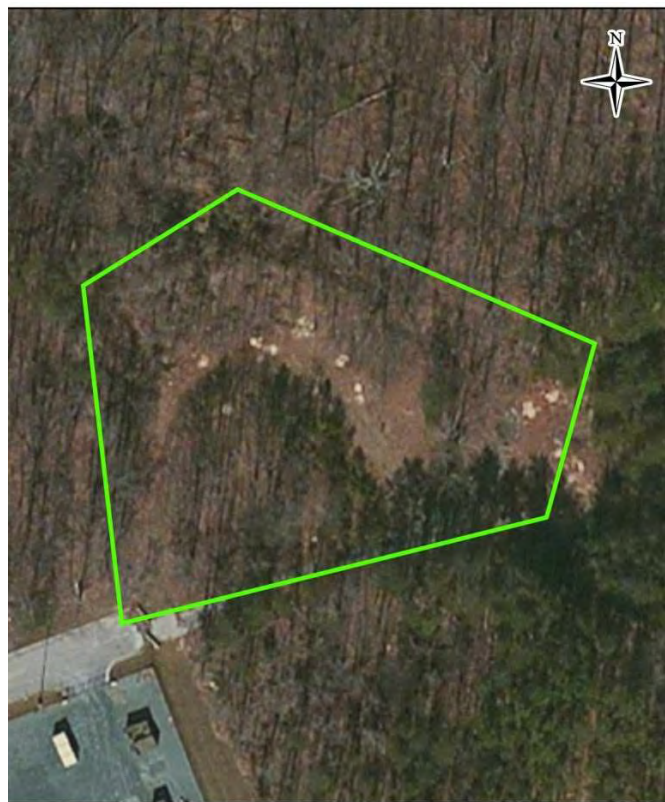
Former Incinerator -- 1943

Contaminants of Potential Concern: metals and dioxins**Media of Concern:** Soil and groundwater**Site Location:** Grids H1 and H2, in the northeastern portion of the installation, 1,000 feet east of the intersection of 21½ Street and State Route 175 (Annapolis Road).**Site Description:** Former Incinerator Building – 1943 was identified as an AOI in a 1998 EBS. The incinerator was present from 1947 to 1975 (Versar 1999b). The EPA (1996) study of the installation did not identify this incinerator, stained soils, or stressed vegetation in this area in any of the historical aerial photographs, although the outline of a building is visible in the 1943 through 1977 historical aerial photographs (EPA 1996).**Previous Studies:** Over the course of previous investigations at this site, nine subsurface soil samples were collected. A review of historical aerial photographs suggests that the former incinerator may have been west of the location sampled in the CSA.

The PA/SI included collecting five surface and six subsurface soil samples that were analyzed for metals and dioxins. In addition, three groundwater monitoring wells were installed, and groundwater samples were collected and analyzed for metals. Soil does not pose a risk at this AOI. The concentrations of chromium, cobalt, and manganese in groundwater cause excess risk at this AOI.

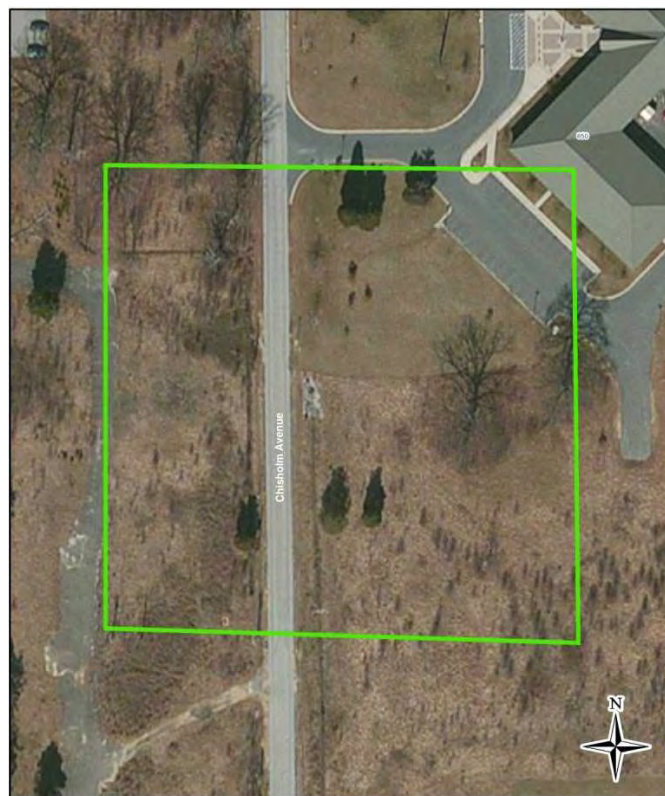
FGGM-005-R-01 - Pistol Range A
0 40 80 160 Feet

Previous Studies: Over the course of previous investigations at this site, five composite surface soil samples were collected as part of the SI and submitted for lead analysis. Lead was detected in soil samples taken at this site at levels below regulatory limits (Malcolm Pirnie 2007).

Current Use: All structures have been demolished. The undeveloped area is flat with grass vegetation with few scattered trees and shrubs.

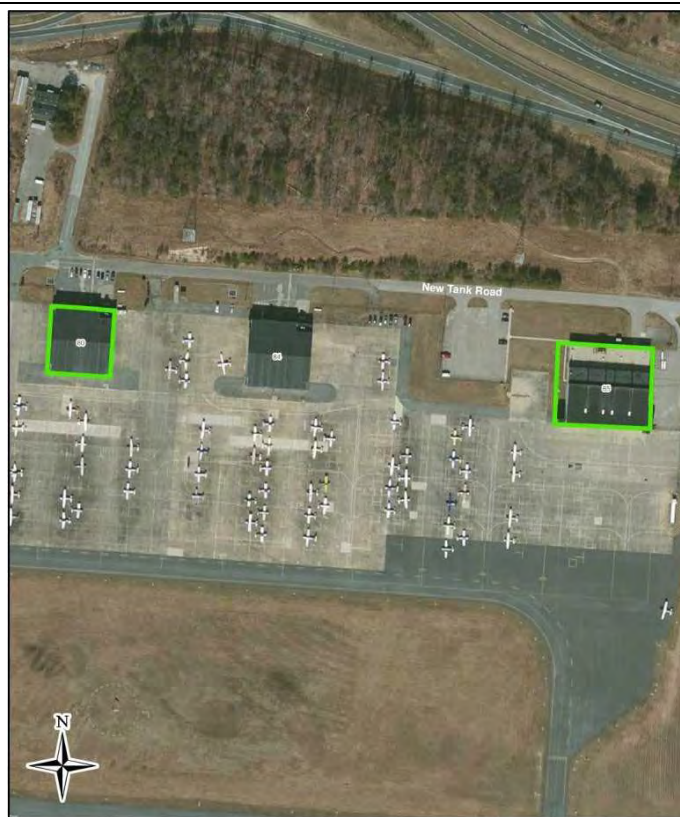
FGGM 72 (OU-27) - POL Storage Tanks, P-080 and P-085

Site Description: FGGM-72 consists of Building/Hangar 80 and Building/Hangar 85, which are both located along Airfield Service Road. A steel 4,000-gallon heating oil tank is located at Building 80, and a steel 5,000-gallon heating oil tank is located at Building 85 (Argonne 1989). The 4,000-gallon UST at Building 80 was installed in June 1988. This tank replaced a steel-constructed 4,000-gallon UST that failed a leak test in May 1988 and was removed by order of MDE. Contaminated soils excavated during the tank removal were disposed of at the sanitary landfill. The MDE case was closed on 21 June 1988 (EA 1992a). The present UST is on the north side of Building 80 and is surrounded by three MWs.

The 5,000-gallon UST at Building 85 was installed in November 1975 (EA 1992a). The tank passed a leak test in May 1988.
