Site Management Plan

2023

Fort George G. Meade, MD

June 2023

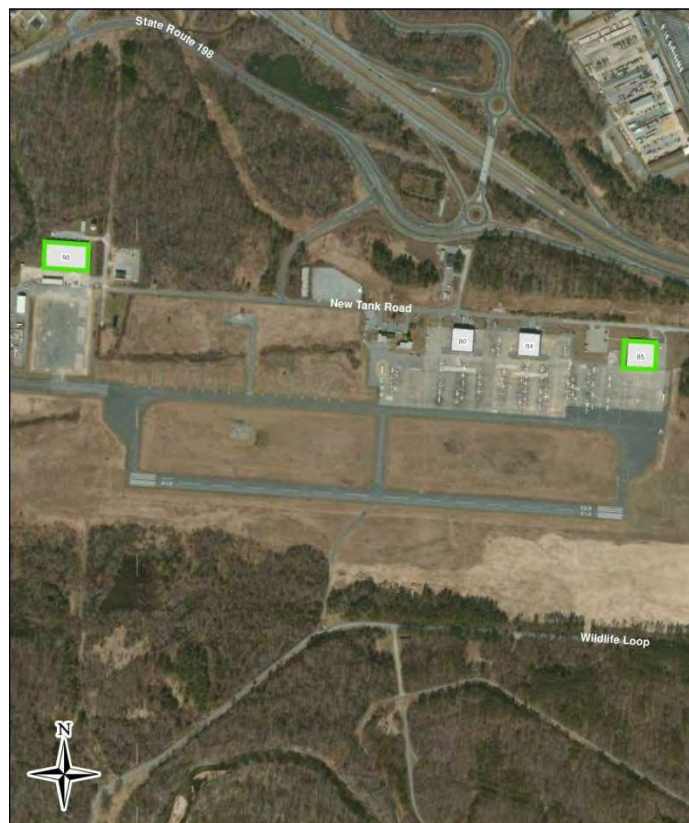
FGGM 73 (OU-28) - Maintenance Shops, Buildings 85 and 90

Site Description: This AOI is for the USTs at Buildings 85 and 90. The 5,000-gallon UST at Building 85 was installed in November 1975. The tank passed a leak test in May 1988.

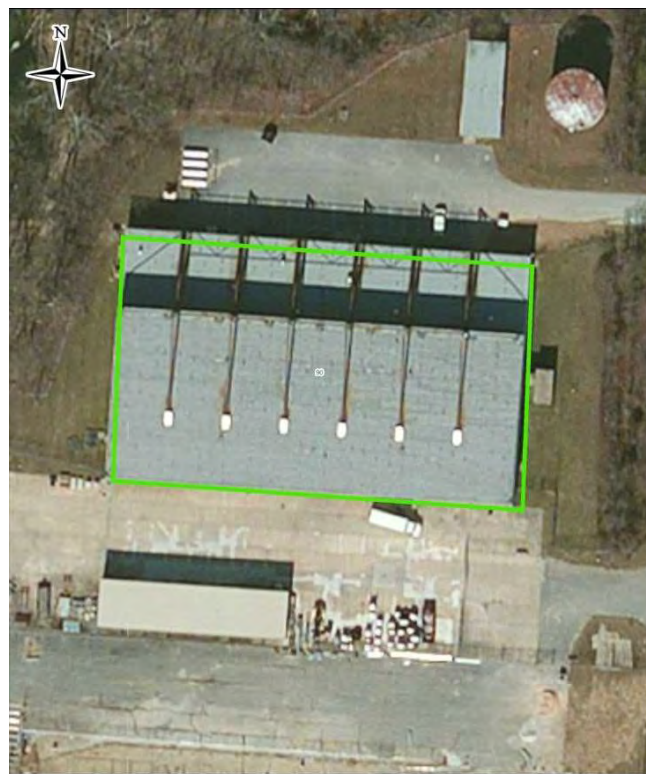
FGGM 80 - Helicopter Hangar 90
0 30 60 120 Feet

Site Description: HHA Building 90 and associated structures were constructed in the early 1980s. Hangar 90 was used to store and maintain helicopters. Typical activities included washing, disassembly, repair, and painting of aircraft. Aviation and diesel fuel, hydraulic and lubricating oils, detergents, and solvents were used, handled, or stored here. Hangar 90 was cleared and taken out of service when it was decommissioned in early 1996.

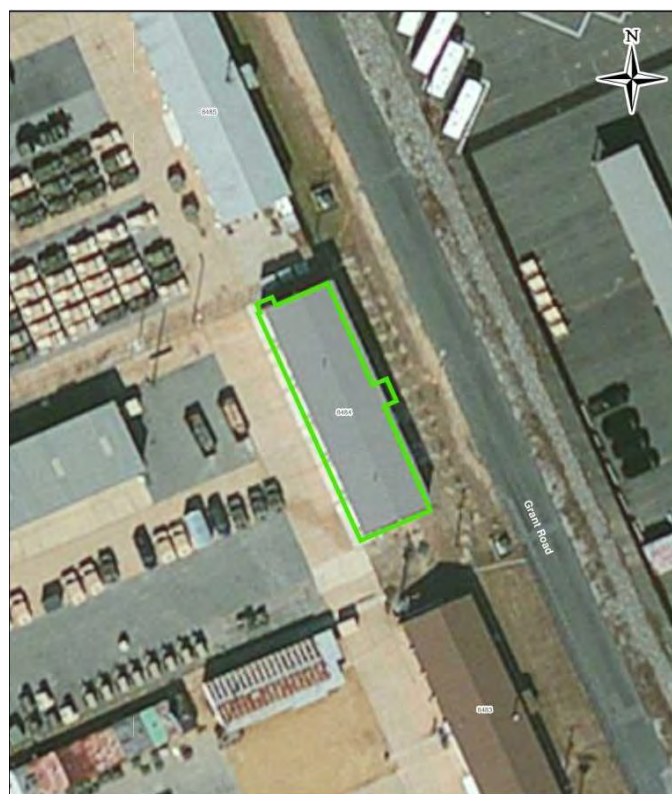
Grant Street at Building 8484
(Spill Notification, September 2009)

Site Description: A small metal box containing unlabeled paint containers was found in a duct bank trench being excavated along Grant Street at Building 8484. ED personnel observed solidified paints, as well as a minor amount of liquid coming from the paint storage box.

Previous Studies: During previous investigations at this site, a maximum PID reading of 224 units was observed, and a grab sample was collected from the bottom of the trench.
