FINAL
SECOND PERIODIC REVIEW REPORT

HUNTER ARMY AIRFIELD
GEORGIA

This is the Second Periodic Review for HAAF. This review includes the Installation Restoration Program site, Pump House #1 (1154A.1015, HAAF 13). HAAF manages underground storage tanks under the Georgia Environmental Protection Division UST Management Program. HAAF is not on the National Priorities List. This Periodic Review was conducted in accordance with United States (U.S.) Army (Army) Regulation 200-1 Environmental Quality, Environmental Protection and Enforcement and *Department of Defense (DoD) Manual 4715.20, Defense Environmental Restoration Program Management* (Army, 2007; DoD, 2012). This review includes the site listed in the table below.

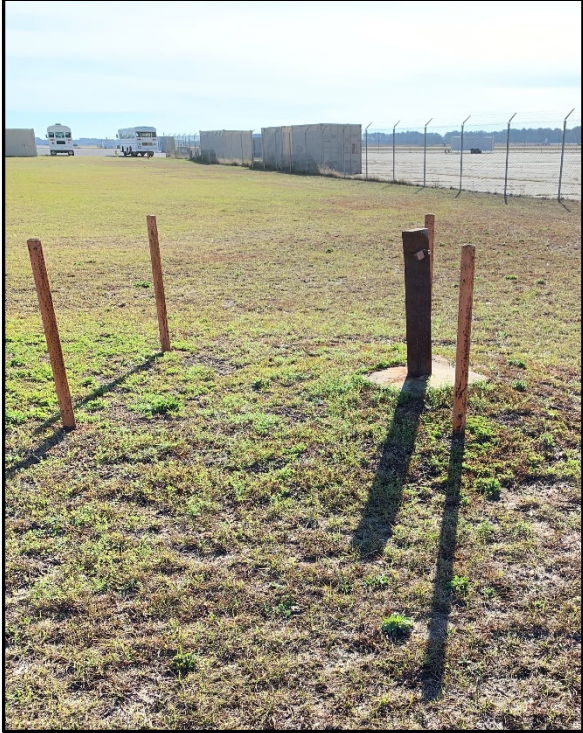
Photograph 1

Location: Hunter Army Airfield	
Date: February 4, 2020	
Description: View toward Release Area No. 1 from the N. Lightning Road fence line looking southeast. Due to access restrictions and active flight line operations, Release Area No. 1 and Release No. 2 could not be accessed by site inspection personnel. Well in foreground is a representative well at HAAF located southwest of the wash rack, but is not associated with the monitoring programs of either Release Area No. 1 or Release Area No. 2

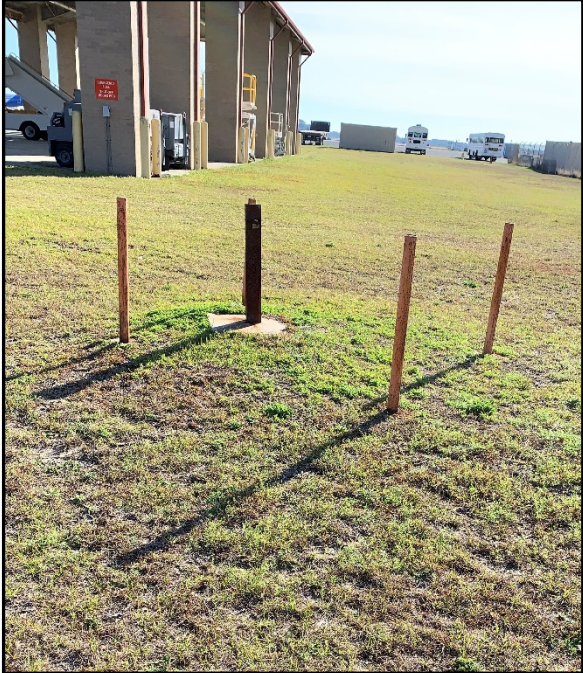
Photograph 2	
Location: Hunter Army Airfield	
Date: February 4, 2020	
Description View toward Release Area No. 1 from the N. Lightning Road fence line looking southeast. Due to access restrictions and active flight line operations, Release Area No. 1 and Release No. 2 could not be accessed by site inspection personnel. Well in foreground is a representative well at HAAF located southwest of the wash rack, but is not associated with the monitoring programs of either Release Area No. 1 or Release Area No. 2
