# Fort Wainwright Cultural Resources Annual Report, 2018

Center for Environmental Management of Military Lands  
Colorado State University  
Fort Collins, CO 80523-1500

December 2019

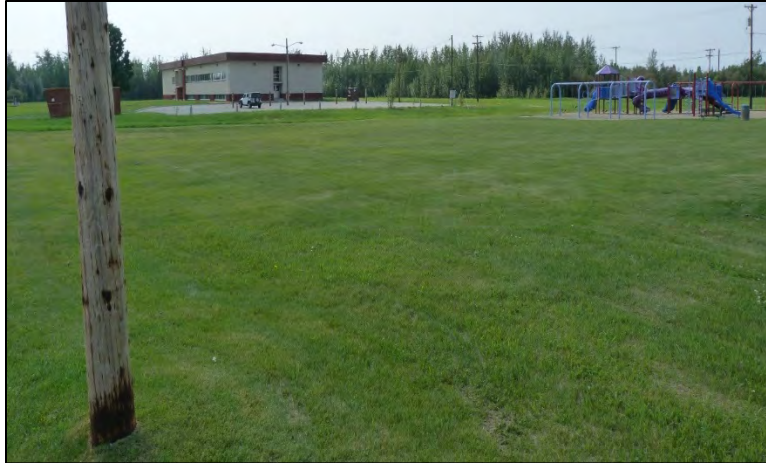
Figure 11. Building 4161, north context, July 2017.

The north elevation of Building 4161 is covered in sandblasted plywood-patterned architectural concrete with one entrance and one bay of windows (Figure 11 through Figure 14). The north elevation entrance is a set of outward opening, half-glass, steel paneled, double doors (Figure 11). Each door measures approximately 6'8" high by 2'9" wide with a 1" frame, the windows measure approximately 2'9" high by 2'2" wide and contain diamond-patterned, wire mesh glass. This type of glass is popular for schools as it prevents large shards of glass from causing injury in the event that the window is broken. The entry is recessed approximately 3'10" creating a weather protected porch with a raised concrete slab and single step, approximately 1' from the ground (Figure 15, Figure 16). Above the doors is a concrete porch roof extending approximately 2' from the building and measuring approximately 6' thick. Above the porch roof is a transom bay of four fixed, horizontal, rectangular thermopane windows, measuring approximately 1'8" high by 6' wide, with metal frame and horizontal muntin (Figure 17). The second from the bottom window-light of glass is covered in a gold mirrored window film. Like the doors, the windows on the north elevation are recessed approximately 3'10 from the face of the building. Horizontal linear recess divides the façade of the building in two, approximately 3' from the ground.

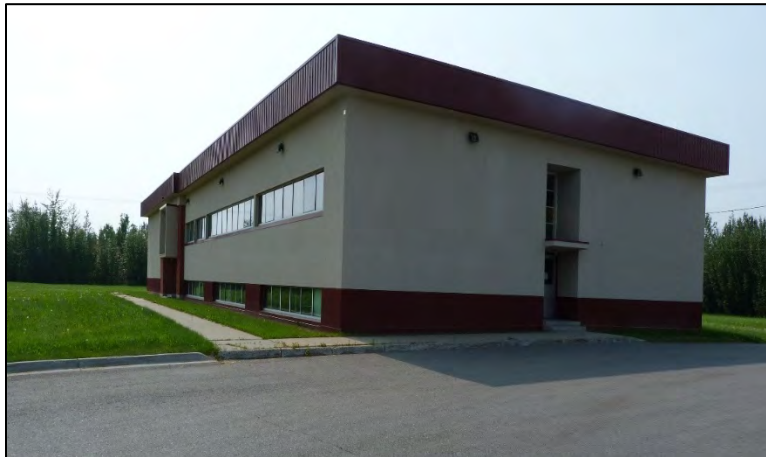
Figure 18. Building 4161, northeast corner, July 2017.

The east elevation of Building 4161 has one entrance of the same steel, half glass, double-doors described above (Figure 18 through Figure 21). Above the doors is a large ten-light, asymmetrical, metal and thermopane window (Figure 22, Figure 23). The right side of the window consists of the same horizontal rectangular, vertically stacked windows present on the north elevation. To the left of the large windows is a set of five horizontal rectangular, vertically stacked windows about half the length of the larger windows. The windows are divided by one mullion and horizontal muntins. Two of the large window-lights and four of the smaller window-lights are covered in gold mirrored window film. The windows, like the doors are recessed into the building. Unlike the windows on the north elevation, the east elevation windows are surrounded by a concrete frame protruding from the building approximately 2'9". This concrete frame serves as a porch roof. The entrance and the above window is located left of center of the elevation. Framing the entryway are two, protruding, red brick mould. The brickwork on the right side of the entryway protrudes away from the building approximately 1' and measures approximately 4' north-south. The brick on the right side of the entryway extends from the ground, nearly to the roofline, thus also bordering the right side of the concrete frame of the entryway windows. The left side brickwork protrudes away from the building approximately, 2'5" and measures 4' north-south. Unlike the brick on the right side, the brick on the left extends only to the height of the concrete patio roof/window frame. The brickwork on the right side of the entryway supports the concrete window frame, and helps to emphasize the asymmetrical nature of the east elevation. The east elevation has two other styles of windows that are combined into sets of ribbon windows. The both of these types of windows measure approximately 2'6" high by 3'8" wide with a 2" metal frame. These rectangular windows are either fixed or awning with an interior window-light with sliding areas allowing for access to the latches. The ground level windows on the north half of the elevation are in a configuration of three sets of windows is four fixed and two awning windows. The

**Design:** Degraded integrity. Building 4161 has undergone significant alterations that have resulted in adverse effects on its design. The building has lost the two superstructures. (Figures 18 and 19) These two superstructures were not original to the building, as seen in the blueprints, their removal is not an adverse effect. (Figure 20) The roof of Building 4161 has been replaced. Like the original, the current roof is flat with a metal fascia, however, the new roof is taller, with a higher fascia. The material of the fascia is still metal, however the flat sheet metal has been replaced with vertically ribbed corrugated metal. (Figures 23 and 24) Replacement of the style of metal covering the fascia is not a significant alteration as it is not

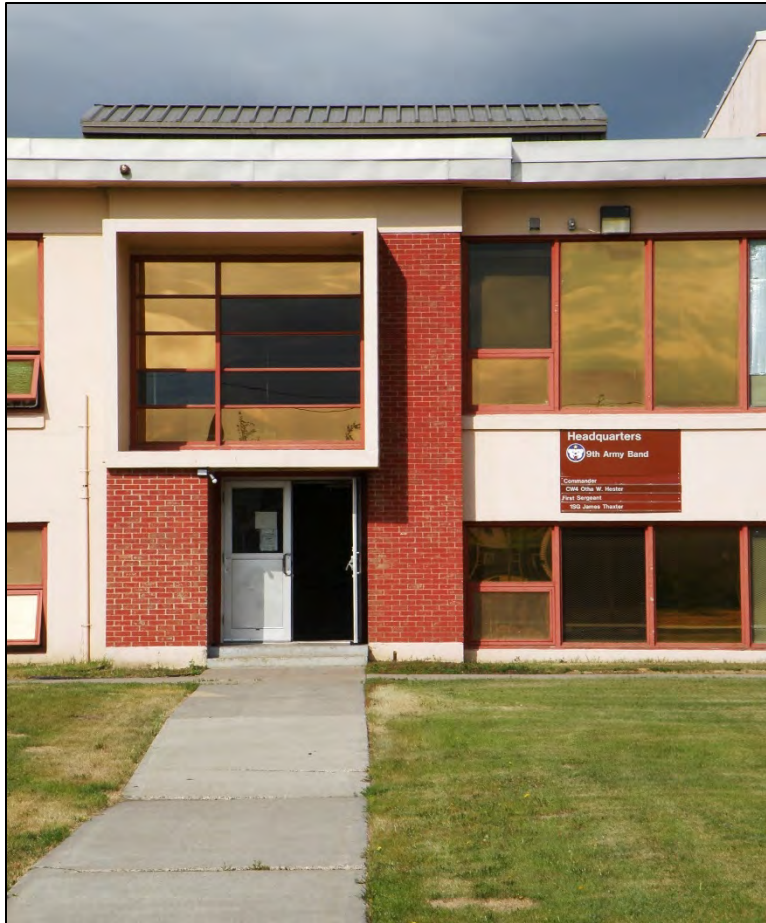
Figure 22. Building 4161, east entrance. ca. 2009.

More significantly than the window and roof alterations is the addition of the loading dock on the west elevation, extending the south elevation approximately 40'. (Figures 21 and 22) The addition to the building did take into account the architectural style and materials of the building, but is only one story and thus causes a second, lower roofline. The though the addition was constructed on the non-character defining western elevation, the south elevation

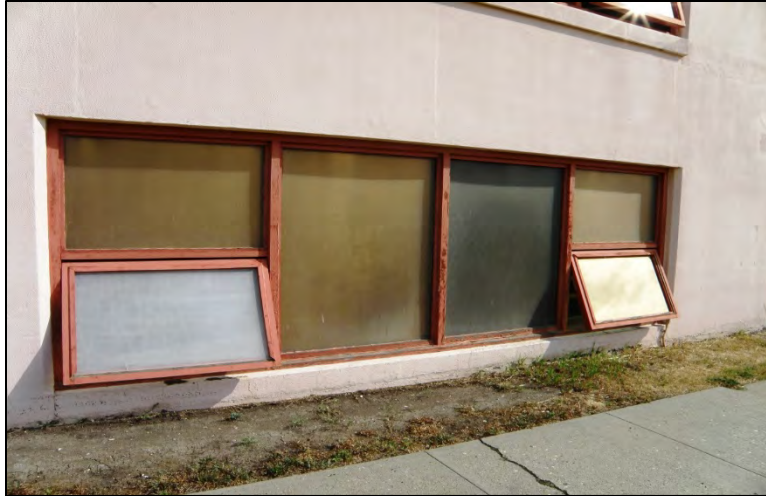
Figure 24. Building 4161, first floor windows. ca. 2009.

second floor sets of windows are, from north to south, five fixed with two awning, seven fixed with two awning, two fixed and one awning, and two fixed and one awning. The ground level windows of the southern half of the elevation are a single fixed and a fixed with an awning window (Figure 24, Figure 25). The second floor windows consist of two fixed and one awning, and one fixed (Figure 26). All of the windows on this elevation are set approximately 11" into the wall, and there is a metal window sill.

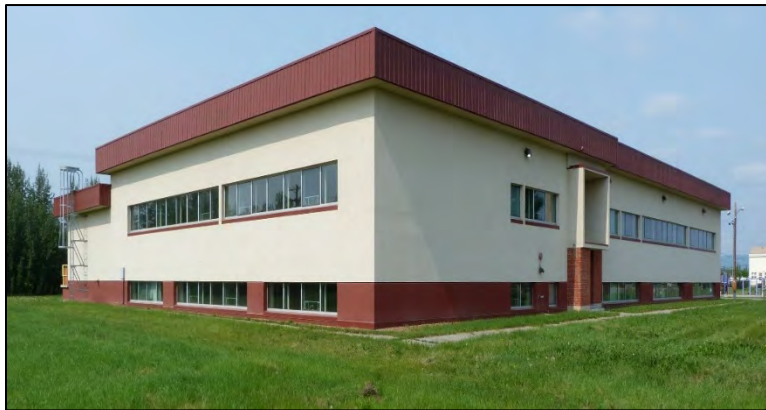
Figure 27. Building 4161, southeast corner, July 2017.

The south elevation of Building 4161 consists of two rows of windows (Figure 27 through Figure 32). The ground floor and second floor windows are the same as those described on the east elevation. The ground floor configuration, from east to west, consist of three fixed and one awning, four fixed and two awning, and three fixed and one awning window. The second floor window configuration, from east to west, consists of five fixed with two awning, and six fixed with two awning windows. The current southern elevation extends to the west beyond the original design. The extension is only one story high and thus has a roofline lower than the rest of the building. The southern elevation has an access ladder to roof.

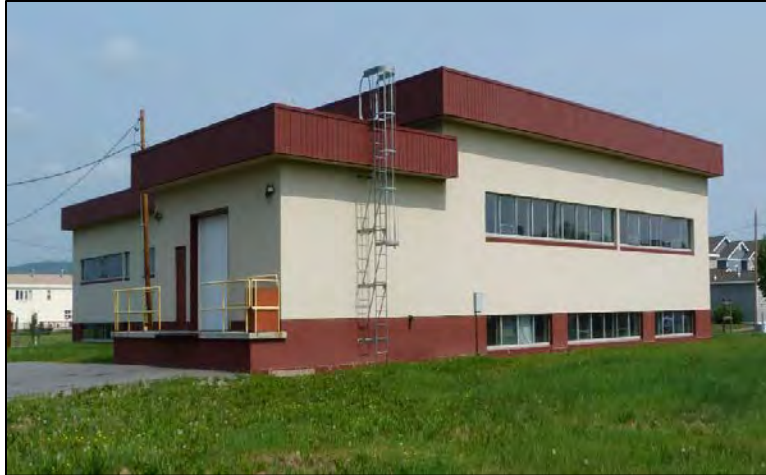
Figure 33. Building 4161, southwest corner, July 2017.

The west elevation can be seen in two sections. (Figure 33 through Figure 38) The first section is the northern portion, and the second, the southern new construction that forms the L-shape. The northern section of the western elevation has the same windows described above. The ground floor configuration, from north to south, is four fixed with two awning, a single fixed, four fixed with two awning and an awning window. The second floor configuration, from north to south, consists of five fixed with two awning, a single fixed, six fixed with two awning, six fixed with two awning, a fixed and final fixed window. The extension of the western elevation is approximately 34' north-south by 43' east-west. This extension includes a loading dock and three doors. The loading dock measures approximately 34'10" north-south by 5' east west, wrapping around the north side of the extension and continuing 14' feet. The loading dock is approximately 2'8" high. The east end of the loading dock has a set of stairs extending 3'6". The loading dock has metal pipe handrails surrounding the majority of the dock. Centered on the western elevation of the loading dock is an aluminum overhead door, measuring approximately 9' high by 9' wide, and inset 1'3" into the wall. To the north of the overhead door is a single metal personnel door with window, that swings outward and to the north. The personnel door measures approximately 6'8" high by 3' wide and the window of the door measures approximately 1'8" high by 5" wide. On the north side of the building extension is a set of outward swinging, metal, personnel double-doors, each measuring approximately 6'8" high by 3' with a 1'8" high by 5" wide window.

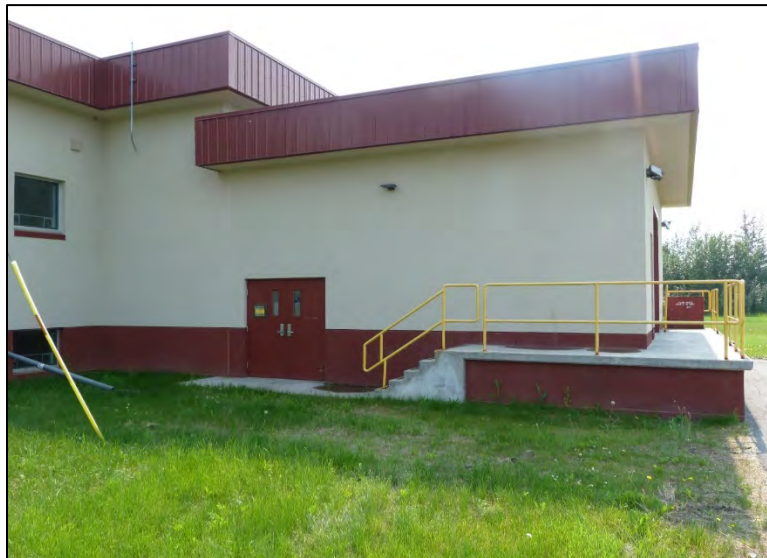
Figure 37. Building 4161, south west extension, July 2017.

McKinley Elementary, no longer serving as a school, became known by its building number, 4161. Building 4161 served as a facility for the 9<sup>th</sup> Army Band beginning in 1990. (Figure 37) After 2009, Building 4161 received several significant alterations, most significantly new

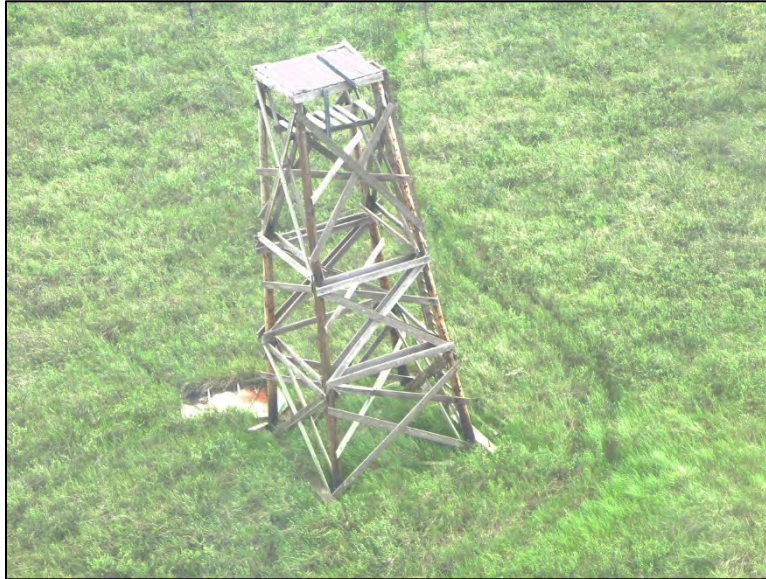
Figure 41. Overview of tower structure FAI-02693 in TFTA.

square plan, four plus-story, wood framed structure, with an unknown foundation (Figure 41). The structure is crossed braced and contains a metal railing surrounding the platform at the top. A centrally located metal ladder leads to the top of the platform on one of the façades. The tower is likely of military construction, but the date is unknown. The boards are experiencing weathering and the structure is deteriorated.

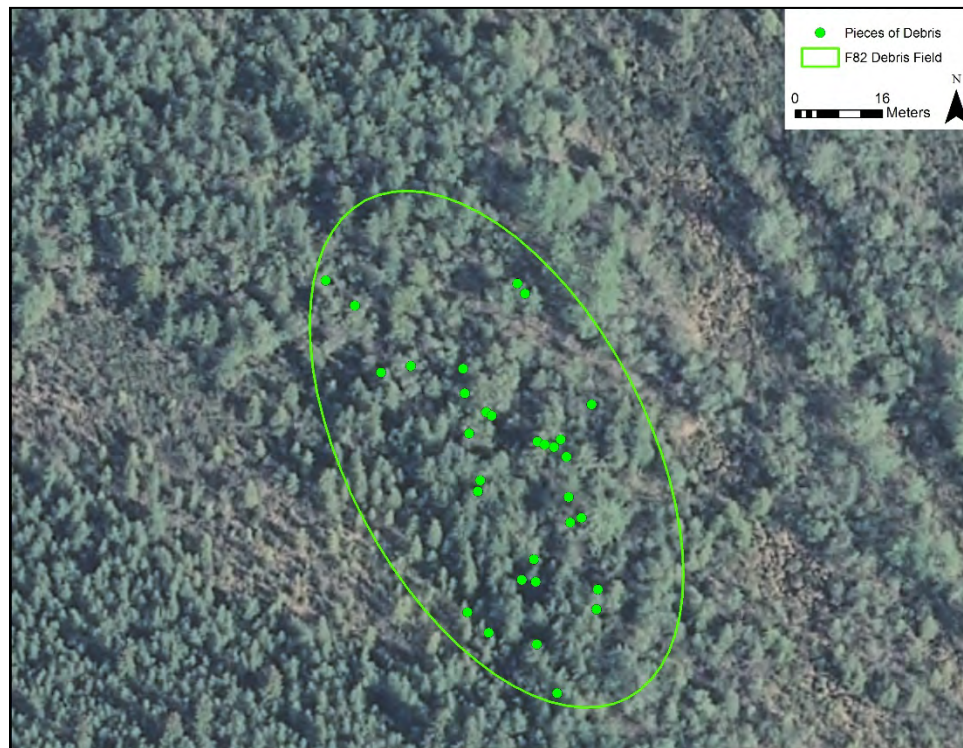
Figure 49. F-82 debris field perimeter.

**Location:** Maintains integrity. Aircraft are inherently mobile. The NRHP recognizes that aircraft are likely not located in the original construction location. The majority of the wreckage of the aircraft is still located at the crash site (Figure 49).

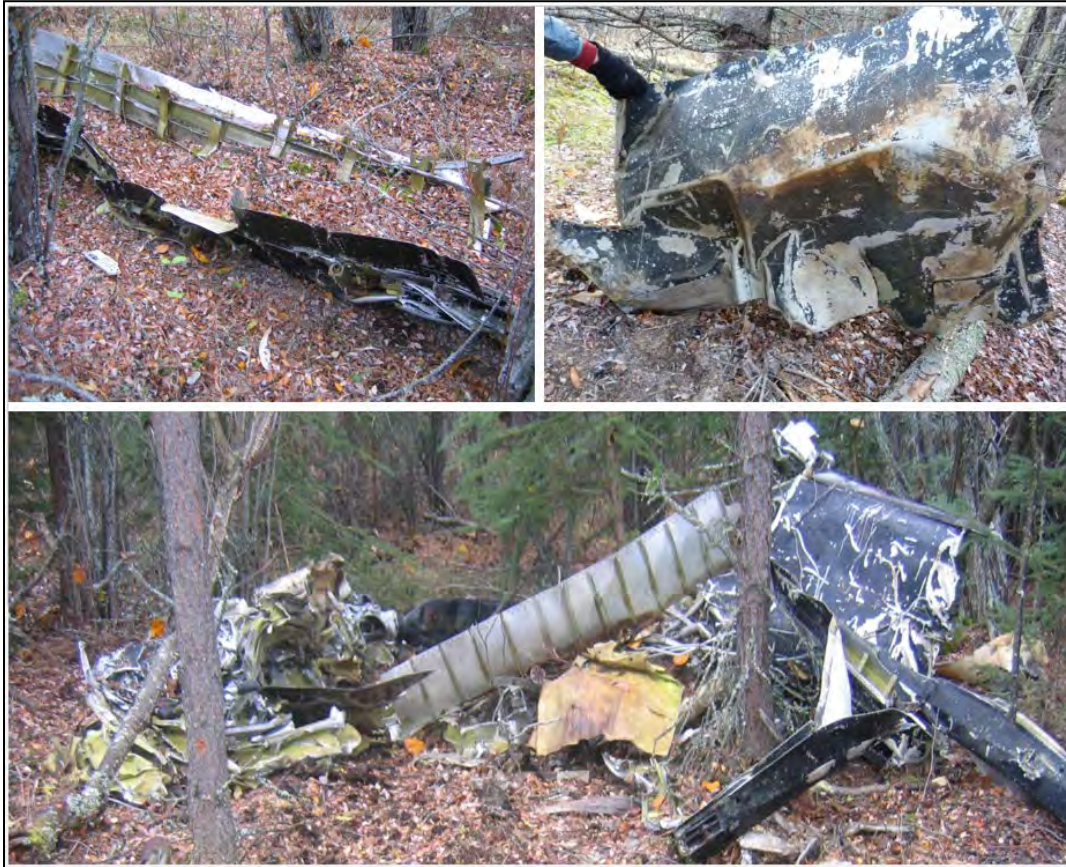
Figure 50. Fuselage pieces.

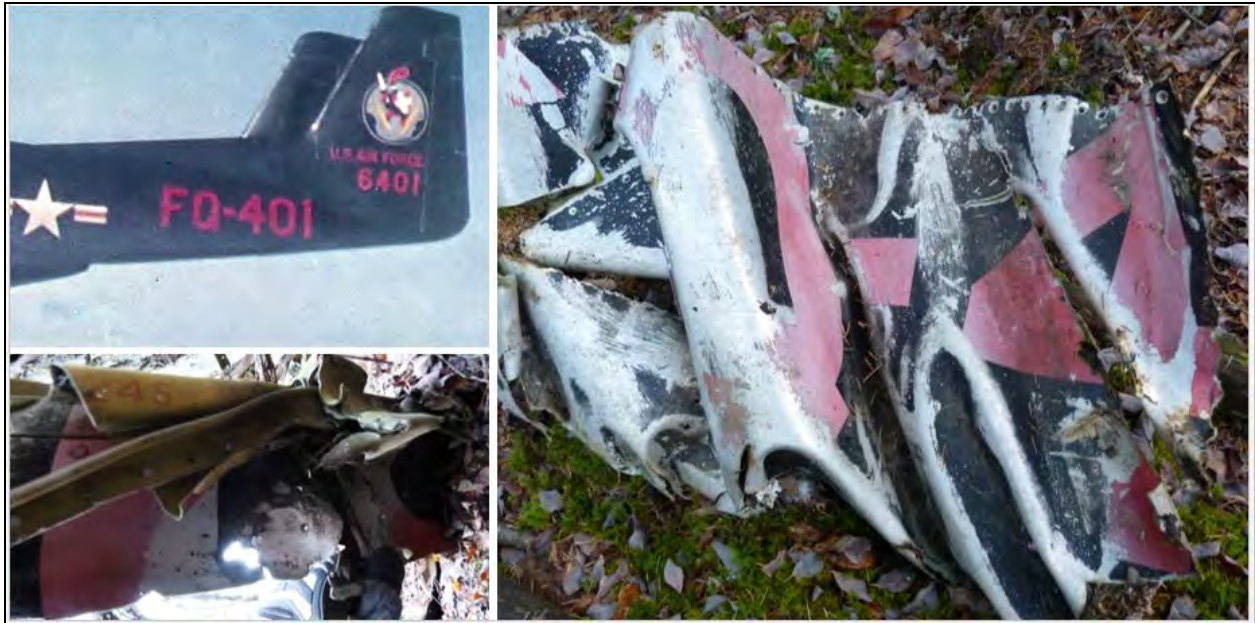
Figure 51. "Buzz" Numbering FQ-497 (FQ=North American F-82, 3 Digits= aircraft number).

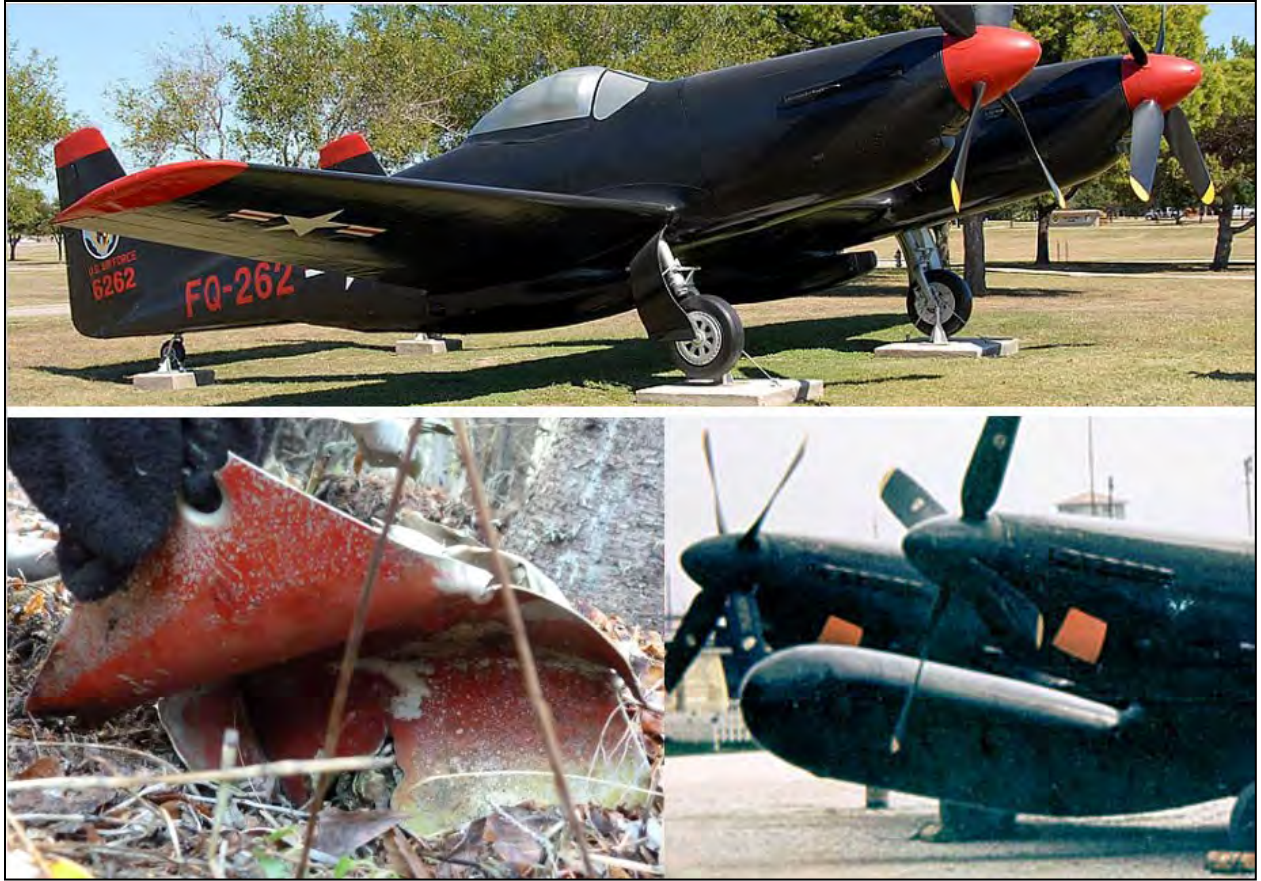
Figure 53. Exterior panel.

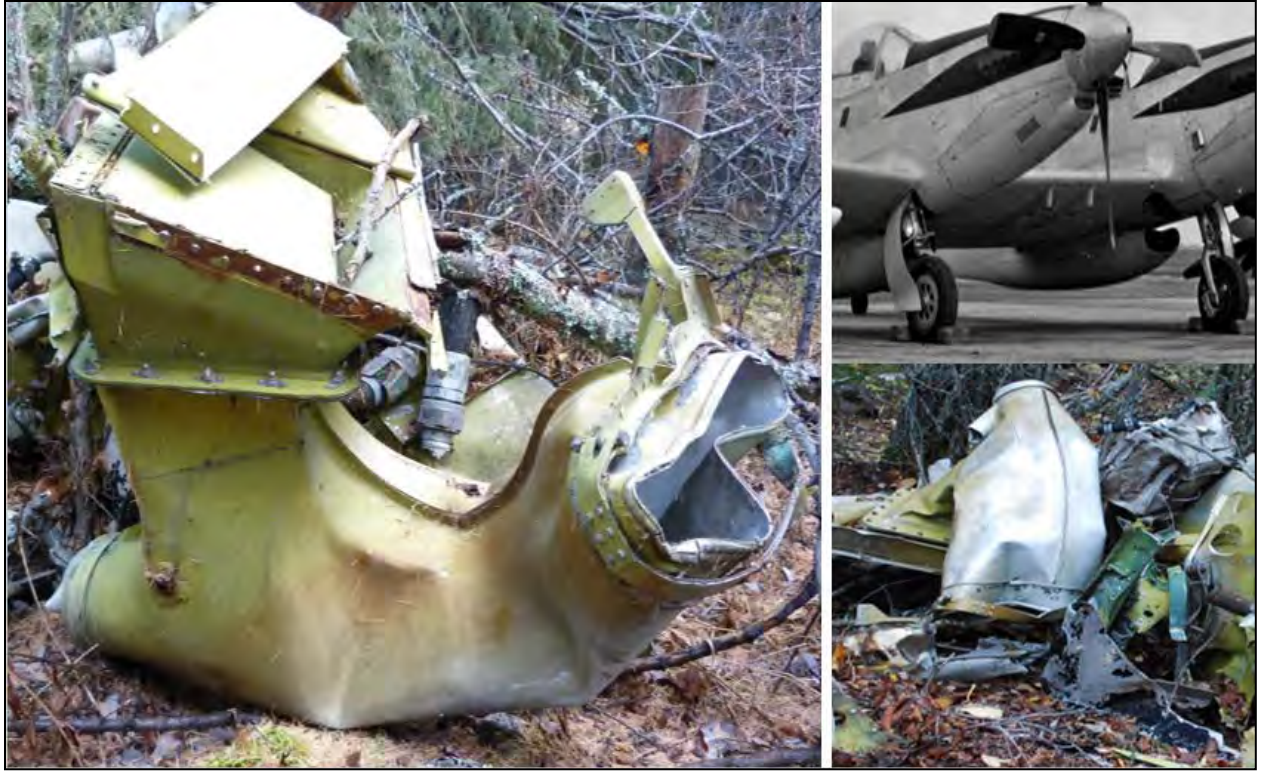
Figure 55. Carburetor intakes.

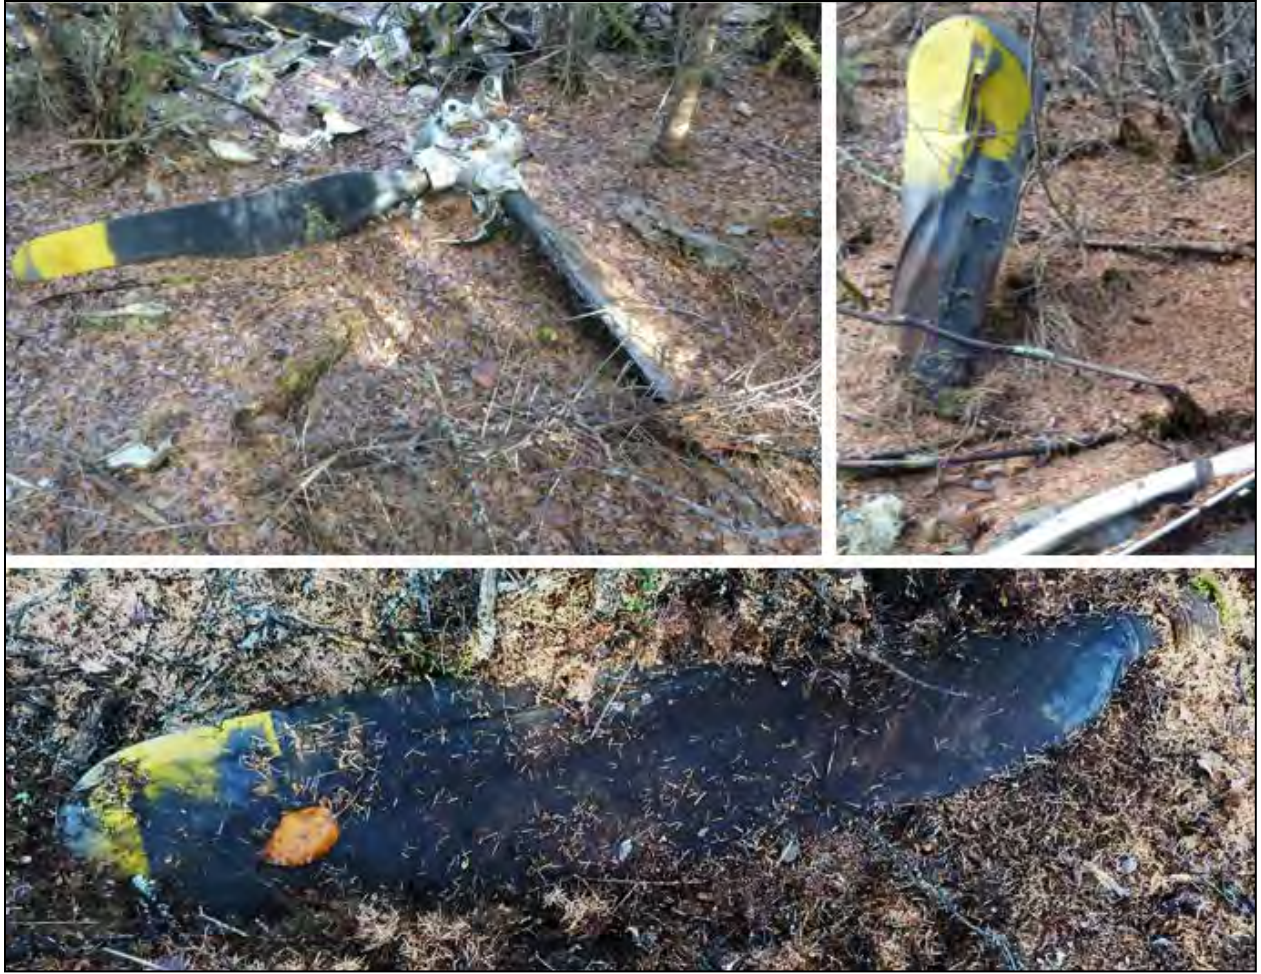
Figure 56. Propellers.

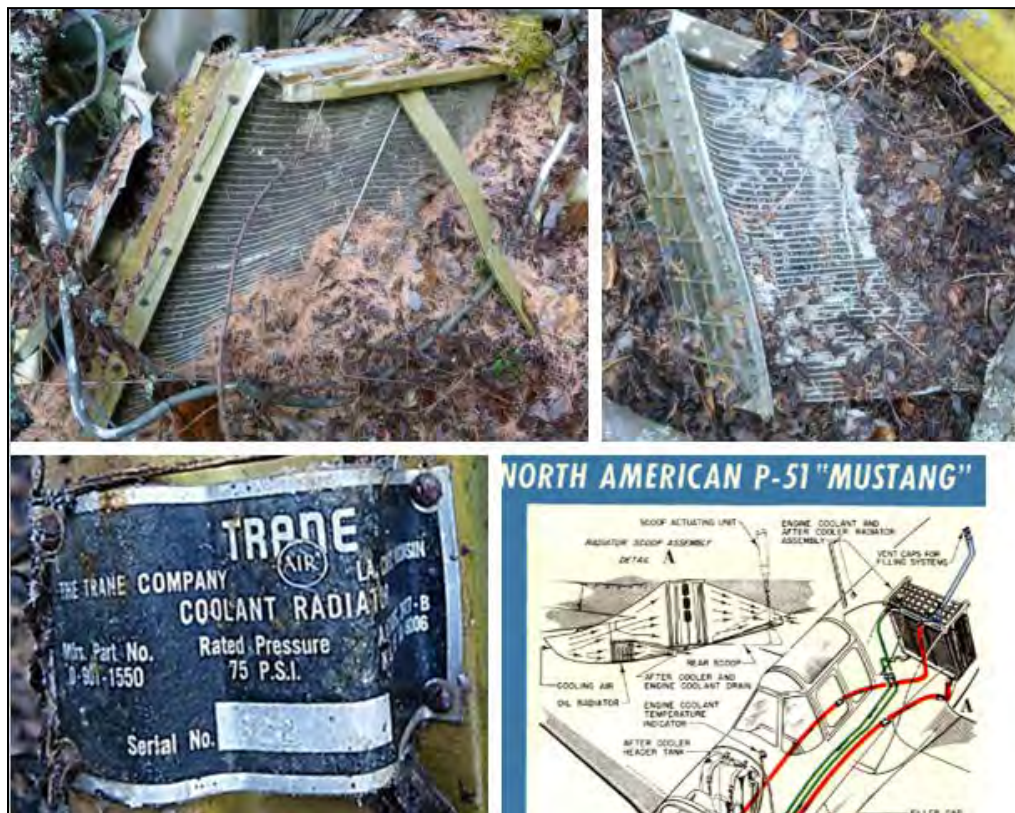
Figure 59. Radiators.

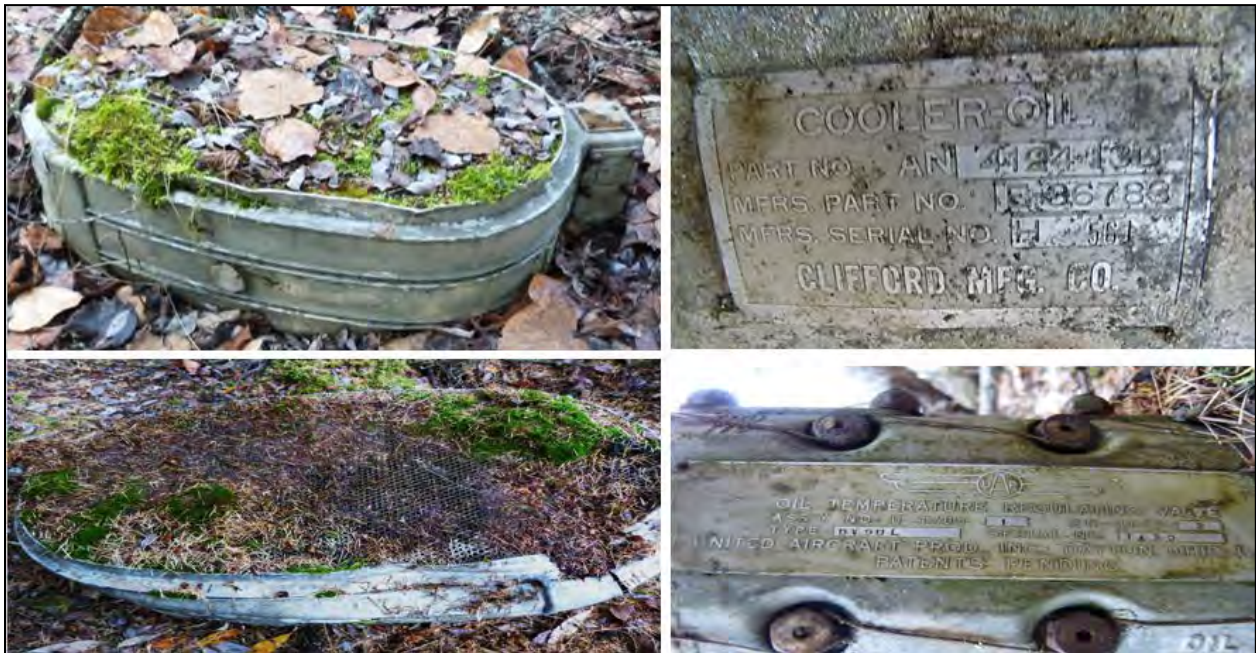
Figure 63. Oil temperature regulator.

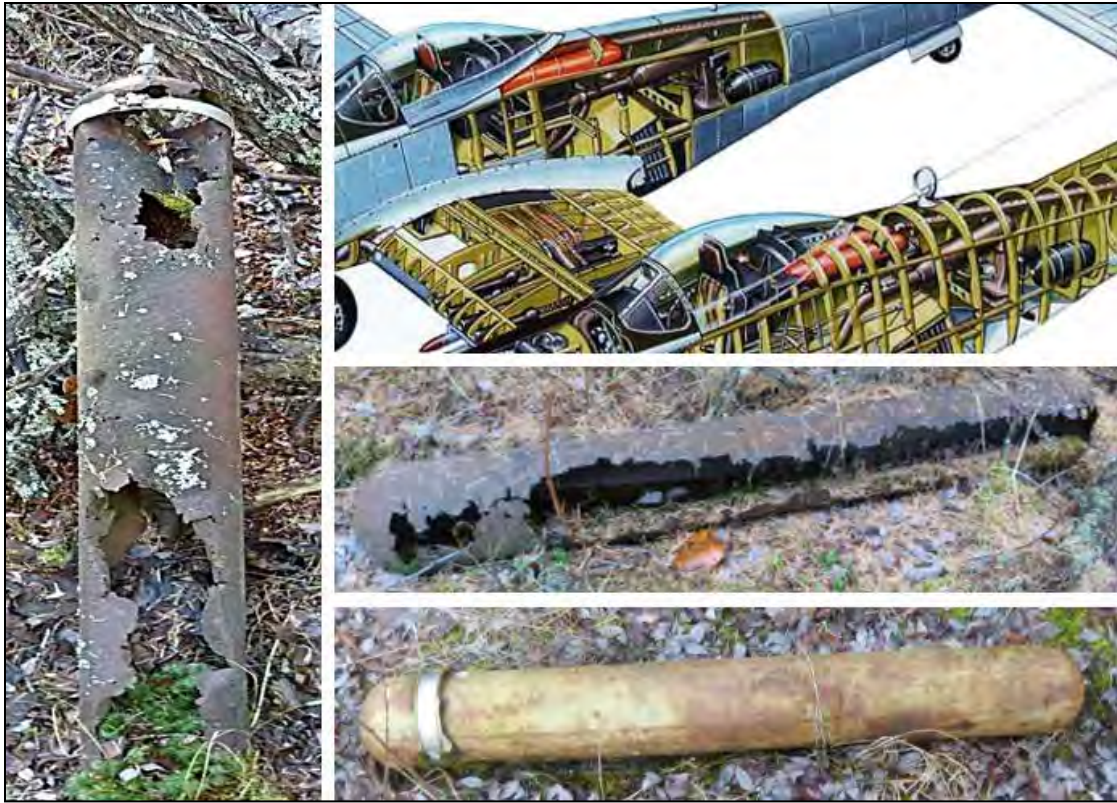
Figure 64. Oxygen bottles.

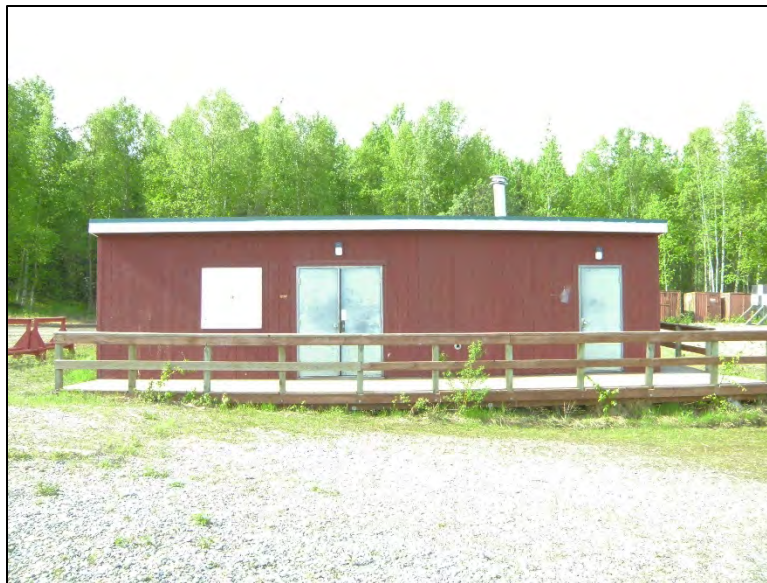
Figure 72. FAI-02695, Building #33 west façade.

This set of buildings is located off of Manchu Road in the western portion of YTA, 29.5 km southeast of Fort Wainwright and 9.3 km east of Eielson Air Force Base (Figure 71). The first building (#33, FAI-02695) is a rectangular plan, one-story, wood framed building, sitting on a post and block foundation and is oriented east/west (Figure 72). The building is clad in red vertical groove plywood and the shed roof is made of corrugated metal. A double door entrance to the left and single door entrance to the right are located on the primary façade which faces east. Each façade contains a single window with simple plywood shutters. A wooden deck with railings had been added to the primary east façade and wraps around to the north side of the building.

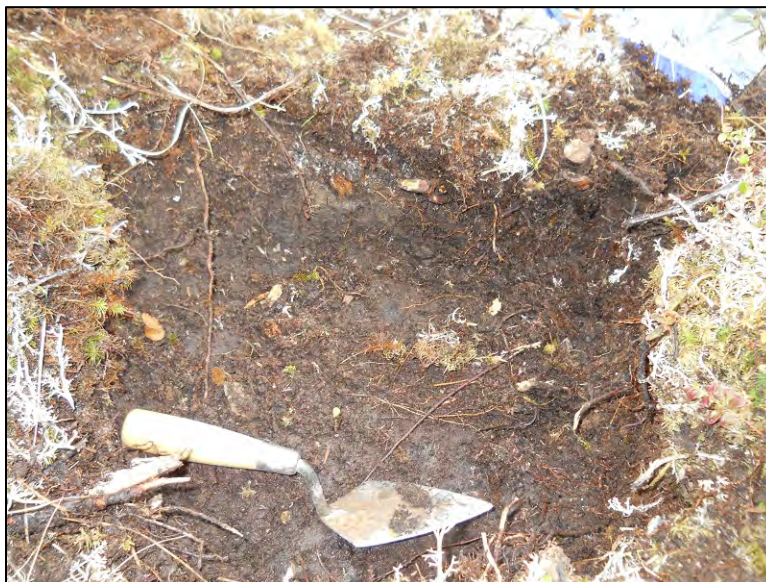
Figure 77. Eastern YTA Firing Point survey area test pit.

(95 acres), NE YTA Firing Point (45 acres), and TA 305 Firing Point (13 acres). The eastern YTA Firing Point is located among the highest hills in the area. Short black spruce and willow are found along ridgelines (Figure 76). Test pits in this location were extremely shallow, measuring only a few centimeters before encountering bedrock (Figure 77). The Vole Creek area is covered with dense black spruce and a moss understory (Figure 78). Test pits reach approximately 20 cmbs. A thin (5 cm) organic layer overlies relatively unaltered silt deposits (Figure 79). Mature spruce forests cover the AFTAC survey area (Figure 80). Bedrock in this area is overlain by 25-30 cm of loess with 10 cm organic layers. A weak B horizon is evident in the profile (Figure 81).

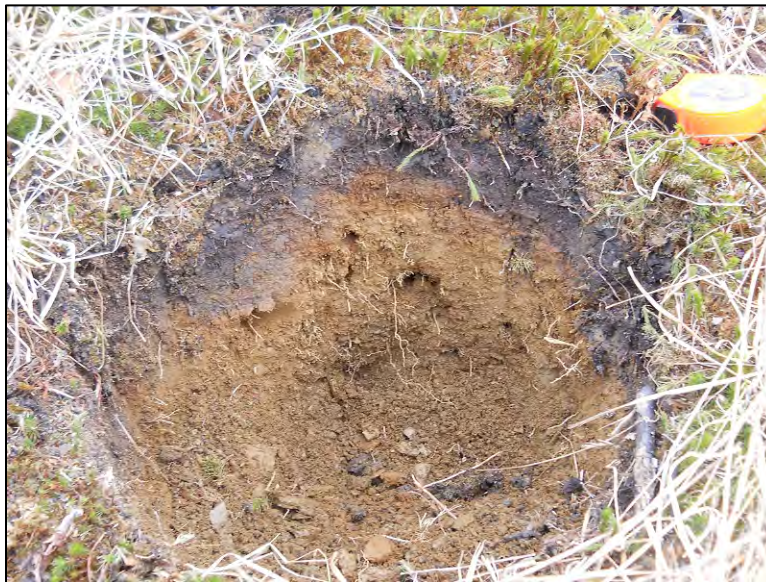
Figure 83. LZ Lynx survey area test pit.

The LZ Lynx survey area had previously been cleared. Grasses and willows make up the majority of the vegetation (Figure 82). Test pits are shallow, up to 20 cm deep, with silt under a 5-10 cm organic layer (Figure 83). In the Beaver Creek survey area, mature white spruce forests cap approximately 25-30 cm of silt (Figure 84). A thin (5 cm) organic layer overlies a thin B horizon (Figure 85). The Transmitter Road survey location is covered by a mature spruce and poplar forest (Figure 86). Test pits reach approximately 20 cmbs. A thin organic horizon overlays silt with a 5-10 cm thick B horizon (Figure 87). The Tire Village survey area is forested with white

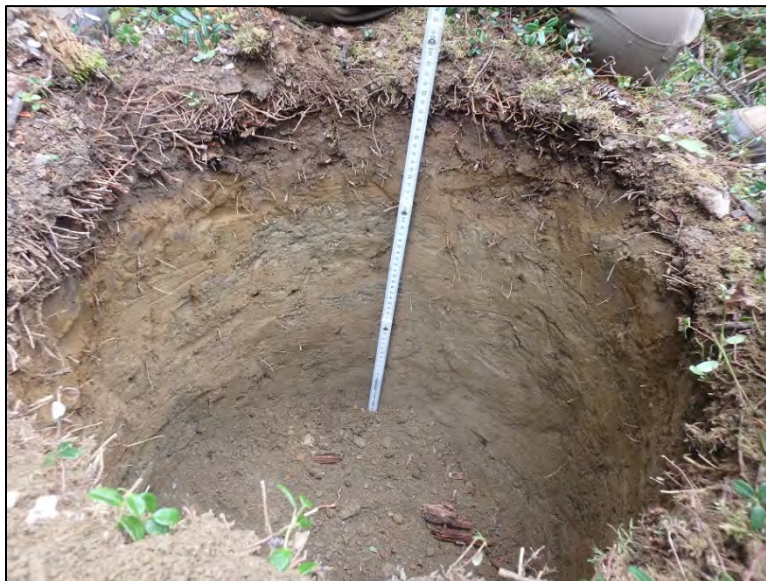
Figure 89. Tire Village survey area test pit.

spruce and had deep sediments (up to 60 cmbs) (Figure 88). Test pits uncover a thin organic horizon overlying thick silts (Figure 89). Soil development is evident in the top 20-30 cm of silt. Finally, the NE Firing Point/TA 305 survey area, located at some of the highest elevation in YTA, has short spruce vegetation and grasses and test pits reaching a maximum of 40 cmbs (Figure 90, Figure 91).

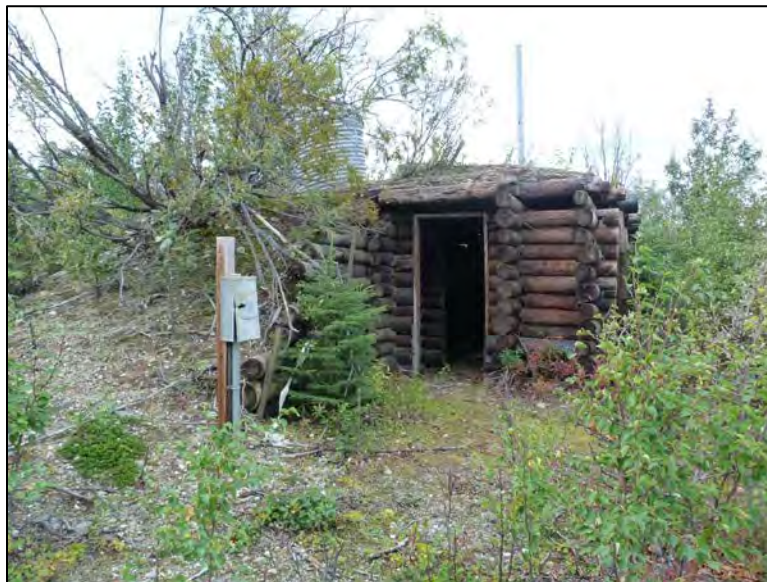
Figure 95. East façade of log building.

This log building is located at the end of Center Road near OP8 in DTA East, 20 km southwest of Delta Junction (Figure 94). The structure is a square plan, one-story, log framed building, sitting on a log foundation. The structure is clad in log and its roof is composed of log and earth (Figure 95, Figure 96). The logs are notched in the corners and drywall was hung in the interior (Figure 97, Figure 98).

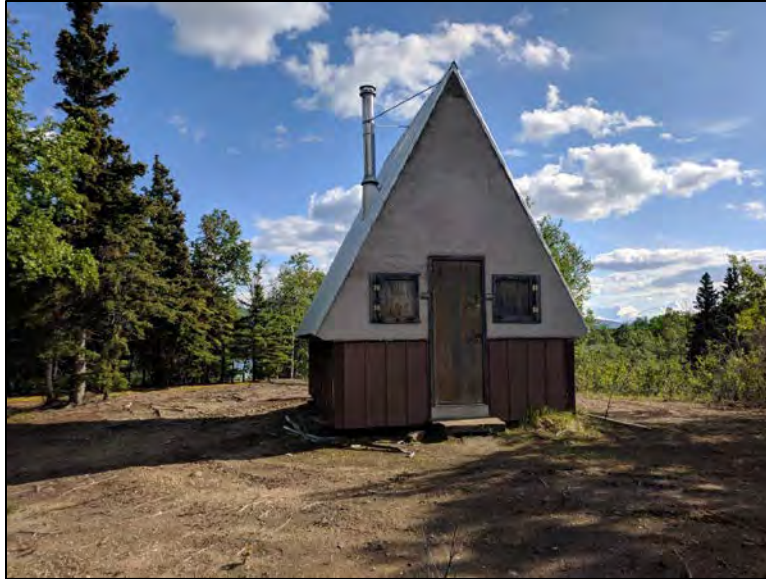
Figure 99. Front façade, XMH-01574.

An A-frame cabin is located in the Twin Lakes camping area off of Twin Lakes Road, 1.8 km east of Meadows Road and 19 km south of Delta Junction (Figure 94). The A-frame cabin is a rectangular frame, two-story, balloon framed building on a horizontal wood beam foundation and is oriented north-south. The bottom third of the building is clad in corrugated metal and the upper two-thirds in plywood, while the steeply gabled roof is clad exclusively in corrugated metal. The primary façade on the north side of the building features a centrally located, single, flush plywood door with two small, square, fixed pane windows with a plywood shutter on each side of the entrance. The back façade's fenestration features a square fixed pane window just below the roofline and a fixed pane, vertical, rectangular window below, both with a single plywood shutter (Figure 99, Figure 100).

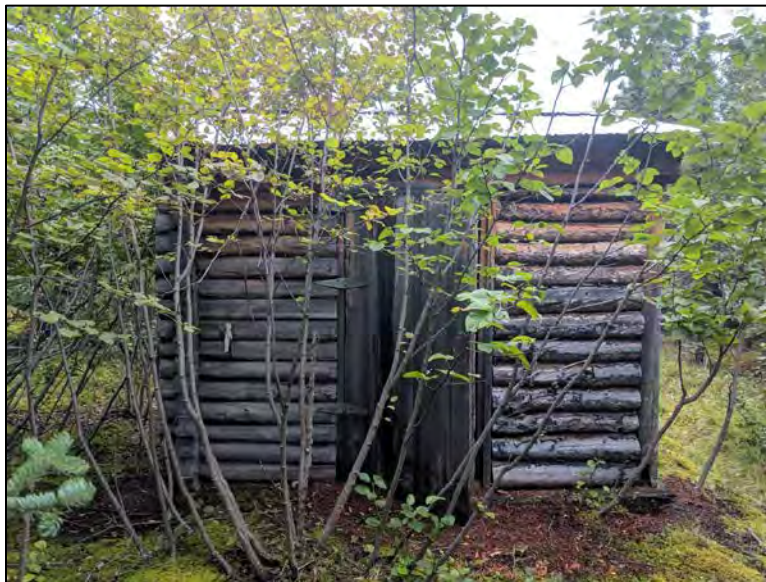
Figure 101. East façade of XMH-01575.

A small cabin is located at the southern end of Twin Lake south, 2.3 km east of Meadows Road and 19 km south of Delta Junction (Figure 94). The cabin is a rectangular plan, one-story, log square/saddle framed building, sitting on a horizontal wood board foundation and is oriented north-south. The cabin is composed of logs and its side gabled roof is clad in corrugated metal (Figure 101).

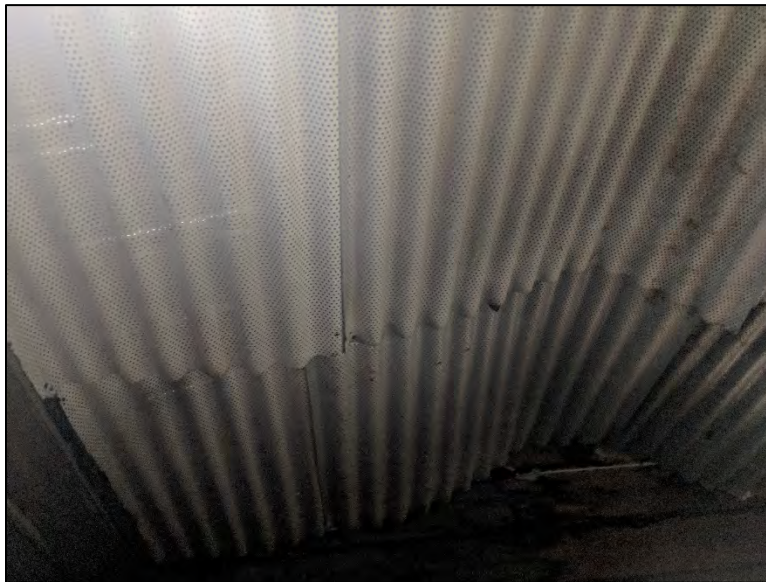
Figure 103. Corrugated metal ceiling in XMH-01575.

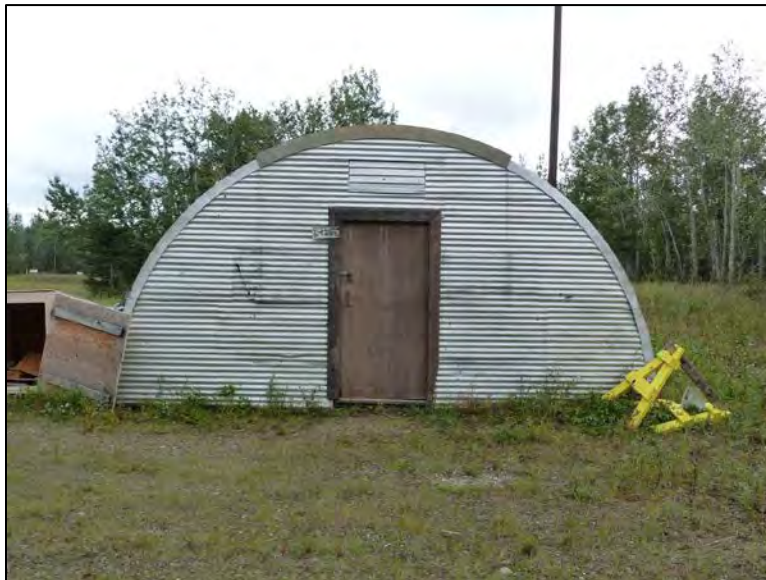
Figure 104. East façade of XMH-01576.

A Quonset Hut is located on the KD Range in DTA East, 800 m west of the Richardson Highway and 7 km south of Delta Junction (Figure 94). The building is a rectangle plan, one-story, metal framed building, sitting on an unknown foundation and is oriented east-west. The overall building, including its rounded roof, is clad in corrugated metal. The east and west façades both feature a centered single, flush wood door for access and the west façade also includes a horizontal, rectangular, fixed window to the immediate right of the door (Figure 104, Figure 105).

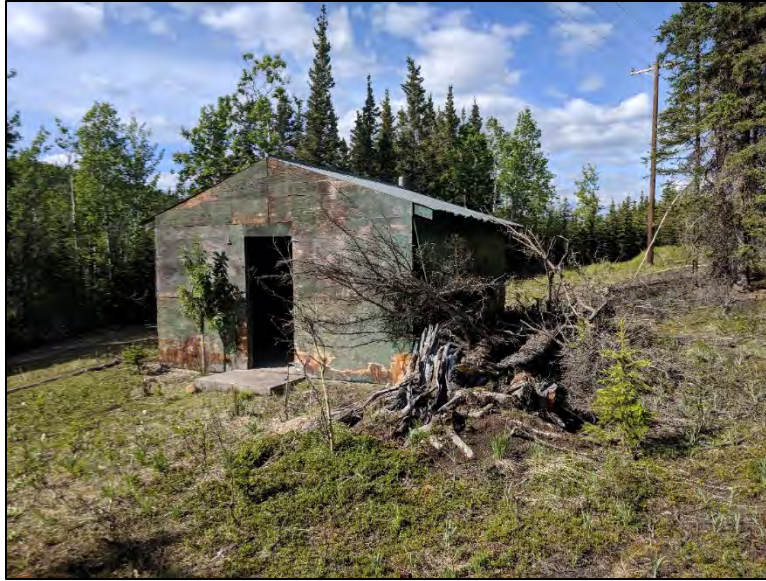
Figure 106. Boy Scout Cabin #1, XMH-01577, south façade.

Three structures making up a Boy Scout Camp are located at the north end of Bolio Lake, 250 m east of Meadows Road, and 15 km south of Delta Junction (Figure 94). The first structure is a rectangular plan, one-story, balloon framed cabin that has a concrete slab foundation. The building is clad in plywood and the front gable roof is clad in corrugated metal and features exposed rafter tails. The entrance is a centrally located opening with three strap hinges located on the cladding to the right, indicating where the door once was. On the back of the building is a centrally located, rough cut, stone masonry chimney leading into a metal chimney pipe backed by metal flashing (Figure 106).

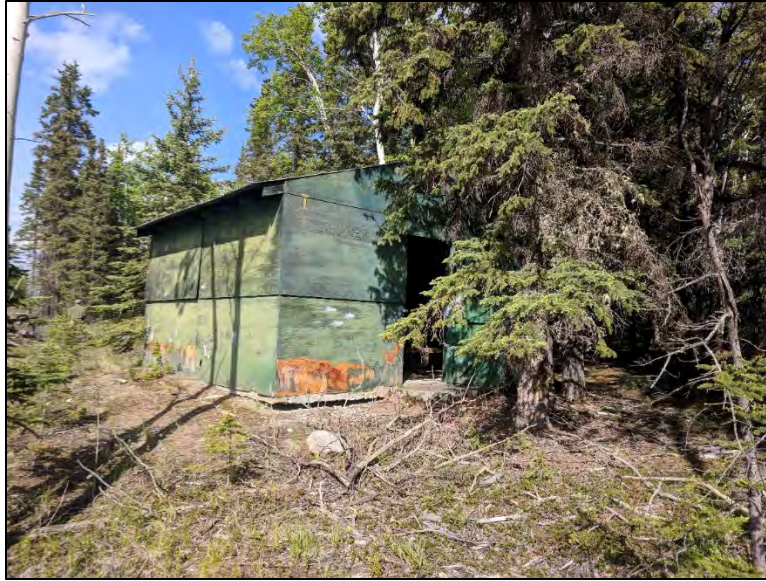
Figure 107. Boy Scout Cabin #2, XMH-01578, southwest corner.

The second cabin in the Boy Scout Camp is also located at the north end of Bolio Lake, 250 m east of Meadows Road, and 15 km south of Delta Junction (Figure 94). The cabin is a rectangular plan, one-story, balloon framed building and has a concrete slab foundation. The building is clad in plywood and the front gable roof is clad in corrugated metal and features exposed rafter tails. The entrance is a centrally located single plywood door and the back façade features a rough cut, stone masonry chimney leading into a metal chimney pipe backed by metal flashing (Figure 107).

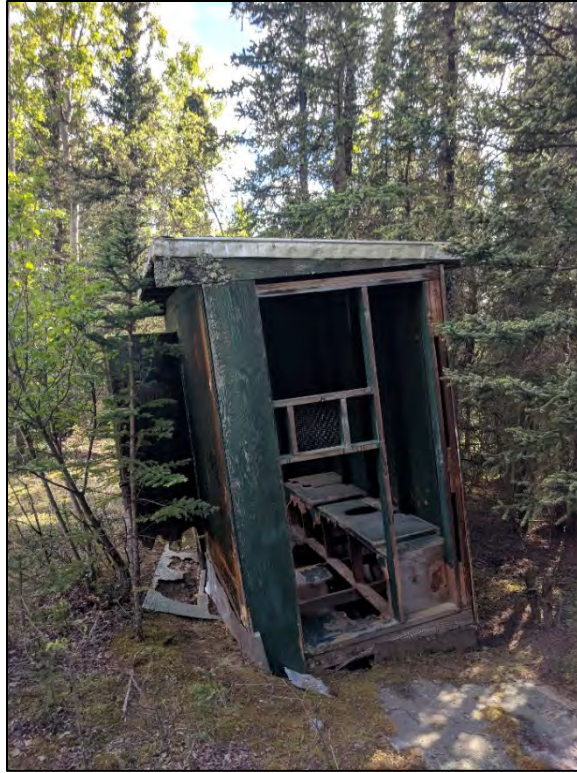
The third structure in Boy Scout Camp located at the north end of Bolio Lake, 250 m east of Meadows Road, and 15 km south of Delta Junction is an outhouse (Figure 94). The outhouse is a rectangular plan, one-story, balloon framed building on a horizontal wooden beam foundation. The building is clad in plywood although areas are missing and its shed roof is clad in metal and asphalt sheeting. The interior of the building features four seats cover the back half of the building and span its length, while the plywood floor below is mostly deteriorated (Figure 108).

Figure 108. Boy Scout Outhouse, XMH-01579, north façade.

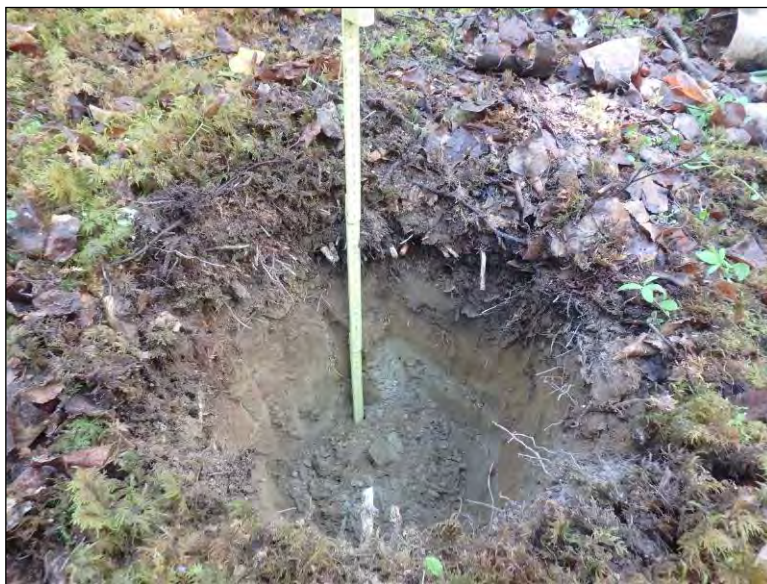
Figure 119. XBD-00450 test pit.

50 cmbs (Table 10). A 10 cm organic layer overlies 40 cm of silt in this location (Figure 118, Figure 119). The upper 30 cm of silt are mottled from oxidation and other soil formation processes. The 10 cm of gray silt overlie schist and angular quartz pebble fractured bedrock.

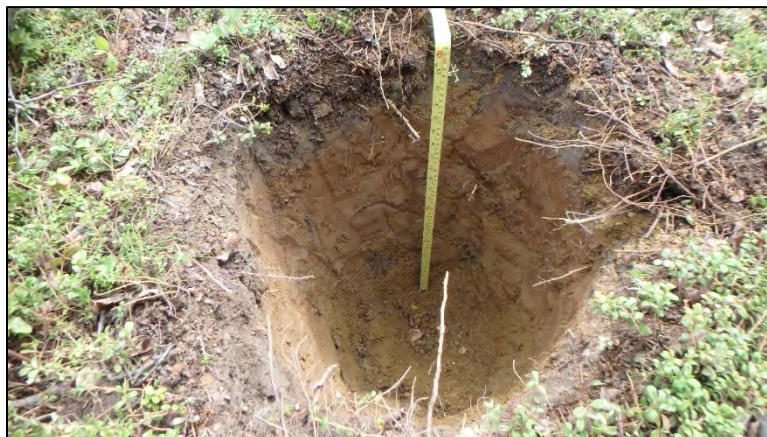
Figure 123. XBD-00451 test pit.

This site is located north of Boot Lake and 24 km west of Delta Junction in DTA West. (Figure 111). The site is 275 m north of the eastern end of the lake on the lower bench of a ridge composed of Paleozoic age metamorphic rock covered in windblown silts (Wilson et al. 2015) (Figure 120). Vegetation consists of Labrador tea, rose, high bush cranberry, raspberry, blueberry, horsetail, moss, grass, fireweed, alder, willow, poplar, and spruce. There is no surface visibility and no noted disturbances. Two shovel tests were excavated on the eastern side of the ridge, but only one on the lower bends (Figure 121). Eleven basalt and chert flakes and a chert scraper were found buried in the test pit, 0-40 cmbs (Table 11). A 10 cm organic layer overlies 40 cm of silt in this location (Figure 121, Figure 122). Shovel tests ended in sandy gravels at 50 cmbs.
