# Fort Wainwright Cultural Resources Annual Report, 2018

Center for Environmental Management of Military Lands  
Colorado State University  
Fort Collins, CO 80523-1500

December 2019

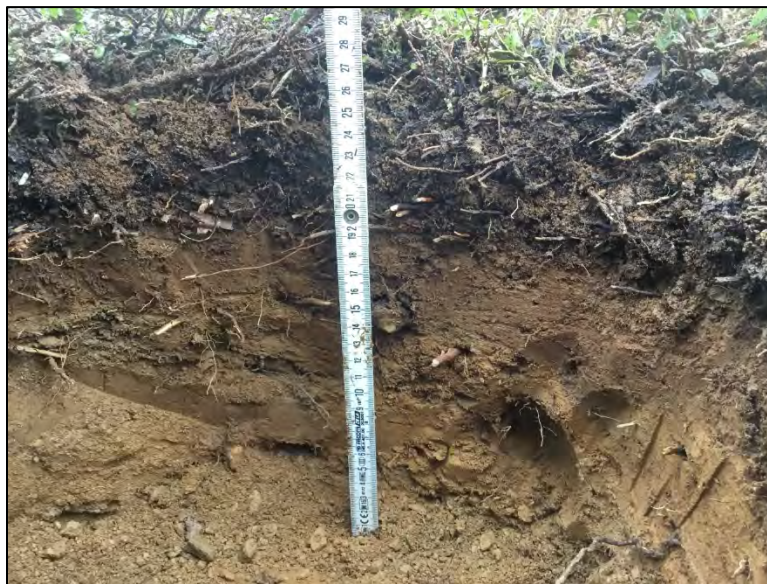
Figure 127. XMH-01567 test pit.

This site is located 756 m south of Butch Lake and 24 km south of Delta Junction in DTA East. (Figure 112). The site is located along a trail following a small glacial moraine overlooking the Jarvis Creek floodplain with a 15-20 m drop to a grassy muskeg area below. Vegetation consists mainly of dwarf birch and low bush cranberry with the occasional small spruce tree (Figure 124). Surface visibility is 10-15% and there are views in all directions. No surface disturbances were noted. Three shovel tests were excavated on the western side of the ridge (Figure 125). One red chert flake was found from 0-15 cmbs (UA2018-080-001). The flake was red and had a patina from possible heat treating. A 10 cm organic layer overlies less than 10 cm of silt in this location (Figure 126, Figure 127). Shovel tests ended in sandy gravels at 30 cmbs.

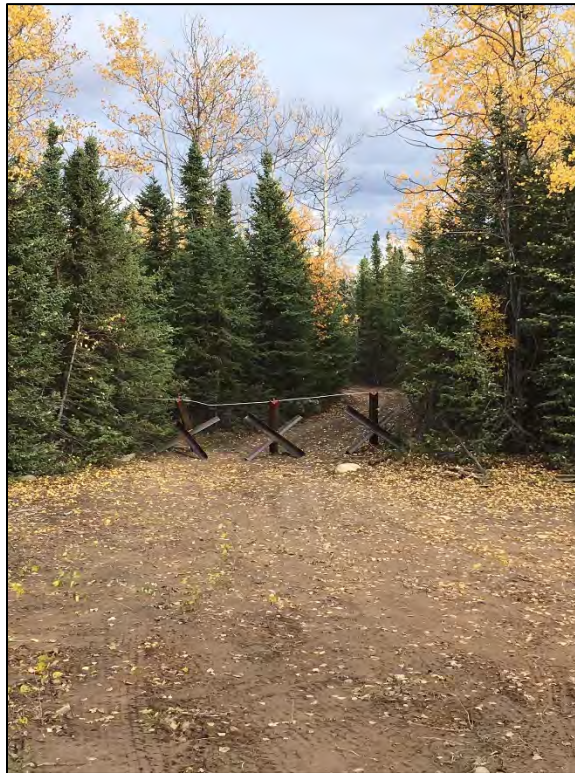
common source of surface erosion of the sites is from trails which often bisect hilltops in the area (n=34). Several of the sites have evidence of recent recreational visits with fire rings (n=3) and one site landform is in use as a gravel pit. Current site photos are provided in Appendix 2. New site protection measures in 2018 include Seibert Stake signage at 59 sites to prevent the military community from driving over sites or digging within site boundaries and the installation of three sets of hedgehogs at the intersection of 33 Mile Loop road and major trails that lead to eligible archaeological sites (Figure 128, Figure 130, Figure 131).

Figure 131. Example of a row of hedge hogs preventing vehicles from travelling a trail through archaeological sites.

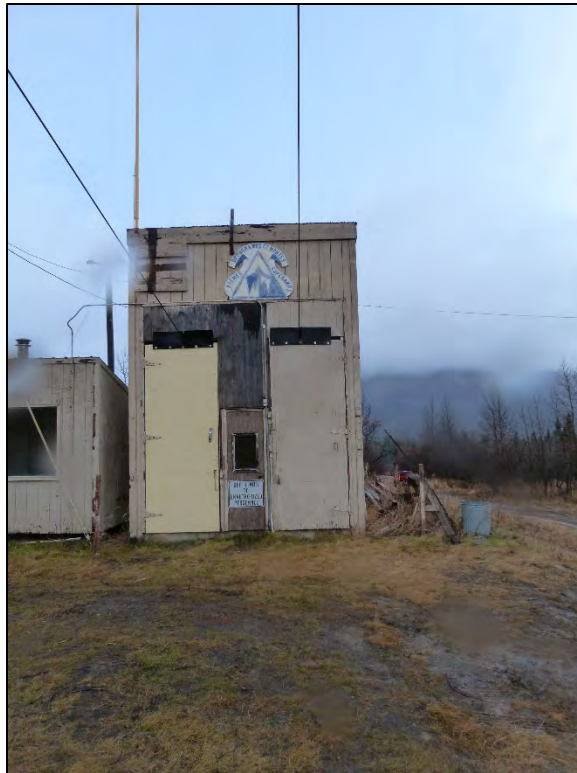
Figure 139. Building 2036, east façade.

Building 2036 is located east of main building complex in BRTA, 288 m east of the Richardson Highway and 58 km south of Delta Junction, Alaska (**Error! Reference source not found.**). The building is a rectangular plan, one-story, balloon framed building, sitting on a concrete slab foundation and is oriented east/west. The building is clad in vertical groove plywood and its shed roof is clad in corrugated metal. The east primary façade, features two, large, tall, flush, single plywood doors that are opened when the lift is running (Figure 139, Figure 140). Between the two doors is a single, plywood access door with a centrally located, rectangular, fixed window. The building features no other fenestration on any of its façades.

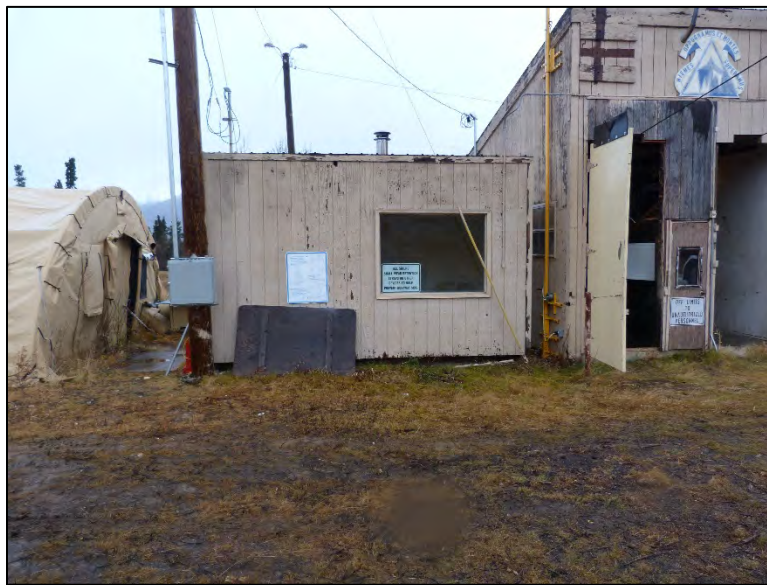
Figure 141. Building 2037, east façade.

Building 2037 is located east of main building complex in BRTA, 288 m east of the Richardson Highway and 58 km south of Delta Junction, Alaska (**Error! Reference source not found.**). The building has a rectangular plan, one-story, balloon framed building, sitting on a horizontal wood beam foundation and is oriented north/south. It is clad in vertical groove plywood and its shed roof is clad in corrugated metal (Figure 141, Figure 142). The primary, south façade features a single, centrally located, twelve panel, wood door, with a centrally located upper panel removed and altered into a window. Flanking the door are two identical, square, fixed pane windows. The only other fenestration located on the building is a large, rectangular, fixed window located on the right half of the eastern façade. Building 2037 is part of the original NWTC complex.

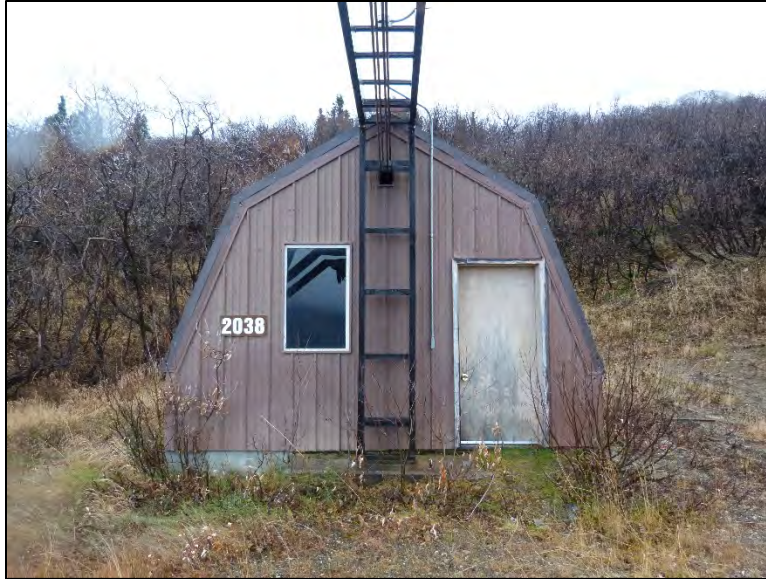
Figure 143. Building 2038, west façade.

Building 2038 is located east of main building complex in BRTA, 1.6 km east of the Richardson Highway and 58 km south of Delta Junction, Alaska (**Error! Reference source not found.**). The building is a rectangular plan, one-story, reinforced CMU building, sitting on a concrete slab foundation and is oriented east/west. It is clad in CMU and corrugated metal and its gambrel roof is clad in asphalt sheeting (Figure 143, Figure 144). The primary west façade features a single, flush, wood door to the far right and a rectangular, fixed, vertical, window on the left. The metal structure supporting the lift reaches the building at the peak of the gambrel roof and continues down the front middle of the façade, securing to the a square concrete slab below. A small rectangular opening just below the peak of the roof provides access to the building for the lift cables. The other facades of the building feature no fenestration. Building 2038 is part of the original NWTC complex.

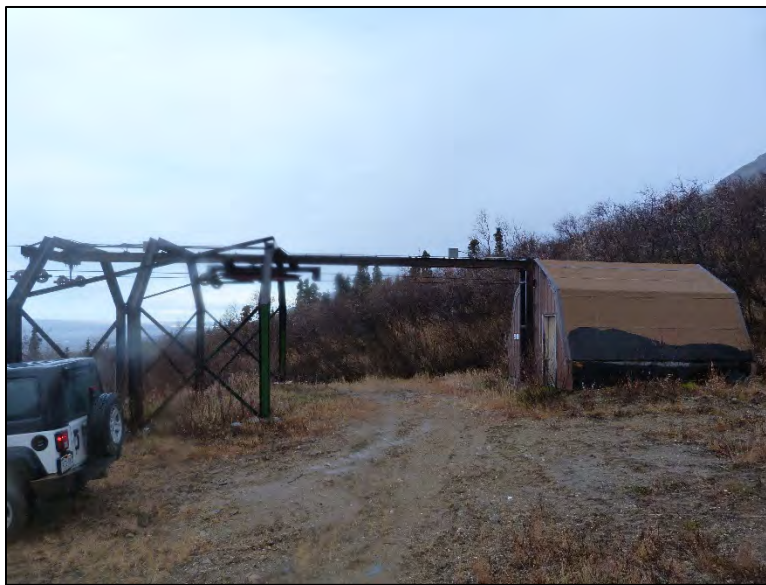
Figure 145. BRTA ski lift, facing north.

The ski lift is located east of main building complex in BRTA, 288 m east of the Richardson Highway and 58 km south of Delta Junction, Alaska (**Error! Reference source not found.**). The ski lift is a linear plan, one to two-story, metal framed structure, with a concrete foundation and is oriented east/west (Figure 145, Figure 146). The lift provides transportation between the upper and lower lift buildings on the site and consists of a large, horizontal, pulley system that is supported by large, metal “T” shaped, poles at regular intervals between the two buildings. The ski lift is part of the original NWTC complex. It was previously surveyed in 2012 and found to have been built in 1980.

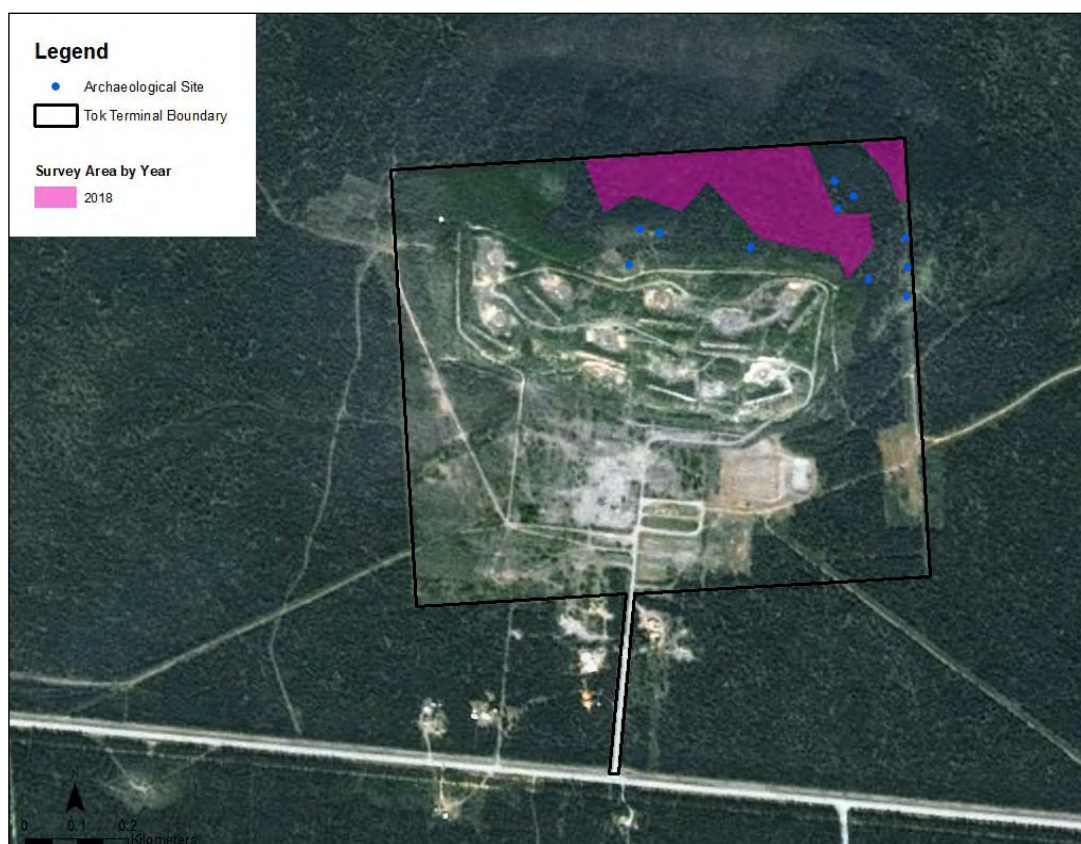
Figure 148. Archaeological surveys at Tok Fuel Terminal in 2018.

Archaeological surveys conducted in association with site monitoring and evaluations at Tok Fuel Terminal in 2018 covered 16 acres (Figure 148). No archaeological sites were found during this survey.

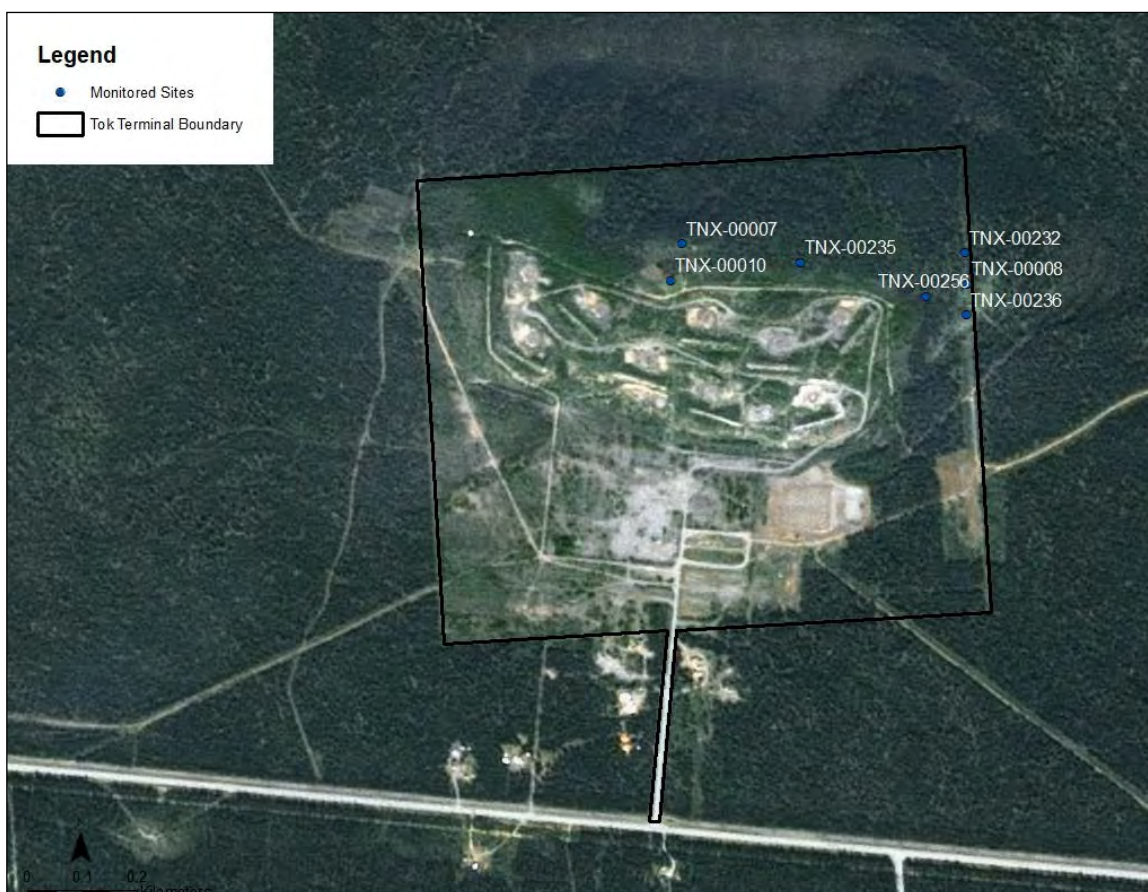
Figure 149. Sites monitored at Tok Fuel Terminal in 2018.

Seven sites were monitored at Tok Fuel Terminal in 2018 (Figure 149, Table 14). Several of these sites (n=5) show erosion or other impacts from recreation. The most common source of surface erosion of the sites is from dirt roads which lead from the base of the hill to the top. Current site photos are provided in Appendix 2. No current site protection measures are in place.

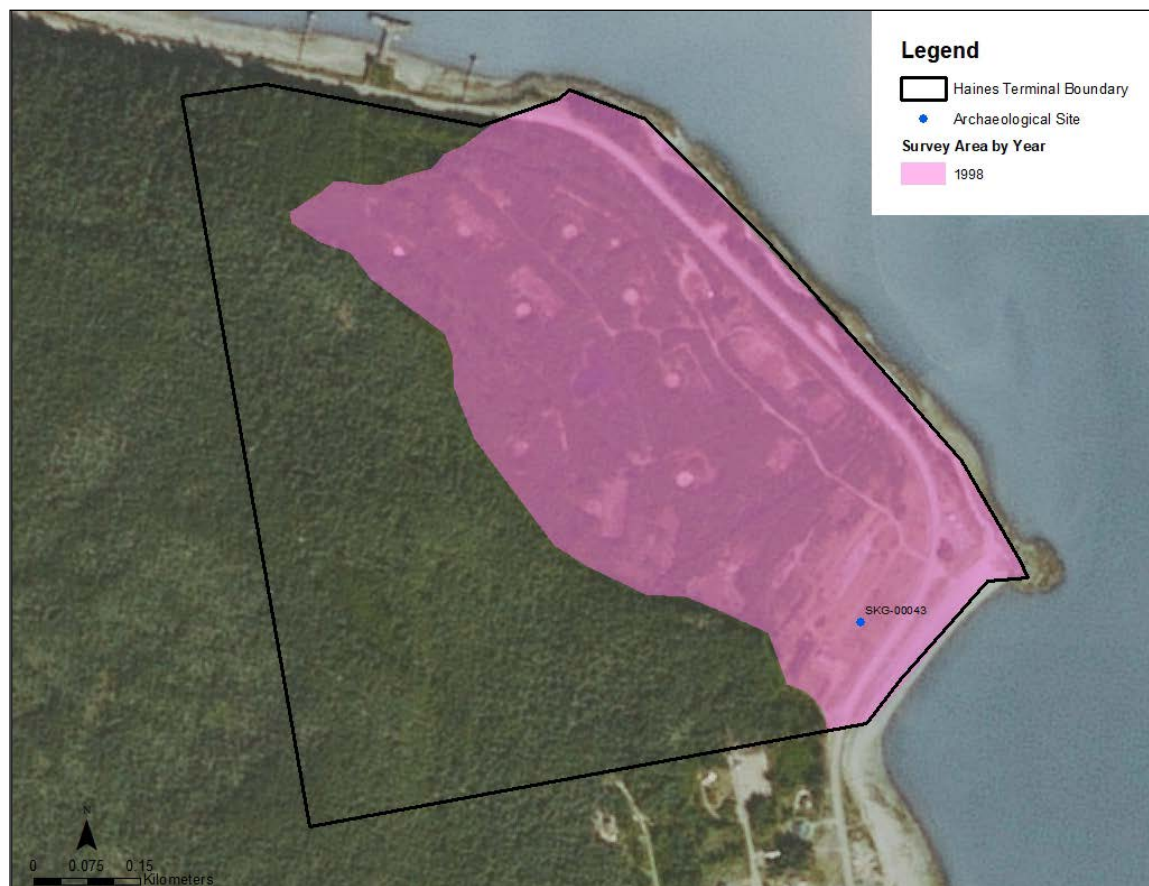
Figure 151. Archaeological sites and surveys in Haines Fuel Terminal, all years.

Haines Fuel Terminal is a 208 acre property managed by USAG Alaska in Haines, Alaska. One prehistoric site, SKG-00043, was found not eligible for the NRHP on 12 January, 2001 (Figure 151). Ninety-four of the 208 acres (45.2%) were surveyed by Northern Land Use Research, Inc. (NLUR) in 1998.
