FINAL
Five-Year Review Report for

**Final
First Five Year Review Report
for the
Munitions Response Site FTAPH-003-R-01
Training Areas 20 and 21**

**Fort A.P. Hill
Fort A.P. Hill, Virginia**

August 2020

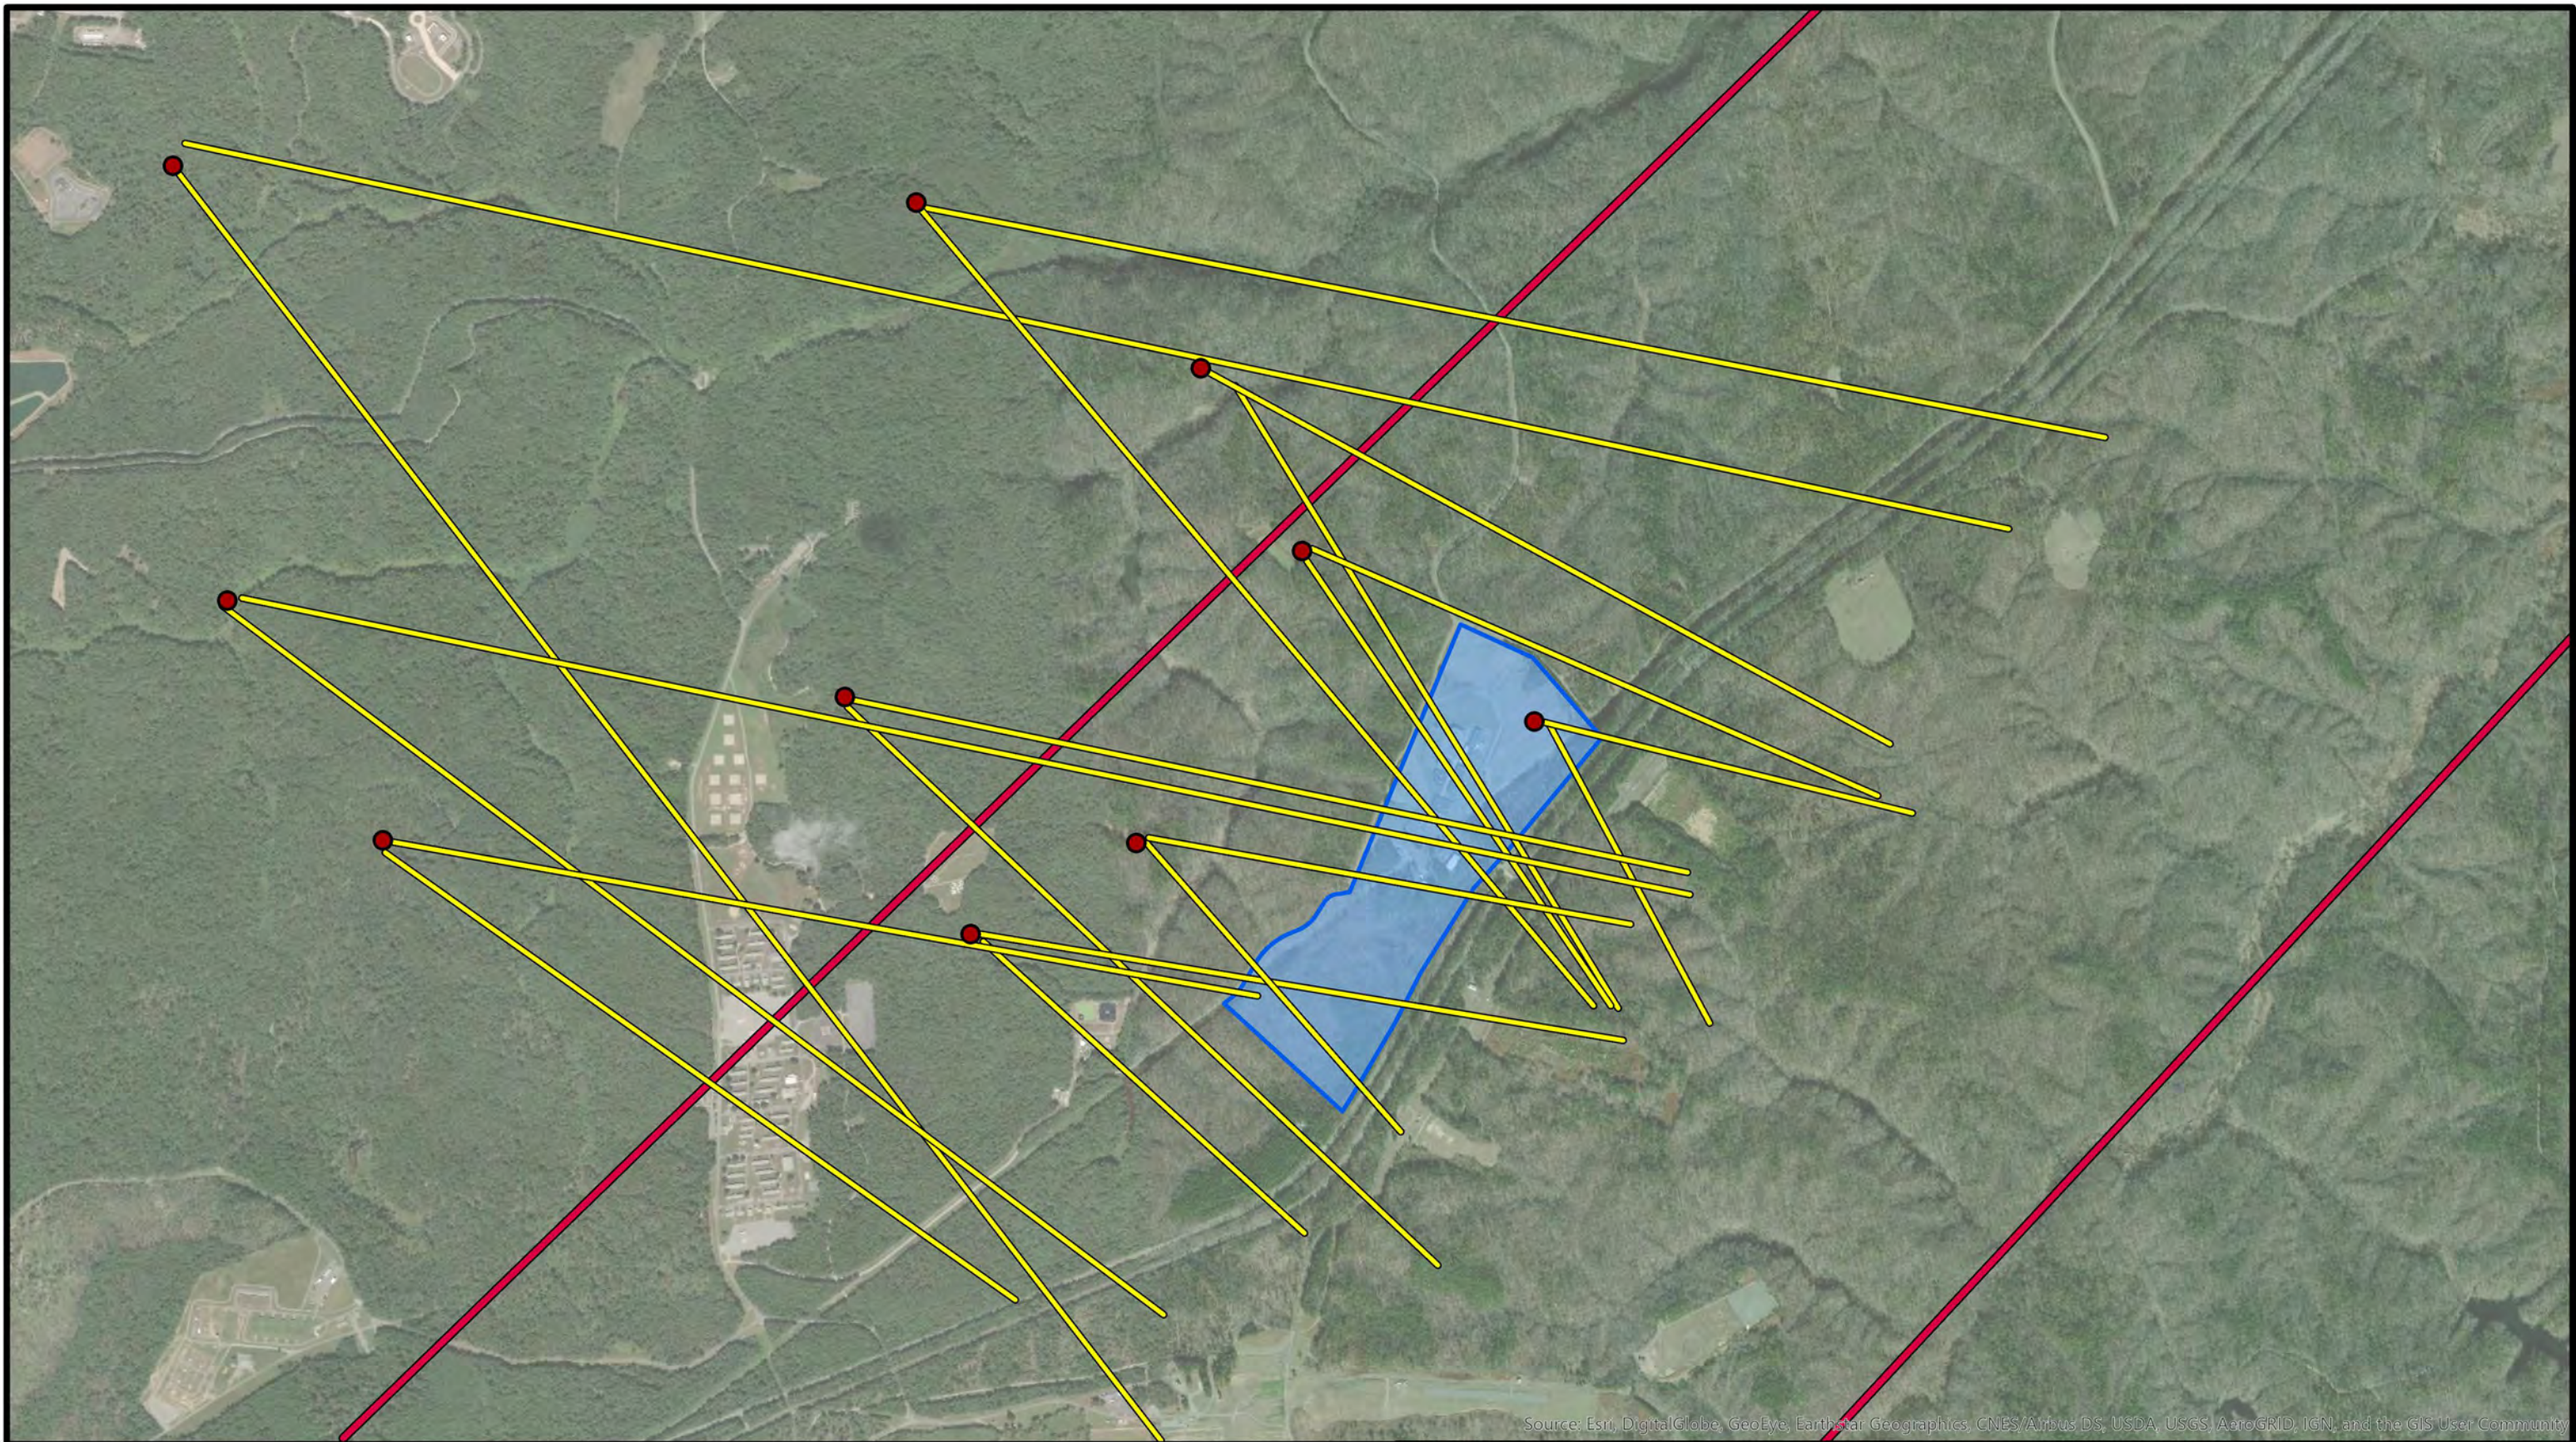
- FiringPoints
- Approximate Range Fan Boundary
- Approximate Bombing Range Boundary
- MRS Boundary

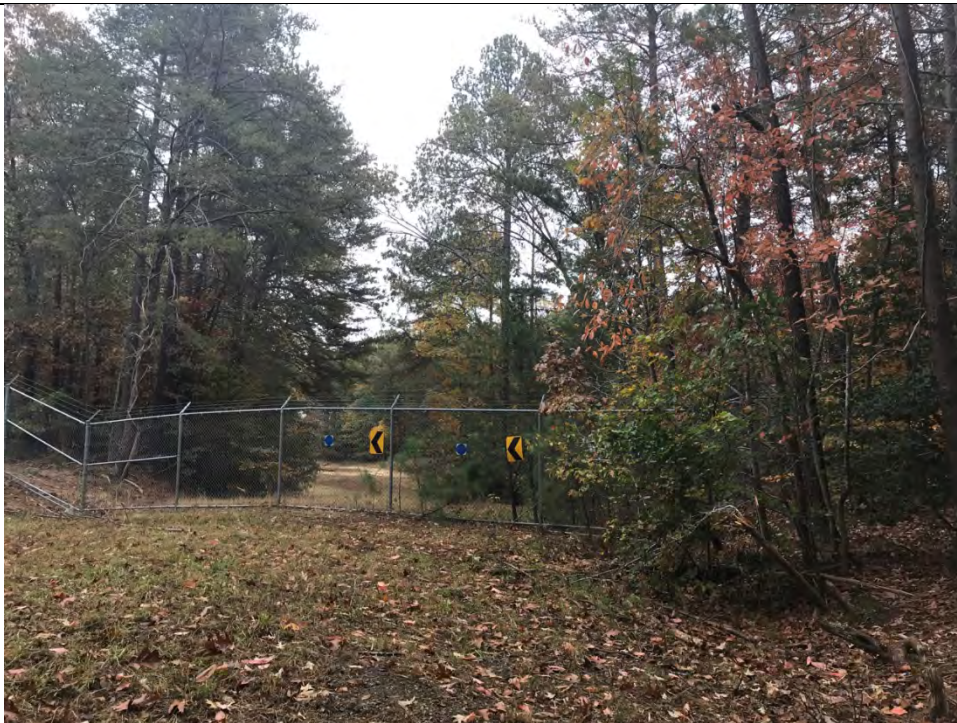
Photo No. 1
(29-October-
2019)

Description:
View of the
southwest
corner of the
boundary
fence.

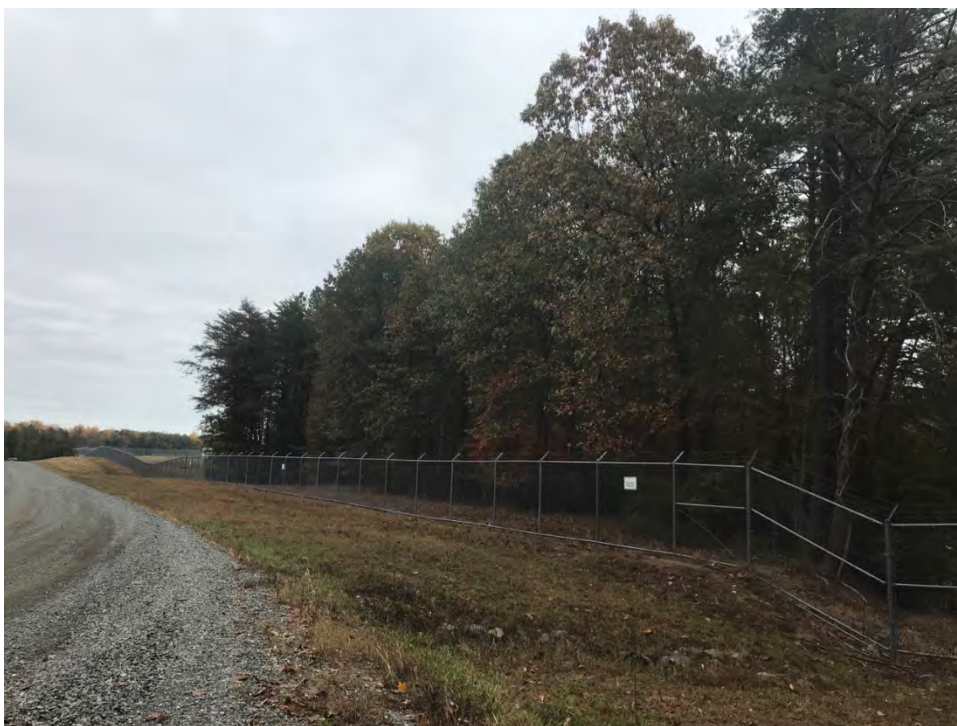
Photo No. 2
(29-October-
2019)

Description:
Boundary
fencing along
the west side
of the MRS
showing
spacing of “No
Trespassing”
signage.

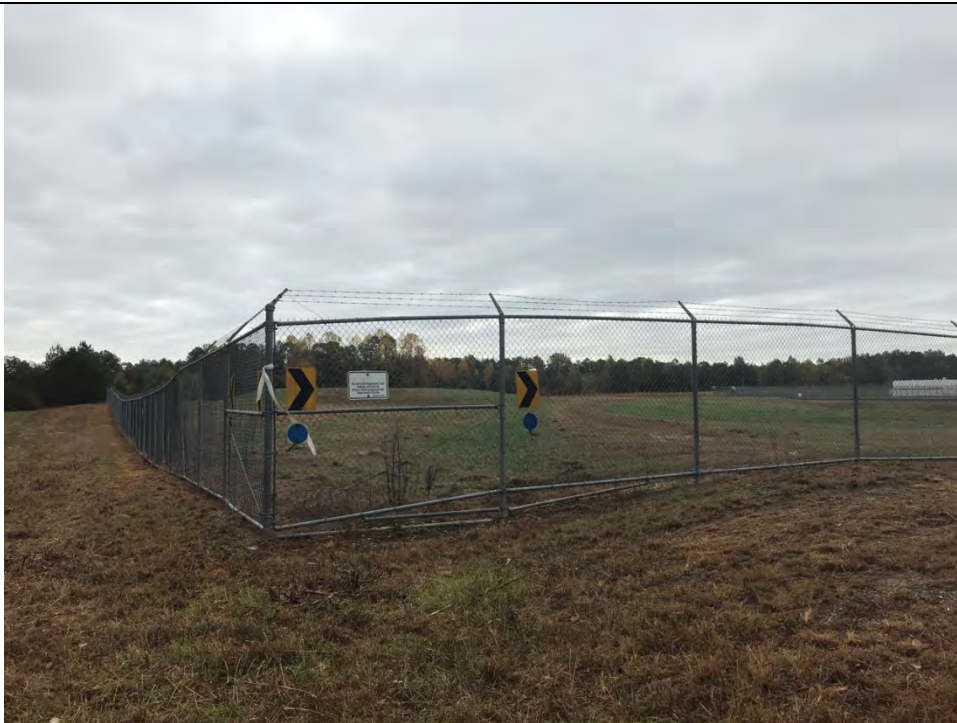
Photo No. 3
(29-October-
2019)

Description:
Northwest
corner of the
boundary
fence with
signage.

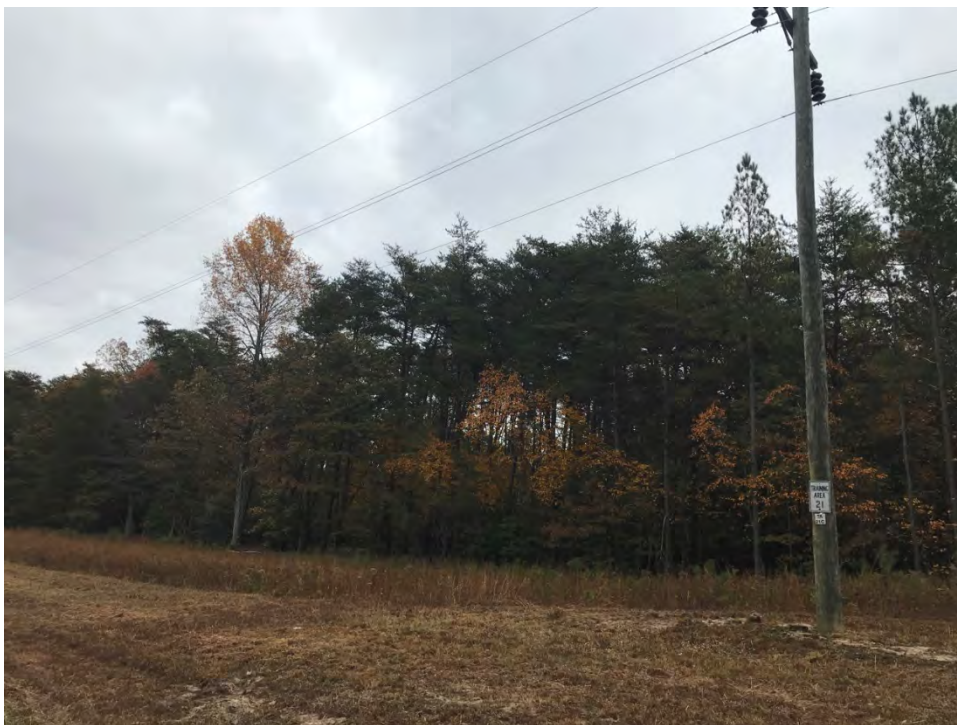
Photo No. 4
(29-October-
2019)

Description:
View showing
signage
indicating
boundary of
training area
21. Southern
portion of site
is wooded.

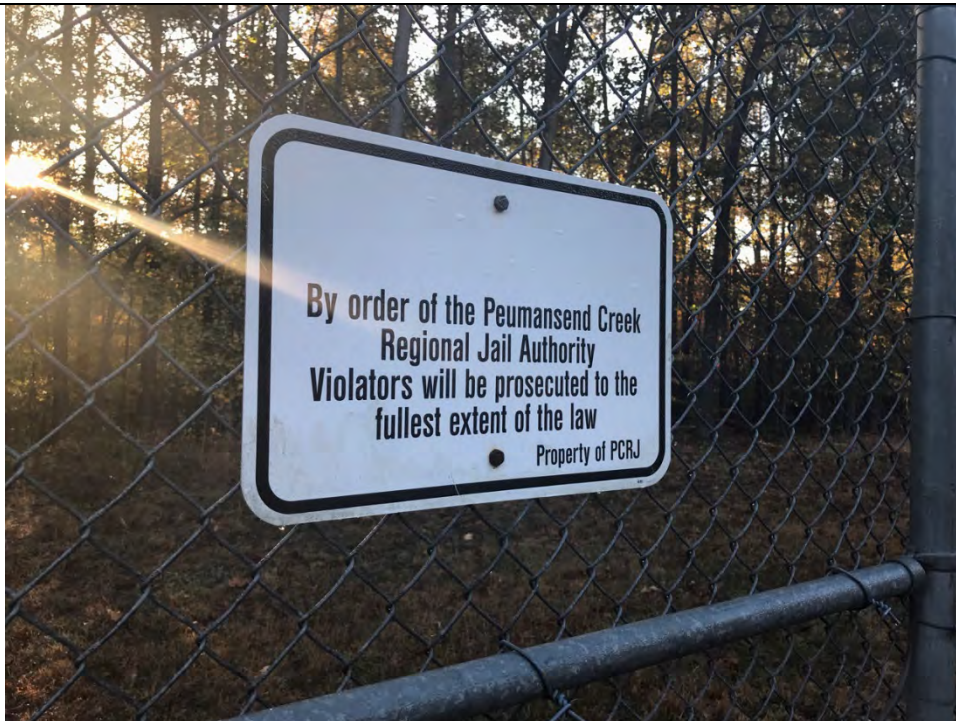
Photo No. 5
(29-October-2019)

- Fencing was in good condition but Caroline Detention Facility staff noted that in some areas trees on Fort A.P. Hill property are growing very close to or into the fence;
- Signage is present as required, however, some signs on the boundary fencing have been faded by the sun (see photos in Attachment 5);
- Access to the site is restricted by the Caroline Detention Facility and the surrounding Fort A.P. Hill;
- The garden on site at the Caroline Detention Facility is no longer being maintained.

Description:
Example of
“No
Trespassing”
sign where
wording has
faded.

Findings	Recommendations
Wording on the “No Trespassing” signs placed along the boundary fence has faded and some signs are no longer fully legible.	Signs with faded text should be replaced.
Trees growing close to and against the boundary fence on Fort A.P. Hill may compromise the future integrity of the fence.	Fort A.P. Hill Roads and Grounds should address any concerns from the Caroline Detention Facility maintenance staff regarding trees close to or against the fence line.

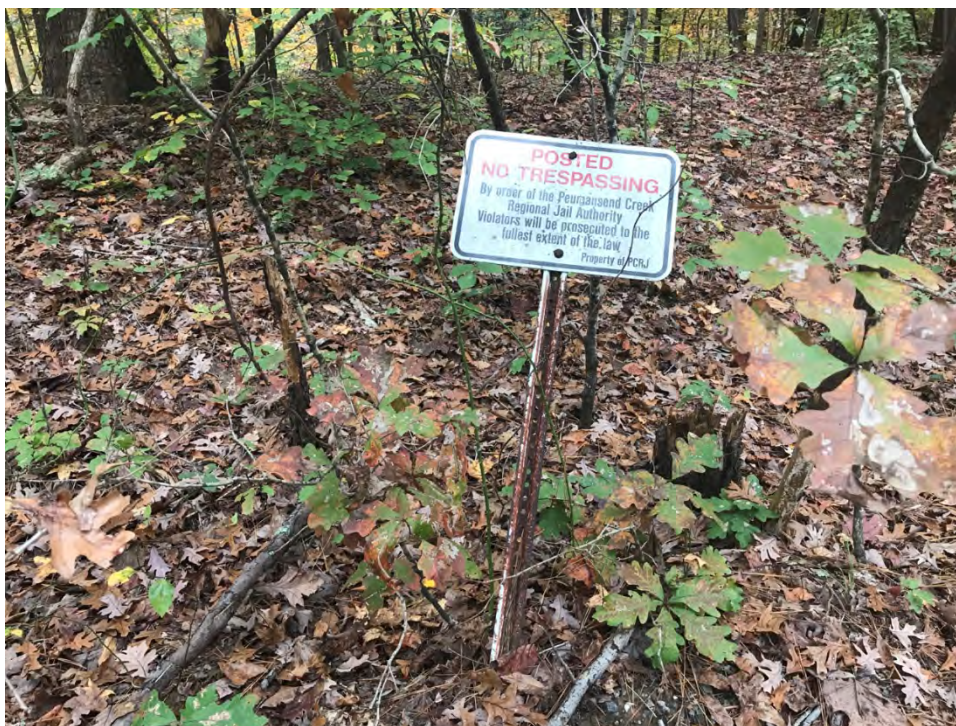
Photo No. 6
(29-October-2019)

Description:
Example of
“No
Trespassing”
sign without
faded words.

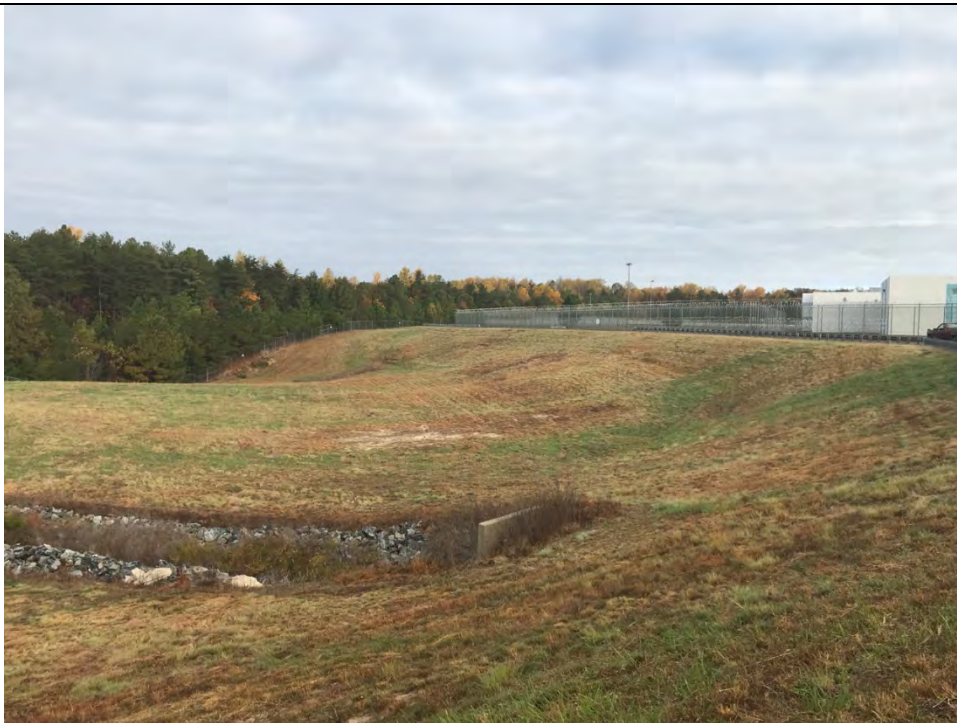
Photo No. 7
(29-October-
2019)

Description:
View from the
parking lot at
the Caroline
Detention
Center
(formerly
PCRJ). View
shows fencing
surrounding
the secure area
and a portion
of the
detention
center
buildings.

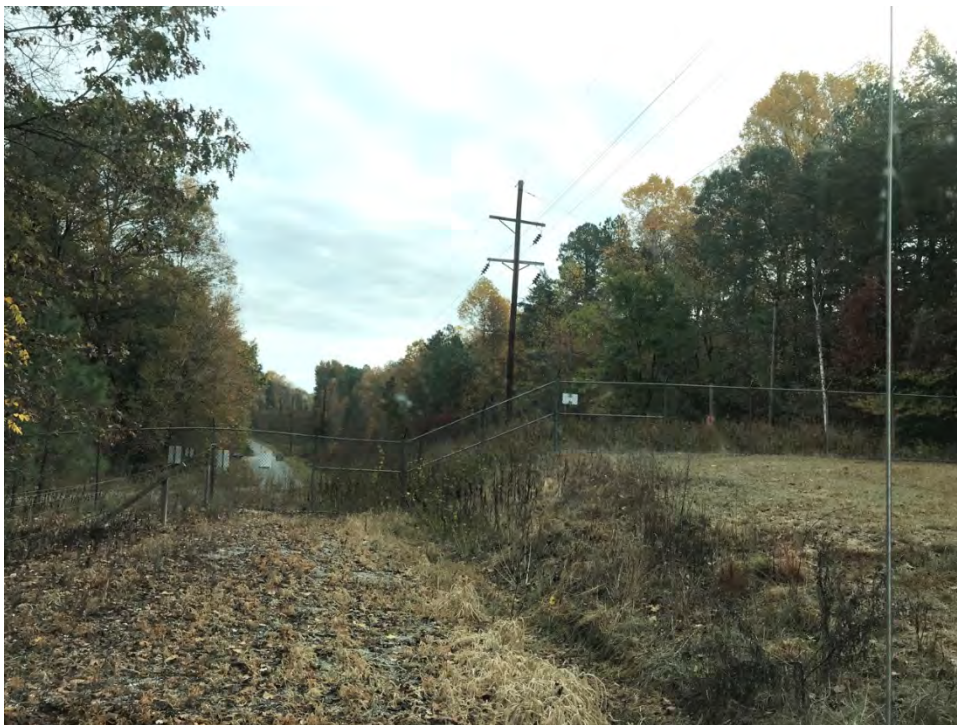
Photo No. 8
(29-October-
2019)

Description:
Boundary
fence along the
north side of
site from the
Caroline
Detention
Center
property
(formerly
PCRJ).
