FINAL PRELIMINARY ASSESSMENT AND SITE INSPECTION OF PER- AND POLYFLUOROALKYL SUBSTANCES

United States Army Garrison- West Point, New York

September 2022

PRELIMINARY ASSESSMENT/SITE INSPECTION OF PFAS AT UNITED STATES ARMY GARRISON-
WEST POINT, NEW YORK

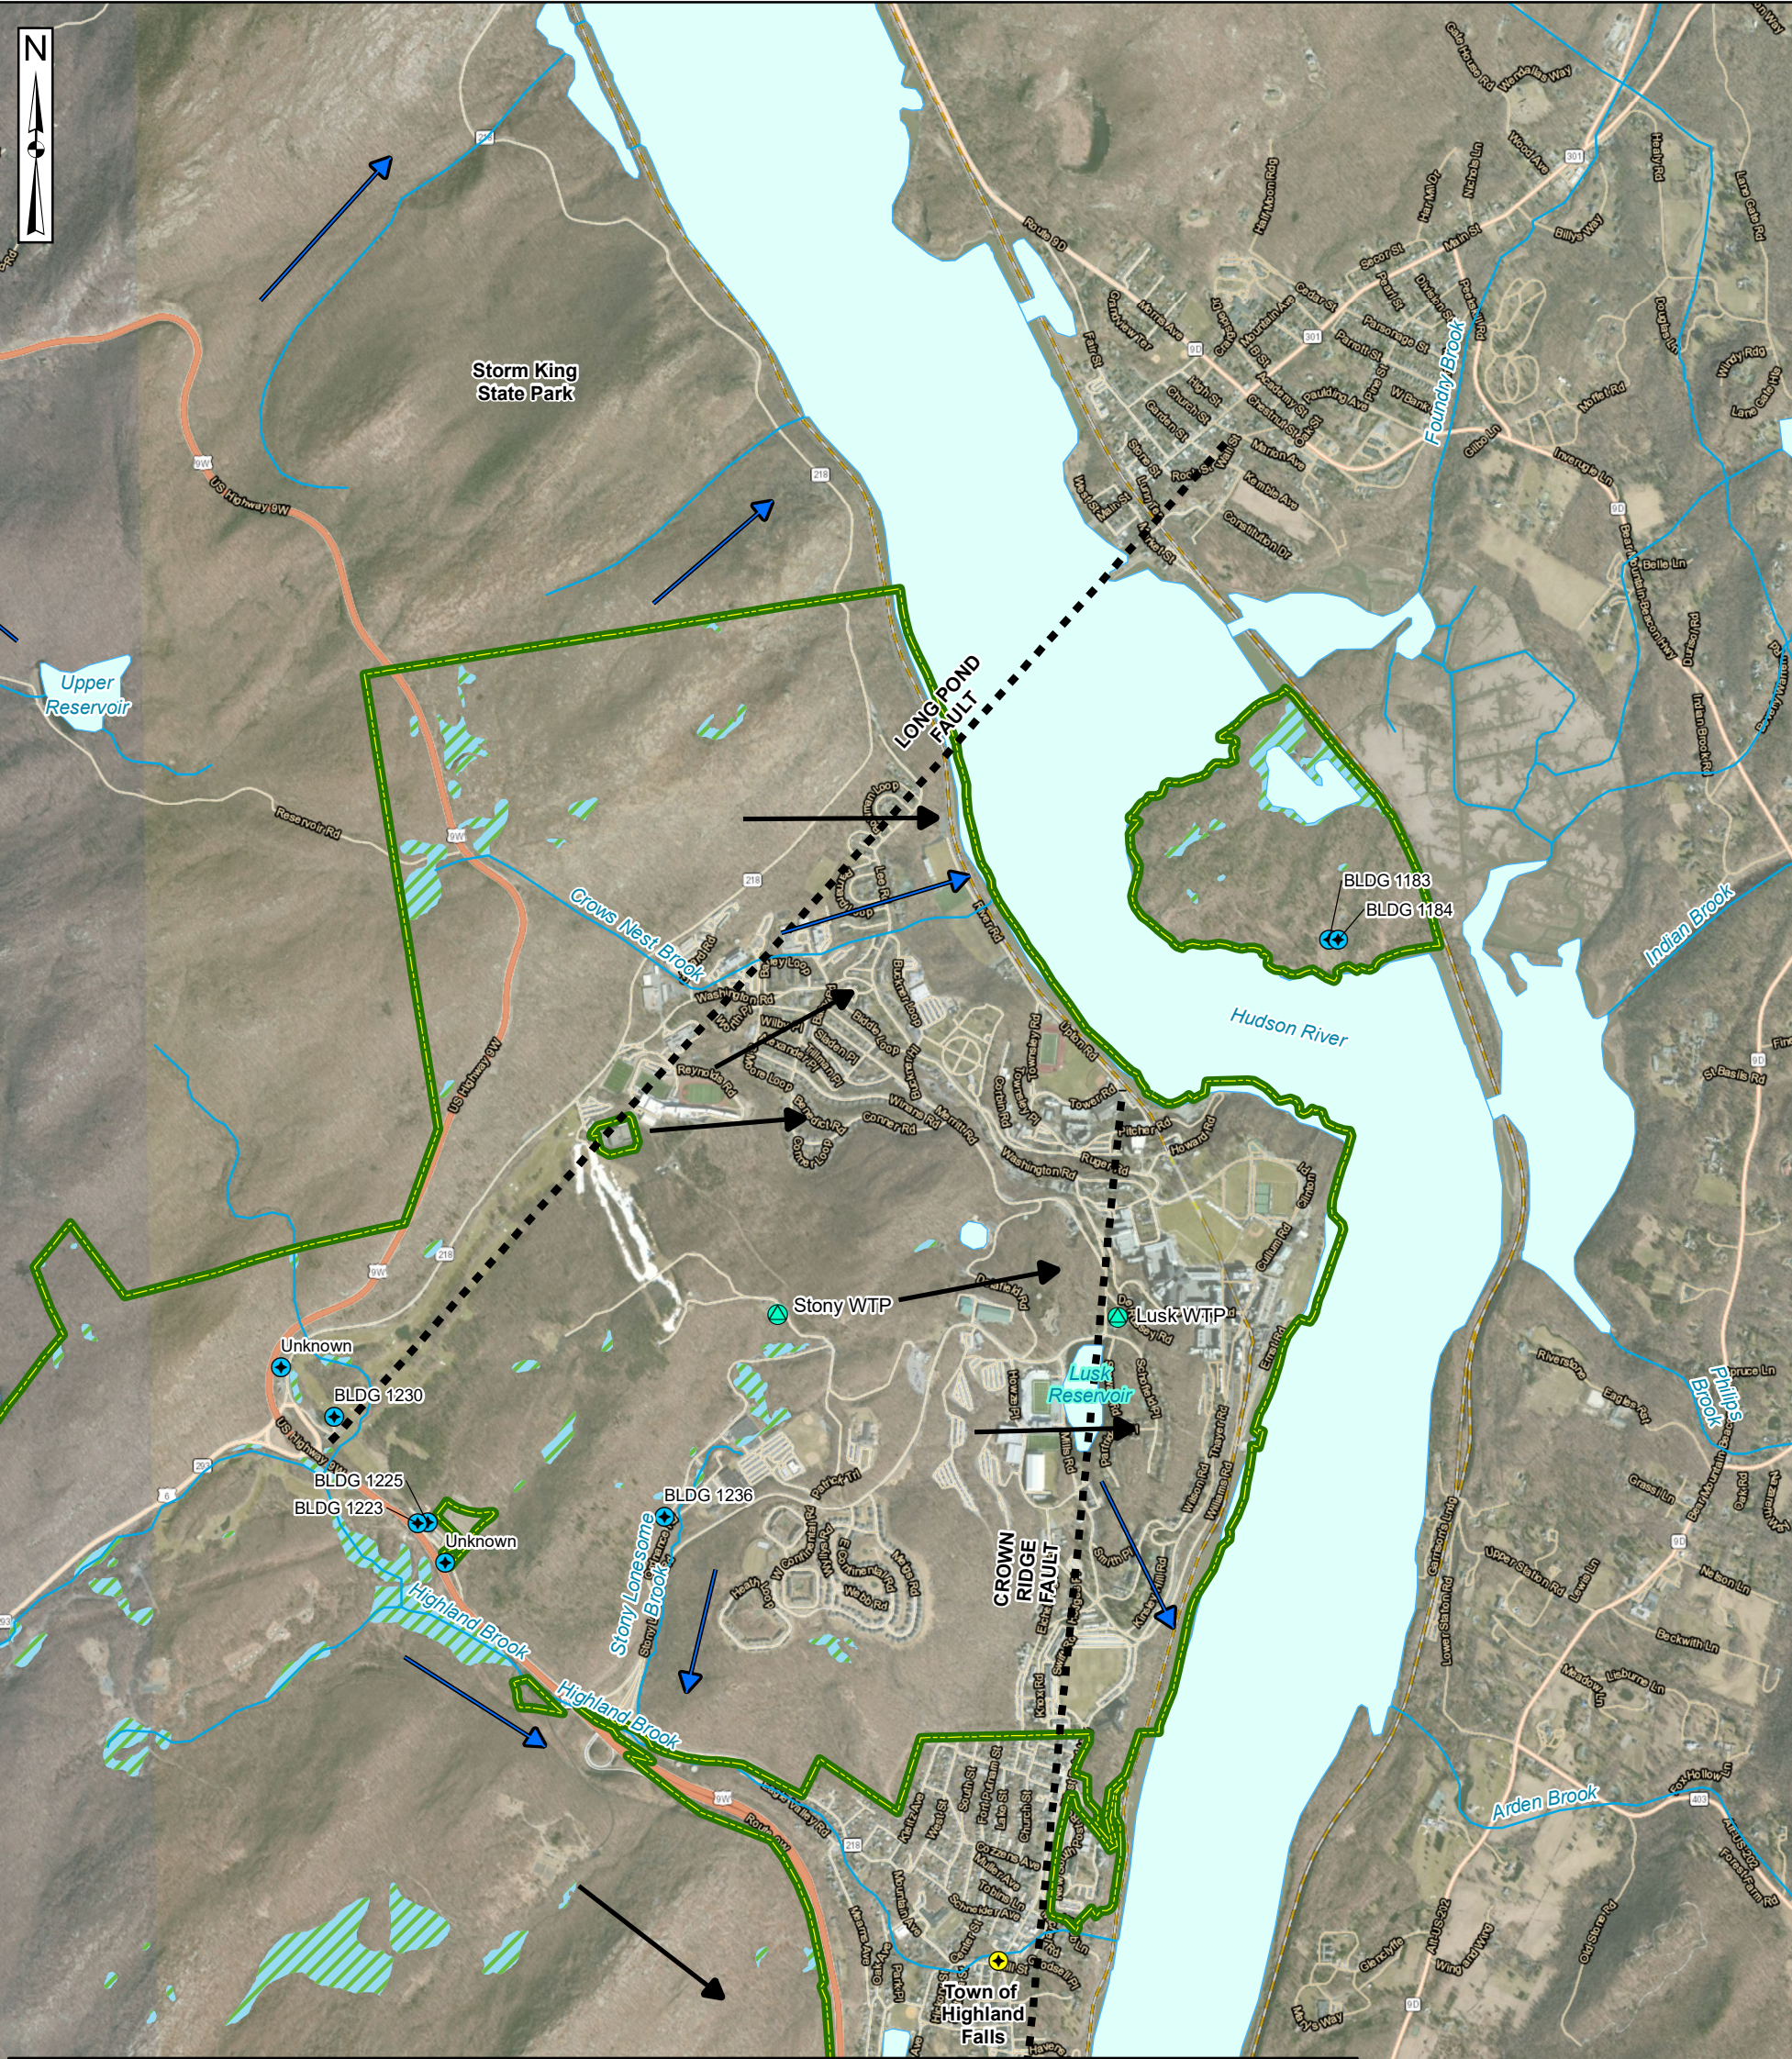
Figure 2-2b
USAG West Point Installation Layout
Main Cantonment Area

Two major normal faults traverse USAG West Point (**Figure 2-2b**). A northeast trending fault, Long Pond Fault, extends from Route 218, passing across the Hudson River and terminating in the town of Cold Spring. A north-northeast fault, Crown Ridge Fault, extends through the long axis of the Lusk Reservoir from Highland Falls and appears to terminate at the Hudson River west of the North Dock (Law Engineering and Environmental Services 1994).

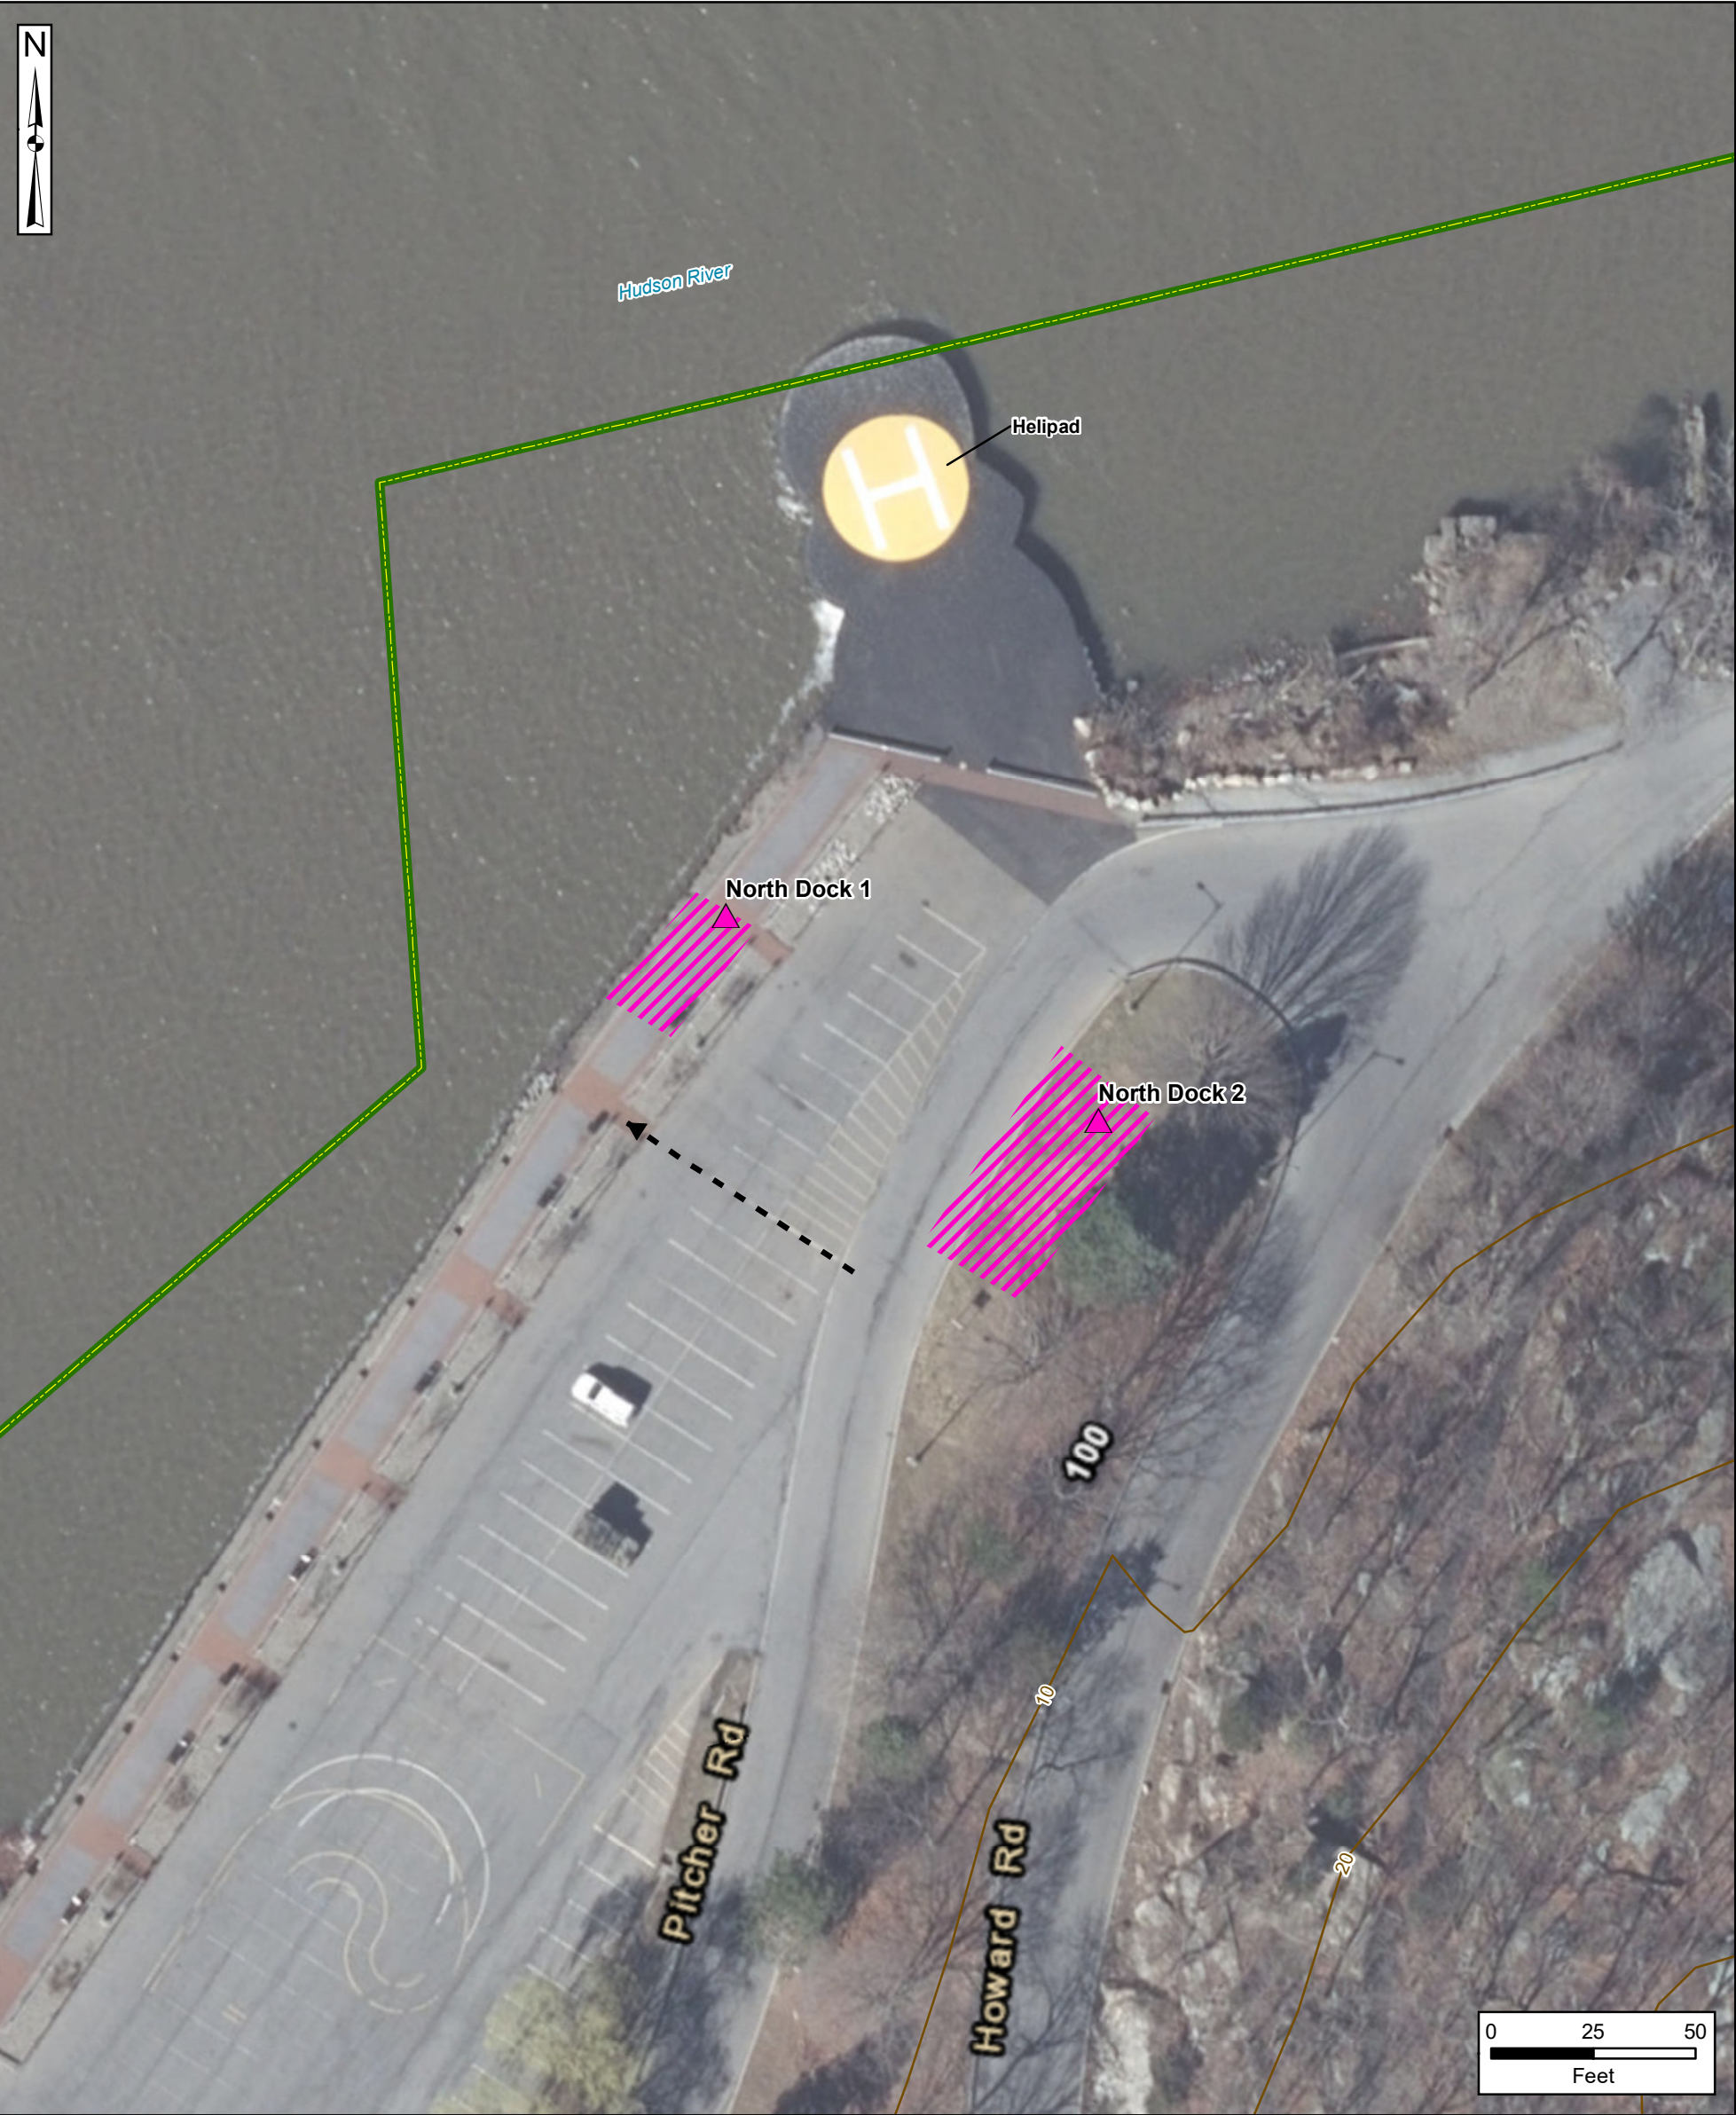
Figure 5-11
Aerial Photo of
North Dock 1 and North Dock 2 AOPIs

The North Dock 1 AOPI is located within Main Post and is located immediately adjacent to the Hudson River proximal to the helipad (industrial/commercial use). The AOPI consists of a paved and gravel area and is surrounded by the Hudson River to the north and west, and a paved parking lot to the east and south (**Figure 5-11**).

The North Dock 2 AOPI is located within Main Post and is located adjacent to North Dock 1 (industrial/commercial use). The AOPI consists of a grassy hill area and is surrounded by paved roadways and/or parking lots to the north, east, and west, as well as additional grassy areas to the south (**Figure 5-11**).

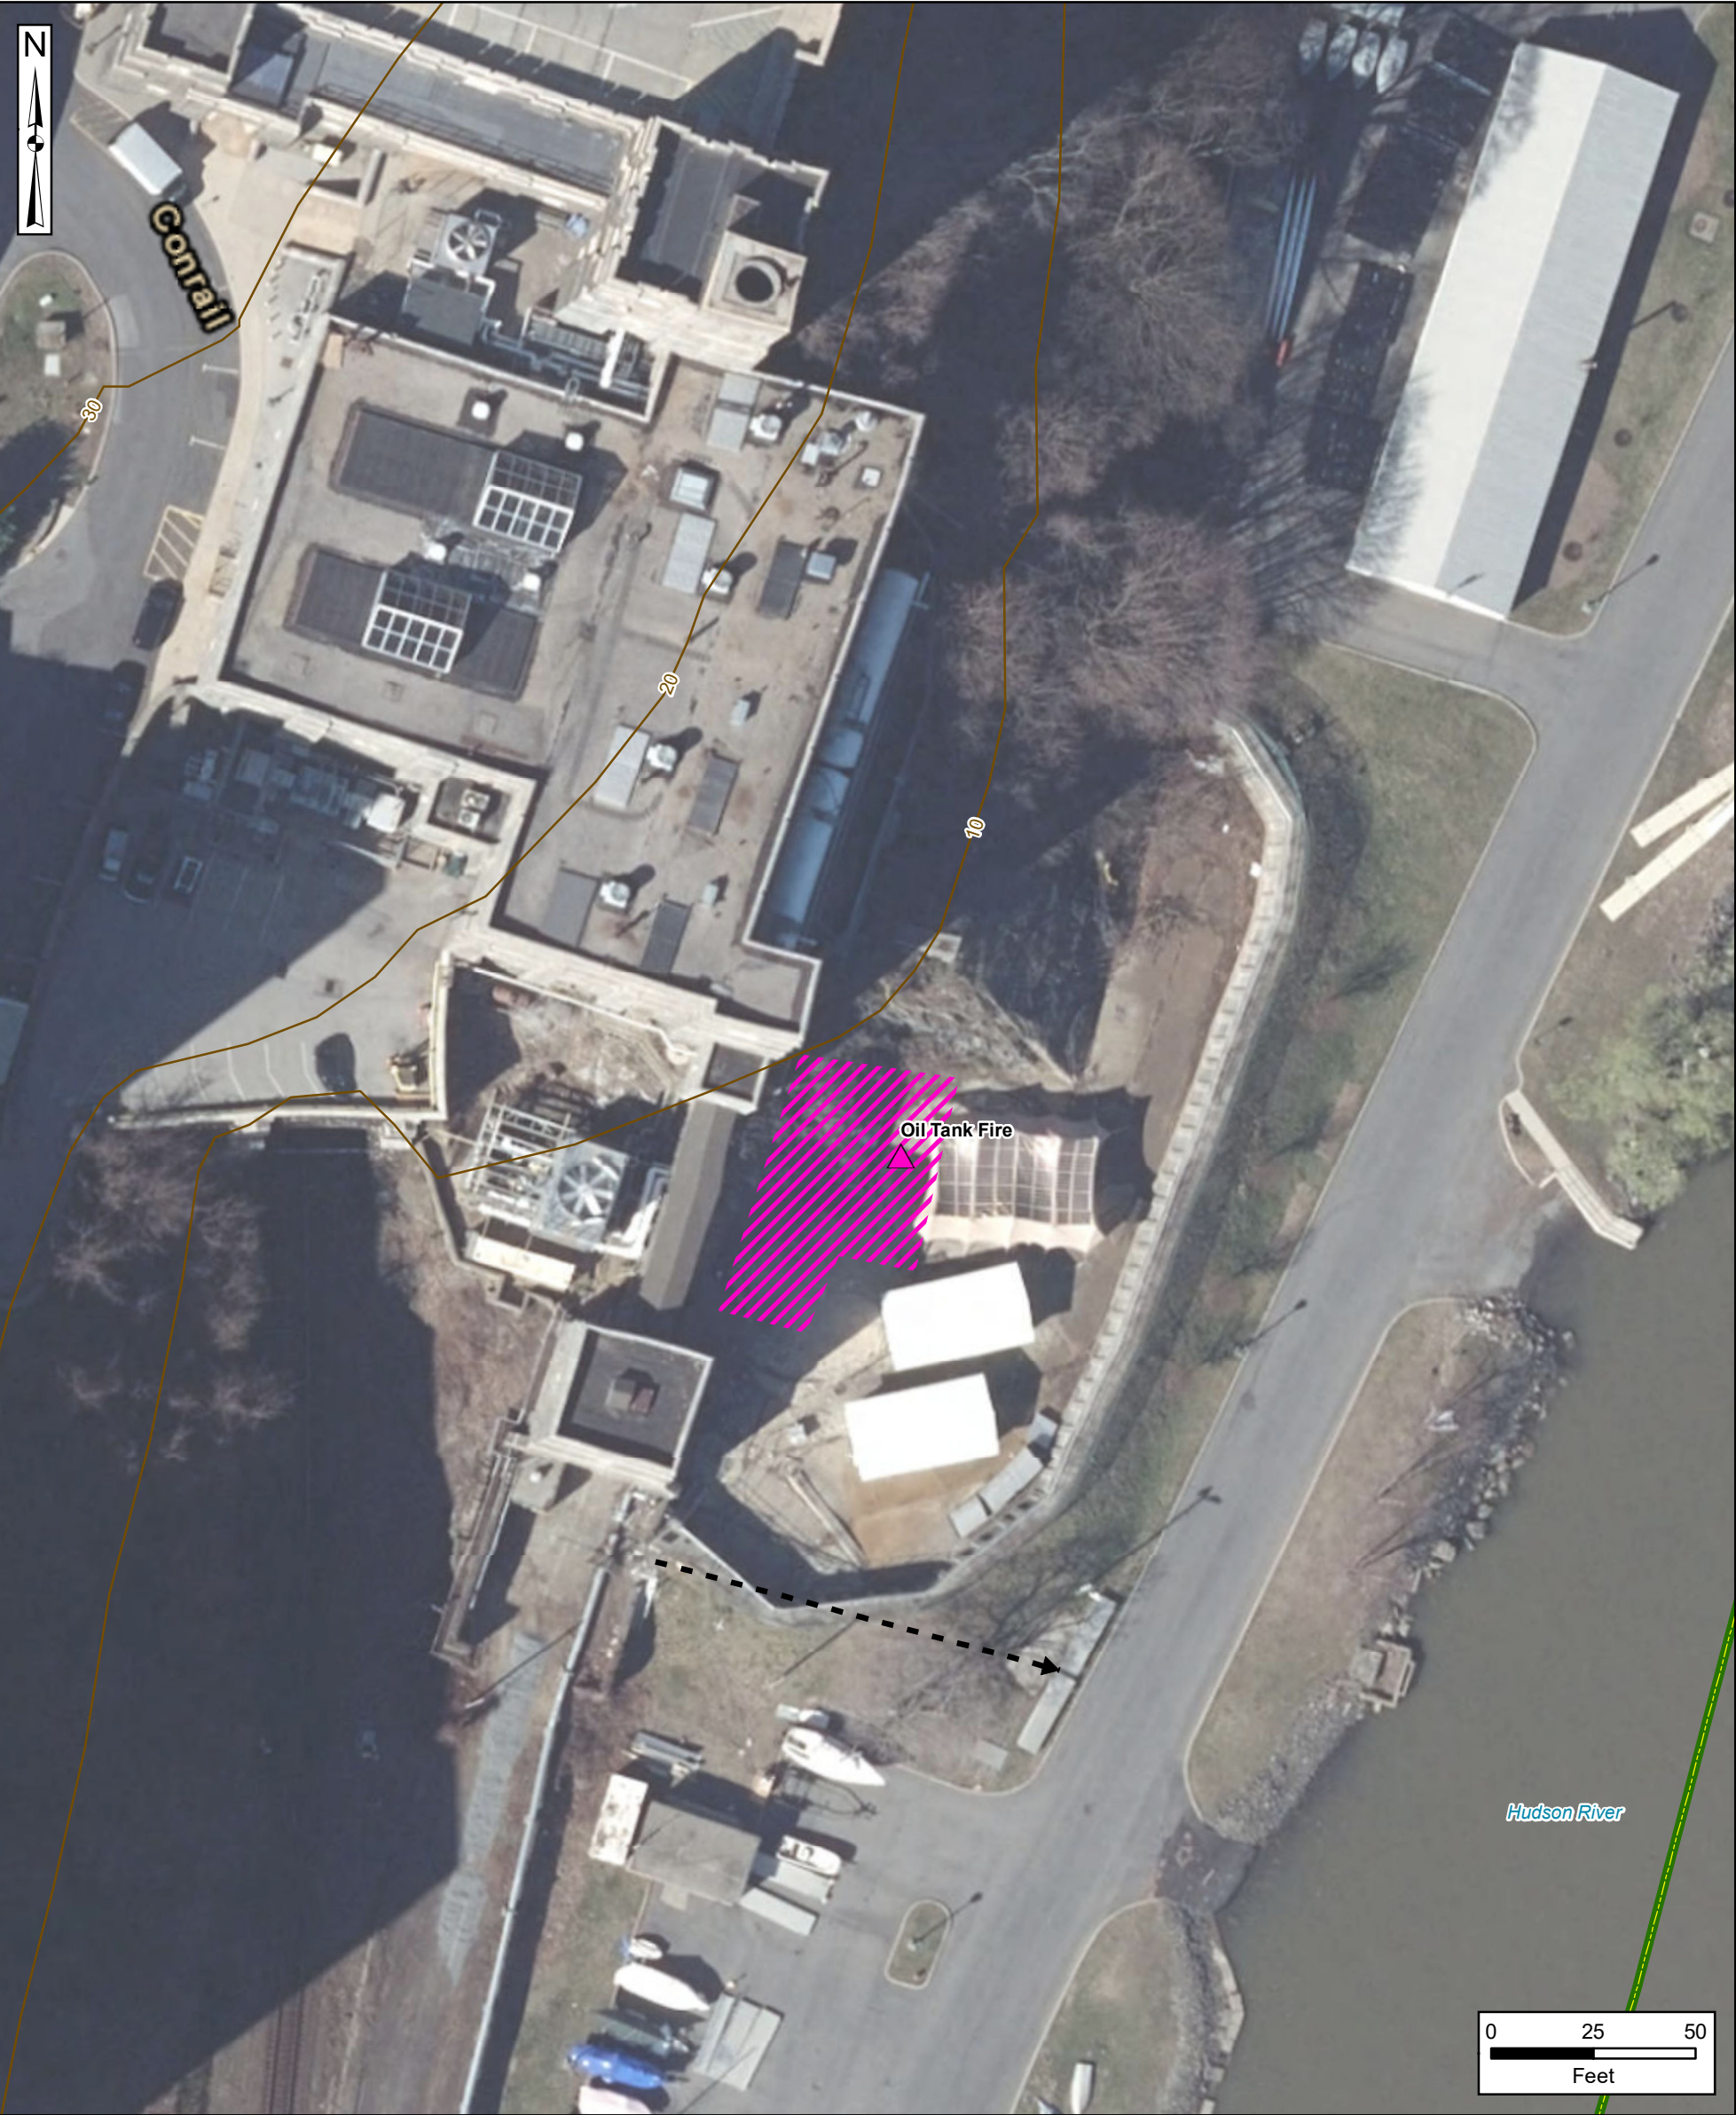
Figure 5-12
Aerial Photo of
Oil Tank Fire AOPI

ends of the area. The AOPI is surrounded by buildings to the west and north, a roadway and the Hudson River to the east, and a parking area to the south (**Figure 5-12**).

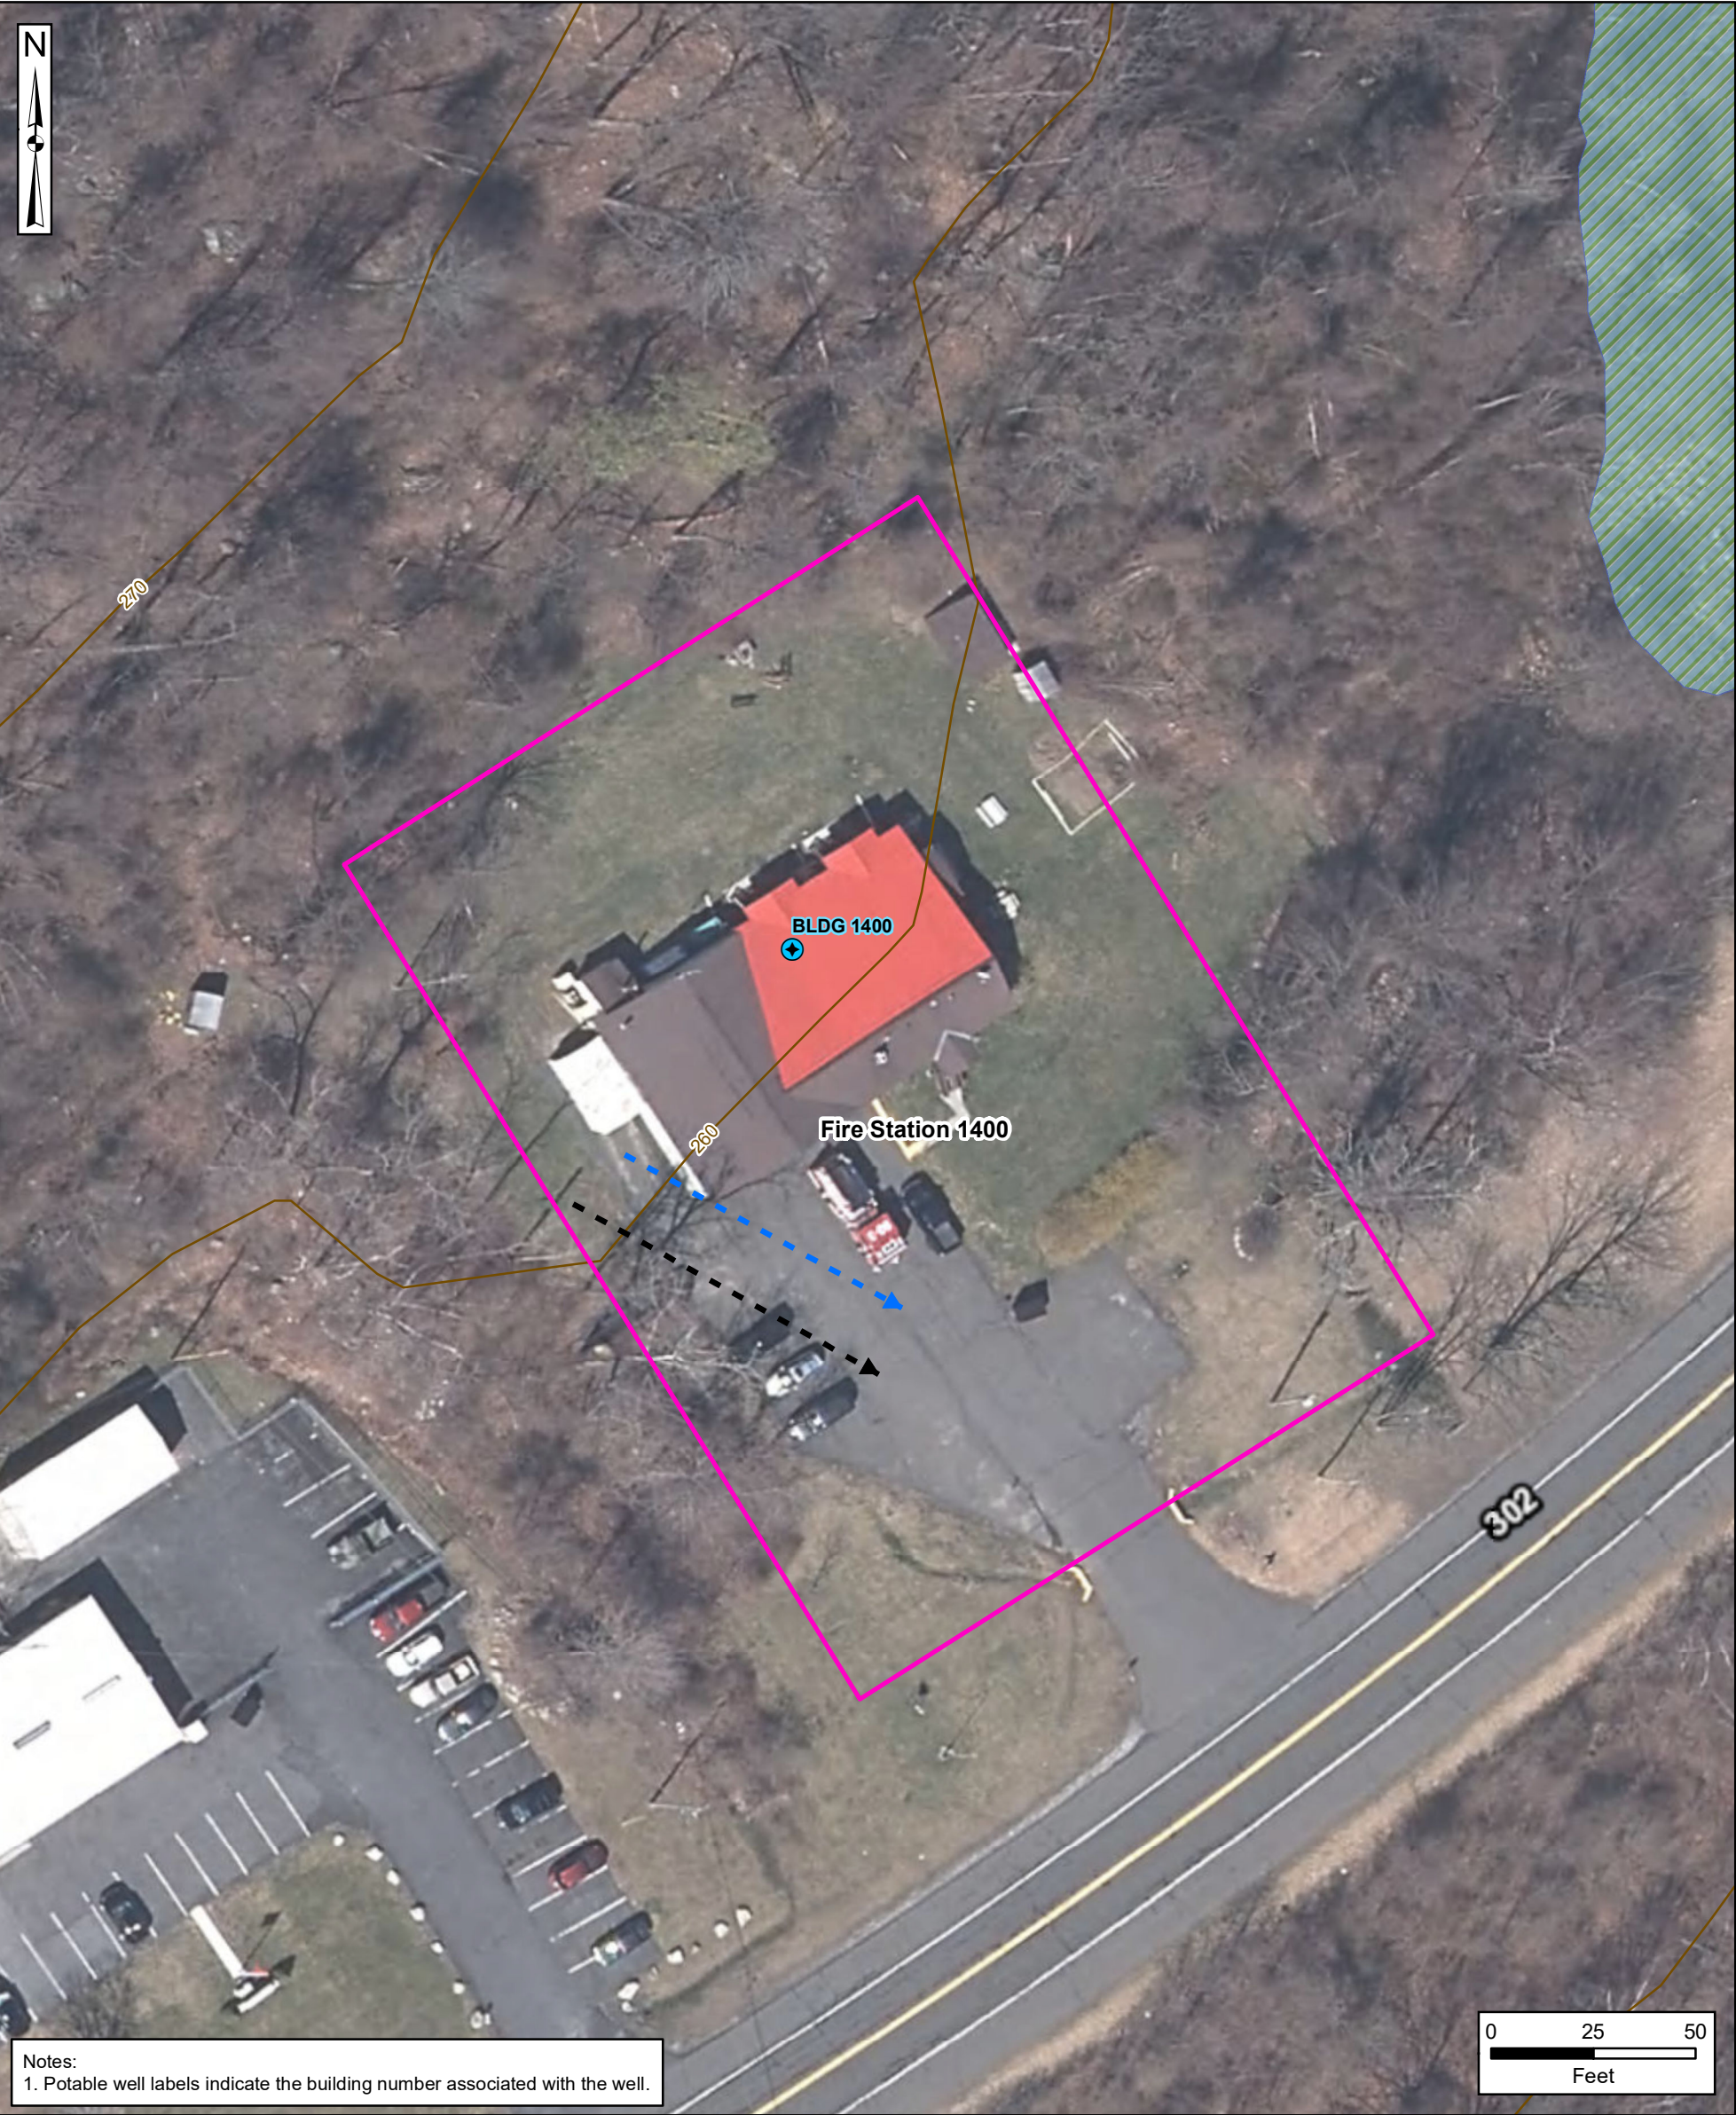
Figure 5-13
Aerial Photo of
Fire Station 1400 AOPI

The Fire Station 1400 AOPI is located within the WPMR. The AOPI consists of an active fire station (industrial use). There is a paved driveway in front of Fire Station 1400 where fire trucks are stored and where vehicles are parked. The AOPI is surrounded by grassy and wooded areas to the north and east, as well as grassy areas, roadways and/or parking lots to the south and west (**Figure 5-13**).

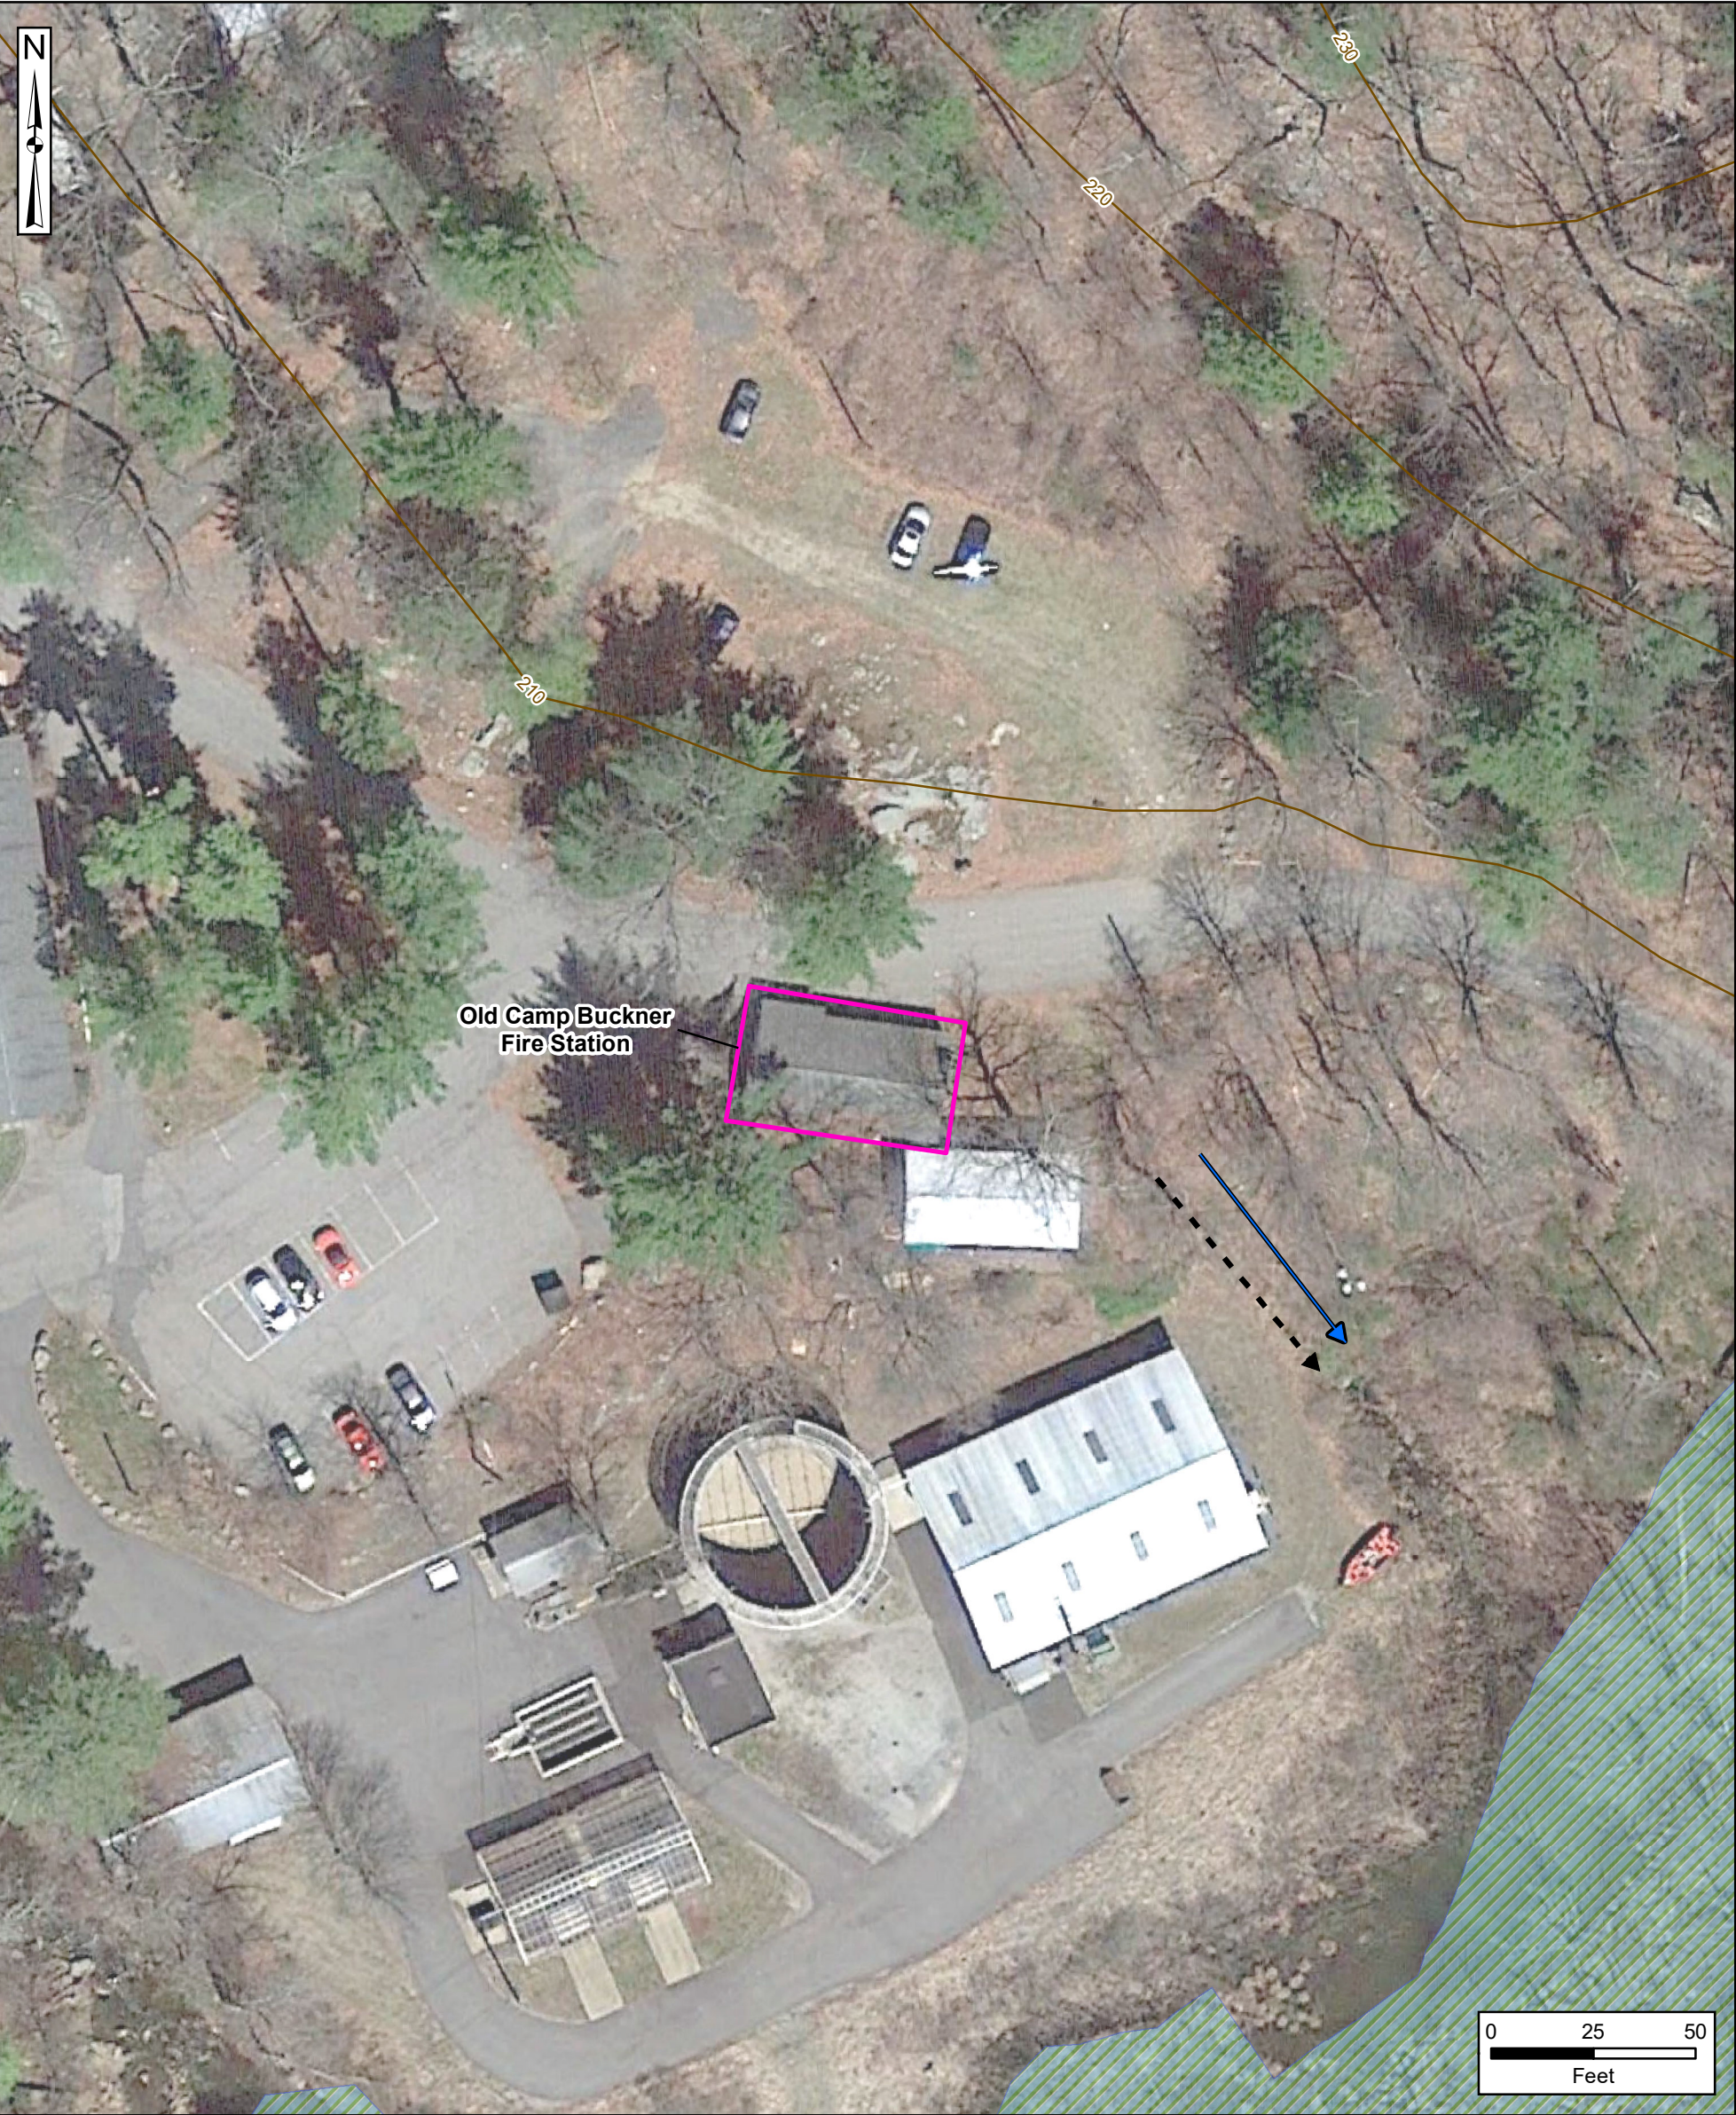
Figure 5-14
Aerial Photo of
Old Camp Buckner Fire Station AOPI

The Old Camp Buckner Fire Station AOPI is located within the WPMR. The AOPI consists of historical fire station (industrial use) and the surrounding pavement where trucks may have been parked. The AOPI is surrounded by a roadway to the north, a grassy and parking area to the west, a grassy area and building to the south, and wooded area to the east (**Figure 5-14**). The Camp Buckner WWTP is located further south of the AOPI.

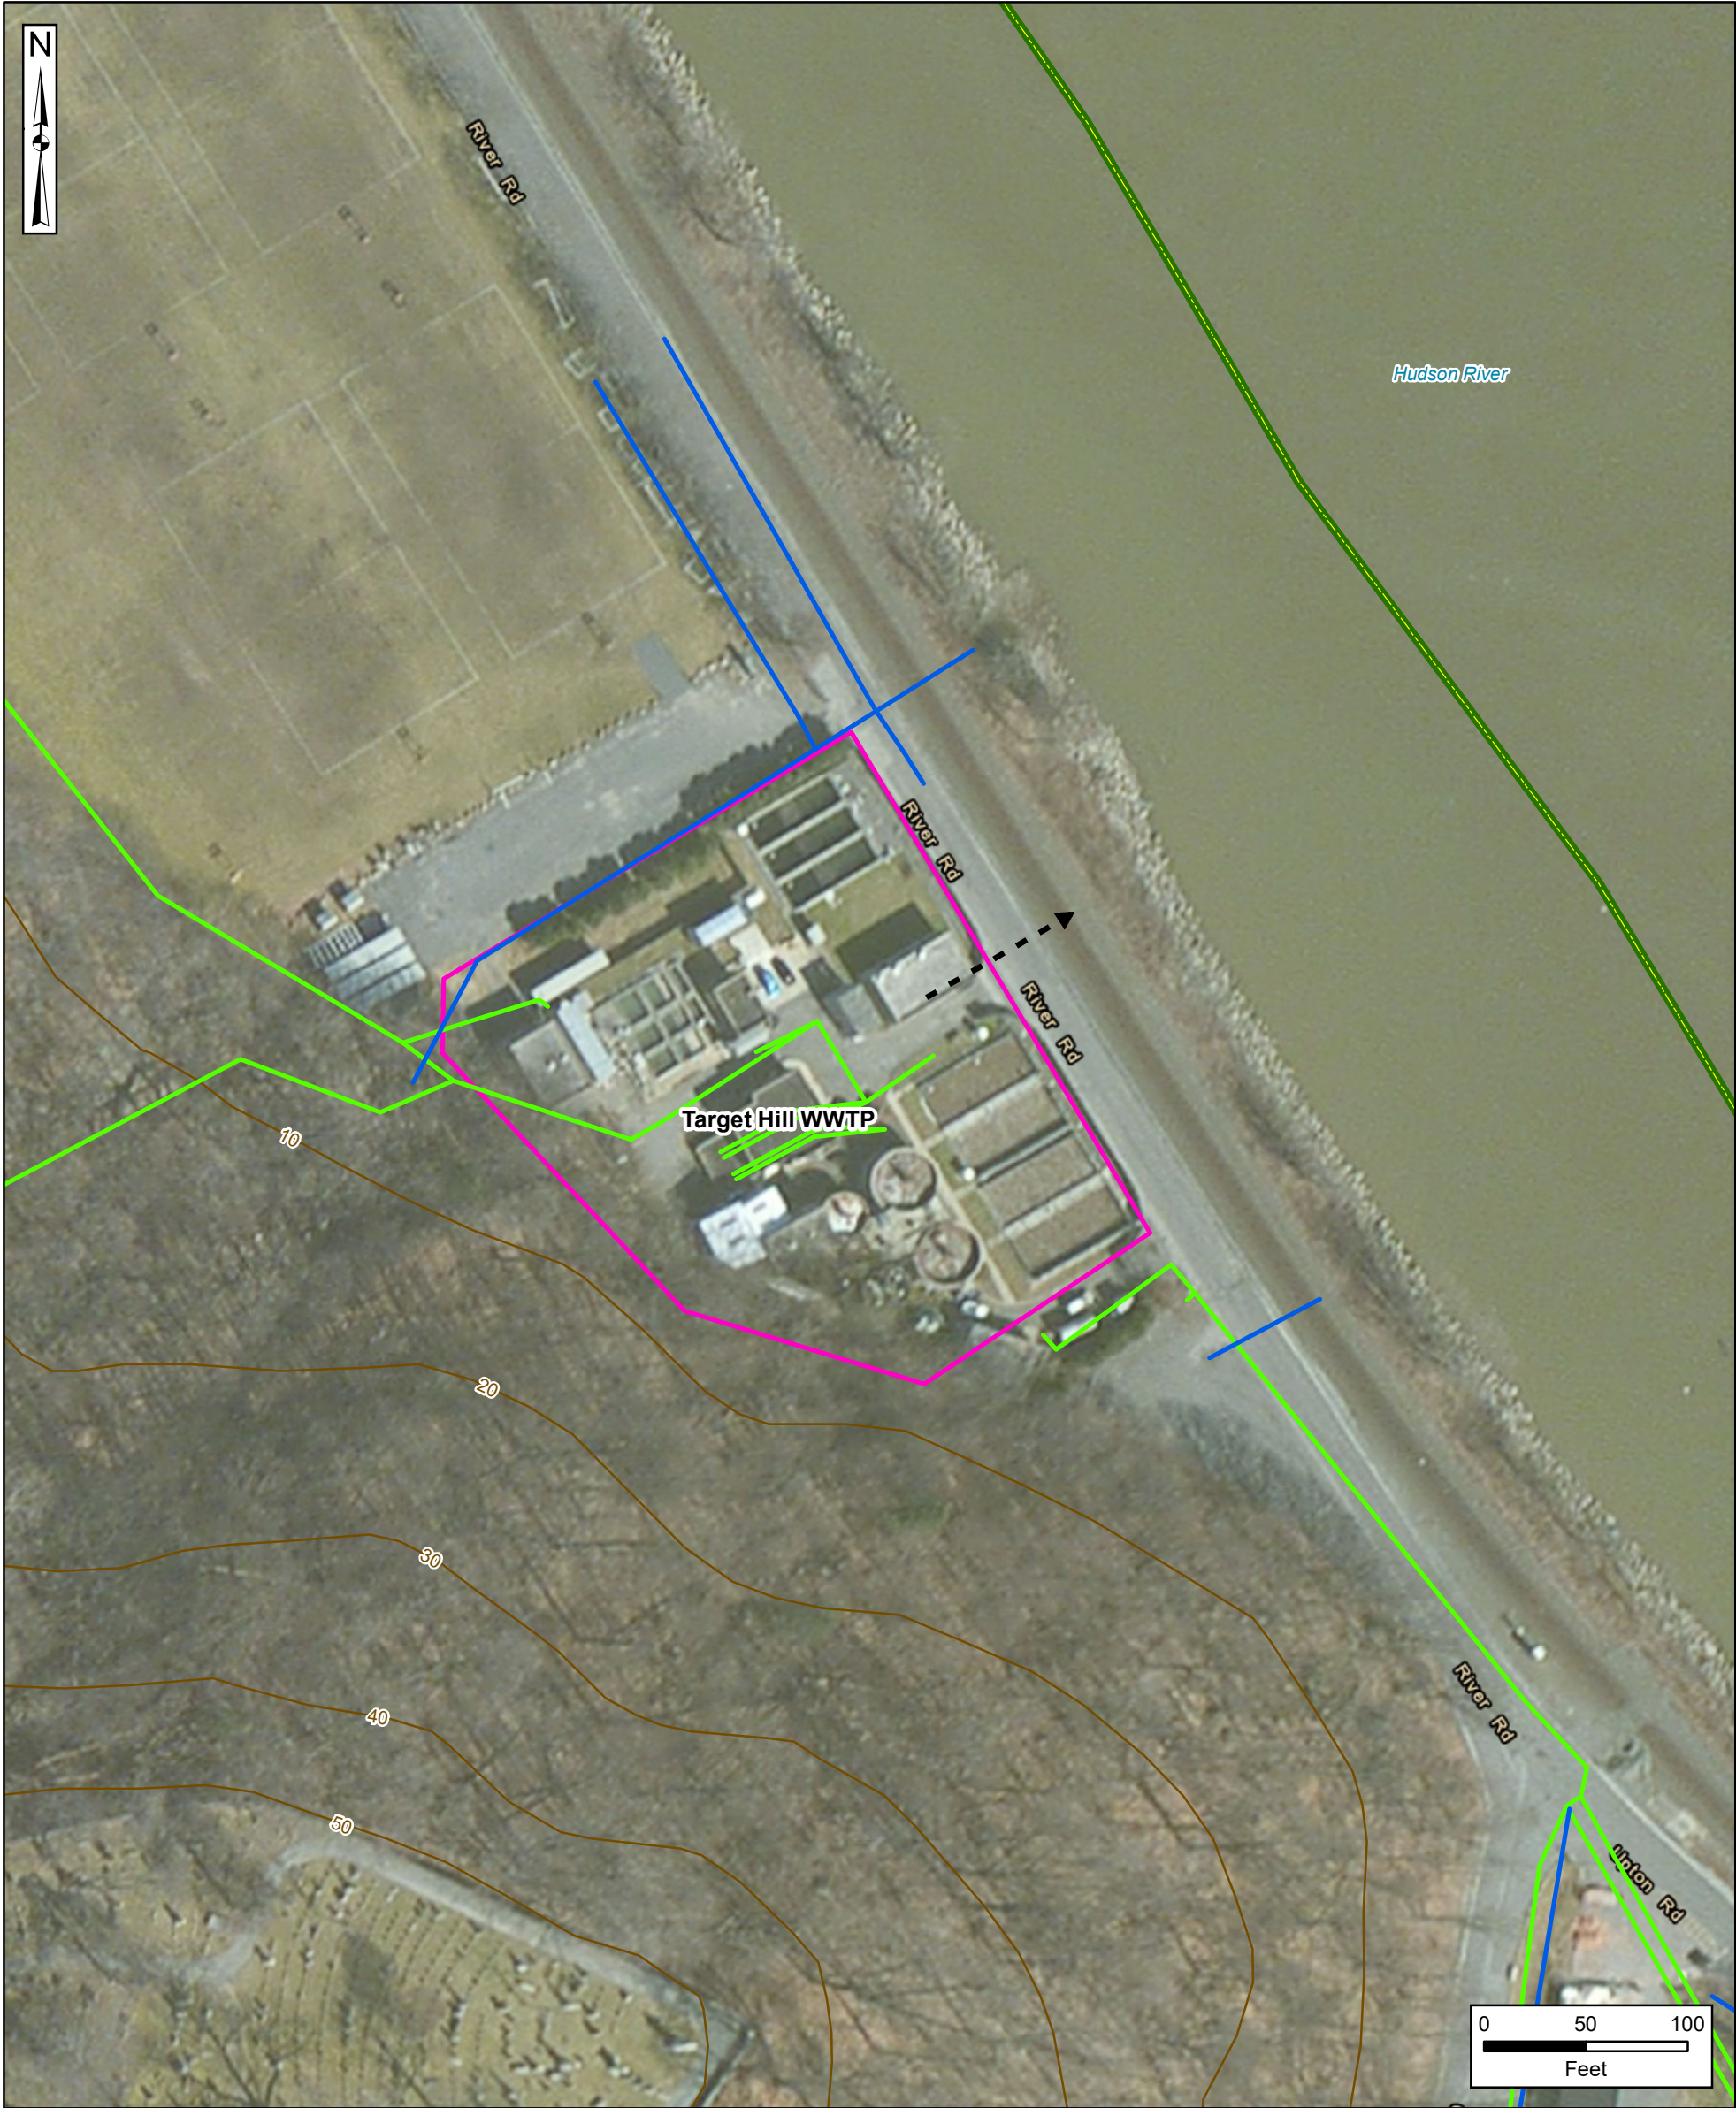
Figure 5-15
Aerial Photo of
Target Hill WWTP AOPI

The Target Hill WWTP is located within Main Post and consists of an active WWTP (industrial use). The AOPI is surrounded by athletic fields to the north and south, the Hudson River to the east, and wooded vegetation to the west (**Figure 5-15**). Both surface water and groundwater flows at the AOPI are to the east, discharging to the Hudson River.
