FINAL PRELIMINARY ASSESSMENT AND SITE INSPECTION OF PER- AND POLYFLUOROALKYL SUBSTANCES

United States Army Garrison- West Point, New York

September 2022

PRELIMINARY ASSESSMENT/SITE INSPECTION OF PFAS AT UNITED STATES ARMY GARRISON-
WEST POINT, NEW YORK

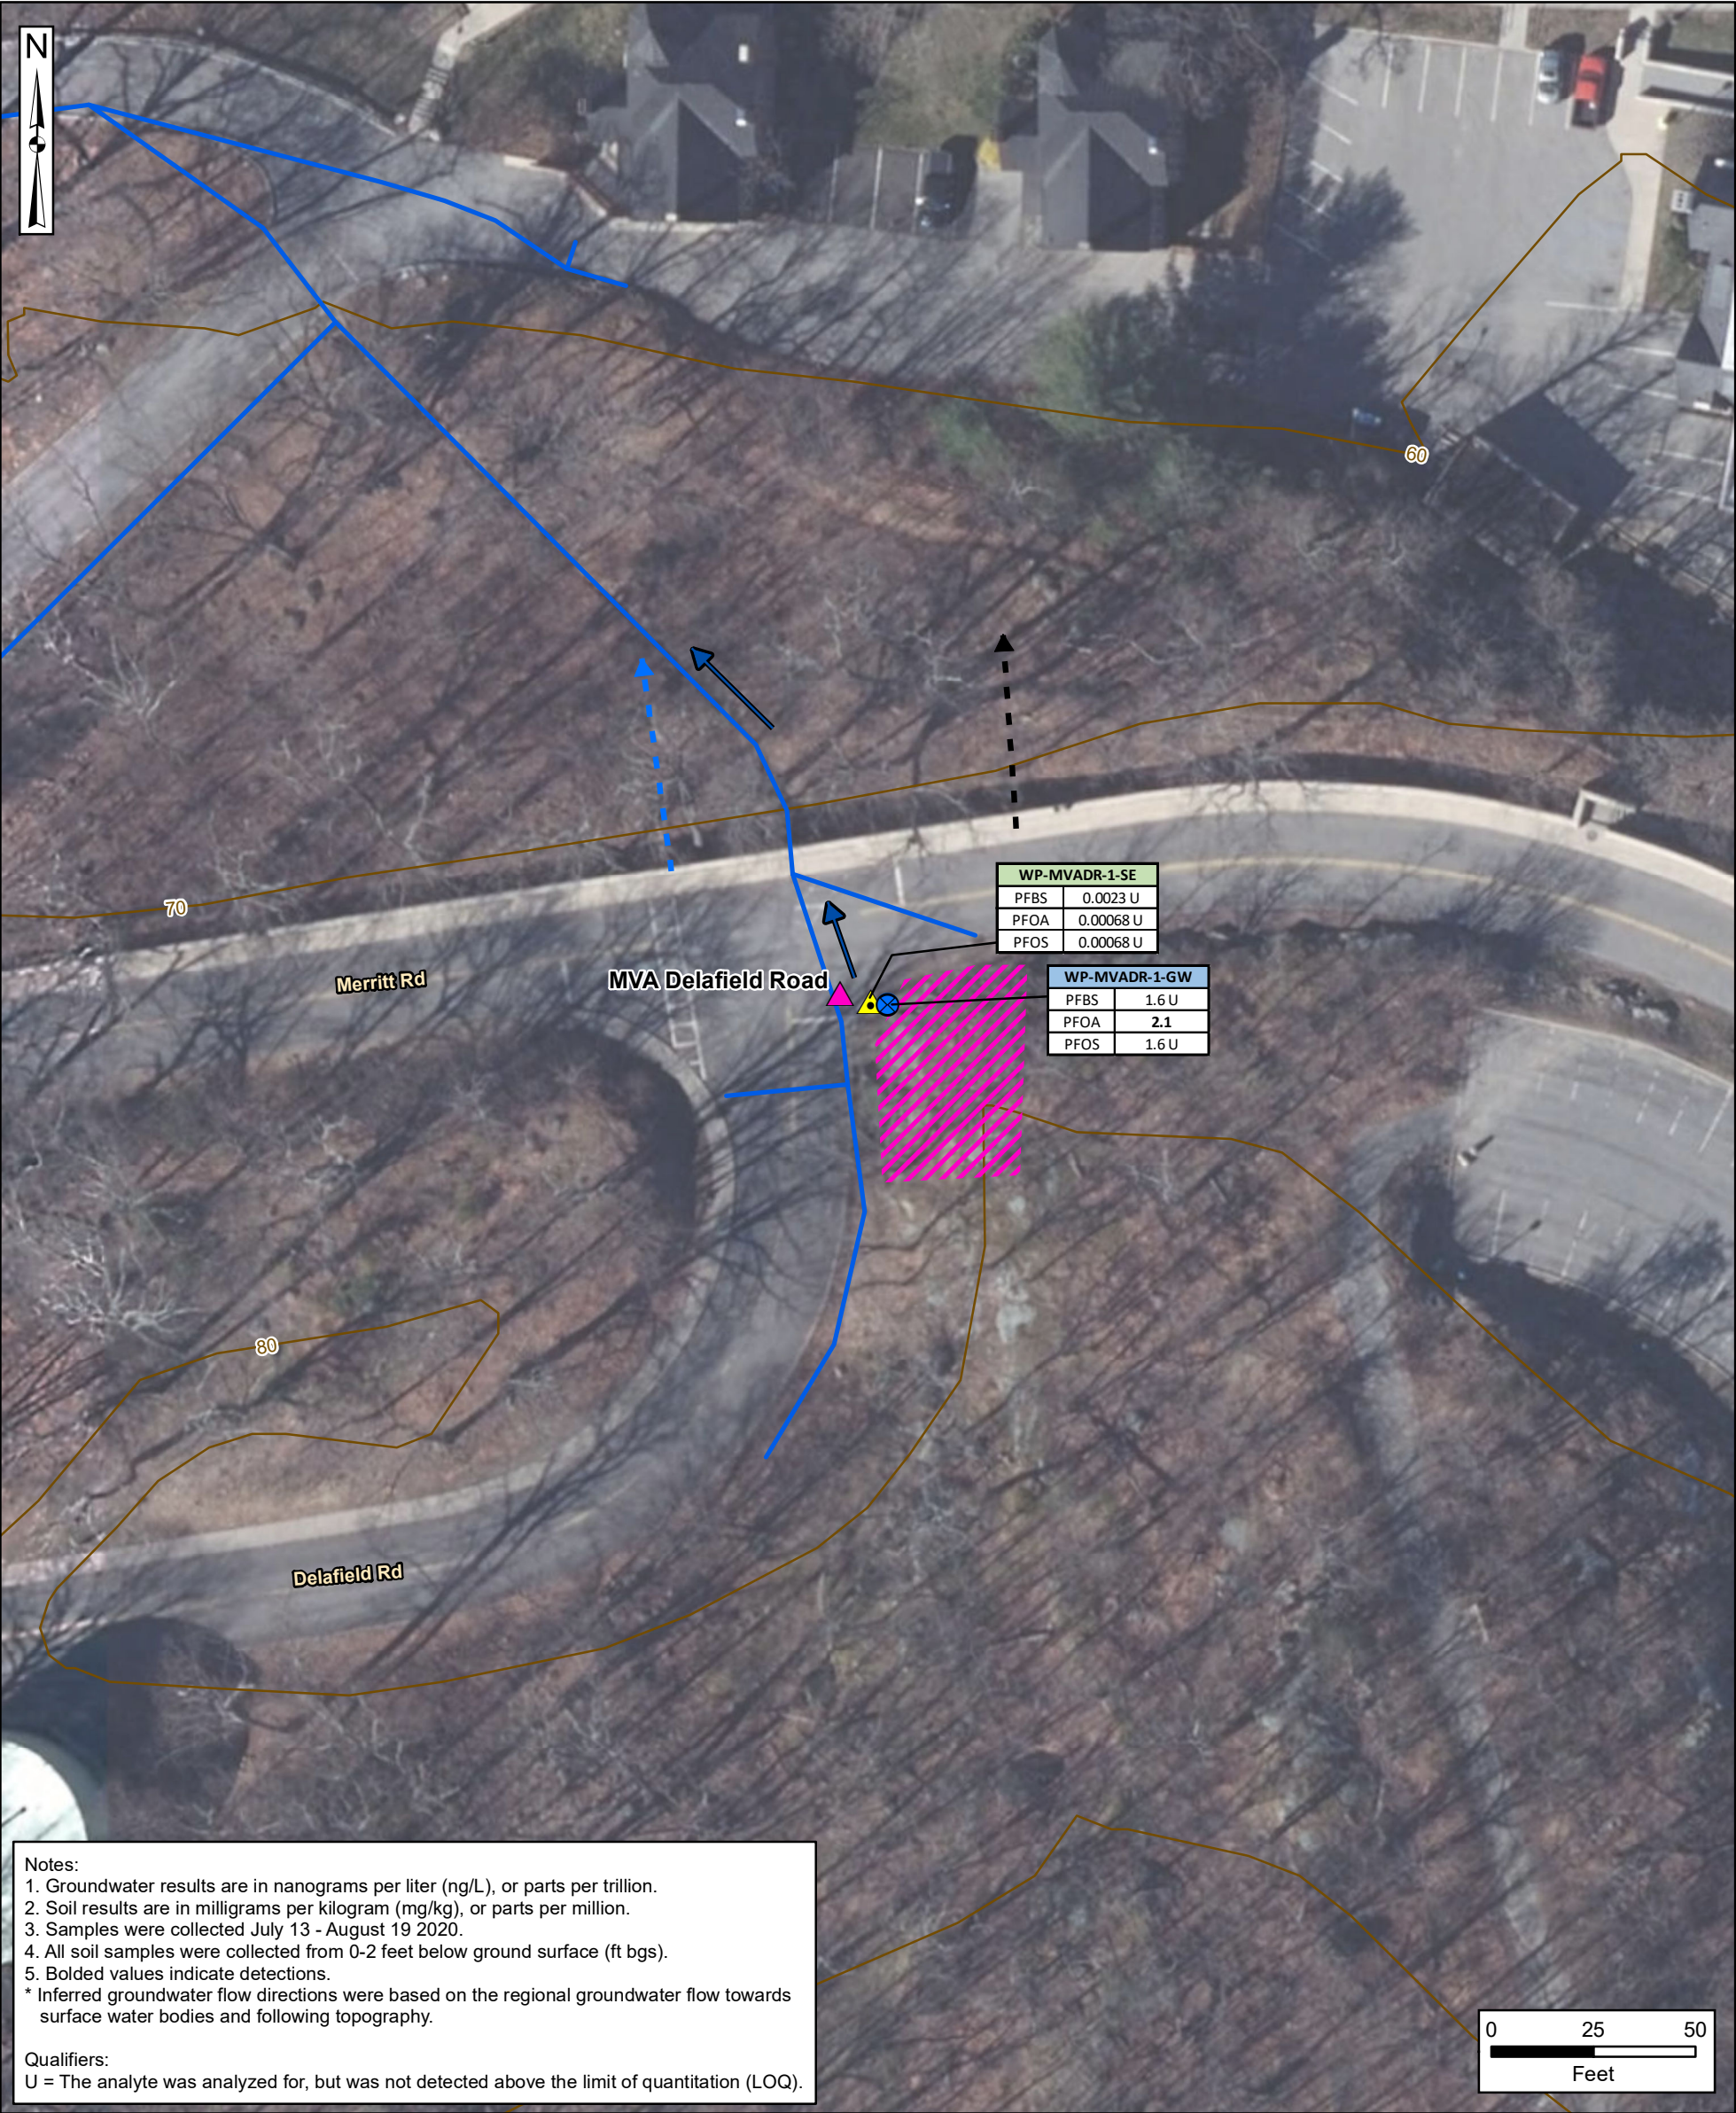
Figure 7-9
MVA - Delafield Road AOPI
PFOS, PFOA, and PFBS Analytical Results

One groundwater sample, WP-MVADR-1-GW, was collected following monitoring well installation located adjacent to a stormwater collection drain downgradient of AFFF uses at the AOPI (**Figure 7-9**).

One sediment sample, WP-MVADR-1-SE, was collected from the stormwater drain downgradient of AFFF uses at the AOPI which likely received AFFF runoff/drainage (**Figure 7-9**).

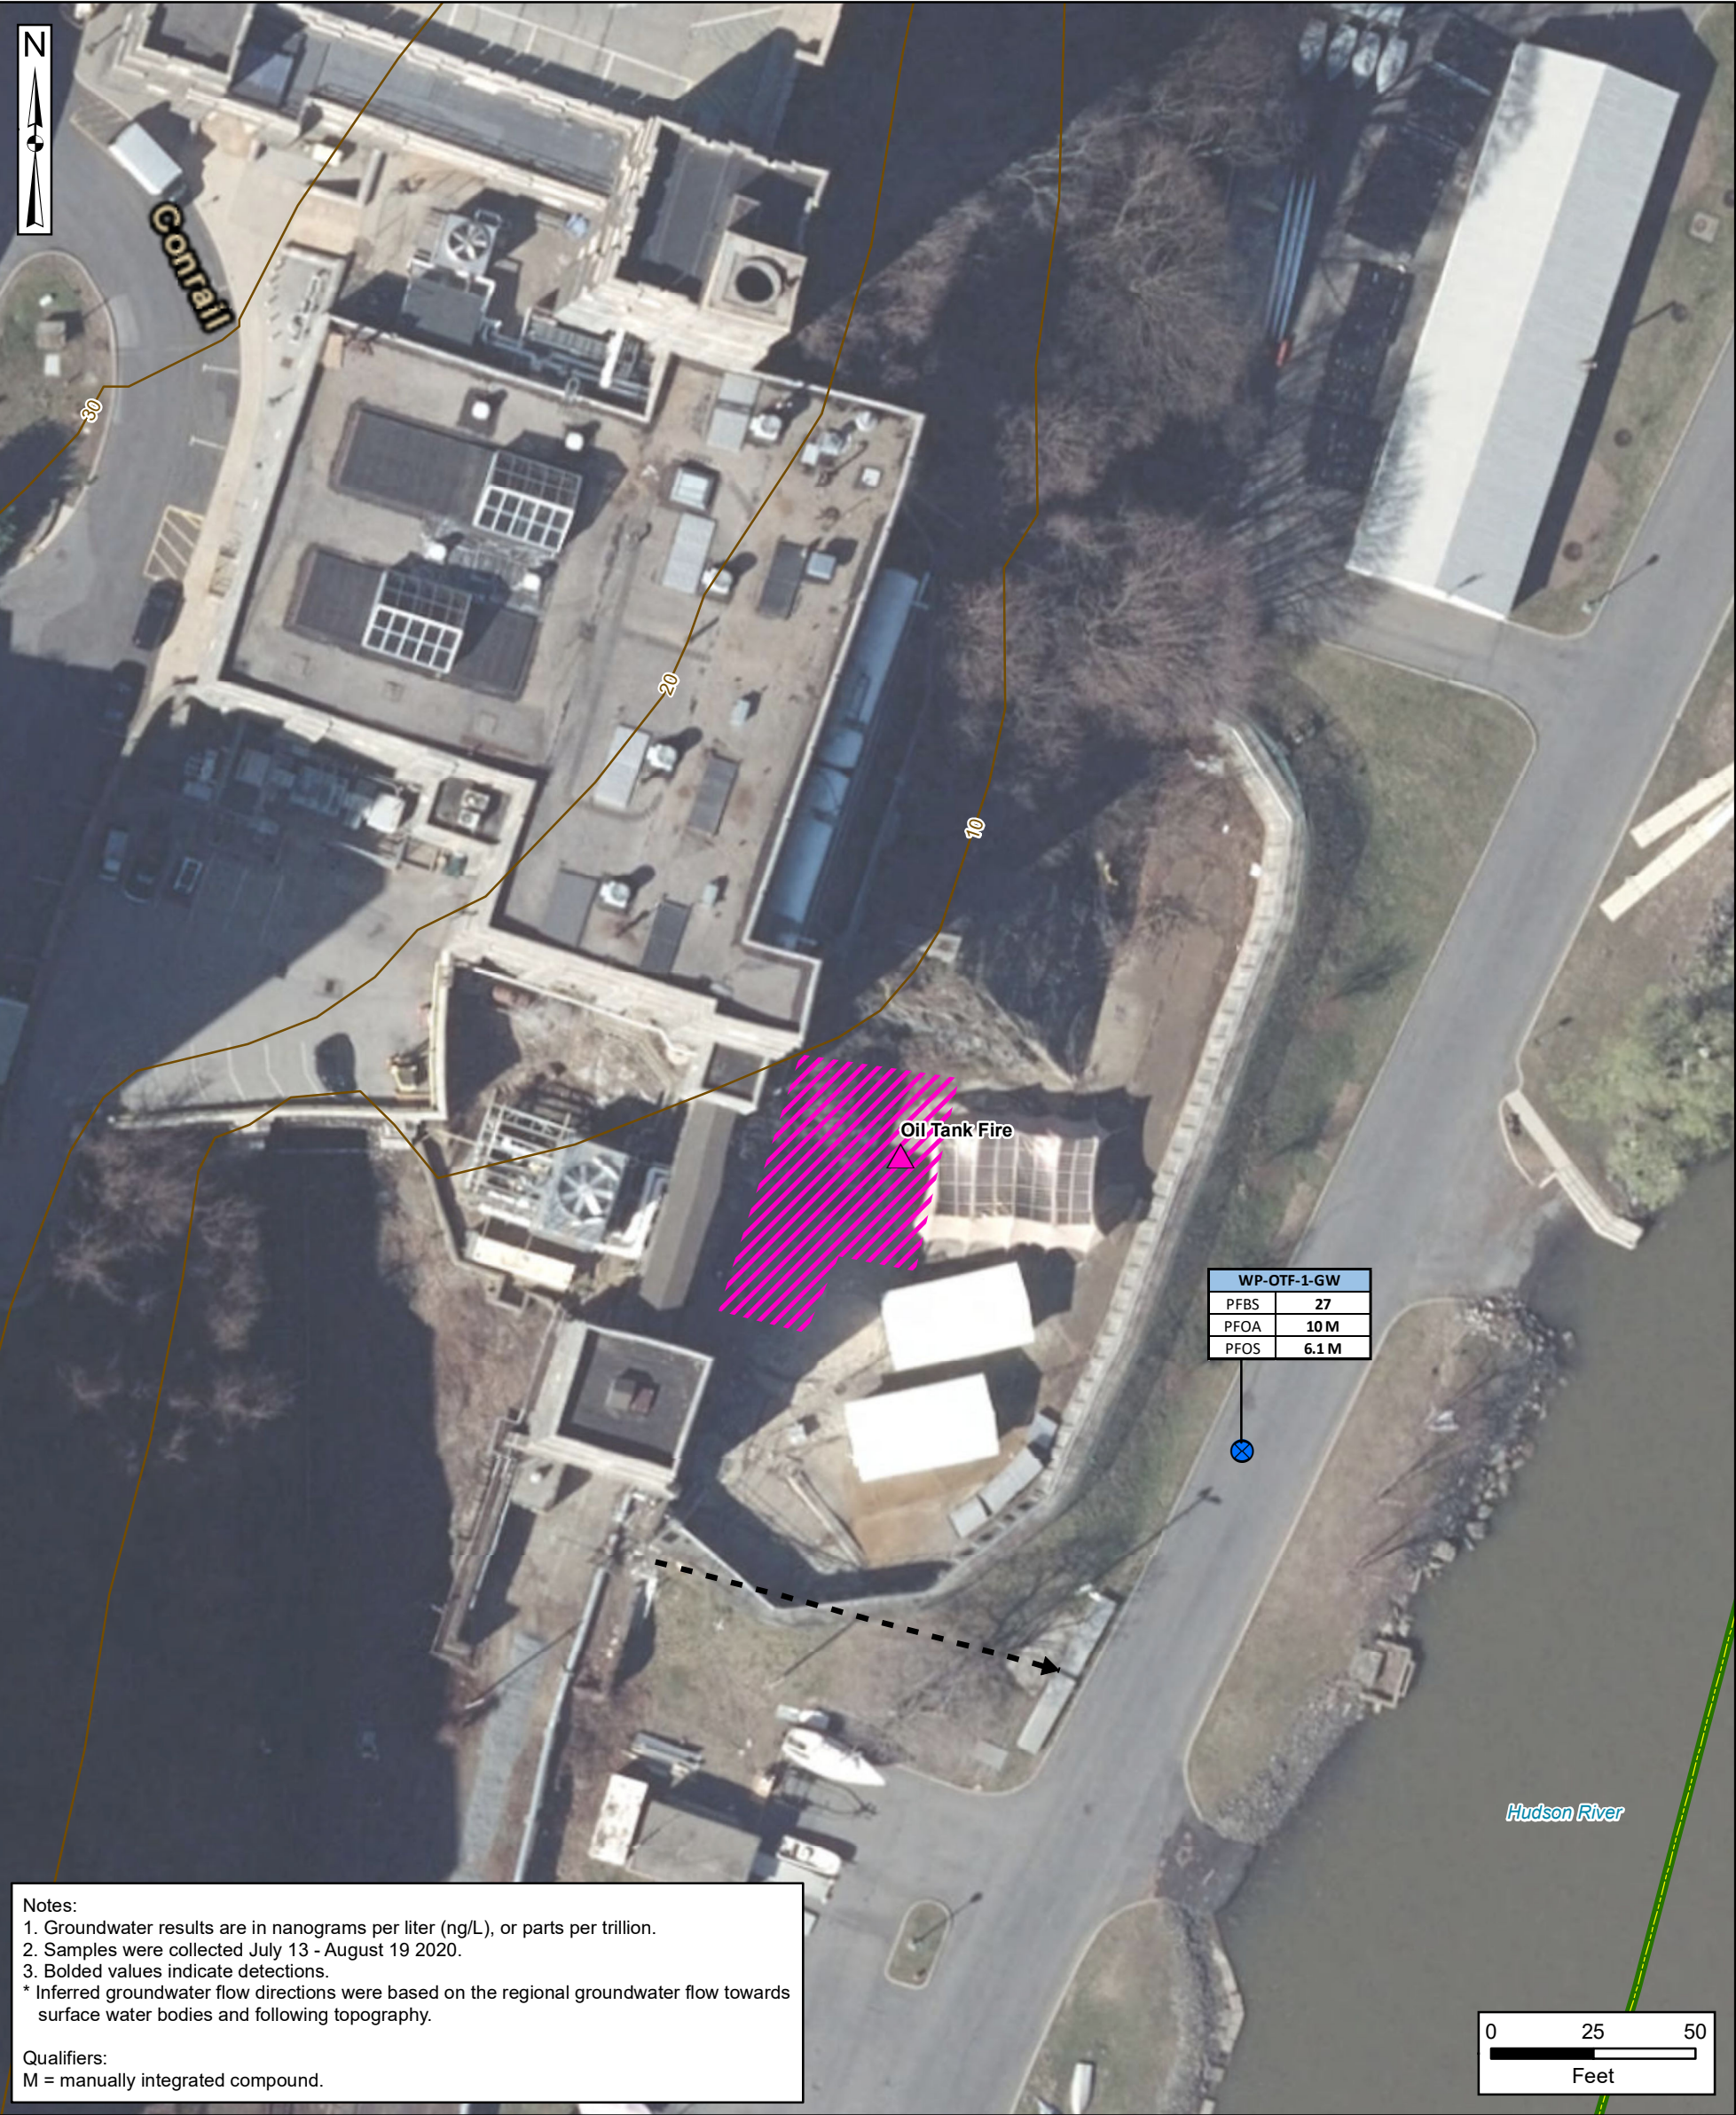
Figure 7-11
Oil Tank Fire AOPI
PFOS, PFOA, and PFBS Analytical Results

One groundwater sample, WP-OTF-1-GW, was collected following monitoring well installation immediately downgradient of the AFFF use area (**Figure 7-11**).
