# Photo-Essay from Operation Joint Endeavor

By Major Andrew Goetz

*The following photo-essay concerns the author's experiences in Bosnia during the period March to May 1996. It will be published in two parts, with this portion including an overview and information about force protection, mine clearing, and mine-dog teams. The fall issue of Engineer will include a discussion on base camps, the engineer construction effort, and heavy division engineer shortfalls. The photographs were taken by Major Goetz and the combat camera crews attached to Task Force Eagle.*

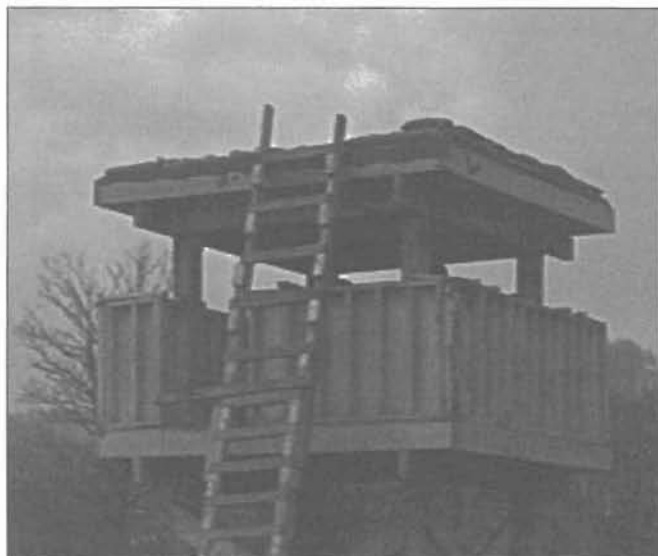
### Photo (left)

Guard towers are a fixture at all base camps. They are constructed primarily by the vertical platoons of the 94th Engineer Battalion. Because of poor soil conditions, a stable surface must be created to set them on. Compacted gravel, sandbags, and wide timber bases solve the problem. The towers are constructed with double walls; sandbags fill the gap between the walls and cover the roof.

To ensure that the force protection structures are safe, engineers inspect every bunker and tower and post an inspection certificate on the facility. The task force engineer takes the certification process seriously and had several structures rebuilt that did not pass the quality-control check. The construction management section attached to the division engineers provides quality assurance.

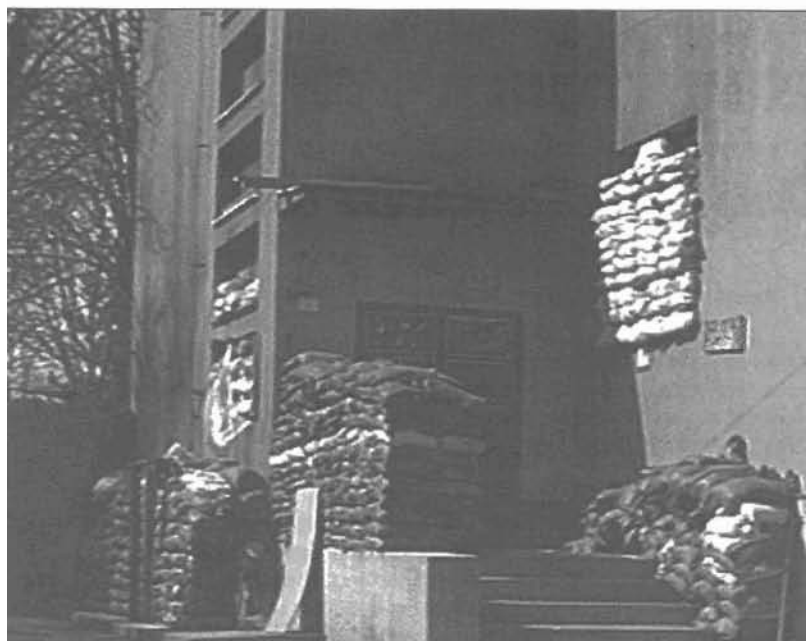
*Photo (left)*

Existing buildings at Tuzla Main are used for a wide range of purposes. This building is similar to many that are used as barracks. The double-decker hootches the U.N. constructed in the open bays are being removed because they pose a fire hazard. Fixed facilities at the old Yugoslavian air base are used for Task Force Eagle headquarters, the mess hall, and unit headquarters.

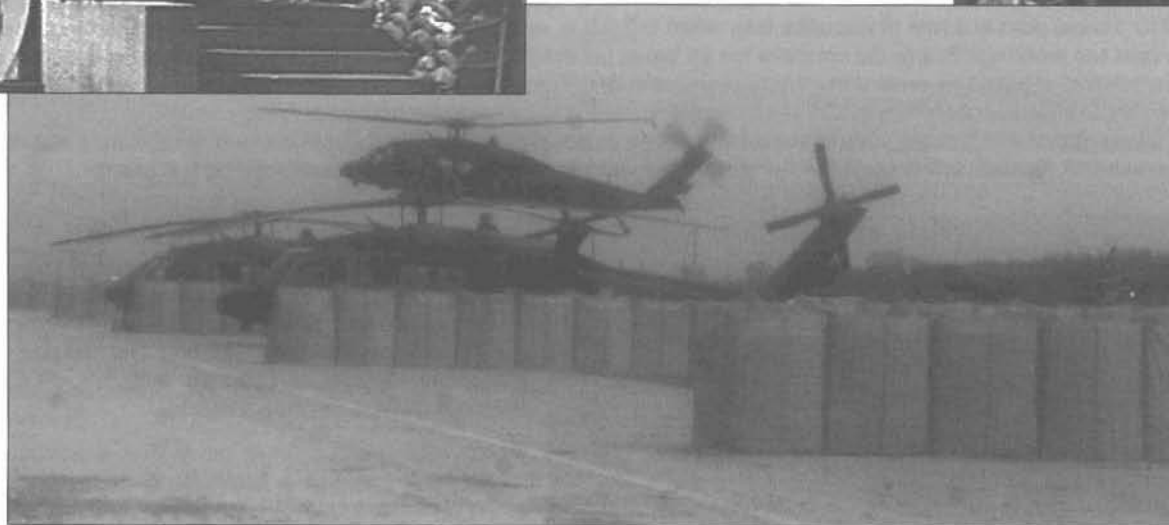
*Photo (above)*

Hesco Bastions are used as helicopter revetments at Comanche Base, Tuzla Main.

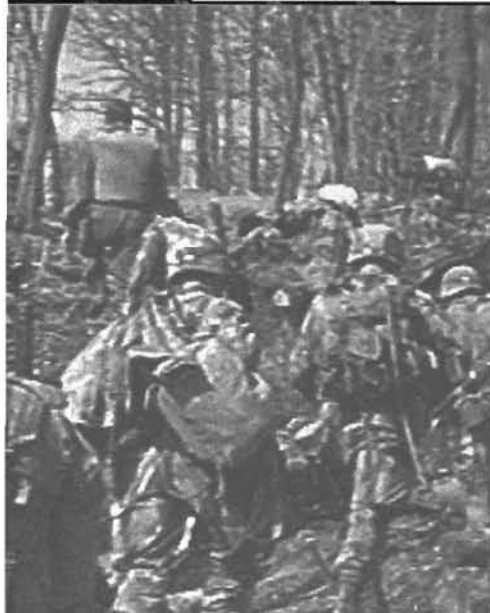
*Photo (left)*

On this day, 1st Squad and 1st Platoon—with an interpreter, a medic, and two Bradleys—linked up with the Serbian engineers—a lieutenant, two soldiers, and a driver—near the edge of the ZOS. We followed the Serb's truck to their trench line. When we reached a point where the road along the trench line was too muddy and steep to drive on, we dismounted and walked.

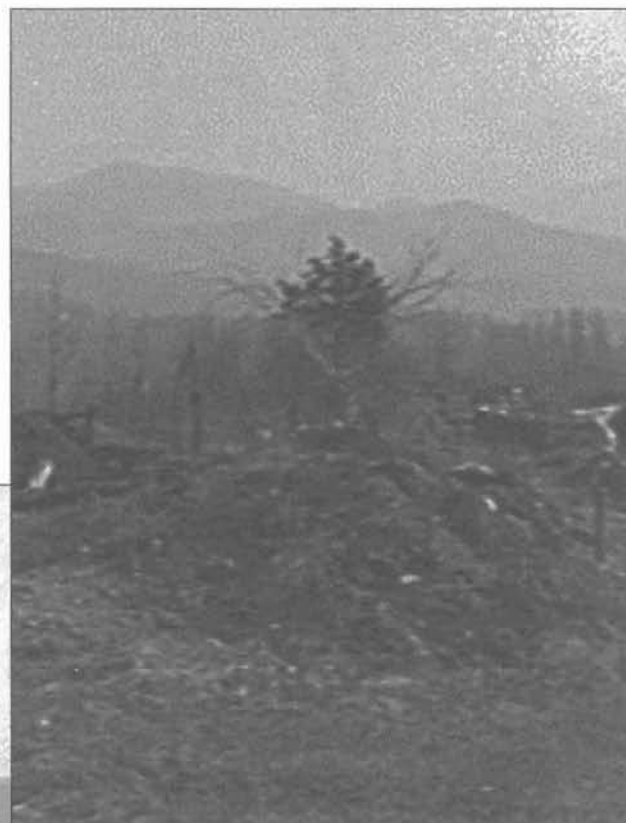
*Photo (above)*

A series of bunkers along the ridge links with the trenches. Fighting positions are spaced randomly along the trench line. Some bunkers are very basic, while others are completely enclosed with doors and windows. Pits behind the trench appear to have once held mortar and/or small-caliber artillery. The positions look across a large valley to the Muslim side of the line. At this point the Muslim trench line is several kilometers away; at other points it is as close as 30 meters.

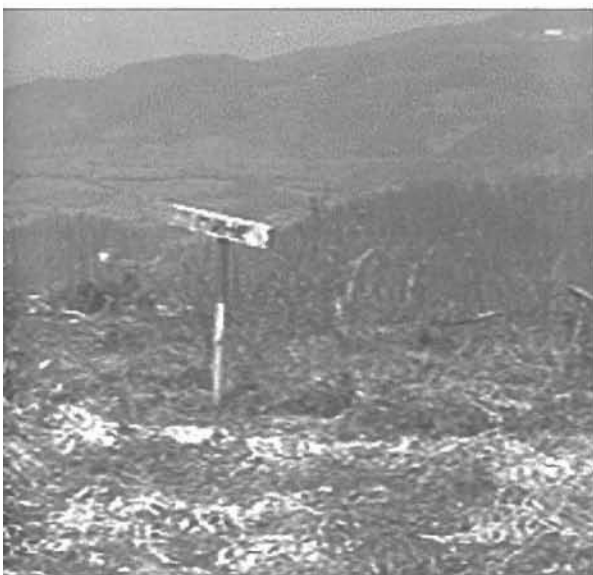
*Photo (left)*

This Serbian mine-marking sign is written in Cyrillic. Part of the Dayton Accord requires the former warring factions to mark their minefields with a barbed-wire fence on all four sides. The Serbs frequently do not do this and can't be convinced it is necessary. First, there aren't enough Serbs to carry the marking materials to minefields in remote locations such as this. Second, since they are taking mines out of the minefields, they don't see a need to mark them. Finally, they are hesitant to mark the Muslim sides of minefields because they don't know if the Muslims have mined them.

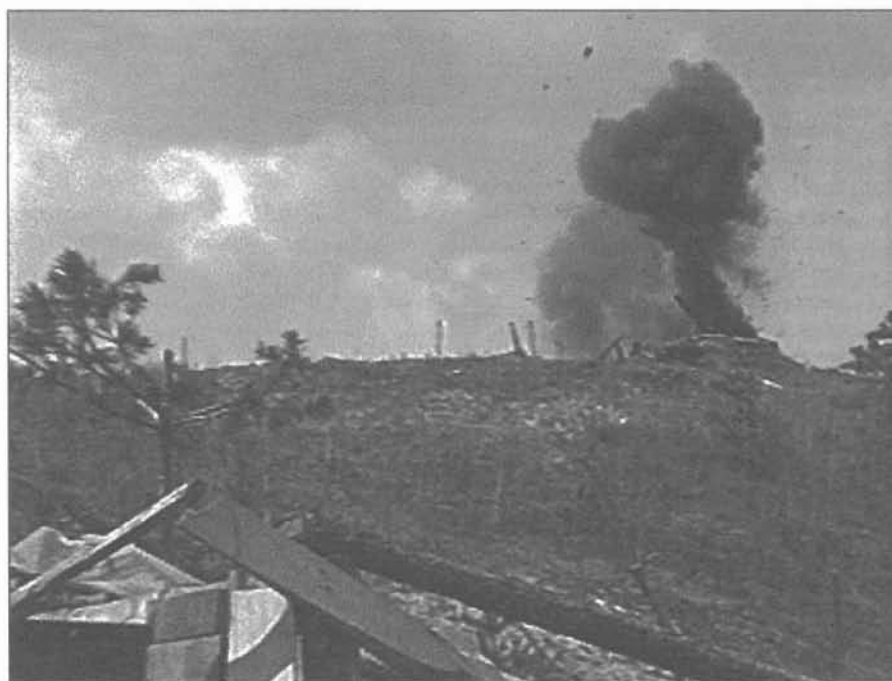
*Photo (below)*

On the first attempt to destroy the mines, the blasting cap fell out of the plastic explosives, causing a misfire. The platoon leader wanted the Serbs to wait 30 minutes before approaching the rigged mines but could convince them to wait only 15 minutes. The Serbian lieutenant then checked the demolitions, re-rigged them, and successfully destroyed the mines.

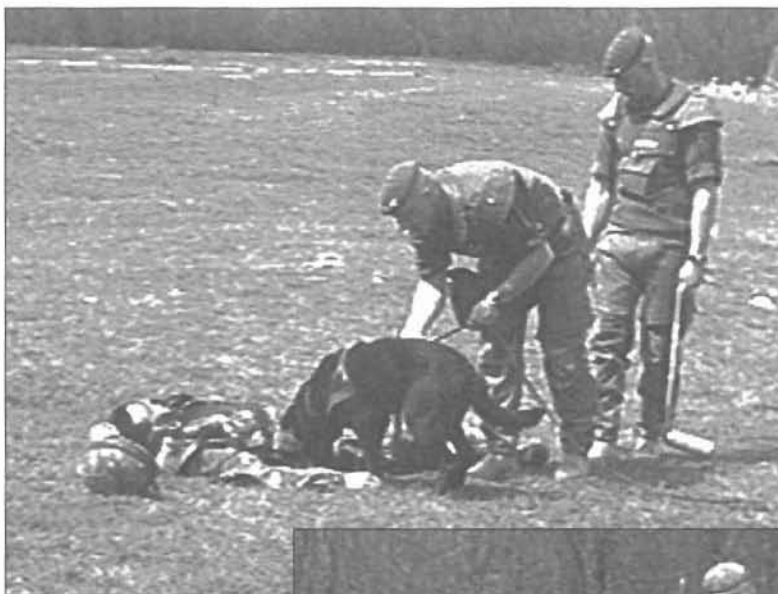
*Photo (left)*

This dog has located a buried mine, and the handler marked it with a mine bonnet. The team is now looking for a bypass. The second soldier marked the lane using a can of blue spray paint secured in long-handled holders. The lane marker sprays on both sides of the dog handler's boots. We should consider using this system for marking assault foot lanes through cleared minefields. (Utility companies use similar paint can holders to mark underground cables and pipes.)

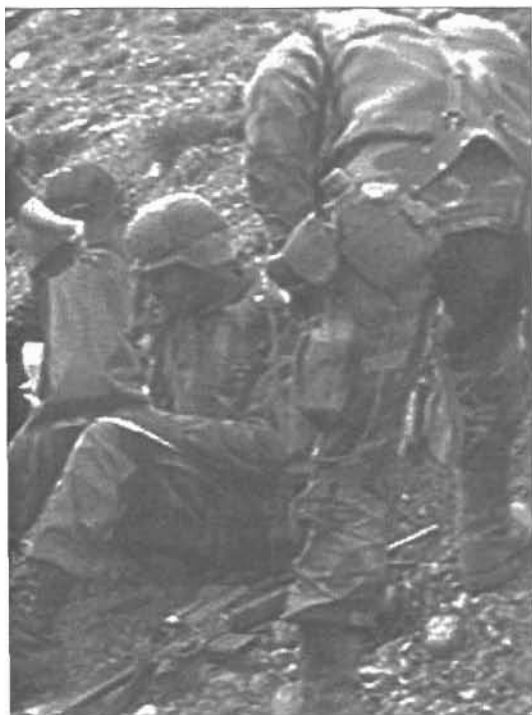
*Photo (above, right)*

Here, the mine-dog team clears around a "casualty," and one soldier marks the cleared area with paint. After a lane to the casualty is cleared and the clearing team is out of the minefield, the rescue team moves along the lane to recover the casualty. The dog identified the mine next to the casualty; it is marked by a mine bonnet.

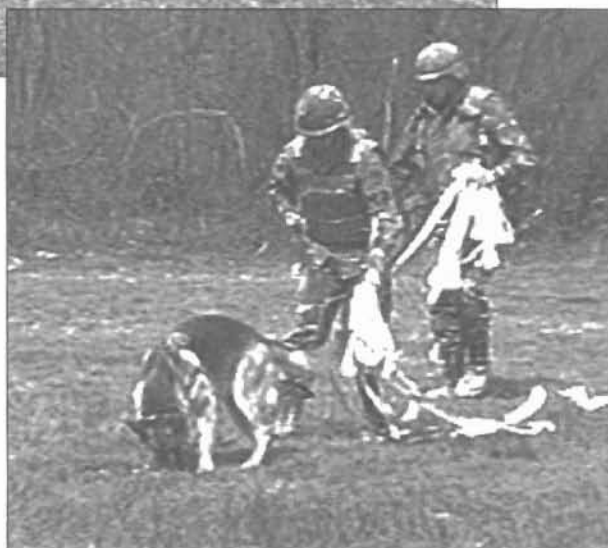
*Photo (far right)*

This U.S. mine-clearing dog is allowed to go forward on a long leash up to 20 feet in front of the handler. (The Swedish team keeps their dogs on very short leashes.) The second soldier marks the lane with engineer tape that is staked at the entrance to the lane and dragged along with the team. This is not a very effective system. In fact, if the training lane was not marked and the engineer tape already staked out, the team would not have used it. This dog successfully located the buried mines in the training lane.
