# BRIDGE RECONSTRUCTION:

## POLISH ENGINEERS PROVIDE ASSISTANCE AFTER 1,000-YEAR FLOOD

*The following article by staff at the Tadeusz Kosciuszko Military Academy, Wrocław, Poland, describes the unexpected 1,000-year flood that inundated southern Poland in July 1997. The authors detail the flood's ruthless destruction of thousands of kilometers (km) of roads and numerous bridges that existed in the watershed. Polish engineers reacted quickly and lent military assistance to the immobilized countryside. The authors describe the engineers' experiences during reconstruction of the area's bridge infrastructure and explain the technical and organizational challenges they faced as well as the solutions employed. Lessons learned concerning the capabilities of small engineer bridging units are emphasized.*

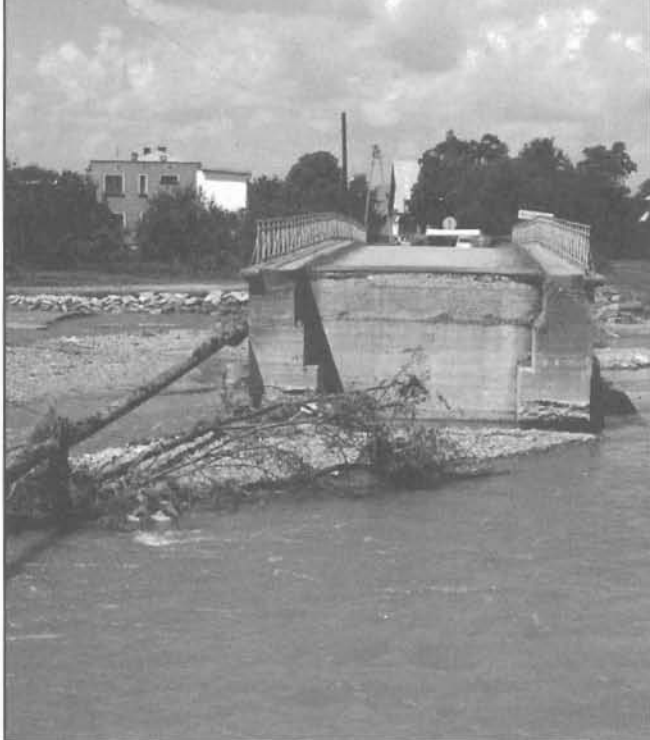
**Figure 2. A washed out embankment behind a bridgehead. A 60-meter section of the access road was destroyed (Bystrzyca Dolna town - Bystrzyca River).**

undermining of bridge supports caused the destruction of load-carrying members of all types of bridges except footbridges. Often, when bridge members withstood the water pressure, their access embankments were destroyed (Figure 2). At some locations new water beds were created (as at Radochów and Wilkanów). In many places, water mass created new, temporary riverbeds, which caused significant damage to areas along their routes. Bridge supports located in meanders of rivers and locations where bridges limited the natural stream width were especially exposed to undermining.

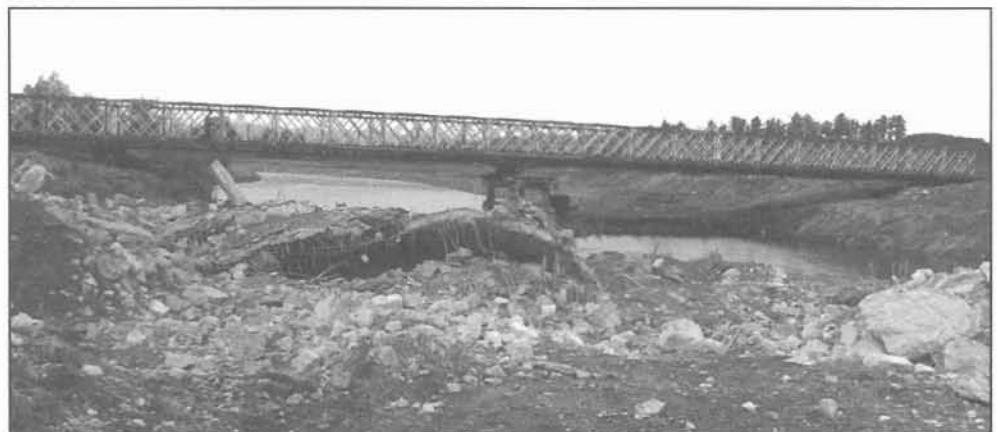
**Figure 3.** A bypass bridge made of DMS-65 structure elements with a continuous beam of 33 meters + 33 meters in length and access spans of 3 meters in length. The remaining parts of a destroyed bridge of 59 meters in length (Pilce town on the Nysa Klodzka River) are shown in the foreground.

possible to build single- or multiple-span bridges, with spans ranging from 3.0 to 45.0 m, and the change modulus 3.0 m in length. Due to the narrow width of water courses in Kotlina Klodzka, engineers reconstructed the bridges using single-span structures. A two-span continuous system was used only at Pilce (Figure 3).

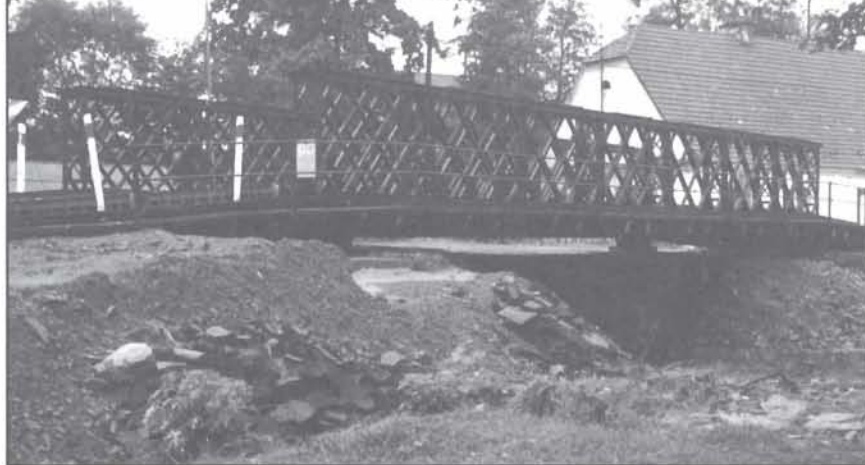
**Figure 4. Free-supported spans in a DMS-65 structure in the basic arrangement. It has a 21-meter span with 6-meter entry spans stretching  $L_c = 7$  meters (Roztoki - Miedzylesie Commune on the Nysa Kłodzka River).**

Within three days, the army built a DMS-65 collapsible temporary bridge next to the destroyed bridge at Roztoki (Miedzylesie Commune, Figure 4, page 14). The road the bridge is built on is an important transport route from Warsaw to Prague and Vienna. Numerous local businesses and thousands of motorists use this road every day. Similar structures were built at Gajnik and Goworów.
