Demolition of WWII-era Red Cross Building and Associated POW Stonework, Fort Leonard Wood

USAG Fort Leonard Wood, Directorate of Public Works

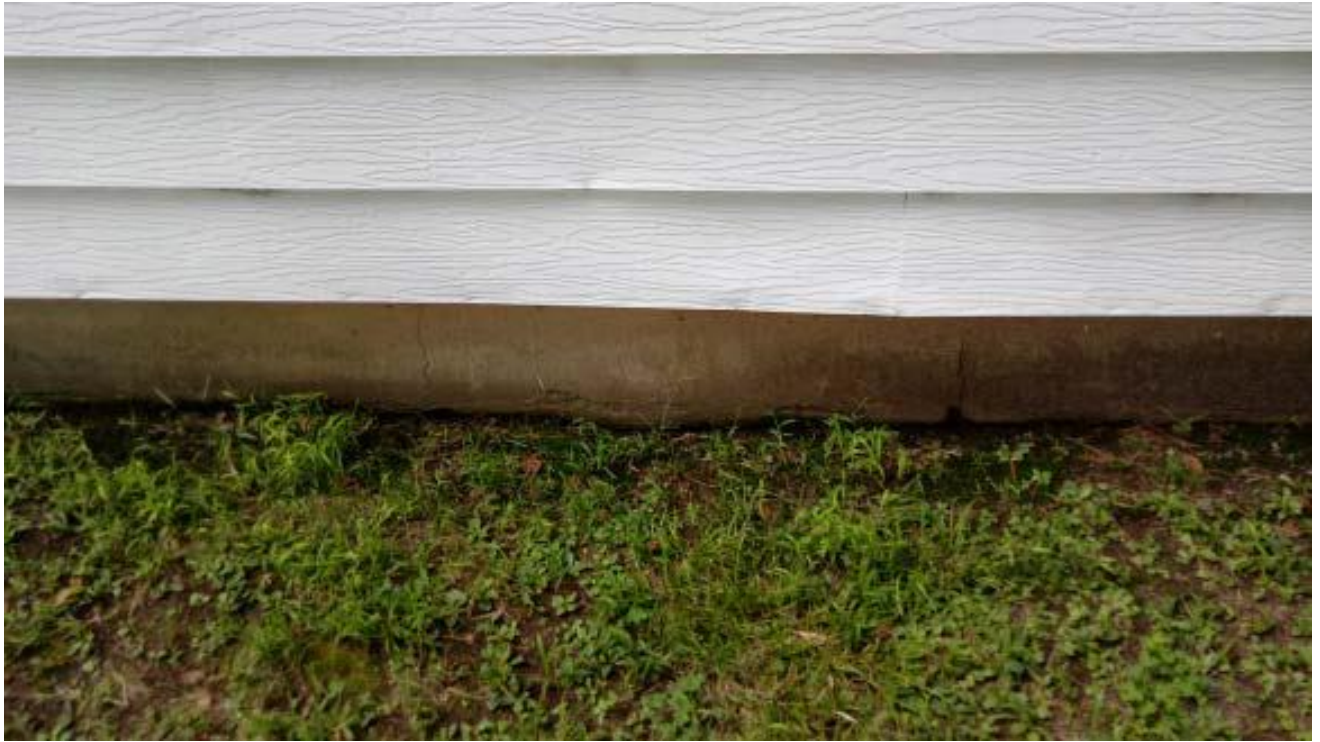
**Figure 1. Foundation cracks due to differential settling.**

Fort Leonard Wood (FLW) is proposing to demolish the WWII-era Red Cross Building (Building 430) and associated German POW-constructed stonework located immediately adjacent to the building and to the north where a WWII-era chapel once stood. Building 430 has been vacant for several years and attempts to find a new occupant have failed. A recent structural analysis conducted by the Directorate of Public Works (DPW) Engineer Division has determined the building is structurally unsound and poses a safety hazard. The north wing and lobby floor structural members yield under the weight of a person and the foundation exhibits quarter inch or larger cracks due to differential settling (Figure 1). In the south wing, the first rafter and kingposts are splitting due to the heavy load from the roof members. Water is infiltrating the basement during rain events, causing accumulated moisture and high levels of mold growth. The cost of repair/renovation exceeds 50% of the cost of replacement with an equivalent facility. Army policy prohibits repairs under these circumstances. Demolition will include removal of the Building 430, asphalt parking area and driveways, propane tank, concrete and stonework walkways, and stonework steps, culverts, and headwalls surrounding the building.

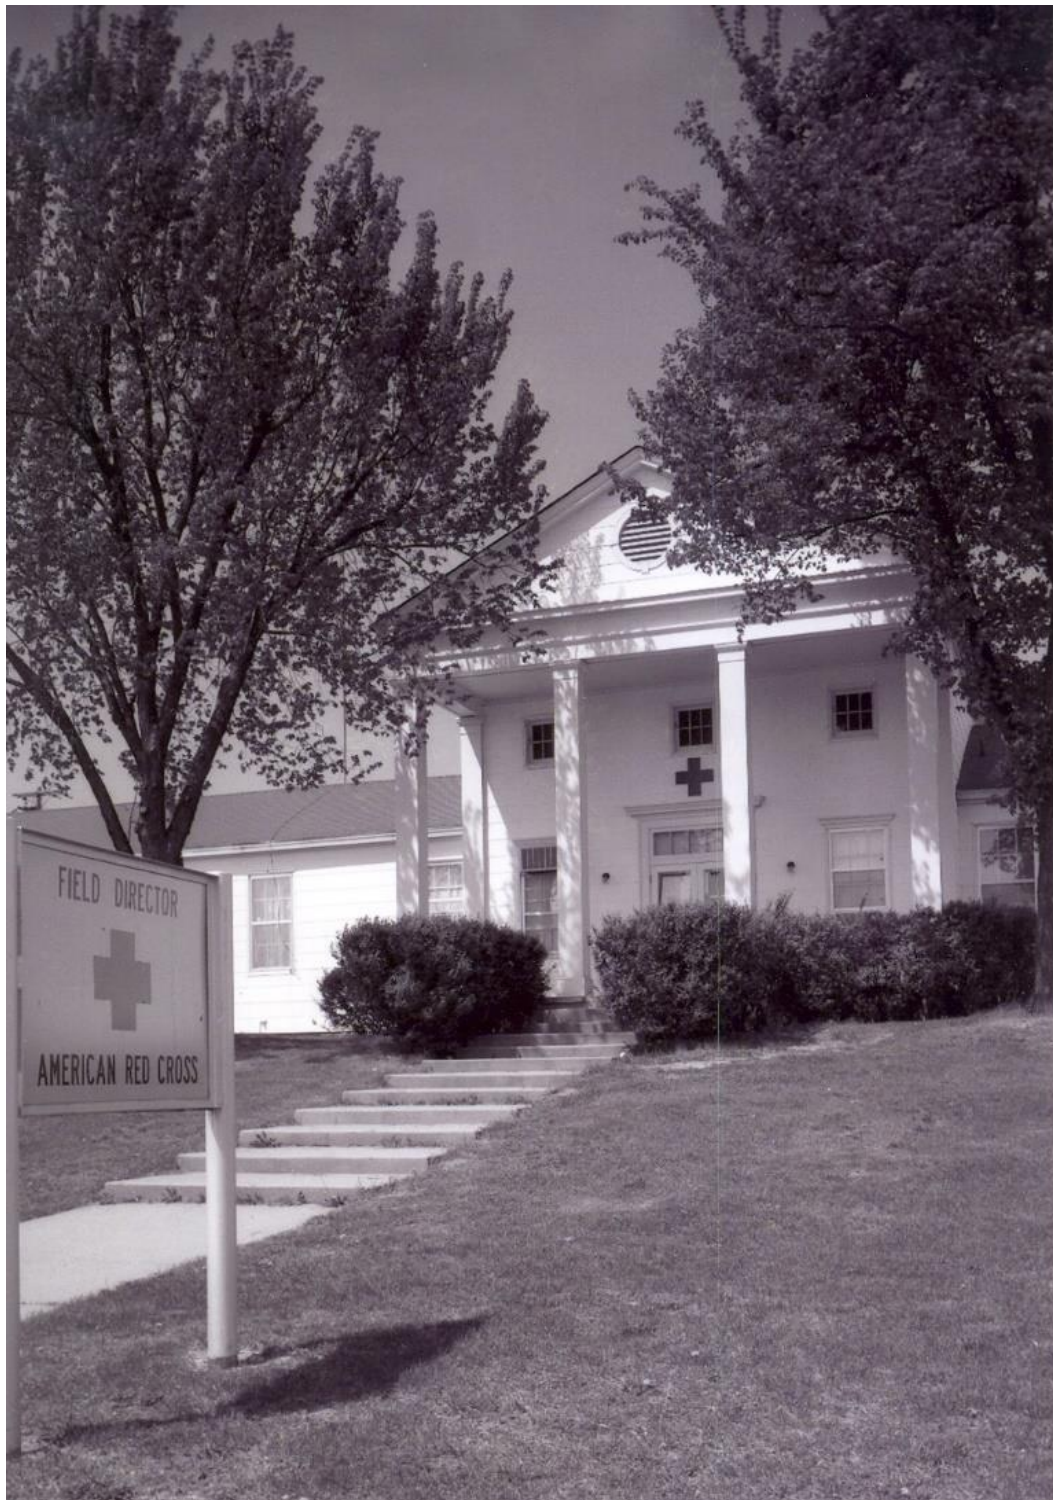
Building 430 was completed in May 1941 under the U.S. Army Mobilization Program, to serve as the local Red Cross Field Director's Office (Figure 3). Architecturally, the building exhibits a unique cross-shaped plan form. The main (east) façade is symmetrical with a central pavilion that extends into a portico supported by four wooden

**Figure 3. Building 430, Red Cross Building, 1969.**

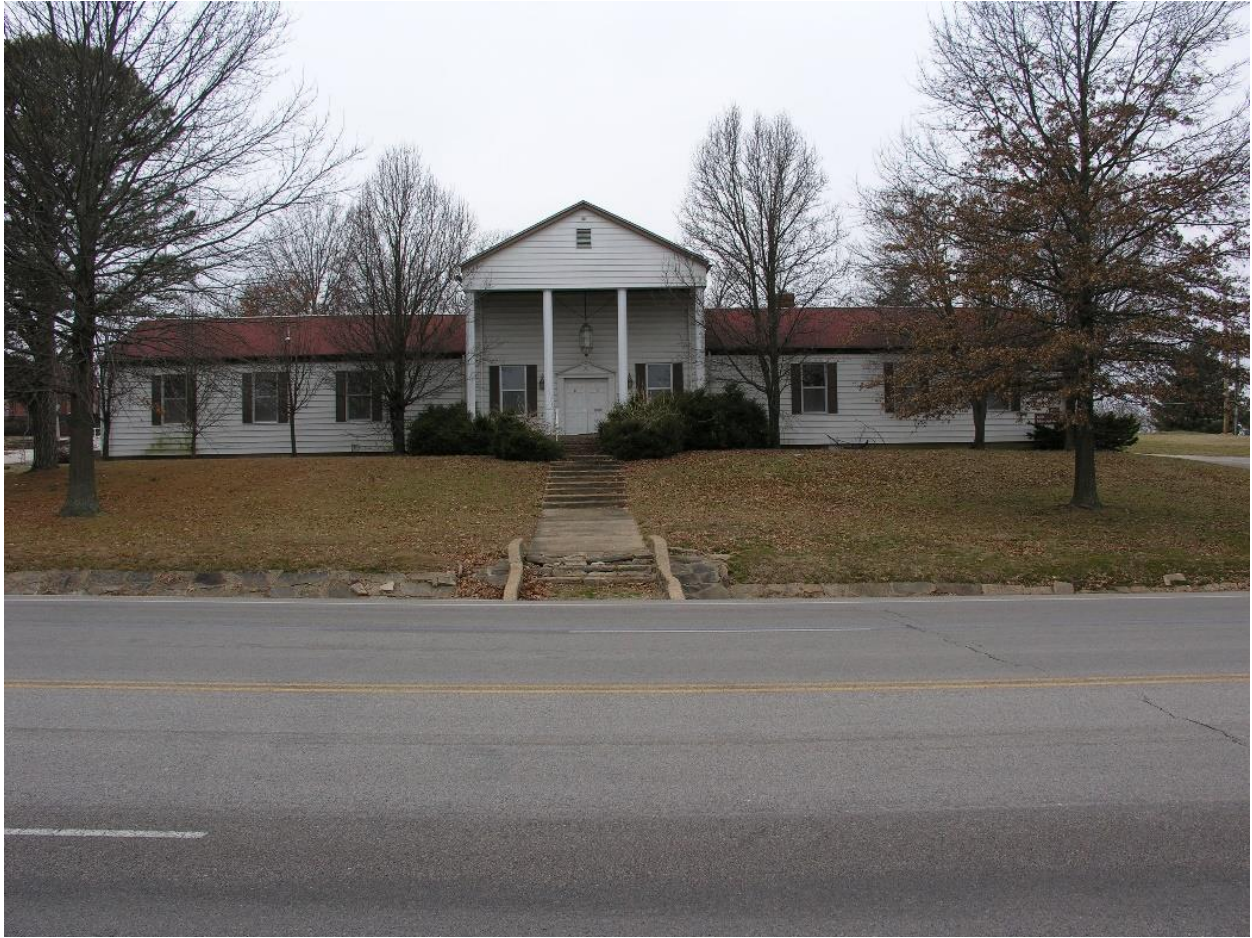
post columns (Figure 4). The floor of the pavilion has a cross scribed into the concrete, and tinted red (Figure 5). The central pavilion has a double door on center with two flanking lights and a single window to either side. To either side of the main pavilion, there are three evenly spaced windows. The windows are one-over-one double-hung windows.

**Figure 4. Building 430 main (east) façade, with POW stonework bridge, steps, and embankment.**

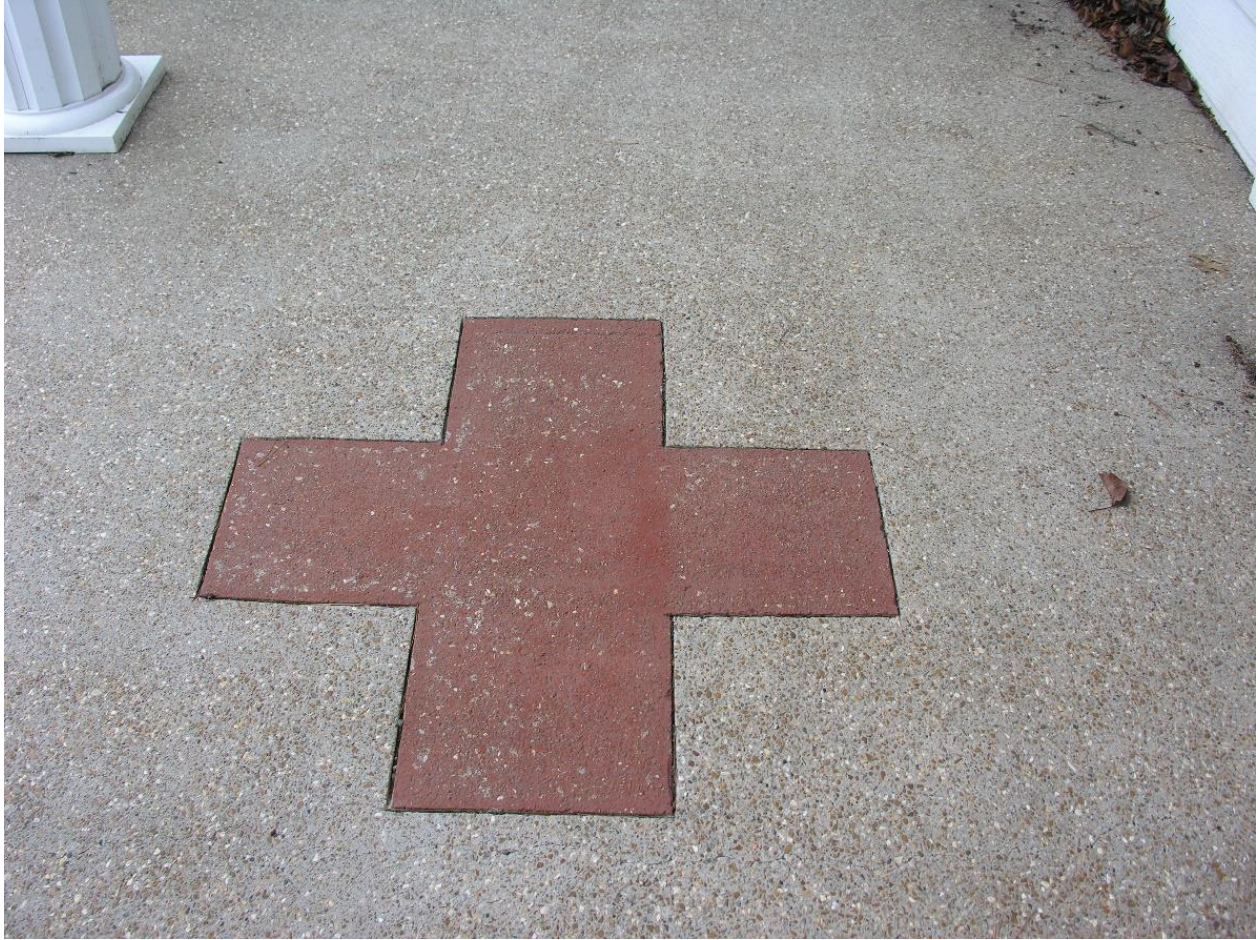
**Figure 5. Red tinted concrete red cross on pavilion floor at main entrance.**

Demolition of Building 430 and POW stonework surrounding the building will have an adverse effect on the historic landscape and may render it no longer eligible for the NRHP. Possible mitigation measures could include preservation and relocation of the red-tinted concrete cross, interpretive signage placed within the remaining courtyard area, and print and digital application versions of an updated FLW historical driving tour. FLW CRM personnel will work with SHPO personnel to develop a Memorandum of

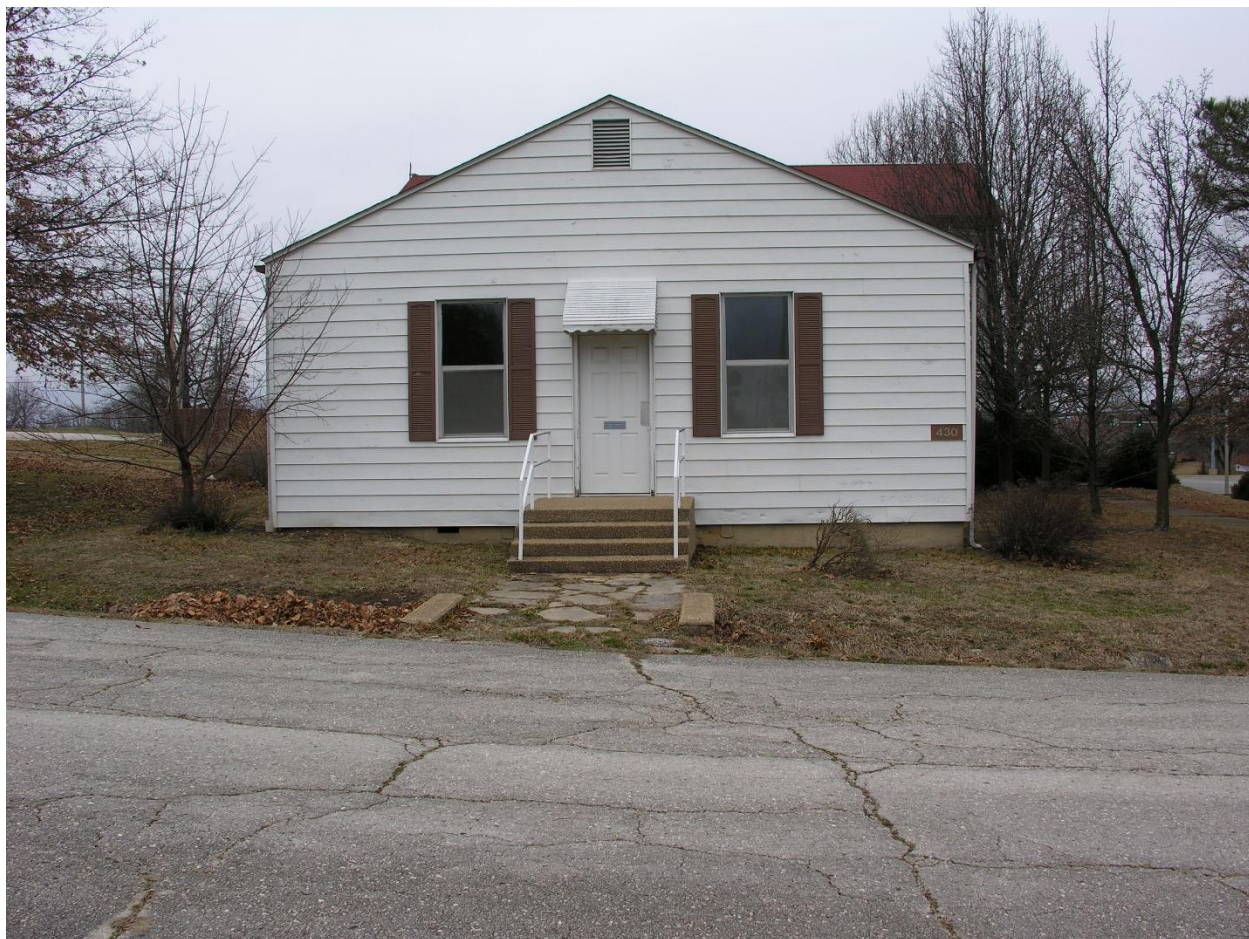
The north façade is without windows or a door. On the south façade there is a single door with two flanking windows (Figure 6). A single rectangular louver is located on center above the door, just below the ridge of the roof. A poured concrete stoop of three steps leads up to the door (Smith *et al.* 2003).

**Figure 6. Building 430 south façade, with POW stonework walkway and lined culvert.**

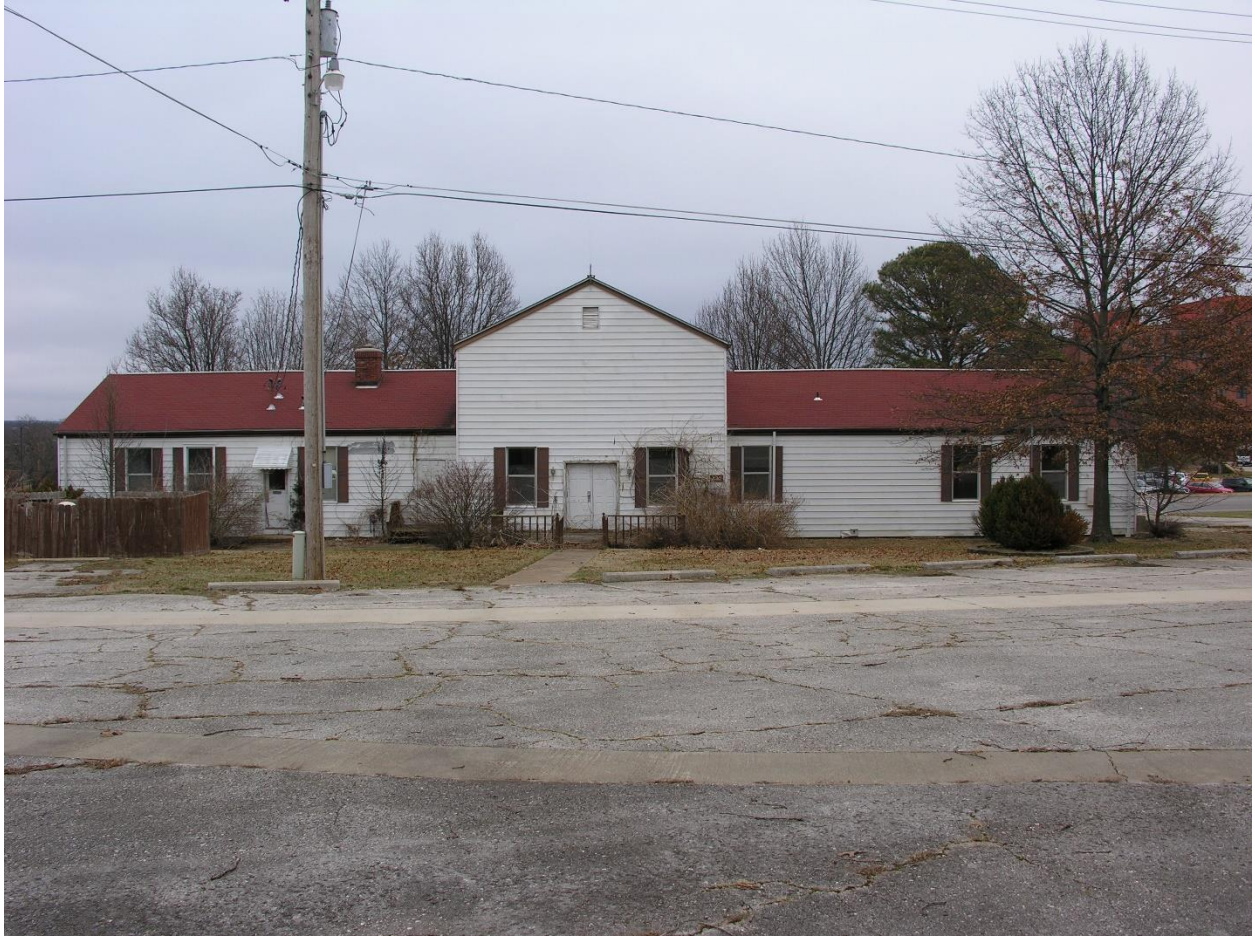
The west façade of Building 430 is asymmetrical. The central pavilion on this façade has a double door with two flanking lantern lights and a single window to either side. To the right side of the pavilion is a flanking window and two spaced windows at the far end. On the left side, there is a door to the immediate left of the pavilion, then a single window, then another door to the left of the window, with two spaced windows at the far north end (Figure 7). The building has undergone changes since its construction in 1941, most notably the replacement of the windows and roofing material and the addition of metal siding over the original wood drop-lap siding (Smith *et al.* 2003).

**Figure 7. Building 430 west (rear) façade.**

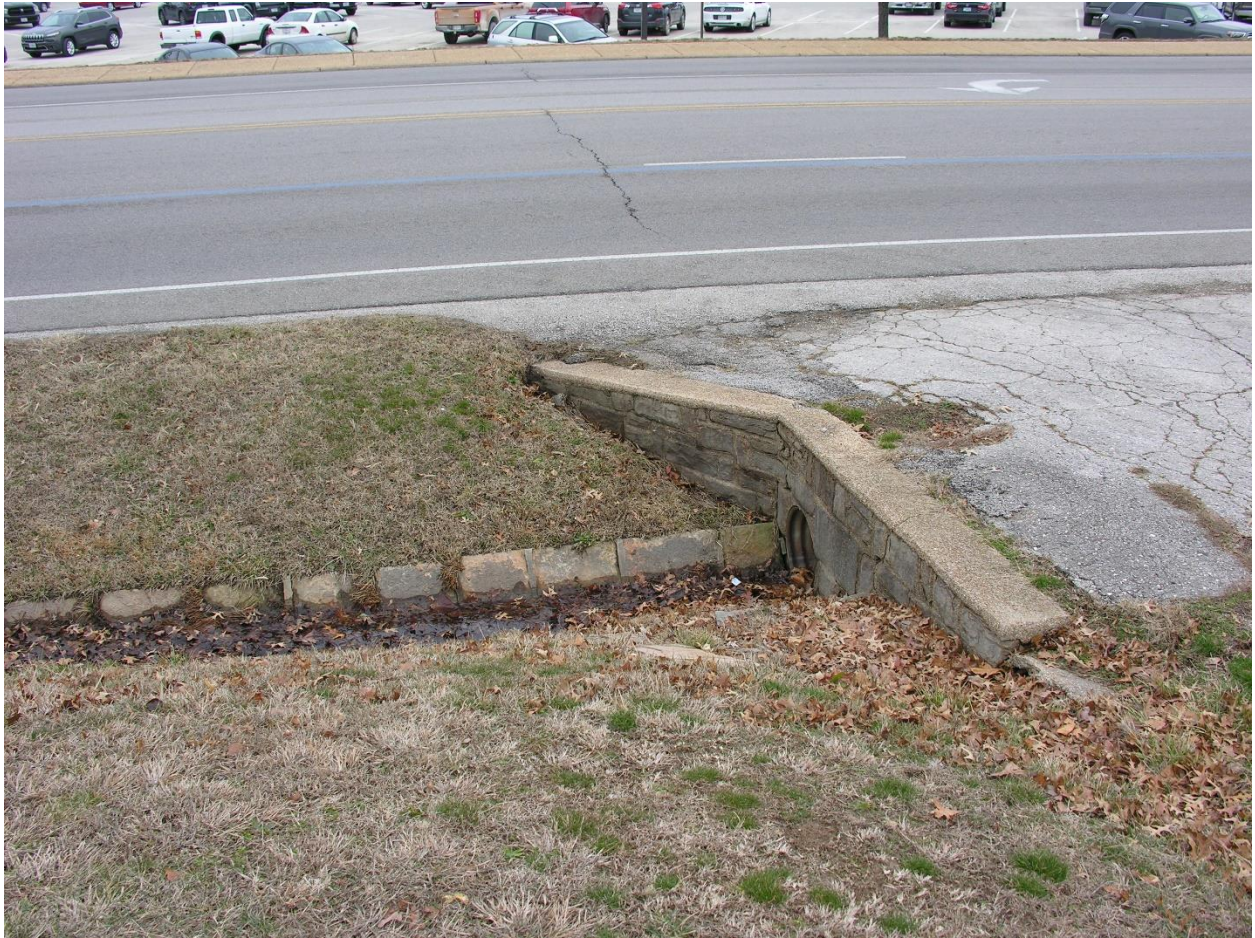
A number of stonework features surround Building 430, both adjacent to the building and immediately to the north where the chapel once stood. These include a stone-lined culvert, bridges spanning the culvert, drainage headwalls, steps, and walkways (Figures 8 and 9). The stonework was constructed by German POWs interned at FLW from 1943-1946.

**Figure 8. POW stonework culvert and headwall.**

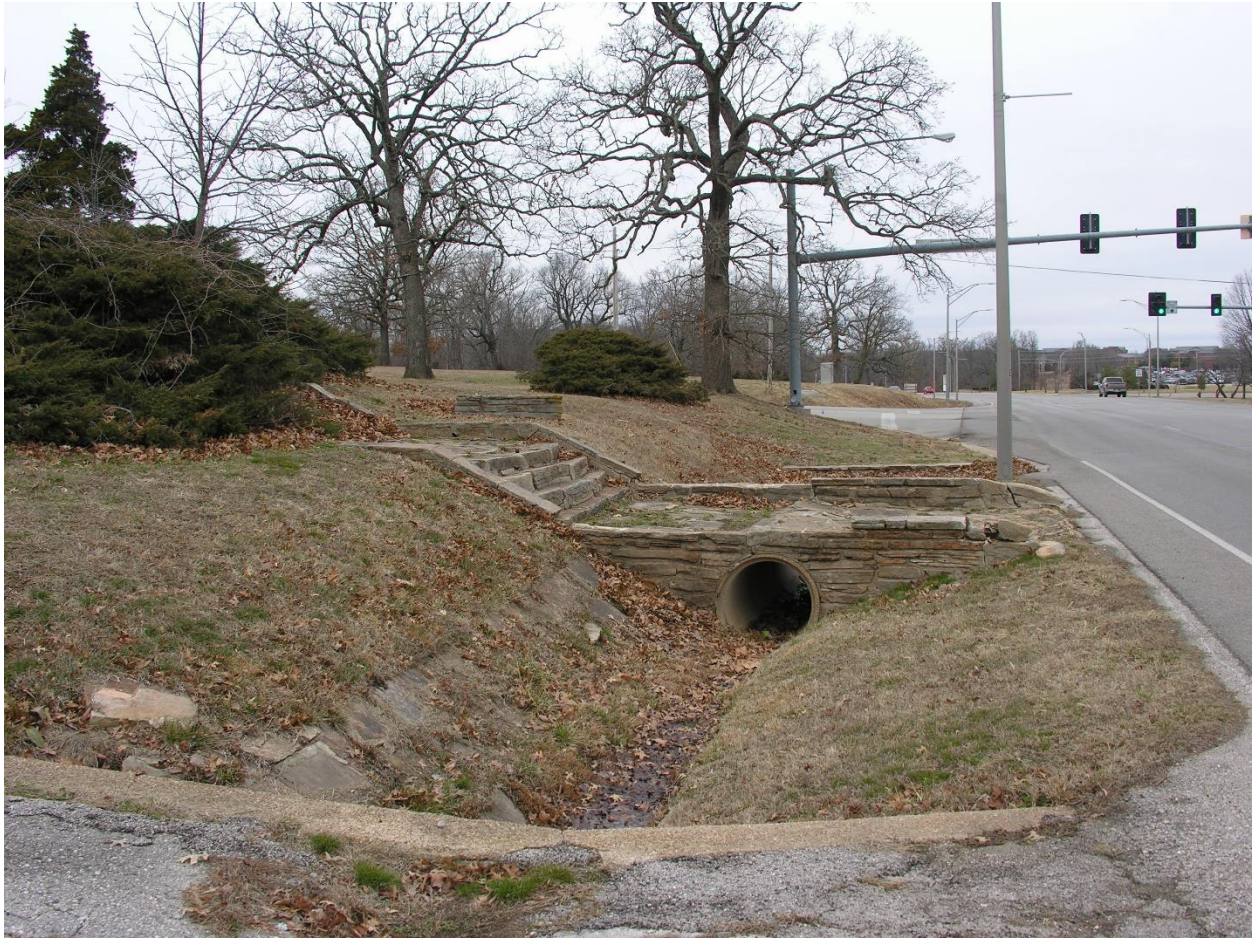
**Figure 9. POW stonework embankment, culvert with bridge, and steps leading to former location of WWII-era chapel.**

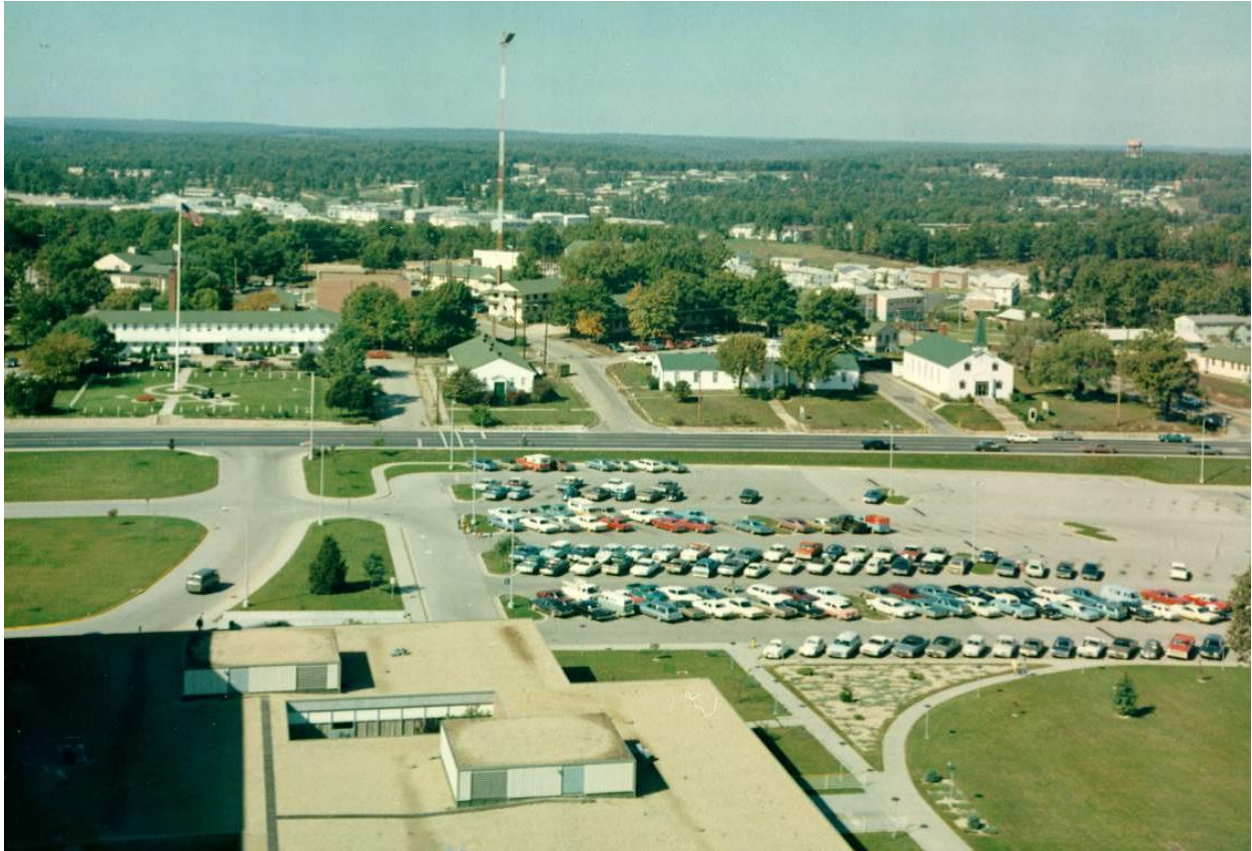
In the early 1960s the buildings in the grouping and the formal landscape on the east side of Missouri Avenue were removed to make way for the post hospital, completed in 1965. The chapel and administrative buildings on the west side of Missouri Avenue were demolished in the late 1980s or early 1990s. The post headquarters building, also eligible for the NRHP, was demolished in 2011 (see Figure 11).

**Figure 11. View from FLW hospital looking west at Post Headquarters and courtyard, civilian personnel building, Red Cross building, and chapel, circa early 1970s.**

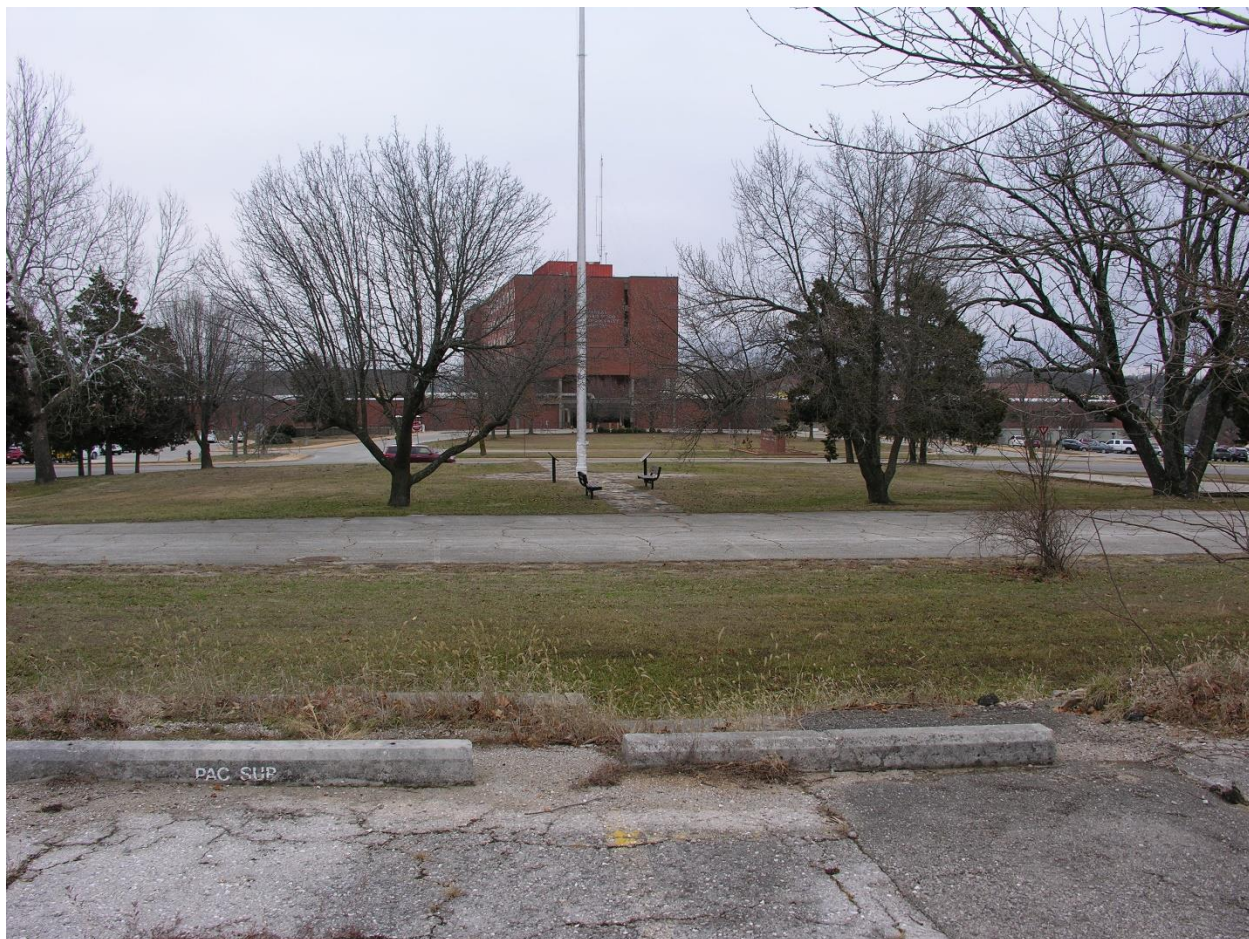
However, Building 430 is also a contributing element to a NRHP eligible historic landscape. With the demolition of Building 401 in 2011, Building 430 is the only remaining building within the historic landscape. Removal of Building 430 and its associated POW stonework will result in a loss of over half of the historic landscape. The remaining landscape features will consist of the courtyard with the flagpole and stonework walkway, low stonework walls flanking the north and south sides of the courtyard, stonework retaining walls, stonework walkways surrounding the former location of Building 401, and approximately 300 feet of the stone-lined embankment along Missouri Avenue (Figures 12 and 13).

**Figure 12. Courtyard and flagpole with POW stonework walkway in front of former location of Building 401.**

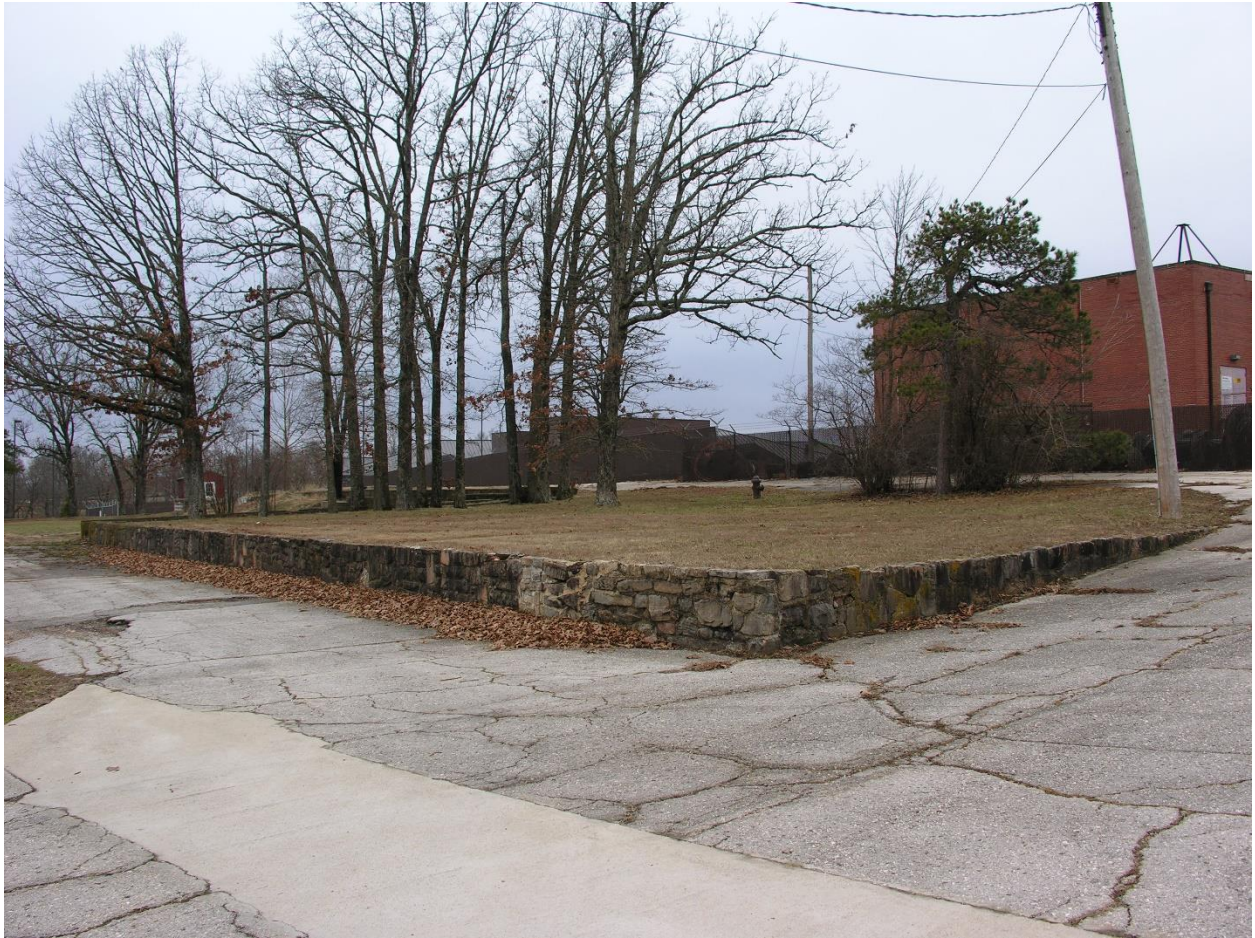
**Figure 13. POW stonework retaining wall; former location of Building 401 to the left of the wall in the background.**
