Test Trench Log - Fort Bliss Landfill - Perimeter_____ or Interior X

Project Name and No.: MSWLF - Limit of Waste Investigation, Fort Bliss, TX

Test Pit No. IT20-39 Direction Advanced down

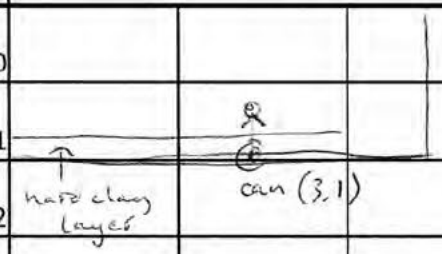
Test Pit No. IT20-42 Direction Advanced Down

USCS characterization of soils encountered: GW, CL Sample Taken: No

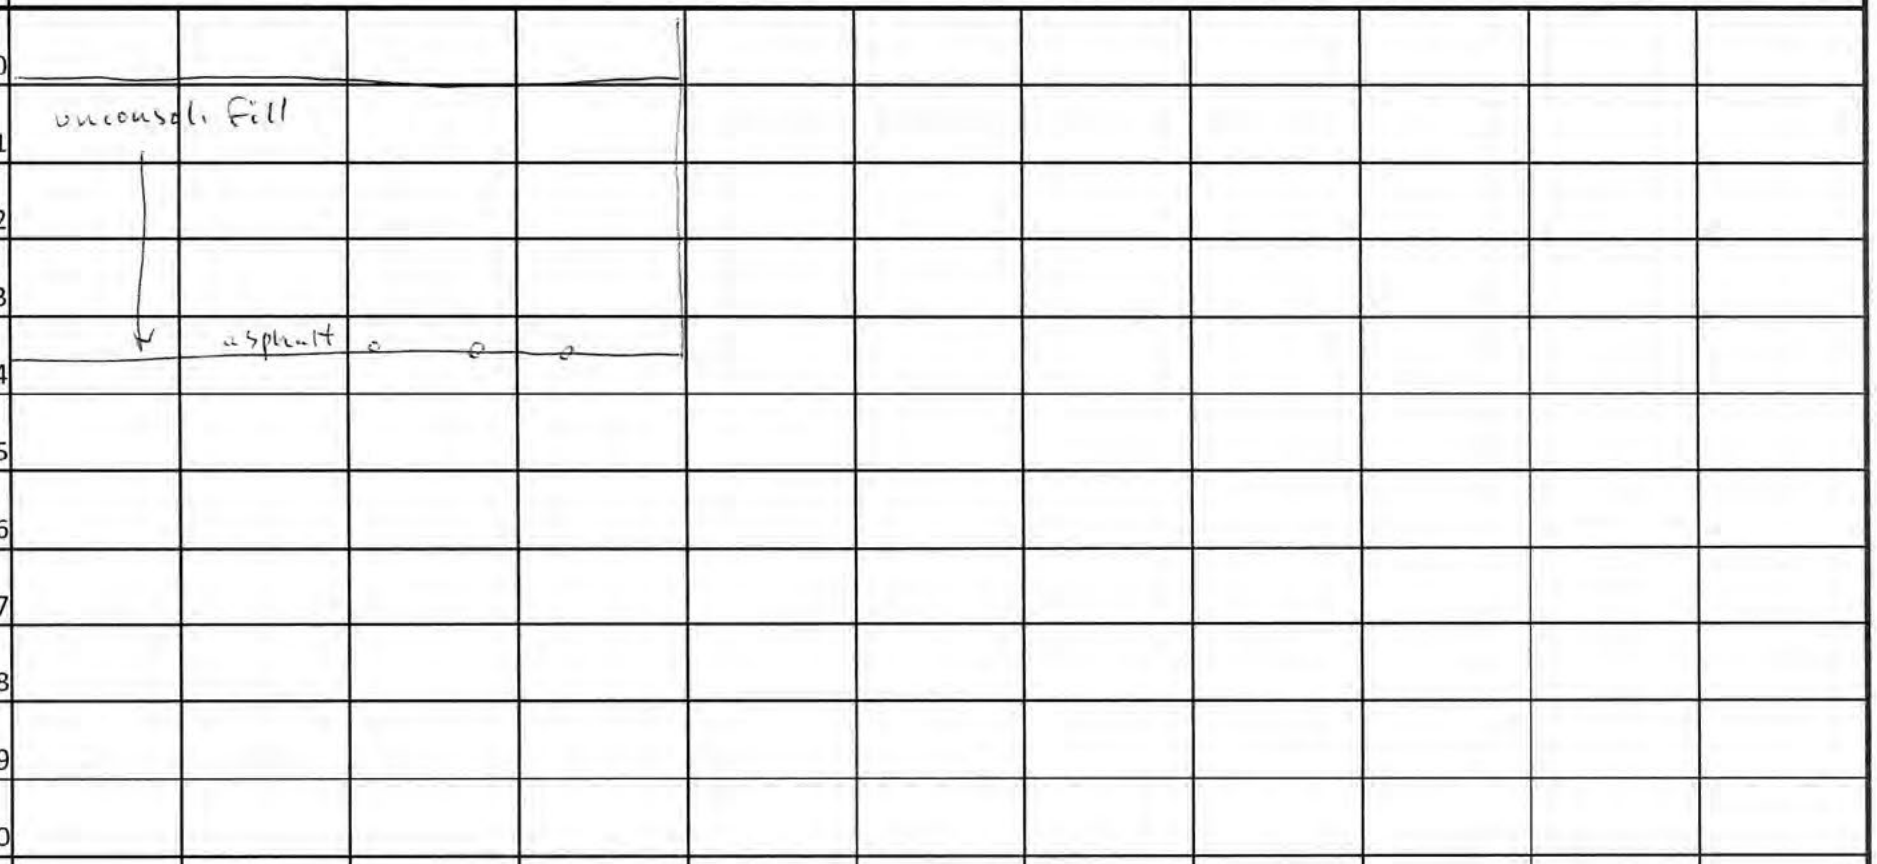
Test Pit No. IT20-51 Direction Advanced Down

USCS characterization of soils encountered: GW Sample Taken: No
