**ELIGIBILITY ASSESSMENT OF THE DURRETT HOUSE  
BUILDING 1541, FT. CAMPBELL, KENTUCKY**

**Prepared for:  
USACE Louisville District  
600 Martin Luther King Drive  
Louisville, Kentucky 40202-2232**

**Prepared by:  
Samiran Chanchani, Ph.D.  
Principal Investigator  
BHE Environmental, Inc.  
11733 Chesterdale Road  
Cincinnati Ohio 45246-3405  
513-326-1500  
[www.bheenv.com](http://www.bheenv.com)**

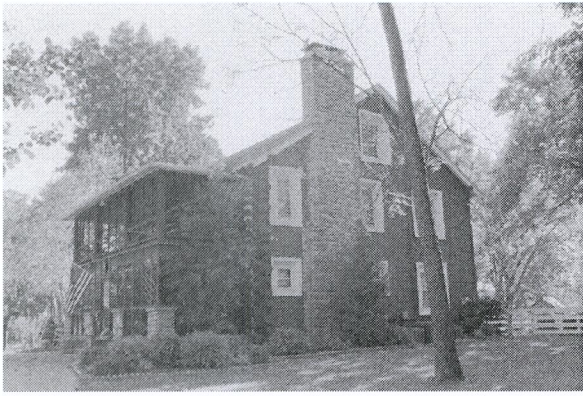
12

Durrett House is predominantly in original condition (Fig. 12), although the kitchen has been modernized (Fig. 13), air conditioning equipment and ducts installed throughout the attic space, and a slight modification made to attach a bathroom to the master bedroom on the second floor. The original two-story log building was constructed in 1932 as a single saddle notched, stacked-log assembly. The chestnut logs are dressed round logs ranging in thickness with the largest diameter logs nearest the base of the building (Fig. 14). This round log style of building is typical of recreational cabins built in this and later eras, but is unlike the preferred style of log construction utilized by most of this area's pioneer builders who hewed the logs square to allow for subsequent siding and interior plaster applications. Some theorists speculate that most pioneer cabins were clad to protect the logs. Others believe it was to conceal the log construction of their homes and render them more aesthetically and socially acceptable. This later theory also would explain the use of lath and plaster to cover the interior walls.

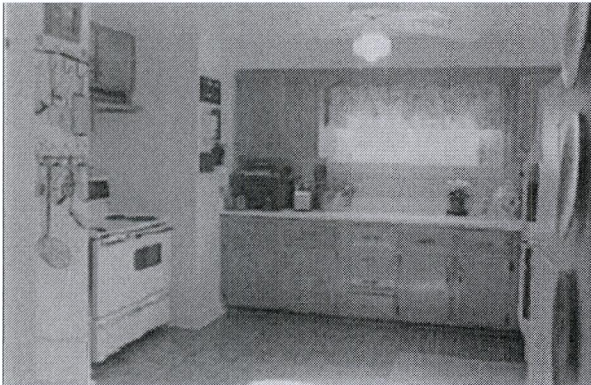
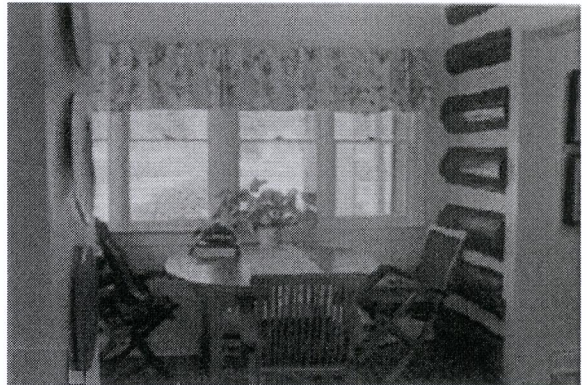
The only major modification to the original design seems to be the changes to the kitchen, which has resulted in a larger and more functional design. Minor alterations to the second floor bathroom, connecting it to the master bedroom, are, likewise, functional changes improving the livability of the home.
