ROCKY MOUNTAIN ARSENAL

ANNUAL COVERS REPORT FOR INTEGRATED COVER SYSTEM 2023

**Revision 0
November 15, 2023**

**U.S. Department of the Army
Shell Oil Company**

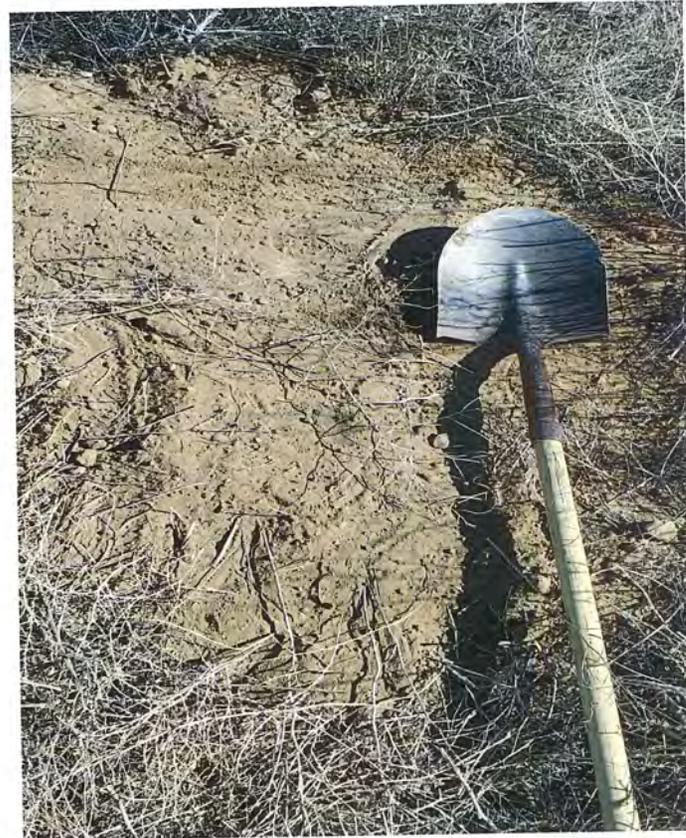
Photo 1

- There were observations of holes approximately 3" deep by 6-8" wide along all the transect routes. These holes were backfilled with existing soil when encountered and not recorded as open inspection items. See attached Photos 1 and 2 for examples of these holes.
- There was an observation of a bare area at Waypoint KH0001 on the east transects. This area was located on a patch of ICS that had successfully burned in the prescribed burn conducted by the USFWS in October of 2022. This area is not considered an open inspection item due to the fact the vegetation is still mostly dormant but was marked with GPS to continue to inspect for growth. Please see attached Photo 3.
