ROCKY MOUNTAIN ARSENAL

2022 RCRA Landfills and Groundwater Monitoring Report

**Revision 0
June 17, 2022**

**U.S. Department of the Army
Shell Oil Company**

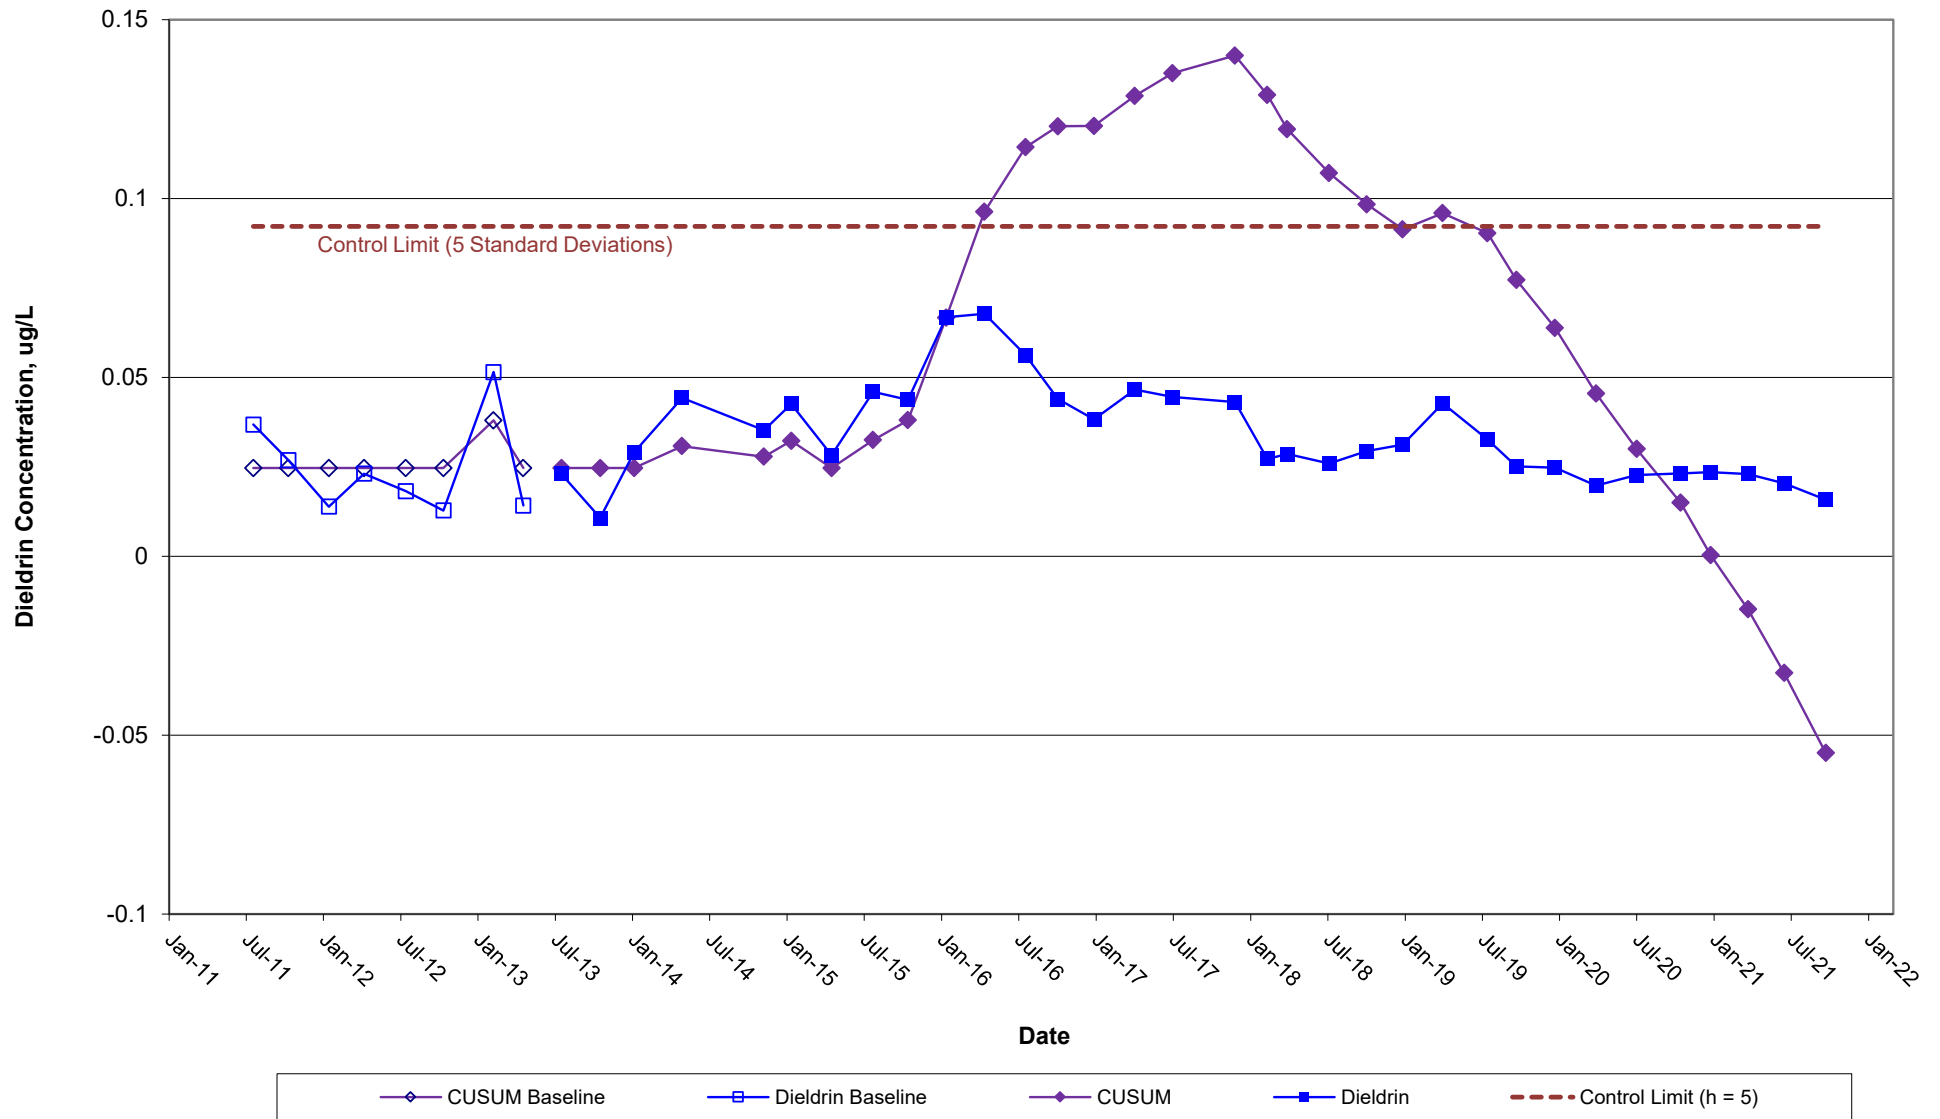
Figure 3.1-1
Shewhart-CUSUM Control Chart
for Dieldrin Concentrations in HWL Well 25194

Figure 3.1-1 shows that the dieldrin concentrations began to decrease after April 2016, although the CUSUM continued to increase. Groundwater levels appear higher in well 25194, beginning in July 2015, which may have mobilized residual contamination that the Army believes existed prior to construction of the HWL. In 2021, measured dieldrin concentrations did not exceed the control limit, and the calculated CUSUM only exceeded the control limit in the sample collected in April 2019 as the CUSUM has generally been decreasing since December 2017.

Interpretation of the current control chart shows an apparent decreasing trend, as is also evident in measured concentrations, because the calculated CUSUM is less than the control limit (Figure 3.1-1). Fluctuations in dieldrin concentrations may indicate variability related to the water level changes. Additionally, the recent dieldrin concentrations in well 25194 are higher than those measured in LDS3 during the post-closure period, which is the nearest LDS sump to well 25194, indicating that the sump is not a likely source of groundwater contamination in this well.
