ROCKY MOUNTAIN ARSENAL

2023 RCRA Landfills and Groundwater Monitoring Report

**Revision 0
June 21, 2023**

**U.S. Department of the Army
Shell Oil Company**

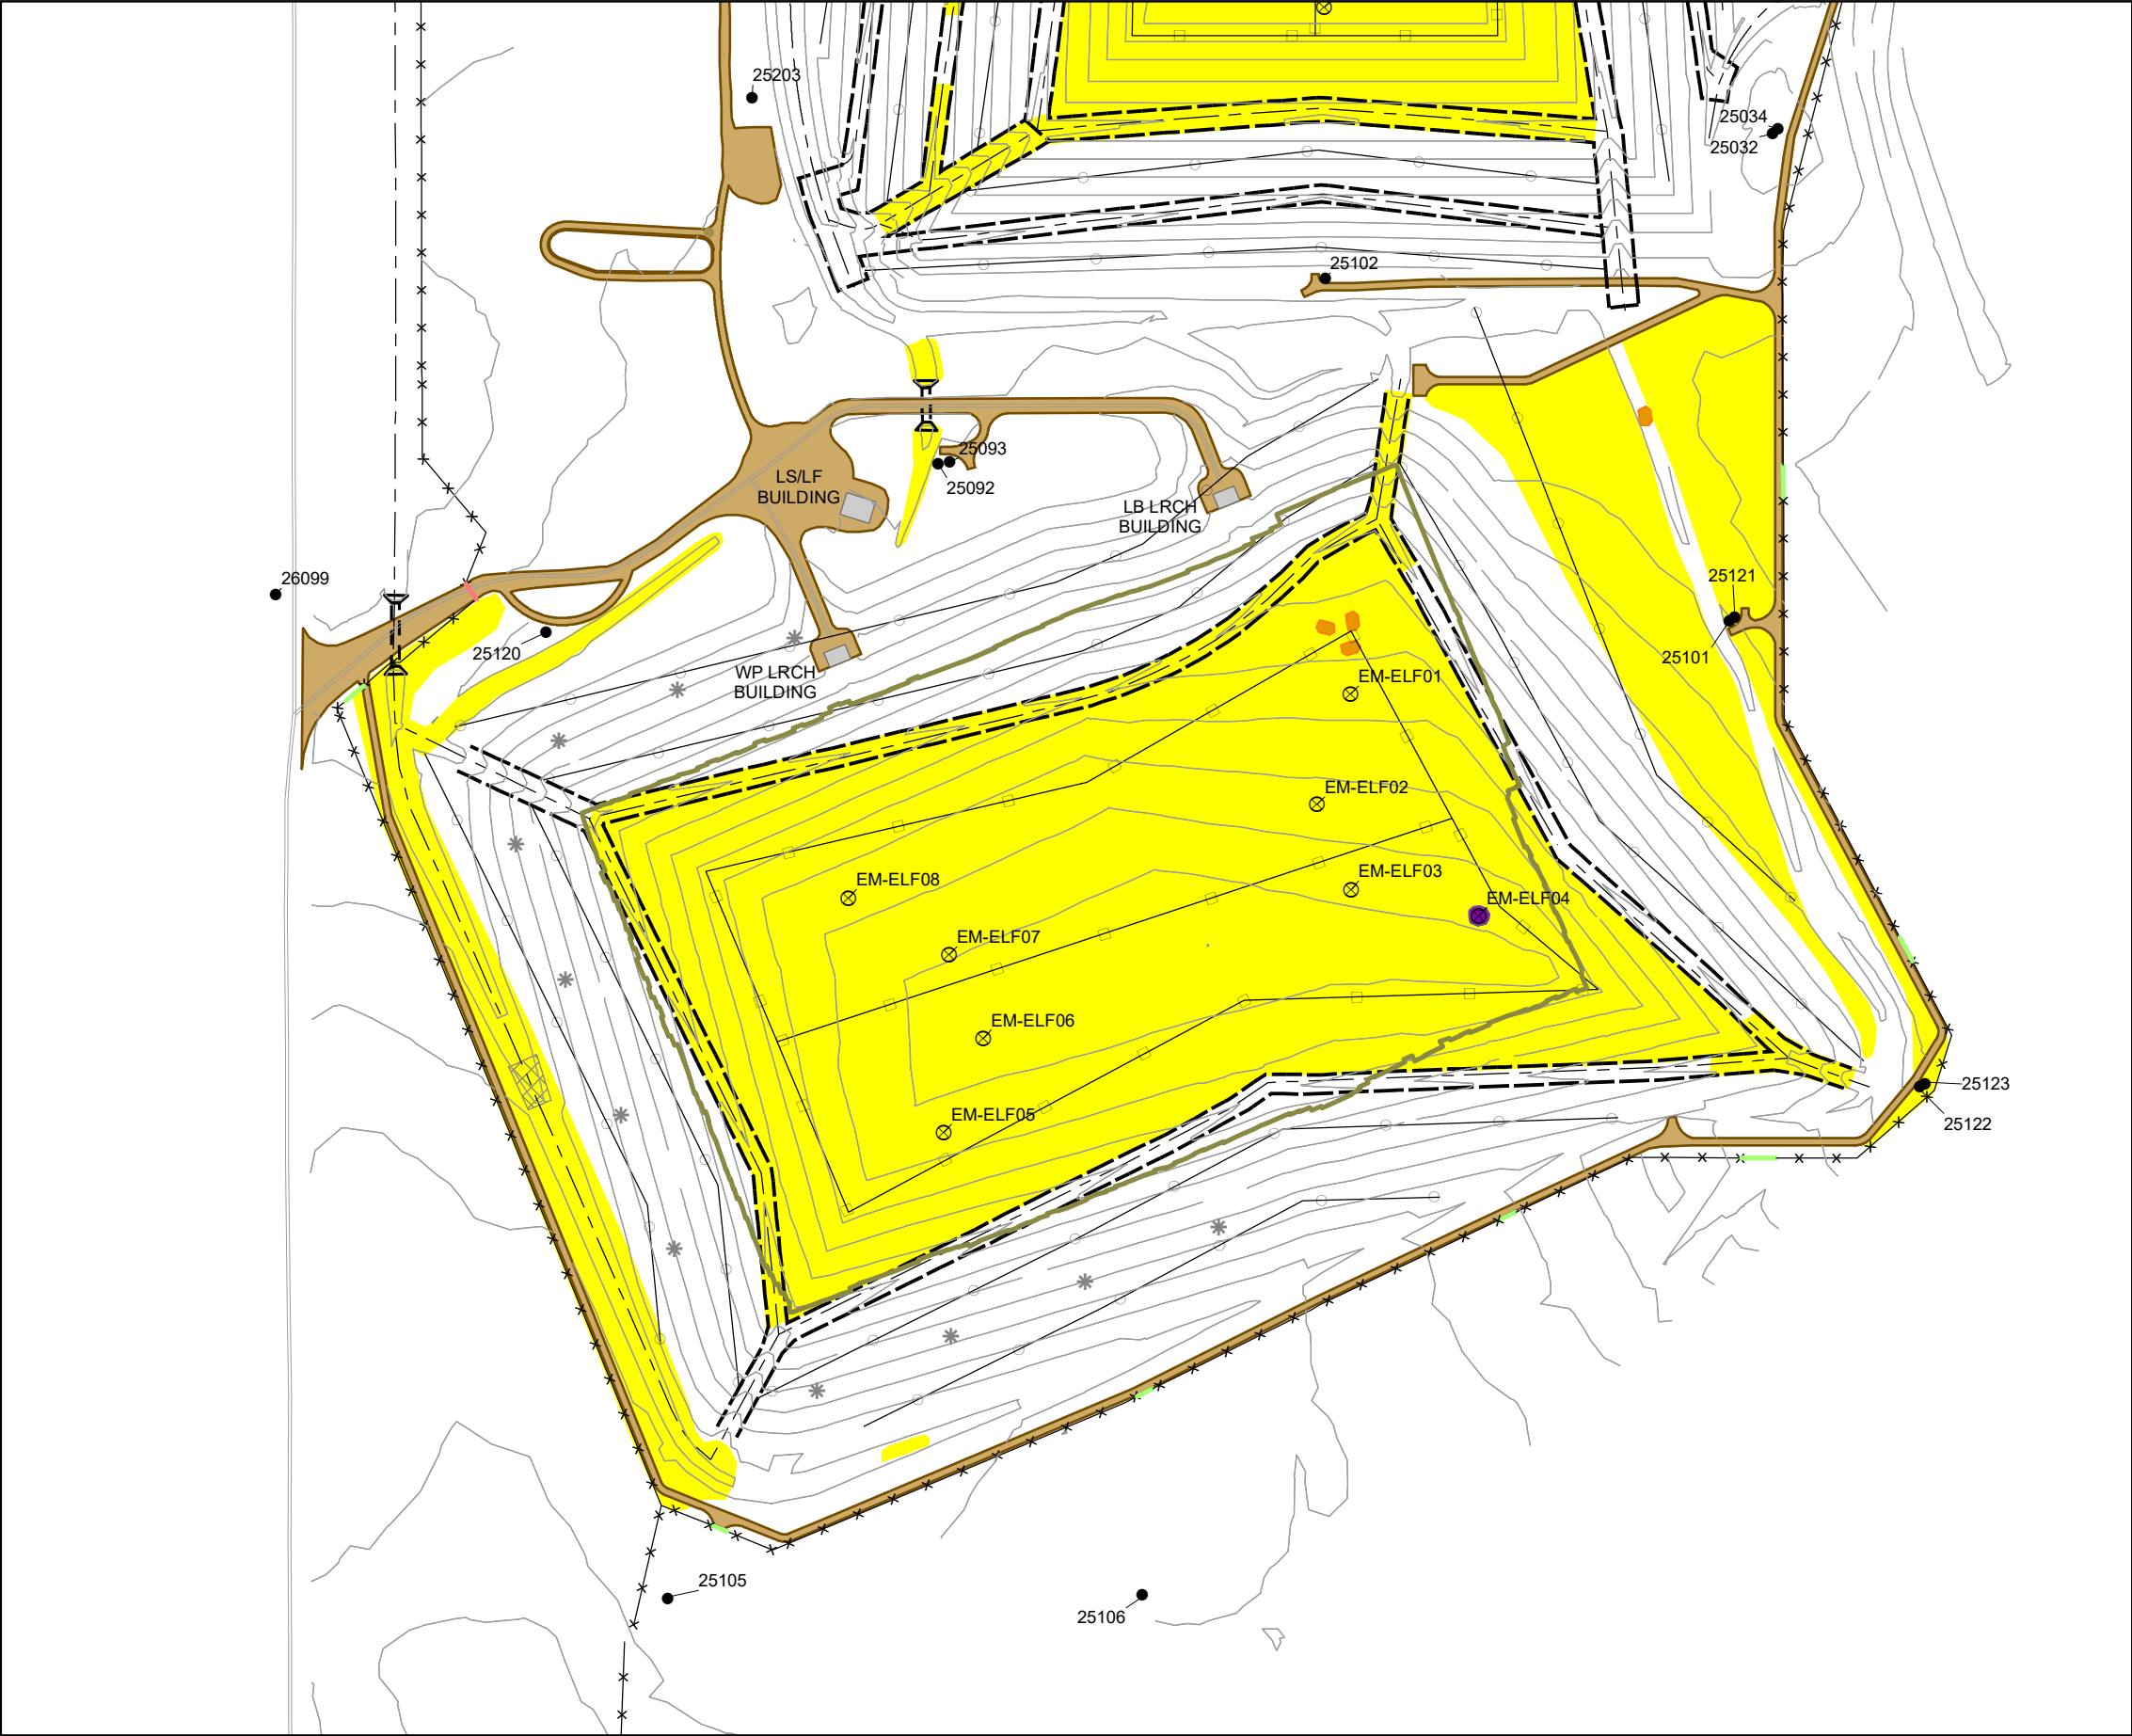
Figure 5.2-1

The OMC Inspectors also recognized weedy species during routine vegetation inspections often performed independently of the Type I and Type II inspections. Documentation of ELF maintenance activities are provided in Appendix C-2 of this report. The locations of maintenance actions are illustrated on Figure 5.2-1.

2023 Enhanced Hazardous Waste Landfill
Routine Maintenance Activities

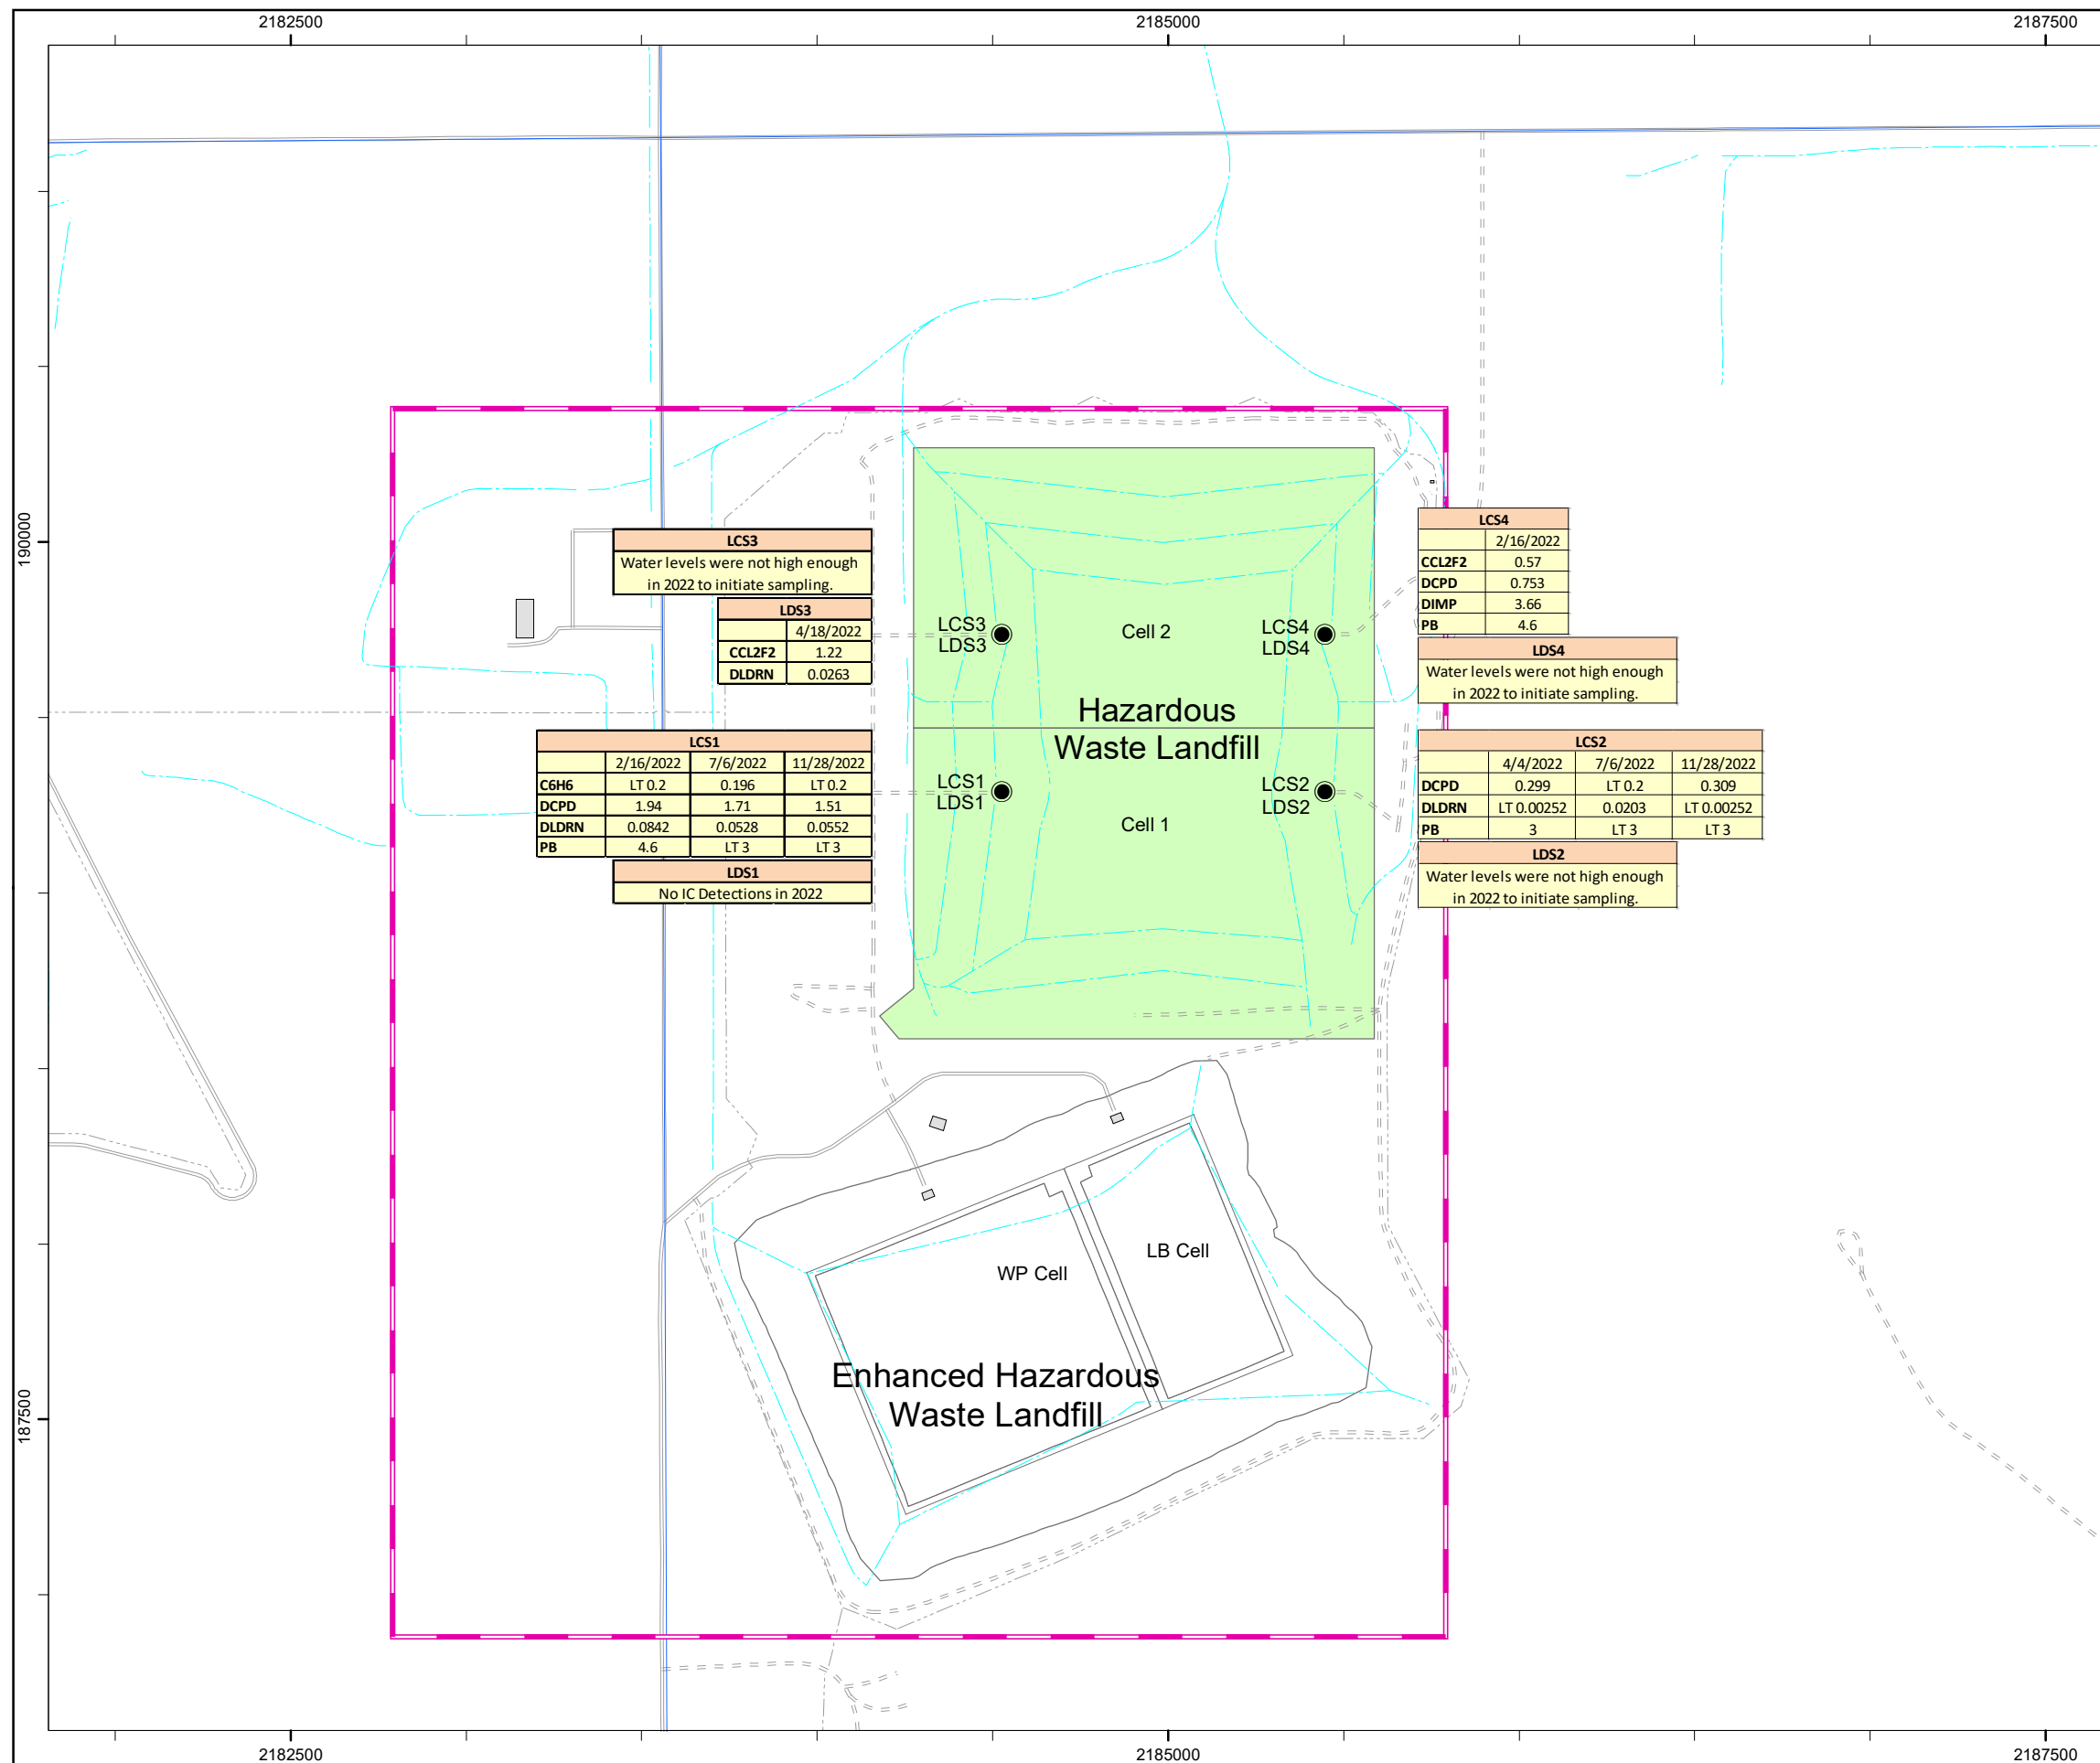
Figure 2.3-2

The samples were collected from the LDS to meet the post-closure monitoring requirements specified in the HWL PCGMP (Navarro 2019b) and were used to evaluate the chemistry of the wastewater to determine potential leakage from the HWL. The ICs detected in the HWL sumps are presented in Figure 2.3-2. Analytical results from the 2022 sampling events at the LCS and LDS sumps are included in the Supporting Documentation Investigative Data subfolder.

Indicator Compounds Detection Map
2022 HWL Leachate Collection and
Leak Detection Systems

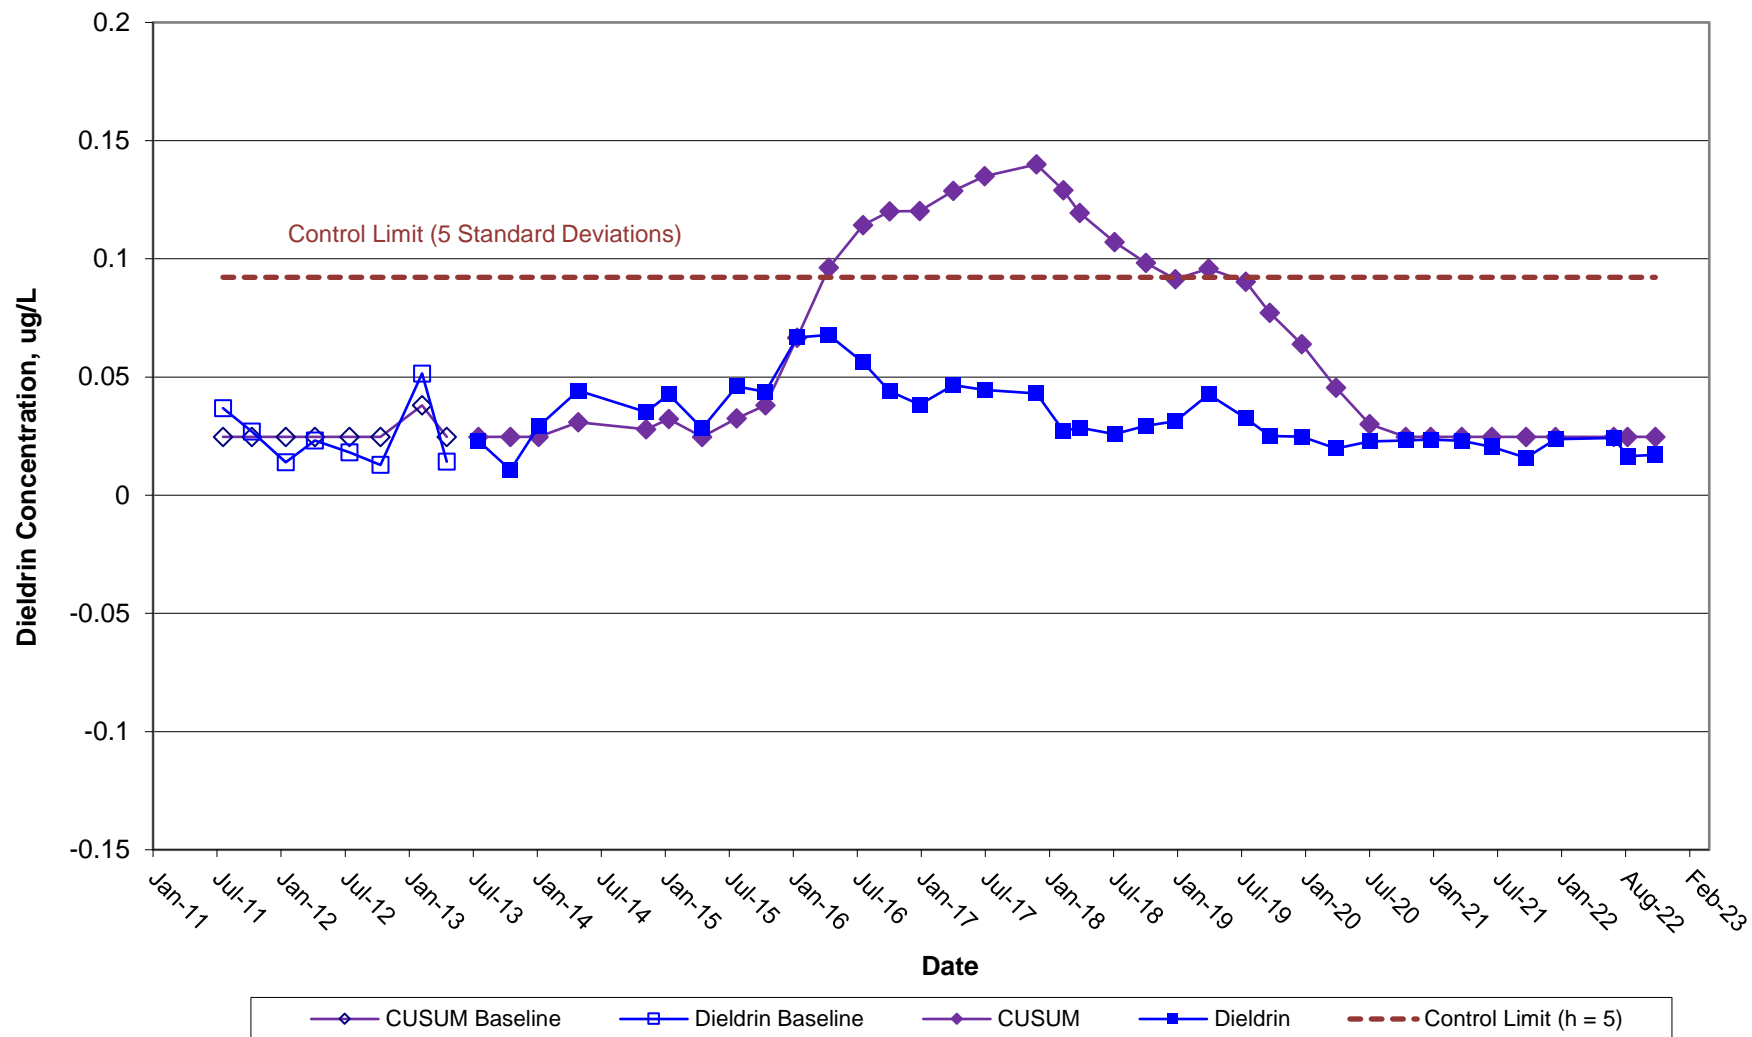
2.2 Areas of poor vigor, disease, over grazing, stress, burned, or discoloration greater than 100 square feet			✓			✓	N/A	
3.0 Engineering and Access Controls

Further evaluation of dieldrin included an intrawell comparison performed using a combined Shewhart-CUSUM control chart to determine whether the HWL impacted the presence of dieldrin in groundwater at well 25194. The plotted data were collected quarterly from July 2011 through October 2022, with the initial eight dieldrin samples in well 25194 used as the baseline. The baseline data were determined to be from a normal distribution with no outliers. These data were used to calculate the cumulative sum (CUSUM) and control limit. The EPA guidance, *Statistical Analysis of Groundwater Monitoring Data at RCRA Facilities, Unified Guidance* (EPA 2009), recommends using a control limit equal to five (h=5) standard deviations above the mean value for baseline data. The combined Shewhart-CUSUM control chart for dieldrin is included as Figure 3.1-1.

Figure 3.1-1 shows that the dieldrin concentrations began to decrease after April 2016, although the CUSUM continued to increase. Groundwater levels appear higher in well 25194, beginning in July 2015, which may have mobilized residual contamination that the Army believes existed prior to construction of the HWL. In 2022, measured dieldrin concentrations did not exceed the control limit, and the calculated the CUSUM has generally been decreasing since December 2017.

Interpretation of the current control chart shows an apparent decreasing trend, as is also evident in measured concentrations and the calculated CUSUM, which is less than the control limit (Figure 3.1-1). Fluctuations in dieldrin concentrations may indicate seasonal variability related to the water level changes. Additionally, the 2022 dieldrin concentrations in well 25194 are lower than those measured in LDS3 during the post-closure period, which is the nearest LDS sump to well 25194, indicating that the sump is not a likely source of groundwater contamination in this well.
