ROCKY MOUNTAIN ARSENAL

2024 RCRA Landfills and Groundwater Monitoring Report

**Revision 0
June 20, 2024**

**U.S. Department of the Army
Shell Oil Company**

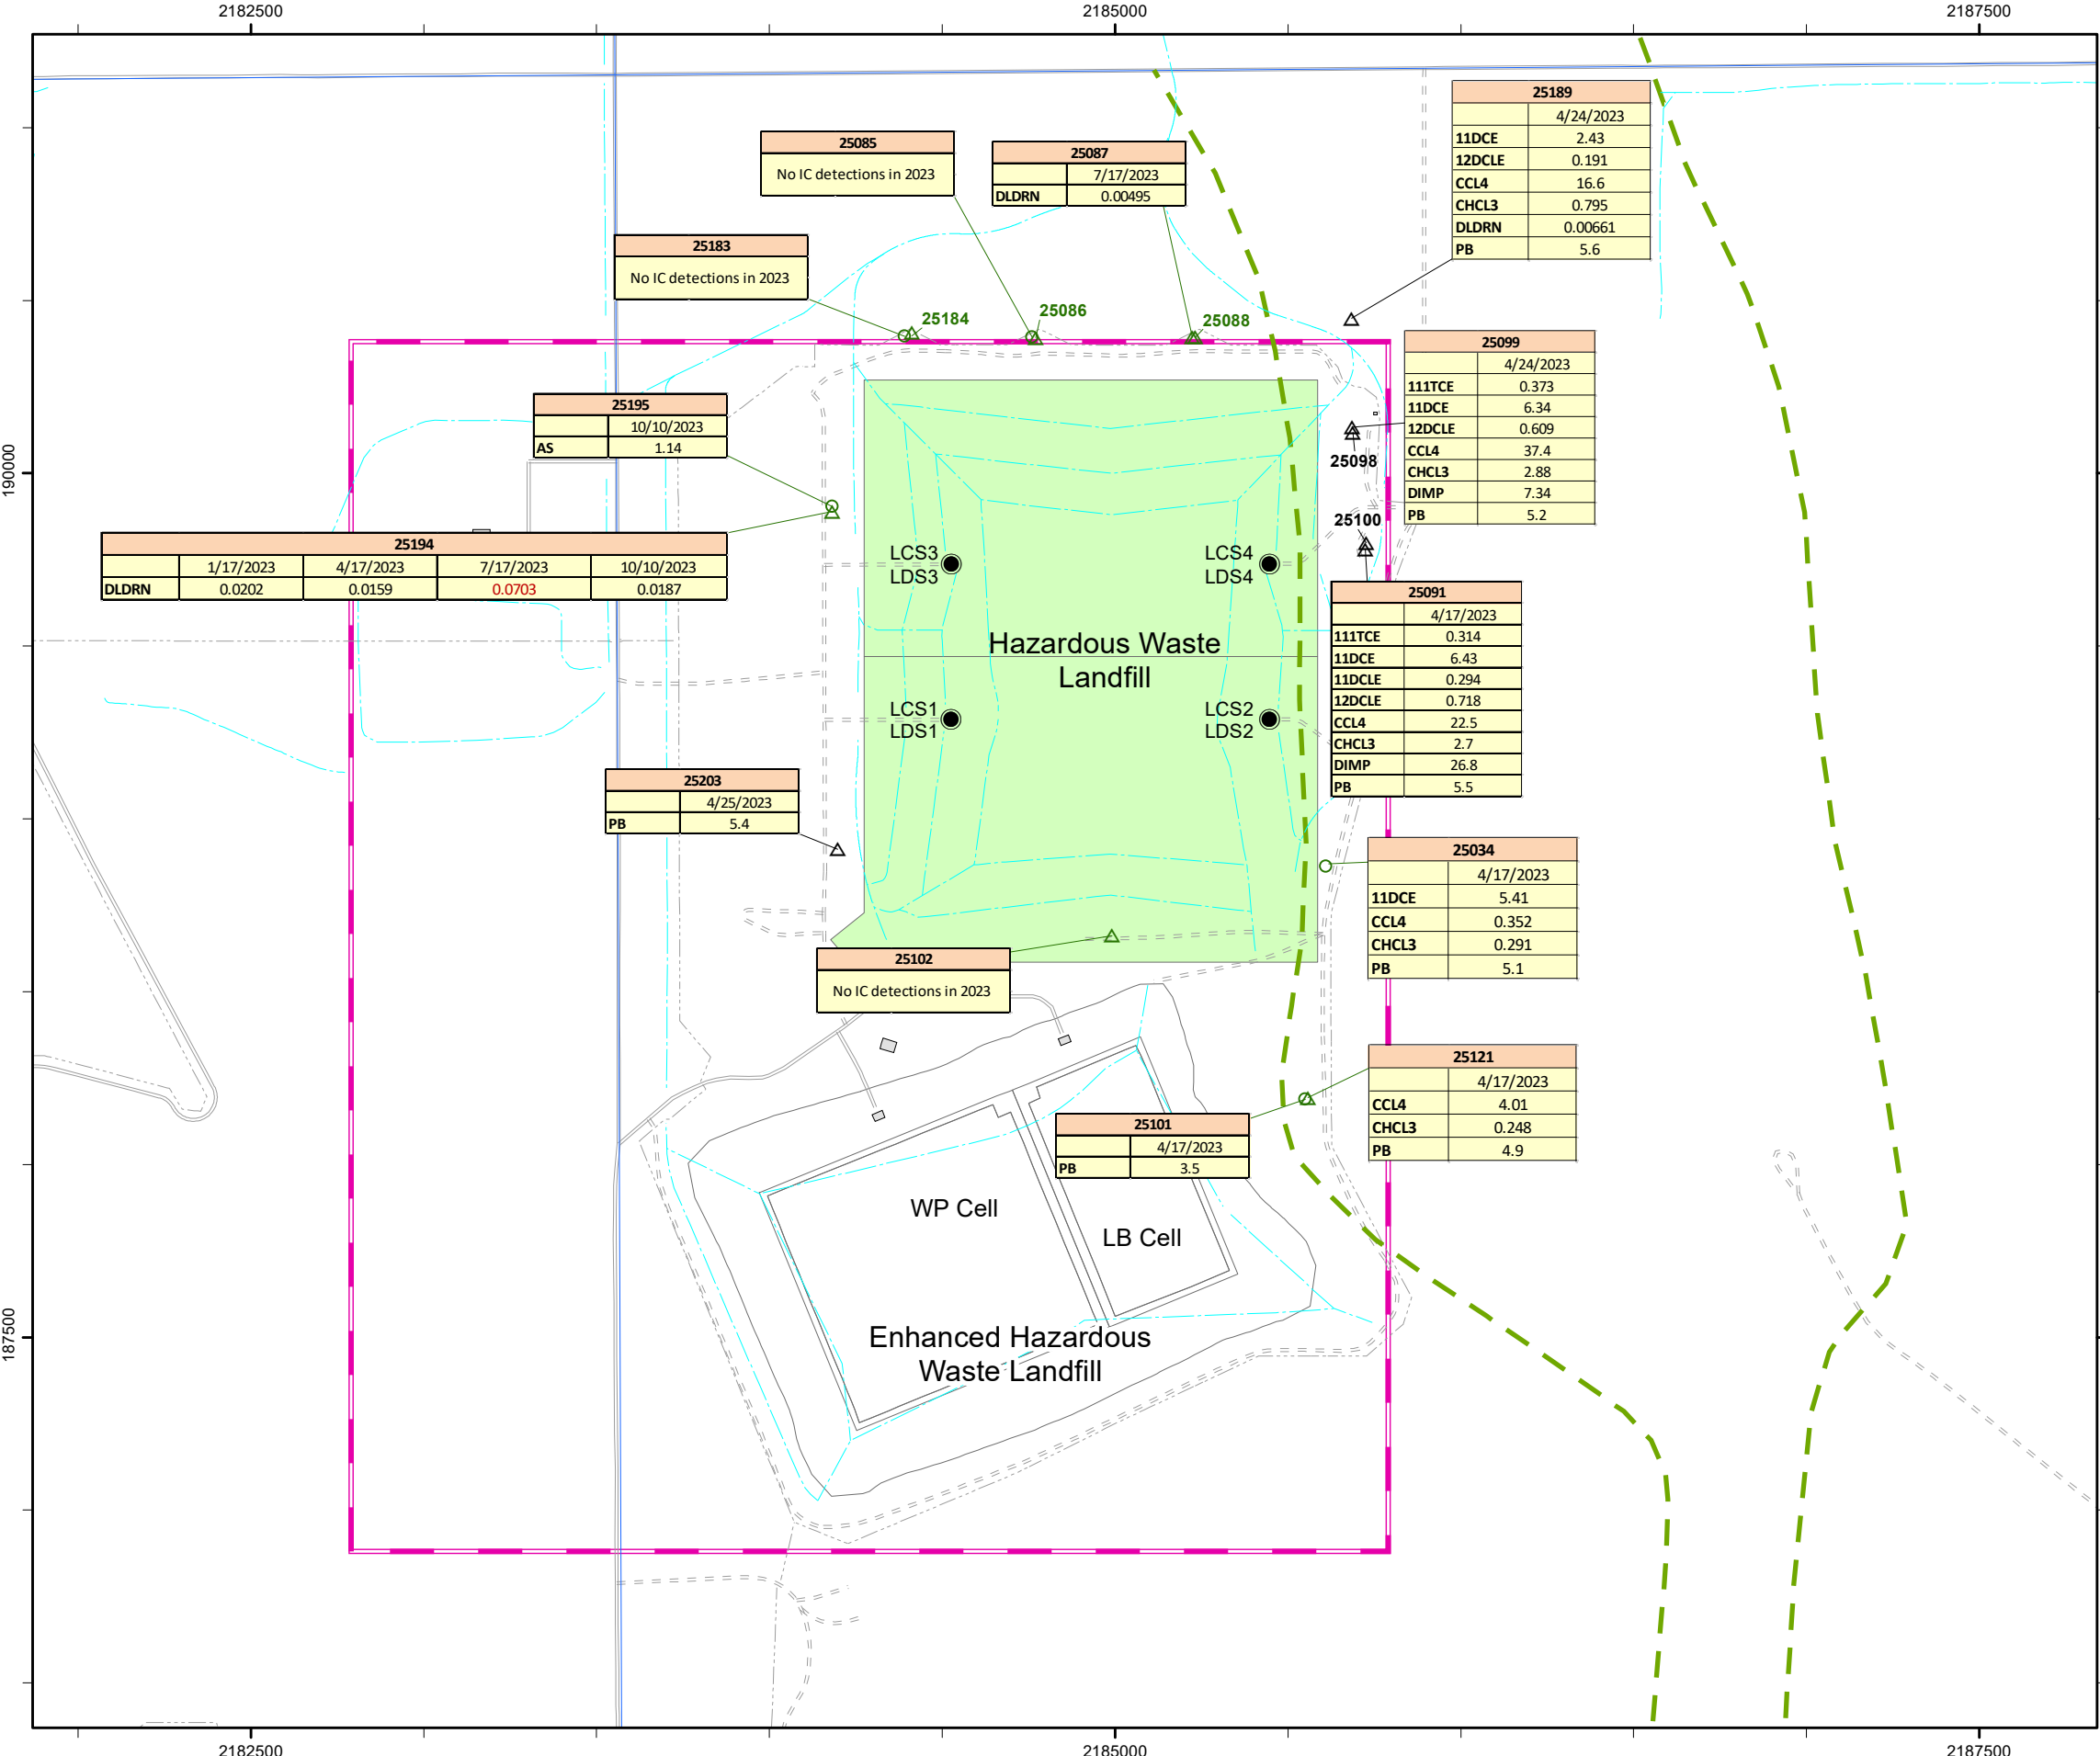
The ICs detected in wells downgradient of the HWL are listed on Figure 2.3-1 with their respective concentrations and sample dates. Arsenic was the only IC detected in the downgradient CFS wells (25195 only). Dieldrin was the only IC detected in the downgradient UFS wells (25087 and 25194). Refer to Section 3.1 for a description of potential sources of dieldrin in well 25194.

While dieldrin was detected in well 25087 at a concentration less than the prediction limit, in well 25194 concentrations ranged from 0.0159 to 0.0703 µg/L. The dieldrin concentration in the sample collected in July 2023 was 0.0703 µg/L, which exceeded the prediction limit of 0.05 µg/L. However, the concentration decreased to below the prediction limit in October 2023 (Figure 2.3-1).
