# **ROCKY MOUNTAIN ARSENAL**

## **ANNUAL COVERS REPORT FOR INTEGRATED COVER SYSTEM 2025**

**November 17, 2025**

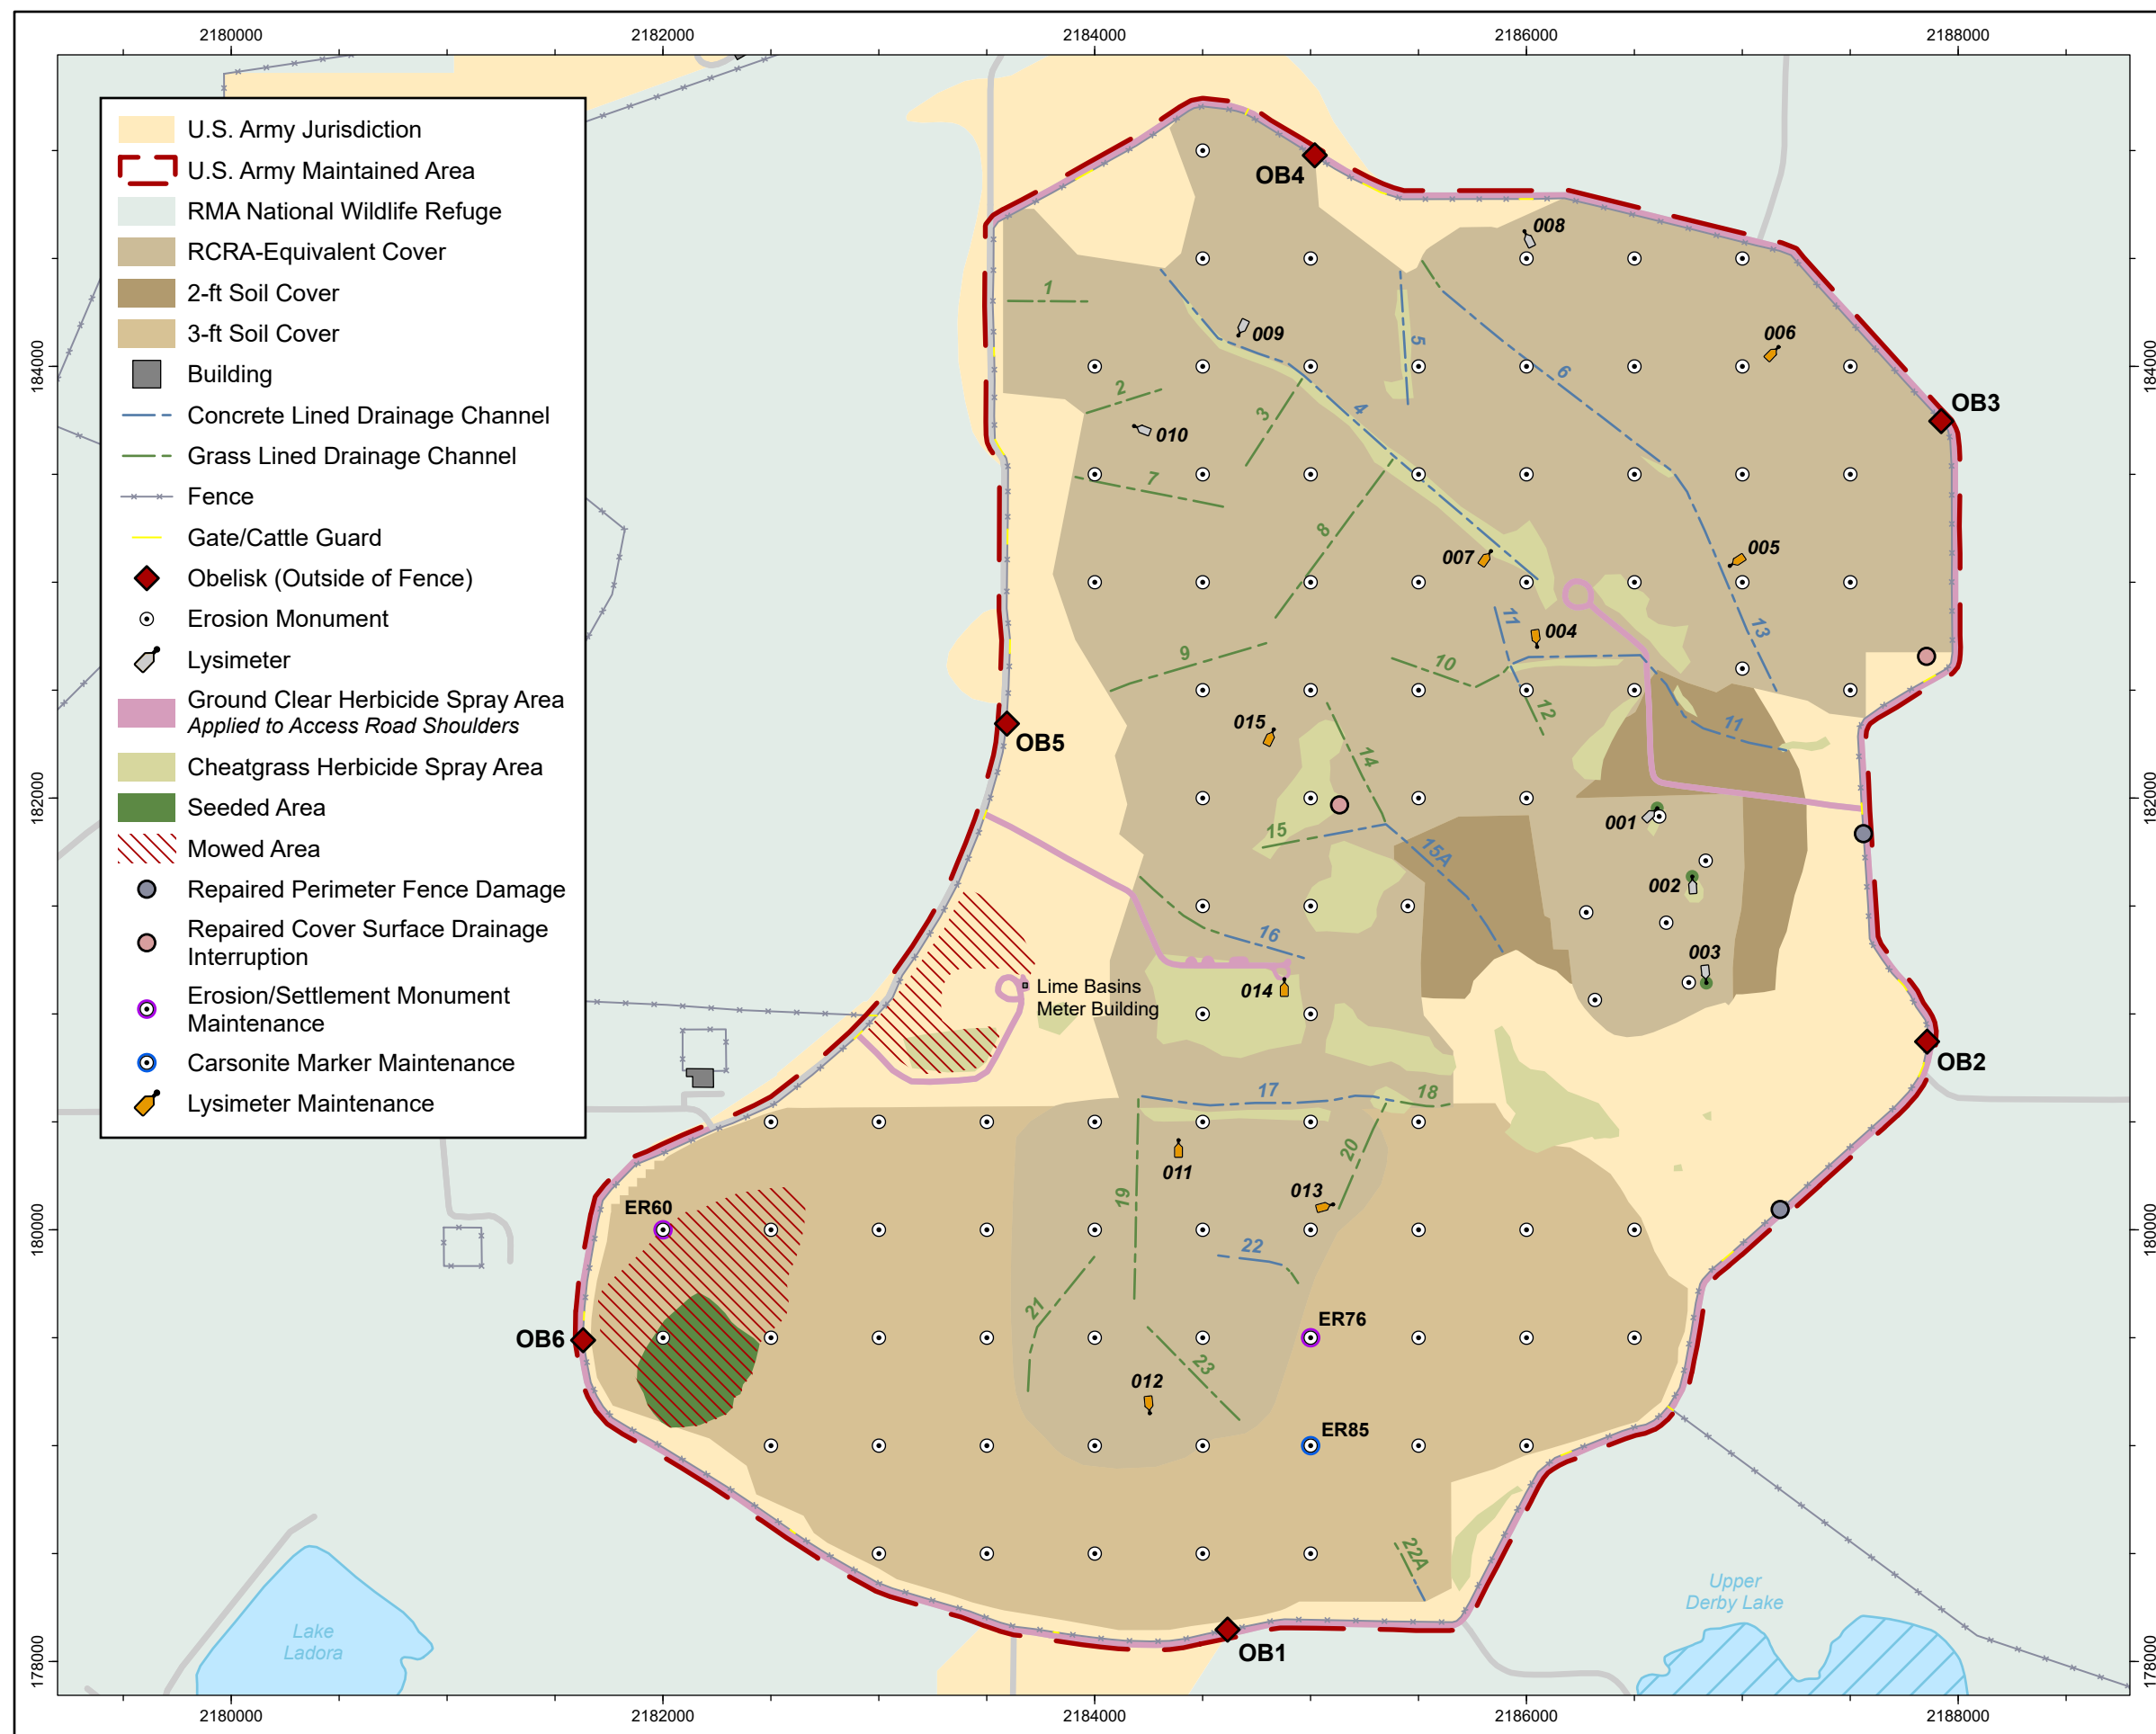
**FIGURE 2.0-1**  
2025 Integrated Cover System  
Maintenance Activities

- (1) The outside shoulder of the Integrated Cover System (ICS) Perimeter Access Road defines the U.S. Army Maintained Area (AMA) boundary.
- (2) The ICS Perimeter Access Road was maintained by a motor grader as needed.
- (3) Ground Clear Herbicide was applied to both shoulders of the ICS Perimeter Road at a width of 2-ft or 5-ft depending on the area. Herbicide was not applied to the interior of the roadway.
- (4) Only Erosion/Settlement Monuments that underwent maintenance are labeled.
- (5) ER60 underwent both Erosion/Settlement Monument and Carsonite Marker maintenance.
