**Building 214, Fort Myer**  
77,310 SQFT

## **Attachment A: Photographs**

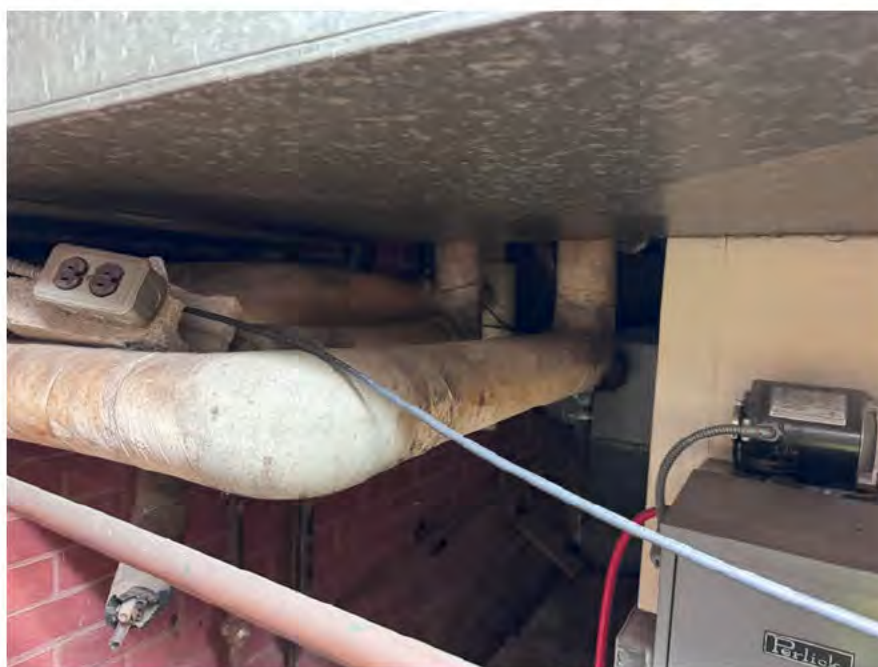
Photo 2: White mastic on TSI in Mech. Room 034 (Sample #2).

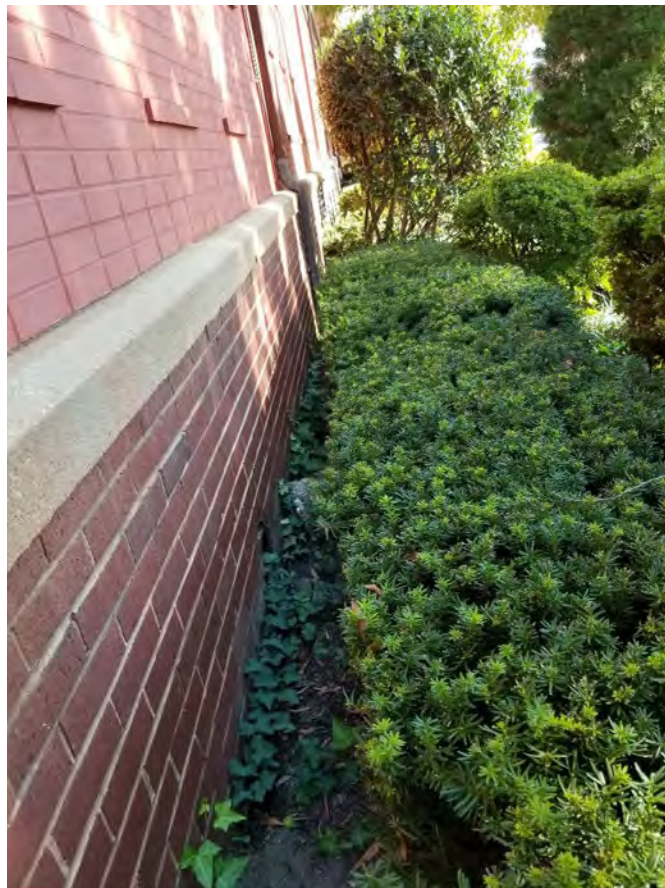
Hedges blocking access to roof drains

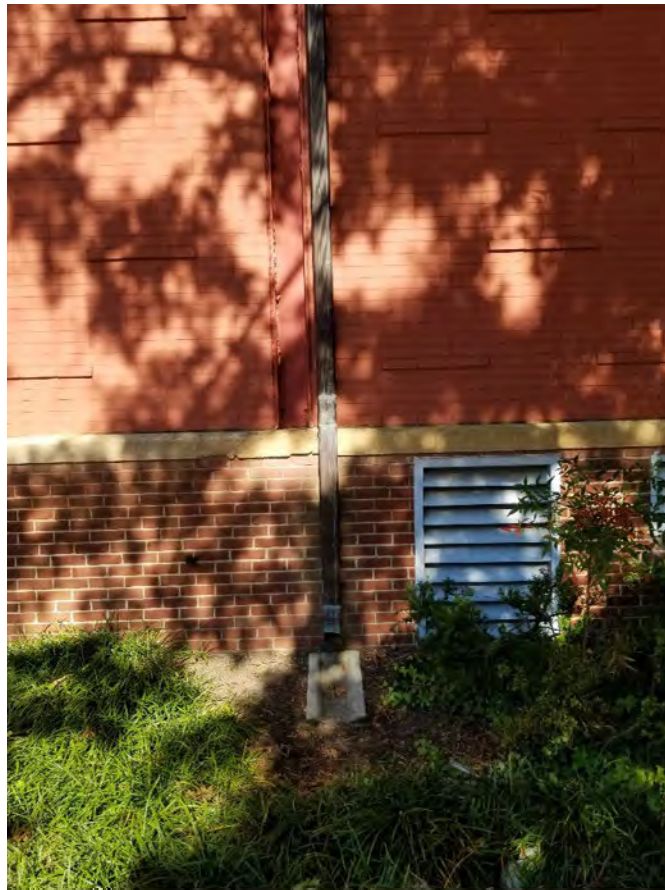
Air intake at grade adjacent to downspout

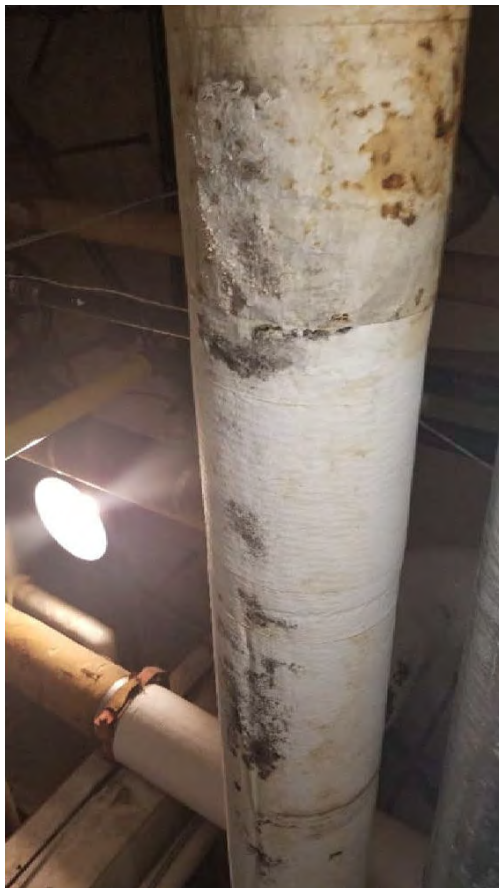
Mold on fiberglass pipe insulation

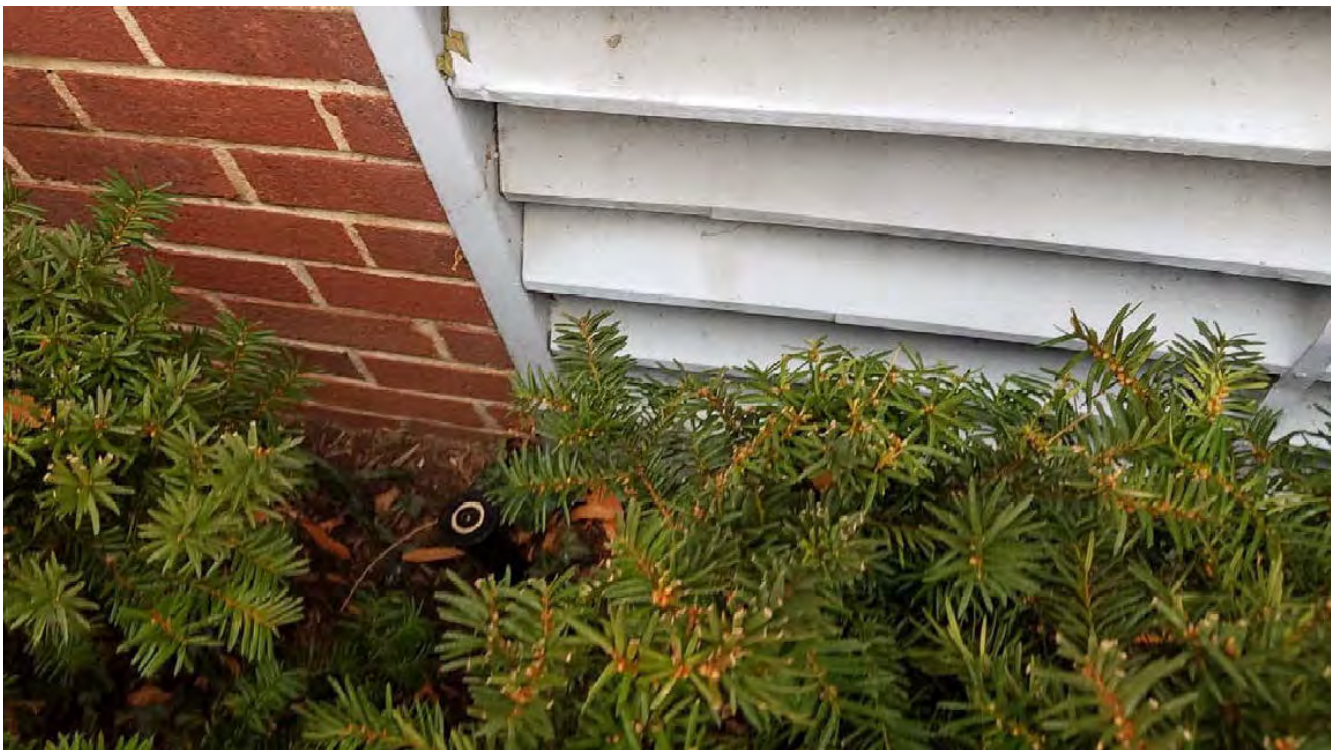
Outside Air Intake at Grade with Irrigation Head in Front of It

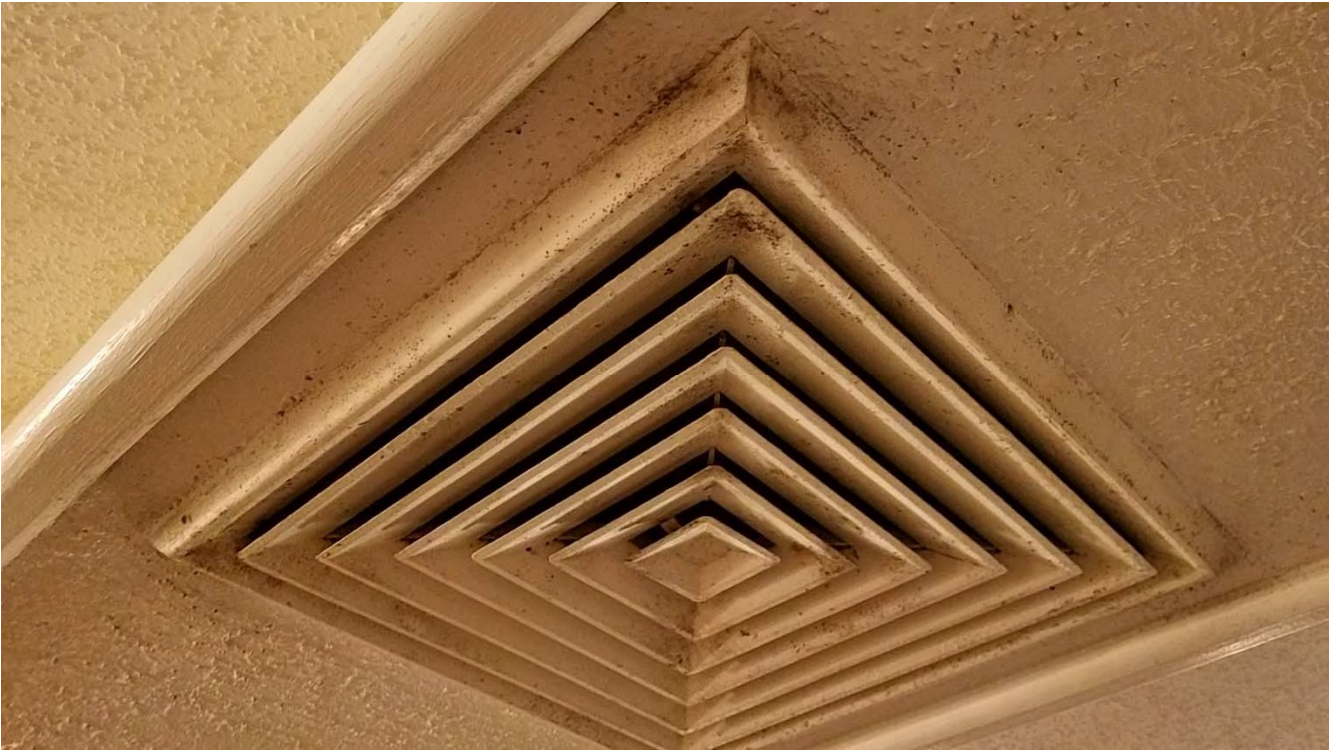
Lamplighter Dining Room Air Diffuser

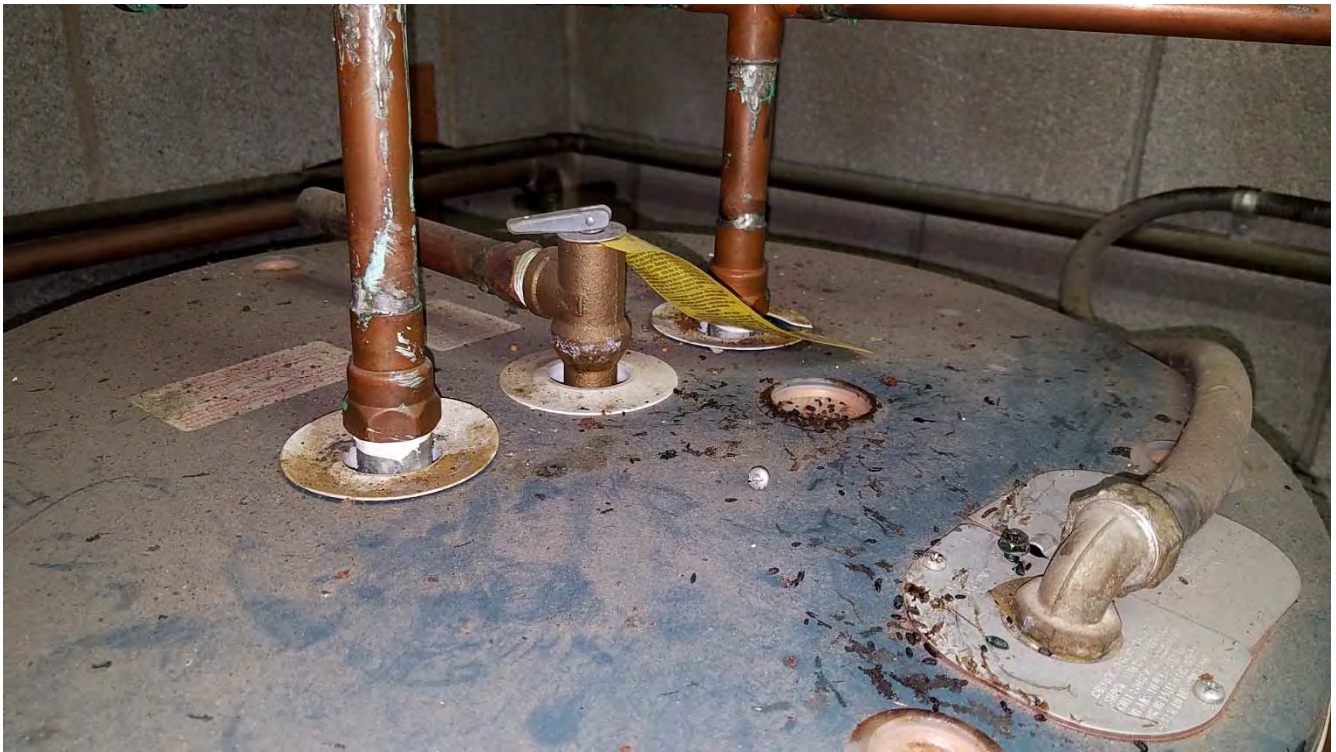
Bathhouse Women's Room Water Heater with Rodent Feces

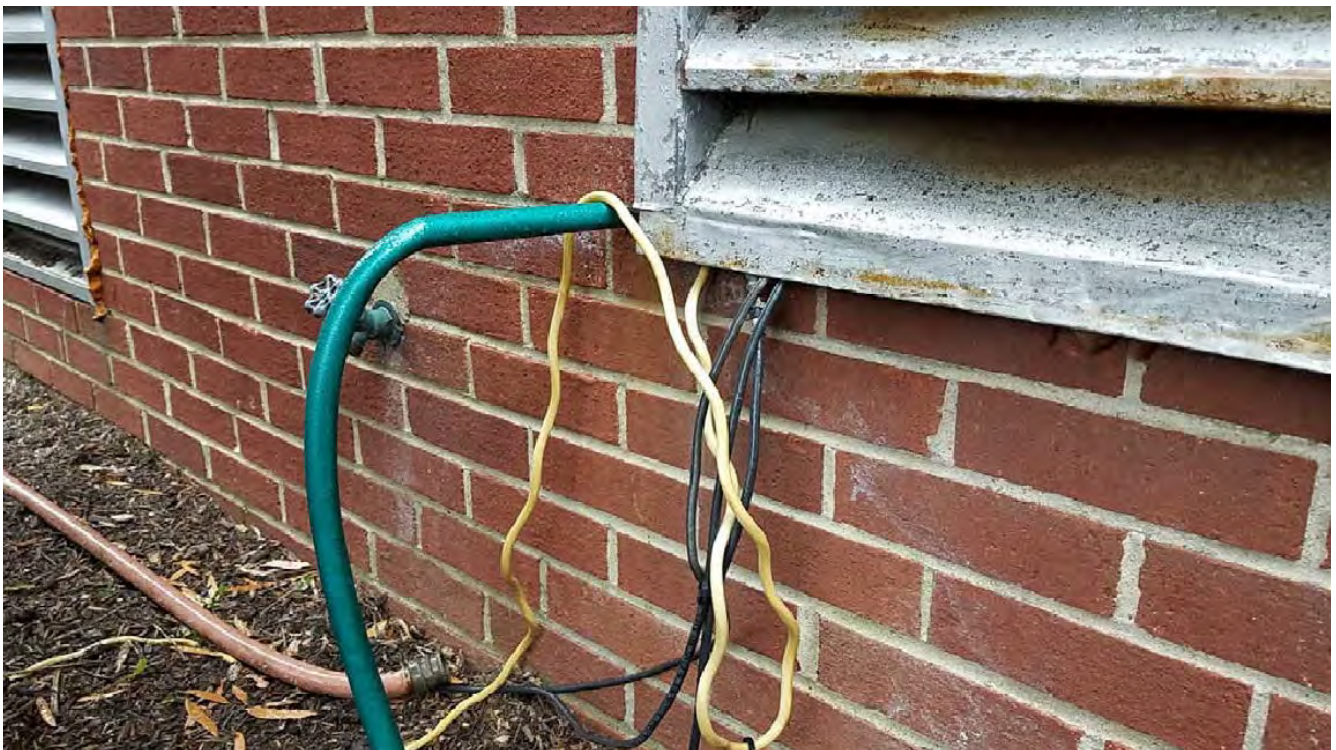
Bathhouse HVAC Louver – Possible Point of Entry for Rodents

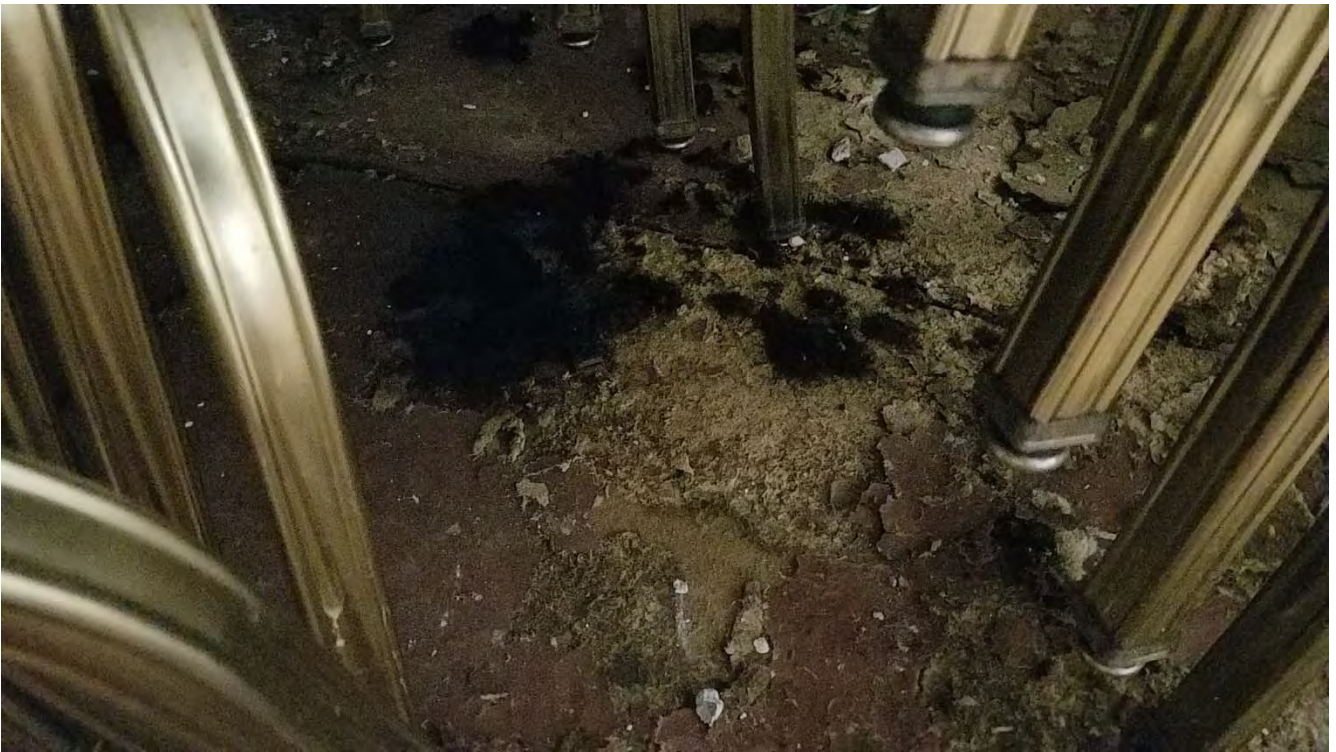
Coat Check Mechanical Room Mold Growth on Floor
